ENBRIDGE GAS DISTRIBUTION INC. POST-CONSTRUCTION ENVIRONMENTAL MONITORING REPORT NO. 1

TORONTO PORTLANDS REINFORCEMENT PROJECT: NORTH END EB-2006-0305

Prepared by Enbridge Gas Distribution Inc. April 9, 2009

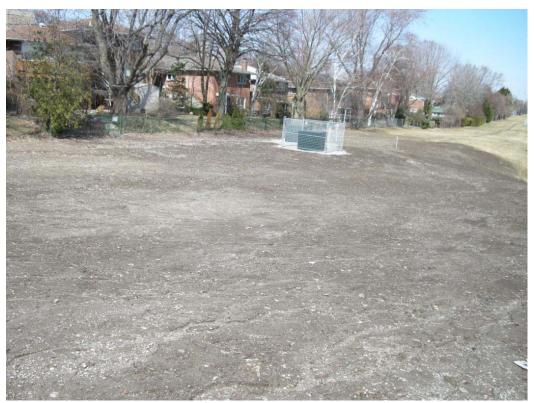
Vegetation has re-established along the majority of the Hydro ROW and Wexford Soccer Fields where it was disturbed due to construction. However, the Hydro ROW north of Sheppard Avenue and east of the Enbridge Jonesville District Station are yet to be restored. These sections will require monitoring over the next year to identify the success of re-vegetation efforts and to identify areas that will require further efforts.

Photo 1 – Looking north at Hydro ROW north of Sheppard Avenue (to be restored)

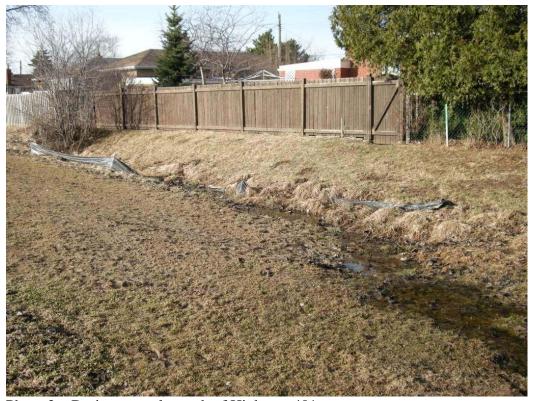
Photo 2 – Drainage swale south of Highway 401

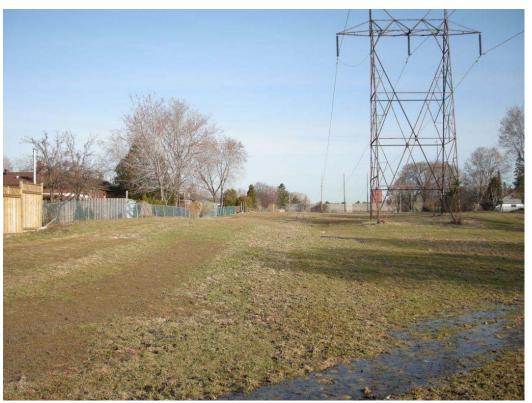
Photo 3: Looking north, south of Highway 401

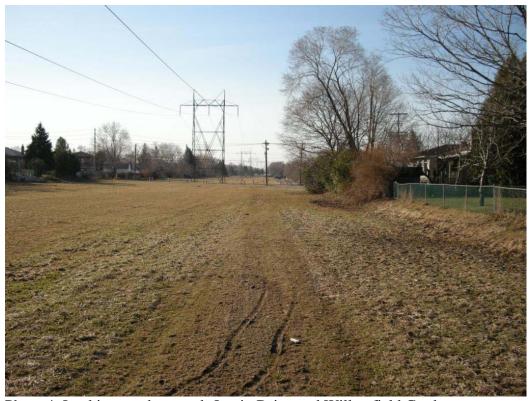
Photo 4: Looking south towards Lupin Drive and Willowfield Gardens

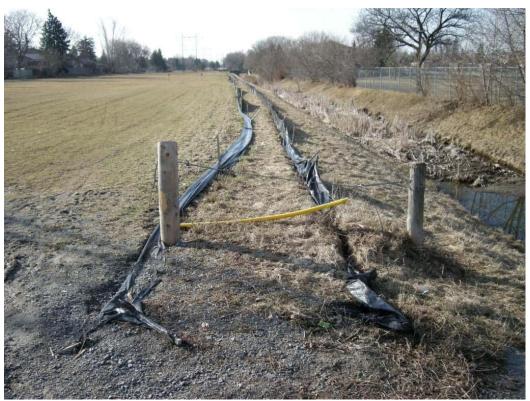
Photo 5 – Looking south along Massey Creek from Lupin Drive

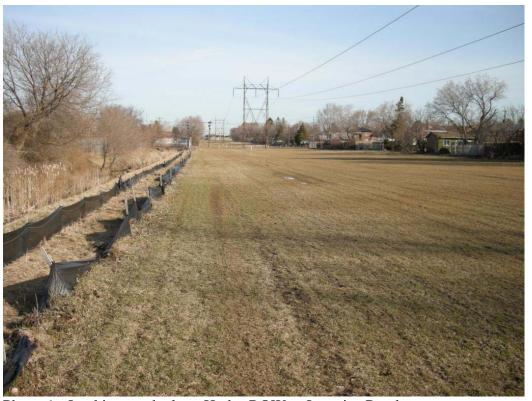
Photo 6 – Looking north along Hydro ROW at Japonica Road

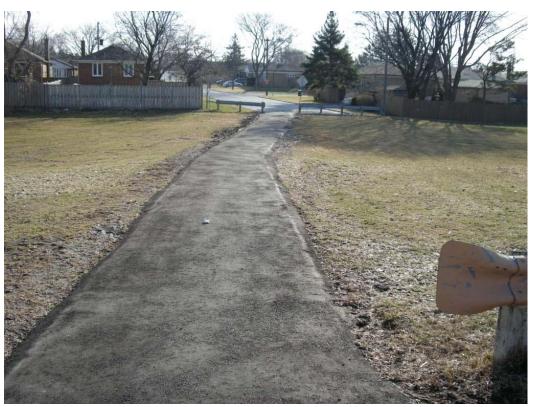
Photo 7 – Restored asphalt pathway at Japonica Road (looking east).

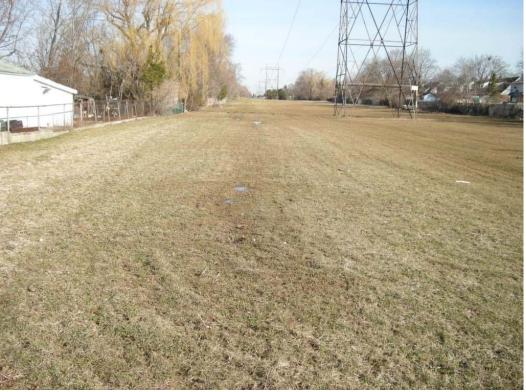
Photo 8 – Looking north along Hydro ROW from Brian Avenue

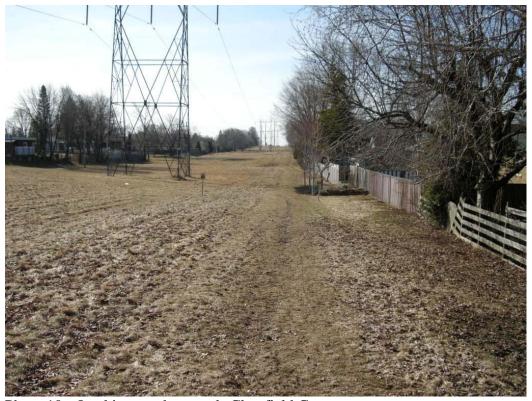
Photo 10 – Looking south towards Clearfield Gate

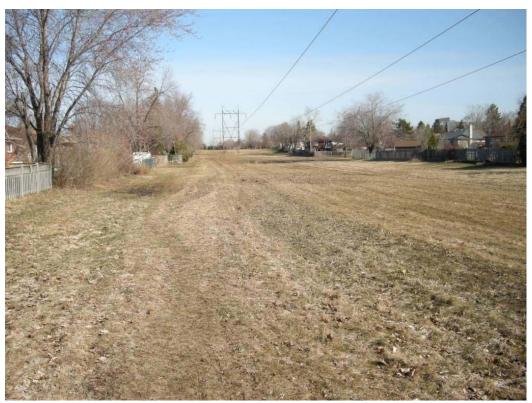
Photo 11 – Looking north from Clearfield Gate

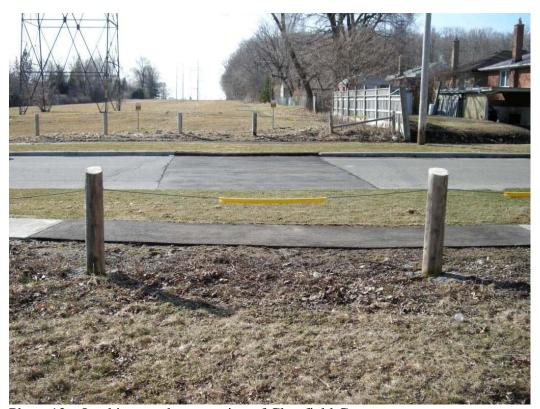
Photo 12 – Looking south at crossing of Clearfield Gate

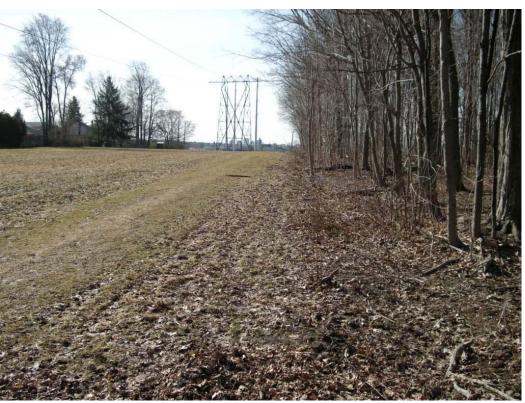
Photo 13 – Looking north at the Wexford Woodlot

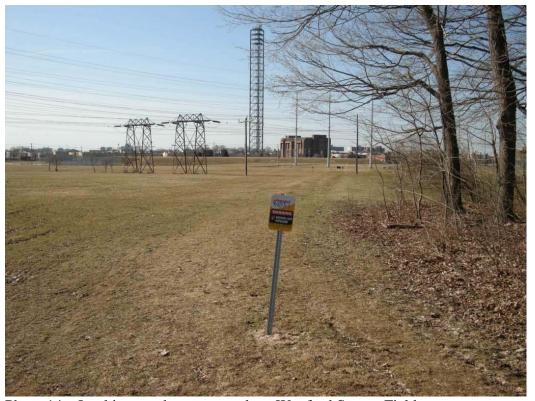
Photo 14 – Looking southwest towards to Wexford Soccer Fields

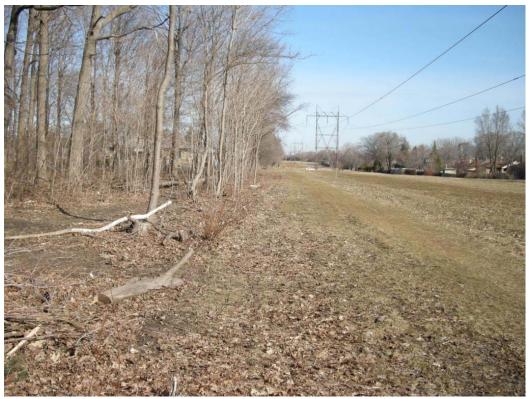
Photo 15 – Looking north along Wexford Woodlot

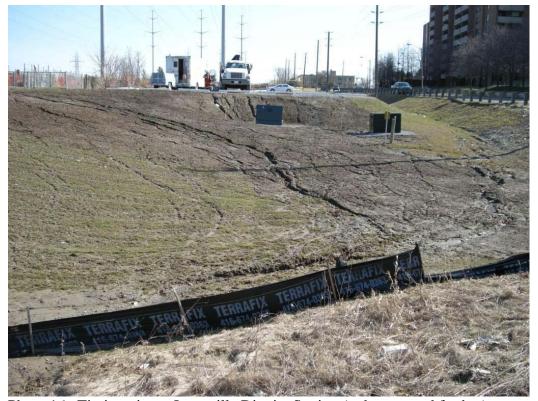
Photo 16 – Tie-in point at Jonesville District Station (to be restored further)

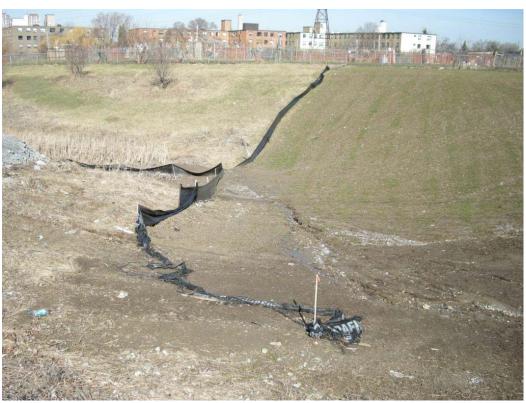
Sediment fencing installed to protect watercourses from sedimentation is in a poor state of disrepair. Fencing should be repaired to protect watercourses from possible sedimentation caused by major rain events. Fencing can be removed in the fall of 2009 (provided re-vegetation is complete).

Photo 17 – Tie-in point at Jonesville District Station (sediment fencing to be repaired)
