**ENBRIDGE GAS DISTRIBUTION INC.
POST-CONSTRUCTION
ENVIRONMENTAL MONITORING REPORT NO.1

GEORGIAN BAY REINFORCEMENT PIPELINE
EB-2007-0782**

Prepared by
Enbridge Gas Distribution Inc.
June 9, 2009

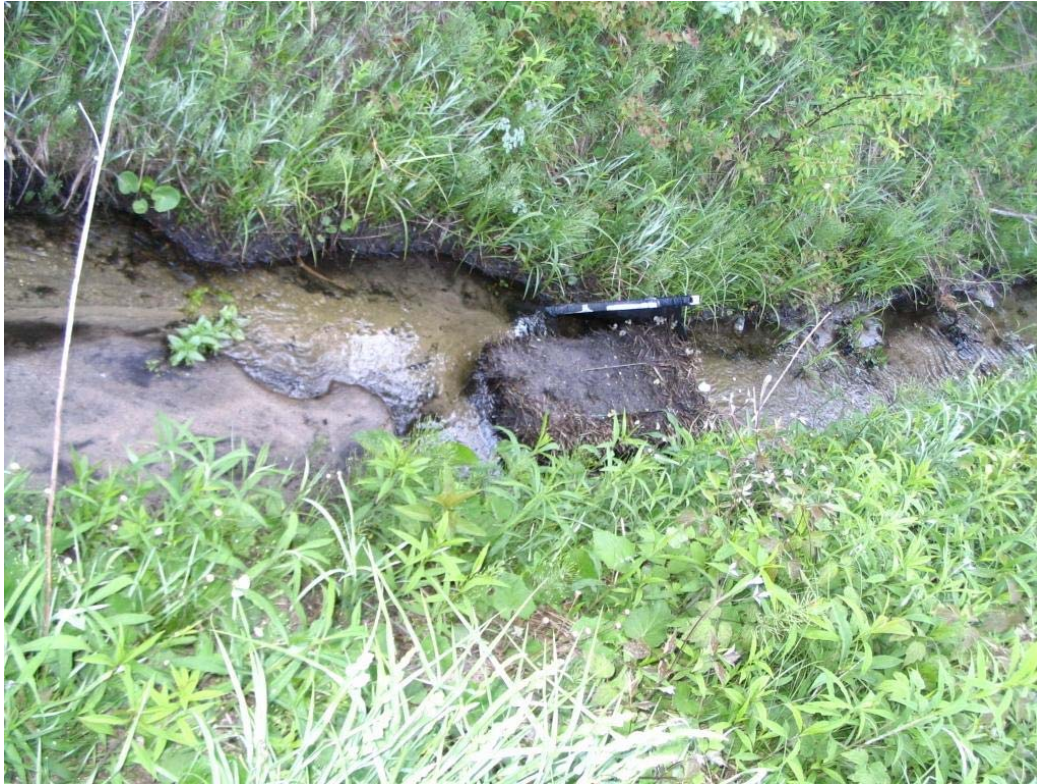
Photo 13 – Wilson Drive; headwater stream with straw bale and sediment fencing

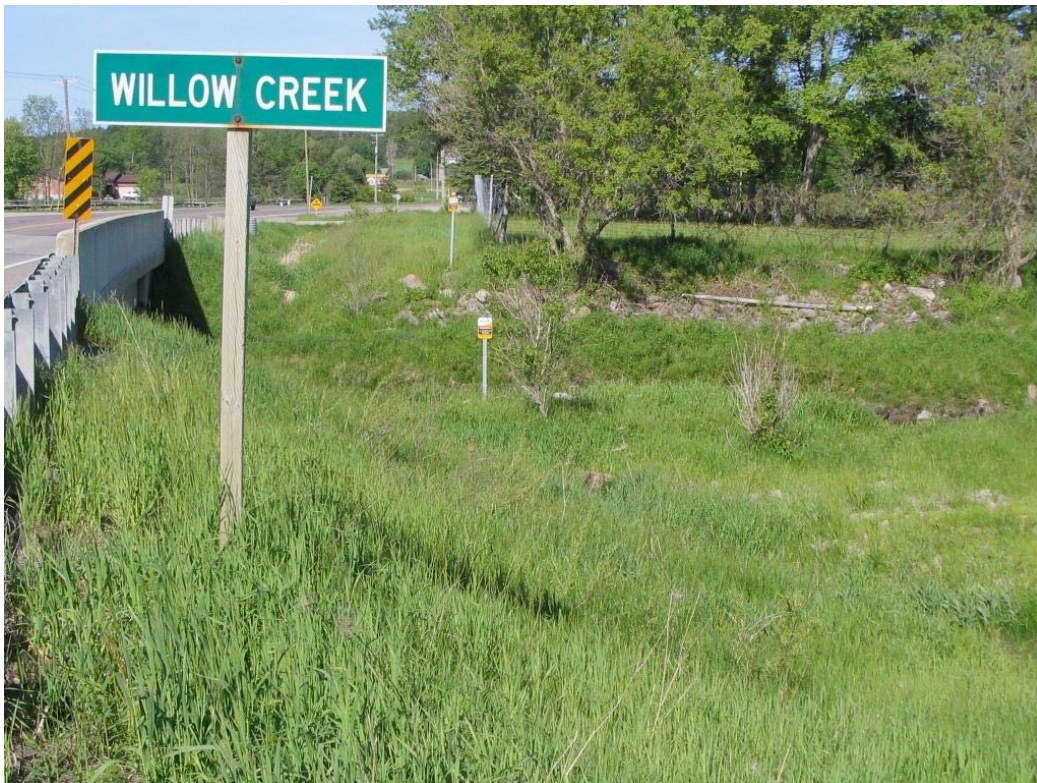
Photo 18 – Highway 26; looking west at crossing of Willow Creek

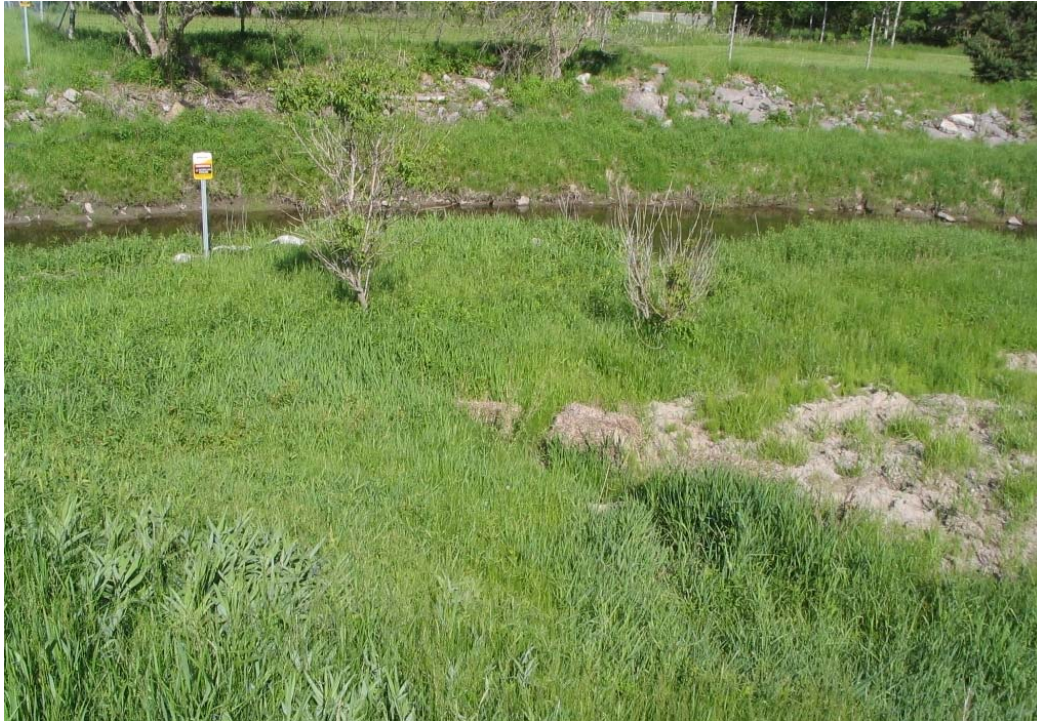
Photo 19 – Highway 26; east side of Willow Creek; sediment control devices to be removed

Erosion control devices such as silt fences, sand bags and straw bale check dams have been installed where required to control any erosion and sedimentation concerns identified. These devices should be removed from the east and west banks of the crossing of Willow Creek and tributaries to the Black Creek on Wilson Drive.
