**Re: Enbridge Gas Distribution Inc. ("Enbridge")  
Pipeline to Serve the Proposed Northland Power Plant - Thorold  
EB-2008-0065 – Ontario Energy Board's Conditions of Approval:  
Interim Monitoring Report**

**ENBRIDGE GAS DISTRIBUTION INC.  
POST-CONSTRUCTION  
ENVIRONMENTAL MONITORING REPORT NO.1  
PIPELINE TO SERVE THE THOROLD COGEN L.P.  
EB-2008-0065**

Prepared by  
Enbridge Gas Distribution Inc.  
June 10, 2010

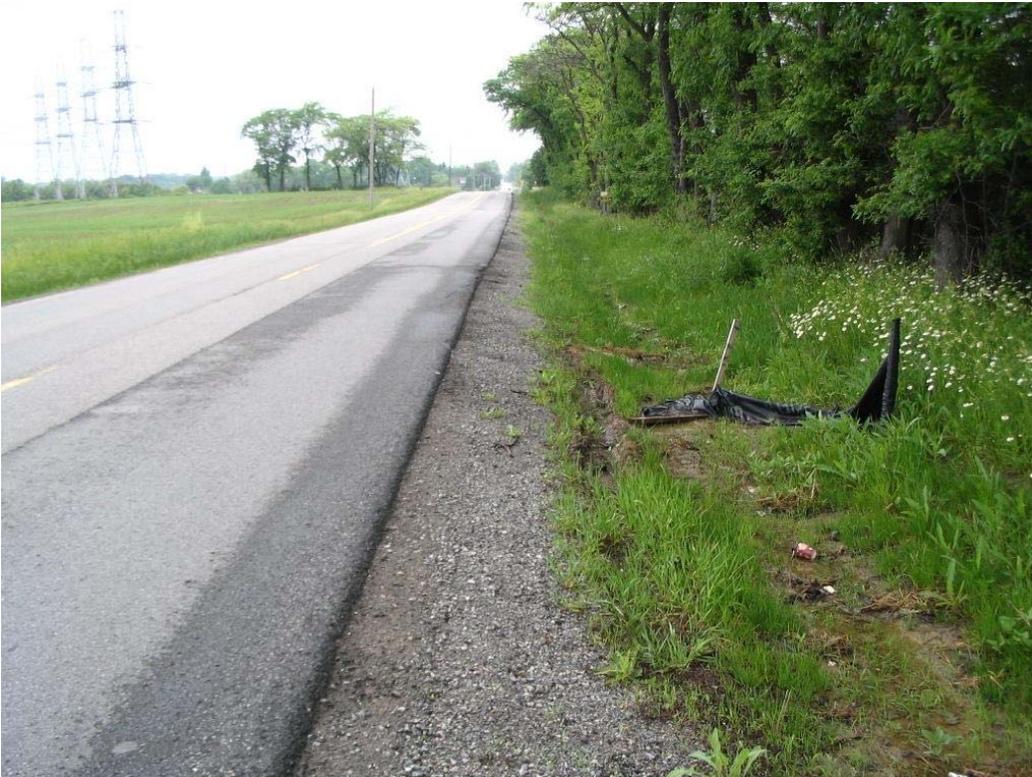
Photo 2 – Looking north along Thorold Townline Road; north of Gate Station

Erosion control devices such as silt fences and straw bale check dams have been installed where required to control any erosion and sedimentation concerns identified. Sediment fencing and straw bales should be removed from the following locations:

- East side of Thorold Townline Road, north of Thorold Townline Road Gate Station (see Photo 2)
- West side of Thorold Townline Road, north and south sides of Beaverdams Creek (see Photo 6 and Photo 8)

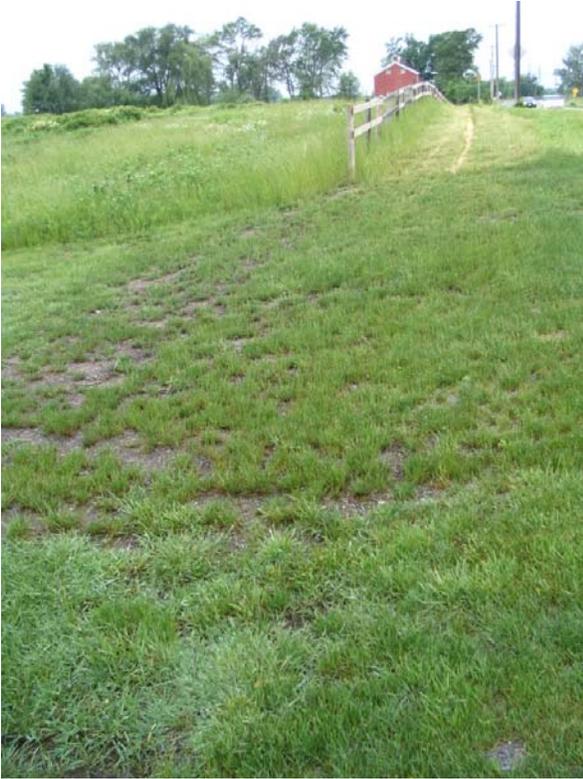
Photo 11 – Looking west, just west of 1021 Beaverdams Road

Vegetation has re-established along portions of the road allowance where it was disturbed due to construction. However, some sections will require additional restoration and revegetation, these include:

- North side of Niagara Falls Road in the vicinity of
  - 1108 Niagara Falls Road (see Photo 14)
  - 1201 Niagara Falls Road (see Photo 11)

These sections will require monitoring over the next year to identify the success of revegetation efforts and to identify areas that will require further efforts.
