**ENBRIDGE GAS DISTRIBUTION INC.  
POST-CONSTRUCTION  
ENVIRONMENTAL MONITORING REPORT NO.2

GEORGIAN BAY REINFORCEMENT PIPELINE  
EB-2007-0782**

Prepared by  
Enbridge Gas Distribution Inc.  
June 25, 2010

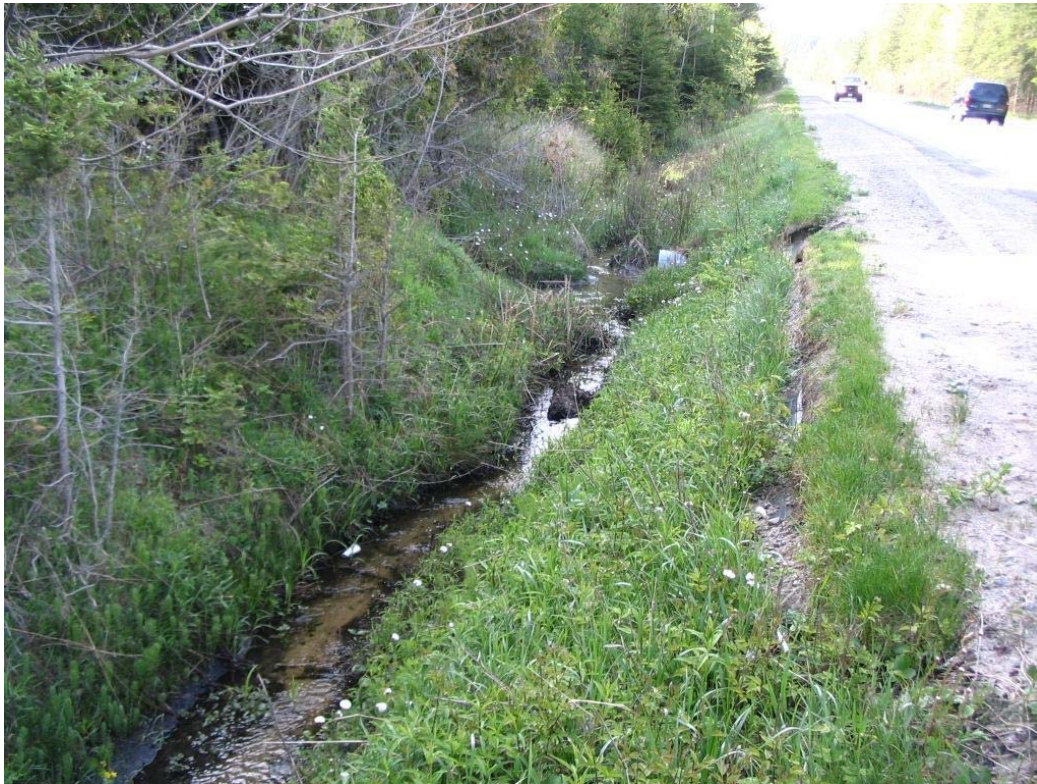
Temporary erosion control devices (i.e. silt fence, sand bags, and straw bales) were installed to control erosion and sedimentation in the vicinity of the headwater stream crossing on Wilson Drive, north of Springwater Provincial Park.

Photo 12 – Wilson Drive; looking south at headwater stream crossing; erosion on bank

As described in the interim monitoring report the Township of Springwater requested that erosion control devices remain in place until revegetation efforts had been successful on disturbed areas in the vicinity of the respective water courses. Revegetation has been successful and the temporary erosion control devices were removed in June 2010.<sup>3</sup>

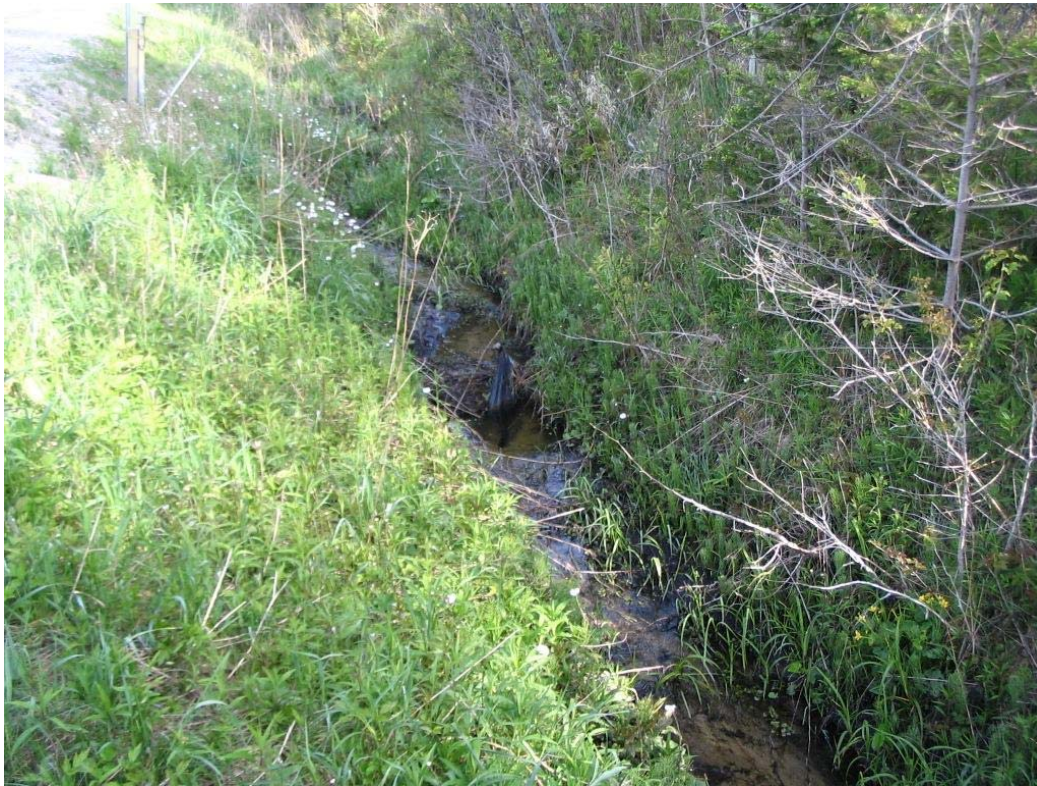
Photo 13 – Wilson Drive; headwater stream with straw bale and sediment fencing

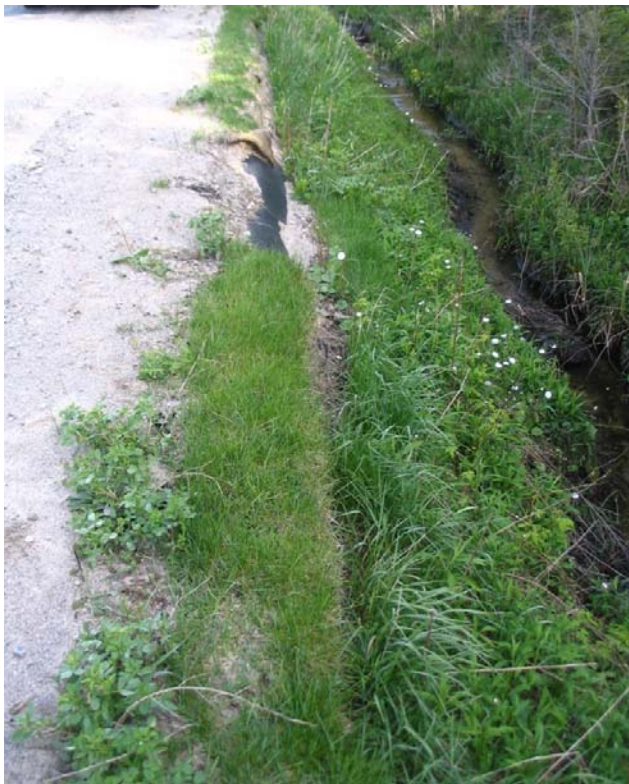
Photo 14 – Wilson Drive; bank erosion at headwater stream crossing
