ENBRIDGE GAS DISTRIBUTION INC. POST-CONSTRUCTION ENVIRONMENTAL MONITORING REPORT NO.2

TECUMSEH GAS STORAGE WELL TW#13H EB-2007-0891 and EB-2008-0387

Prepared by Enbridge Gas Distribution Inc. July 12, 2010

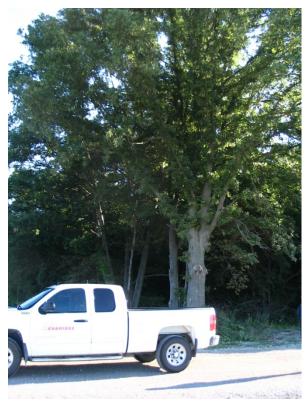
The Interim Post Construction Monitoring Report ("Interim Report") filed on October 26, 2009, identified two outstanding issues regarding topsoil replacement and vegetation in the vicinity of TW#13H. As indicated in the Interim Report the topsoil has been replaced and the area reinstated for agricultural purposes. The large specimen tree to the north of TW#13H was monitored in June 2010 and did not show any visible stress in its foliage.

Photo 3: Specimen Tree; looking north from TW#13H
