TILTRAN SERVICES INC.

Re: Maintenance Inspection Report -- Our Ref. No. 23403LSP
Clinton Power – MS1 & MS 2 Semi-annual inspections

Please find attached the report for the semi-annual inspections completed September 9, 2010 at two locations.

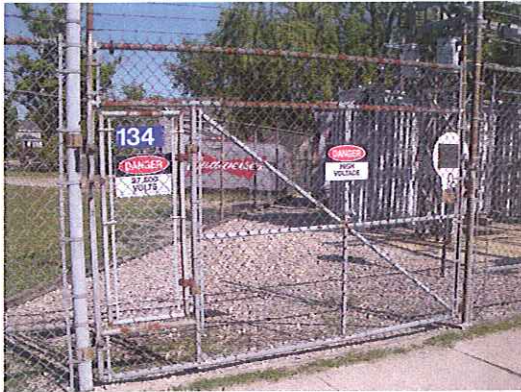
- Witnessed the effectiveness of weed spray- Dead weeds.

- Weed spray program should be completed twice per year
- Replace ceramic lightning arresters with polymer type.
- Inspect broken wire strands on the south feeder red phase reclosure to determine the overall condition of the cable and if re-termination or replacement is required

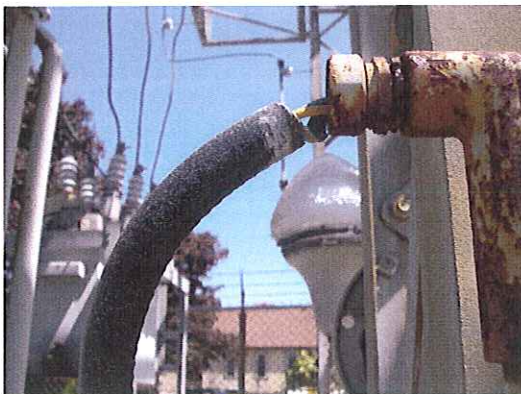
- New growths of weeds were observed and larger ones were removed during inspection.
- Photo cell lighting tested and found one of the bulbs was burned out. Bulb replaced from stock in building.
- Broken wire strands seen on reclosers south feeder red phase as mentioned in previous inspection report.
