**Re: Enbridge Gas Distribution Inc. ("Enbridge")  
Ontario Energy Board ("Board") Docket No.: EB-2009-0187  
Pipeline to Serve the Proposed York Energy Centre Power Plant  
Conditions of Approval - Monitoring Reports**

**Pipeline to Serve York Energy  
Centre LP Interim Post  
Construction Environmental  
Monitoring Report**

EB-2009-0187

May 11, 2012

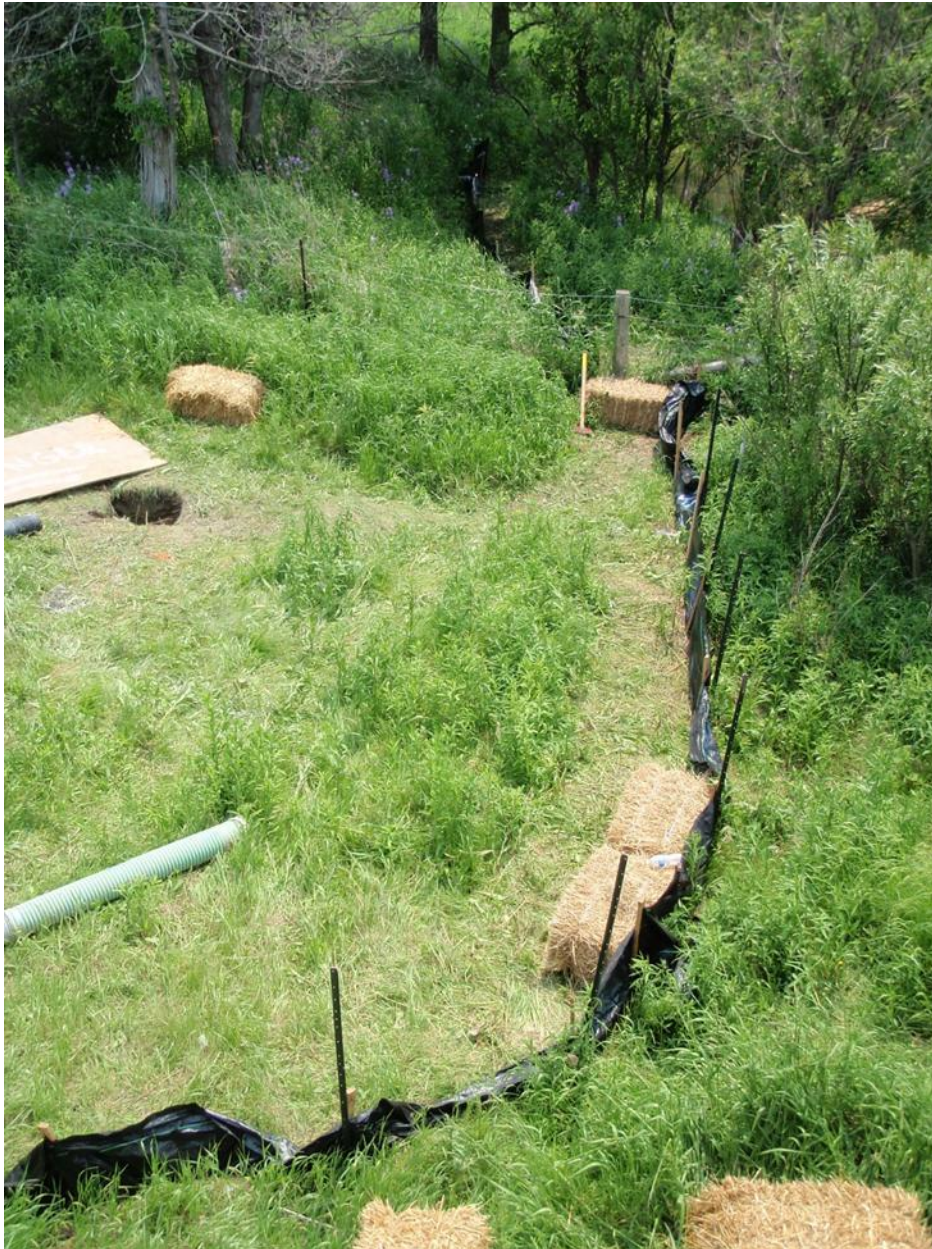
**Photo 1      Erosion protection measures (silt fence and relief pit) setup up parallel to  
watercourse prior to drilling (June 7, 2011)**

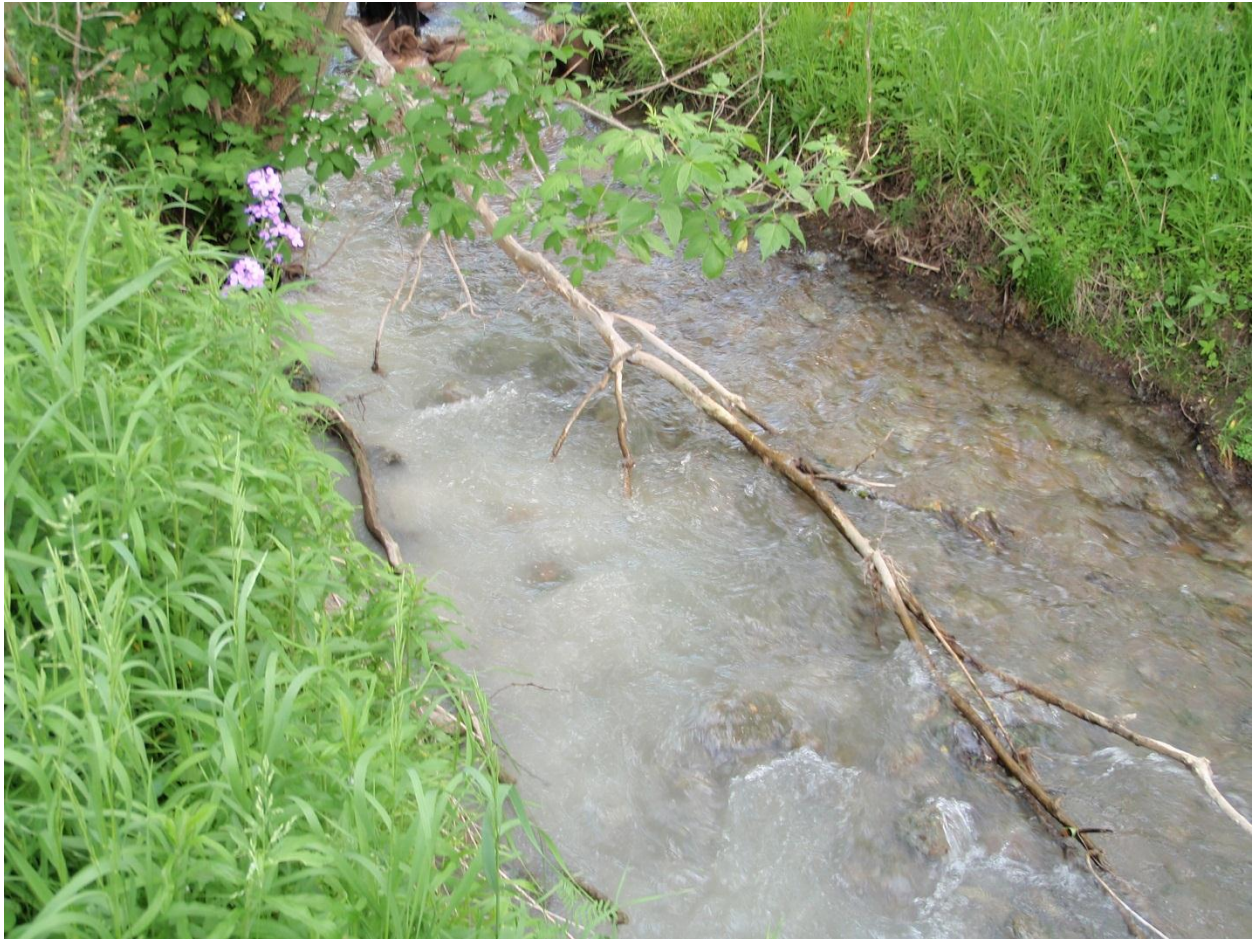
**Photo 2      Drilling fluid release observed into WC5 (June 7, 2011)**

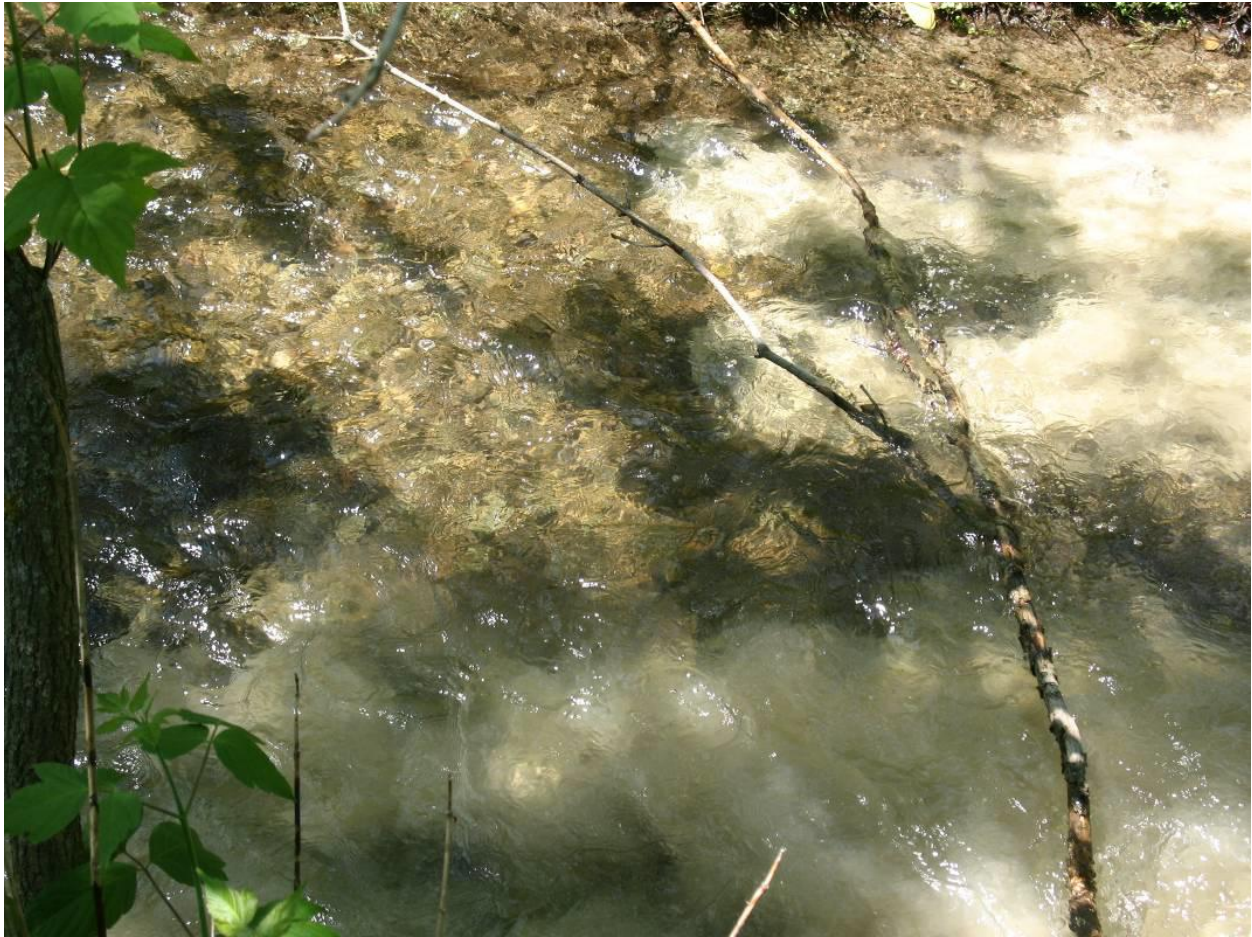
**Photo 3      Close-up of drilling fluid release within the channel bed at WC5 (June 7, 2011)**

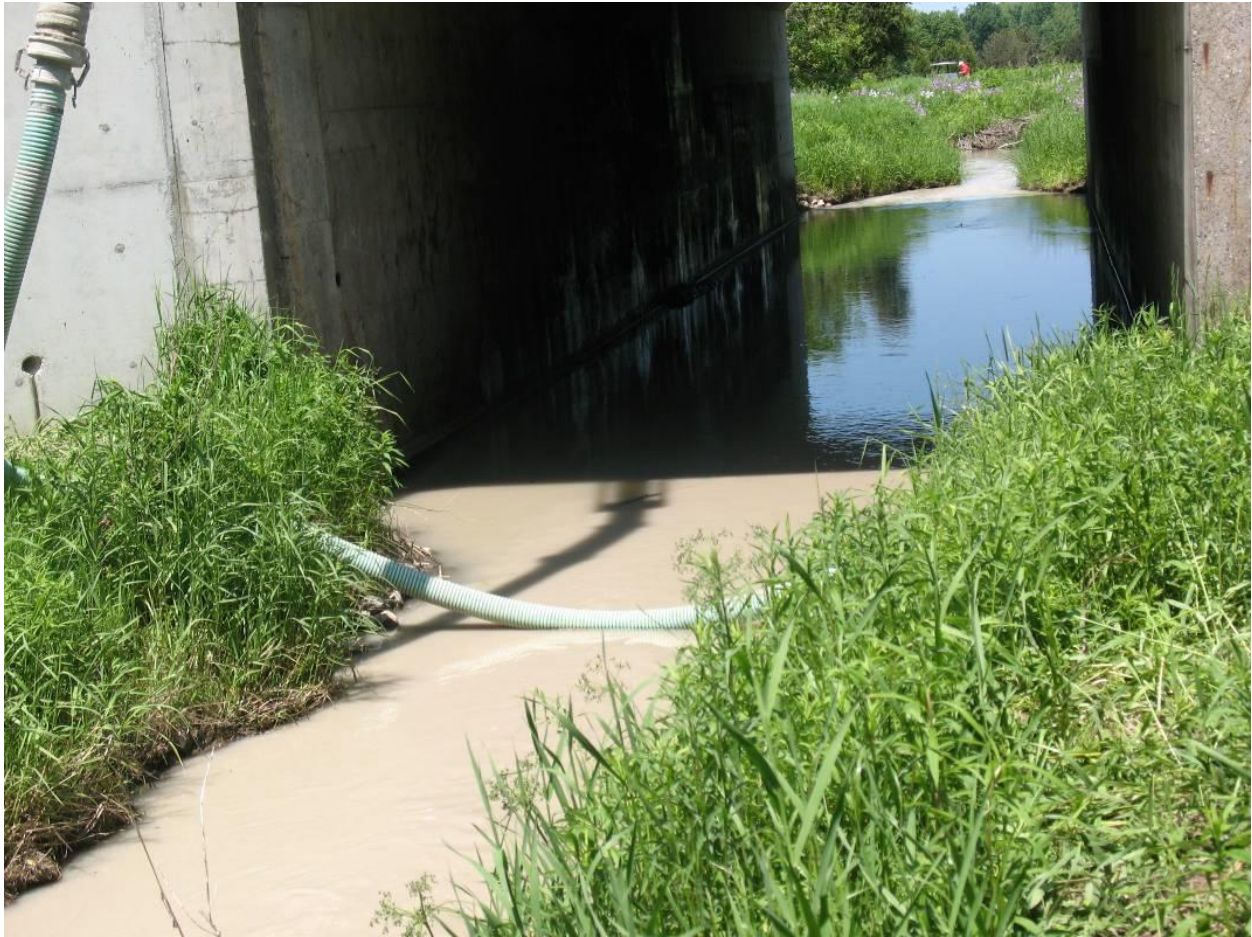
**Photo 4      View of WC5 downstream immediately after release (June 7, 2011)**

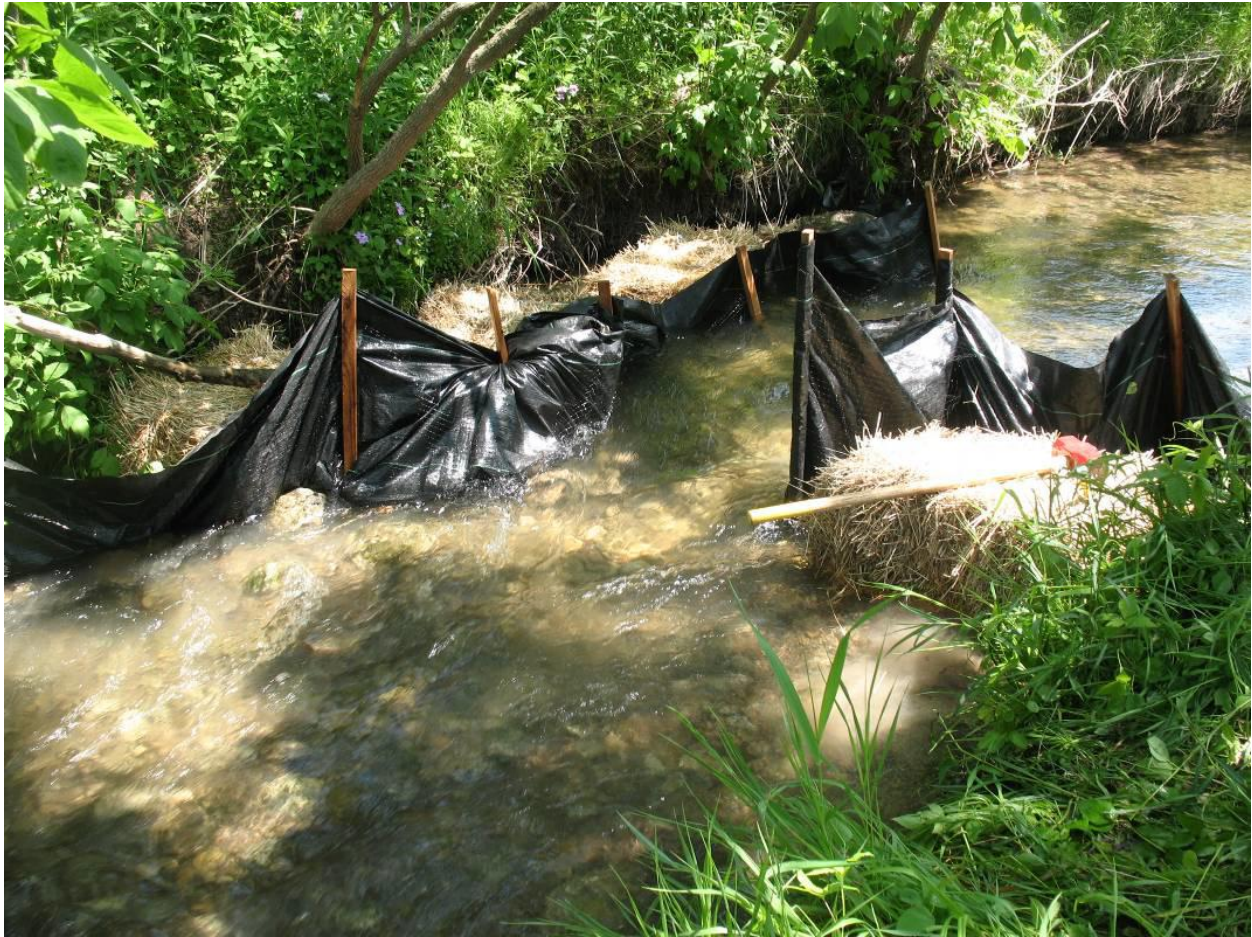
**Photo 5**      **In-stream protection measures installed immediately after release to limit exposure of watercourse to drilling mud (June 7, 2011)**

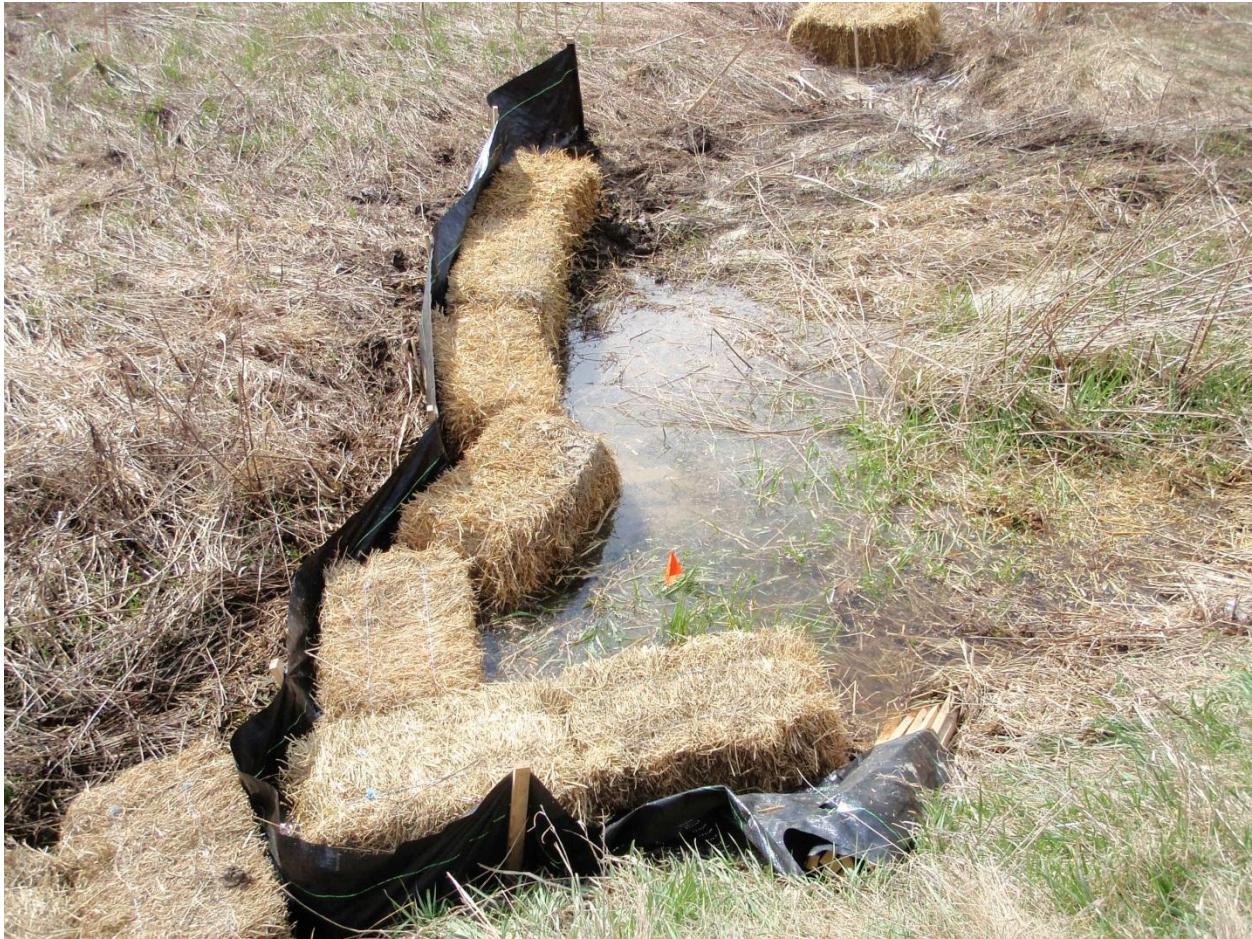
**Photo 6      Sediment barrier adjacent watercourse installed prior to drilling (May 5, 2011)**

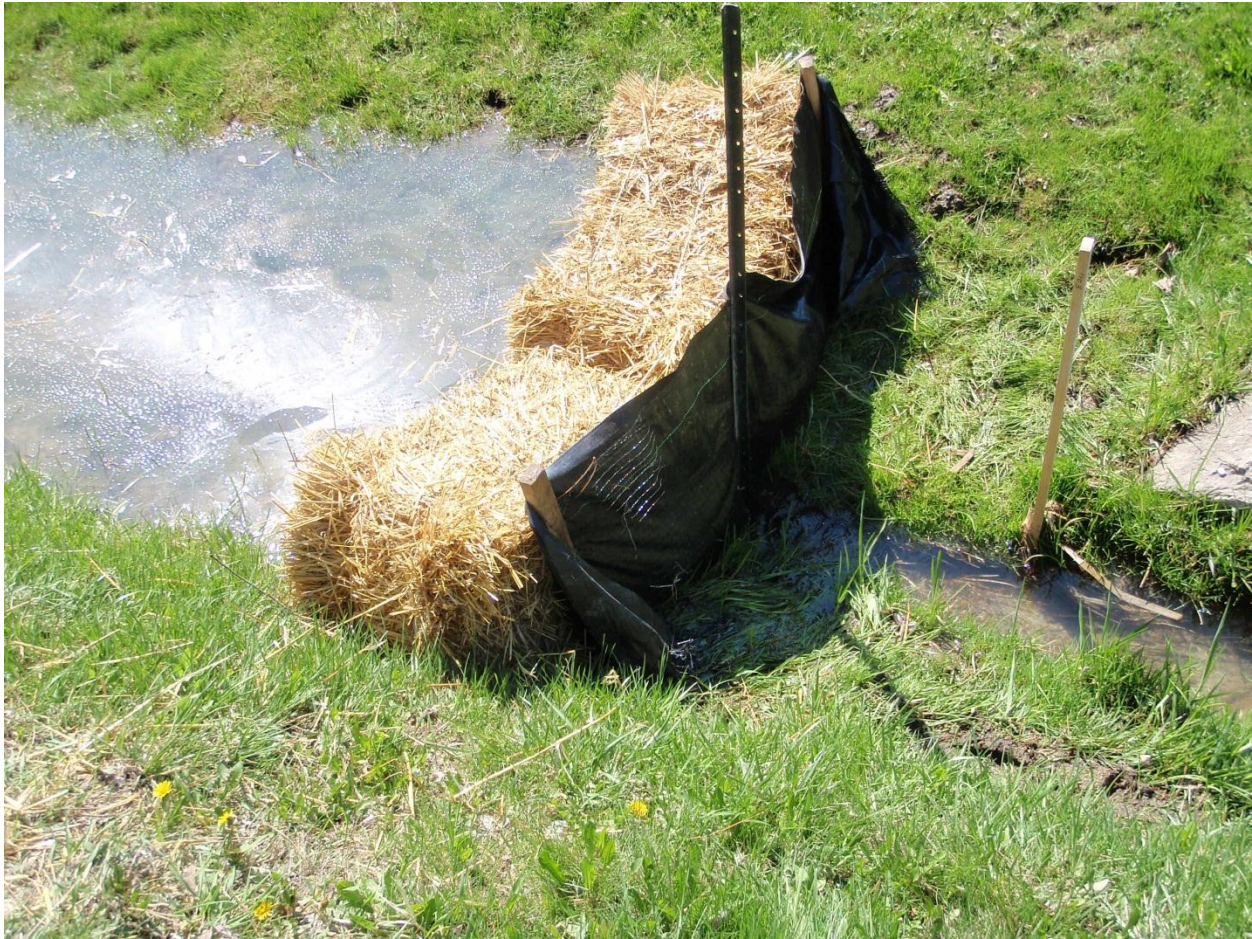
**Photo 7**      **Check-dam installed in non-fisheries watercourse prior to drilling (drainage ditch)  
(May 7, 2011)**

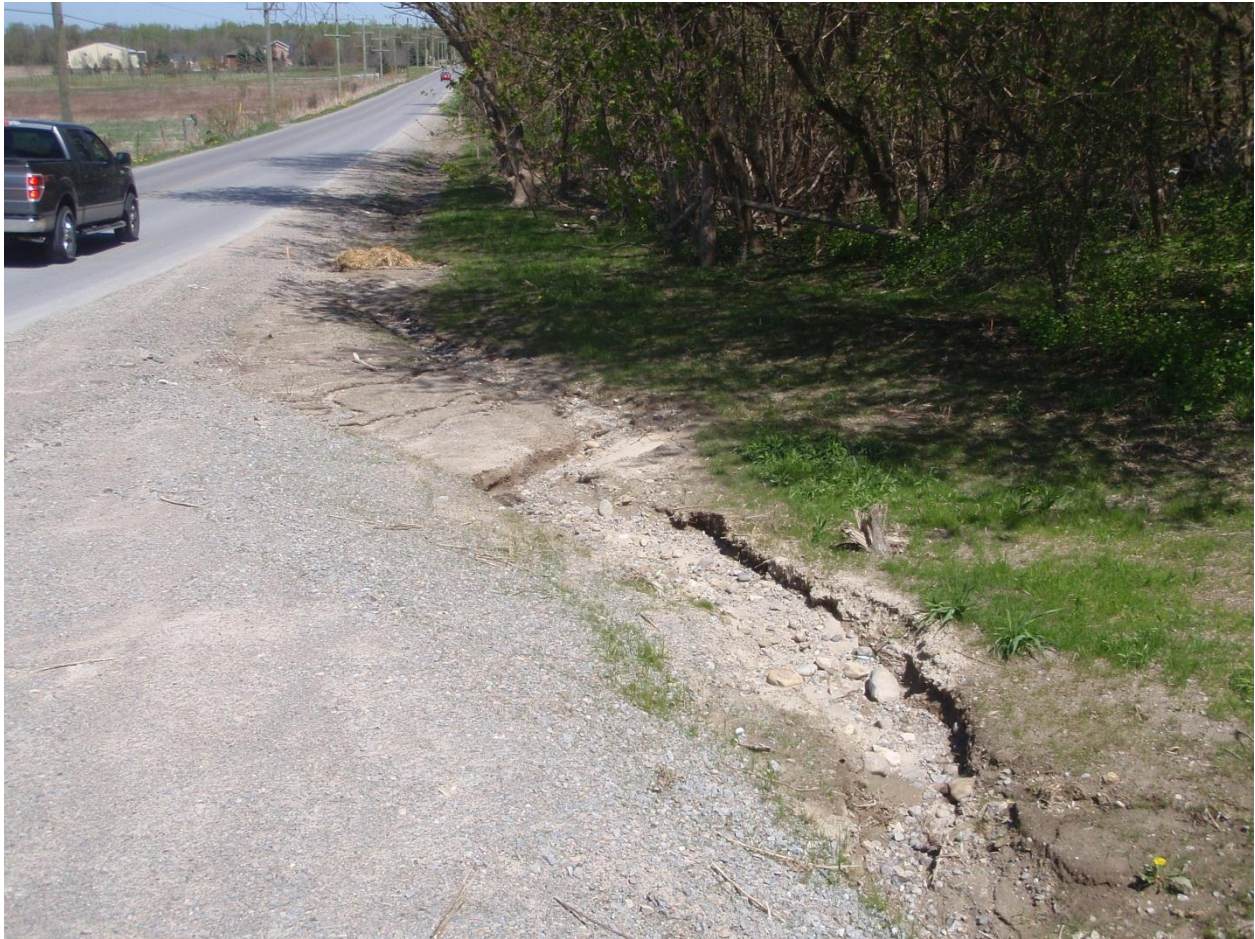
**Photo 8      Surface erosion (gully) on ditch line on slope located on the east side of  
Dufferin Street, directly north of Miller's Side Road (May 5, 2012)**

4. East side of Dufferin Street directly north of Miller's Side Road additional erosion control blankets should be installed along the bottom of the exposed drainage ditch to further limit the potential for further insizing and limit the sediment loading into the provincially significant wetland at the bottom of the slope. It is also recommended that sediment loading downslope of the exposed slope be removed from the culvert and replaced on the slope as required.

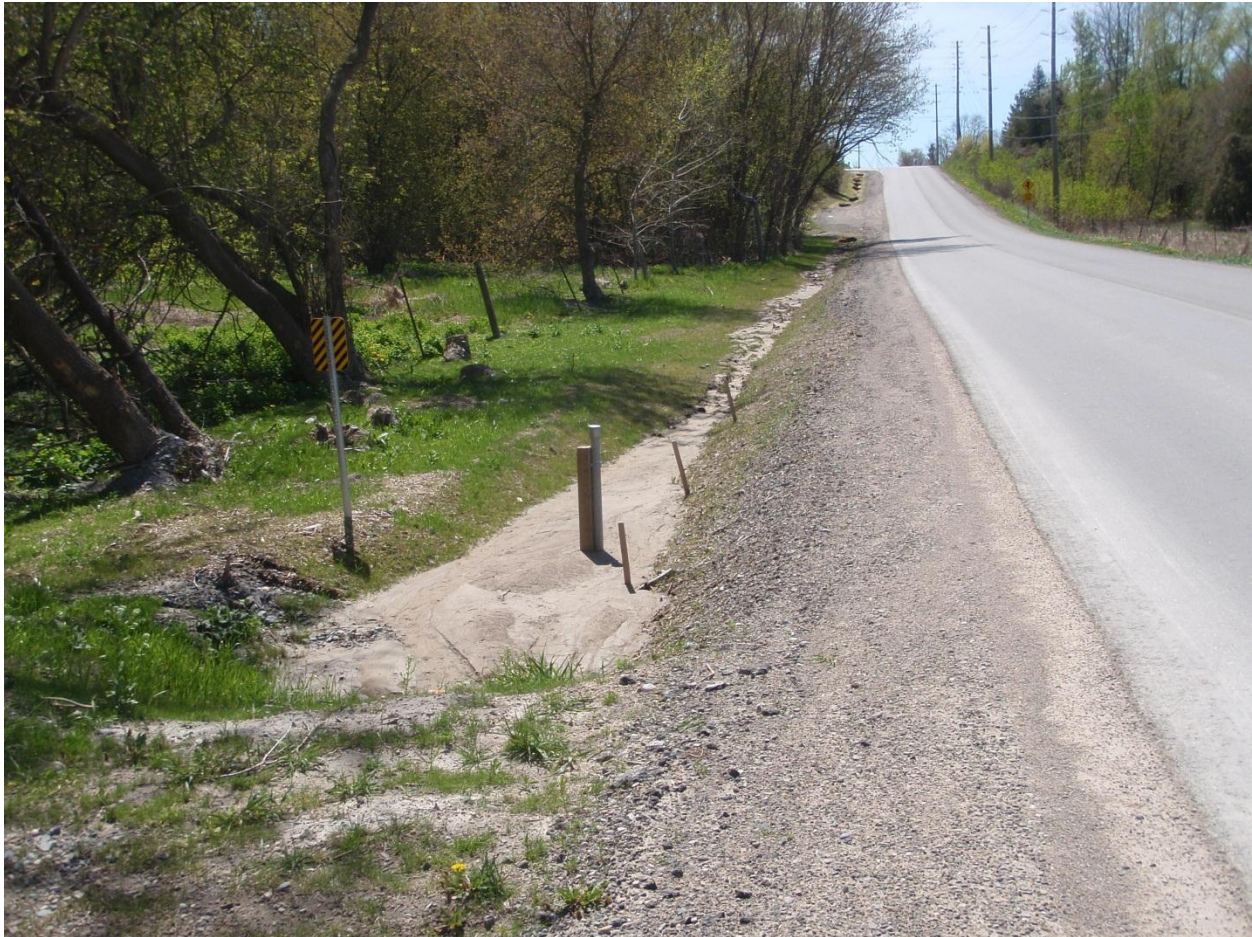
**Photo 9**      **Sediment deposits located downgradient of gully identified in Photo 9 (May 5, 2012)**

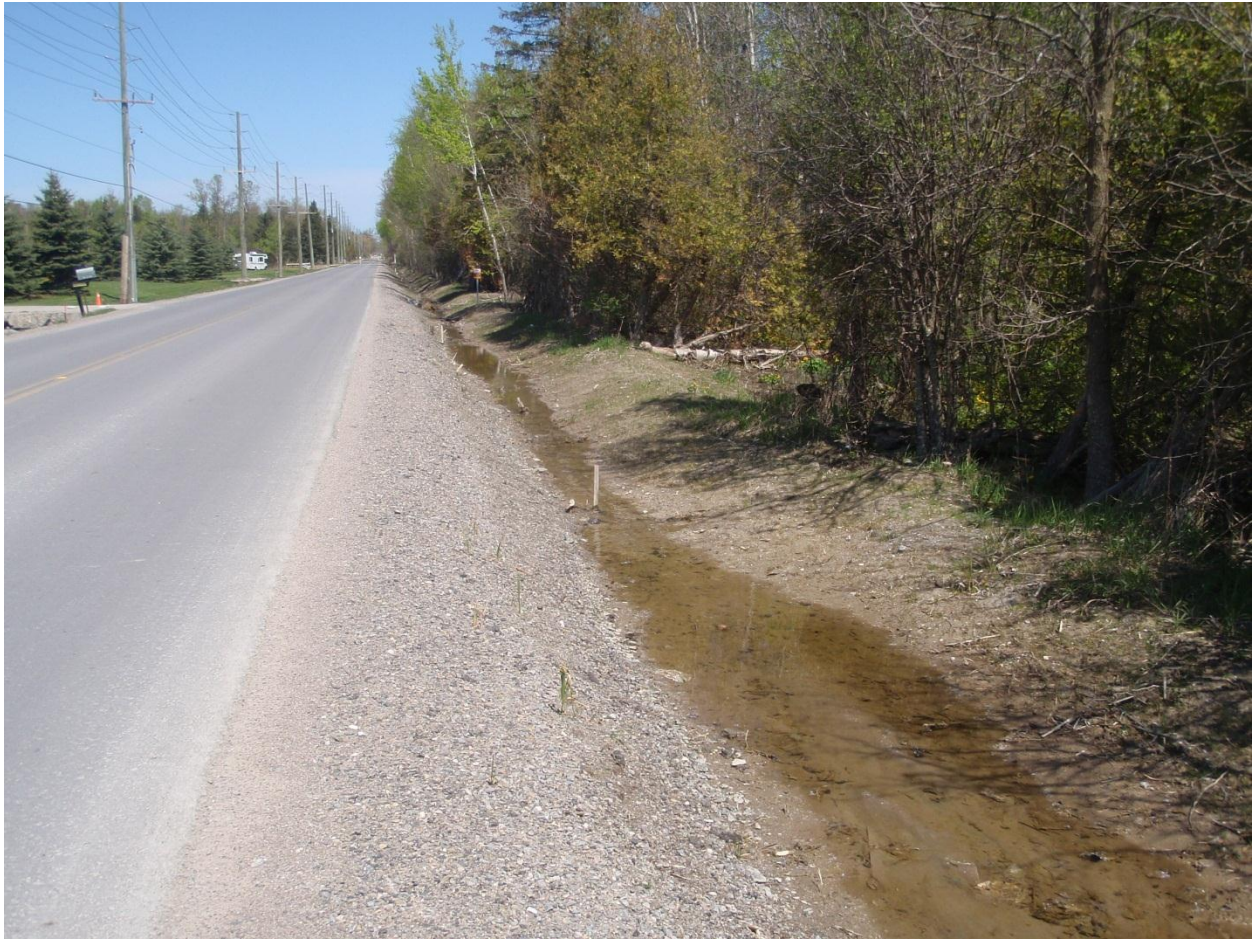
**Photo 10**      **Poor vegetation establishment over excavated ditchline on the east side of Dufferin Street, South of the YEC (May 5, 2012)**

6. Primarily a result of the completion of the installation of the pipeline during late fall conditions, not conducive to adequate germination to fully stabilize slopes, there are various additional areas where vegetation establishment should be augmented by hydro seeding to prevent erosion on exposed slopes as the primary concern for the reclamation of the pipeline (e.g., Photo 13; Appendix B). Stantec recommends that all previously disturbed areas be appropriately vegetated and meet pre-construction conditions.

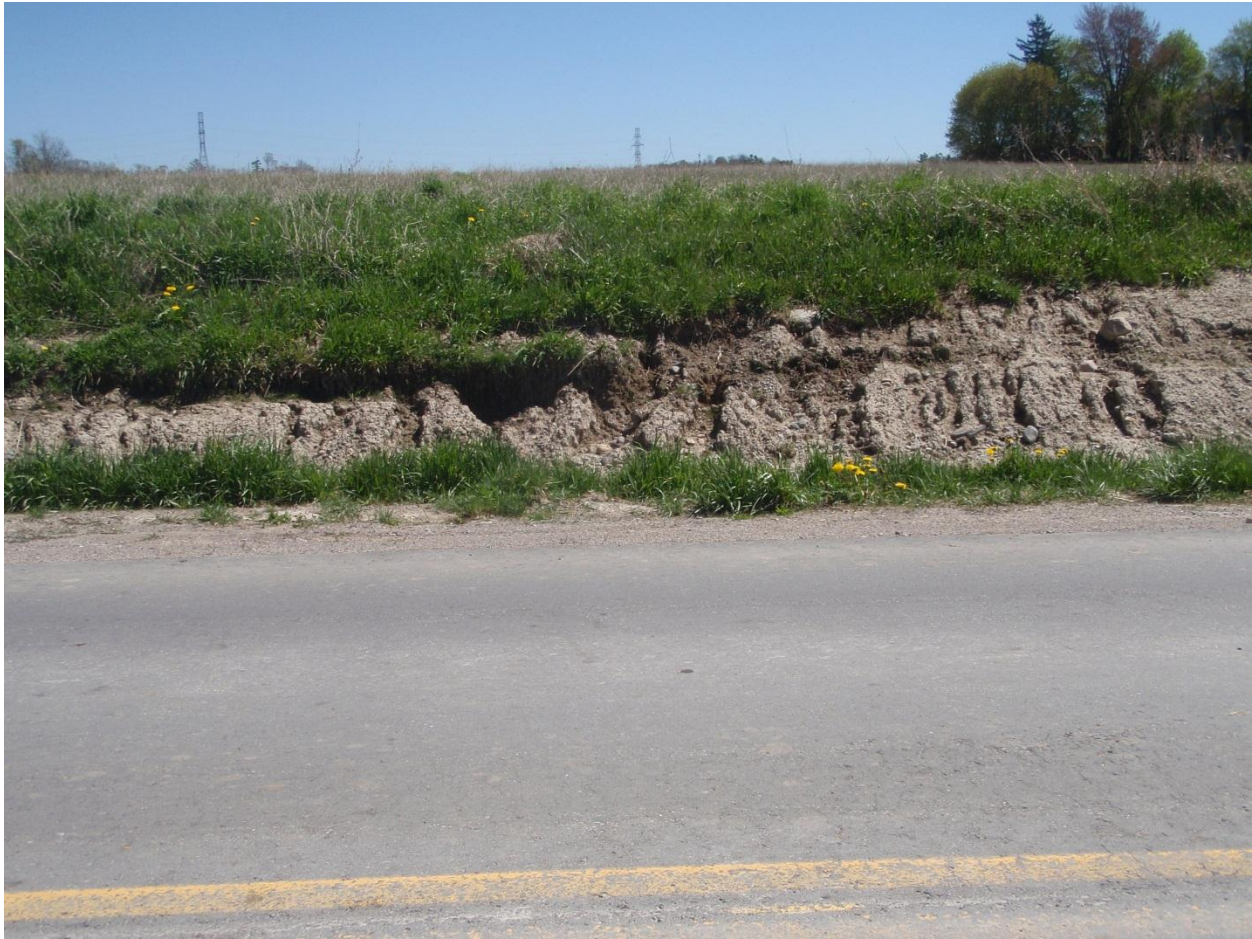
**Photo 11**      **Slumping of road backslope on the east side of Dufferin Street, directly south of Miller's Side Road (May 5, 2012)**

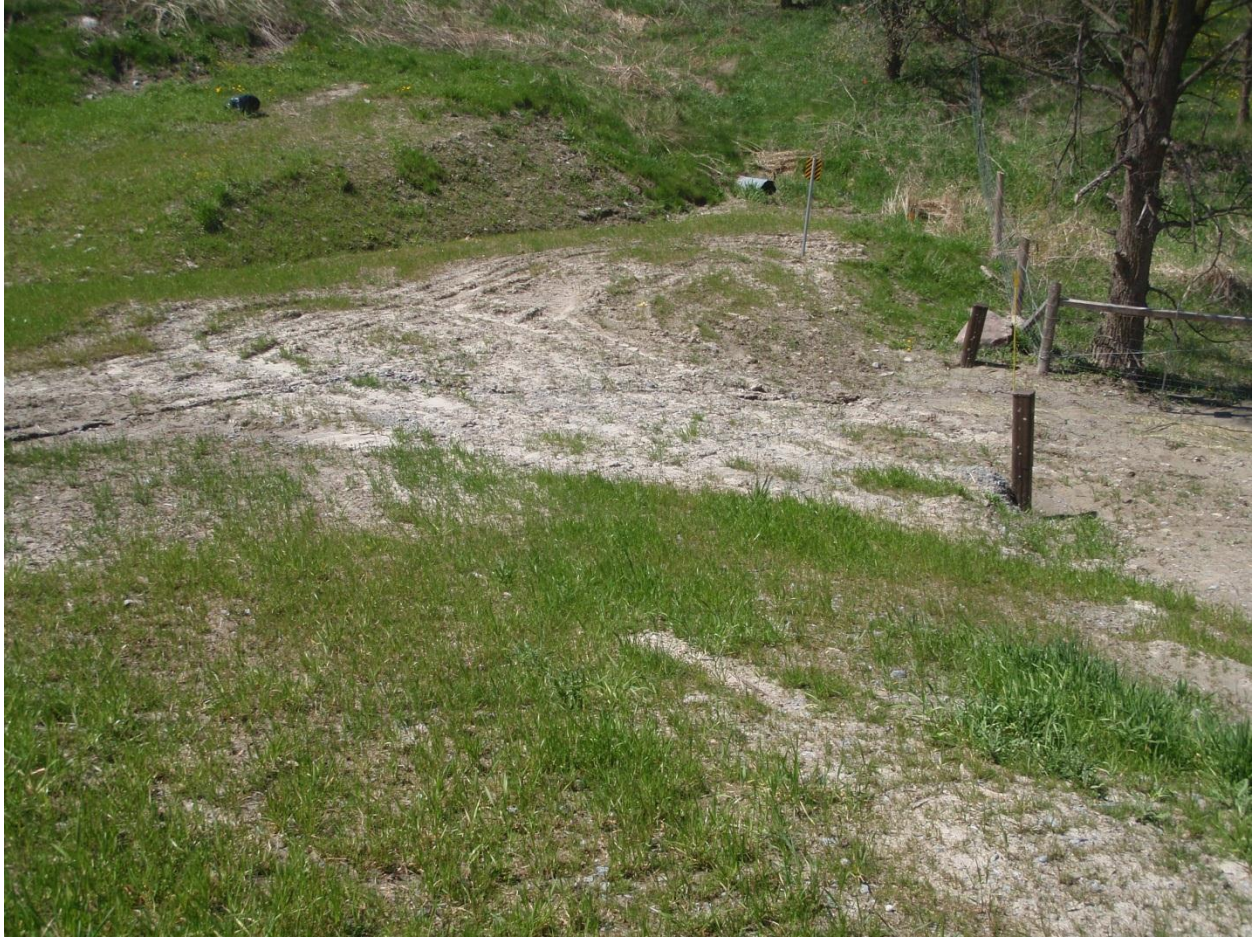
**Photo 12**      **Poor vegetation establishment on a steep embankment on the the northwest intersection of the Davis Drive and Dufferin Street intersection (May 5, 2012)**

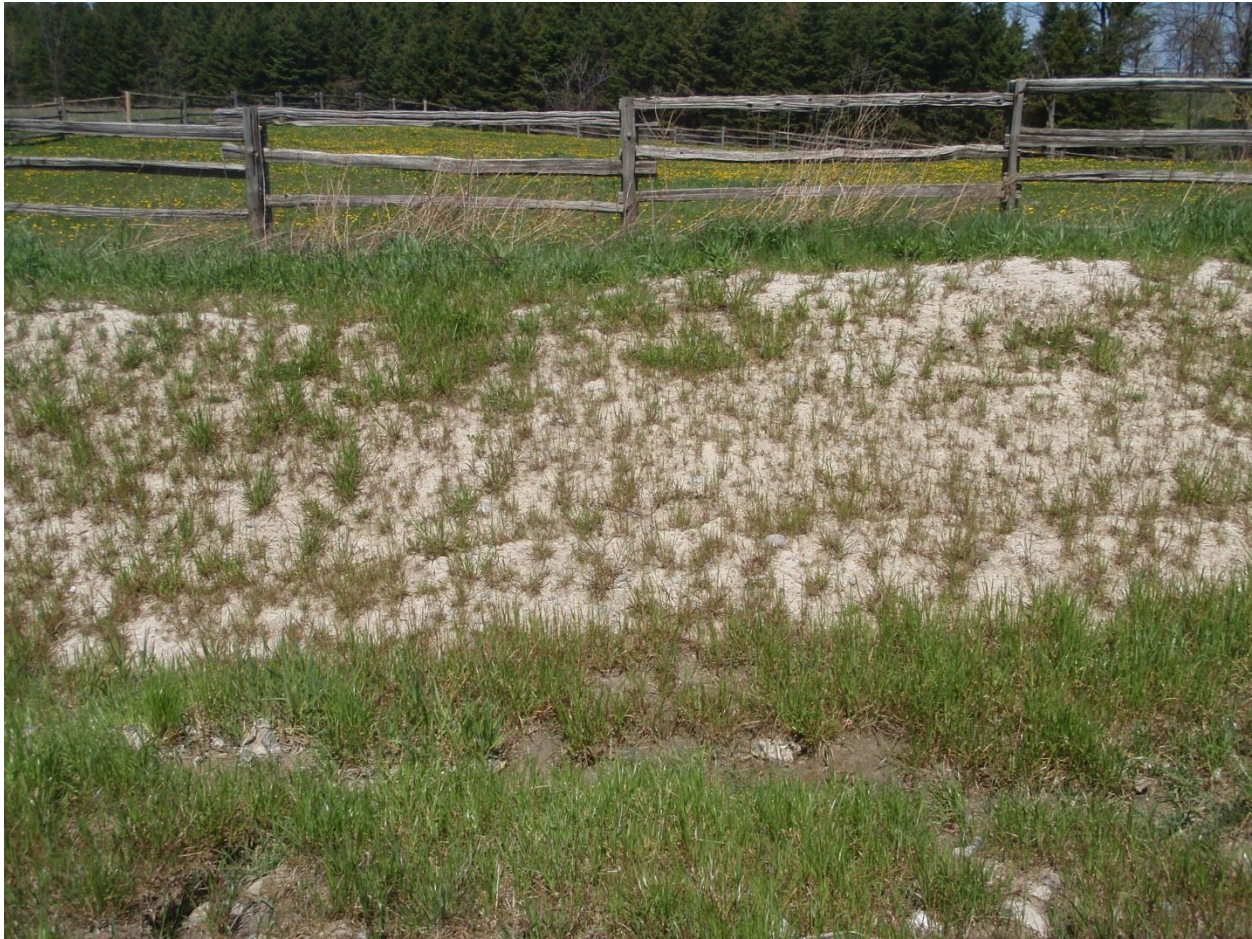
**Photo 13**      **Poor vegetation establishment on the north backslope of Davis Drive, east of Dufferin Street (May 5, 2012)**

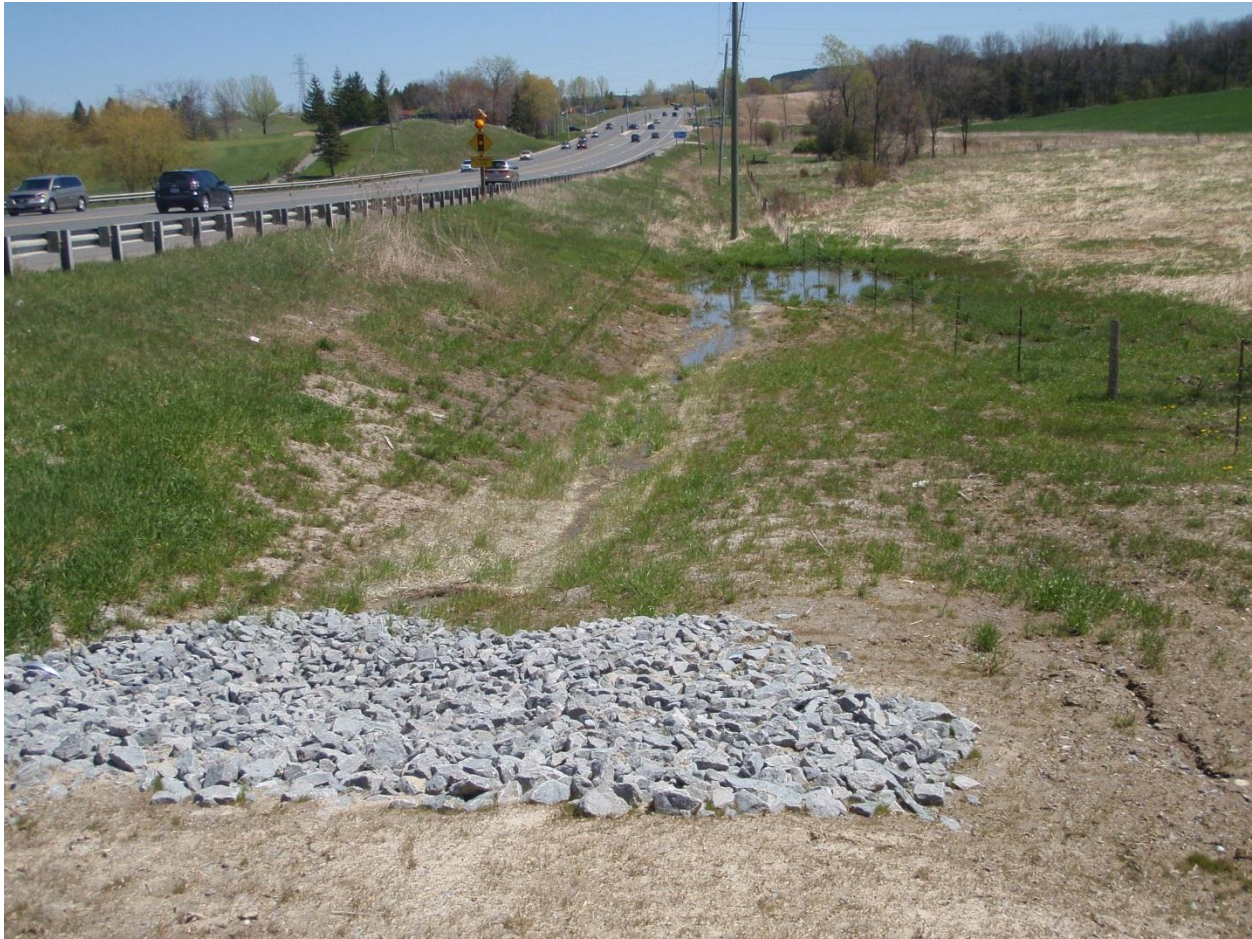
**Photo 14      Poor vegetation establishment near WC6 directly west of Jane Street (May 5, 2012)**

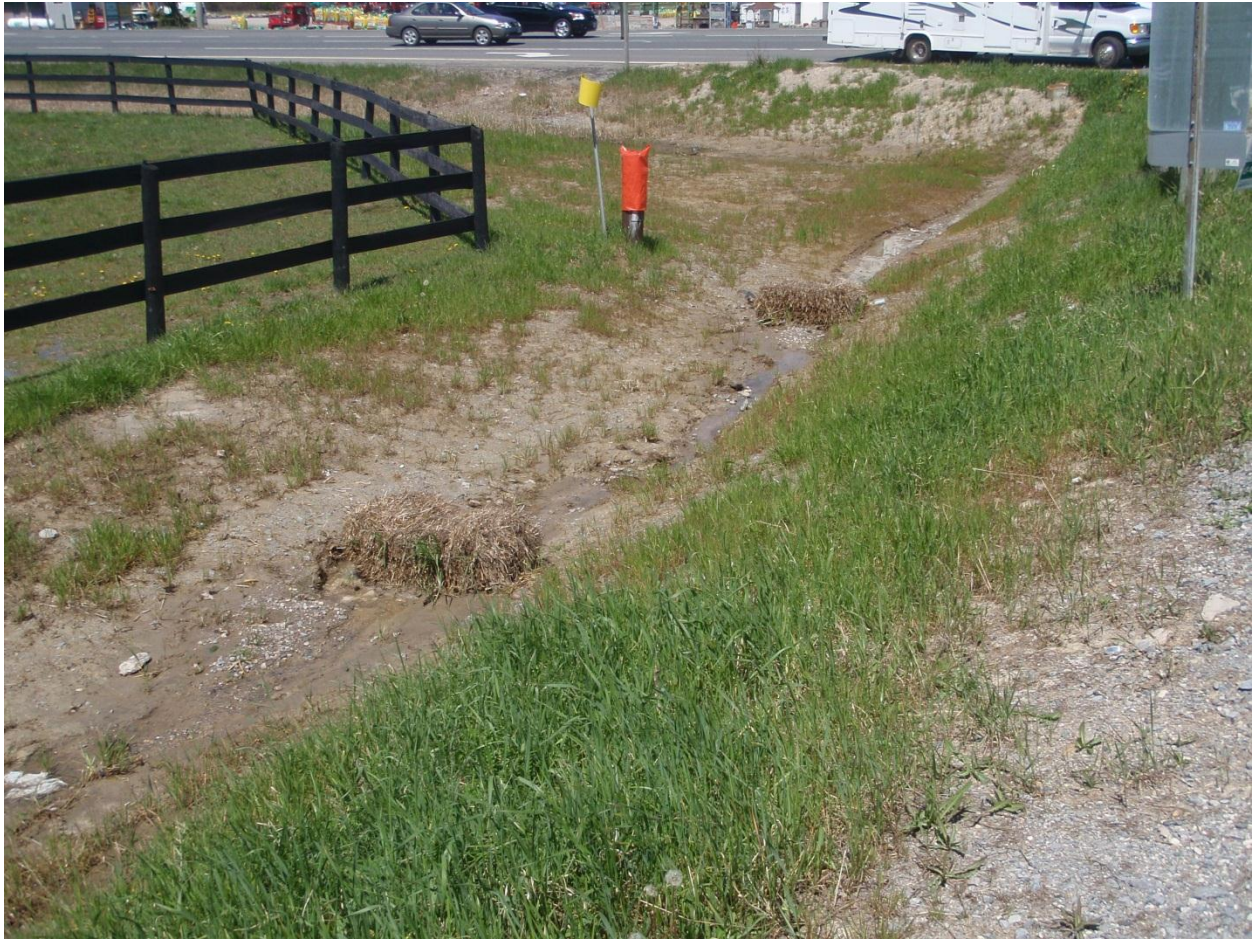
**Photo 15      Erosion and sediment deposits southwest corner of the Jane Street and Davis  
Drive intersection (May 5, 2012)**

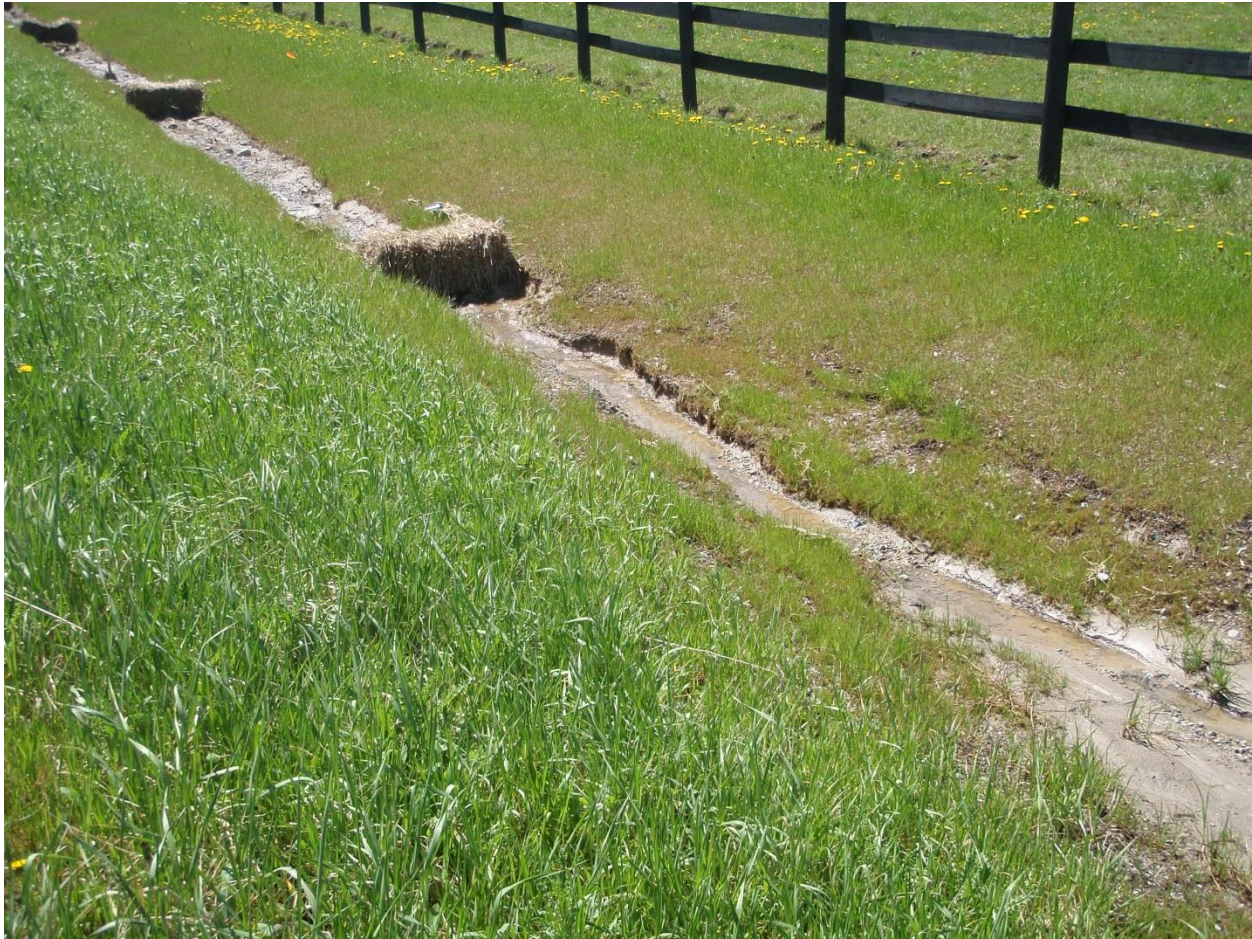
**Photo 16      Erosion and sediment deposits southeast corner of the Jane Street and Davis  
Drive intersection (May 5, 2012)**

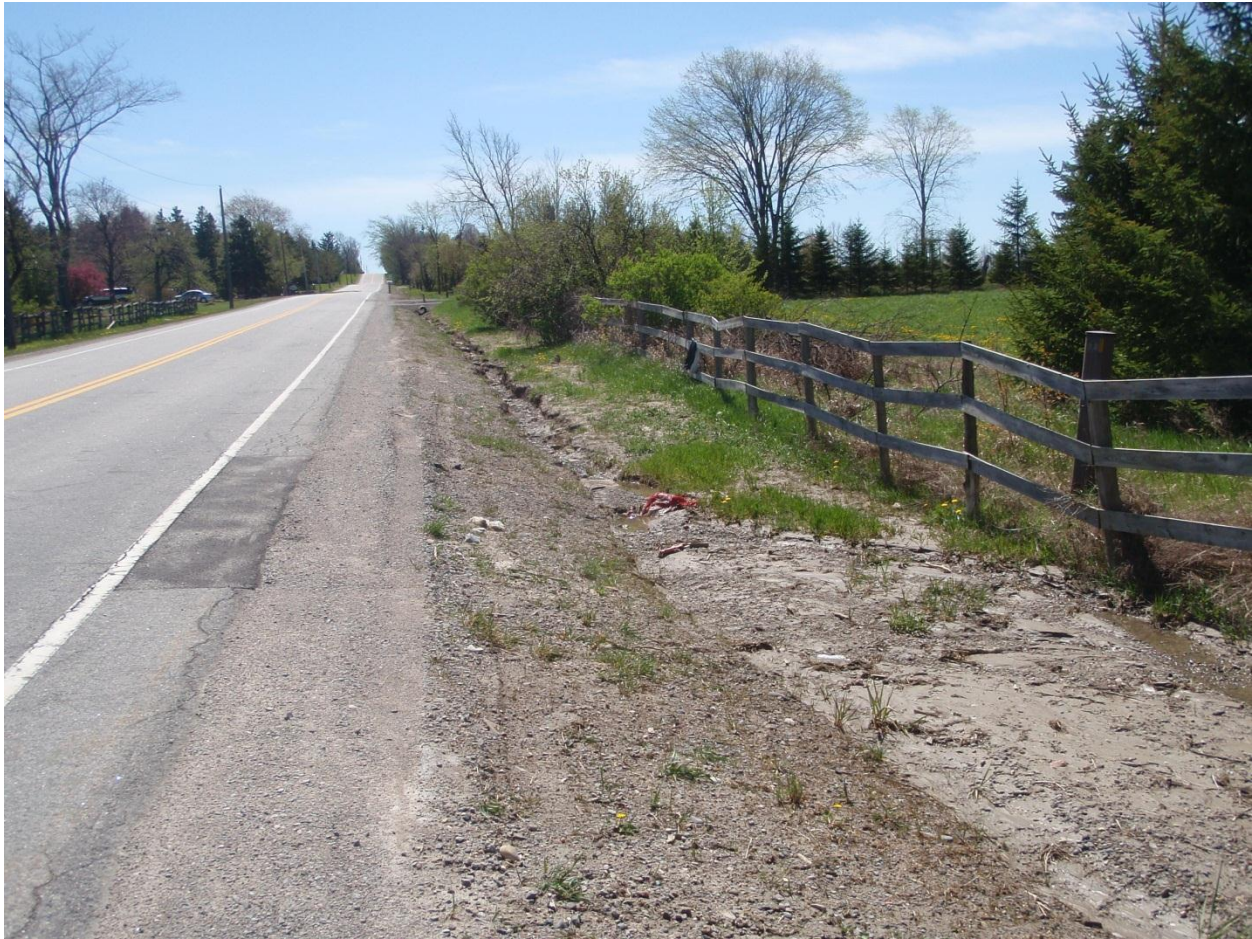
**Photo 17      Erosion and sediment deposits east side of Jane Street (May 5, 2012)**

1. On the east ditch of Jane St., replace the eroded mulch and eroded areas, and cover with erosion control blankets properly anchored to limit the potential for the mulch to get washed away and or erosion.
