### 3.3 Municipal Station #3 – Town Line Road and Tillson Street

3.4 Municipal Station #4 – 10 Lisgar Avenue

### Municipal Station #5 – North Street and Woodcock

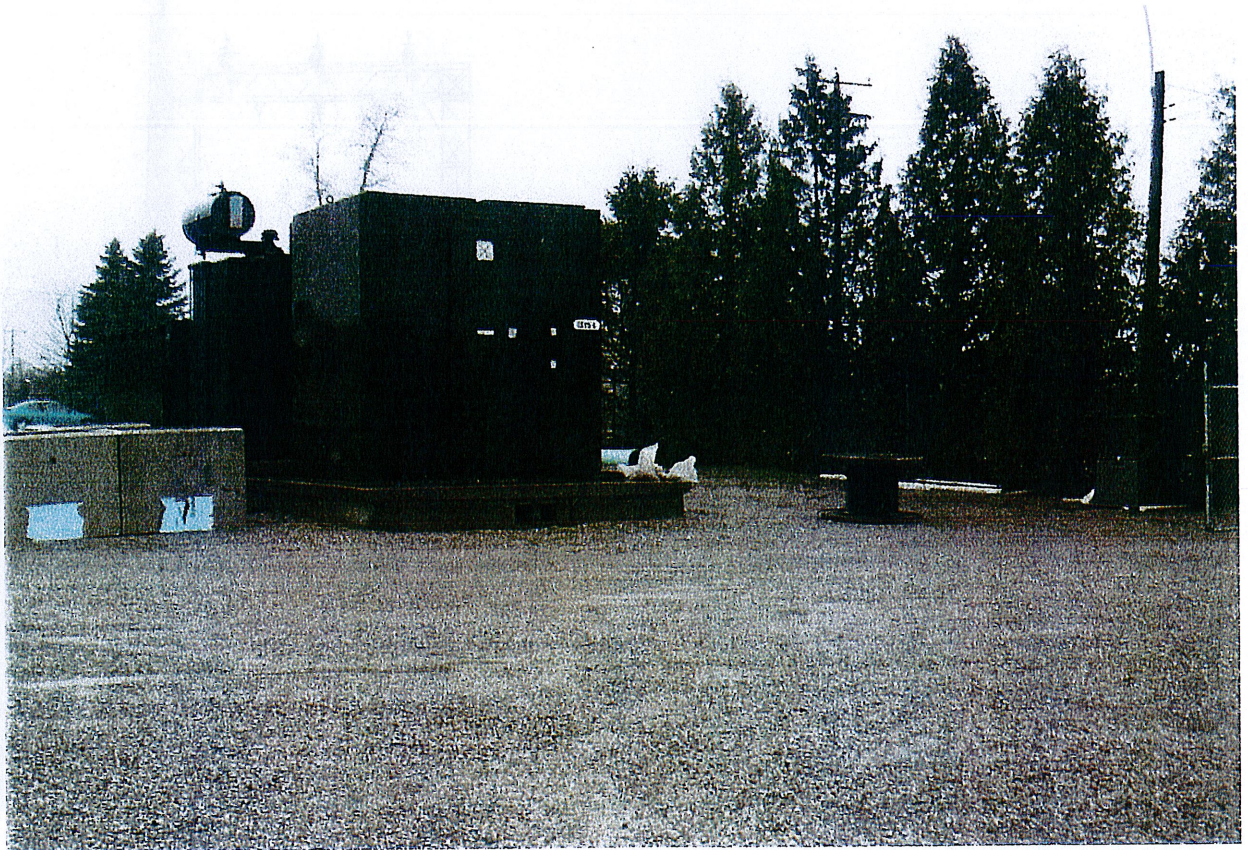
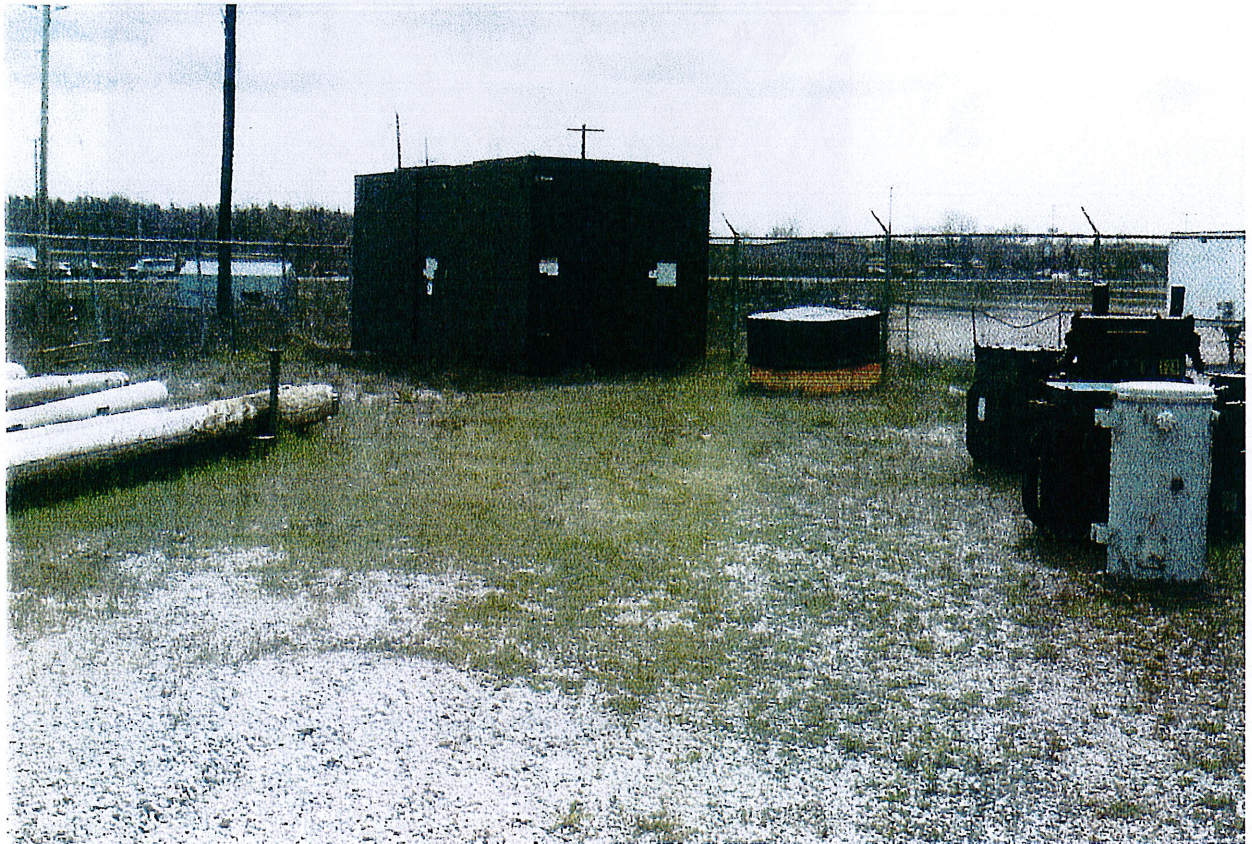
- There is a 5000 kVA transformer located here, 27.6/4.16 kV, 1977 vintage.
- Impedance: 5.24%

- This station supplies three 4.16 kV feeders (one out of service) via air circuit breakers.
- Warning and location signs need to be added at this location.
- Fencing seems adequate; however, severe tree trimming is required along the north fence.
- The 27.6 kV fuses appear to be 125E, which should be adequate.
- Spill containment curb is at this transformer, but it needs to be repaired.
- This site also contains the PCB storage container. Records of PCB transactions are located here, as well as in the office.
- A sign should be added to the main gate to indicate that this is a PCB storage site. The signs on the container are good.
- The long-range plan is to remove #3 MS from service and move it totally to the site of MS#1, and to retire the MS#1 equipment.

- A spill containment curb should be added at MS #5.
- There is a minor oil leak at the transformer, near the base – MS #5.
- ★ **At MS #3, severe tree trimming is required along the north fence.**

- ★ **Spill containment curb needs to be repaired at MS #3.**
- A sign should be added to the main gate, at MS #3, to indicate that this is a PCB storage site.

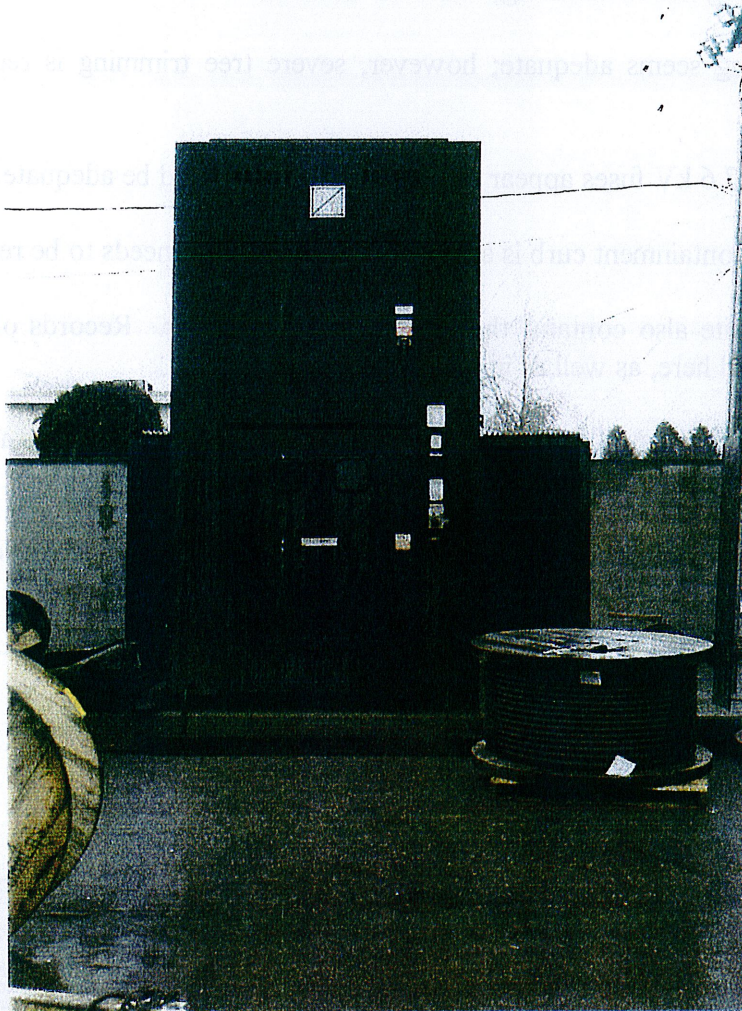
- There is a 5000 kVA transformer located here, 27.6/4.16 kV, 1975 vintage.
- Impedance: 5.49%
- This station supplies four 4.16 kV feeders, via fuses.
- We were unable to determine the size rating of the 27.6 kV fuses.
- Warning and location signs should be added to the gate and fence.

- This station is located in the back yard of the storage-garage building. The gate to the structure is left open during working hours. We believe this is a risky situation, which could be corrected by either adding remote control to the rear gate, or fencing the substation separately.
- There is a propane tank located in this yard as well, which is apparently slated for removal.
- Spill containment curb has been added around the transformer.

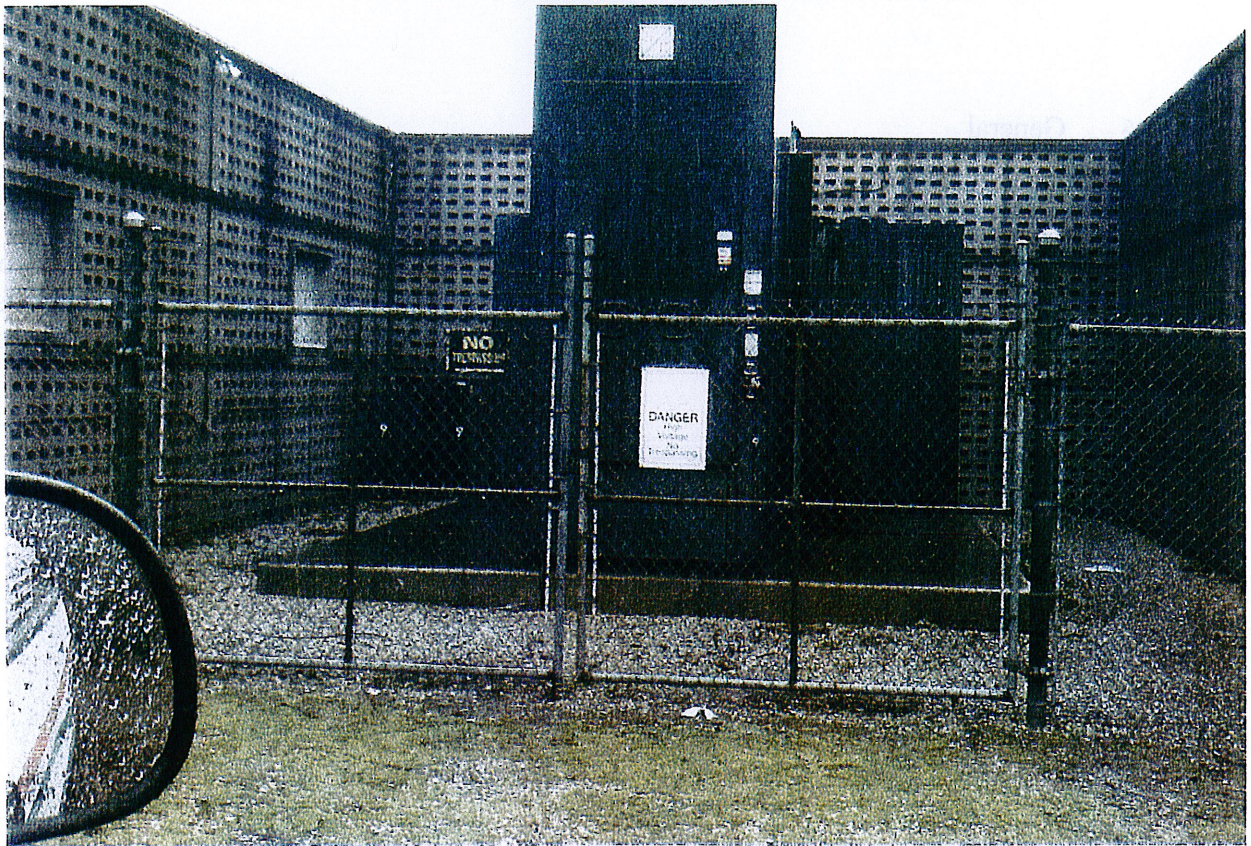
- There is a 5000 kVA, 27.6/4.16 kV transformer located here.
- Impedance: 5.24%
- This station supplies three 4.16 kV feeders via fuses and disconnects on the 4.16 kV.

- We were unable to determine the size rating of the 27.6 kV fuses.
- Fencing is adequate.
- Location signs should be added to the front of the building.
- There is no spill containment, but a curb could be added around the transformer.

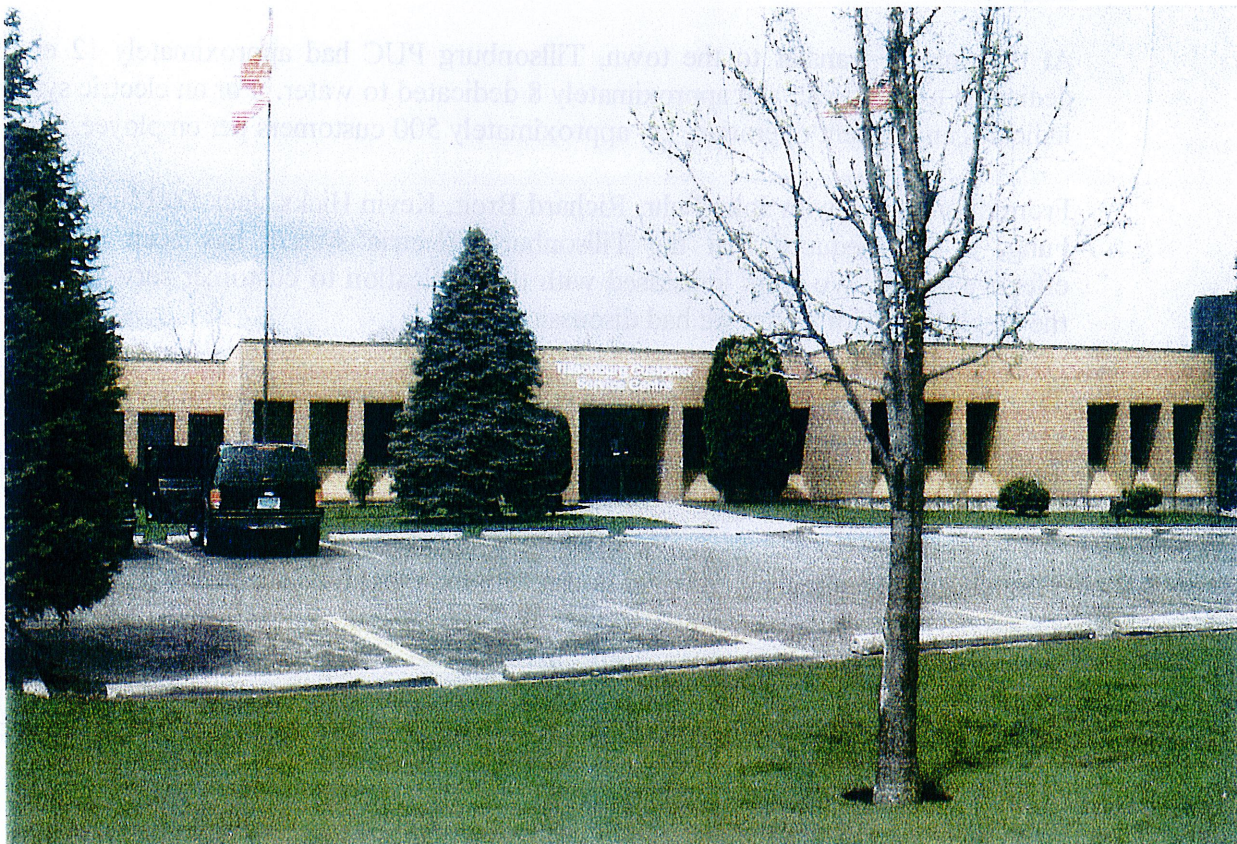
**3.7 Buildings**

As well as the substation properties, Tillsonburg PUC owned the office, garage and warehouse building located at 10 Lisgar Avenue, now known as Tillsonburg Customer Service Centre.
