Re: Enbridge Gas Distribution Inc. ("Enbridge")
EB-2011-0323 Alliston Reinforcement Project
Conditions of Approval - Interim Monitoring Report

**ENBRIDGE GAS DISTRIBUTION INC.
POST-CONSTRUCTION
ENVIRONMENTAL MONITORING REPORT NO.1
ALLISTON PIPELINE REINFORCEMENT PROJECT
EB-2011-0323**

Prepared by
Enbridge Gas Distribution Inc.
May 8, 2013

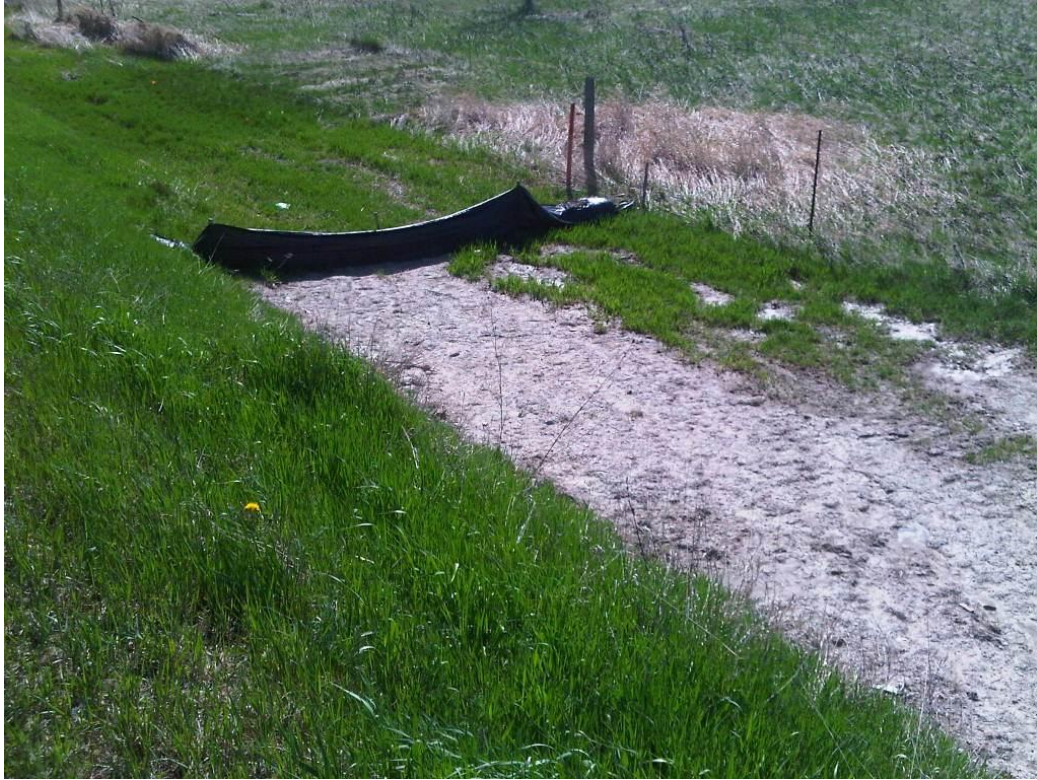
Photo 3: Sediment fence; west of Cookstown Creek

Erosion control devices such as silt fences and straw bale check dams have been installed where required to control any erosion and sedimentation concerns identified. Sediment fencing should be repaired at the Cookstown Creek crossing.

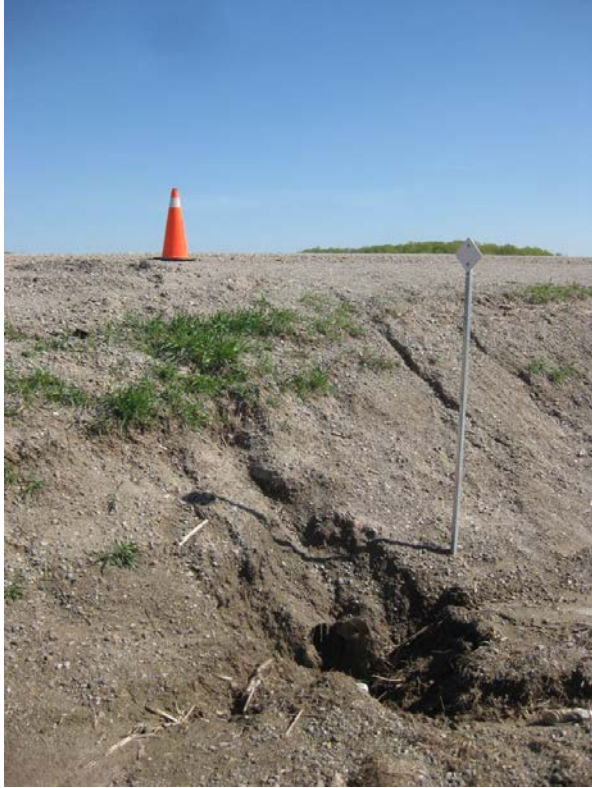
Photo 9 – Highway 89, in vicinity of 9 Line – Obstructed culvert
