**Dow Moore, Corunna and
Seckerton Pipeline Project
Final Post Construction
Environmental Monitoring Report**

EB-2010-0302

Prepared by:
Stantec Consulting Ltd.
300-675 Cochrane Drive, West Tower
Markham, ON L3R 0B8

June 27, 2013

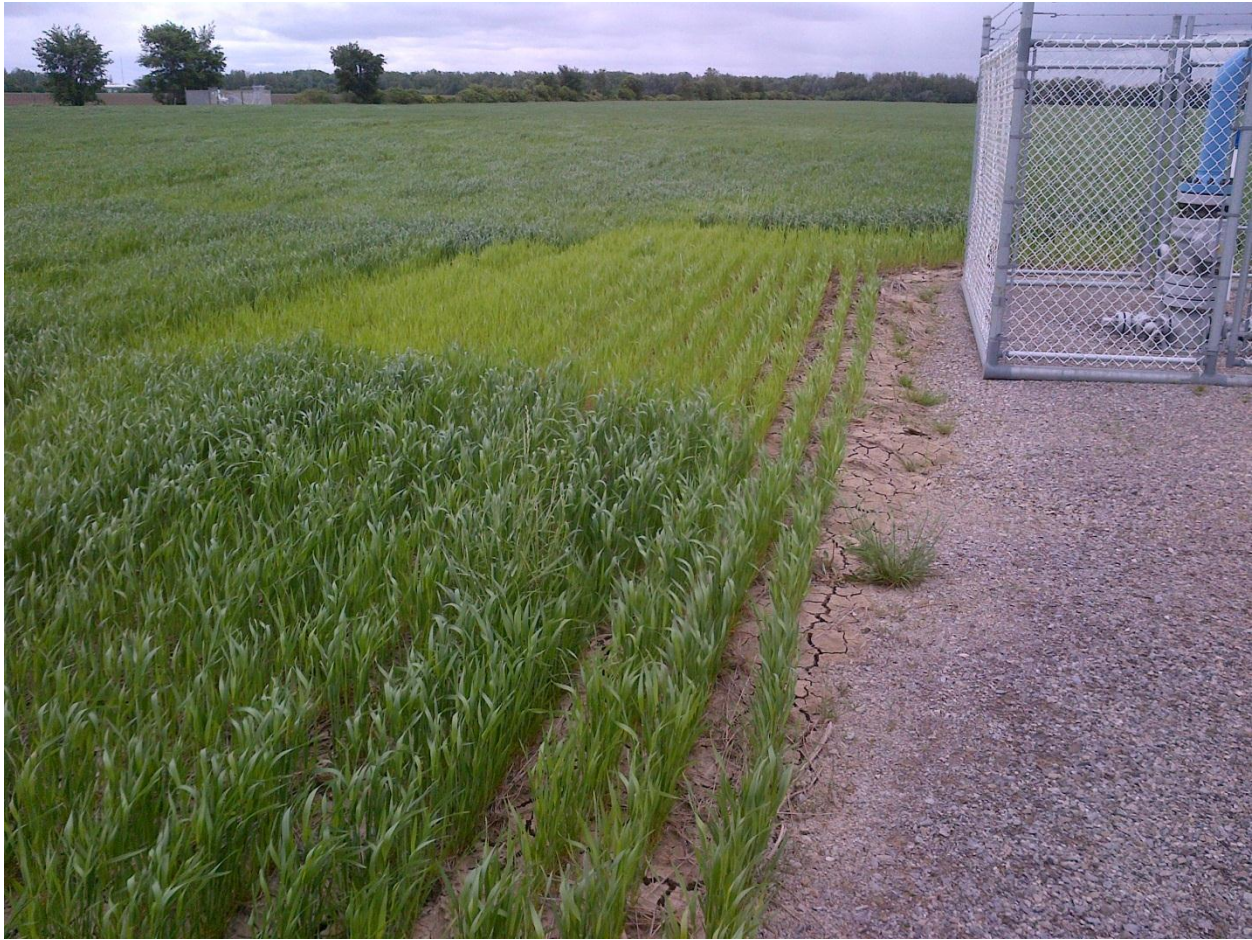
There were some crops planted in fall 2012 that appear to have potentially been affected (limited germination rates) within proximity to areas which were disturbed in 2011 or within the ROW compared to vegetation establishment at other areas adjacent the ROW. Crop establishment rates appear to be affected by potential water impoundment limiting germination rates as they appear correlated with micro-topographical low areas within the flat field (see Photo 4). These issues are assumed to be primarily a surficial drainage issue that should improve once repairs to drainage tiles have been executed and drainage can appropriately be maintained.

Photo 1 **Crop establishment affected on a previously disturbed area on the southern portion of the Seckerton Gathering Line (May 24, 2013).**

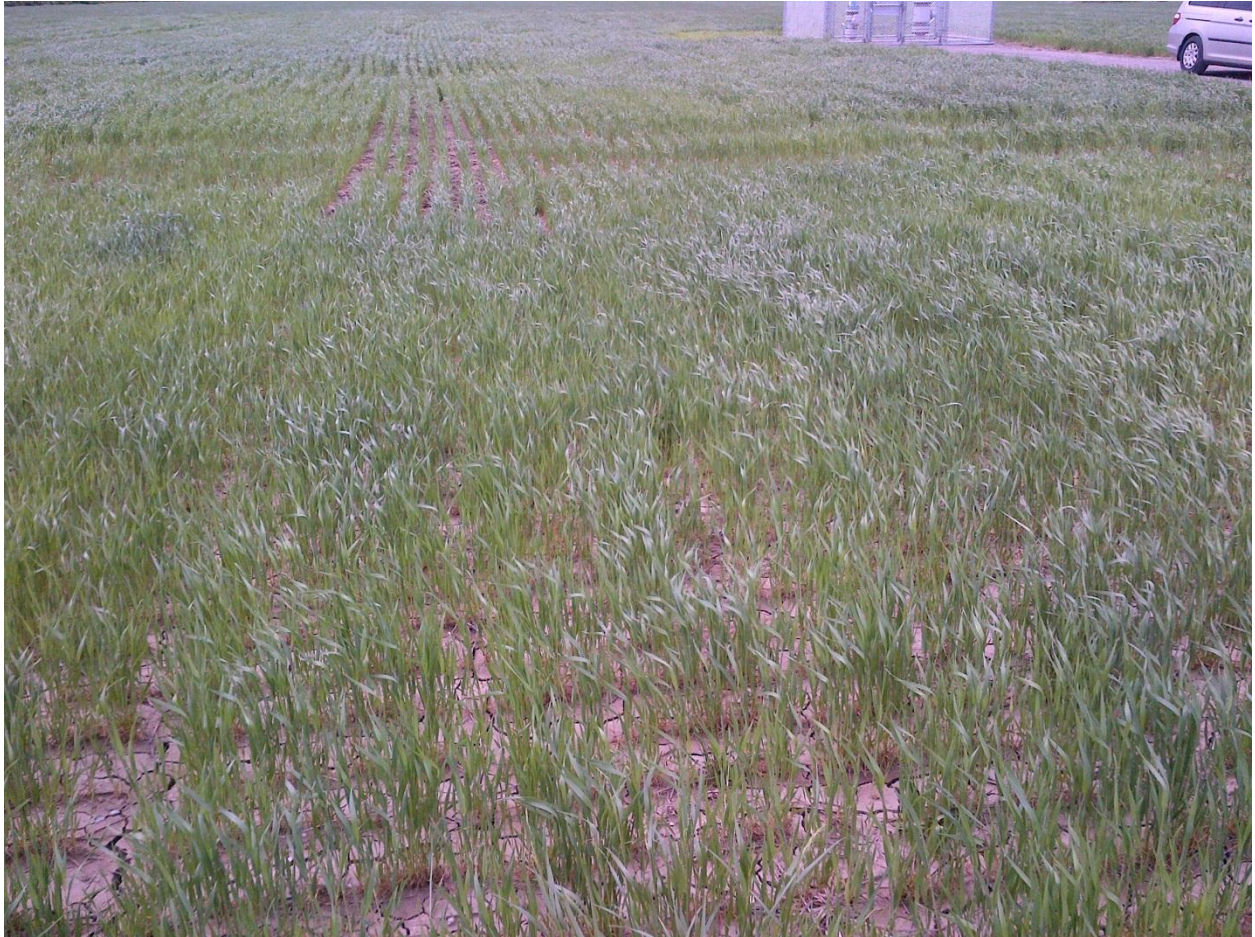
Photo 2 Crop establishment affected on a previously disturbed area on the southern portion of the Seckerton Gathering Line (May 24, 2013).

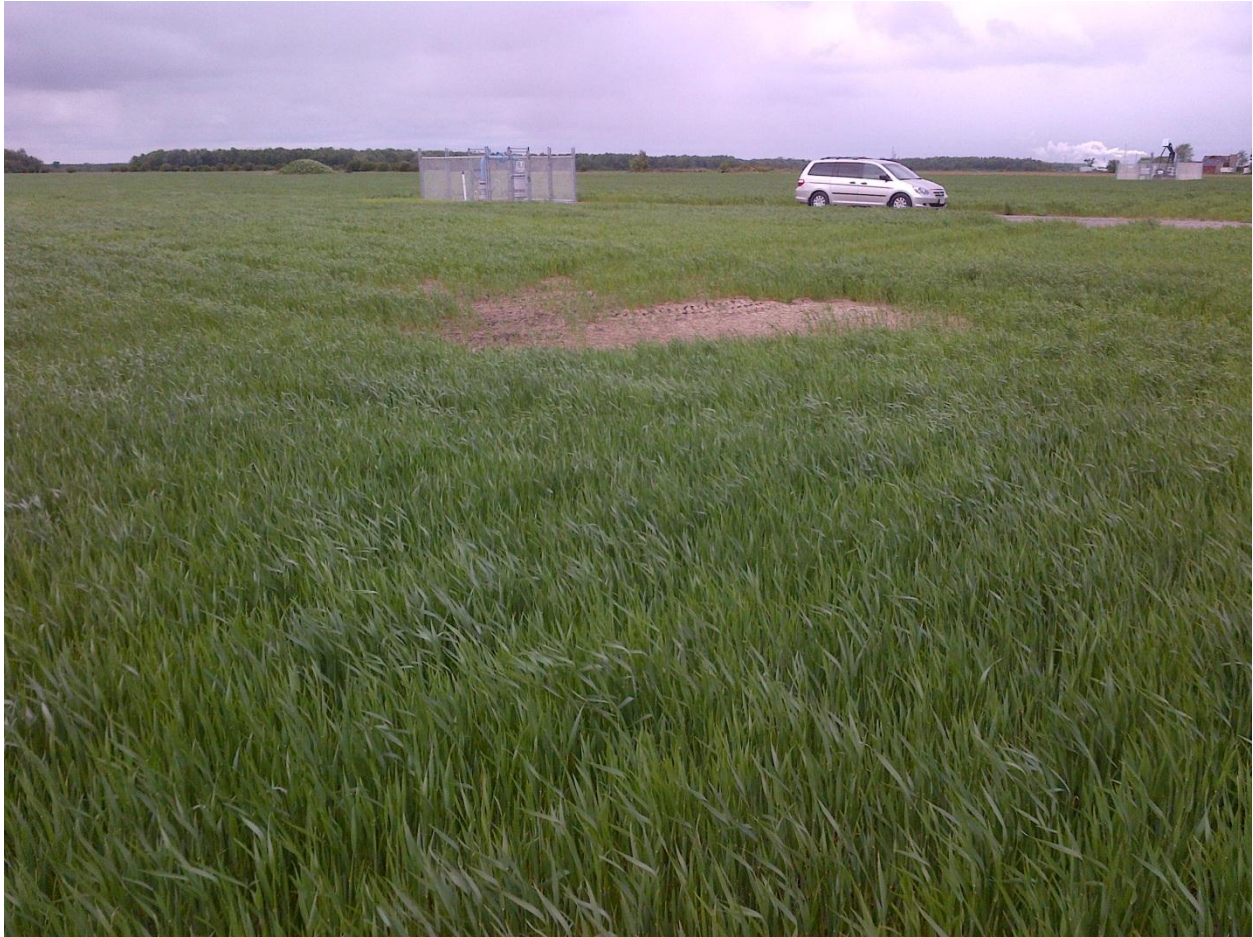
Photo 3 Bare area with limited crop establishment on the south end of the Seckerton Gathering Line assumed to be a result of water impoundment (May 24, 2013).

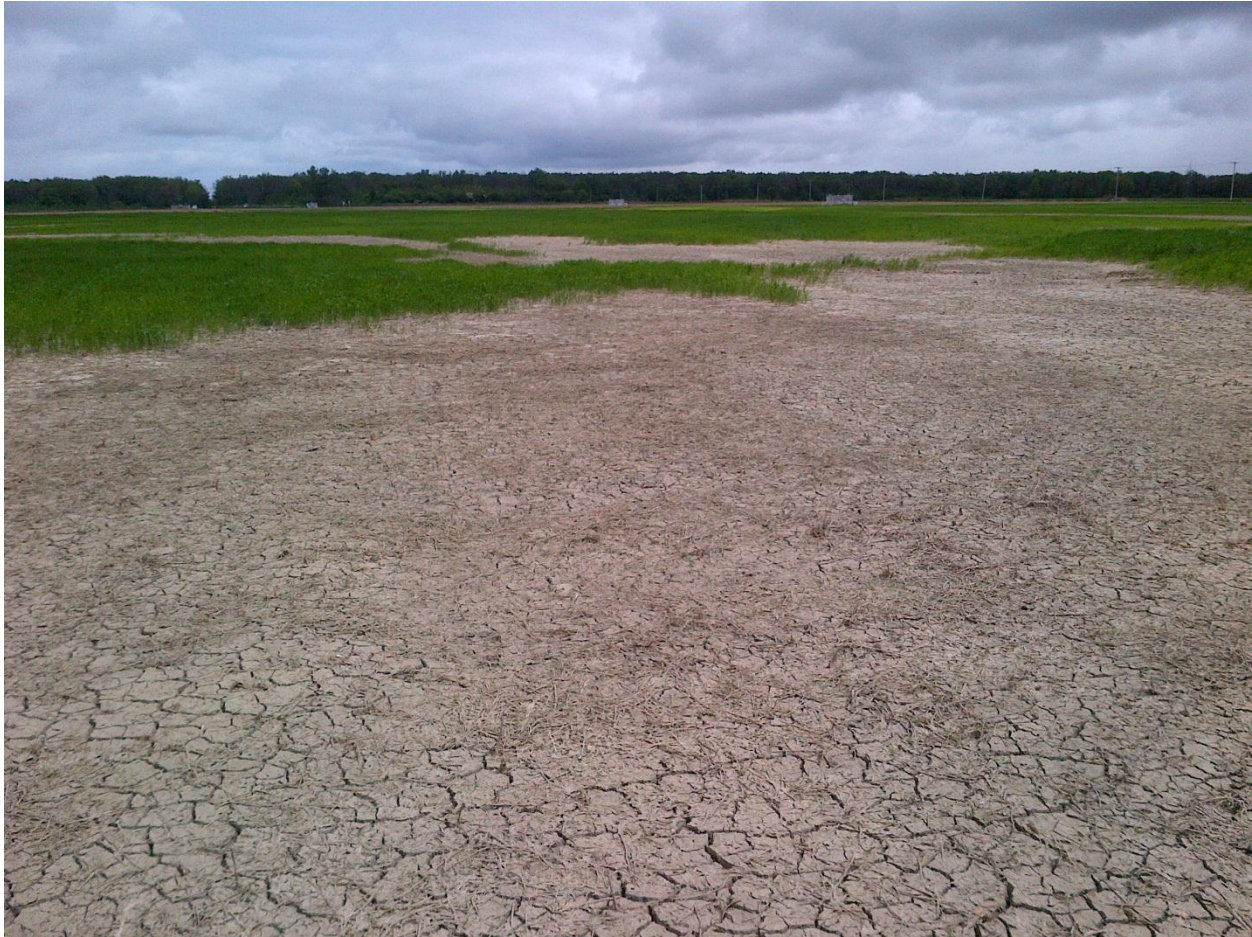
Photo 4 **Bare area with limited crop establishment on the Seckerton Gathering Line directly north of Rokeby Line (May 24, 2013).**

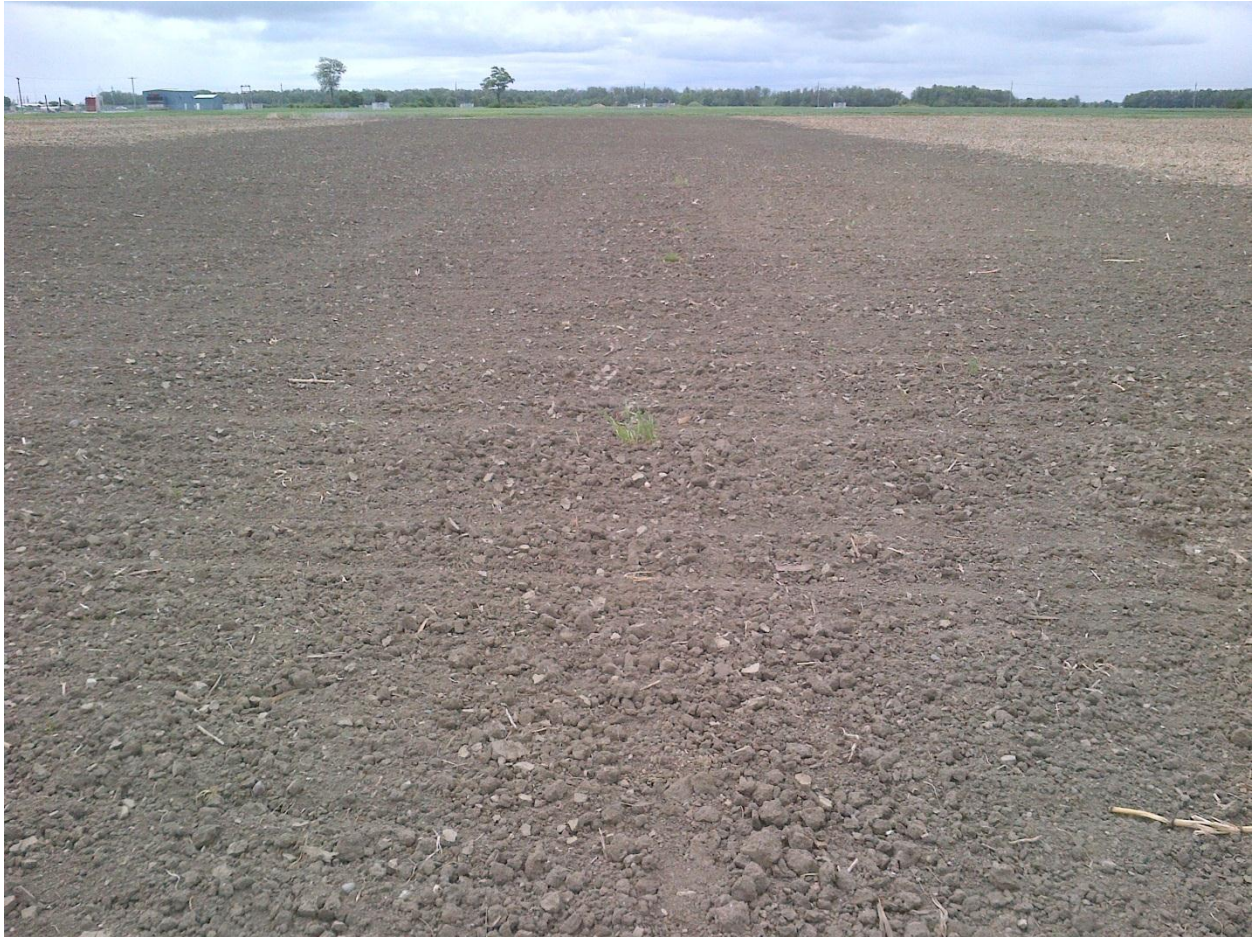
Photo 5 Recently cultivated topsoil near the north end of the Seckerton Gathering Line (May 24, 2013).

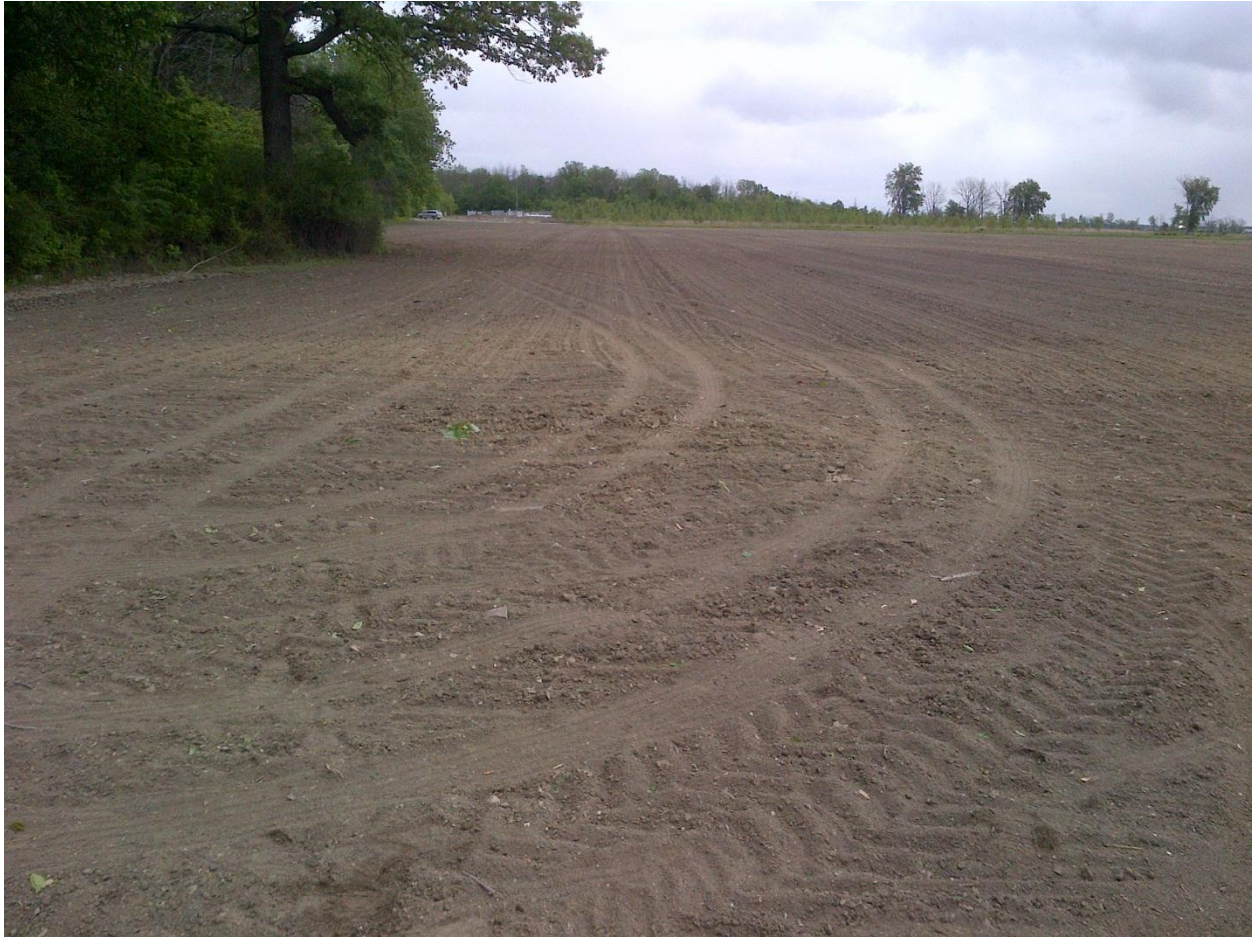
Photo 6 Recently cultivated topsoil along the Interconnect Pipeline directly south of the Dow Moore Metering Station (May 24, 2013).

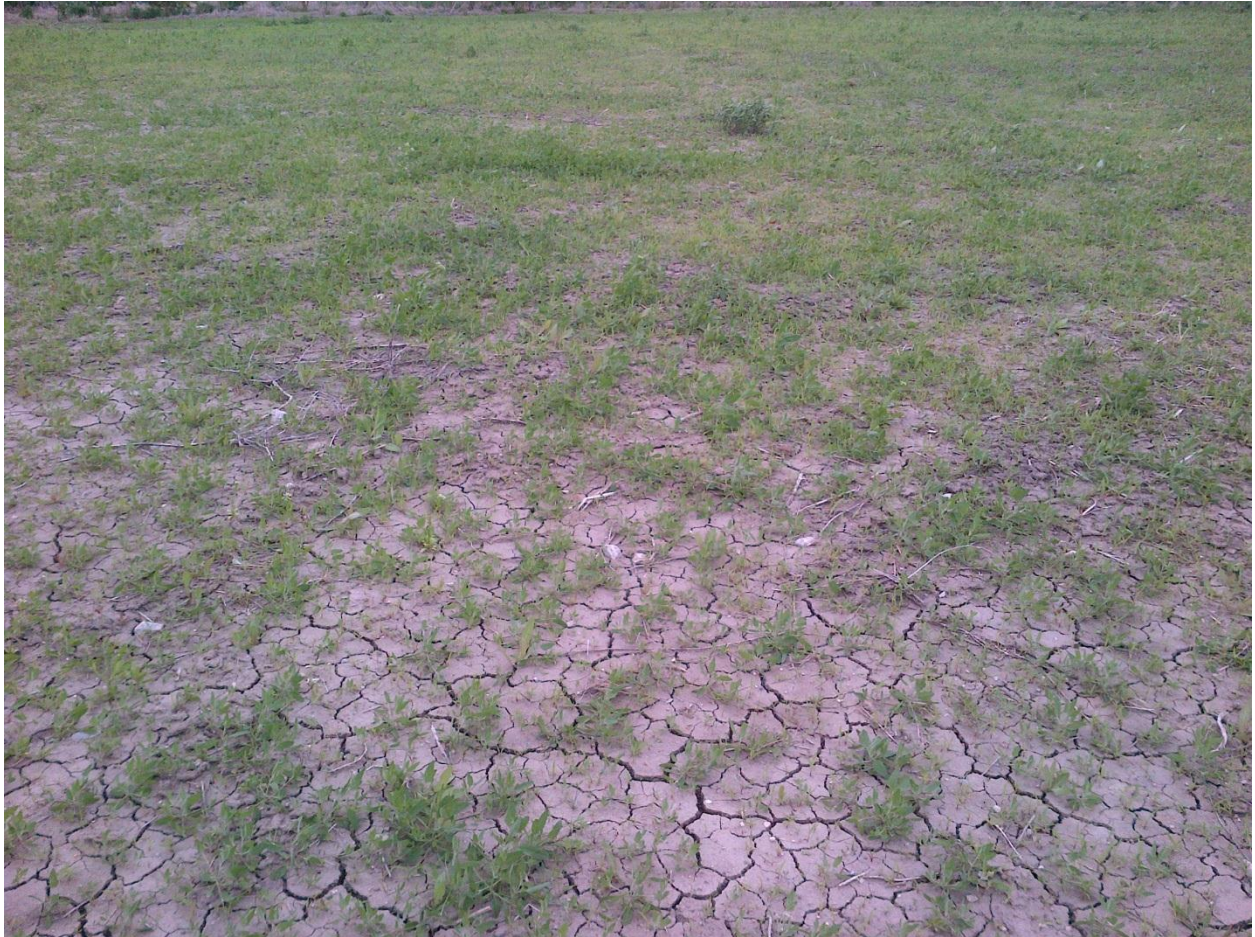
Vegetation re-establishment also appears limited within some of the non-cultivated fields on the ROW (see Photos 7 and 8). An additional seeding program is recommended to be considered with an appropriate seed mix to limit weed establishment on these disturbed areas.

Photo 7 **Current vegetation conditions in a non-cultivated natural area on the ROW at the Seckerton Meter Station Tie-in (May 24, 2013).**

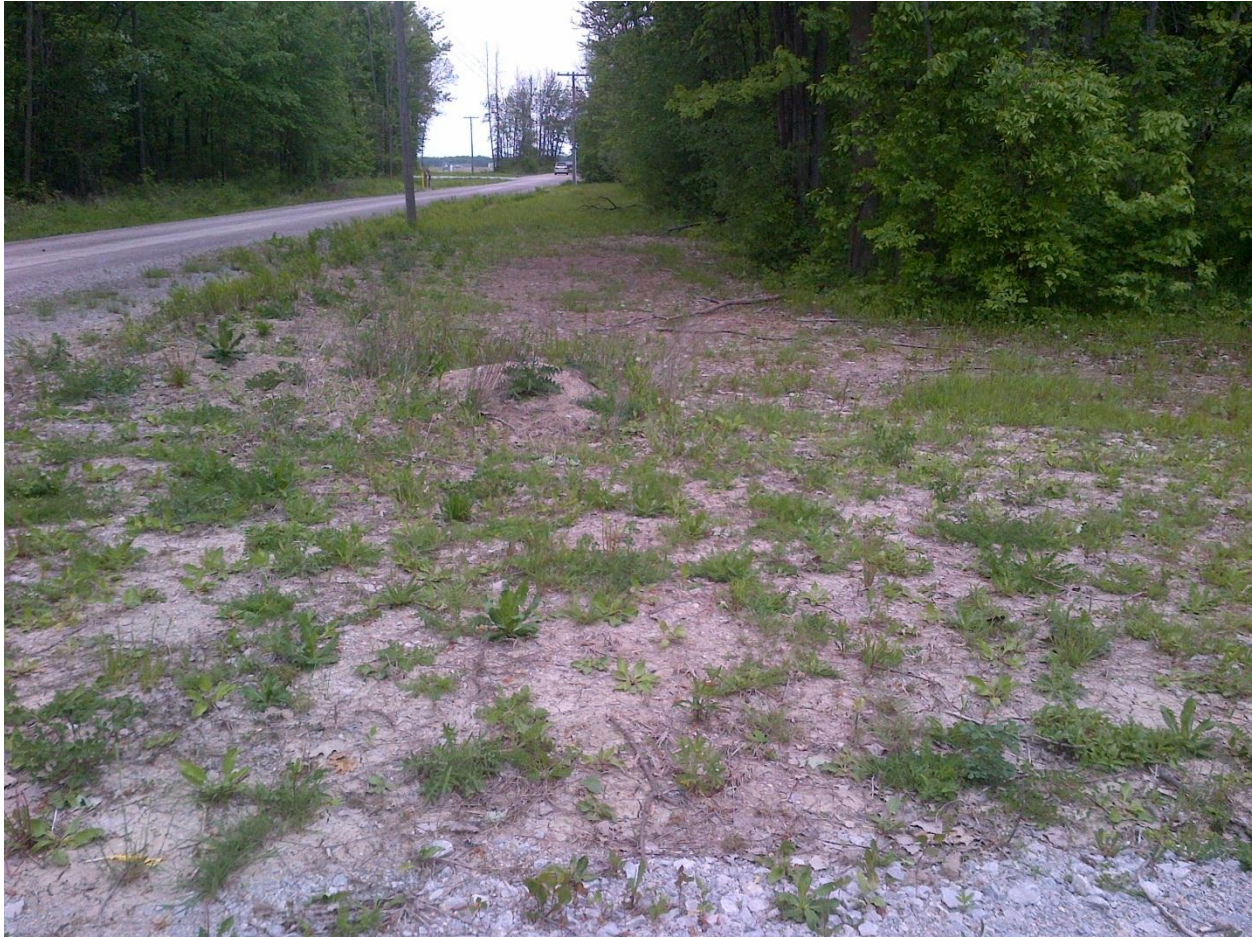
Photo 8 Vegetation establishment within the ROW bi-secting the woodlot on the Interconnect Pipeline, north of the Seckerton Meter Station (May 24, 2013).

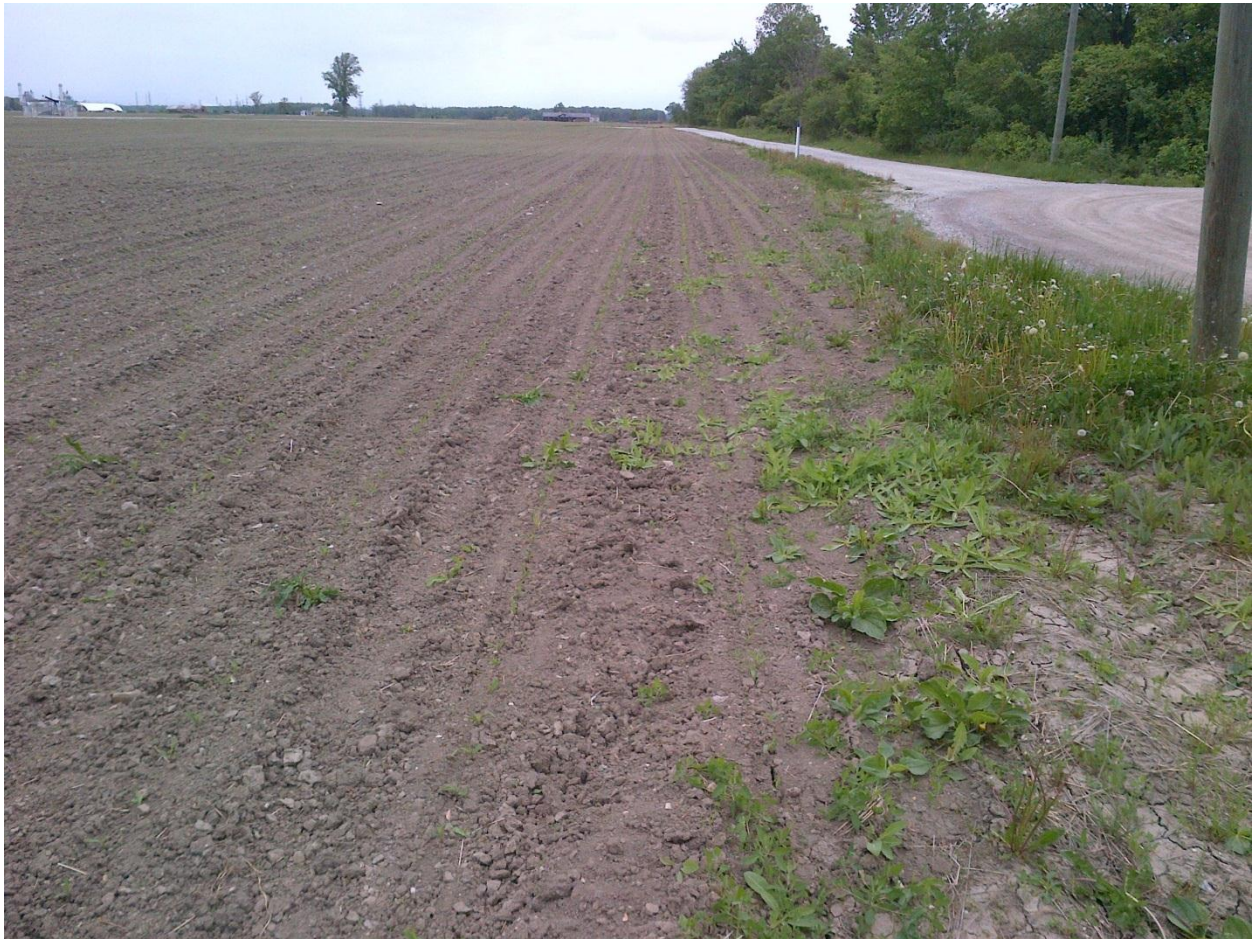
Photo 9 Recently cultivated topsoil on the Interconnect Pipeline ROW adjacent the existing access road (May 24, 2013).

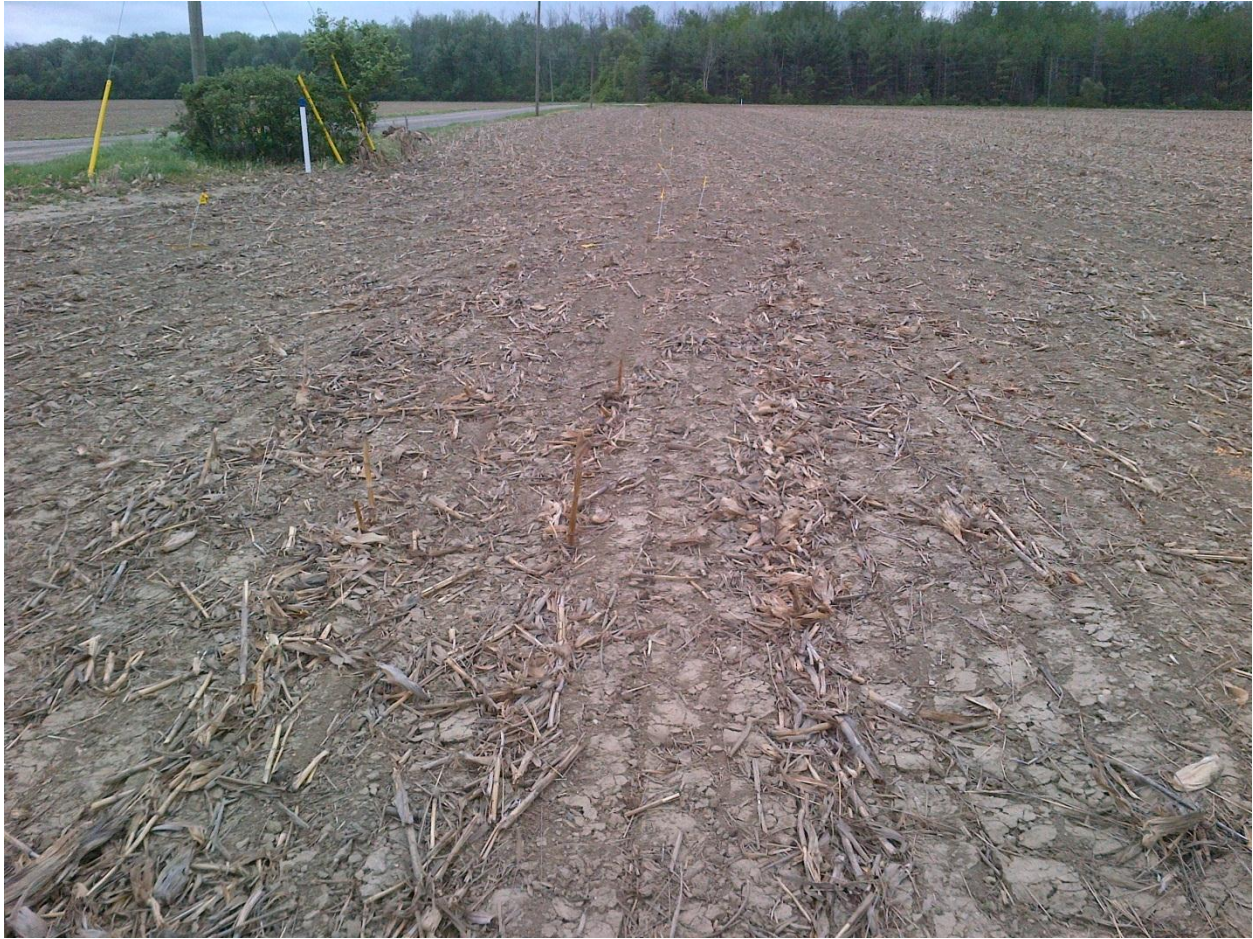
Photo 10 Recently cultivated topsoil on the Interconnect Pipeline ROW west of the Corunna Tie-in (May 24, 2013).
