Re: Enbridge Gas Distribution Inc. ("Enbridge")
EB-2012-0031 Angus Reinforcement Pipeline Project
Conditions of Approval - Interim Monitoring Report

**ENBRIDGE GAS DISTRIBUTION INC.
POST-CONSTRUCTION
ENVIRONMENTAL MONITORING REPORT NO.1
ANGUS REINFORCEMENT PIPELINE PROJECT
EB-2012-0013**

Prepared by
Enbridge Gas Distribution Inc.
July 22, 2013

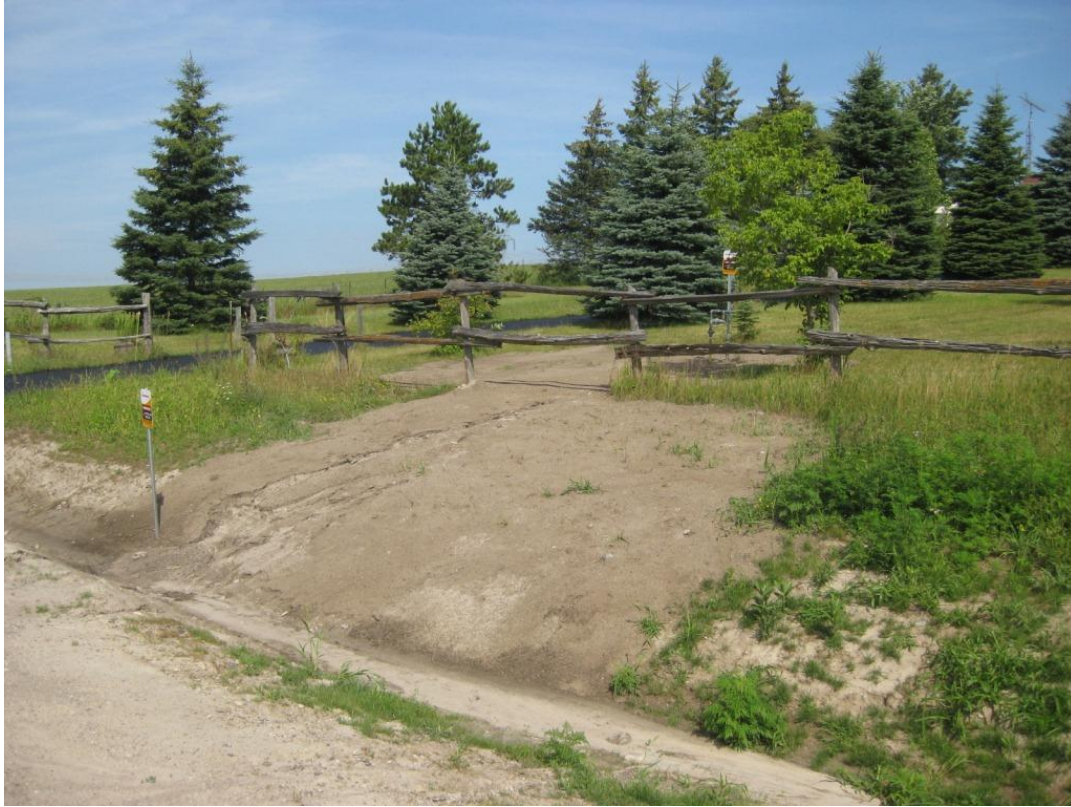
Vegetation has re-established along portions of the road allowance where it was disturbed due to construction. However, a significant number of sections will require additional restoration and revegetation, these include road allowances on the north side of County Road 21 in the vicinity of these addresses:

Photo 3: 5162 County Road 21 looking north; ground disturbance resulted from gas service installation, not pipeline construction

These sections will require monitoring over the next year to identify the success of revegetation efforts and to identify areas that will require further efforts.

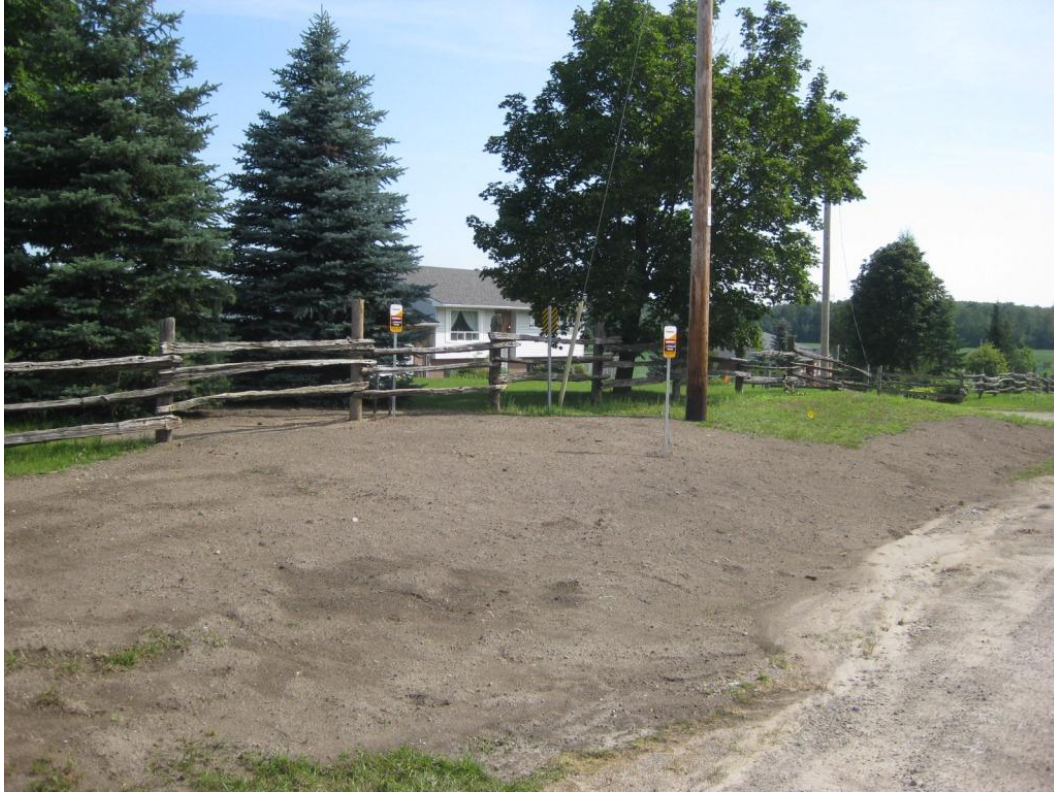
Photo 7: 5628 County Road 21 looking east; ground disturbance resulted from gas service installation, not pipeline construction
