# **Wellington North Power Inc.**

2014 Distribution Rate Application

Response to Board Staff Interrogatories

OEB File Number: EB-2013-0178

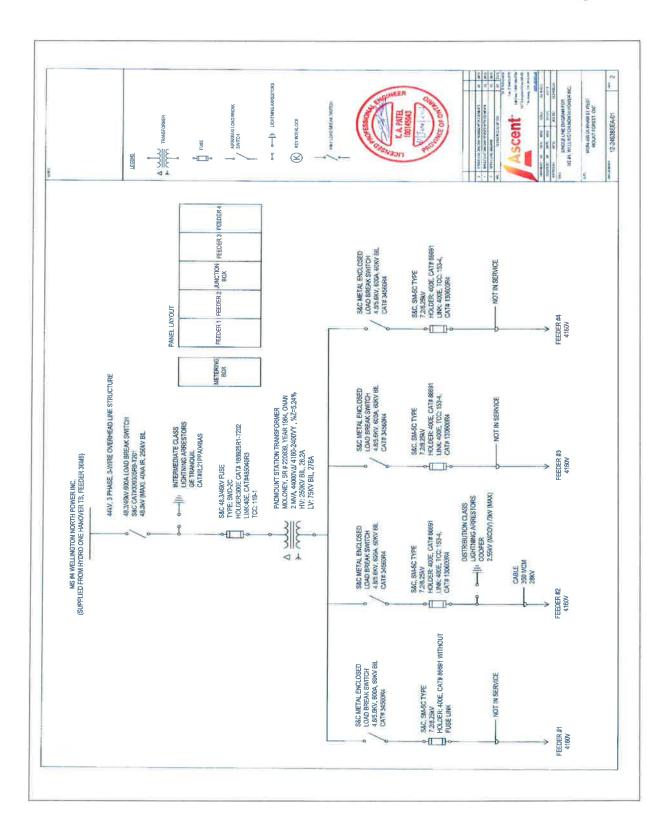
The Mt. Forest substation is the oldest of the utility at an age of 49 years, it also shares many of the same issues as other stations in terms safety and shows signs of age. It does although contain a much more serious issue. The system neutral has been attached only to the station ground grid, which in extremely dangerous, Due to this fact, it was recommended that the station be de-energized during inspection. The neutral system must be re-engineered prior to re-energization.

Inspection revealed that other equipment deficiencies are also present. The transformer secondary side cables are improperly installed and are putting pressure on the transformer radiator. Furthermore, test results also suggest that there are problems with feeder cables.

Remaining problems found in the station are similar as in the other stations. There are missing locks on power transformers and distribution-side switchgear, wiring code violations, bonding and grounding issues and operating nomenclature must be updated.

The station is classified as "Red" due to the age of the transformer, the system neutral connection, and diagnostic test results. This station is a candidate for replacement.

Comments:	Recomme	noted de	e-energ	ization	immediat	ely
System	neutral	must be	18-engi	neered	and replac	cod Concern Lesting.
0011	101171011	D. S. Section Ch.	Carrifes	12-15 10	0/1 / 5 6 6/1/	70377191
