Re: Enbridge Gas Distribution Inc. ("Enbridge")
EB-2012-0013 Angus Reinforcement Pipeline Project
Conditions of Approval - Final Monitoring Report

**ENBRIDGE GAS DISTRIBUTION INC.
POST-CONSTRUCTION
ENVIRONMENTAL MONITORING REPORT NO.2
ANGUS REINFORCEMENT PIPELINE PROJECT
EB-2012-0013**

Prepared by
Enbridge Gas Distribution Inc.
May 27, 2014

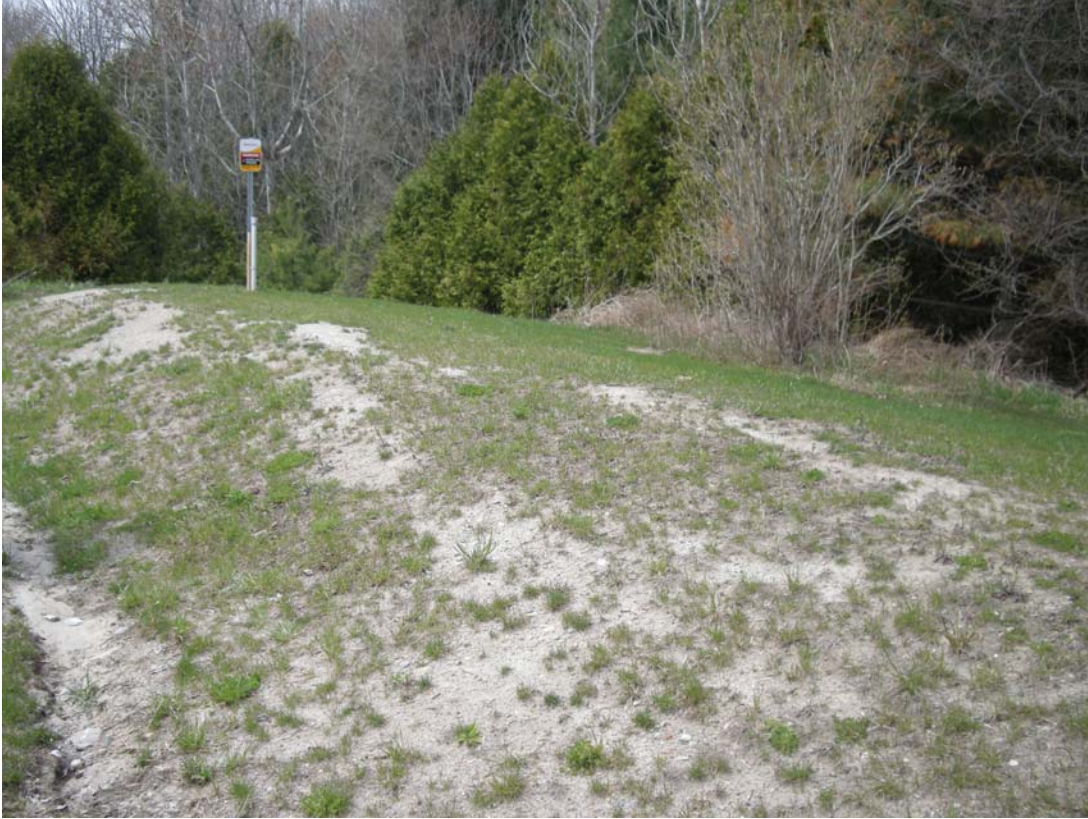
Photo 1: Looking west of 4940 County Road 21

- South side of Innisfil Beach Road in vicinity of 4118 Innisfil Beach Road
- Approx. 20 meters west of 4940 County Road 21
- Approx. 100 meters west of 4992 County Road 21
- North side of County Road 21 in vicinity of 5327 County Road 21

Erosion, evidenced by rills and gullies in the bank and ditch of the road allowance occurred along several sections of the north side of County Road 21 (refer to locations above). This was addressed by regrading the areas, covering the areas with topsoil followed by the appropriate seed mix and covered with coir erosion control matting but most of the above areas require additional attention and restoration, which will be completed by the end of September, 2014.

Vegetation has reestablished along the road allowances in some of the areas mentioned above where it was disturbed due to construction but most areas require additional attention and restoration efforts, which will be completed by the end of September, 2014.

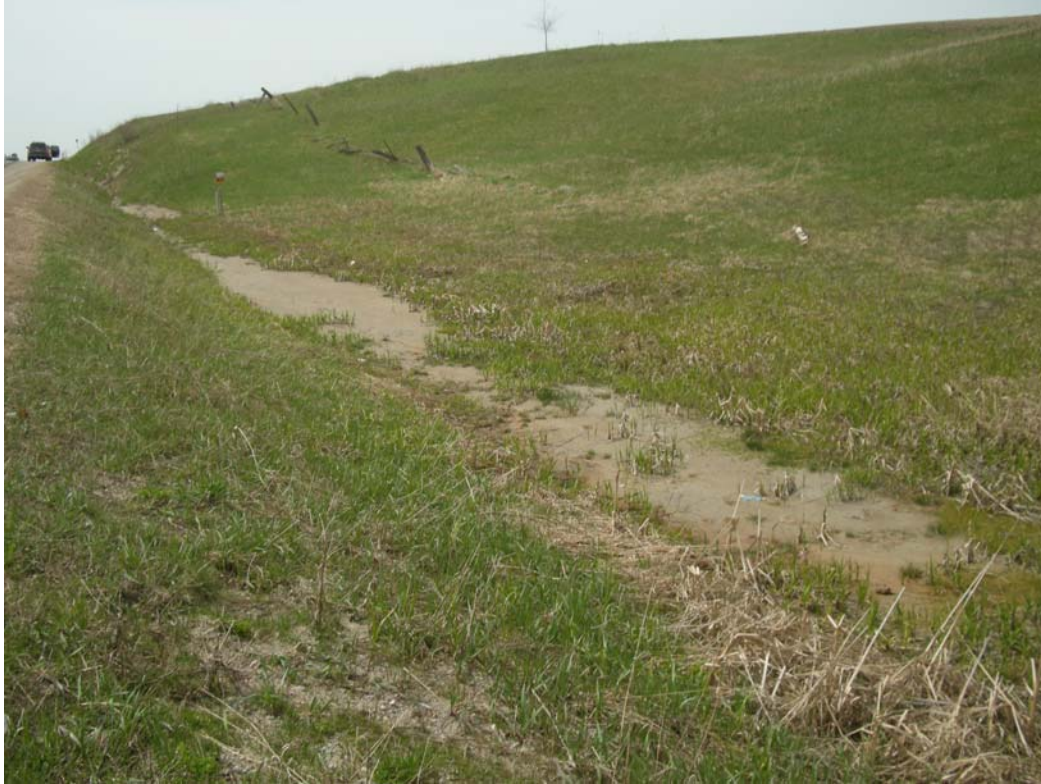
Photo 3: Looking west of 4992 County Road 21

Erosion control devices such as silt fences and straw bales were installed where required to control any erosion and sedimentation concerns identified. The straw bales at the following location will be removed:

- Approx. 20 meters west of 4992 County Road 21

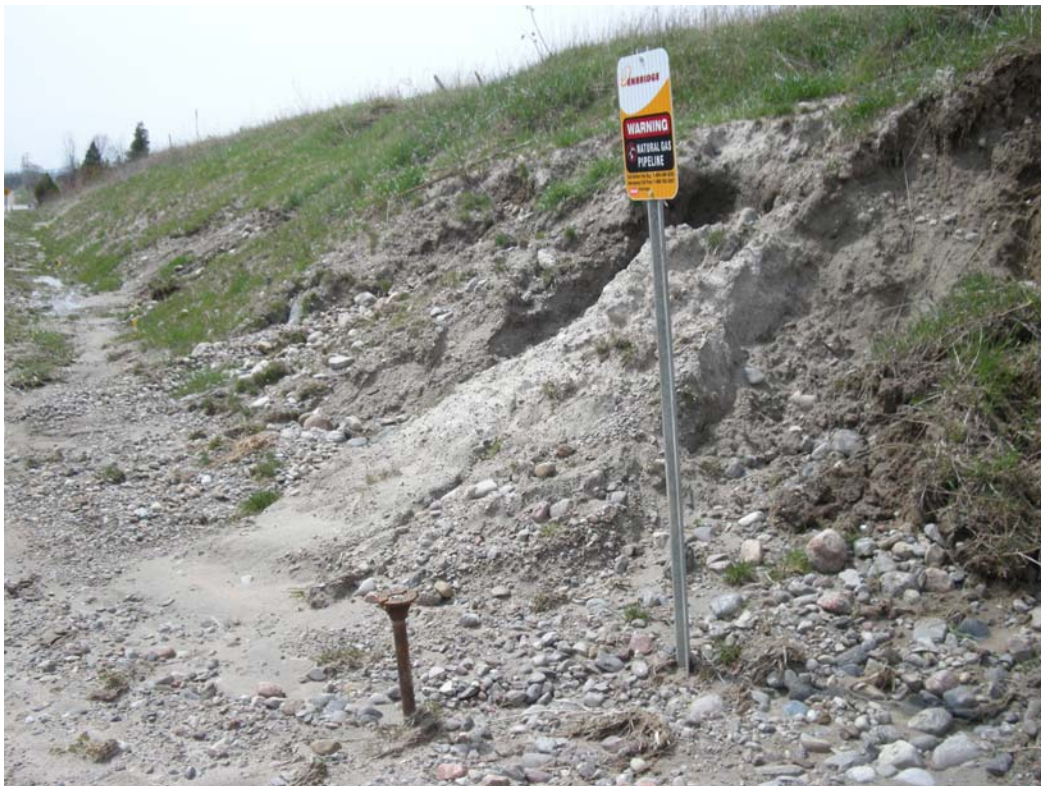
Photo 4: Looking west on north side of County Road 21 in vicinity of 5057 County Road 21

- 4905 County Road 21
- 5977 County Road 21
- 5057 County Road 21
- 5162 County Road 21
- 5628 County Road 21
- 6070 County Road 21
