**Re: Enbridge Gas Distribution Inc. ("Enbridge")
EB-2011-0323 Alliston Pipeline Reinforcement Project
Conditions of Approval - Final Monitoring Report**

**ENBRIDGE GAS DISTRIBUTION INC.
POST-CONSTRUCTION
ENVIRONMENTAL MONITORING REPORT NO.2
ALLISTON PIPELINE REINFORCEMENT PROJECT
EB-2011-0323**

Prepared by
Enbridge Gas Distribution Inc.
May 29, 2014

PHOTO LOG (May 23, 2014)

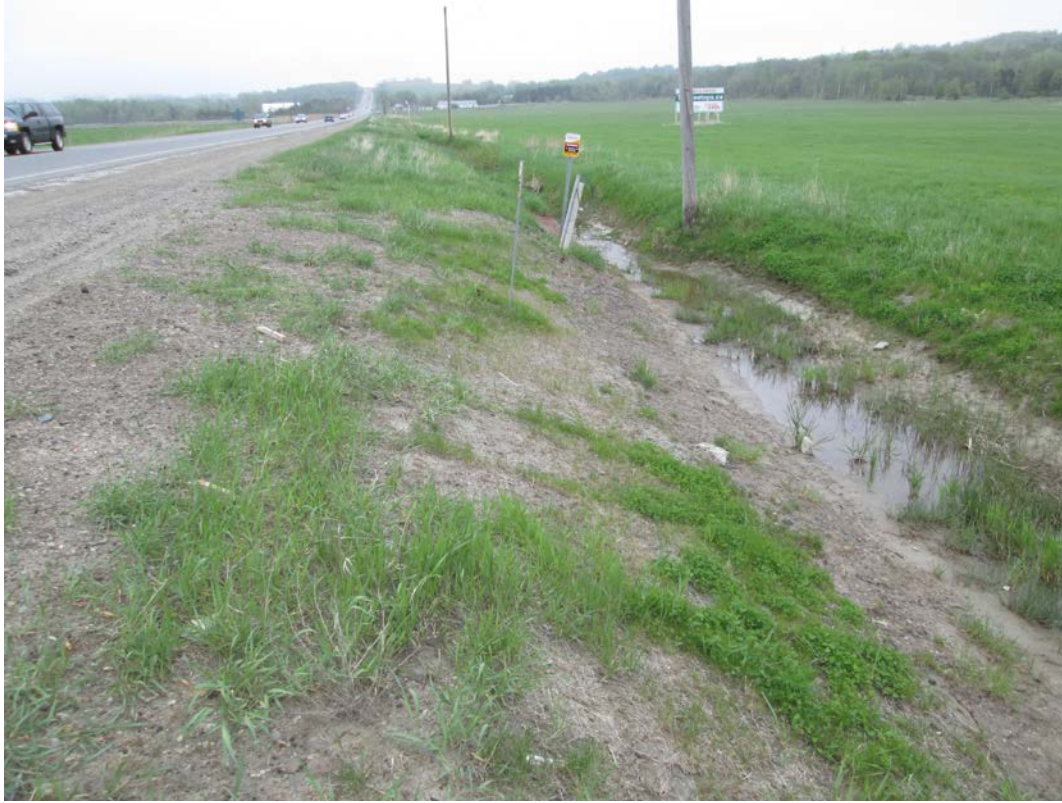
Photo 3: 5856 Highway 89 (south side of roadway)

Soil settlement, evidenced by sinkholes, occurred in the vicinity of the valve stem located on the south side of Highway 89, at 5856 Highway 89. Regrading, along with revegetation was undertaken to restore the appropriate grade. Due to the extreme winter weather, full vegetative growth was delayed. Additional topsoil and seed with erosion control matting will be added to this location by the end of September, 2014.
