Re: Enbridge Gas Distribution Inc. ("Enbridge")
EB-2012-0382 Durham York Energy Centre
Conditions of Approval - Interim Monitoring Report

ENBRIDGE GAS DISTRIBUTION INC. POST-CONSTRUCTION ENVIRONMENTAL MONITORING REPORT NO.1

DURHAM YORK ENERGY CENTRE PIPELINE EB-2012-0382

Prepared by Enbridge Gas Distribution Inc. June 24, 2014

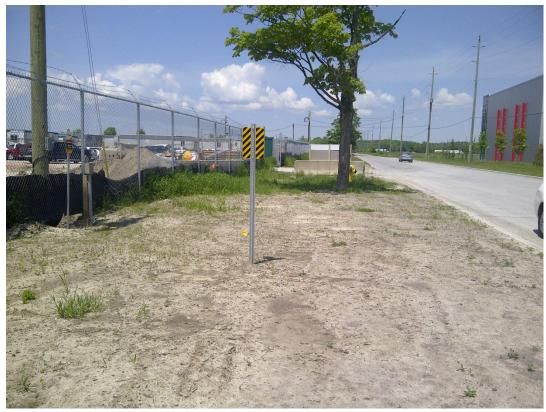
Photo 1: Approx. 450m south of South Service Road on west side of Osborne Road

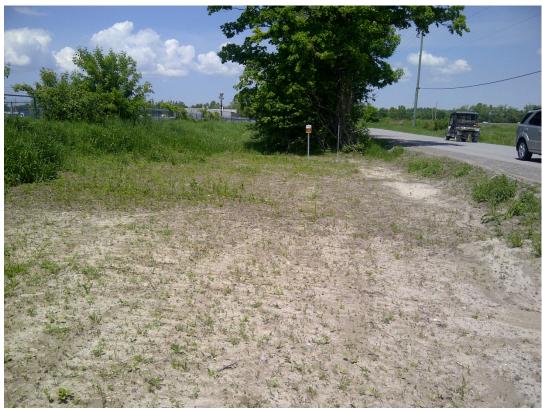
Photo 2: Approx. 300m south of South Service Road on west side of Osborne Road

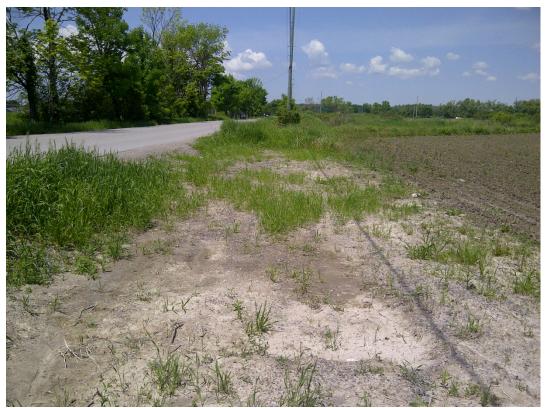
Photo 1: Approx. 300m south of South Service Road on east side of Osborne Road

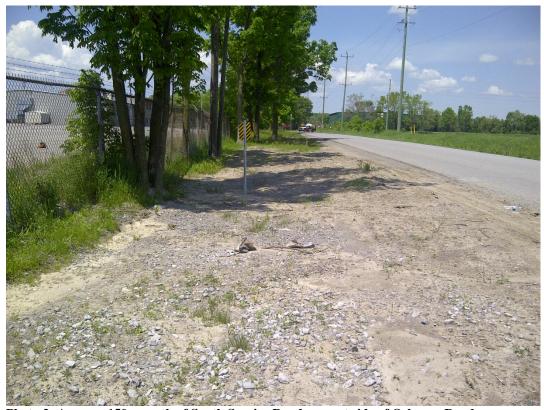
Photo 2: Approx. 150m south of South Service Road on west side of Osborne Road

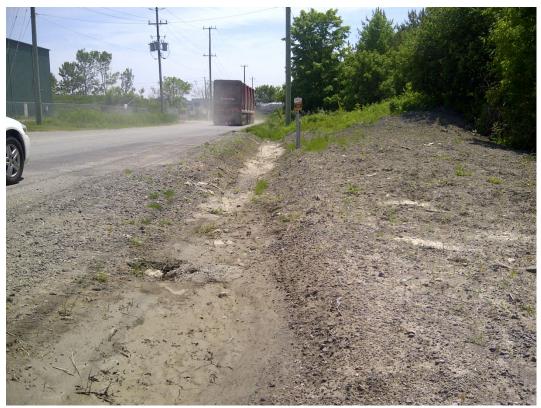
Photo 3: Approx. 200m south of Baseline Road on west side of McKnight Road

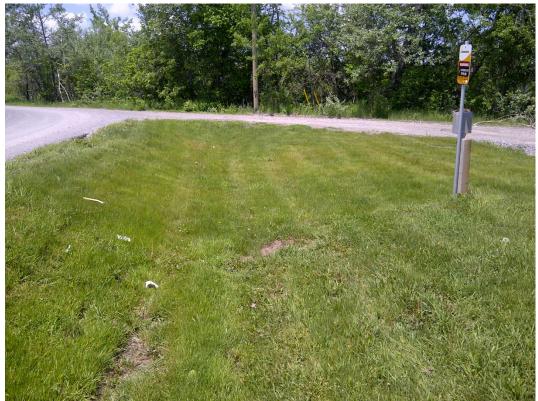
Photo 4: Approx. 100m south of Baseline Road on east side of McKnight Road

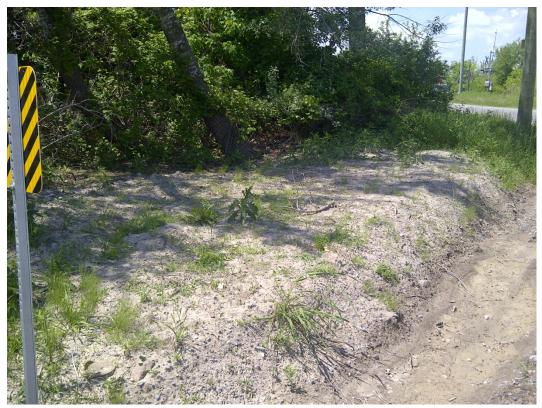
Photo 5: Approx. 100m south of Baseline Road on west side of McKnight Road

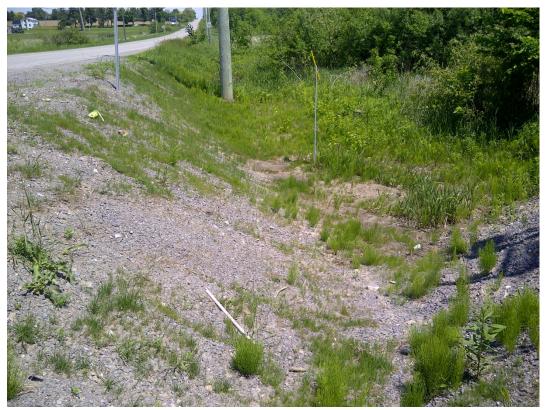
Photo 6: South side of Baseline Road across from Hancock Road

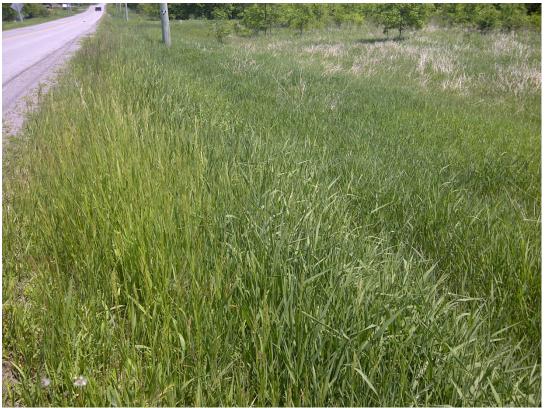
Photo 7: Approx. 50m east of Hancock Road on south side of Baseline Road

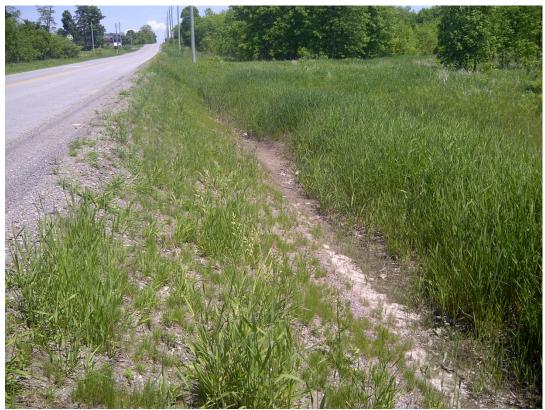
Photo 8: Across from 1892 Baseline Road on the south side

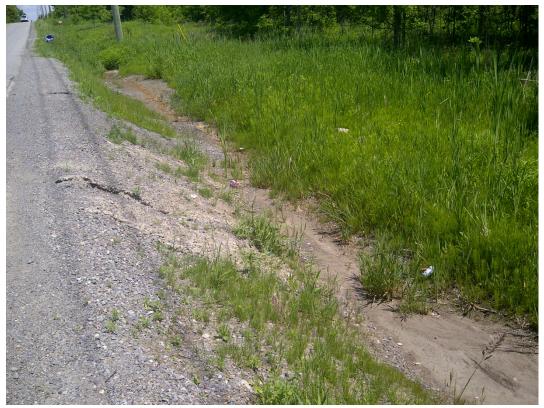
Photo 9: Approx. 40m east of 1898 Baseline Road on the south side

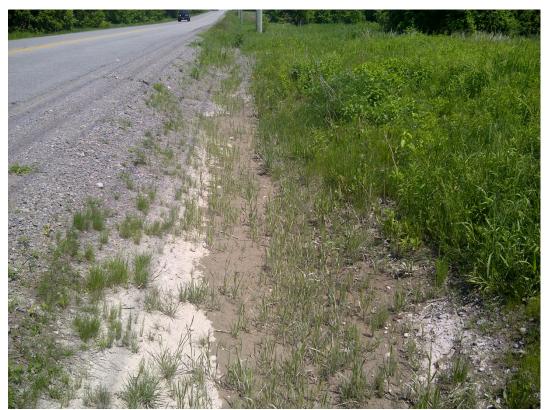
Photo 10: Approx. 150m east of 1898 Baseline Road on the south side

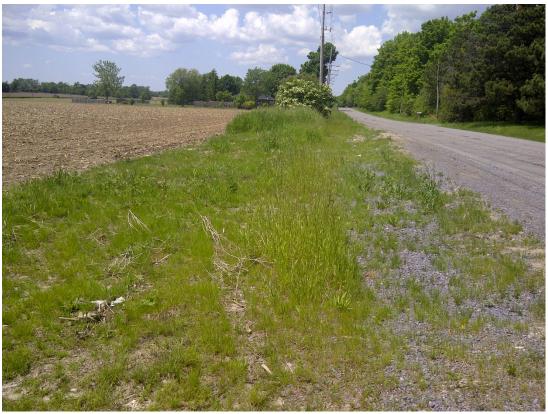
Photo 11: Approx. 100m north of Baseline Road on west side of Solina Road

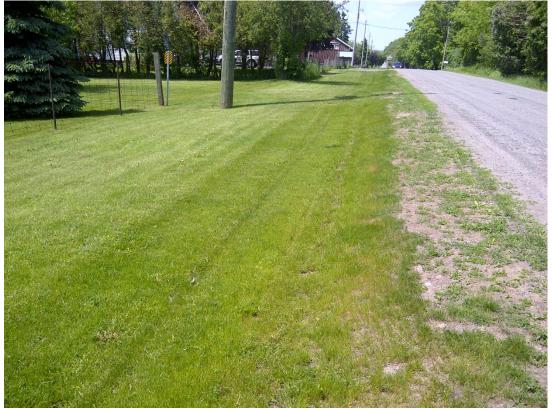
Photo 12: 1184 Solina Road

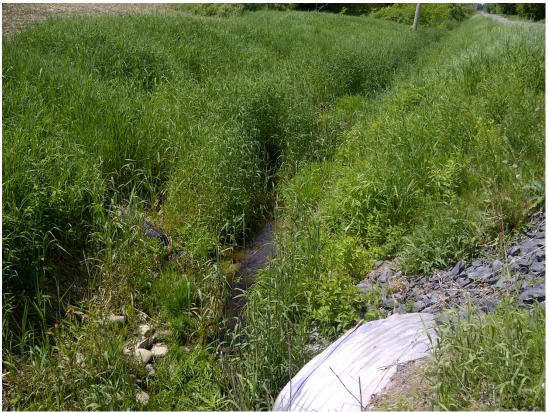
Photo 13: Approx. 200m north of 1480 Solina Road on west side (Darlington Creek)

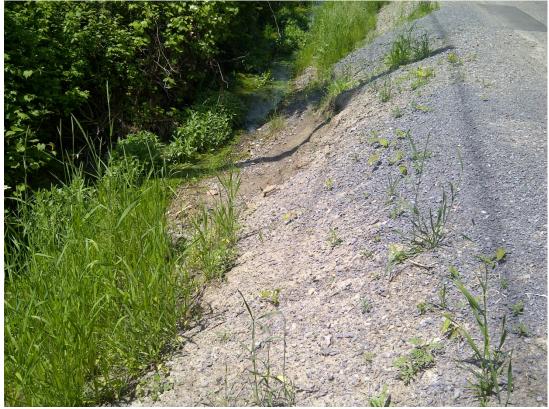
Photo 14: Approx. 150m north of 1387 Solina Road

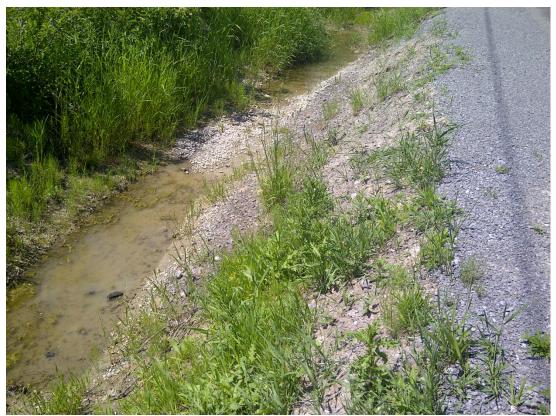
Photo 15: Approx. 180m north of 1387 Solina Road

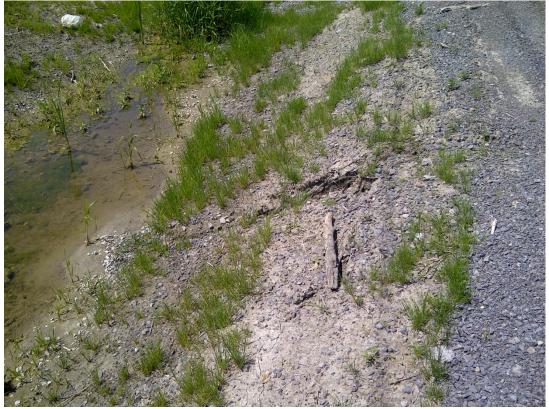
Photo 16: Approx. 200m north of 1387 Solina Road on the west side

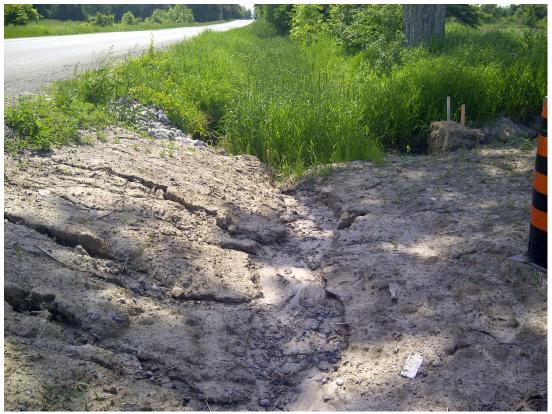
Photo 17: North West corner of Bloor Street and Solina Road

- North west corner of Bloor Street and Solina Road
- Approx. 200 m south of Concession Road 4 and Regional Road 57

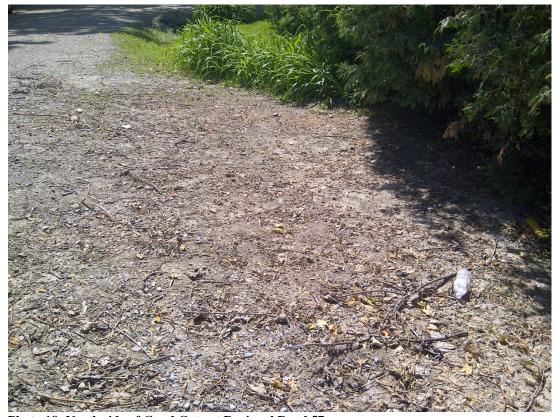
Photo 18: North side of Gaud Gate at Regional Road 57

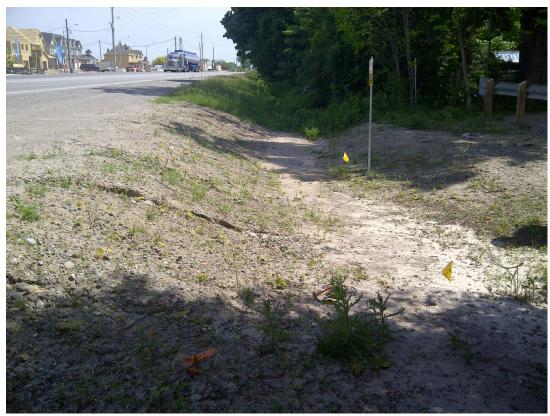
Photo 19: West side of Regional Road 57 at Gaud Gate

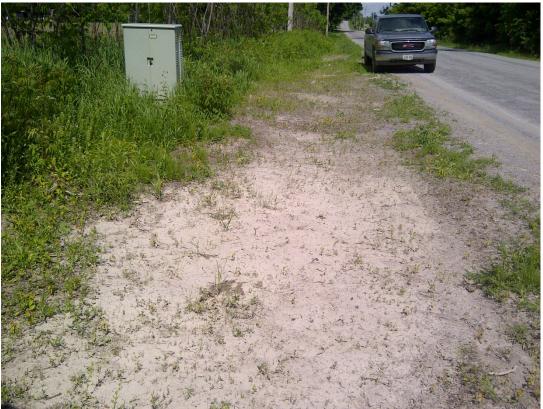
Photo 20: North East corner and East side of Old Scugog Road at Concession Road 4

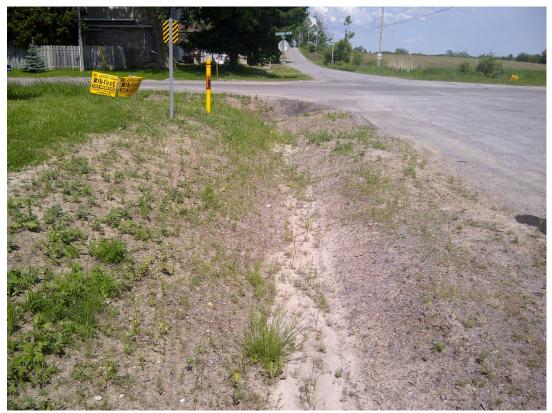
Photo 21: North West corner of Concession Road 4 and Regional Road 57

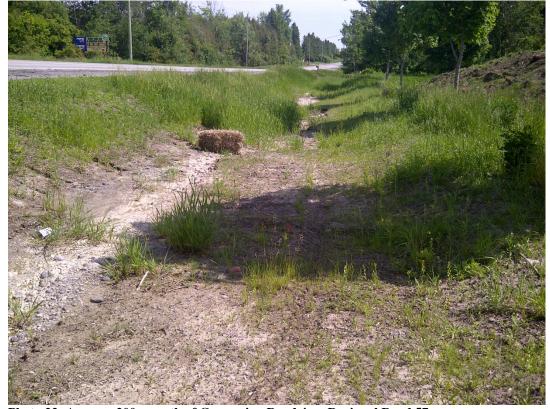
Photo 22: Approx. 200m south of Concession Road 4 on Regional Road 57

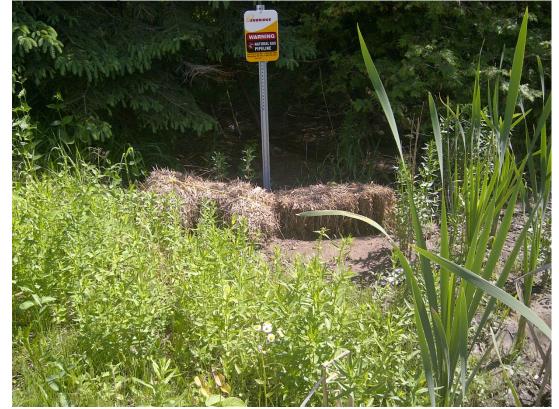
Photo 24: 3784 Regional Road 57

Erosion control devices such as silt fences and straw bale check dams have been installed where required to control any erosion and sedimentation concerns identified. Straw bales should be repaired or replaced with coir logs at the Bomanville Creek Crossing (near 3784 Regional Road 57).

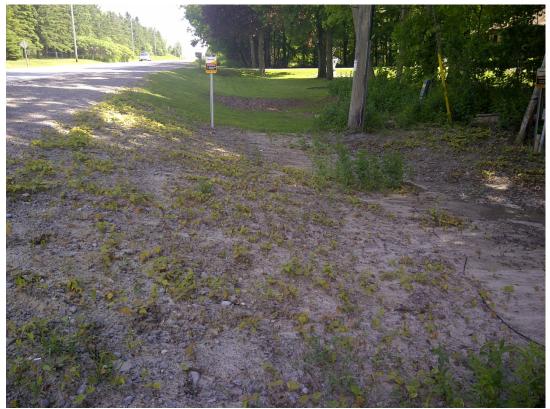
Photo 25: North of 3690 Regional Road 57

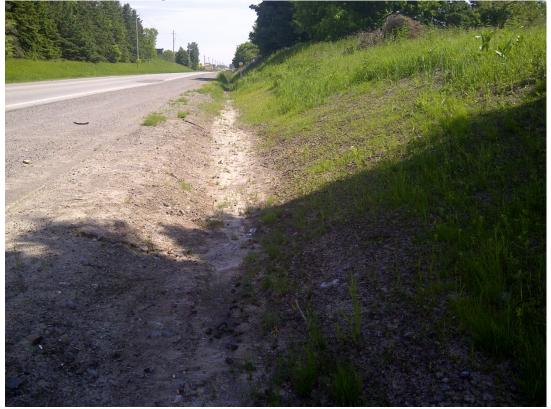
Photo 26: Approx. 170m south of 3690 Regional Road 57

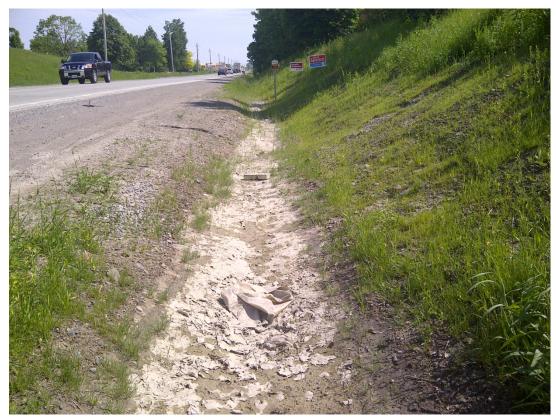
Photo 27: Approx. 300m south of 3690 Regional Road 57

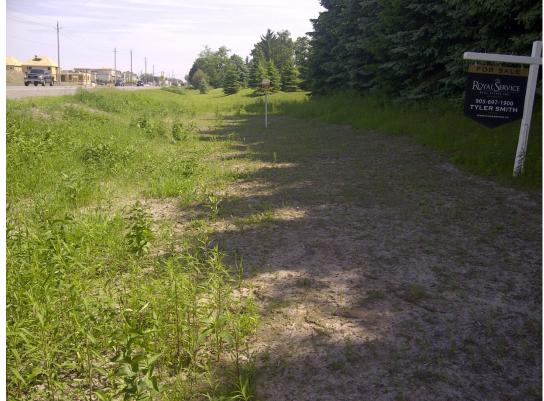
Photo 28: Approx. 200m north of Gaud Gate on Regional Road 57
