Ottawa Reinforcement Project Interim Post Construction Environmental Monitoring Report

EB-2012-0099

Prepared by: Stantec Consulting Ltd. 400-1331 Clyde Avenue Ottawa, ON K2C 3G4

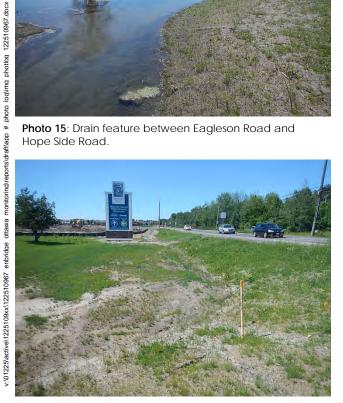
Photo 17: On-going residential development on Old Richmond Road.

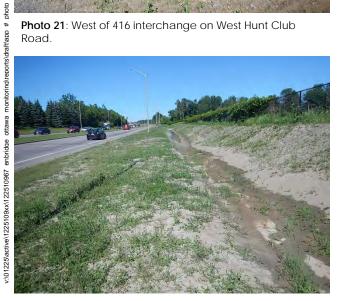
Photo 23: West Hunt Club Road east of Cedarview Drive and Highway 416.

- c. Bare areas along the south side of West Hunt Club Road from west of the 417 interchange to the eastern terminus at West Hunt Club and Greenbank Road should be hydroseeded and covered with erosion control blankets where appropriate to encourage vegetation establishment (e.g., Photo 21, 23; Appendix B).
