Re: Enbridge Gas Distribution Inc. ("Enbridge")
EB-2012-0013 - Angus Reinforcement Pipeline Project
Conditions of Approval – Addendum to Final Monitoring Report

**ENBRIDGE GAS DISTRIBUTION INC.
POST-CONSTRUCTION
ENVIRONMENTAL MONITORING REPORT NO.2
ANGUS REINFORCEMENT PIPELINE PROJECT
EB-2012-0013**

Prepared by
Enbridge Gas Distribution Inc.
October 8, 2014

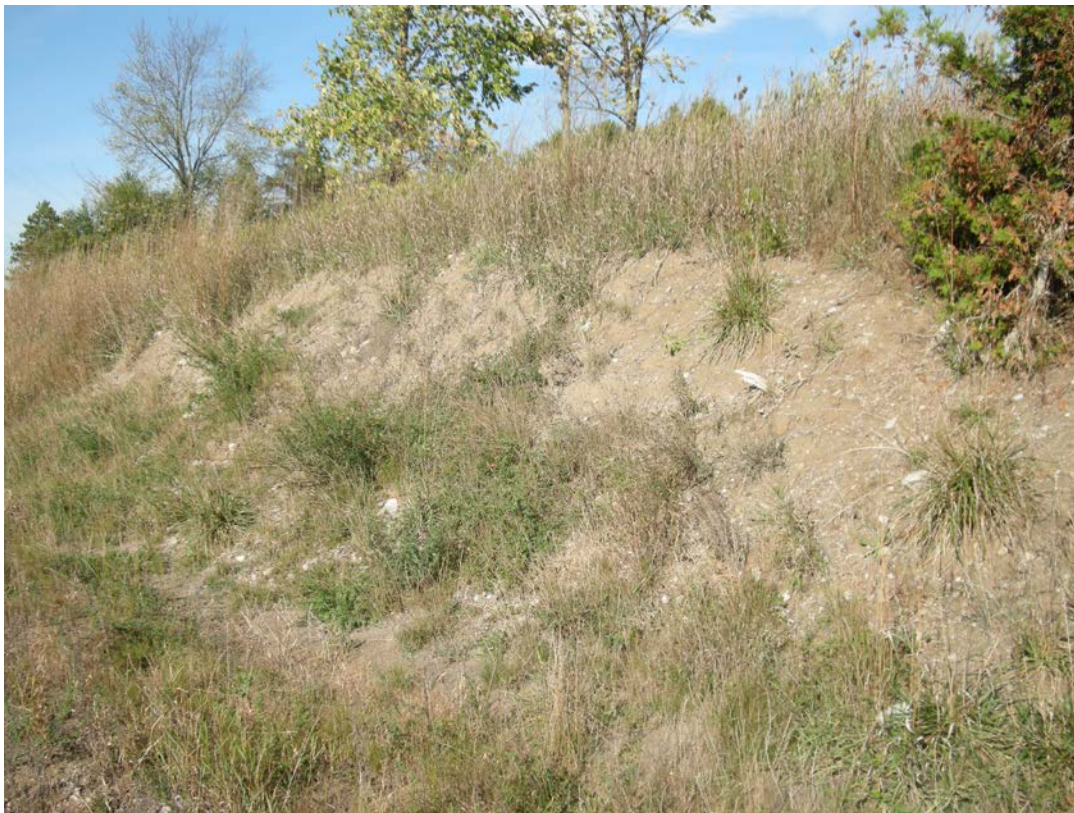
Photo 6: Approximately 50 meters east of 5162 County Road 21

The bank approximately 50 meters east of 5162 County Road 21 was incorrectly identified as being impacted due to Enbridge's construction activities, so remediation was not conducted in this area as indicated in the interim and final post-construction environmental monitoring reports (see Photo 6 in Appendix B).
