Re: Enbridge Gas Distribution Inc. ("Enbridge")
EB-2011-0323 – Alliston Reinforcement Pipeline Project
Conditions of Approval – Addendum to Final Monitoring Report

**ENBRIDGE GAS DISTRIBUTION INC.
POST-CONSTRUCTION
ENVIRONMENTAL MONITORING REPORT ADDENDUM LETTER**

**ALLISTON PIPELINE REINFORCEMENT PROJECT
EB-2011-0323**

Prepared by
Enbridge Gas Distribution Inc.
October 27, 2014

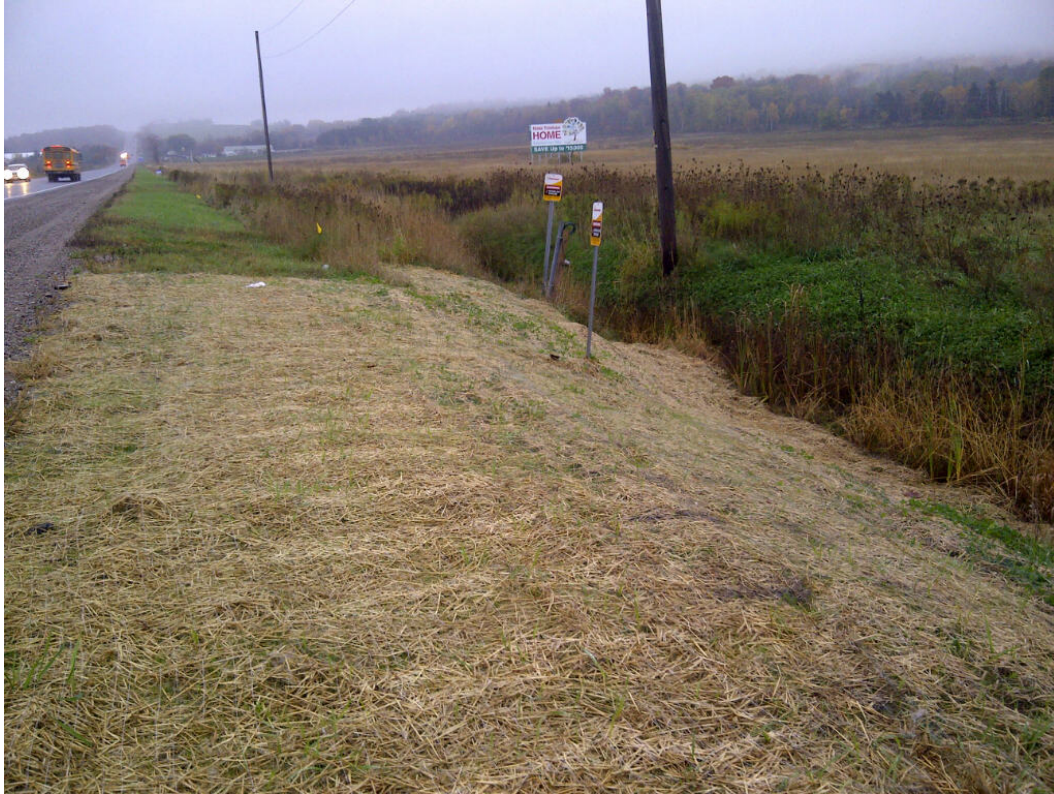
Photo 1: 5856 Highway 89 (south side of roadway)

Soil settlement, evidenced by sinkholes, occurred in the vicinity of the valve stem located on the south side of Highway 89, at 5856 Highway 89. Regrading, along with revegetation was undertaken to restore the appropriate grade. Erosion control matting was applied along with topsoil and seed in this area.
