**Re: Enbridge Gas Distribution Inc. ("Enbridge")  
Ontario Energy Board ("Board") Docket No.: EB-2012-0099  
Ottawa Reinforcement Project  
Conditions of Approval – Final Monitoring Report**

**Ottawa Reinforcement Project  
Final Post Construction  
Environmental Monitoring  
Report**

EB-2012-0099

May 5, 2015

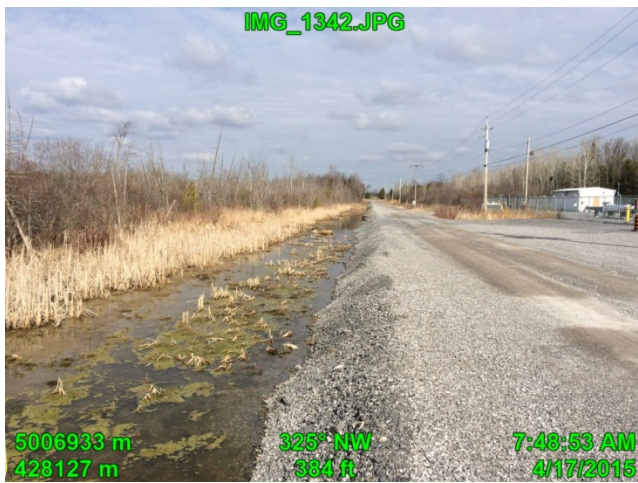
**Photo 1:** Typical conditions within wetland feature along TCPL Compressor Station 1217 access road immediately adjacent to the Richmond Gate Station.

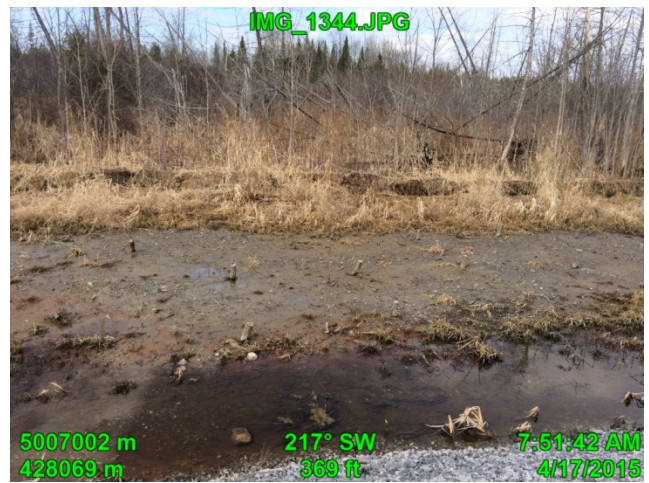
**Photo 2:** Live stakes within wetland feature along TCPL Compressor Station 1217 access road that have not regenerated.

A follow-up site visit is recommended later in the growing season to determine if more root wads have started to establish, or if further reclamation efforts are required to restore the original vegetation community to the Goulbourn Wetland Complex PSW.

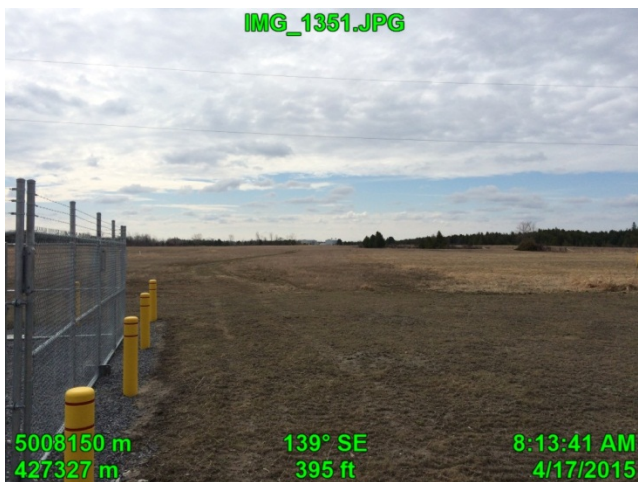
**Photo 3:** Current reclaimed condition of the TCPL right-of-way looking south from Flewellyn Road towards TCPL Compressor Station 1217

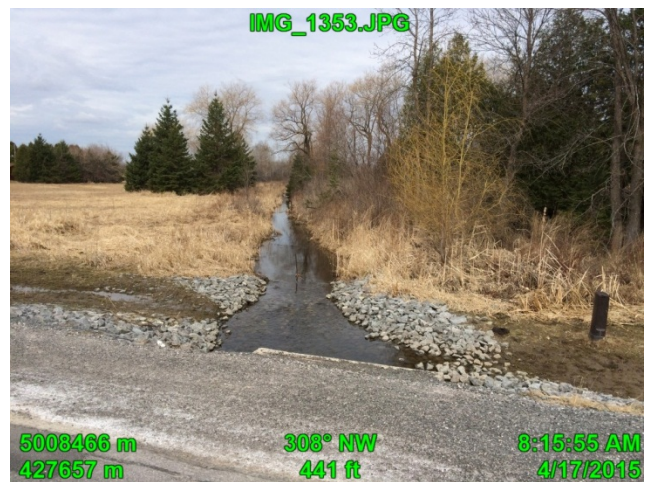
**Photo 4:** Current condition at the crossing of a tributary to Flowing Creek Phase1 Drain along Flewellyn Road west of Huntley Road.

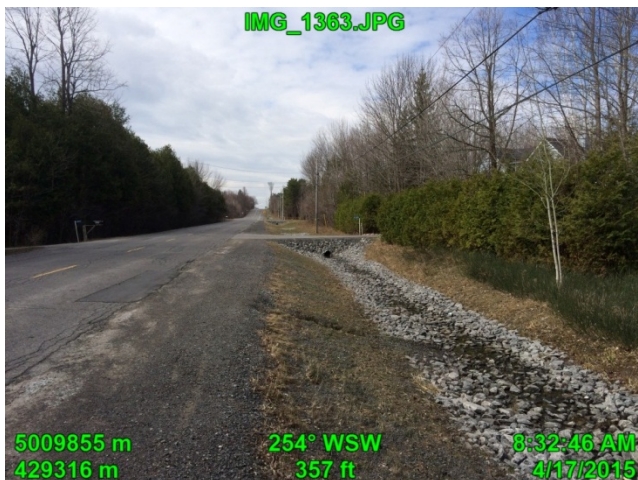
**Photo 5:** Current condition of the reclaimed alignment along Flewellyn Road east of Huntley Road

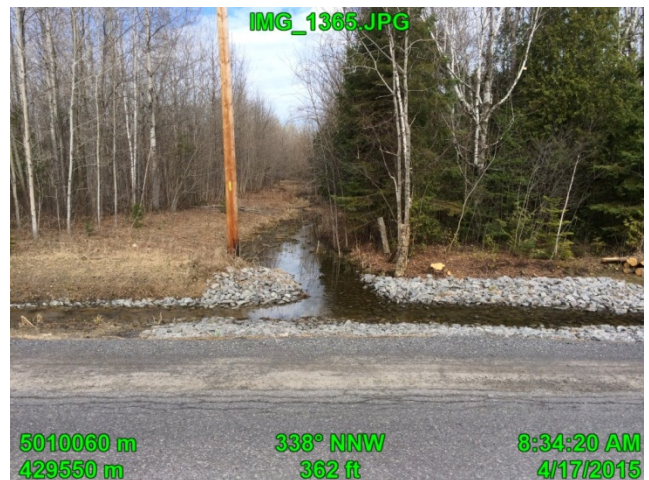
**Photo 6:** Current condition of an unnamed watercourse entering the roadside ditch along Flewellyn Road east of Huntley Road

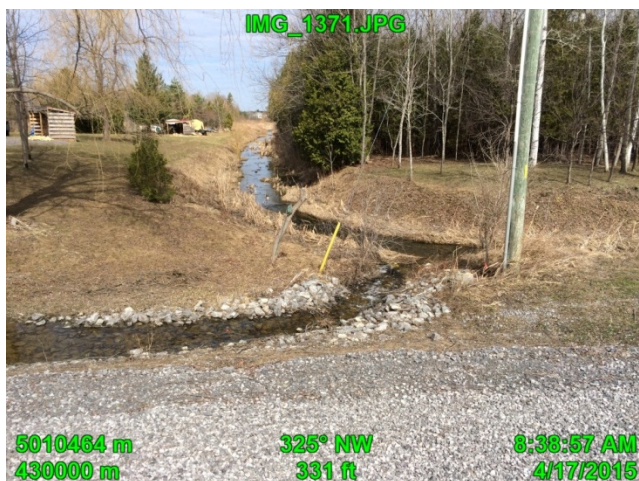
**Photo 7:** Current condition of reclaimed roadside ditch confluence with the Faulkner Drain along Flewellyn Road

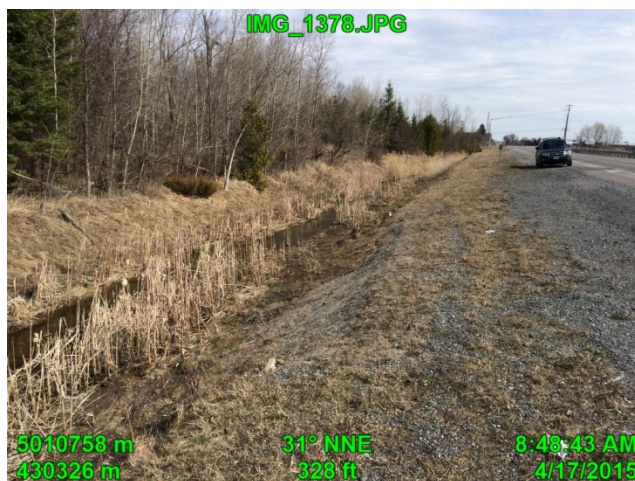
**Photo 8:** Current location of a previous bentonite spill along Flewellyn Road west of Shea Road – note area has been reclaimed properly

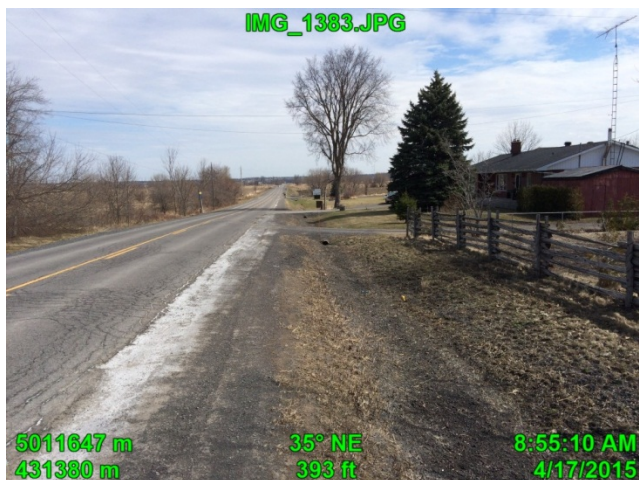
**Photo 9:** General alignment conditions along Flewellyn Road east of Shea Road and west of Faulkner Trail

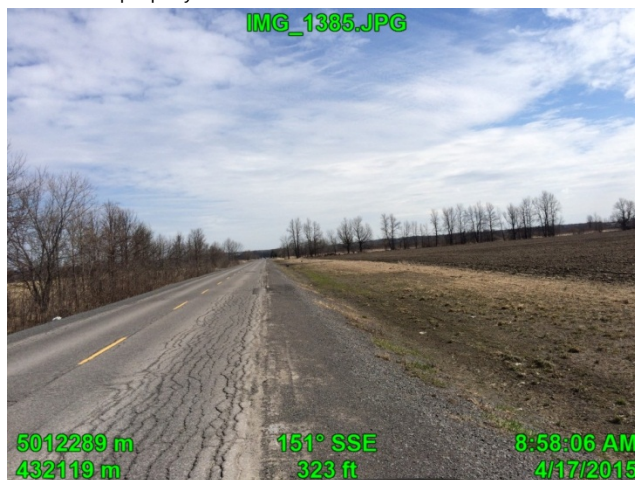
**Photo 10:** Typical roadside alignment conditions along Flewellyn Road west of Faulkner Trail – note the early establishment of vegetation

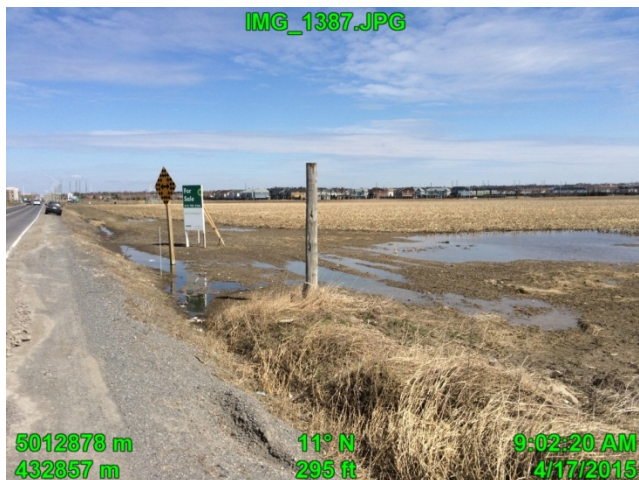
**Photo 11:** Large, unvegetated TWS within an agricultural field along Eagleson Road at the intersection with Flewellyn Road – revegetation is anticipated during the agricultural planting season

A follow up visit to this location is recommended further on in the growing season to determine the success of the crop planted by the land owner/farmer within the TWS.

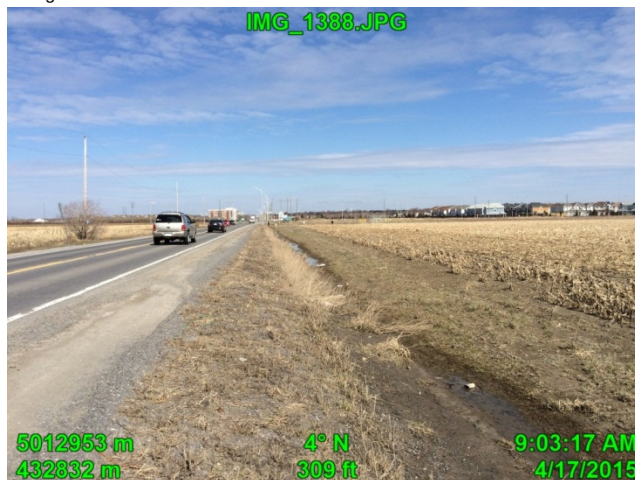
**Photo 12:** Typical roadside alignment conditions along Eagleson Road – note the establishment of vegetation

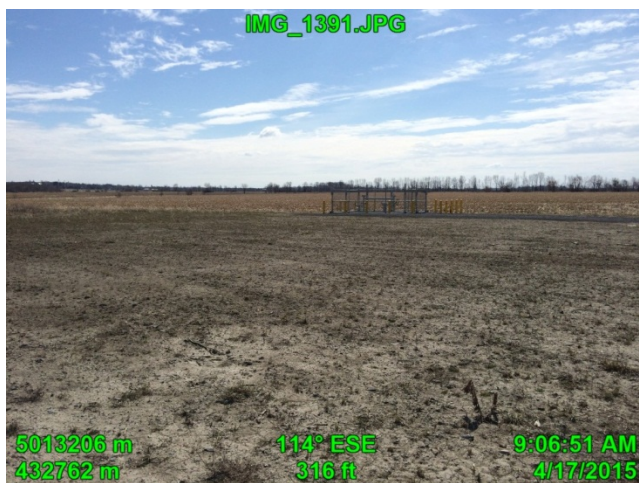
A TWS was constructed in a fallow area along Eagleson Road to facilitate the construction of an access road and valve station at the southeast corner of the Eagleson/Hope Side Road intersection. Currently, the site is sparsely vegetated and naturally re-establishing with species found on adjacent lands (**Photo 13, Appendix C**). The timing of the 2014 work likely limited the ability for vegetation to re-generate. It is anticipated vegetation density will continue to grow as the growing season progresses.

**Photo 13:** Large, unvegetated TWS at the valve station location at the intersection of Eagleson Road and Hope Side Road – note vegetation has not established at this location

A follow up visit to this location is recommended further on in the growing season to confirm revegetation of the exposed area is satisfactory.

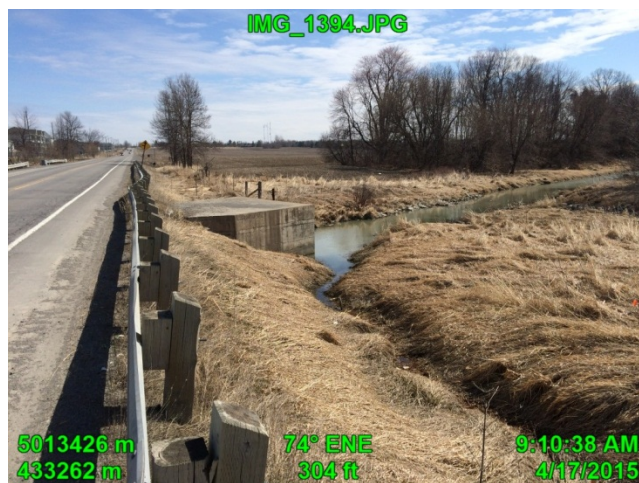
**Photo 14:** Current conditions along the alignment at the Monahan (Main) Drain along Hope Side Road

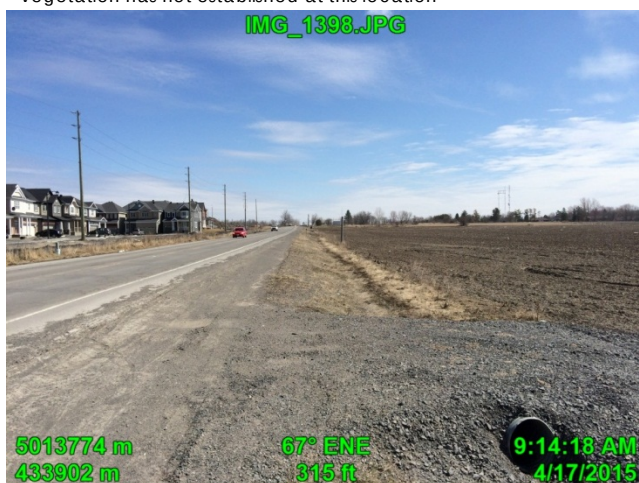
**Photo 15:** Typical roadside alignment conditions along Hope Side Road east of Crownridge Drive

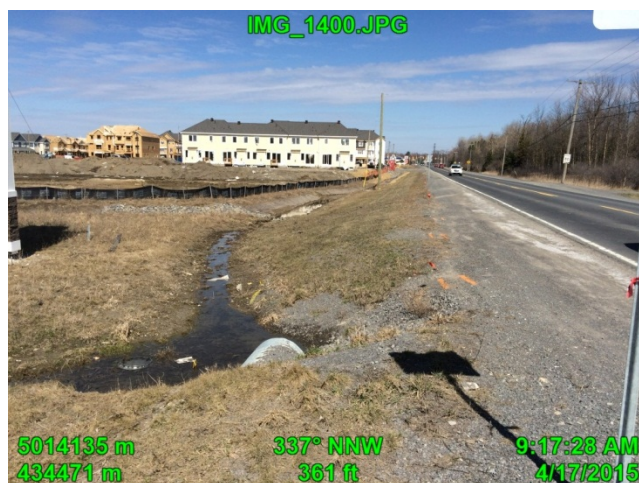
**Photo 16:** Current condition of roadside ditch within alignment at the intersection of Hope Side Road and Old Richmond Road – note ongoing residential development

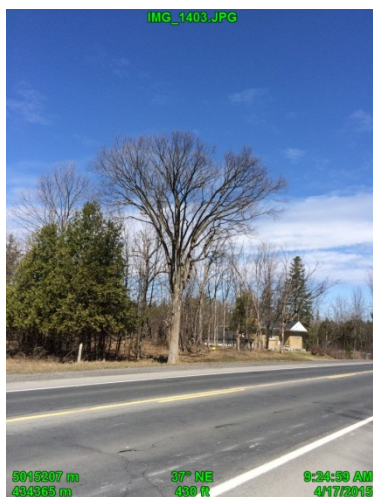
**Photo 17:** Current condition of Mature American Elm tree within the alignment along Old Richmond Road identified in the interim monitoring report – note tree is currently in good health

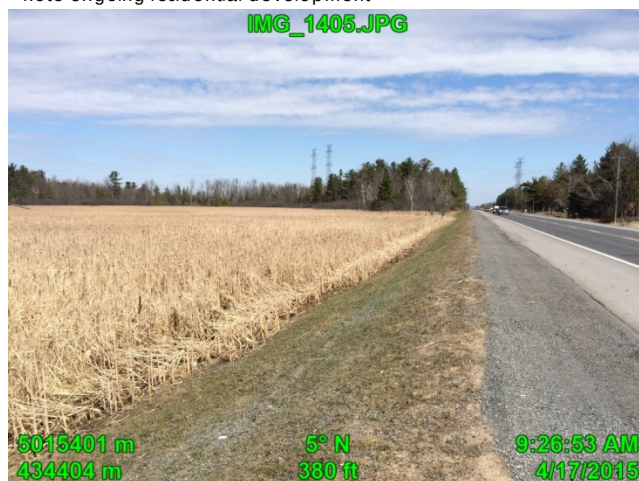
**Photo 18:** Current condition of the reclaimed alignment along Old Richmond Road adjacent to a feature within the Stony Swamp Wetland Complex PSW north of Stonehaven Drive

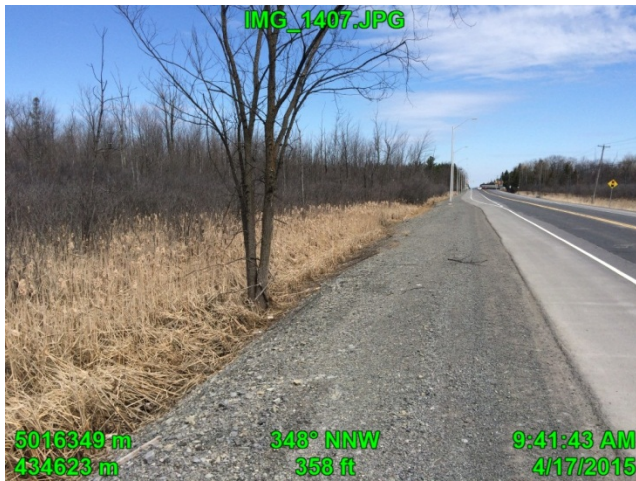
**Photo 19:** Current condition of the reclaimed alignment along Old Richmond Road adjacent to a feature within the Stony Swamp Wetland Complex PSW south of West Hunt Club Road

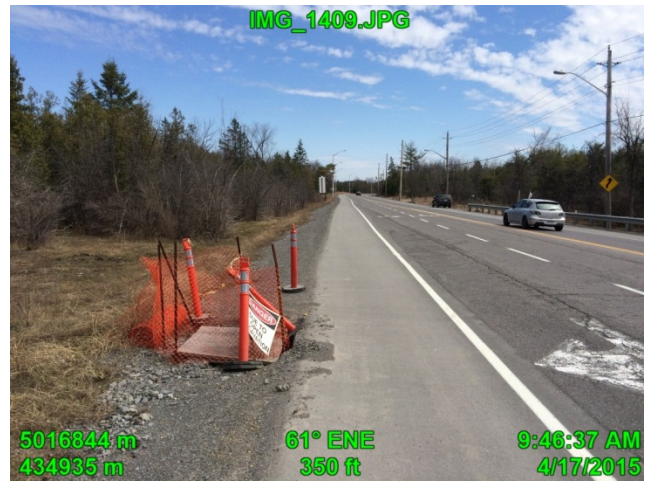
**Photo 20:** An open excavation along the reclaimed alignment along West Hunt Club Road between Old Richmond Road and Moodie Drive

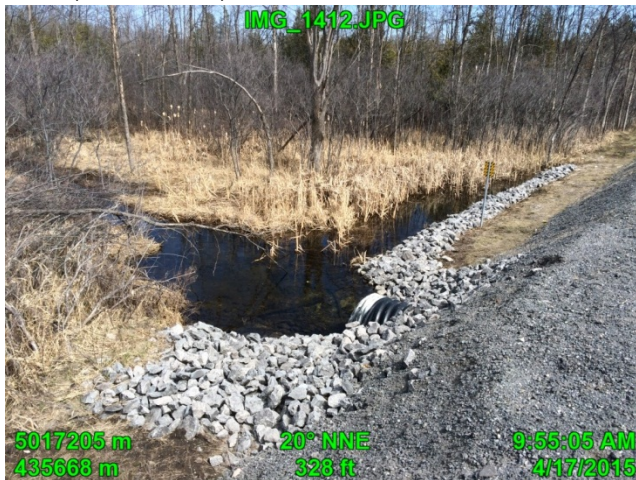
**Photo 21:** Condition of a reclaimed unnamed watercourse originating from the Stony Swamp Wetland Complex PSW within the alignment along West Hunt Club Road east of Moodie Drive

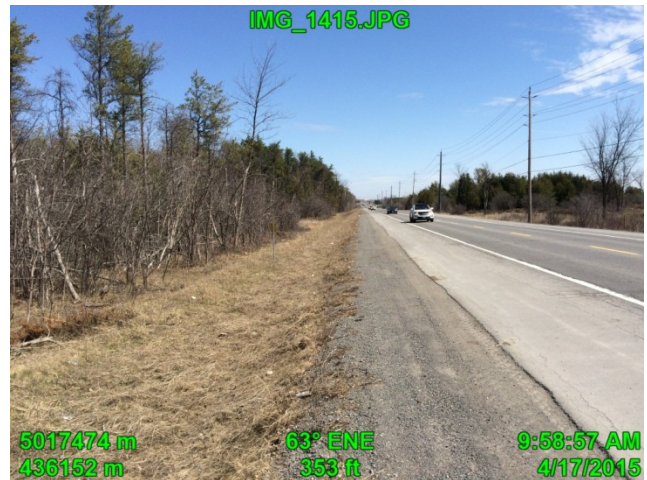
**Photo 22:** Current conditions within the alignment along West Hunt Club Road between Moodie Drive and Highway 416 – note vegetation is established

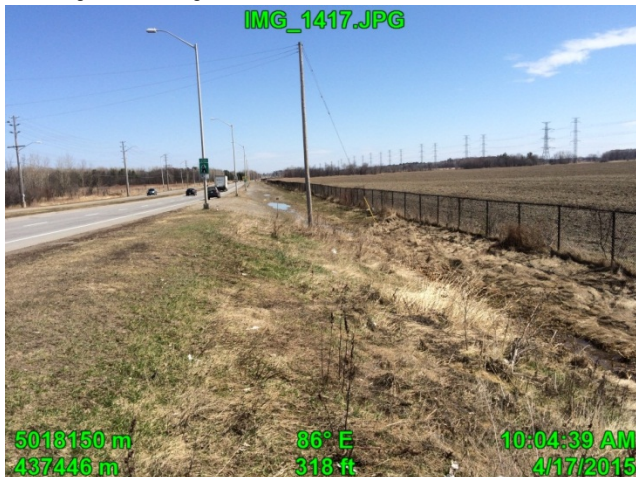
**Photo 23:** Current location of a previous bentonite spill along West Hunt Club Road east of Highway 416 – note area has been reclaimed properly and vegetation is established

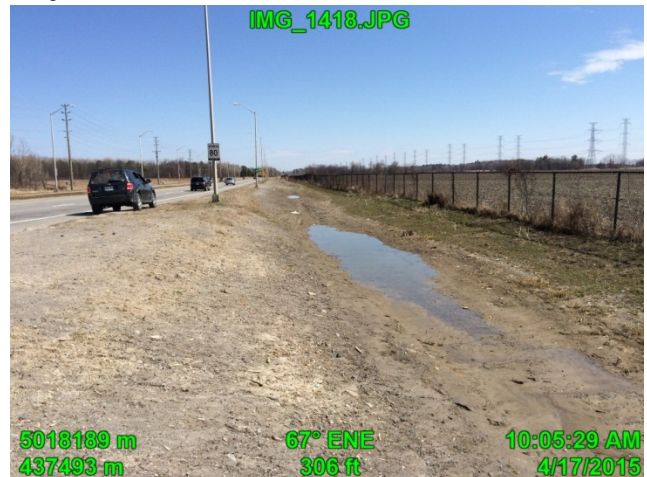
**Photo 24:** One of several areas along West Hunt Club Road between Highway 416 and Greenbank Road that require further revegetation – note standing water

A follow up visit to this location is recommended further on in the growing season to confirm revegetation of the exposed area is satisfactory.

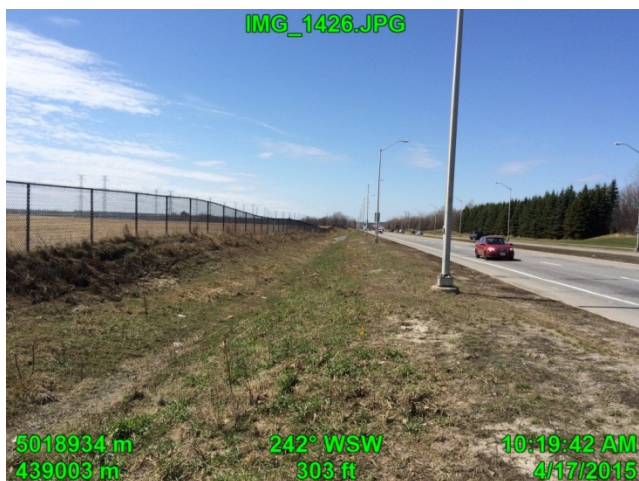
**Photo 25:** Typical conditions within alignment along West Hunt Club Road west of Greenbank Road – note vegetation is established

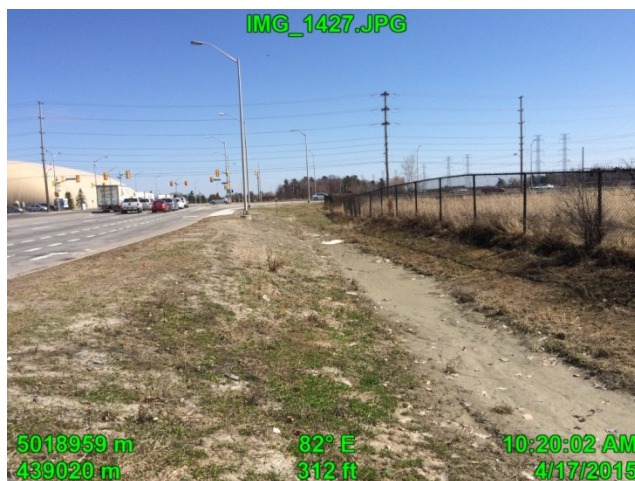
**Photo 26:** Current condition of alignment along West Hunt Club Road at Greenbank Road – note vegetation has not established and soil is exposed

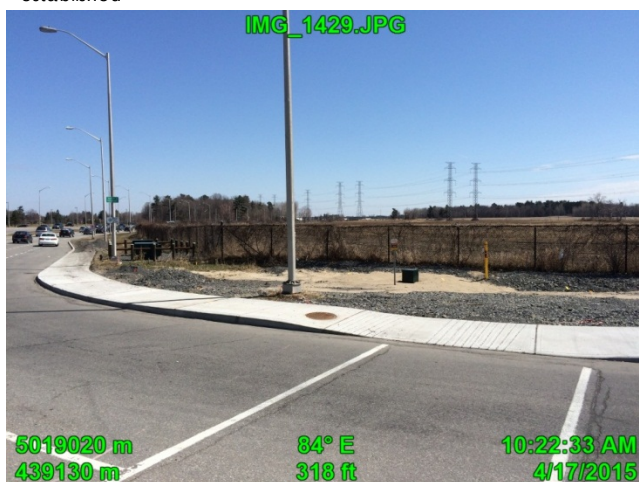
**Photo 27:** Current condition of the southeast corner at the intersection of West Hunt Club Road and Greenbank Road – note construction activities are ongoing

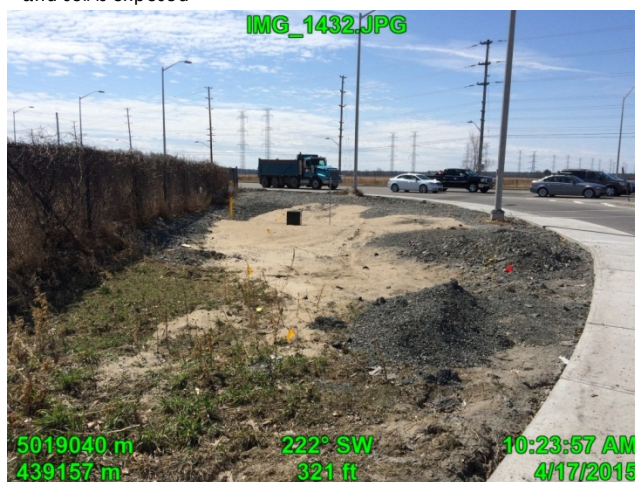
**Photo 28:** Current condition of the southeast corner at the intersection of West Hunt Club Road and Greenbank Road – note construction activities are ongoing
