INTERIM ENVIRONMENTAL MONITORING REPORT
**Innes Road Pipeline Replacement
Project**

EB-2012-0438 EB-2014-0017

Prepared by Dillon Consulting Limited

June 2015 – 13-8395

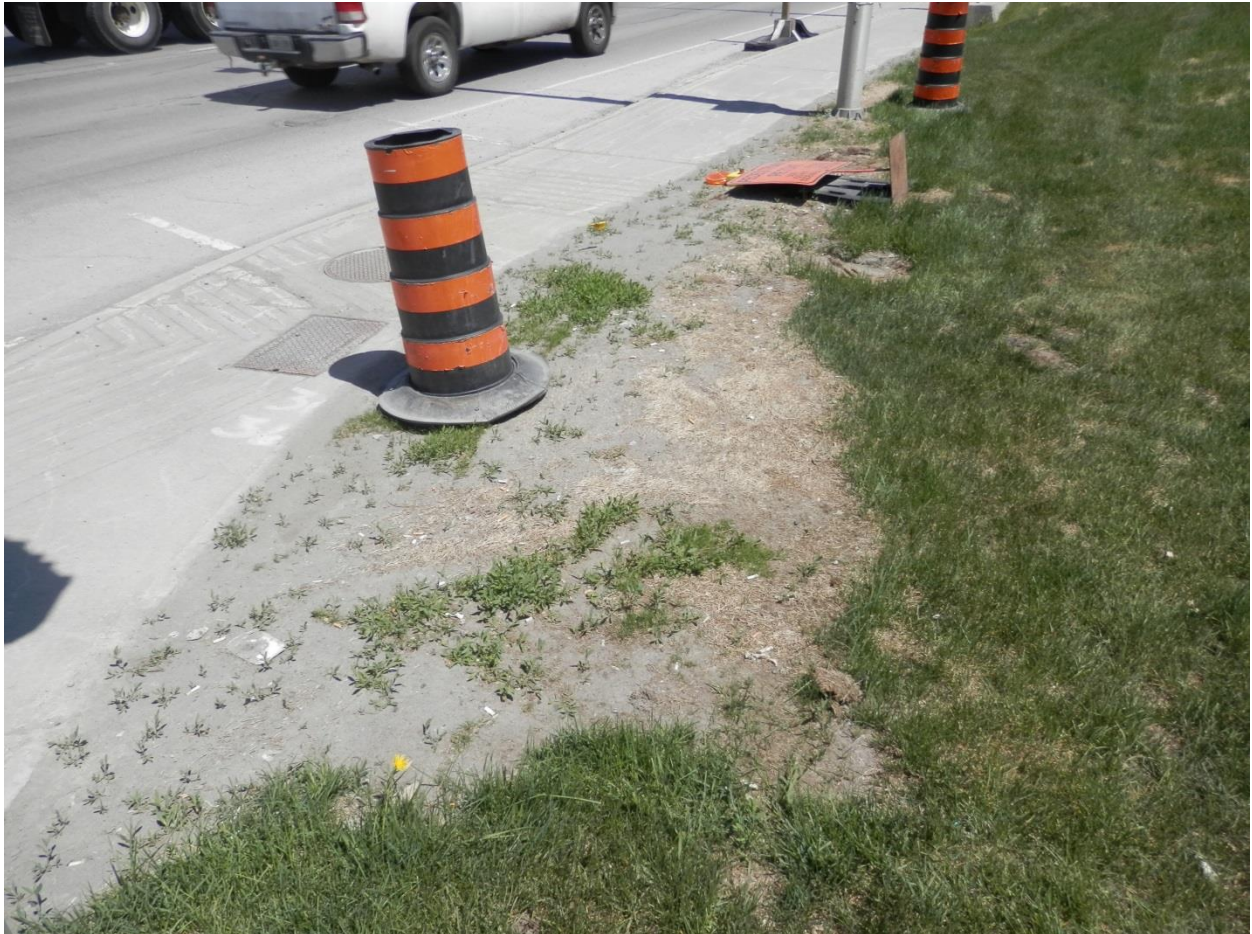
LOCATION #B4

Vegetation	Adjacent to ESSO Station	B4	Bare patch of grass adjacent to the sidewalk	<ul style="list-style-type: none"> Increased soil erosion potential Poor aesthetics 	<ul style="list-style-type: none"> Over-seed bare patches with fresh seed and water (Summer 2015) Hydro-seeding recommended
Trench Subsidence	Adjacent to ESSO Station	B5	Soil under sidewalk subsiding	<ul style="list-style-type: none"> Sidewalk collapse Minor hazard 	<ul style="list-style-type: none"> Repair as appropriate (Summer 2015) Over-seed bare patches with fresh seed and water (Summer 2015) Periodic visual inspection is recommended
Vegetation	Adjacent to Costco parking	B6	One dead ornamental tree (species unknown)	<ul style="list-style-type: none"> Loss of urban tree canopy Poor aesthetics 	<ul style="list-style-type: none"> Replace dead tree (Summer 2015)
Vegetation	Adjacent to Costco parking	B7	One pine tree has been cut down	<ul style="list-style-type: none"> Loss of urban tree canopy Poor aesthetics 	<ul style="list-style-type: none"> Replace cut tree (Summer 2015)

Proposed Action and Schedule:

- Over-seed bare patches – suggest Hydroseeding if available. (Summer 2015)
- Water fresh seeds as appropriate. (Summer 2015)

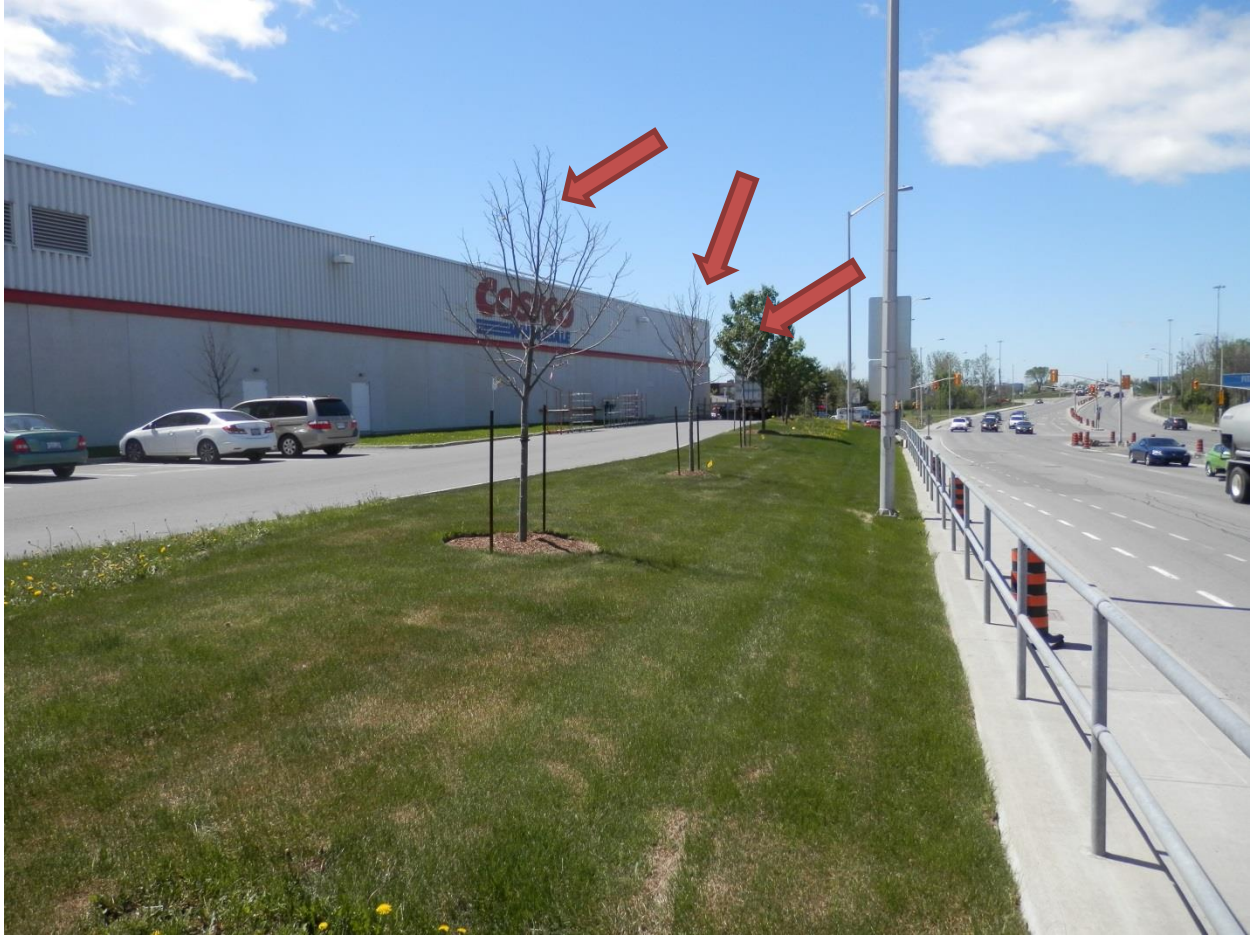
LOCATION #B8

Biophysical Element	Location	Number on Map	Outstanding Issues	Potential Adverse Environmental Effect	Proposed Action and Schedule
Vegetation	Adjacent to Costco parking	B8	Three 'Redmond Linden' trees have died	<ul style="list-style-type: none"> Loss of urban tree canopy Poor aesthetics 	<ul style="list-style-type: none"> Replace dead trees (Summer 2015)
Trench Subsidence	Adjacent to Costco parking	B9	Small trench subsidence in grass	<ul style="list-style-type: none"> Minor hazard 	<ul style="list-style-type: none"> Repair as appropriate (Summer 2015) Re-seed grass around bare patches. (Summer 2015)
Vegetation	Adjacent to Costco parking	B10	One dead ornamental tree (species unknown)	<ul style="list-style-type: none"> Loss of urban tree canopy Poor aesthetics 	<ul style="list-style-type: none"> Replace dead tree (Summer 2015)
Vegetation	Adjacent to Costco parking	B11	Dead ornamental shrubs (species unknown)	<ul style="list-style-type: none"> Loss of landscape vegetation Poor aesthetics 	<ul style="list-style-type: none"> Replace dead shrubs with hardier species (Summer 2015)

Proposed Action and Schedule:

- Replace all three dead trees (Summer 2015)

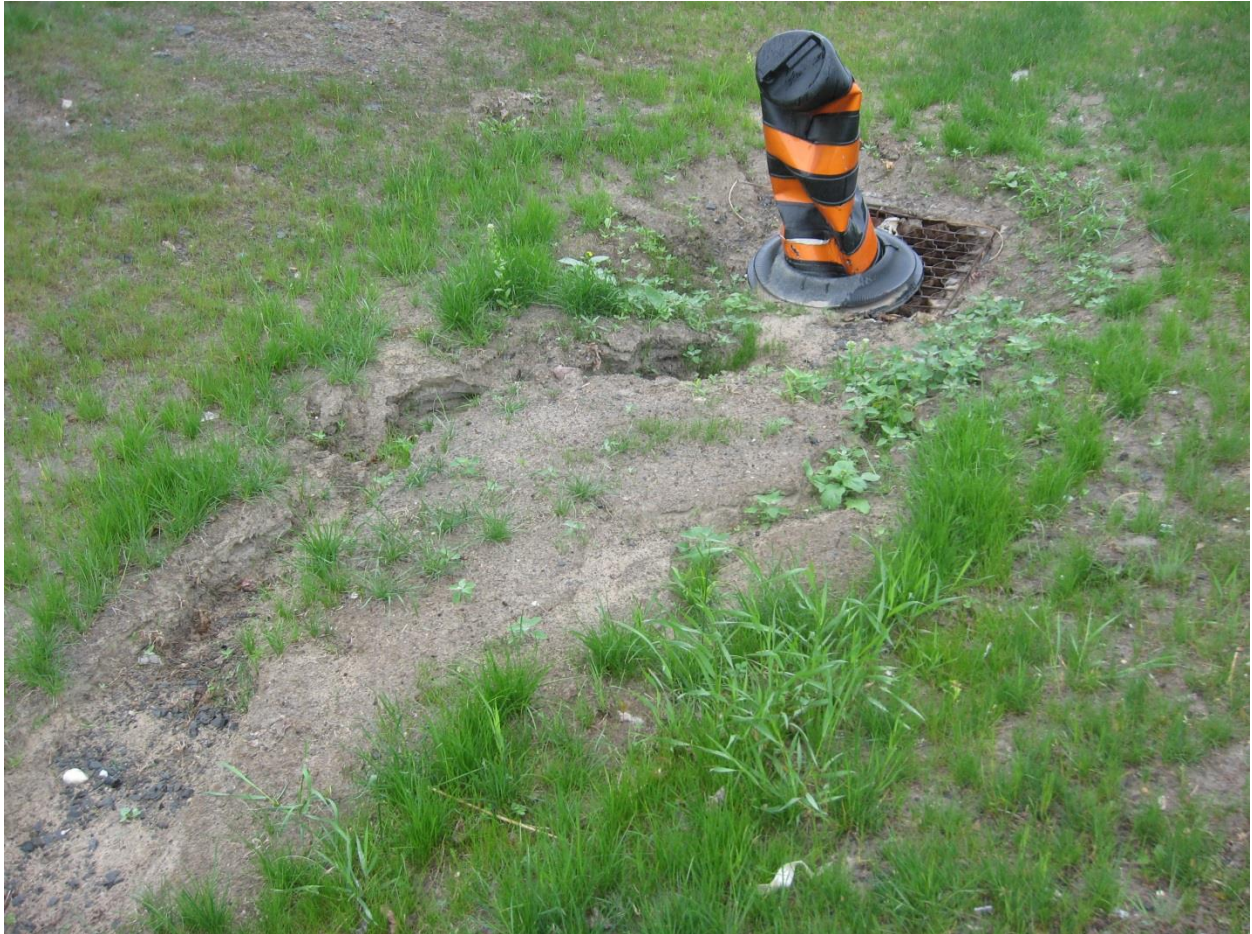
PHOTO #C22

Biophysical Element	Location	Number on Map	Outstanding Issues	Potential Adverse Environmental Effect	Proposed Action and Schedule
Erosion	East of Bantree St.	C22	Area upslope (east) of stormwater drain has eroded	<ul style="list-style-type: none"> Increased sediment load into stormwater system Erosion of grass Damage to stormwater infrastructure 	<ul style="list-style-type: none"> Re-grade soil around stormwater drain (Summer 2015) Place geotextile and Rip-rap or other material in ditch to mitigate erosion potential (Summer 2015) Over-seed bare patches – suggest Hydroseeding if available. (Summer 2015)
Vegetation	East of Bantree St. to St Laurent	C23 – C27	Bare patch of grass adjacent to the sidewalk	<ul style="list-style-type: none"> Increased soil erosion potential Poor aesthetics 	<ul style="list-style-type: none"> Over-seed bare patches – suggest Hydro-seeding if available. (Summer 2015)

Proposed Action and Schedule:

- Re-grade soil around stormwater drain (Summer 2015)
- Place Rip-rap or other material in ditch to mitigate erosion potential (Summer 2015)
- Over-seed bare patches – suggest Hydroseeding if available. (Summer 2015)

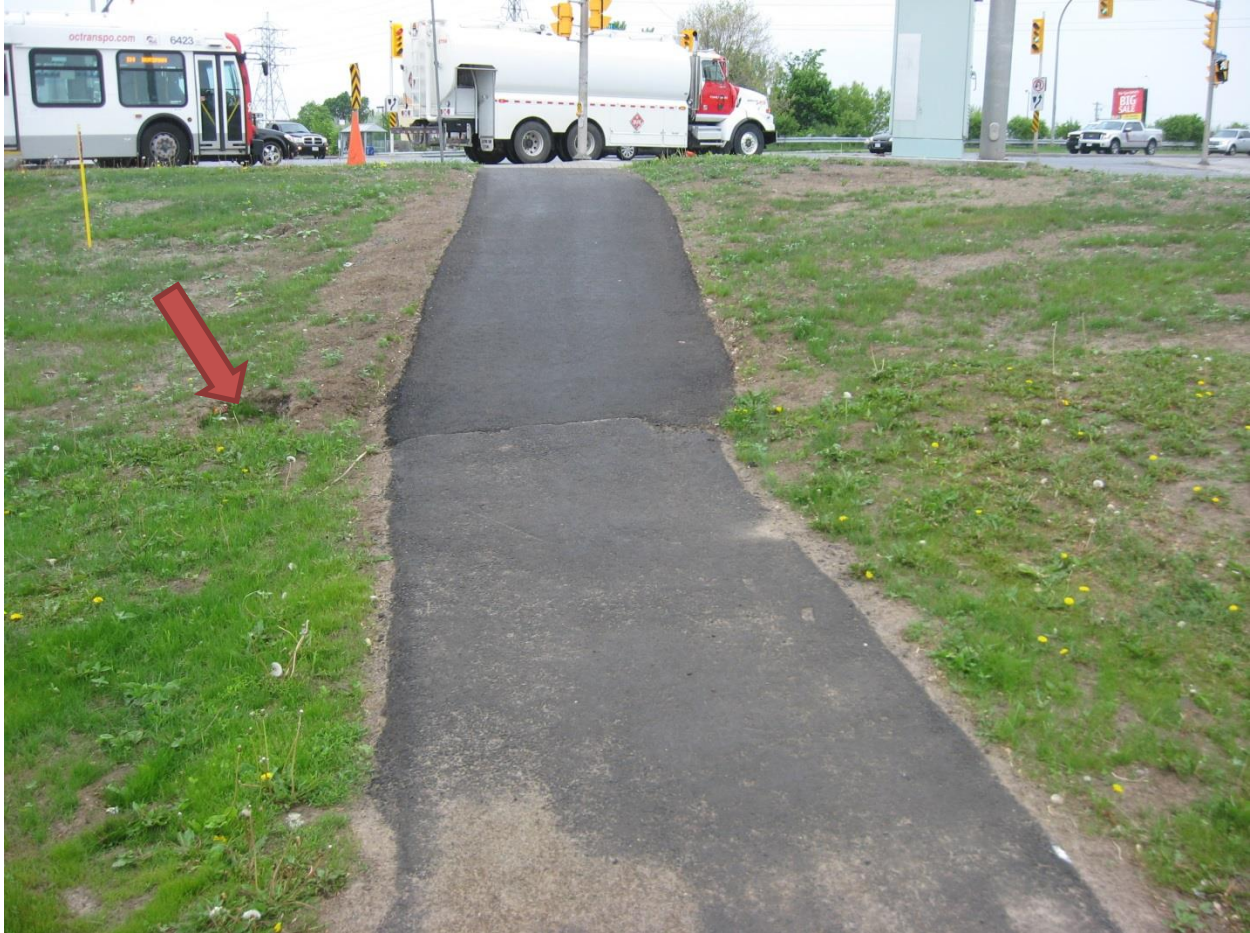
PHOTO #C28

Trench Subsidence	SE Corner of St. Laurent and Innes Rd.	C28	Minor trench subsidence adjacent asphalt sidewalk	<ul style="list-style-type: none"> Minor hazard 	<ul style="list-style-type: none"> Repair as appropriate (Summer 2015) Over-seed bare patches with fresh seed and water (Summer 2015) Periodic visual inspection is recommended
Vegetation	Corner of St. Laurent and Innes Rd.	C29	Bare patch of grass adjacent to the parking lot	<ul style="list-style-type: none"> Increased soil erosion potential Poor aesthetics 	<ul style="list-style-type: none"> Over-seed bare patches – suggest Hydro-seeding if available. (Summer 2015)
Vegetation	NE Corner of St. Laurent and Innes Rd.	C30	Bare patch of grass adjacent to the parking lot	<ul style="list-style-type: none"> Increased soil erosion potential Poor aesthetics 	<ul style="list-style-type: none"> Over-seed bare patches – suggest Hydro-seeding if available. (Summer 2015)

Proposed Action and Schedule:

- Over-seed bare patches – suggest Hydroseeding if available. (Summer 2015)
- Water fresh seeds as appropriate. (Summer 2015)
