Ottawa Reinforcement Project

Conditions of Approval – Addendum Final Monitoring Report

ENBRIDGE GAS DISTRIBUTION INC. POST-CONSTRUCTION ENVIRONMENTAL MONITORING REPORT ADDENDUM LETTER

OTTAWA REINFORCEMENT PROJECT EB-2012-0099

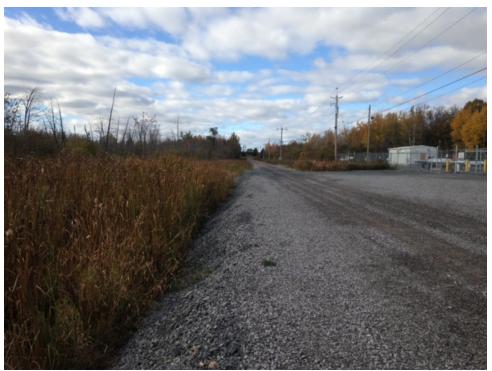
Photo 1: West side of Trans-Canada Pipeline Access Road (adjacent to Richmond Gate Station); looking north

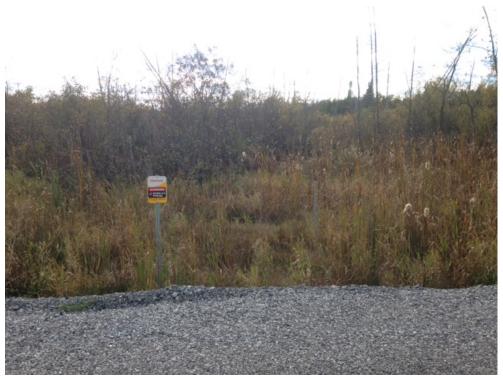
Photo 2: Trans-Canada Pipeline Access Road (adjacent to Richmond Gate Station); looking west into Provincially Significant Wetland

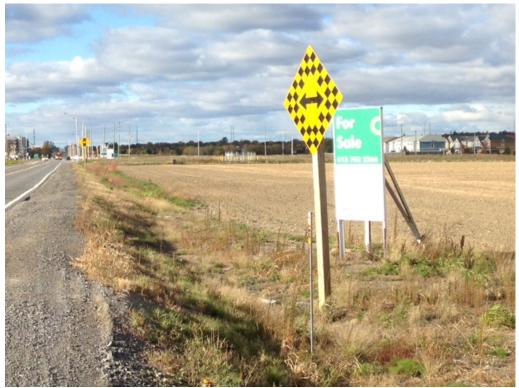
Photo 3: East side of Eagleson Road at Flewllyn Road; looking north

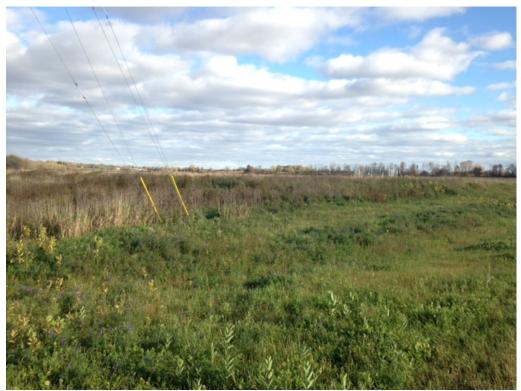
Photo 4: On Eagleson Road at intersection of Hope Side Road (east side); looking south/east at valve station location

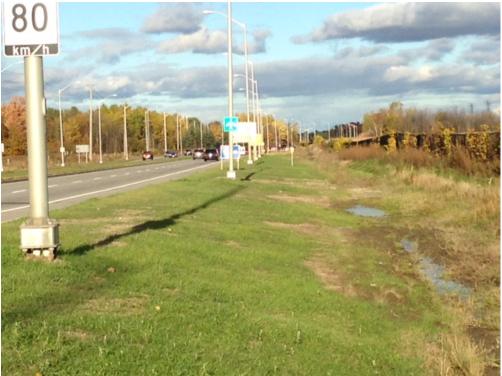
Photo 5: South side of West Hunt Club Road, east of Cedarview Road; looking east towards Graham Creek (Greenbank)

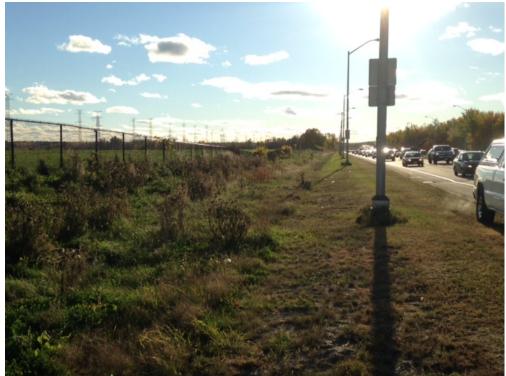
Photo 6: South side of West Hunt Club Road, west of Greenbank Road; looking west

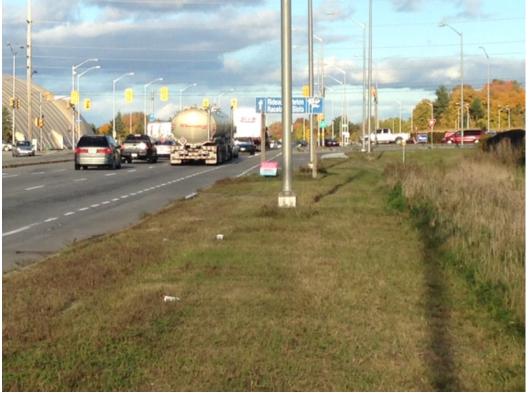
Photo 7: South side of West Hunt Club Road, west of Greenbank Road; looking east towards intersection

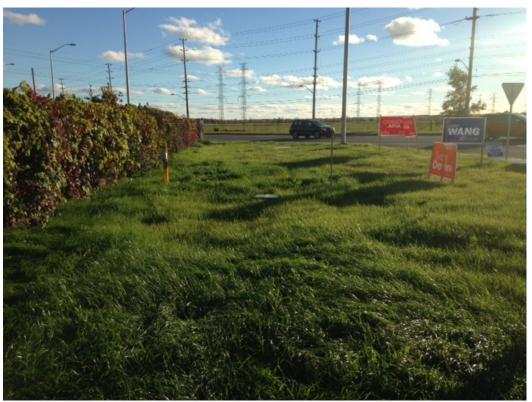
Photo 8: At southeast corner of West Hunt Club Road and Greenbank Road
