Rear Lot Supply Remediation Plan

DRAFT 2

August 1, 2014

Prepared by: System Planning & Standards

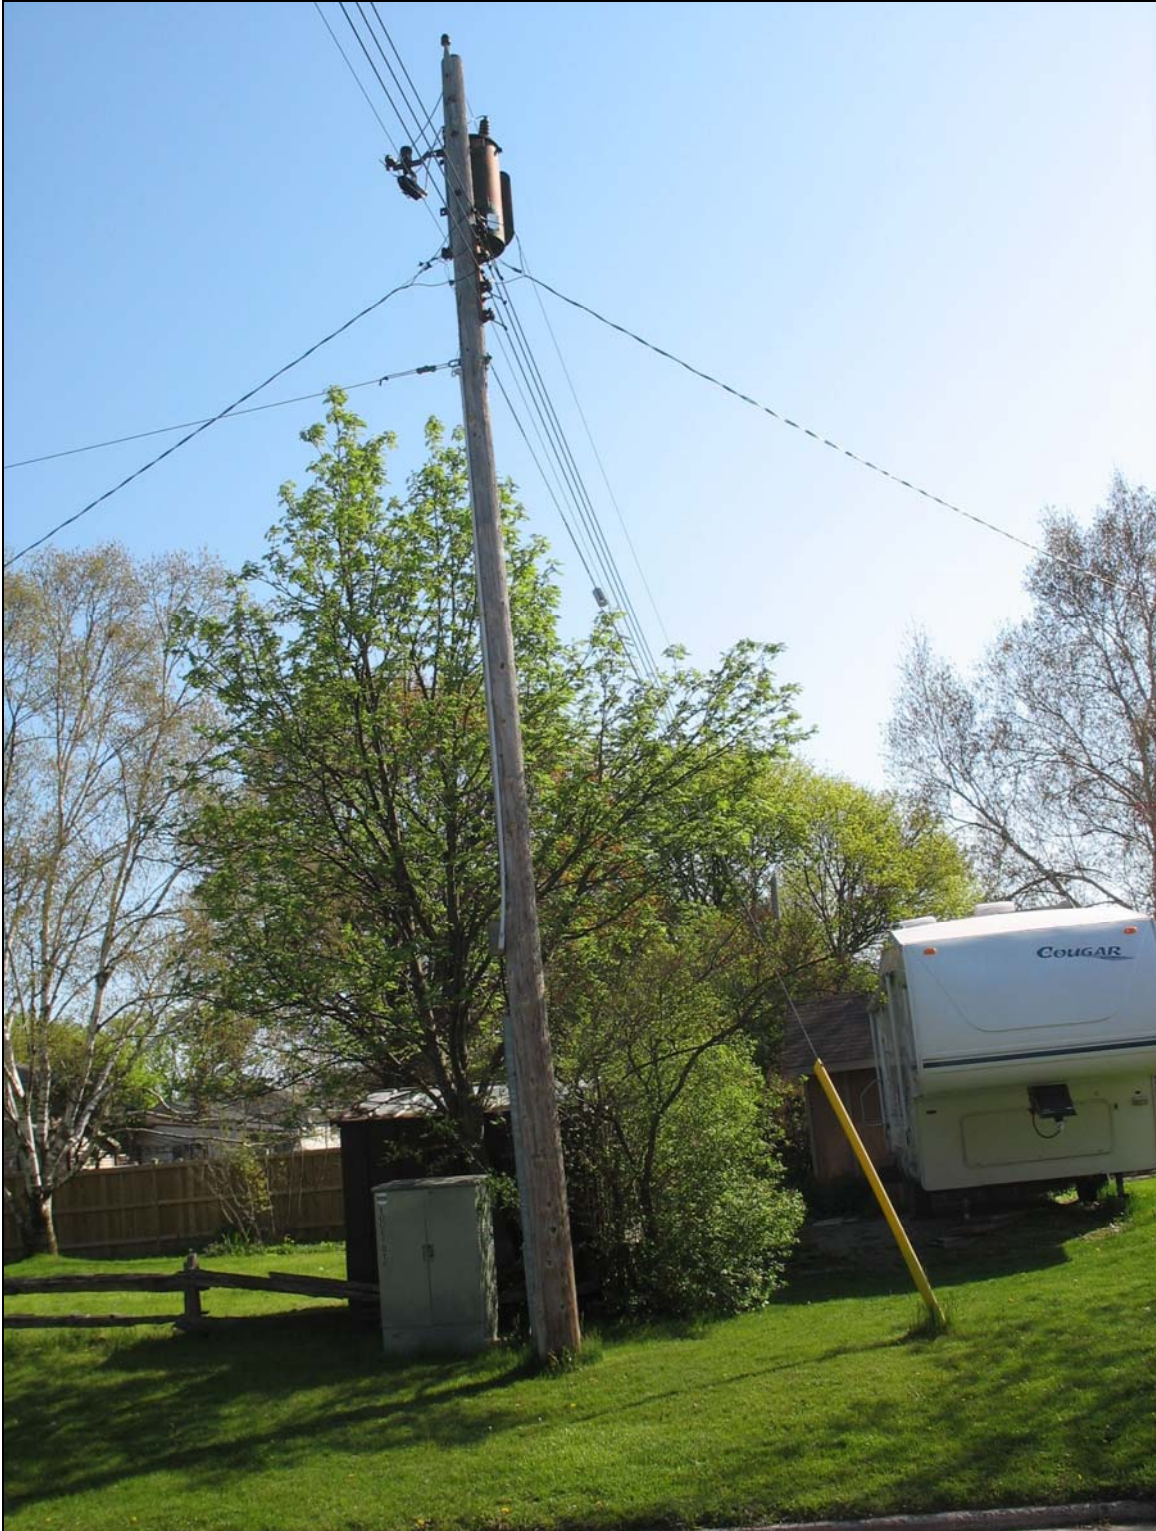
Figure 8. Reasonably accessible pole at rear lot

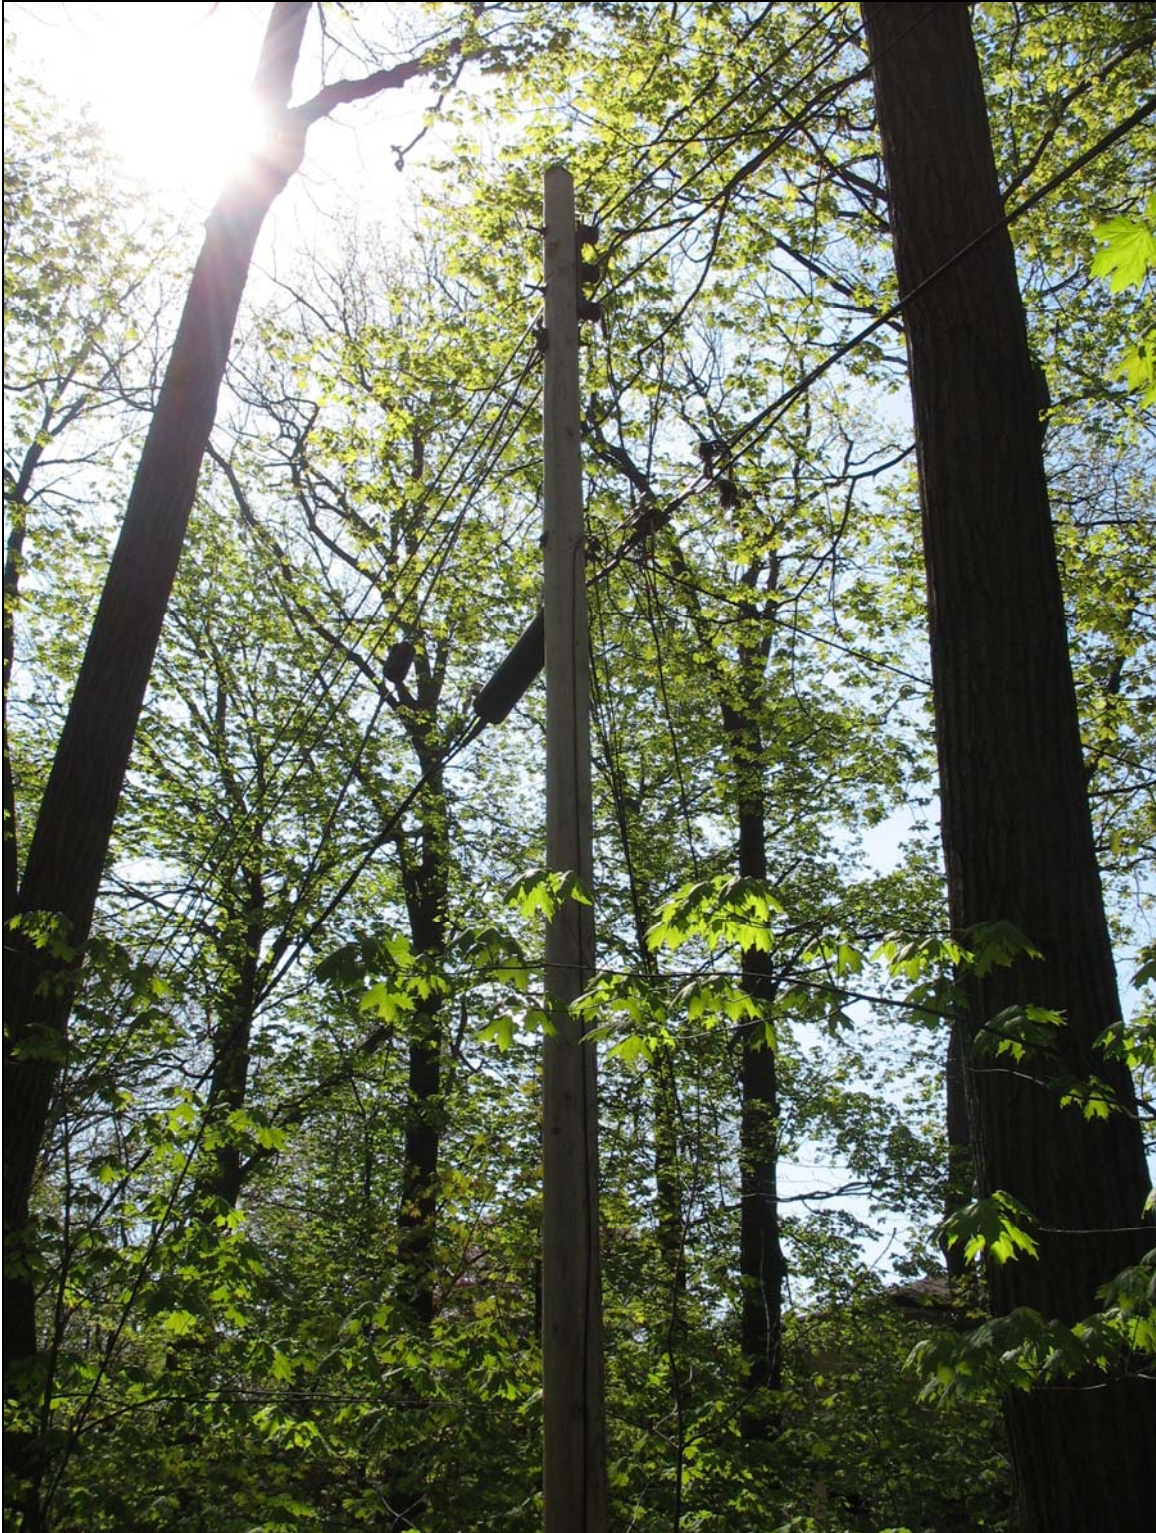
Figure 9. Obstruction of equipment caused by large trees

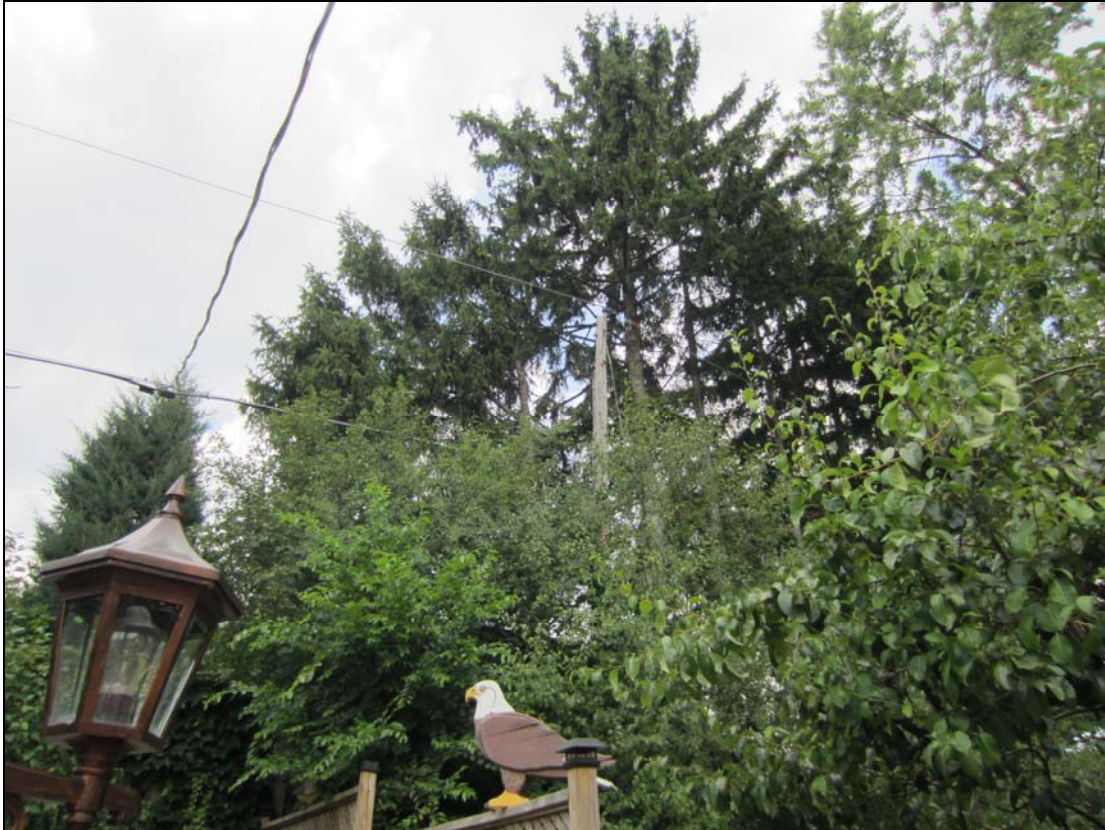
Figure 10. Inaccessible pole in poor condition (cracked and rotten)

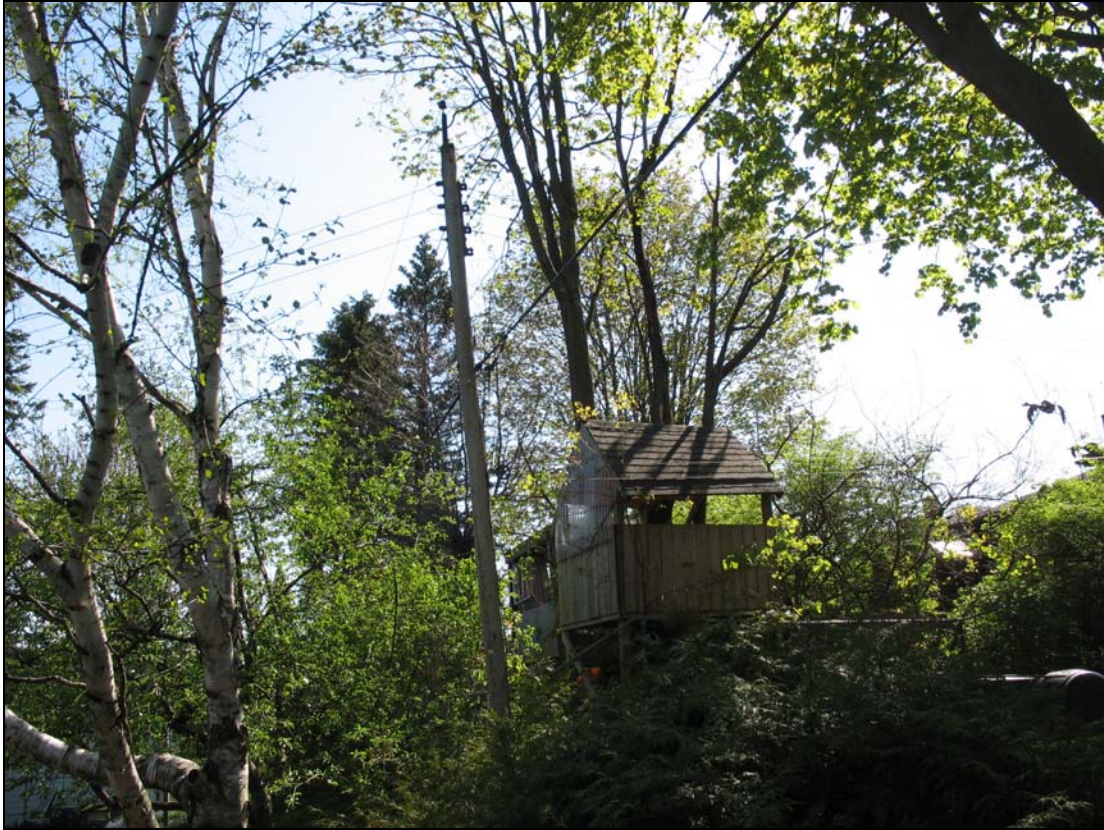
Figure 11. Pole obstruction caused by customer construction

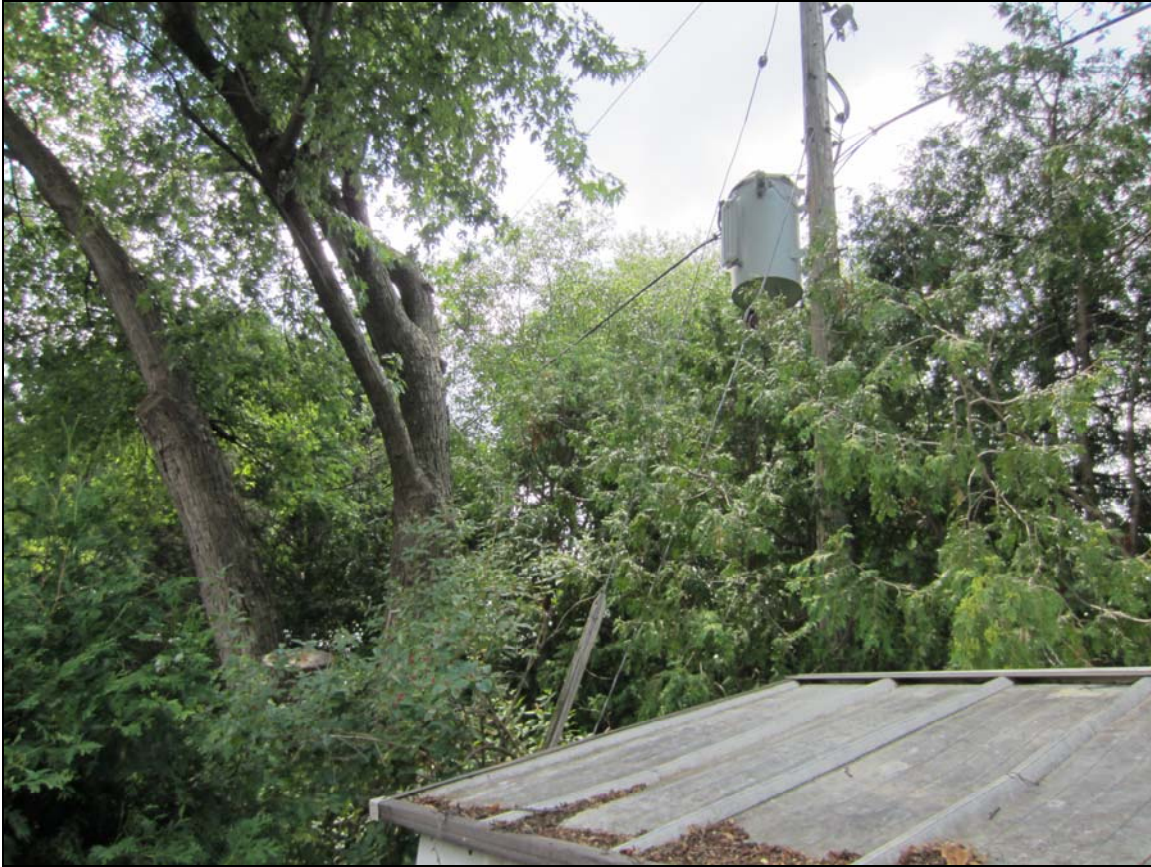
Figure 12. Pole and transformer surrounded by vegetation
