**Re: Enbridge Gas Distribution Inc. ("Enbridge")  
EB-2015-0037 – Innes Road Pipeline Project (formerly EB-2012-0438 and  
EB-2014-0017) Conditions of Approval – Final Monitoring Report**

**ENBRIDGE GAS DISTRIBUTION INC.  
FINAL POST-CONSTRUCTION ENVIRONMENTAL MONITORING REPORT  
Innes Road Pipeline Replacement Project  
EB-2012-0438  
EB-2014-0017  
EB-2015-0037**

Prepared by  
Enbridge Gas Distribution Inc.  
May 2016

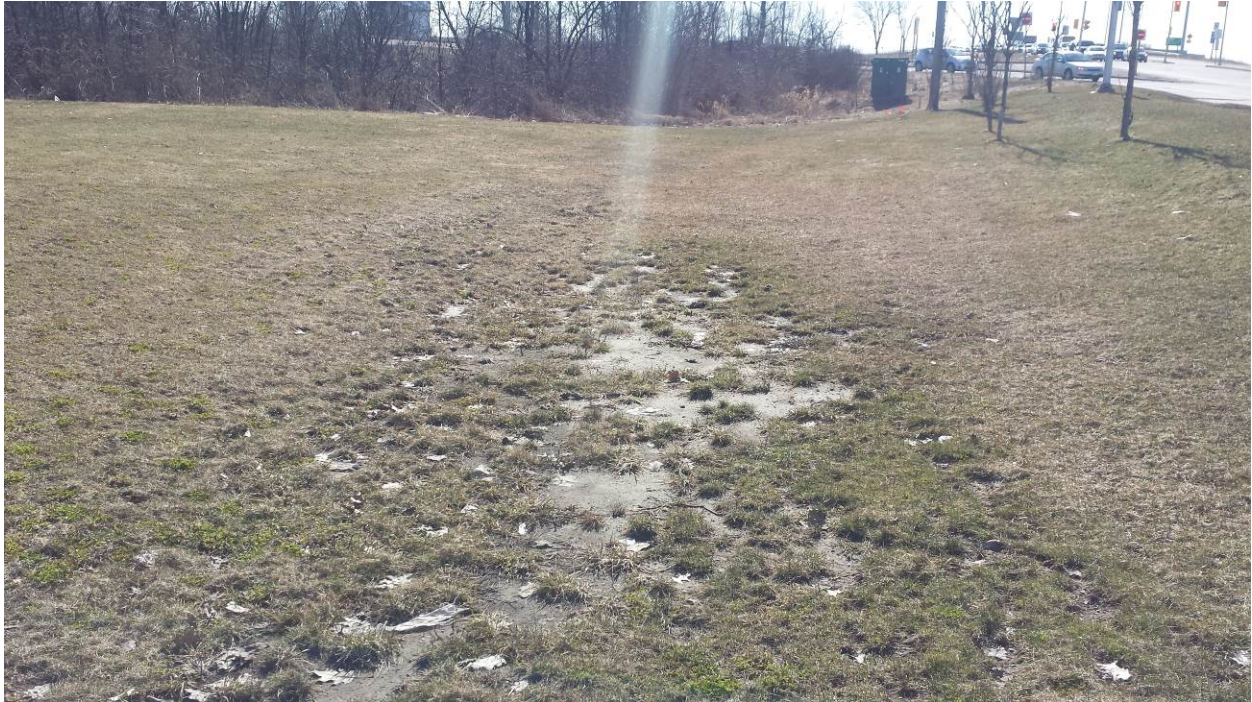
<b>Table 1: Summary of Outstanding Issues</b>				
<b>Photo Log #</b>	<b>Location</b>	<b>April 15, 2016 Observations</b>	<b>Action Item and discussion</b>	
<b>Phase 1 – Innes Road at Highway 417 Crossing</b>				
1	Adjacent to Travelodge - South side of Innes Rd.	<ul style="list-style-type: none"> <li>Some bare patches in grass remain</li> <li>Small trench subsidence in grass</li> </ul>	<ul style="list-style-type: none"> <li>Restored to appropriate grade and revegetated by adding fill, topsoil and then seed.</li> </ul>	
2	Adjacent to Travelodge - South side of Innes Rd.	<ul style="list-style-type: none"> <li>Unable to confirm tree health status at this time of year</li> </ul>	<ul style="list-style-type: none"> <li>Historical Images (April 2009) from Google earth show the tree in declining health prior to project commencement. No further action is required.</li> </ul>	
<b>Phase 2 – Innes Road, East of Highway 417 to Blair Road</b>

Photo 1a: Bare patches of grass. In front of the Travelodge looking west.

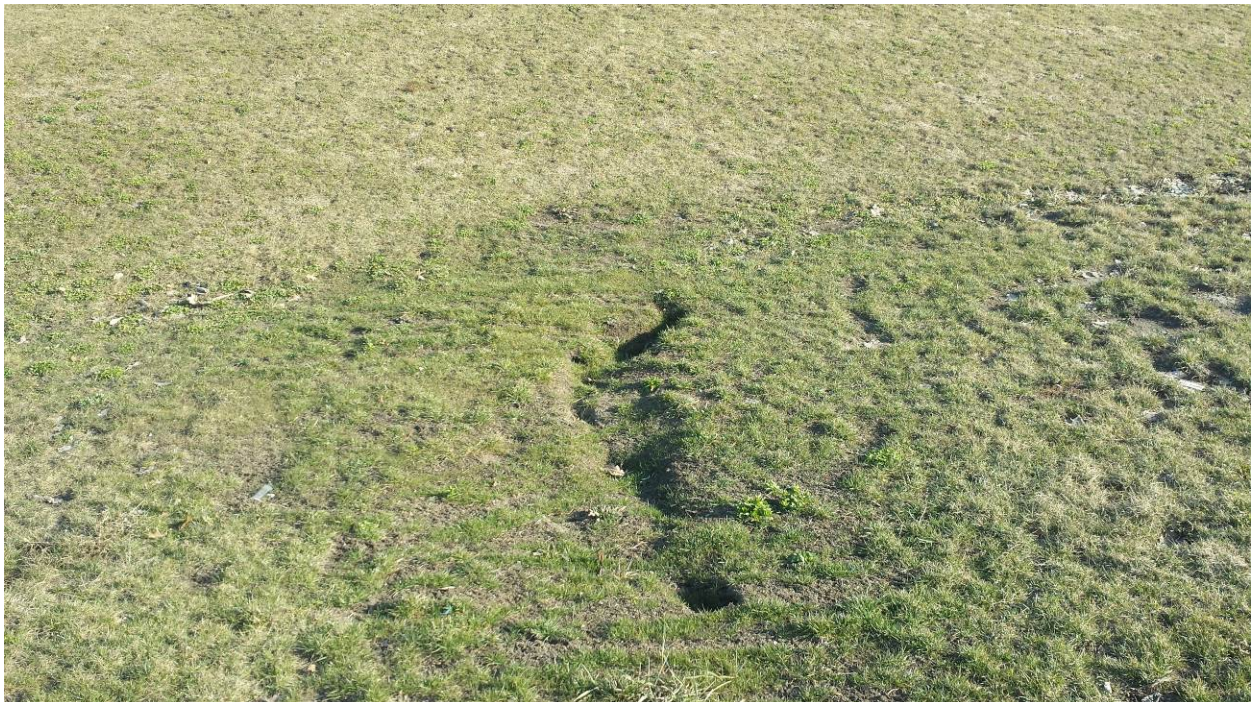
Photo 1b: Soil subsidence in front of the Travelodge.

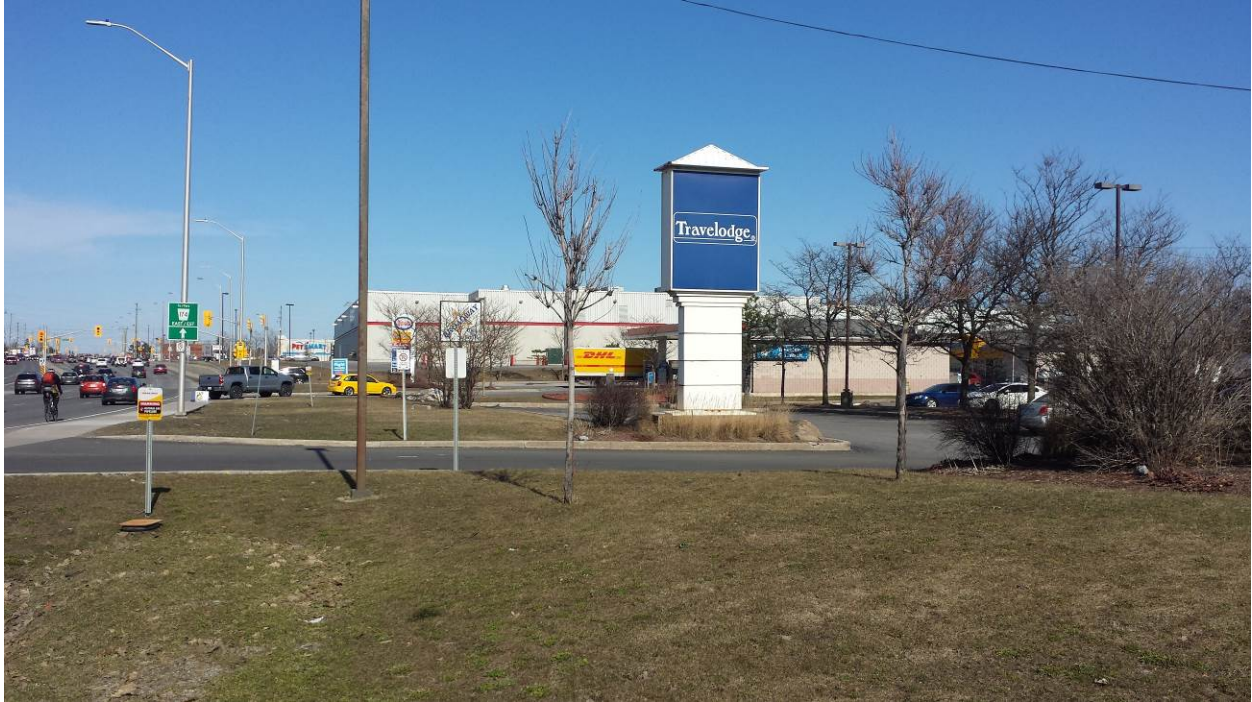
Photo 2: Tree health unconfirmed. North of the Travelodge looking east.

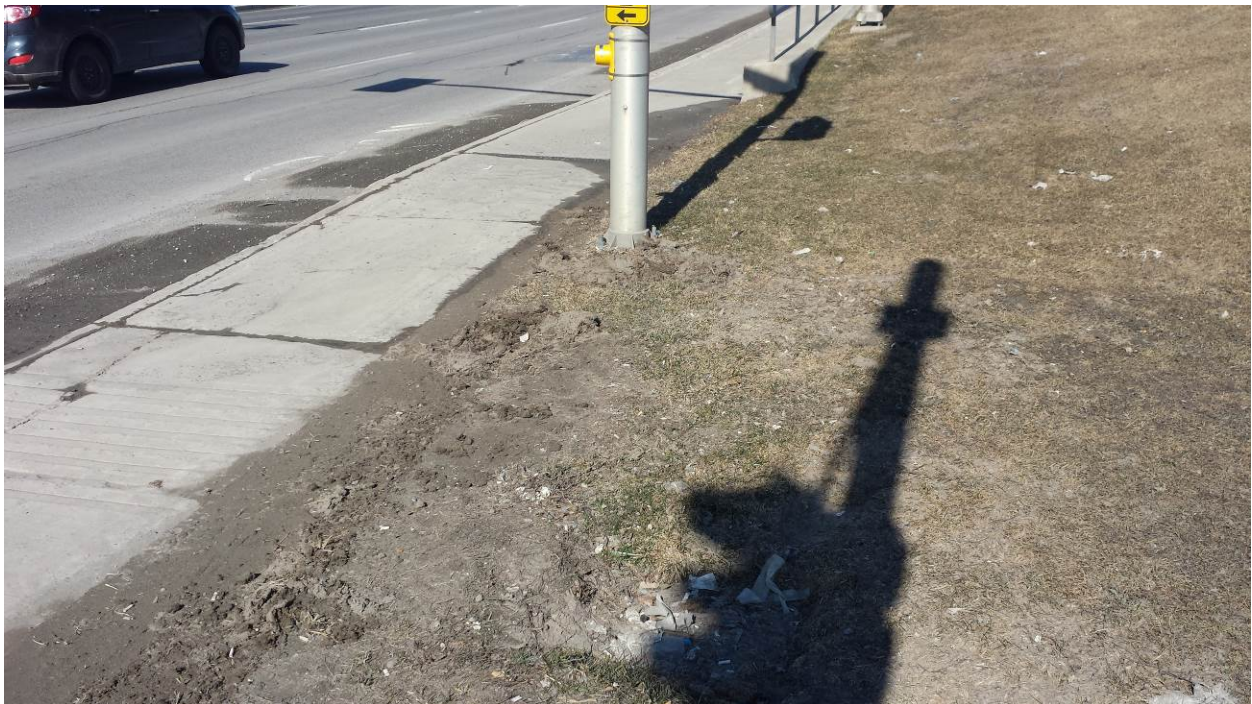
<b>Photo Log #</b>	<b>Location</b>	<b>April 15, 2016 Observations</b>	<b>Action Item and discussion</b>	<b>May 16, 2016 Observations and discussions</b>
3	North West corner of Costco - South side of Innes Rd.	<ul style="list-style-type: none"> <li>Bare patch of grass remains adjacent to sidewalk</li> <li>Sediment from winter sanding/salting activities remains on sidewalk and adjacent grass area</li> </ul>	<ul style="list-style-type: none"> <li>Enbridge revisited affected areas and added top soil and seed as needed.</li> <li>Due to the high volume of pedestrian, vehicle and road maintenance activities full revegetation is not anticipated.</li> <li>Due to the erosion and vegetation issues that were noted in this area prior to construction, no follow up visits will be completed</li> </ul>	N/A
(April 2016) 4a, b and c (May 2016) 12a, b, c, d, and e	Adjacent to Costco parking - South side of Innes Rd.	<ul style="list-style-type: none"> <li>Unable to determine health of replacement trees at this time of year.</li> </ul>	<ul style="list-style-type: none"> <li>Unable to determine health. Enbridge will perform a site visit later in the season to assess the health of the trees. Upon assessment further action, if needed, will be taken.</li> </ul>	<ul style="list-style-type: none"> <li>Significant leaf growth was documented</li> <li>Full growth is expected and no additional actions need to be taken.</li> </ul>

Photo 3: Bare patch of grass on the North West Corner of Costco.

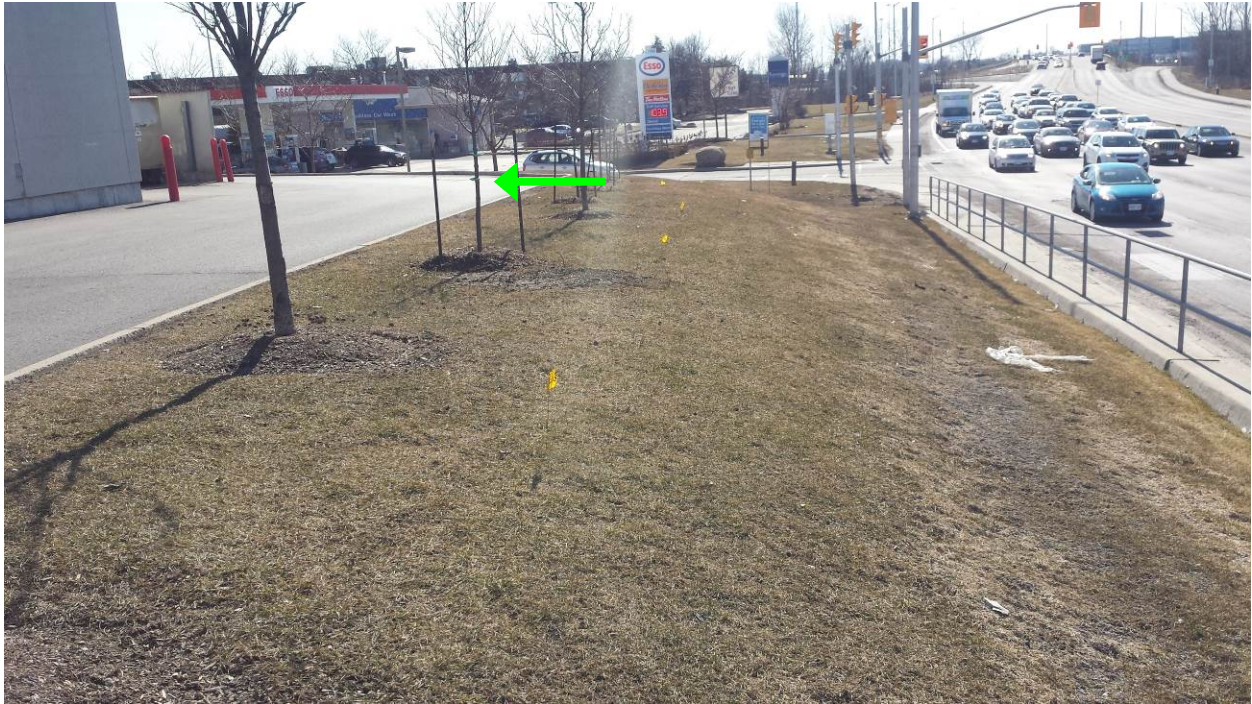
Photos 4a: Trees with unconfirmed health on the North side of Costco.

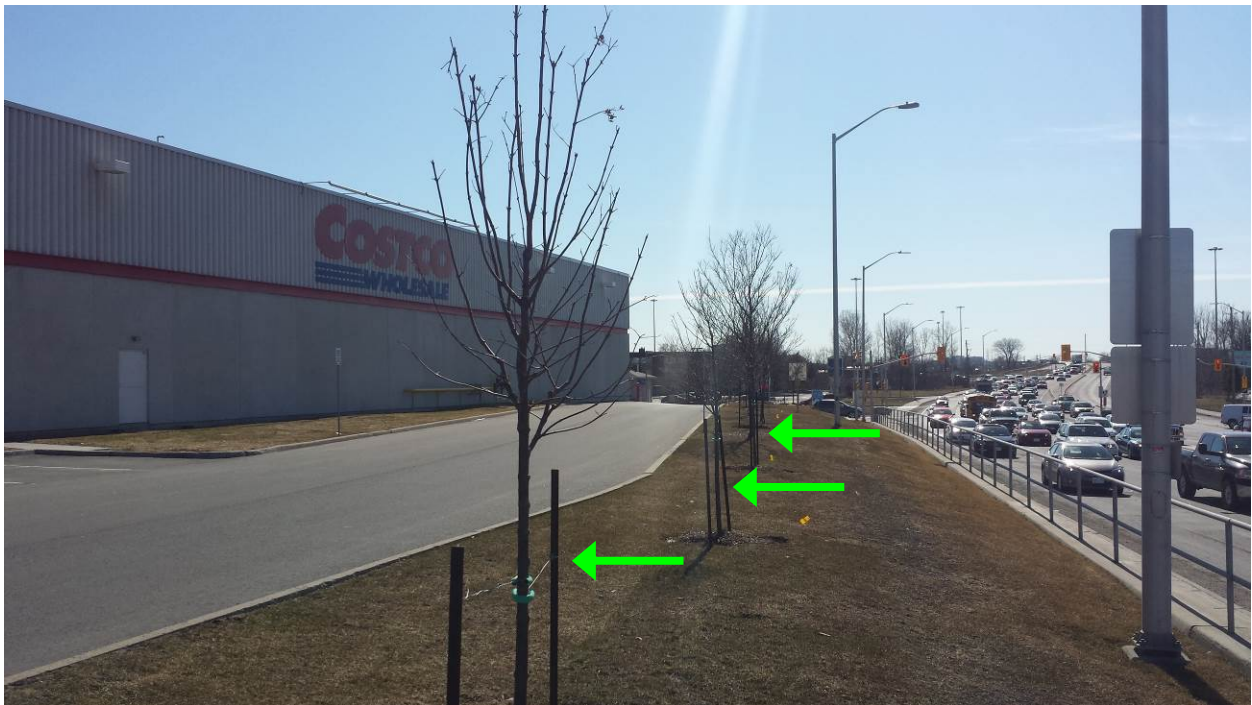
Photos 4b: Trees with unconfirmed health on the North side of Costco.

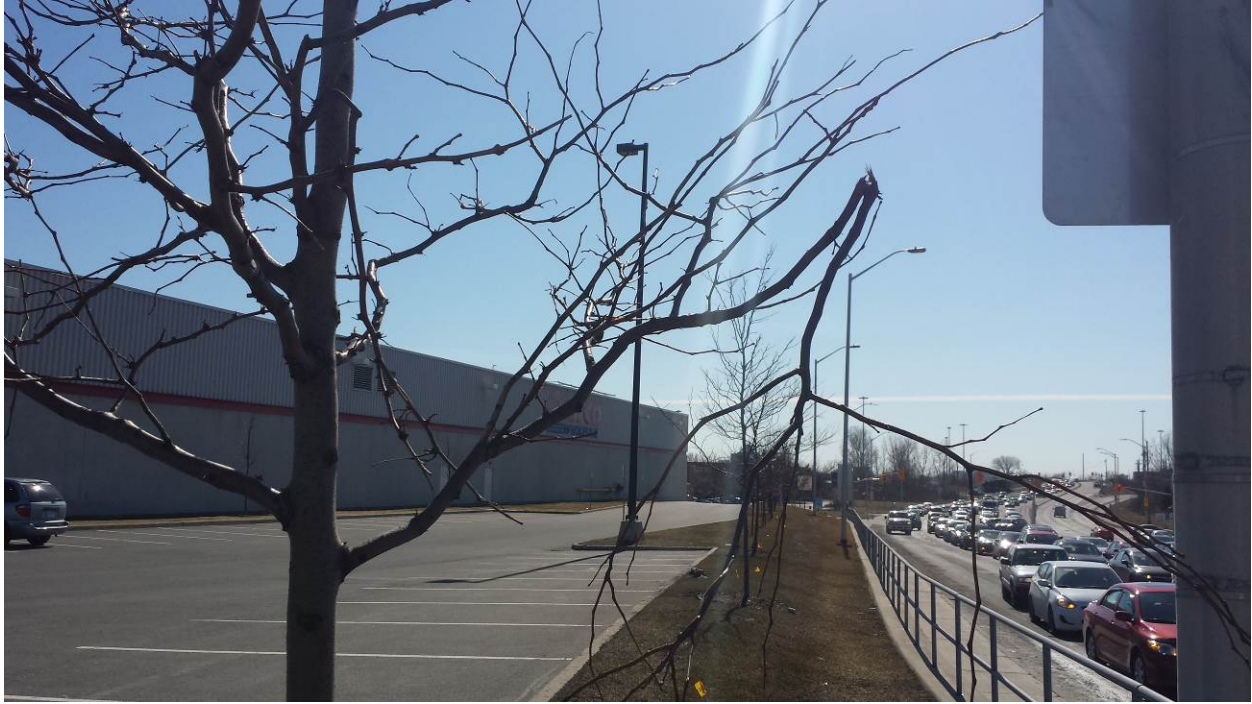
Photos 4c: Trees with unconfirmed health on the North side of Costco.

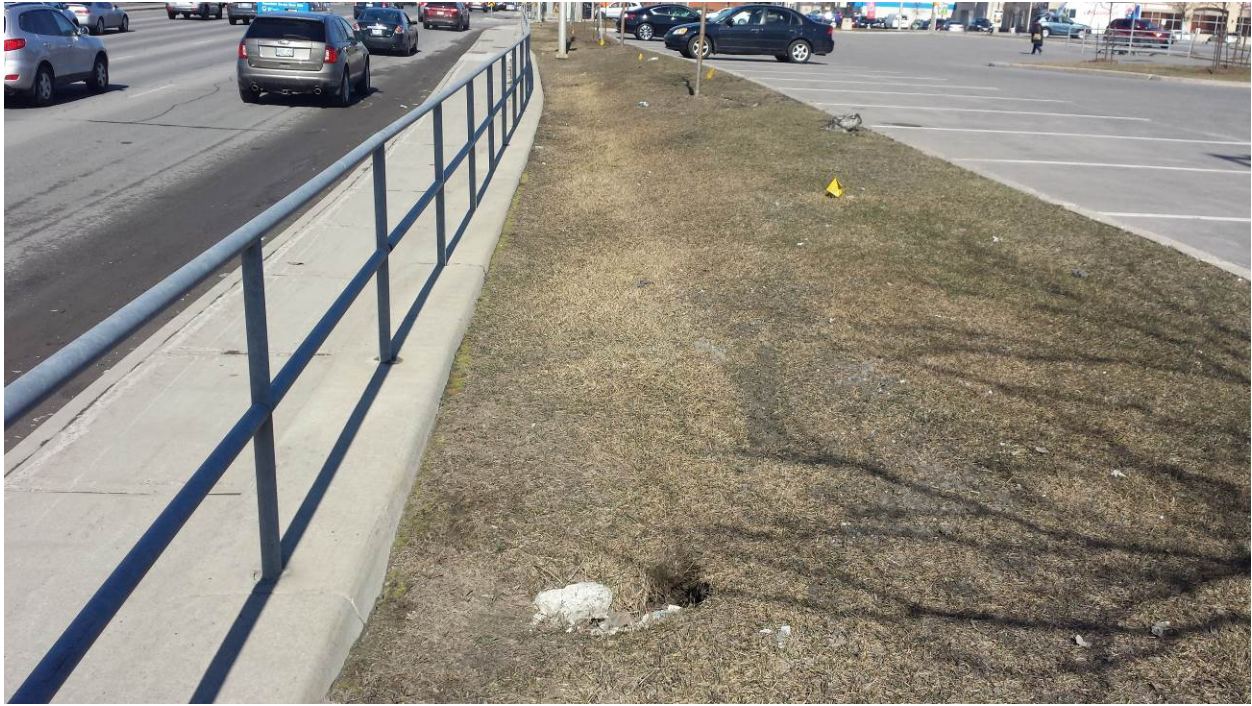
5	North west of the ESSO Station - South side of Innes Rd.	<ul style="list-style-type: none"> <li>Subsidence remains</li> </ul>	<ul style="list-style-type: none"> <li>Revegetated and restored to appropriate grade by adding fill, topsoil and then seed.</li> </ul>	N/A
6, 7	Adjacent to Costco parking - South side of Innes Rd.	<ul style="list-style-type: none"> <li>Small trench subsidence beside guard rails</li> <li>Small trench subsidence next to sidewalk curbing.</li> </ul>	<ul style="list-style-type: none"> <li>Revegetated and restored to appropriate grade by adding fill, topsoil and then seed.</li> </ul>	N/A
<b>Phase 3 – Innes Road, West of Highway 417 (Windmill Lane) to St. Laurent Blvd.</b>				
<b>Photo Log #</b>	<b>Location</b>	<b>April 15, 2016 Observations</b>	<b>Action Item and discussion</b>	
8a, b, and c	East of Bantree St. to St Laurent – South side of Innes Rd	<ul style="list-style-type: none"> <li>Bare patch of grass adjacent to the sidewalk remains</li> <li>Sand and salt from winter road maintenance activities covers soil in much of the area</li> </ul>	<ul style="list-style-type: none"> <li>Enbridge revisited affected areas and added top soil and seed as needed.</li> <li>Due to the high volume of pedestrian, vehicle and road maintenance activities full revegetation is not anticipated.</li> <li>Due to the erosion and vegetation issues that were noted in this area prior to construction no follow up visits will be completed</li> </ul>

Photos 6: Trench subsidence on the North side of Costco.

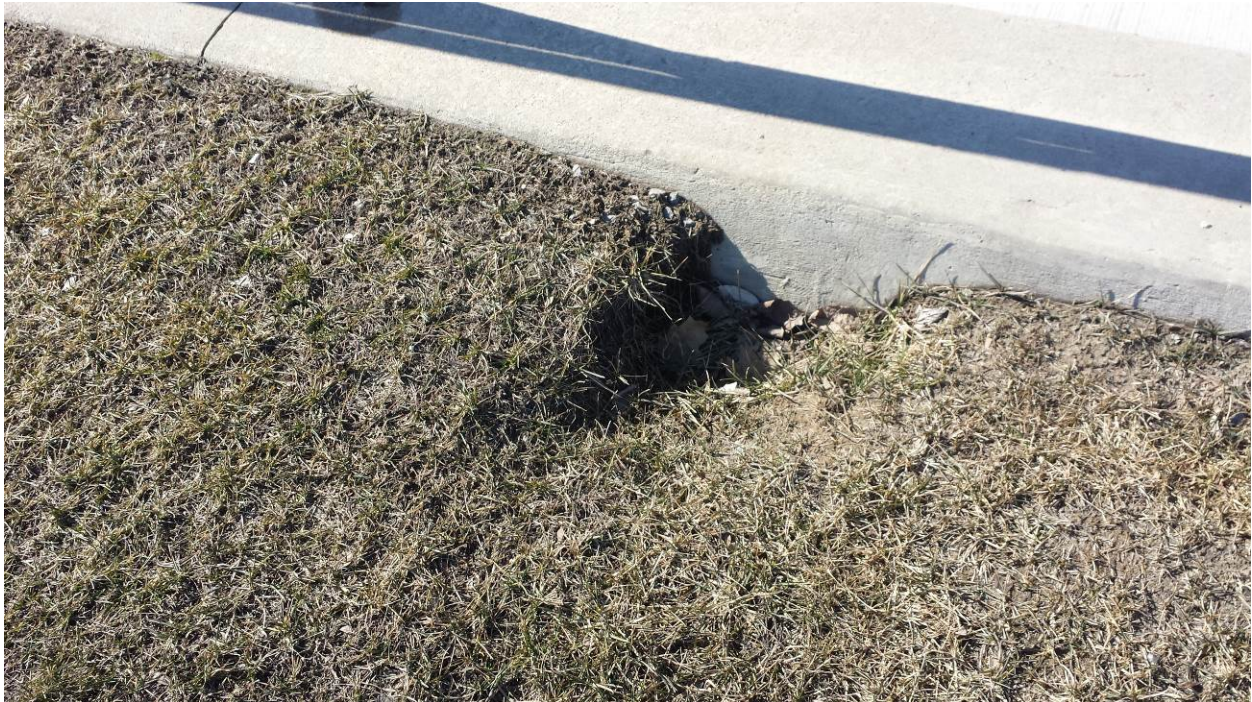
Photos 7: Trench subsidence on the North side of Costco.

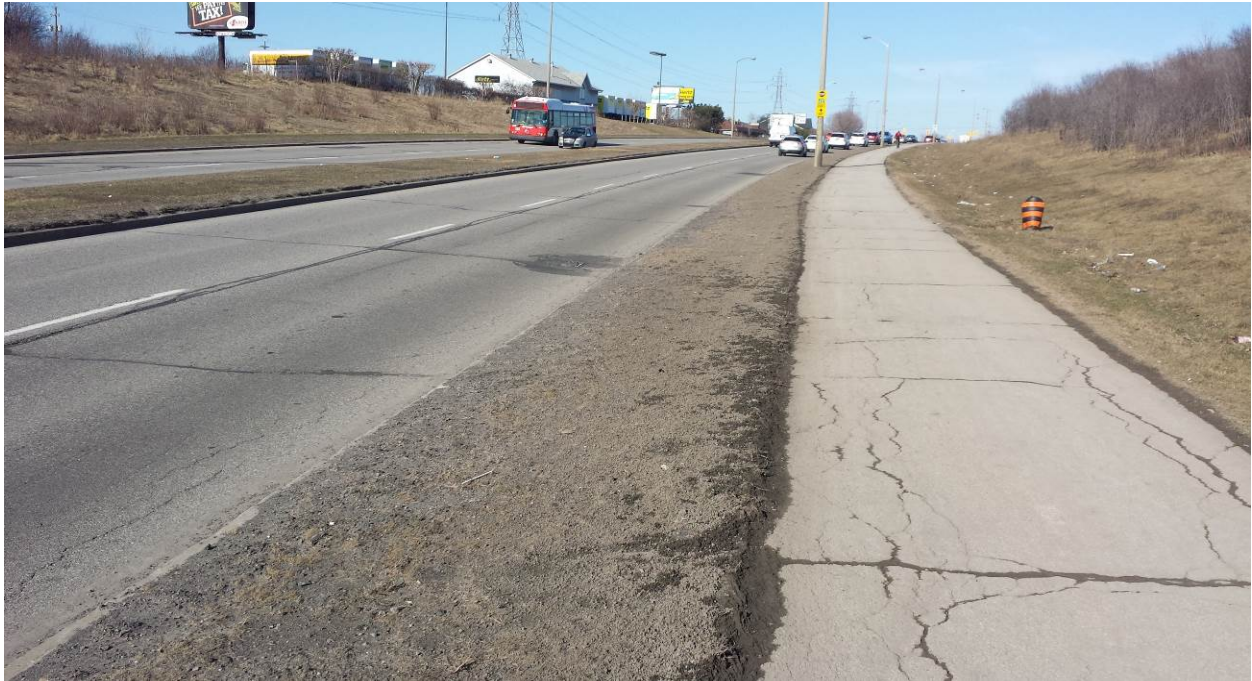
Photo 8a: Bare patches of grass from East of Bantree St to St Laurent on the South side of Innes Rd.

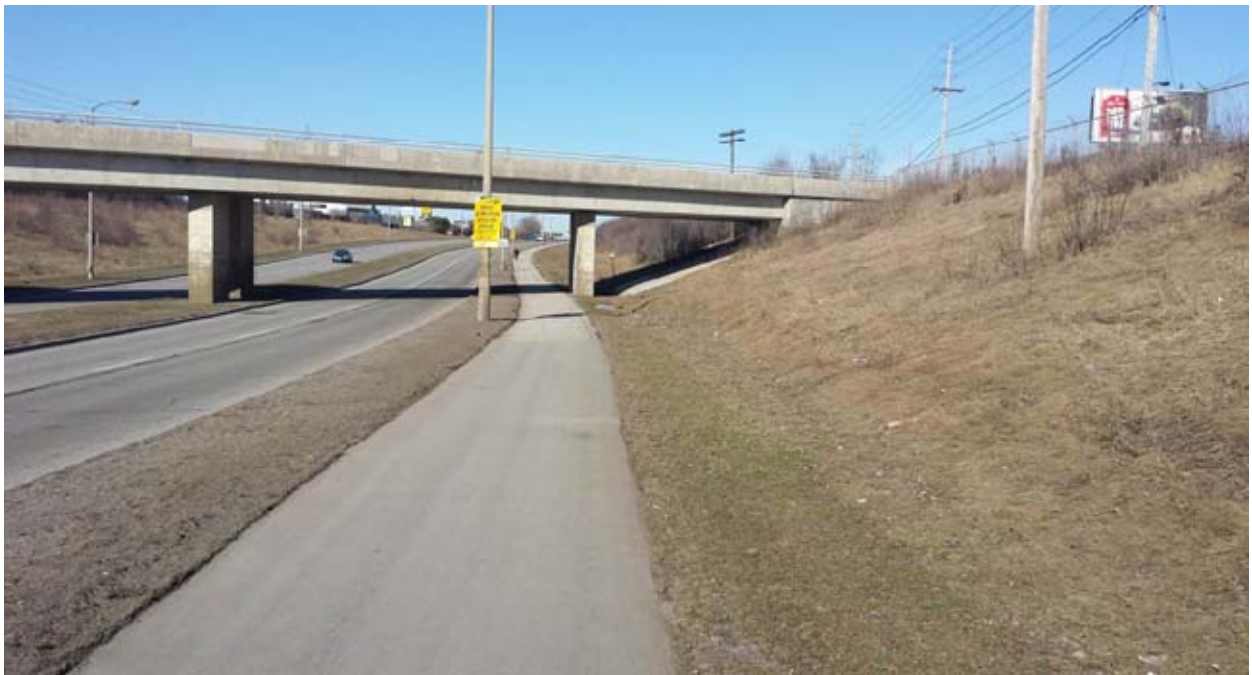
Photo 8b: Bare patches of grass from East of Bantree St to St Laurent on the South side of Innes Rd.

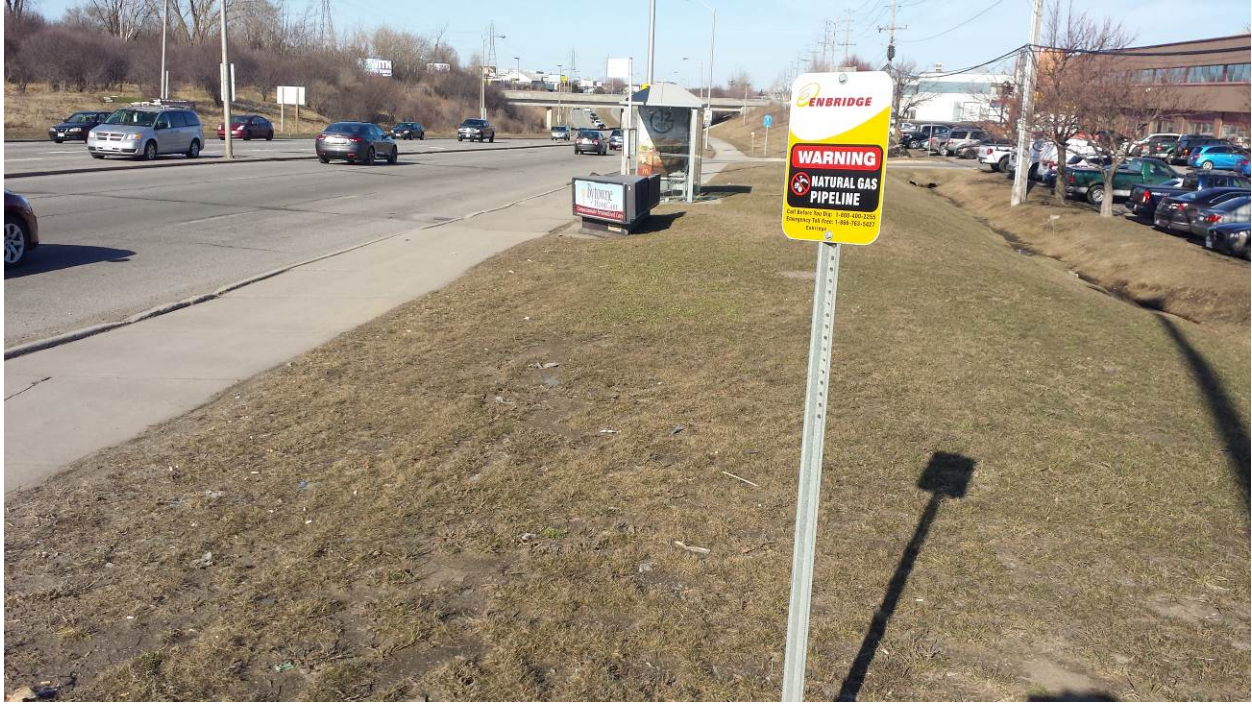
Photo 8c: Bare patches of grass from East of Bantree St to St Laurent on the South side of Innes Rd.

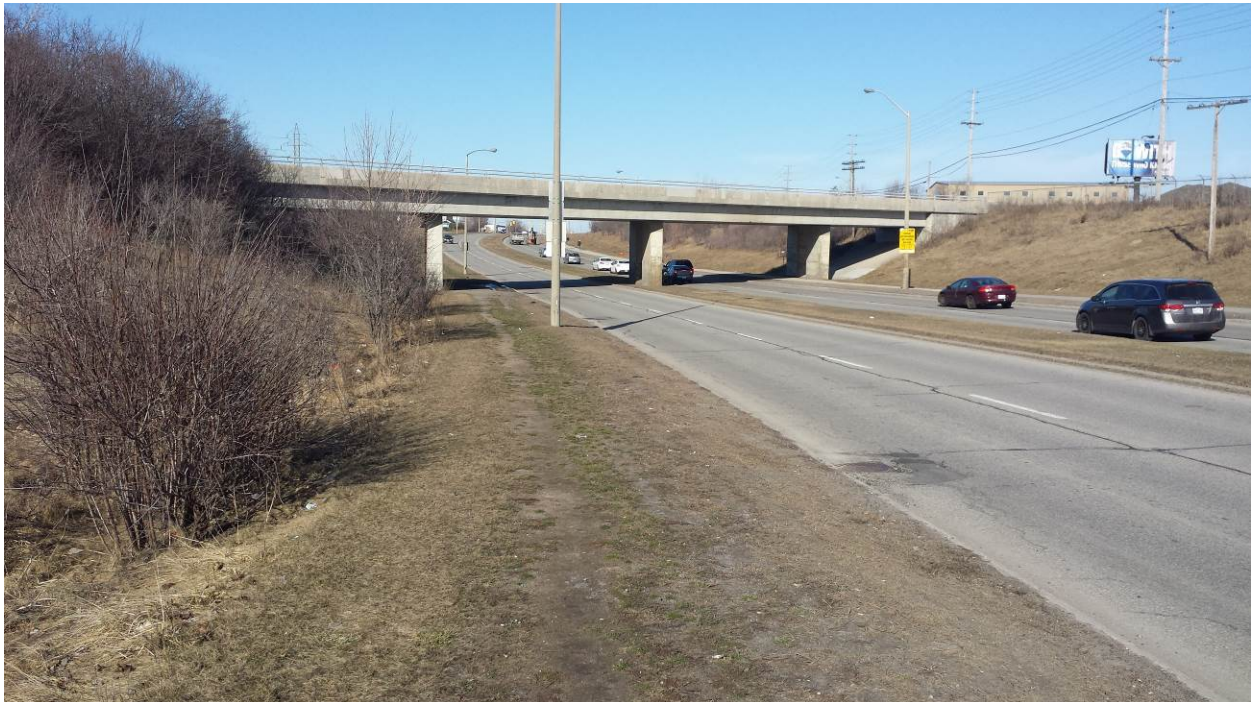
9a, b, and c	Bantree St. to St. Laurent – North side of Innes Rd	<ul style="list-style-type: none"> <li>Bare patches of grass remain along Innes road</li> <li>Some natural revegetation has occurred</li> </ul>	<ul style="list-style-type: none"> <li>Enbridge revisited affected areas and added top soil and seed as needed.</li> <li>Due to the high volume of pedestrian, vehicle and road maintenance activities full revegetation is not anticipated.</li> <li>Due to the erosion and vegetation issues that were noted in this area prior to construction no follow up visits will be completed</li> </ul>	
10	NE Corner of St. Laurent and Innes Rd.	<ul style="list-style-type: none"> <li>Bare patch of grass remains along Innes Road</li> </ul>	<ul style="list-style-type: none"> <li>Enbridge revisited affected areas and added top soil and seed as needed.</li> <li>Due to the high volume of pedestrian, vehicle and road maintenance activities full revegetation is not anticipated.</li> <li>Due to the erosion and vegetation issues that were noted in this area prior to construction no follow up visits will be completed</li> </ul>

Photos 9a: Bare patches of grass from Bantree St to St Laurent on the North side of Innes Rd.

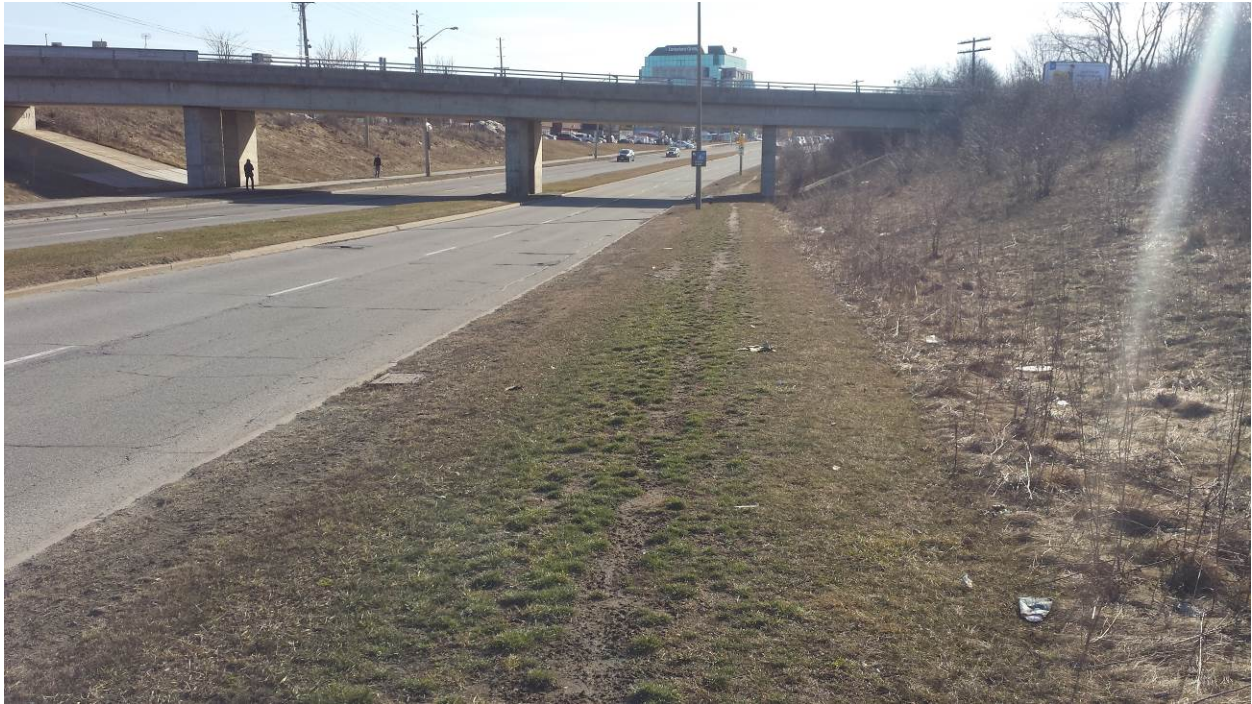
Photos 9b: Bare patches of grass from Bantree St to St Laurent on the North side of Innes Rd.

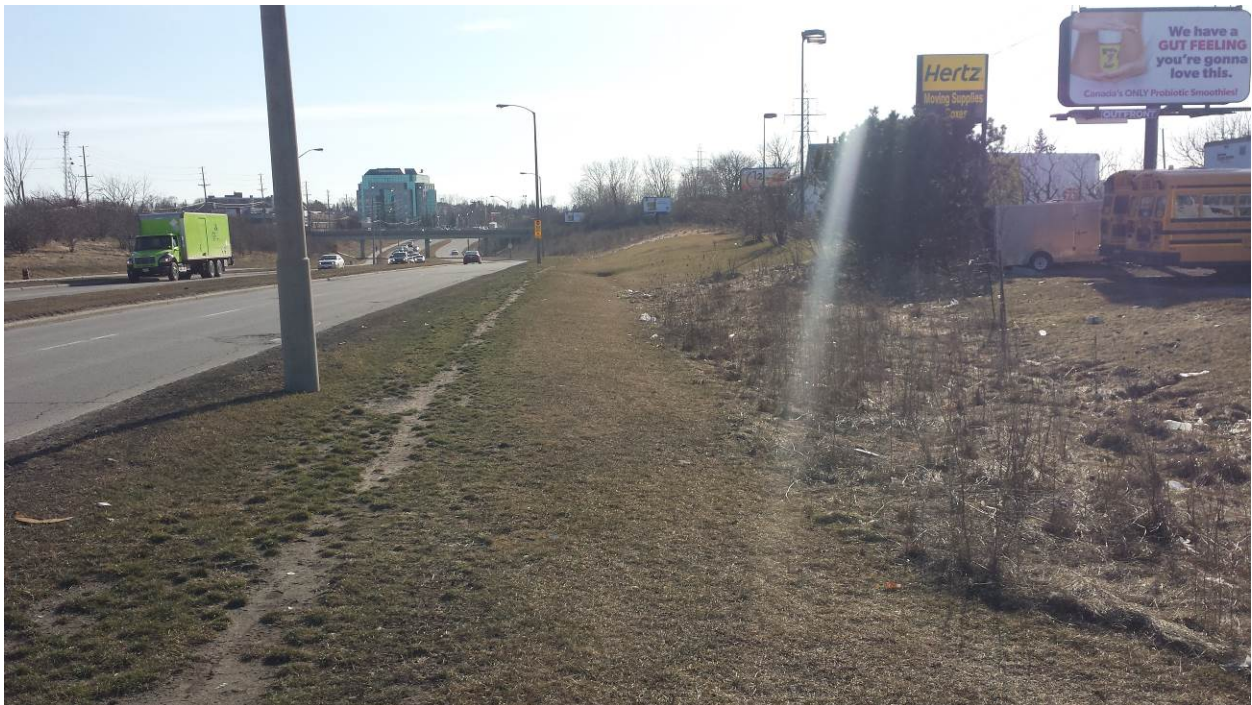
Photos 9c: Bare patches of grass from Bantree St to St Laurent on the North side of Innes Rd.

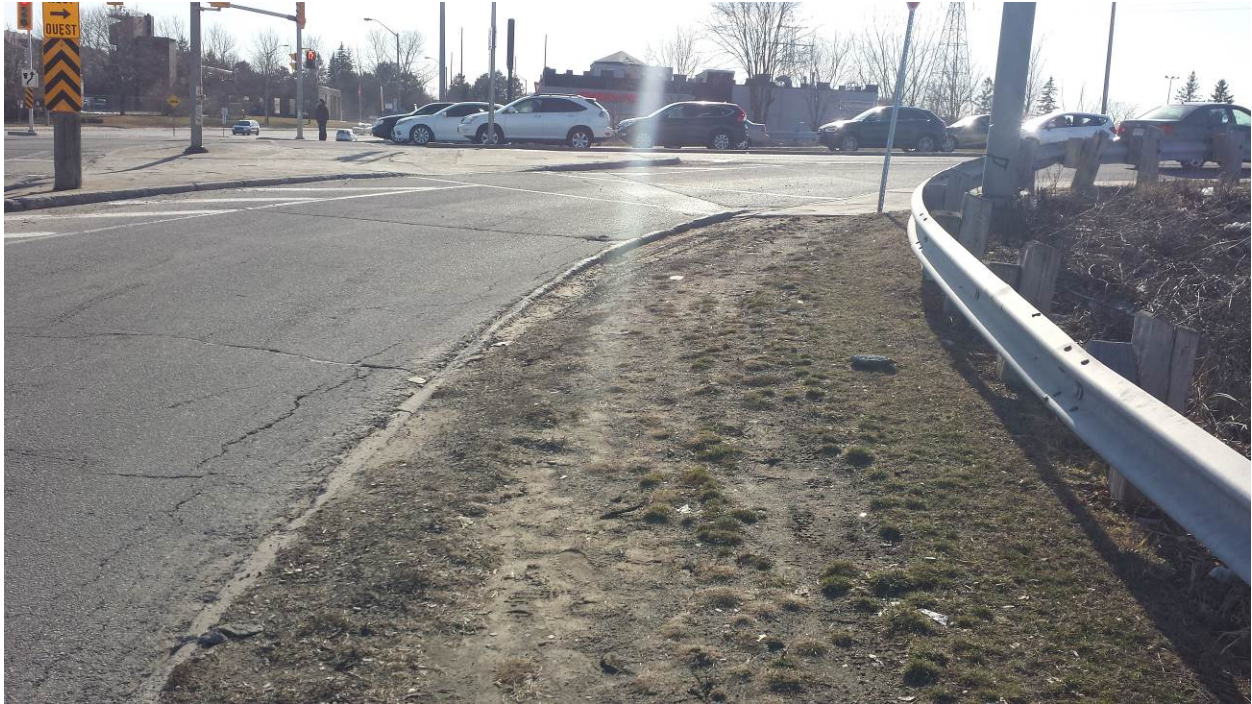
Photo 10: Bare patch of grass at the North East corner of St Laurent and Innes Rd.

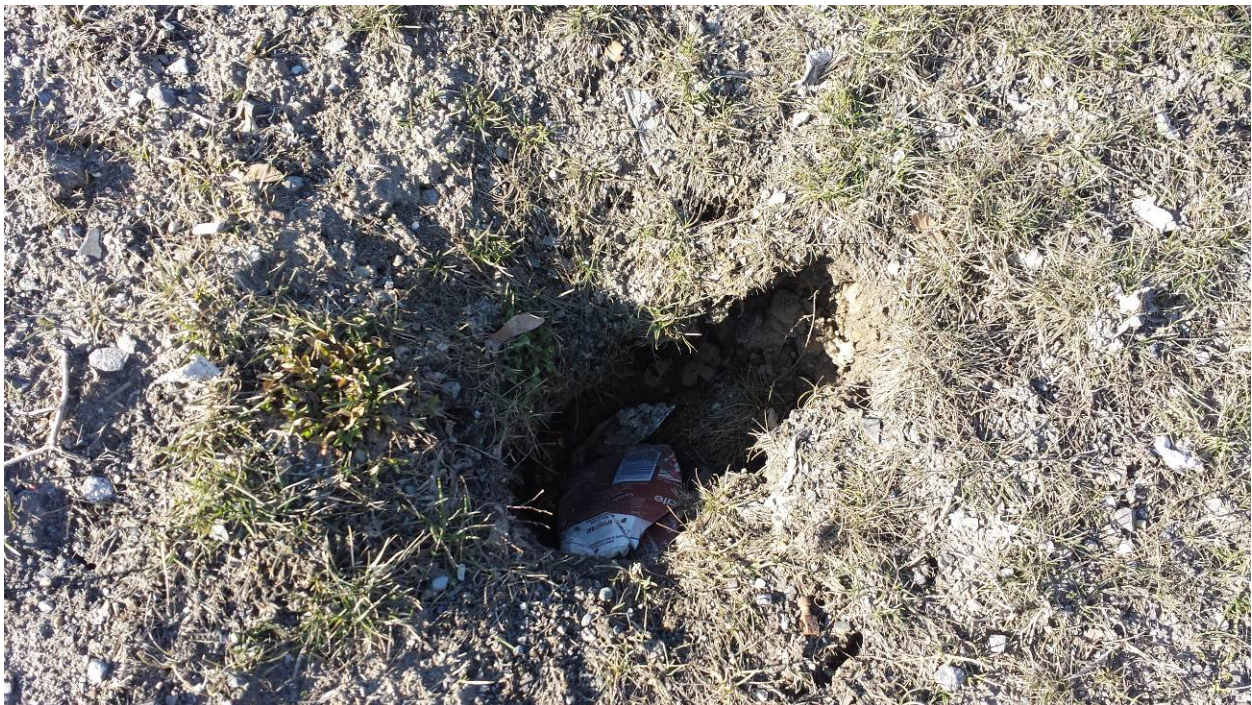
11	SE Corner of St. Laurent and Innes Rd.	<ul style="list-style-type: none"> <li>Minor trench subsidence adjacent to asphalt sidewalk</li> </ul>	<ul style="list-style-type: none"> <li>Revegetated and restored to appropriate grade by adding fill, topsoil and then seed.</li> </ul>

Photo 11: Soil subsidence at the South East corner of St Laurent and Innes Rd.

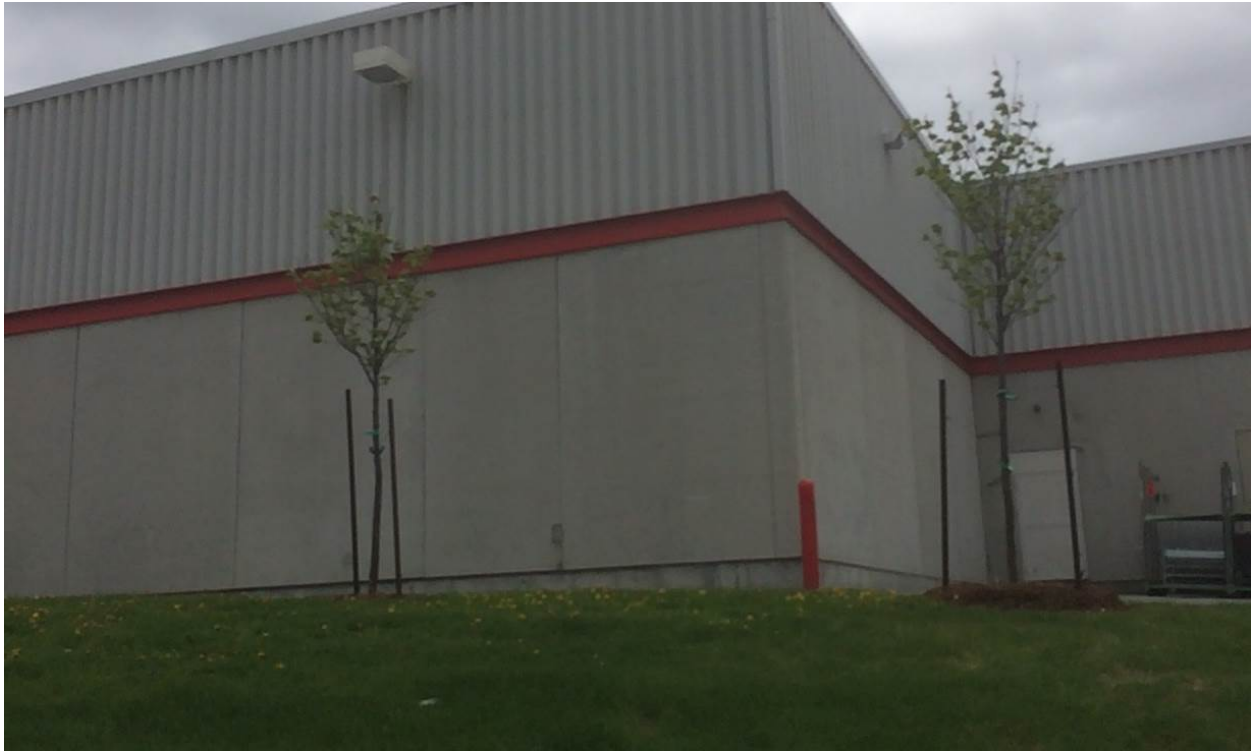
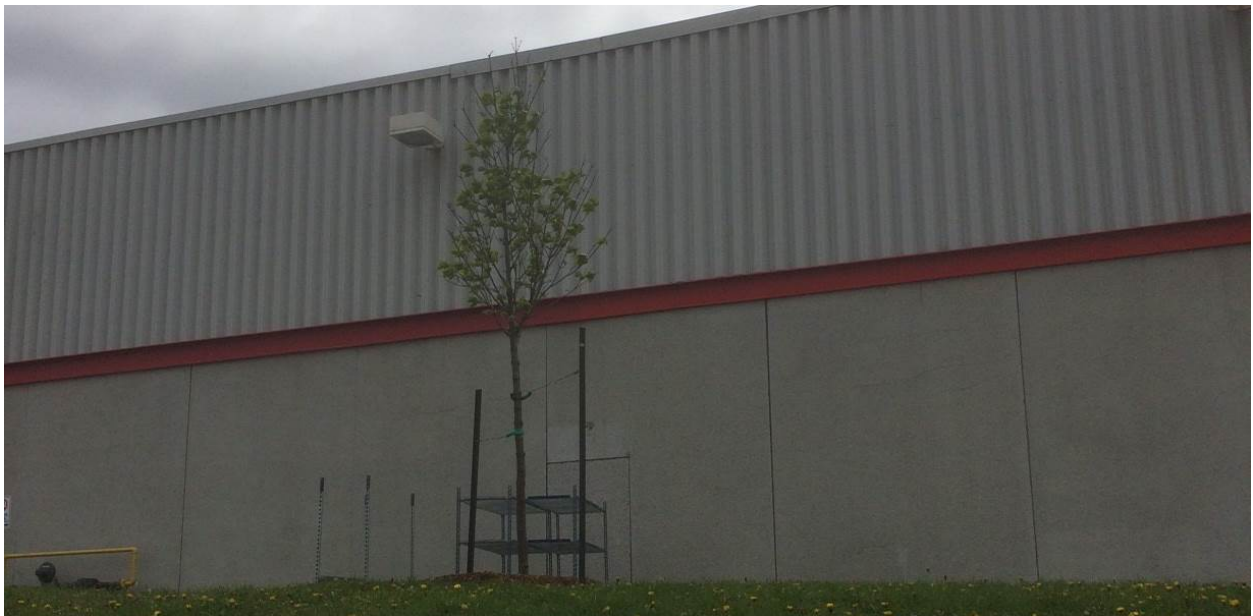
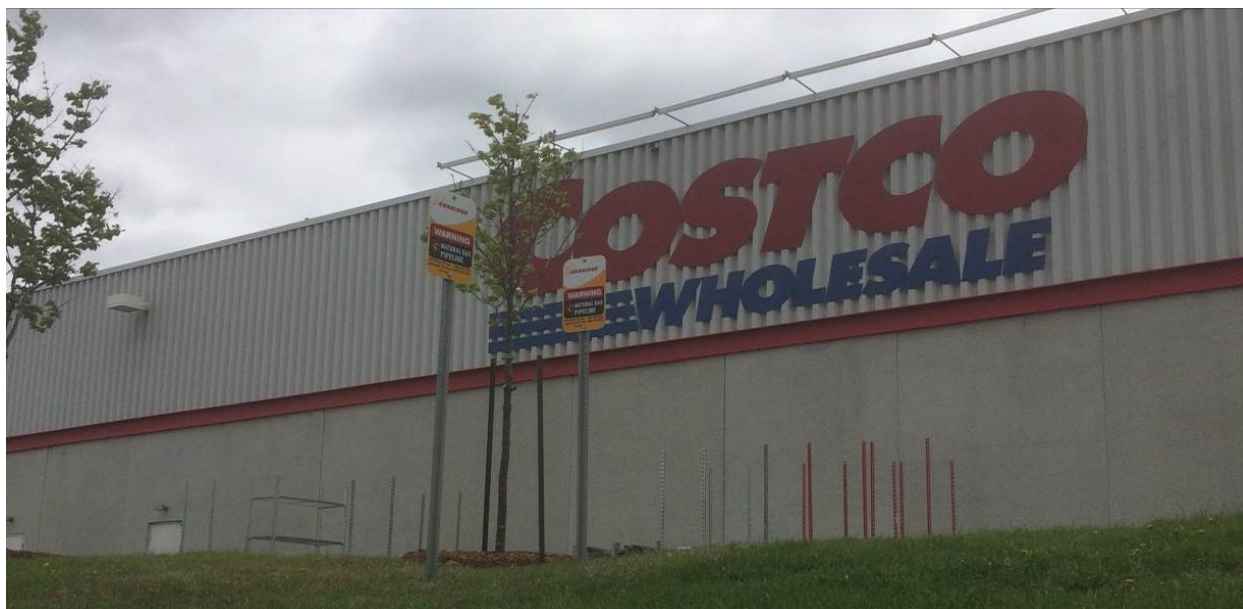
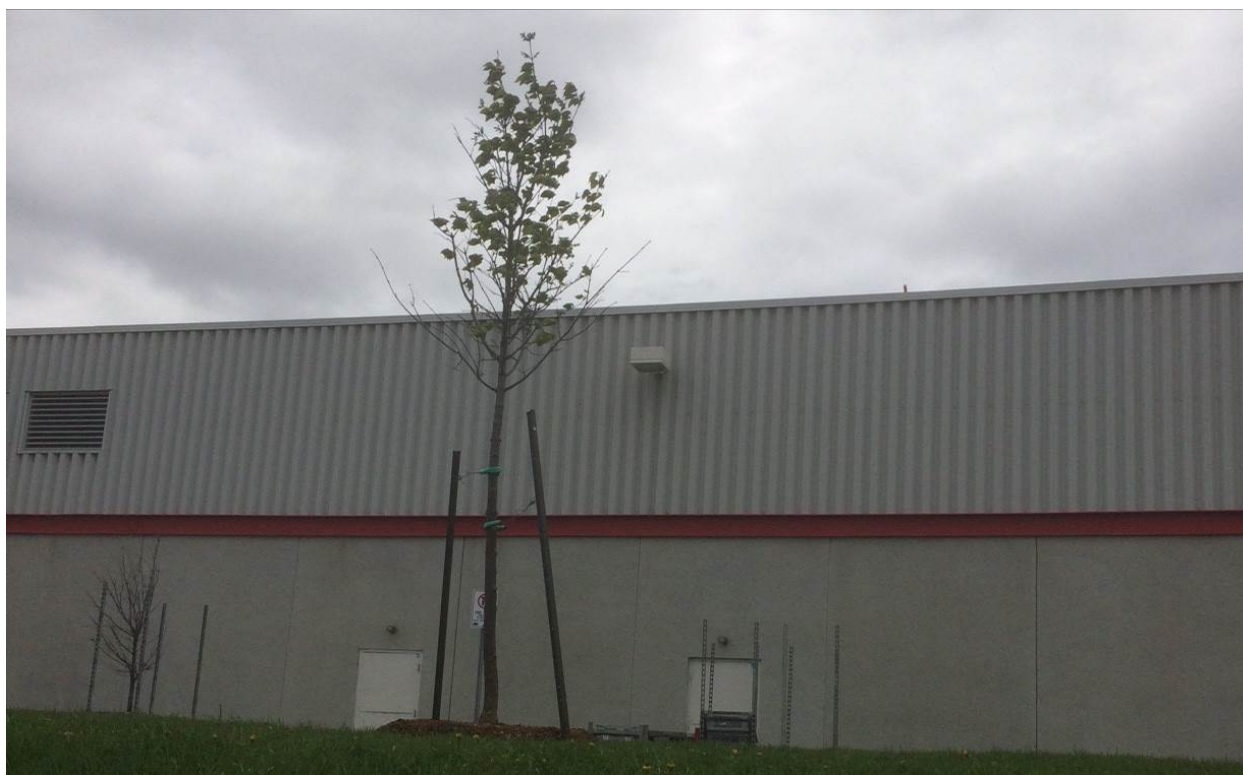
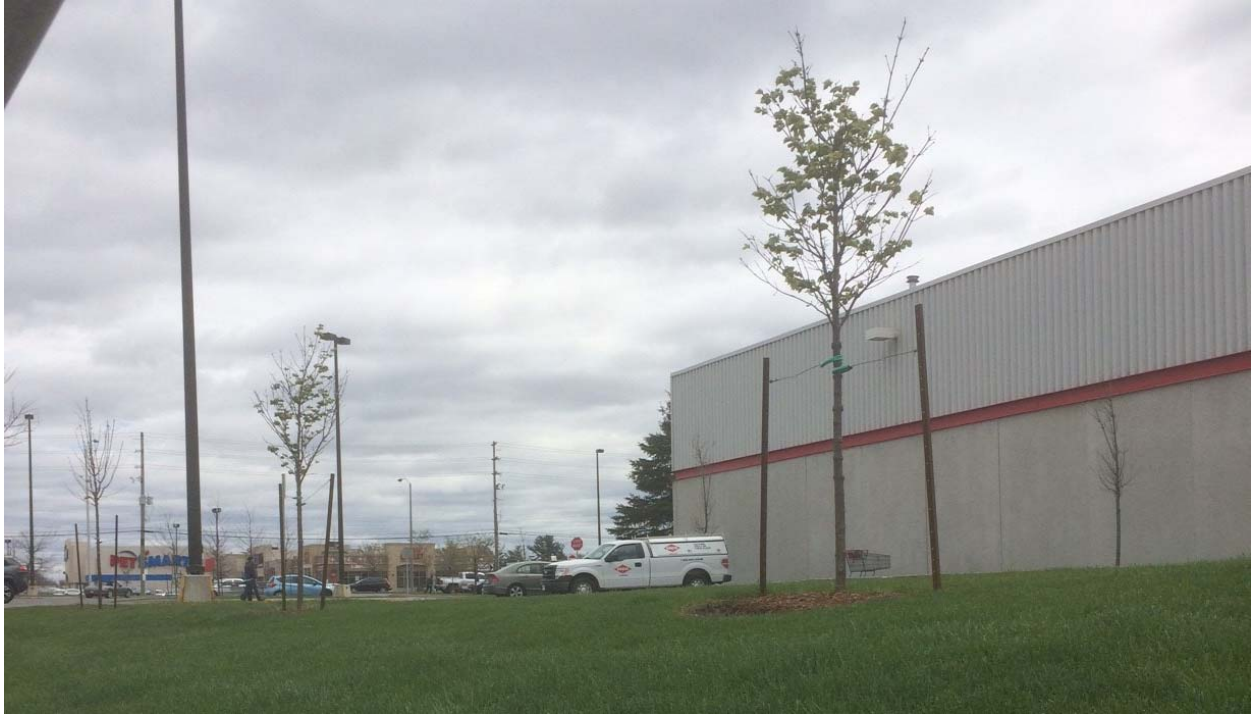
during this site visit and based on these observations, sufficient growth is expected to return. The results of the follow up visit are identified in Appendix B, Table 1 and are documented in the Appendix C Photo Log.

Photo 12a: Trees on the North side of Costco.
