**Re: Enbridge Gas Distribution Inc. (“Enbridge”)
EB-2016-0054 – Seaton Land Development Pipeline Project
Conditions of Approval – Post Construction Report**

**Enbridge Gas Distribution Inc.
Interim Post-construction
Environmental Monitoring Report
Pipeline to Serve the Seaton Land
Development
EB -2016-0054**

PRE-CONSTRUCTION AND POST- CONSTRUCTION PROPERTY CONDITION ASSESSMENTS

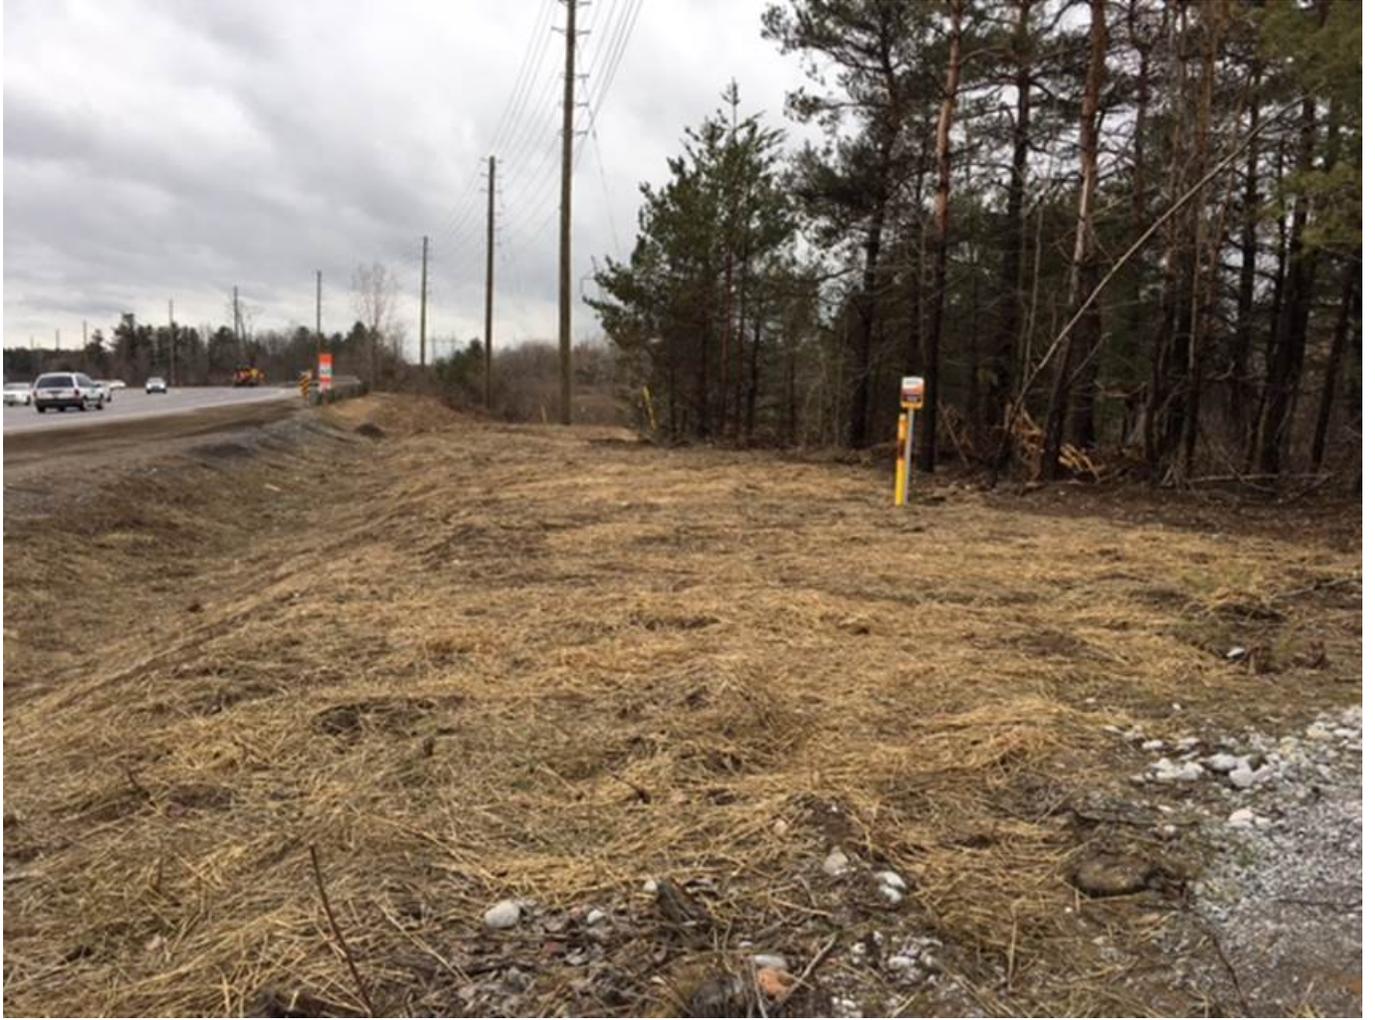
Photo 5: West of Brock Rd (looking east).

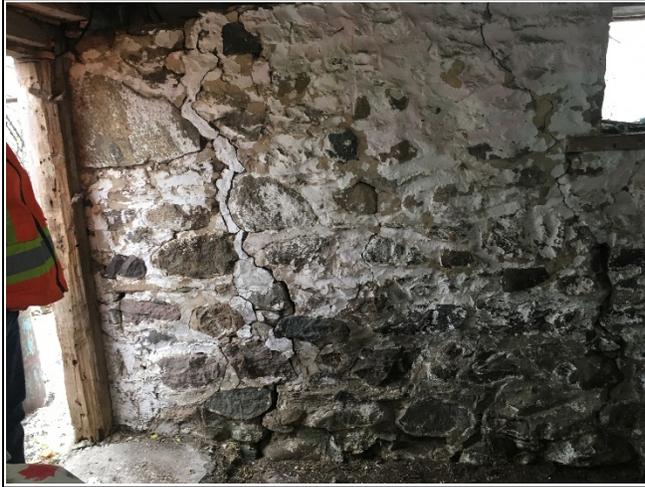
Photo 1: E1 – View of a crack on south foundation wall in the basement

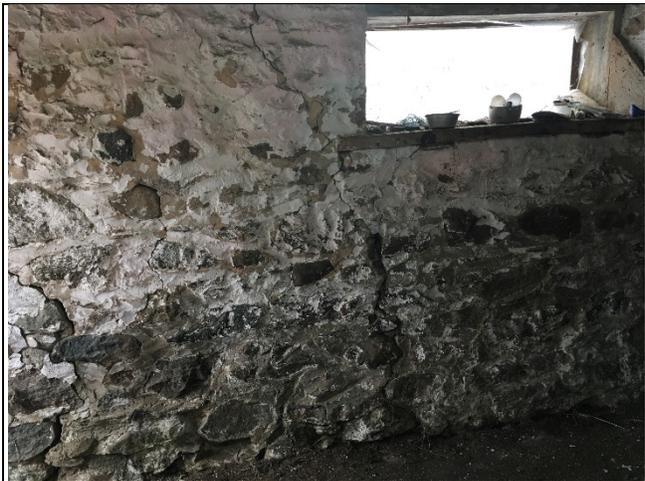
Photo 3: E2 – View of crack on south foundation wall in the basement

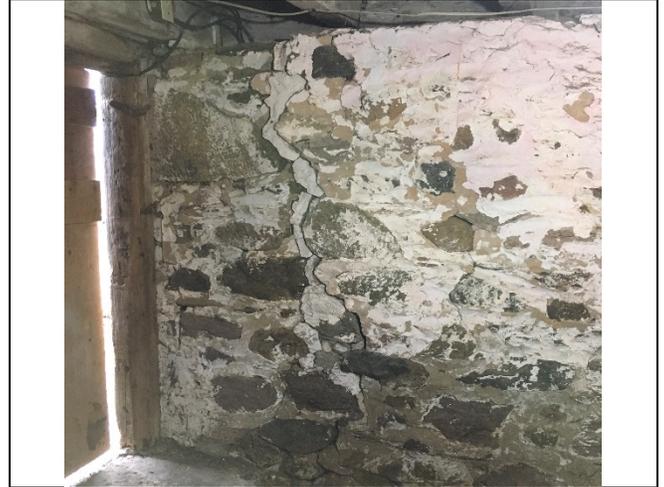
Photo 2: No significant change to the crack on the south foundation wall was observed.

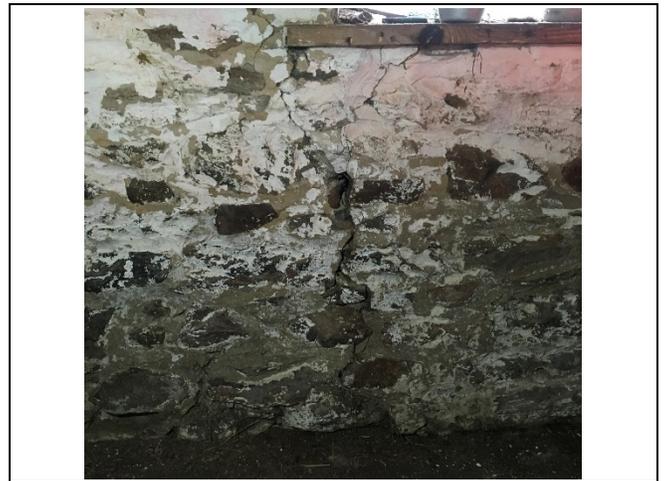
Photo 4: No significant change to the crack on the south foundation wall was observed.

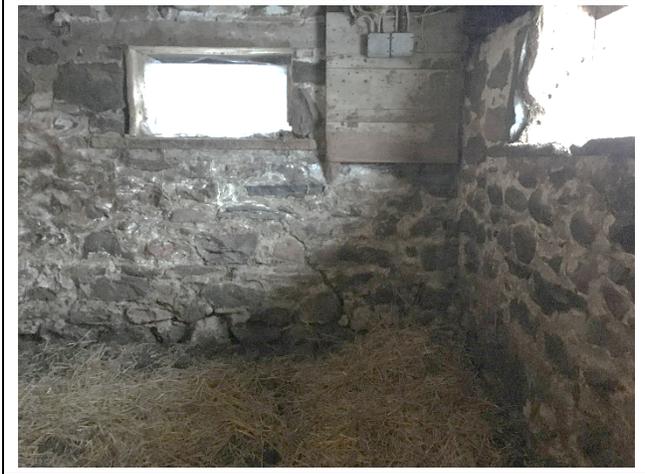
Photo 13: E7 –View of a crack on the west foundation wall (Animal Stable # 3)

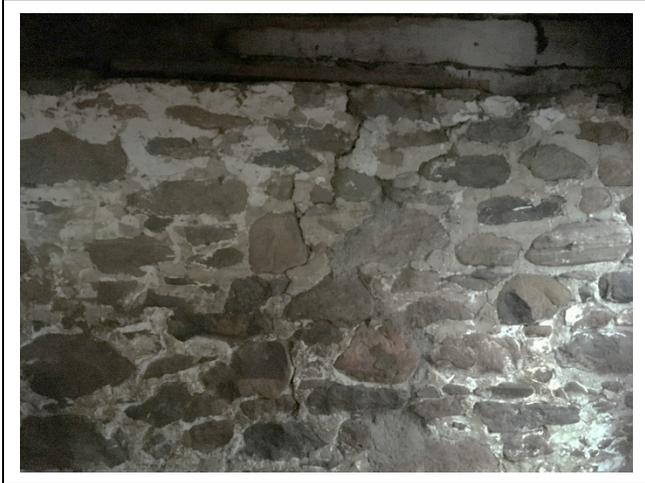
Photo 15: E8 – View of a crack on the north foundation wall

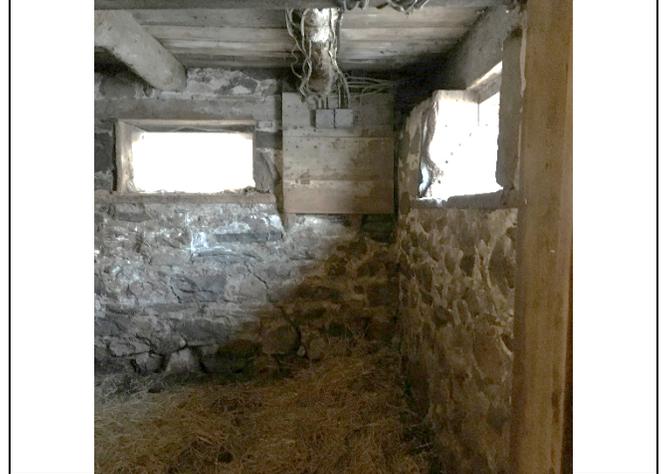
Photo 14: No significant change to the crack on the west foundation wall was observed.

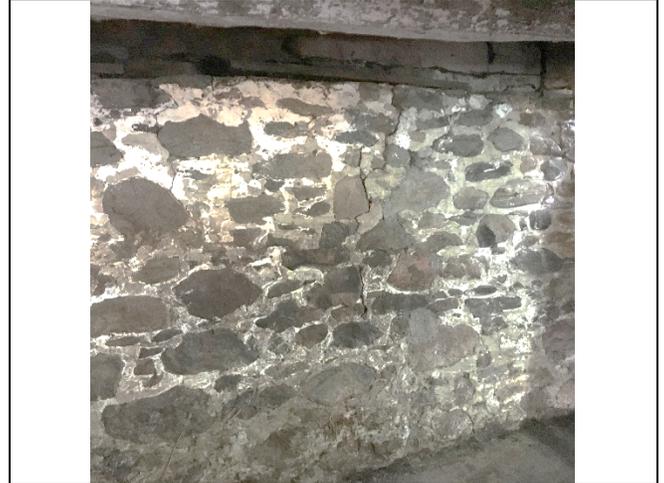
Photo 16: No significant change to the (north foundation wall) crack was observed.

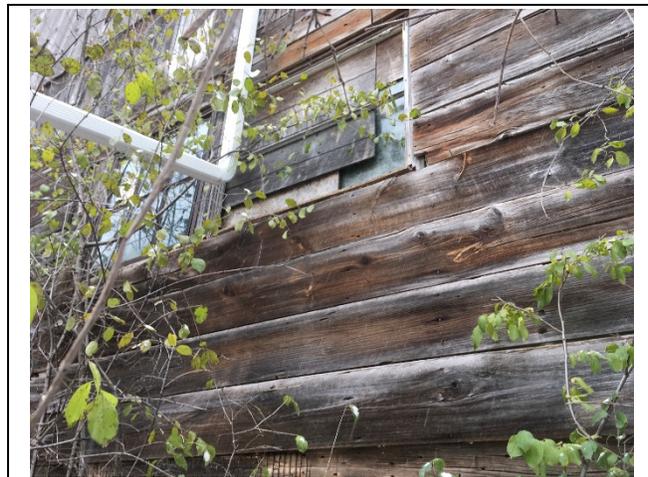
Photo 41: E21 – View of the boarded damaged window and damaged wood boards on the south elevation

E-21	Exterior Walls - Wood Siding	South Elevation	View of the boarded damaged window and damaged wood boards on the south elevation (See Photograph 41).	No significant change to the condition of damaged window and wood boards was observed (See Photograph 42).	
E-22	Exterior Walls - Wood Siding	South Elevation	View of the south elevation storage opening (See Photograph 43).	View of the damaged wood boards on the south elevation (See Photograph 44).	
E-23	Exterior Walls - Wood Siding	South Elevation	View of the damaged wood siding in the south elevation (See Photograph 45).	No significant change to the south elevation damaged wood boards was observed. (See Photograph 46).	
E-24	Exterior Walls - Wood Siding	South Elevation	General view of the south elevation (See Photograph 47).	In general, the condition of the south elevation appears to be consistent with the pre-construction assessment. (See Photograph 48).

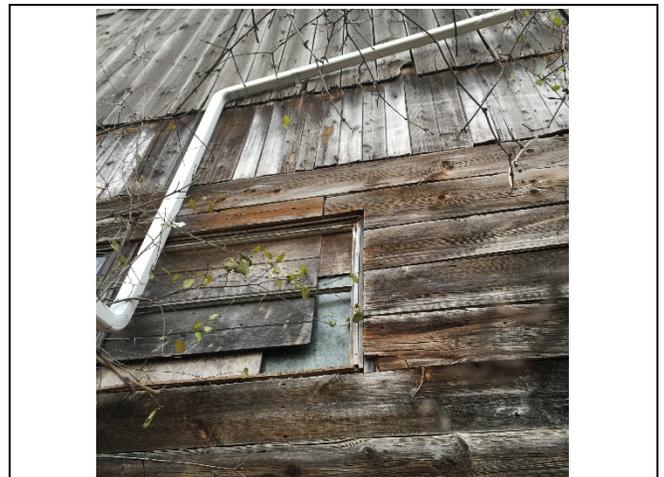
Photo 42: No significant change to the condition of damaged window and wood boards was observed.

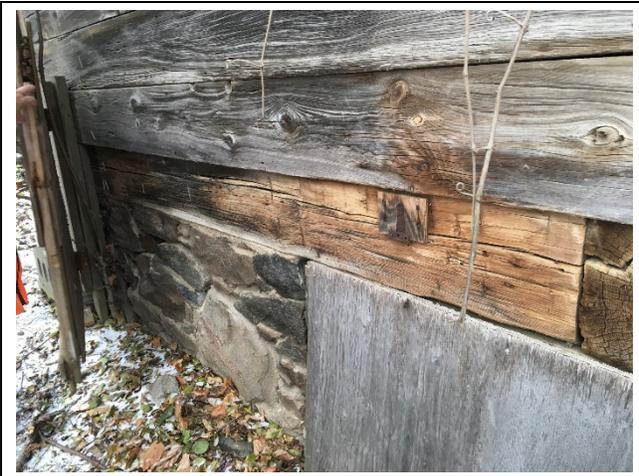
Photo 45: E23 – View of the damaged wood boards on the south elevation

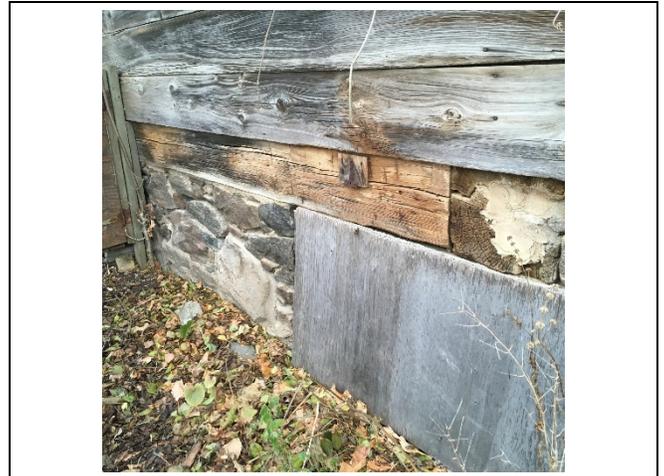
Photo 46: No significant change to the south elevation damaged wood boards was observed.

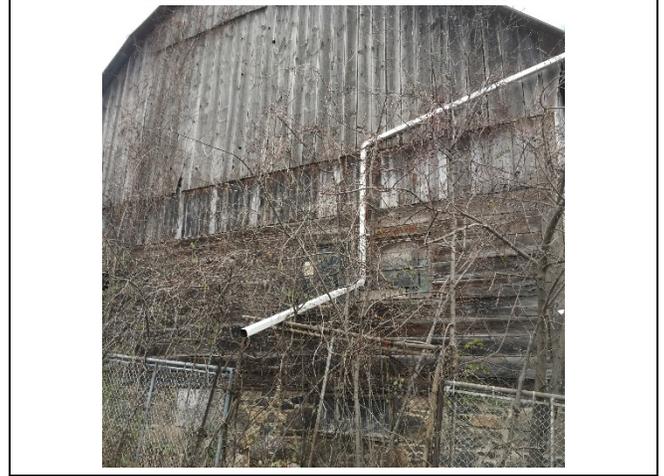
Photo 50: On the south elevation, no significant change to the damaged wood boards was observed.

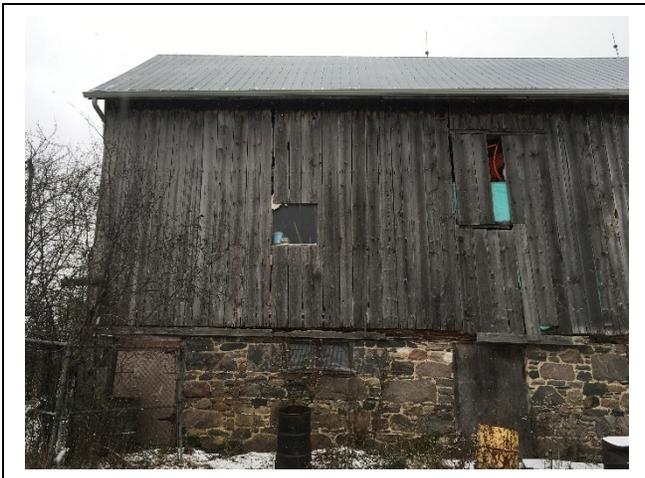
Photo 51: E26 – View of the damaged wood boards on the east elevation

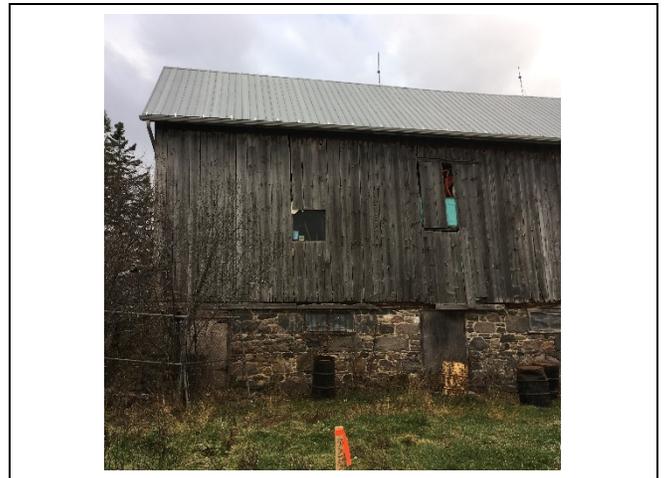
Photo 52: No significant change to the damaged wood boards was observed on the east elevation

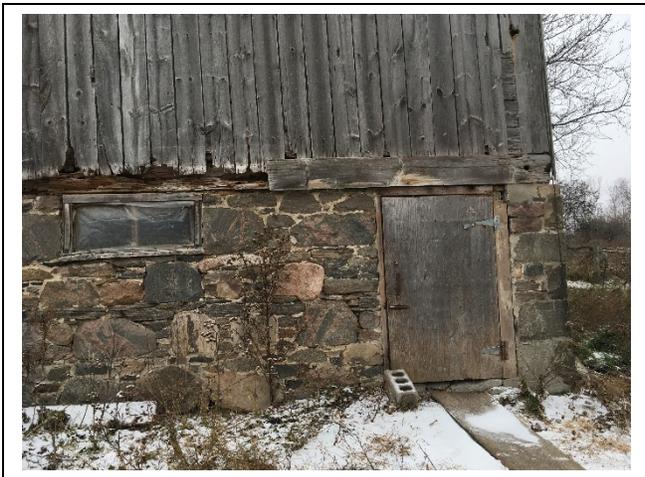
Photo 53: E27 – Closer view of the damaged wood boards on the east elevation

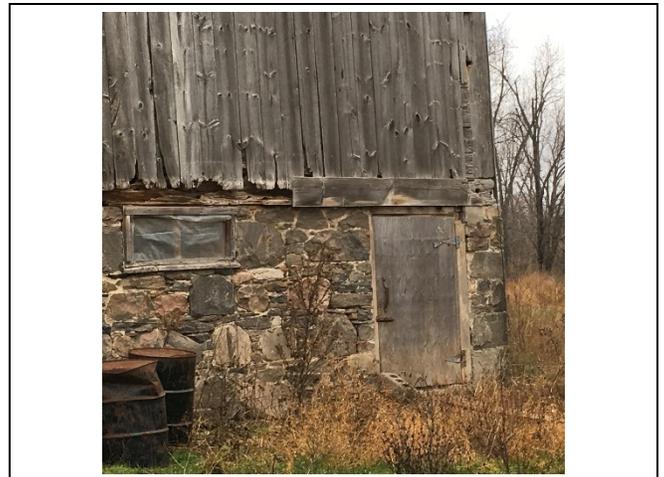
Photo 54: No significant change to the damaged wood boards was observed on the east elevation.

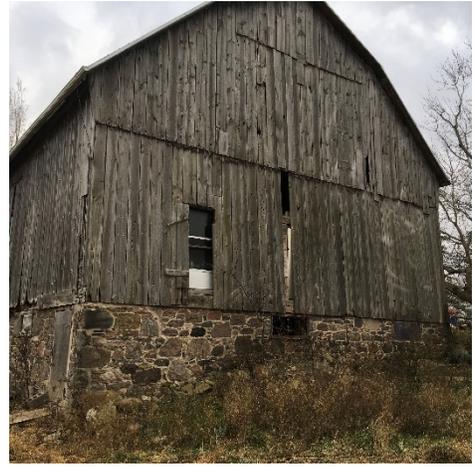
Photo 56: On the north elevation no significant change to the damaged wood boards was observed.

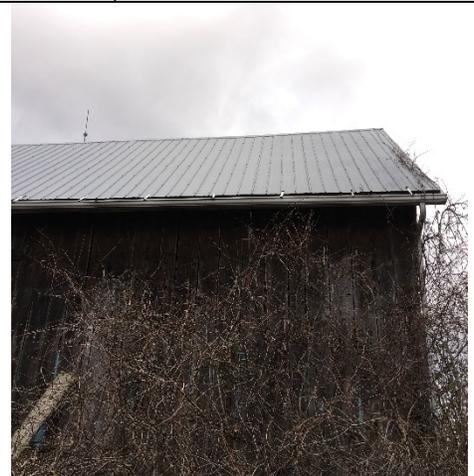
Photo 60: No significant change to the damaged wood boards was observed on the west elevation.
