**Re: Enbridge Gas Distribution Inc. (“Enbridge”)  
EB-2016-0054 – Seaton Land Development Pipeline Project  
Conditions of Approval – Post Construction Report - Correction**

**Enbridge Gas Distribution Inc.  
Interim Post-construction  
Environmental Monitoring Report  
Pipeline to Serve the Seaton Land  
Development  
EB -2016-0054**

# PRE-CONSTRUCTION AND POST- CONSTRUCTION PROPERTY CONDITION ASSESSMENTS

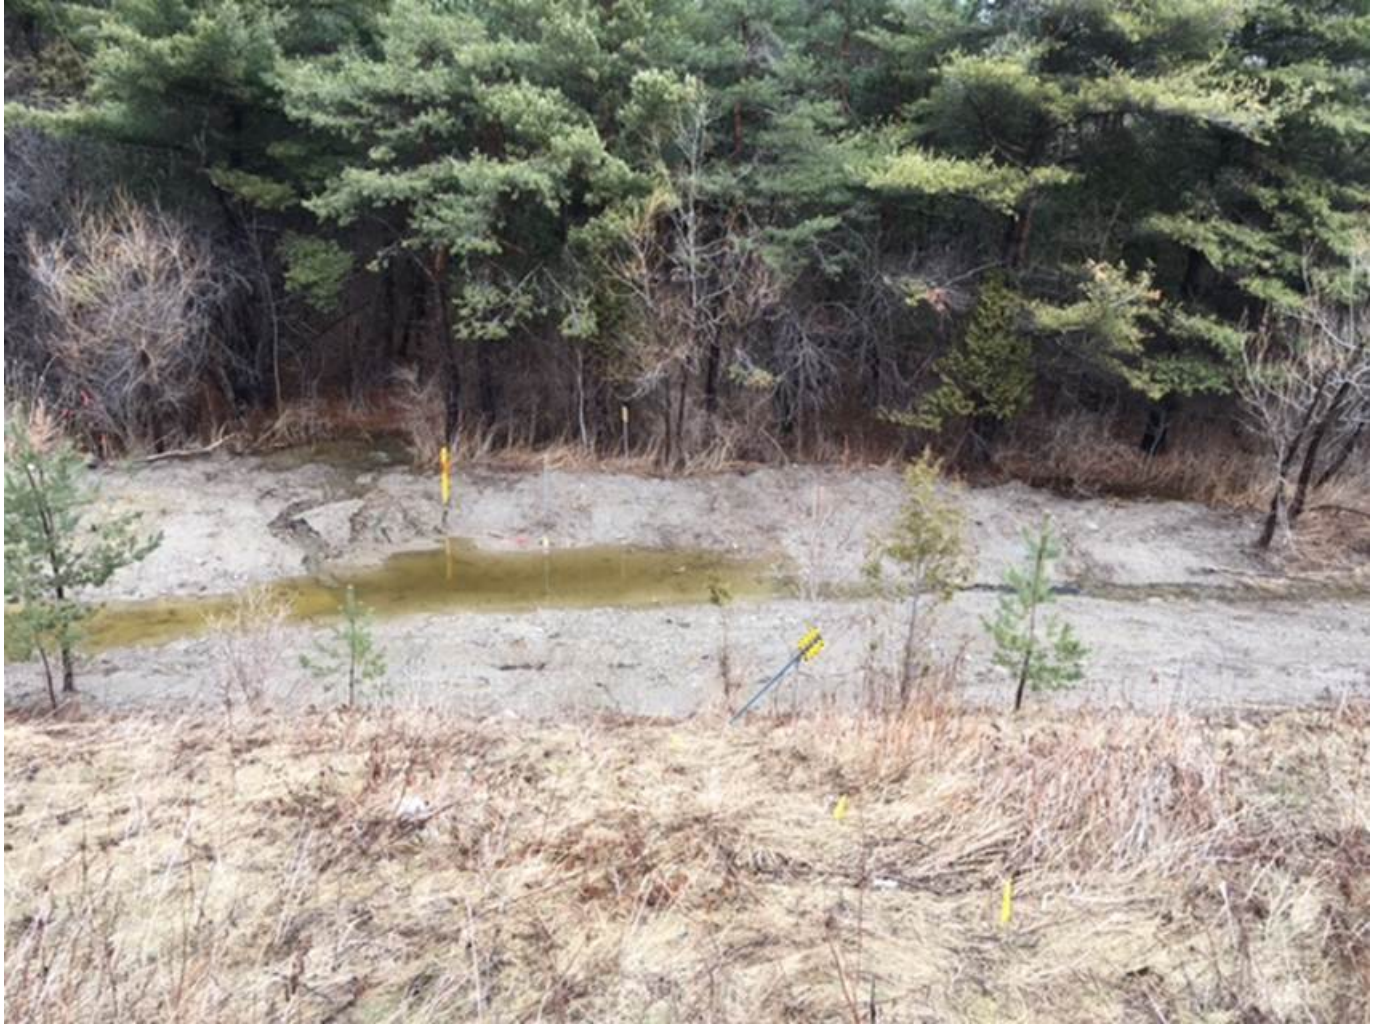
<b>Photo #</b>	<b>Location</b>	<b>Current Condition</b>	<b>Action</b>
<b>Photo 1</b>	Taunton Rd and Sideline 16 tie-in pit (looking North)	In complete. Drainage resembles pre-construction condition.	Further seeding required. No further action for the drainage.
<b>Photo 2</b>	Taunton Rd and Sideline 16 tie-in pit (looking North- East)	In complete. Drainage resembles pre-construction condition.	Further seeding required.
<b>Photo 3</b>	Regulator Station east of Brock Rd (looking north-west).	In complete. Construction was finished in December.	Requires grading and seeding
<b>Photo 4</b>	Regulator Station east of Brock Rd (looking East).	In complete. Construction was finished in December.	Requires grading and seeding
<b>Photo 5</b>	West of Brock Rd (looking east).	Complete.	Follow up required assessing vegetation growth.
<b>Photo 6</b>	East side of Urfe Creek (looking west).	Complete. The Creek was seeded and straw was placed over top as a temporary over-winter ESC measure.	Follow up required assessing vegetation growth.

Photo 1: Taunton Rd and Sideline 16 tie-in pit (looking north)

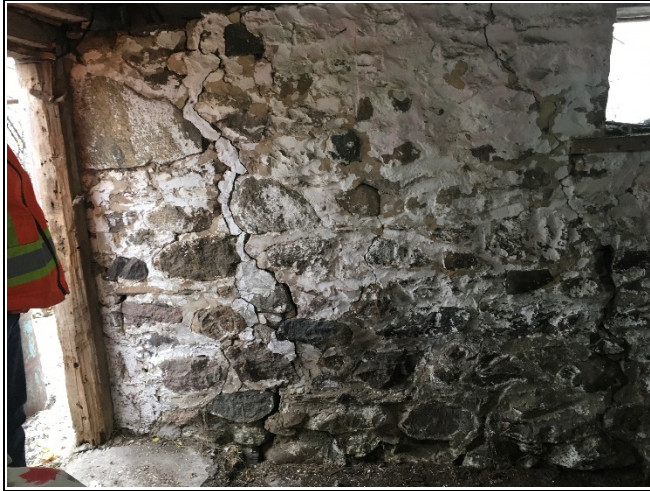
Photo 1: E1 – View of a crack on south foundation wall in the basement

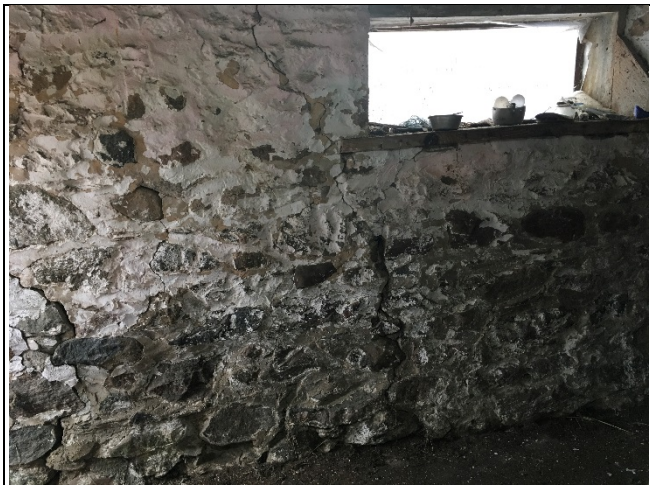
Photo 3: E2 – View of crack on south foundation wall in the basement

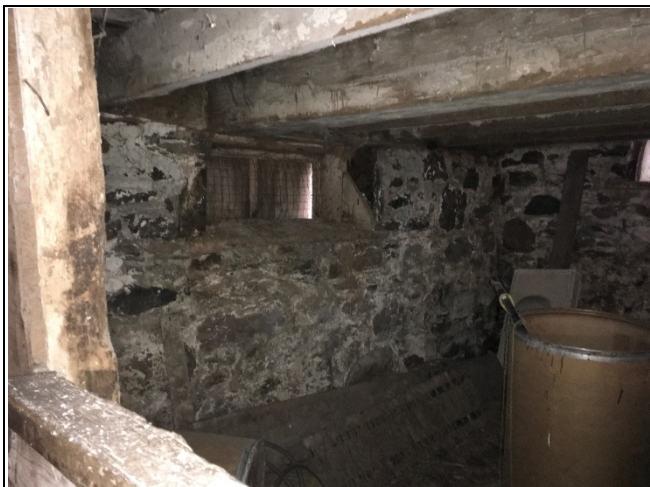
Photo 5: E3 – View of the southwest foundation wall

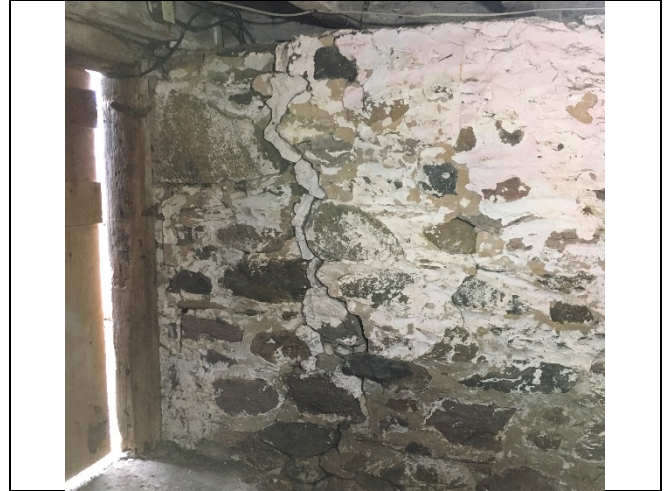
Photo 2: No significant change to the crack on the south foundation wall was observed.

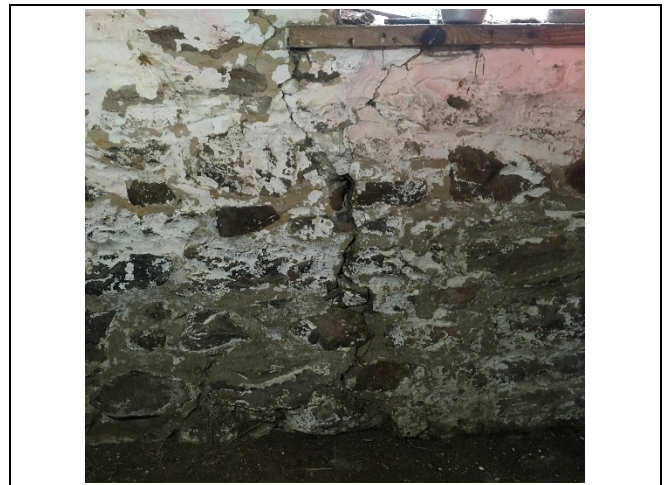
Photo 4: No significant change to the crack on the south foundation wall was observed.

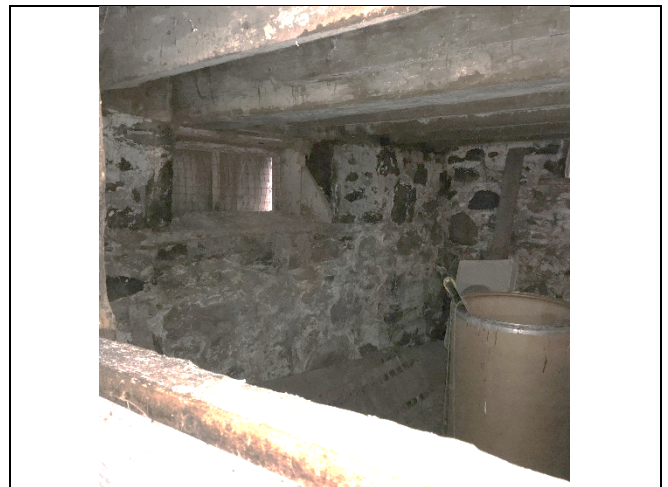
Photo 6: No significant change to the south foundation wall.

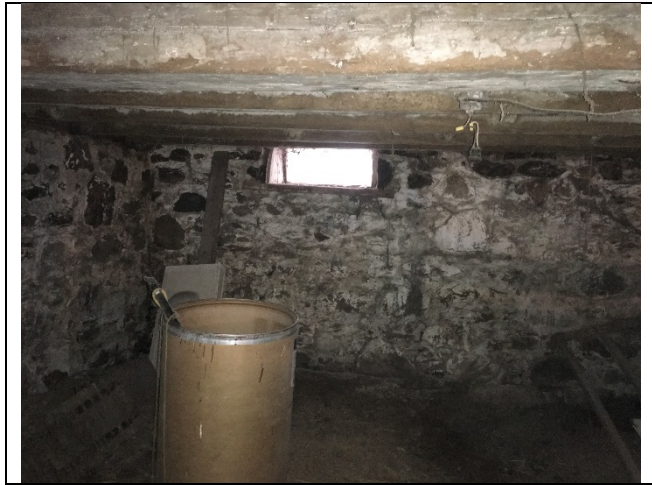
Photo 7: E4 –View of the west foundation wall

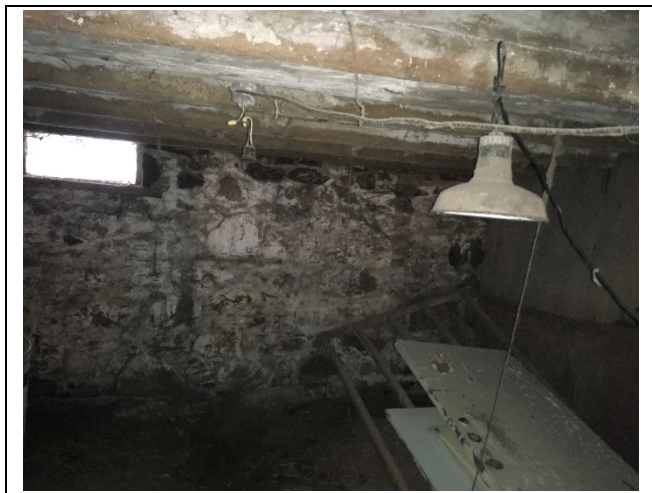
Photo 9: E5 – View of the west foundation wall.

E-5	Foundation Wall	West Elevation	View of the west foundation wall (See Photograph 9).	No significant change to the west foundation wall. (See Photograph 10).	
E-6	Foundation Wall	West Elevation	View of the west foundation wall (See Photograph 11).	No apparent change to the west foundation wall (See Photograph 12).	
E-7	Foundation Wall	West Elevation	View of a crack on the west foundation wall (Animal Stable # 3) (See Photograph 13).	No significant change to the crack on the west foundation wall was observed (See Photograph 14).	
E-8	Foundation Wall	North Elevation	View of a crack on the north foundation (See Photograph 15).	No significant change to the (north foundation wall) crack was observed. (See Photograph 16).	
E-9	Foundation Wall	East Elevation	On the east elevation a view of the basement door access (See Photograph 17).	The condition of the basement door access appears to be similar to the pre-construction assessment. (See Photograph 18).

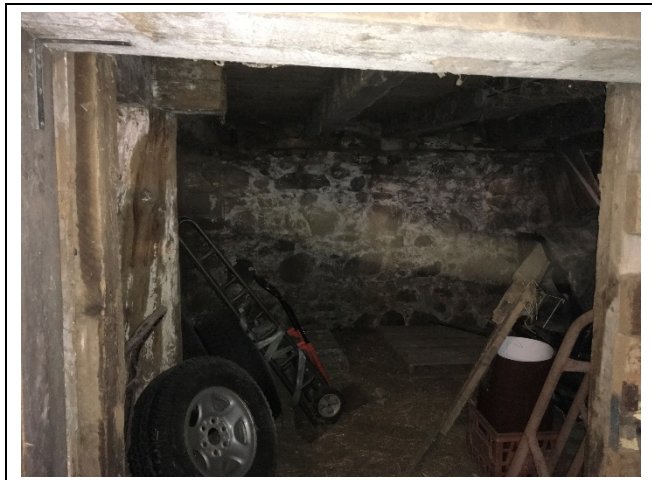
Photo 11: E6 – View of the west foundation wall

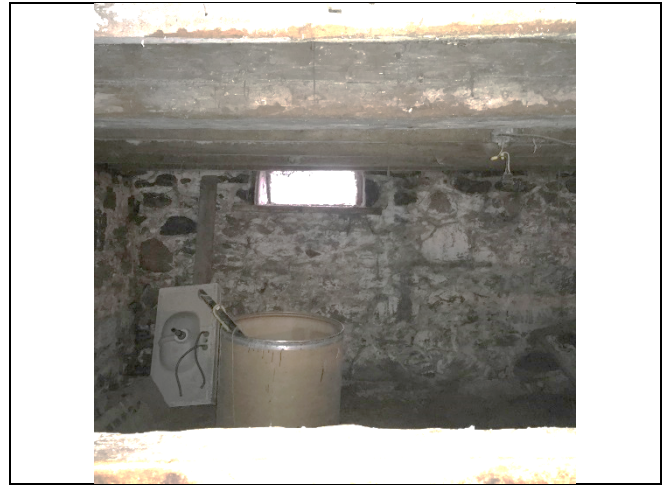
Photo 8: No significant change to the condition of the west foundation wall was observed following the construction.

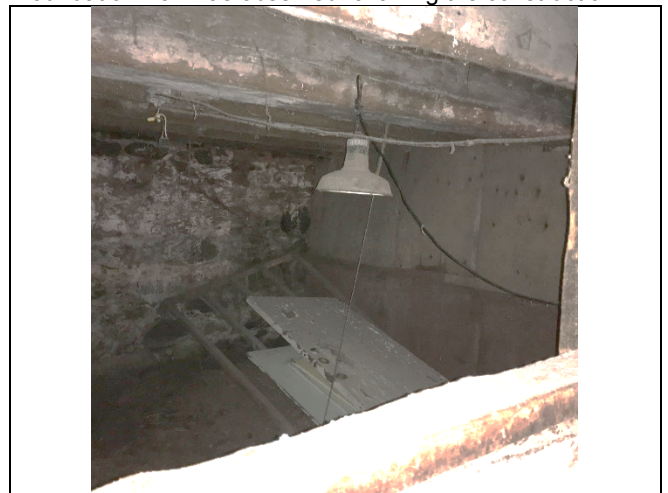
Photo 10: No significant change to the west foundation wall.

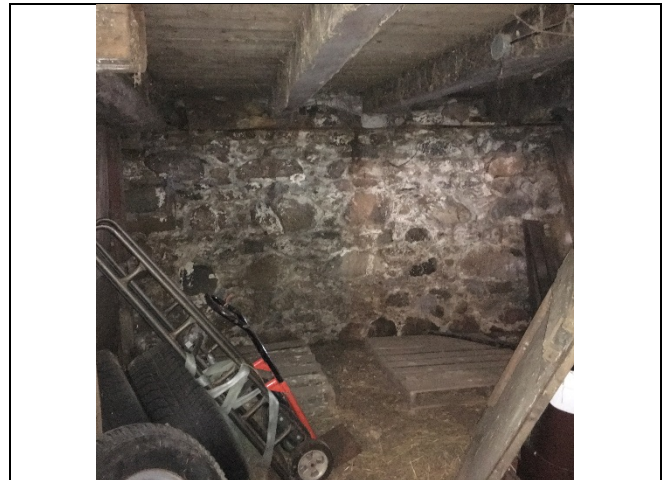
Photo 12: No apparent change to the west foundation wall

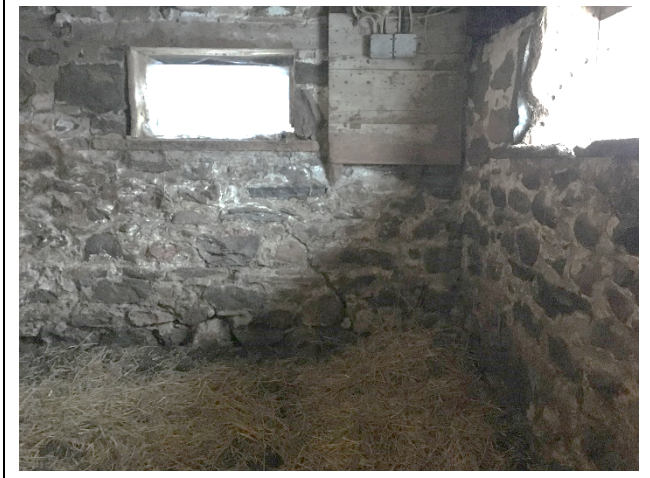
Photo 13: E7 –View of a crack on the west foundation wall (Animal Stable # 3)

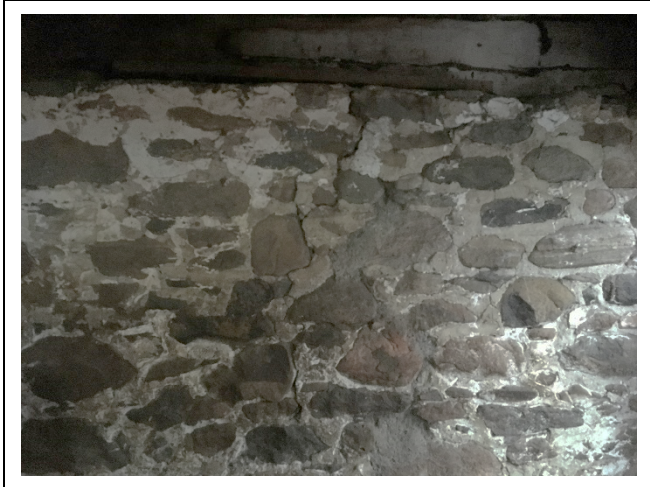
Photo 15: E8 – View of a crack on the north foundation wall

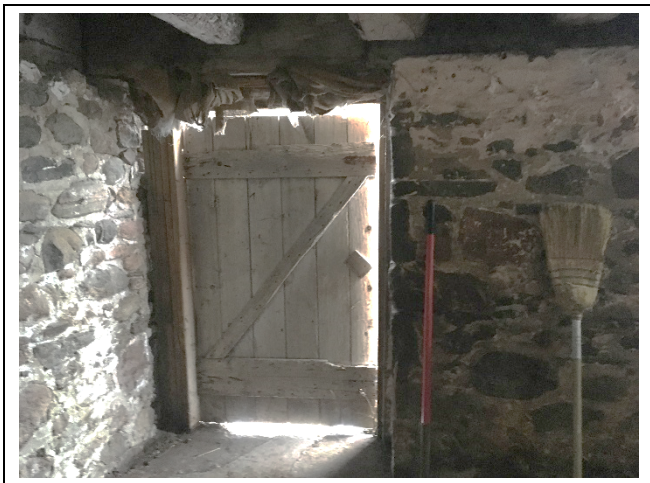
Photo 17: E9 – On the east elevation,- a view of the basement door access

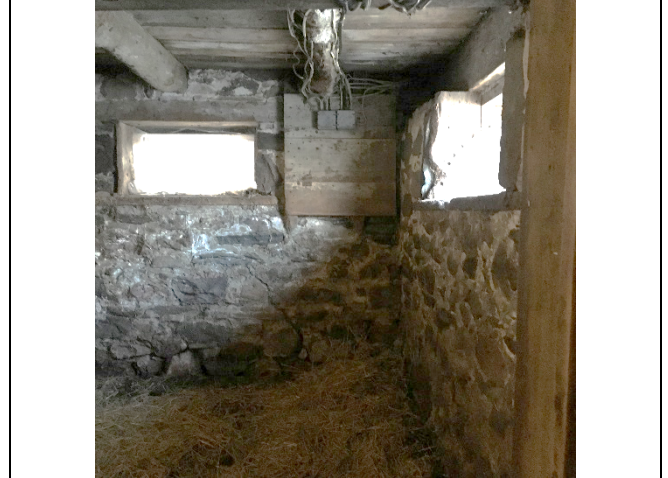
Photo 14: No significant change to the crack on the west foundation wall was observed.

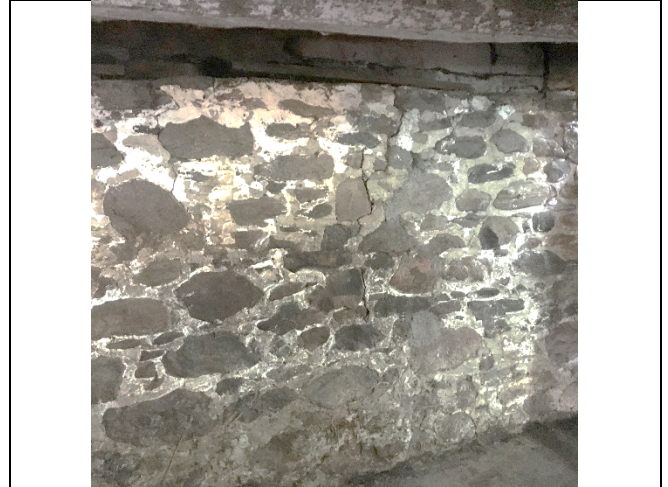
Photo 16: No significant change to the (north foundation wall) crack was observed.

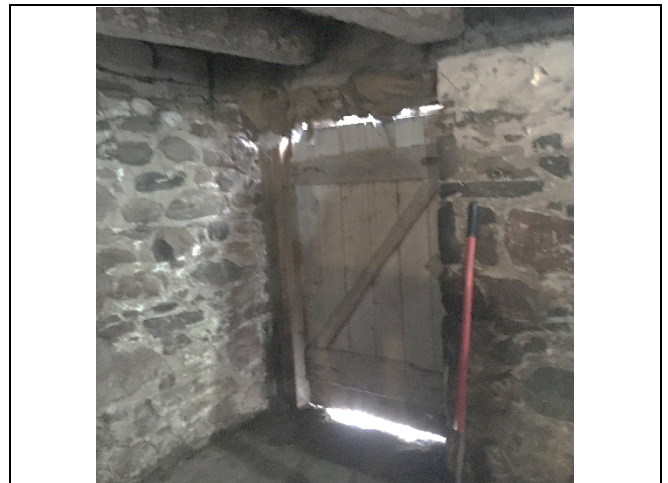
Photo 18: The condition of the basement door access appears to be similar to the pre-construction assessment.

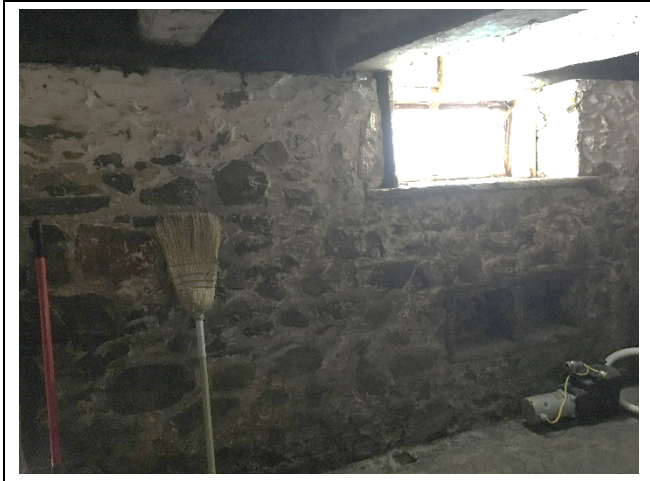
Photo 19: E10 – View of the east foundation wall

E-10	Foundation Wall	East Elevation	View of the east foundation wall (See Photograph 19).	The condition of the east foundation wall appears to be consistent with the initial assessment (See Photograph 20).	
E-11	Foundation Wall	East Elevation	Another view of the east foundation wall (See Photograph 21).	he east foundation wall appears to be similar to the pre-construction assessment (See Photograph 22).	
E-12	Foundation Wall	East Elevation	View of the east foundation wall towards the entrance door (See Photograph 23).	The east foundation wall appears to be consistent with the pre-construction assessment. (See Photograph 24).	
E-13	Foundation Wall	South Elevation	Exterior view of the south foundation wall (See Photograph 25).	The south foundation wall appears to be similar with the pre-construction assessment. (See Photograph 26).	
E-14	Foundation Wall	South Elevation	View of the south foundation wall around the window(See Photograph 27).	The condition of the south foundation wall appears to be consistent with the initial assessment (See Photograph 28).

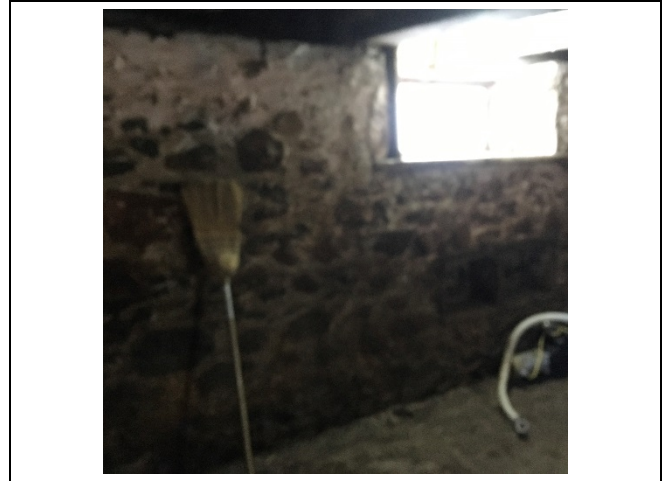
Photo 20: The condition of the east foundation wall appears consistent with the pre-construction assessment.

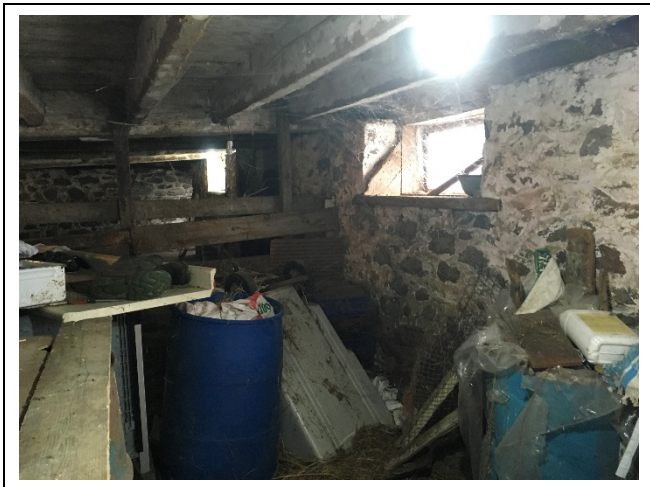
Photo 21: E11 – Another view of the east foundation wall

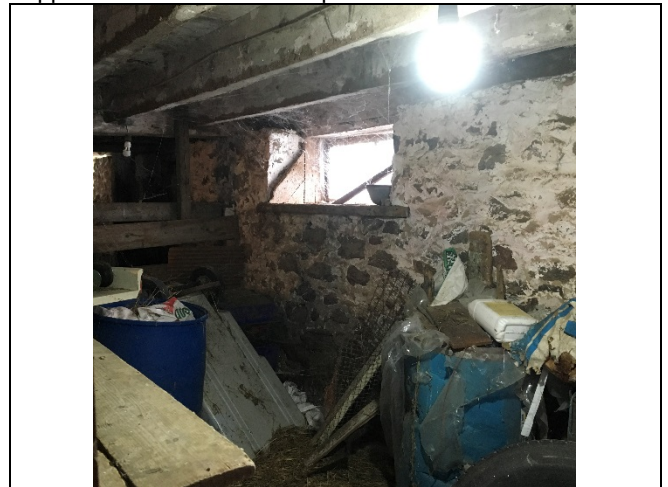
Photo 22: The east foundation wall appears to be similar to the pre-construction assessment.

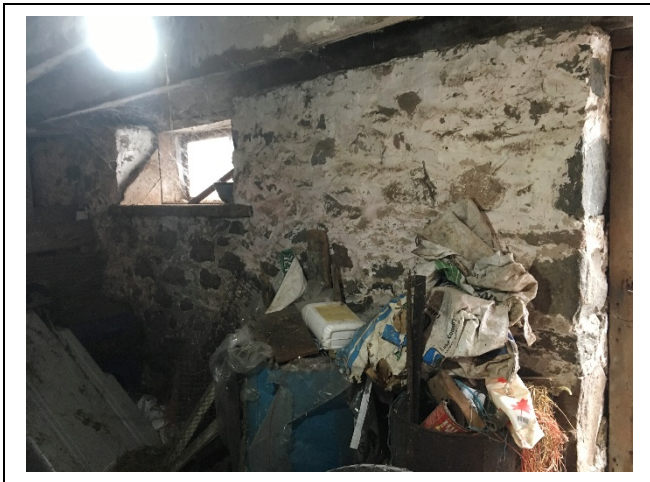
Photo 23: E12 –View of the east foundation wall towards the entrance door

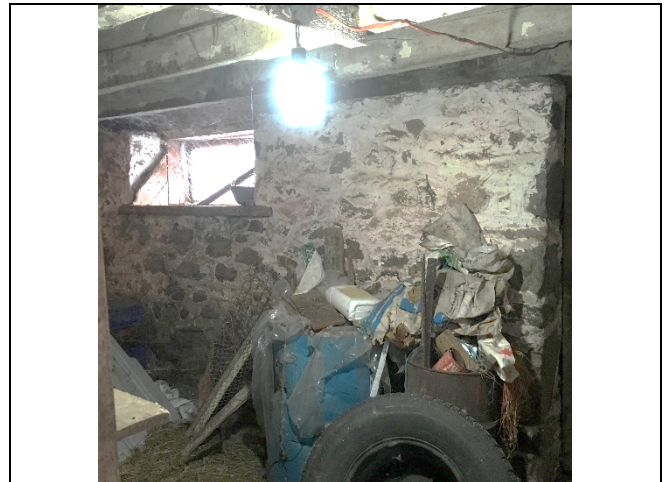
Photo 24: The east foundation wall appears to be consistent with the pre-construction assessment.

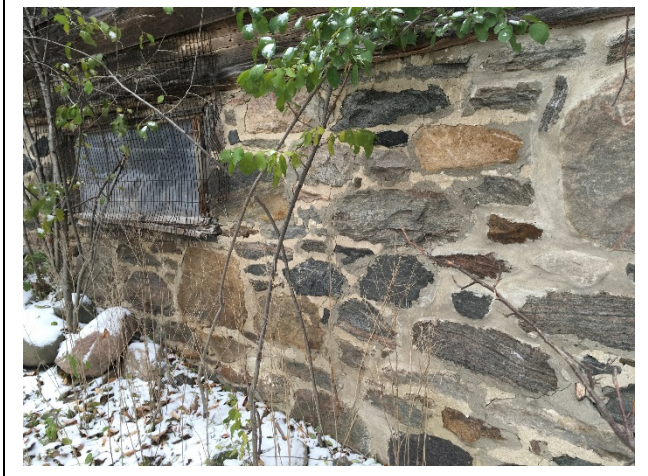
Photo 25: E13 – Exterior view of the south foundation wall

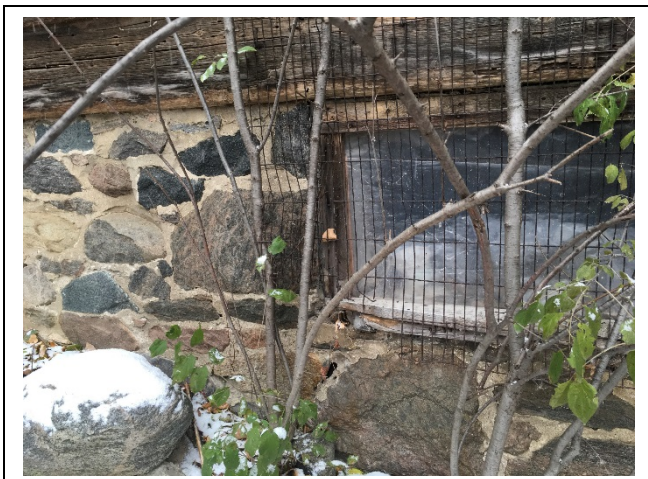
Photo 27: E14 – View of the south foundation wall around the window

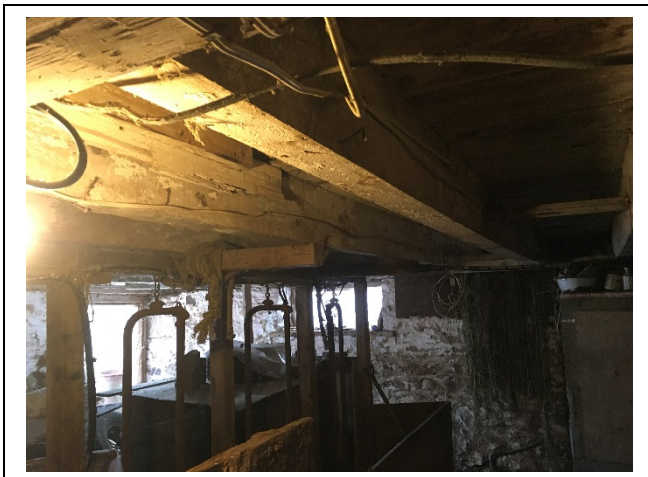
Photo 29: E15 – View of the floor joists in the basement

E-15	Superstructure	Basement - Floor Wood Framing Structure	View of the floor joists in the basement (See Photograph 29).	The condition of the floor joists appear to be similar to the pre-construction assessment.(See Photograph 30).	
E-16	Superstructure	Basement - Floor Wood Framing Structure	View of the wood post and floor joists in the basement (See Photograph 31).	The condition of the wood post and floor joist appear to be consistent with the initial assessment (See Photograph 32).	
E-17	Superstructure	First Floor - Wood Roof Framing Structure	View of the first floor wood roof frame structure (See Photograph 33).	The condition of the wood roof frame structure appears to be similar with the pre-construction assessment (See Photograph 34).

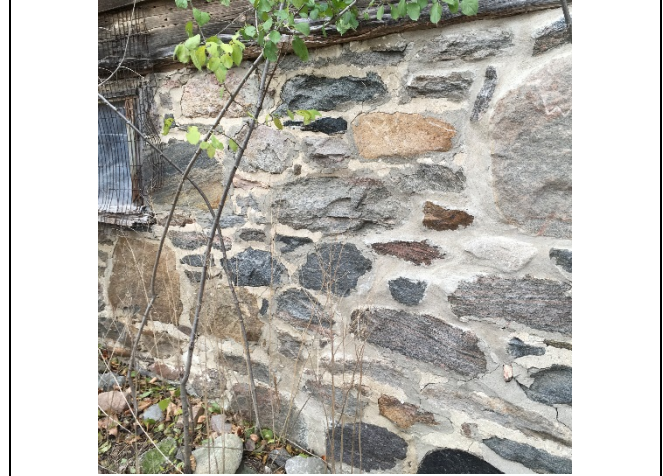
Photo 26: The south foundation wall appears to be similar with the pre-construction assessment.

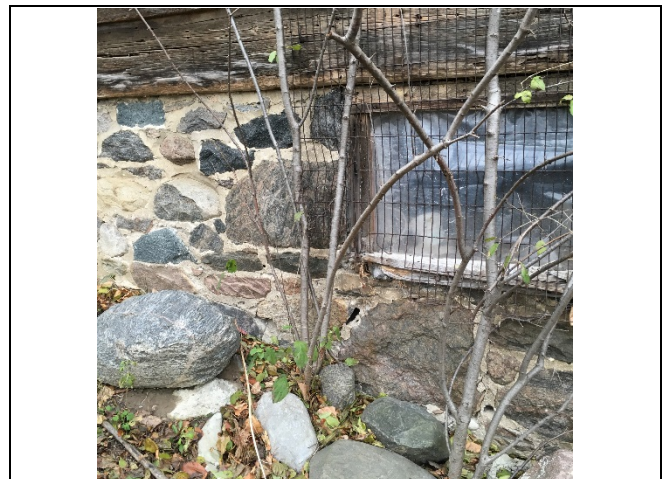
Photo 28: The observed condition is consistent with the pre-construction assessment.

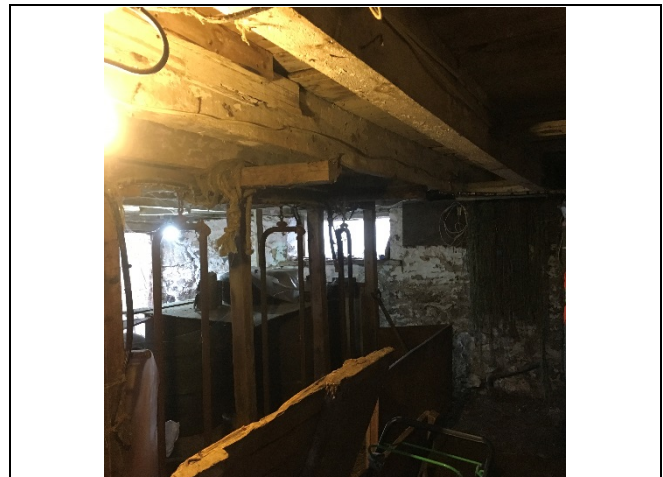
Photo 30: The condition of the floor joists appear to be similar to the pre-construction assessment.

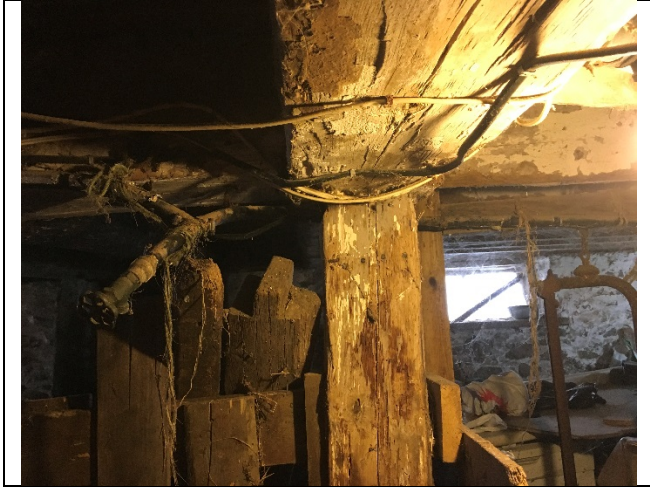
Photo 31: E16 – View of the wood post and floor joist in the basement

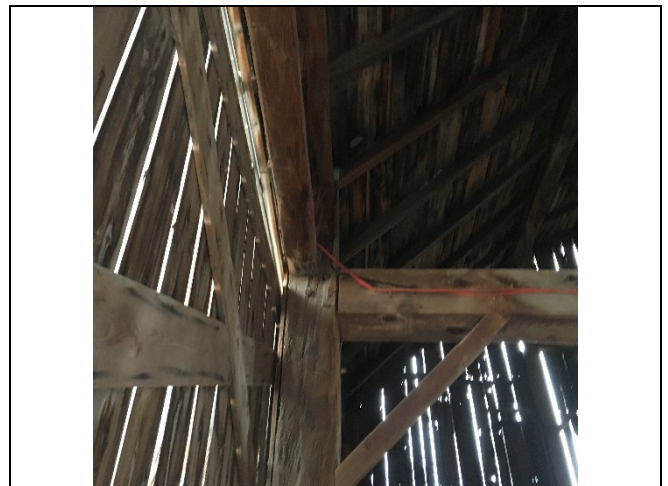
Photo 36: The condition of the wood roof frame structure appears to be consistent with the pre-construction assessment.

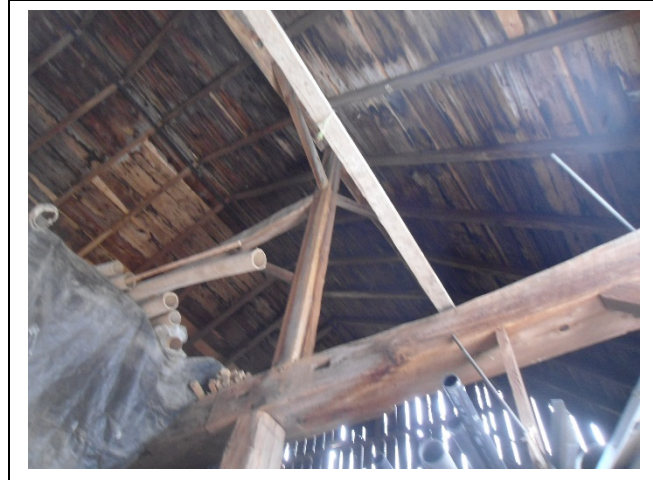
Photo 37: E19 – View of the roof wood frame structure

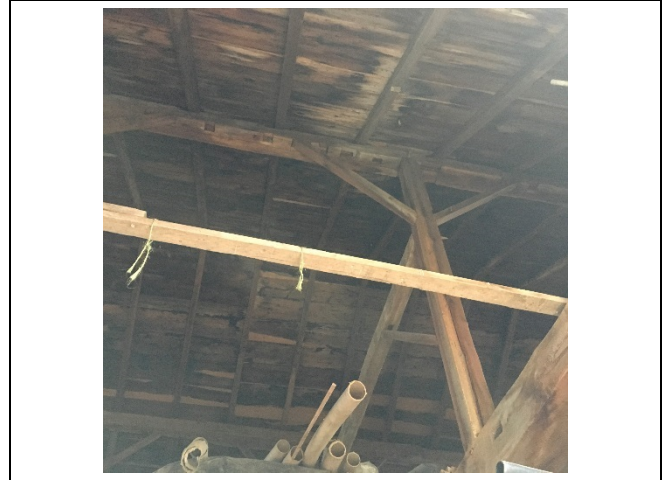
Photo 38: The condition of the wood roof frame structure appears to be similar with the initial assessment.

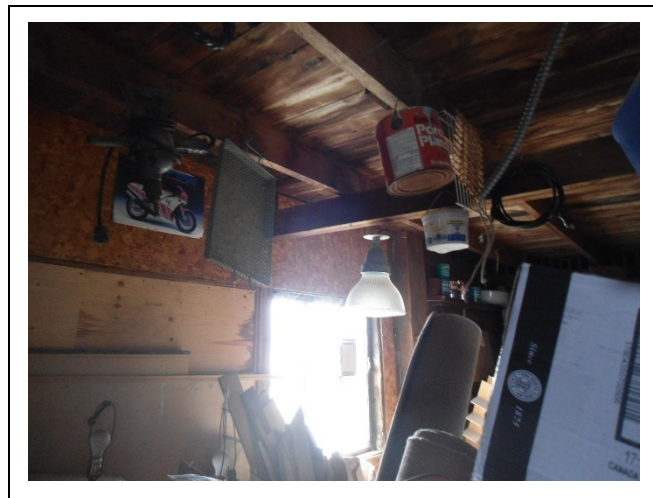
Photo 39: E20 - View of the first floor the exposed ceiling structure in the storage area

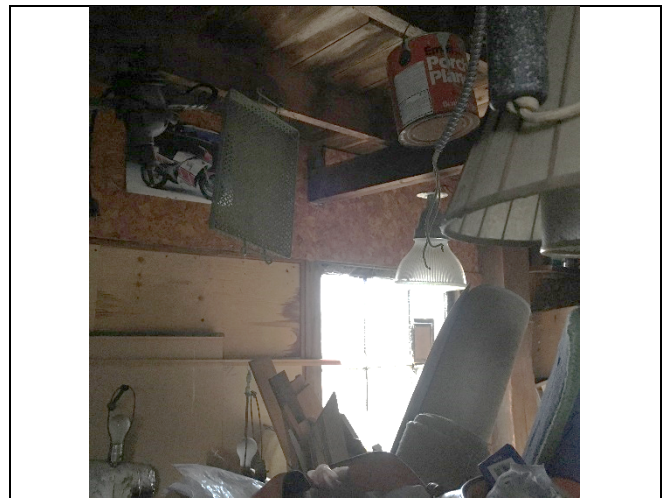
Photo 40: The condition of the exposed ceiling structure in the storage area appears to be consistent with the initial assessment.

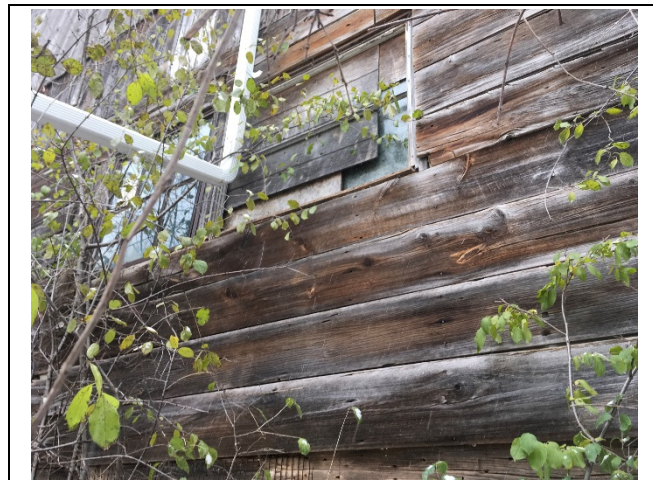
Photo 41: E21 – View of the boarded damaged window and damaged wood boards on the south elevation

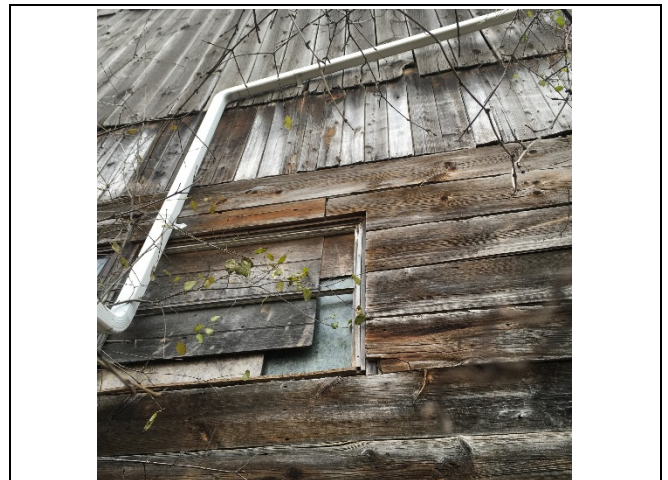
Photo 42: No significant change to the condition of damaged window and wood boards was observed.

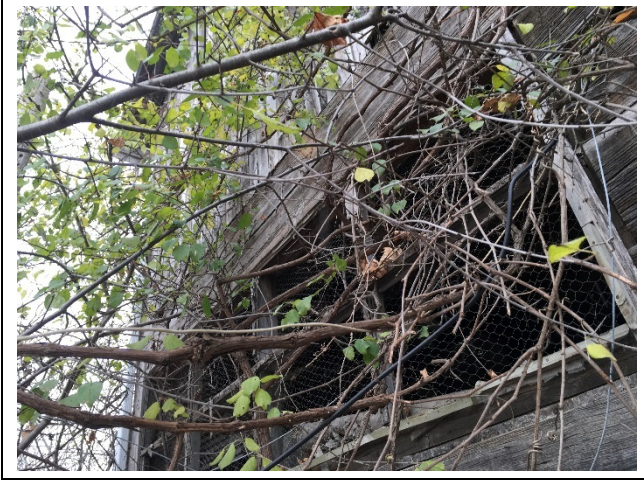
Photo 43: E22 – View of the south elevation storage opening

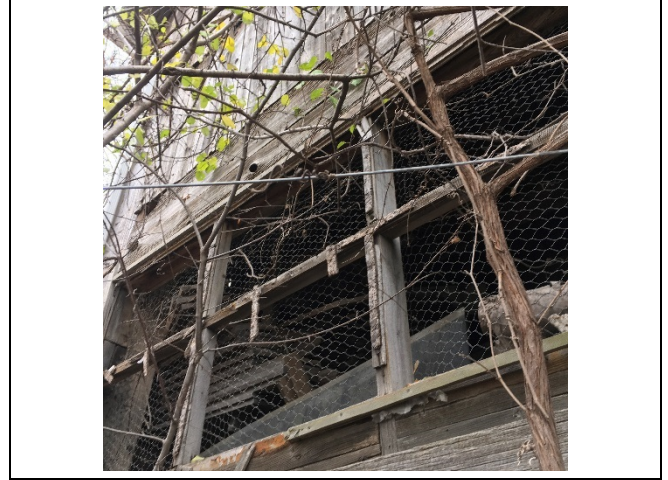
Photo 44: At the south elevation storage opening, no significant change was observed.

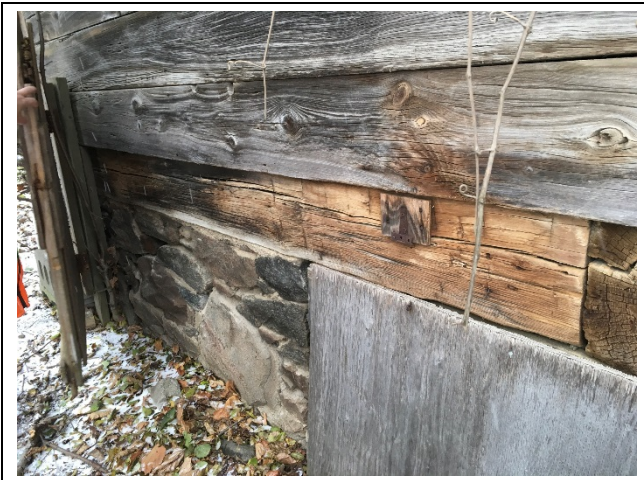
Photo 45: E23 – View of the damaged wood boards on the south elevation

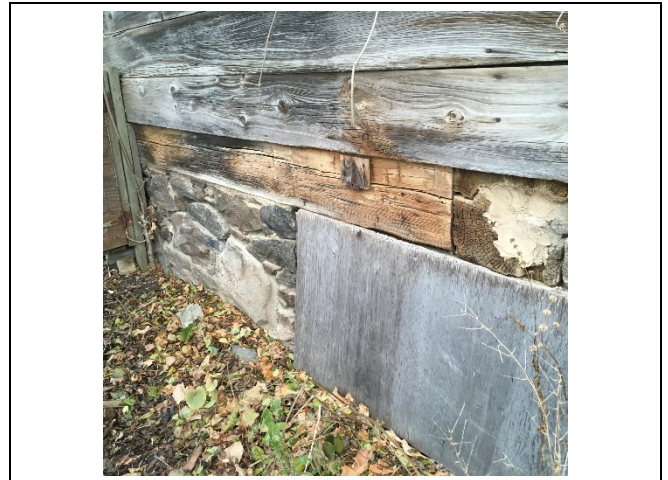
Photo 46: No significant change to the south elevation damaged wood boards was observed.

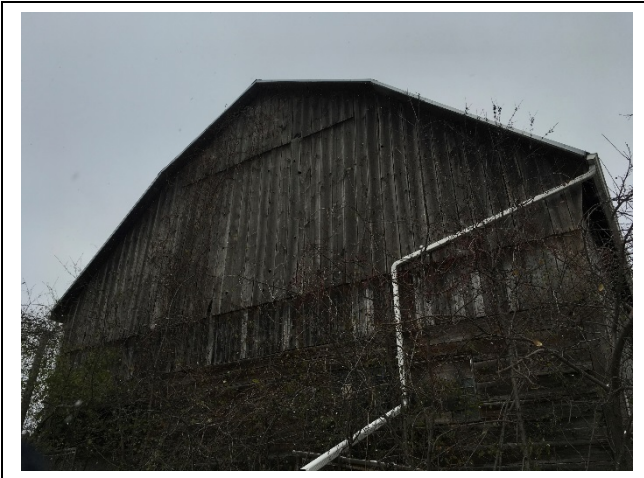
Photo 47: E24 – General view of the south elevation

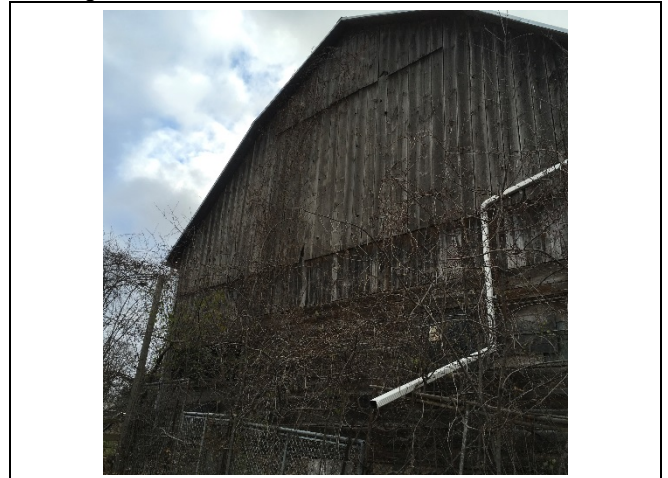
Photo 48: In general, the condition of the south elevation appears to be consistent with the pre-construction assessment.

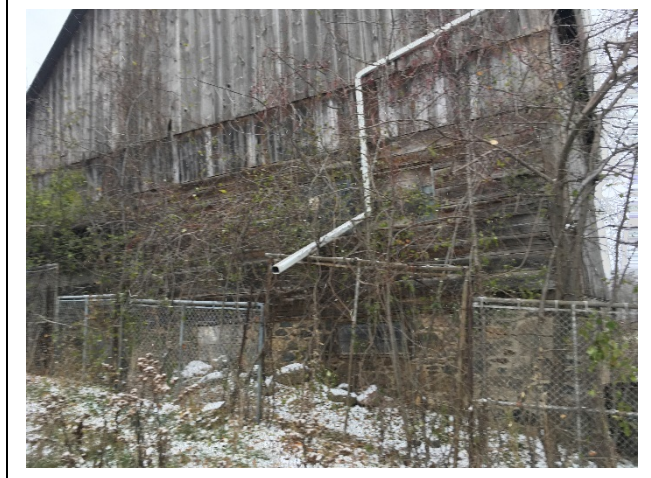
Photo 49: E25 – View of the south elevation

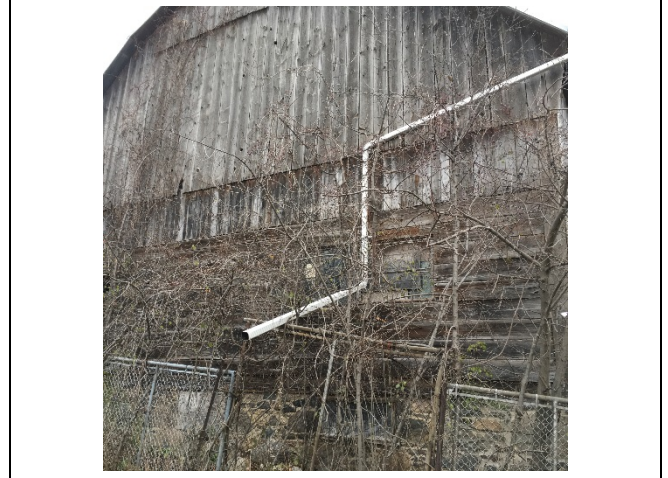
Photo 50: On the south elevation, no significant change to the damaged wood boards was observed.

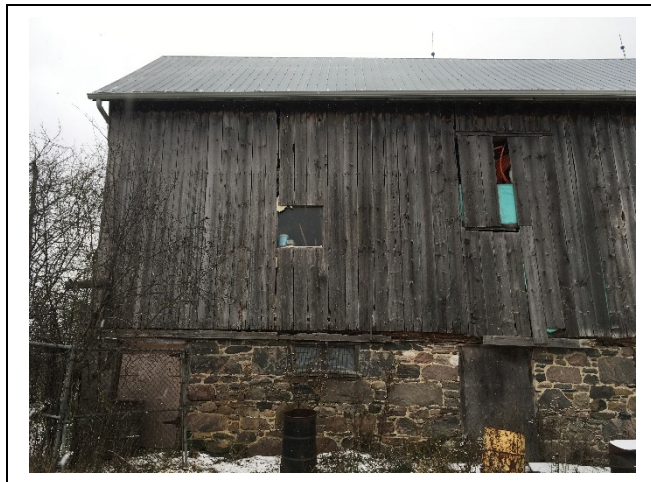
Photo 51: E26 – View of the damaged wood boards on the east elevation

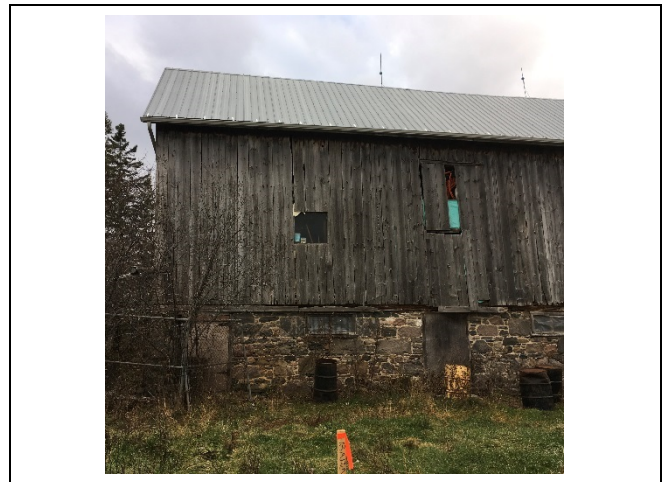
Photo 52: No significant change to the damaged wood boards was observed on the east elevation

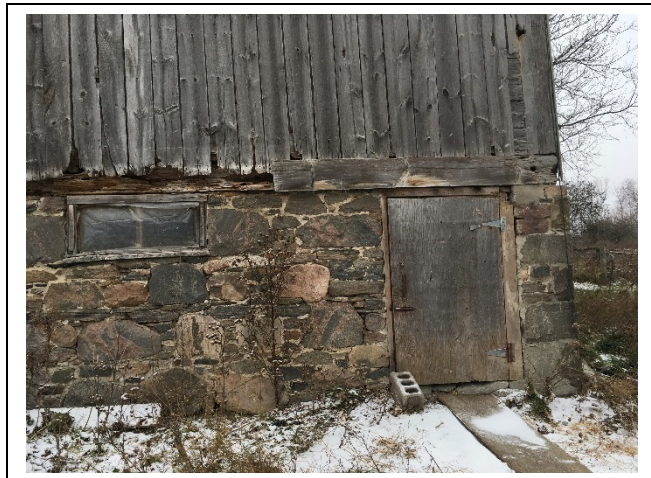
Photo 53: E27 – Closer view of the damaged wood boards on the east elevation

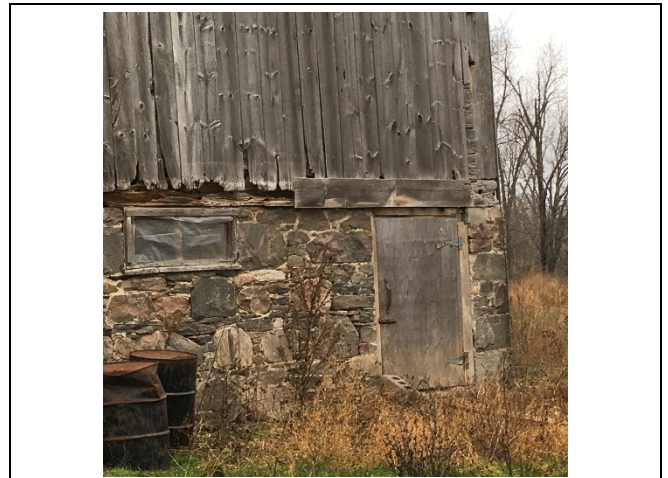
Photo 54: No significant change to the damaged wood boards was observed on the east elevation.

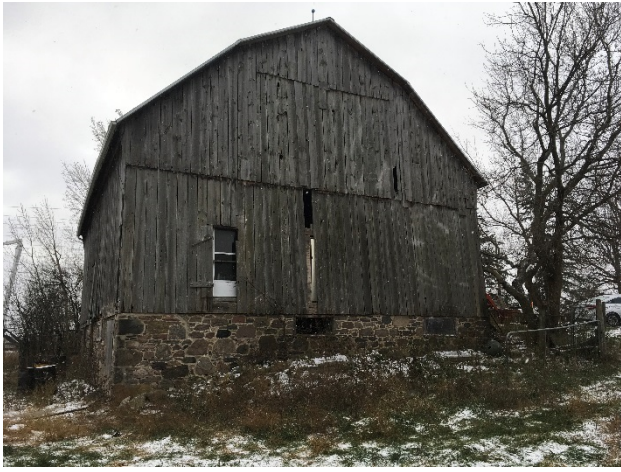
Photo 55: E28 – General view of the north elevation

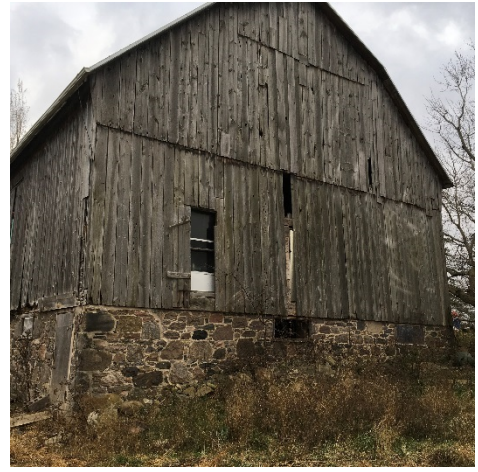
Photo 56: On the north elevation no significant change to the damaged wood boards was observed.

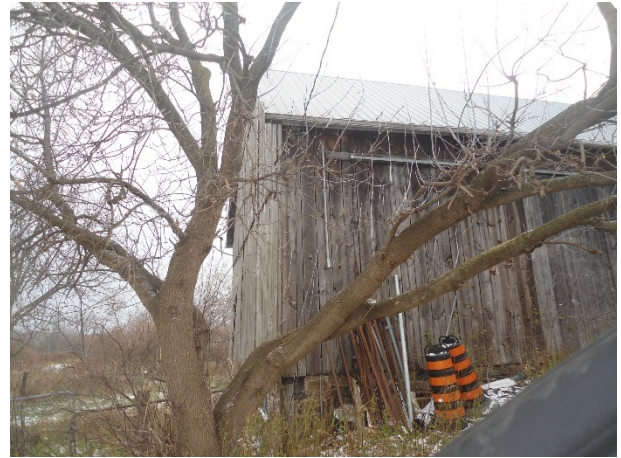
Photo 57: E29 – View of the west elevation

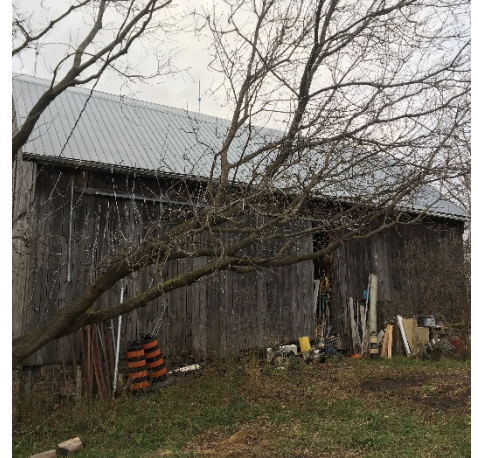
Photo 58: The condition of the west elevation appears to be similar to the pre-construction assessment.

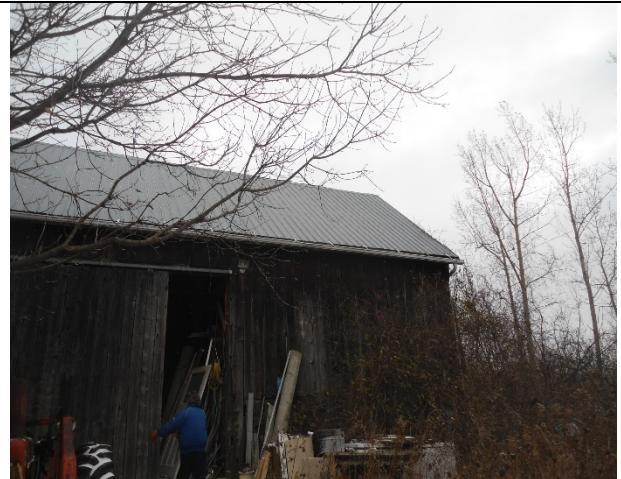
Photo 59: E30 – View of the north portion of the west elevation

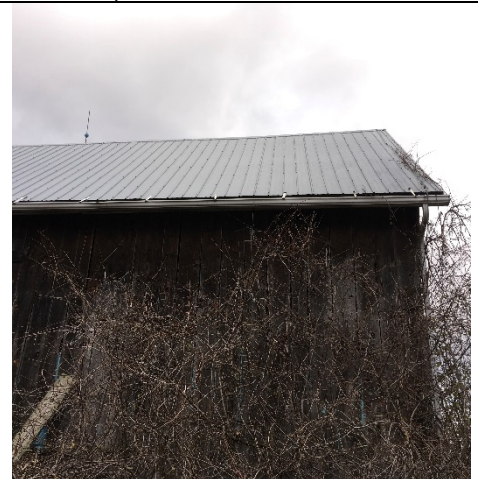
Photo 60: No significant change to the damaged wood boards was observed on the west elevation.

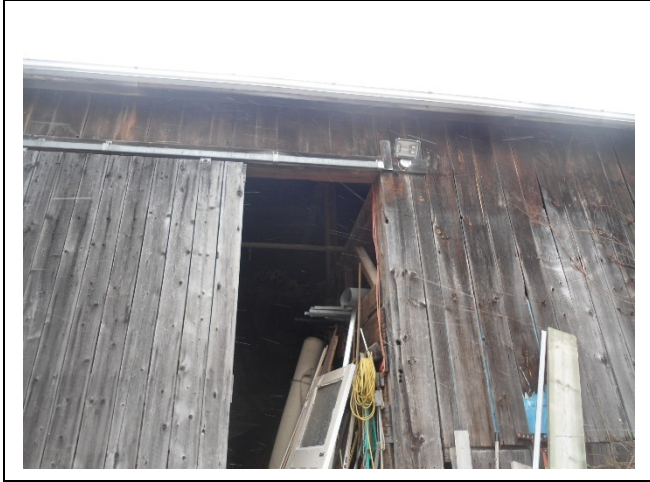
Photo 61: E31 – View of the wood boards above the sliding door

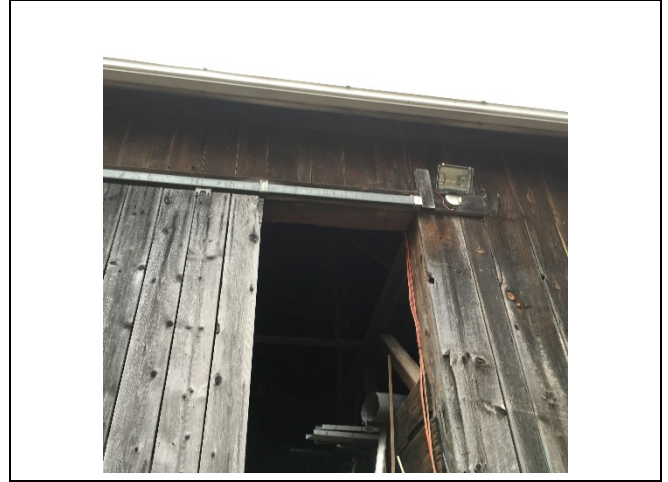
Photo 62: The condition of the wood boards above the sliding door appears unchanged.

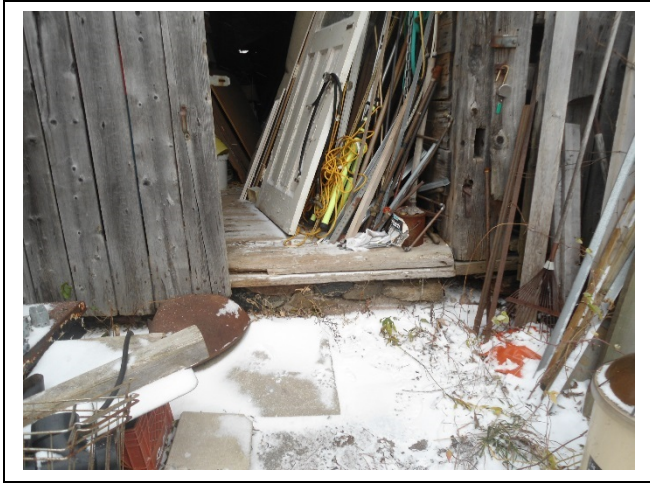
Photo 63: E32 –View of the lower portion of the sliding door

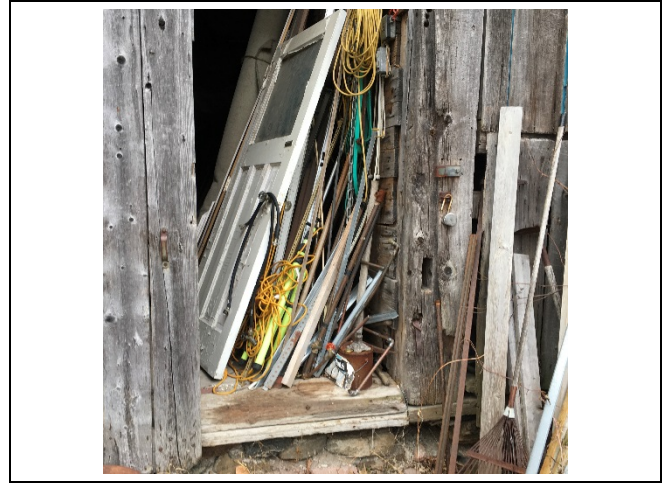
Photo 64: The condition of the lower portion of the sliding door appears to be consistent with the pre-construction initial assessment.
