**Re: Enbridge Gas Distribution Inc. (“Enbridge”)  
EB-2016-0054 – Seaton Land Development Pipeline Project  
Conditions of Approval – Post Construction Report - Correction**

**Enbridge Gas Distribution Inc.  
Interim Post-construction  
Environmental Monitoring Report  
Pipeline to Serve the Seaton Land  
Development  
EB -2016-0054**

# PRE-CONSTRUCTION AND POST- CONSTRUCTION PROPERTY CONDITION ASSESSMENTS

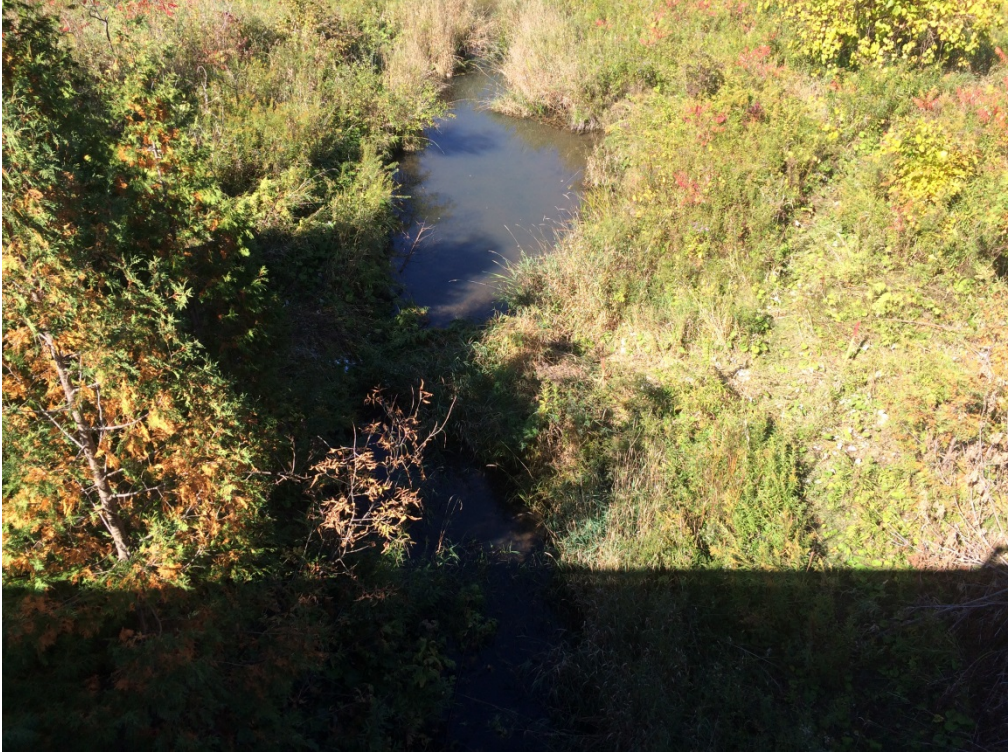
Photo 1: Condition of Urfe Creek on October 12, 2016 prior to the inadvertent Release

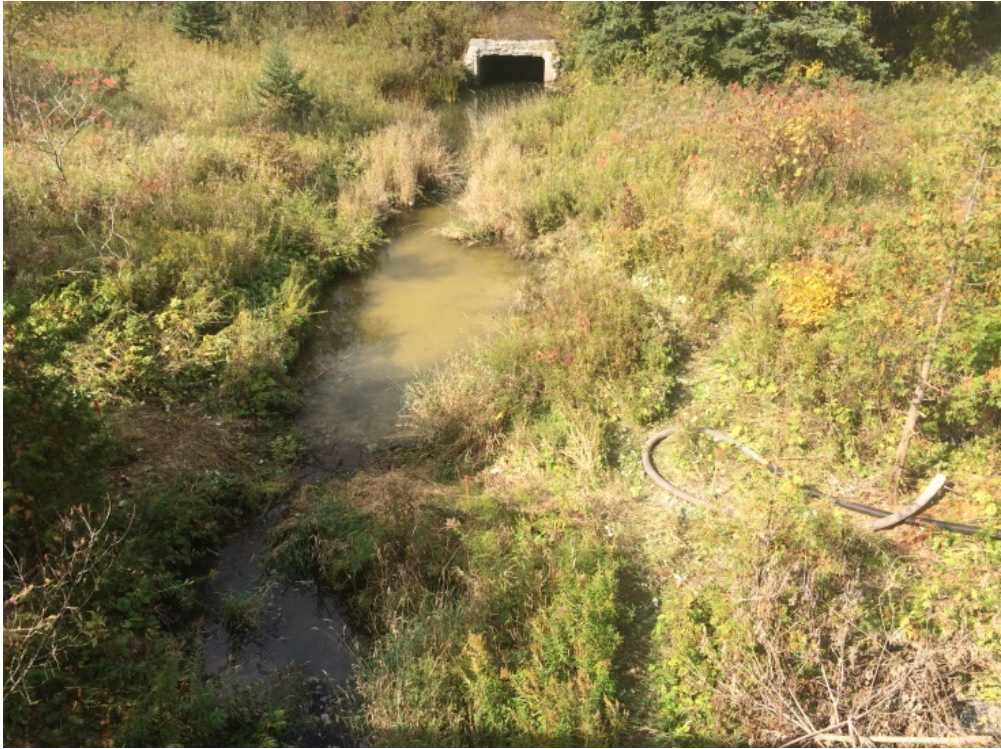
Photo 2: Condition of Urfe Creek on October 14, 2016 after the meeting with the MNRF and the TRCA
