Ottawa River Power Corporation Substation Condition Assessment Report

Project: 17153

costello
Utility Consultants

September 2017

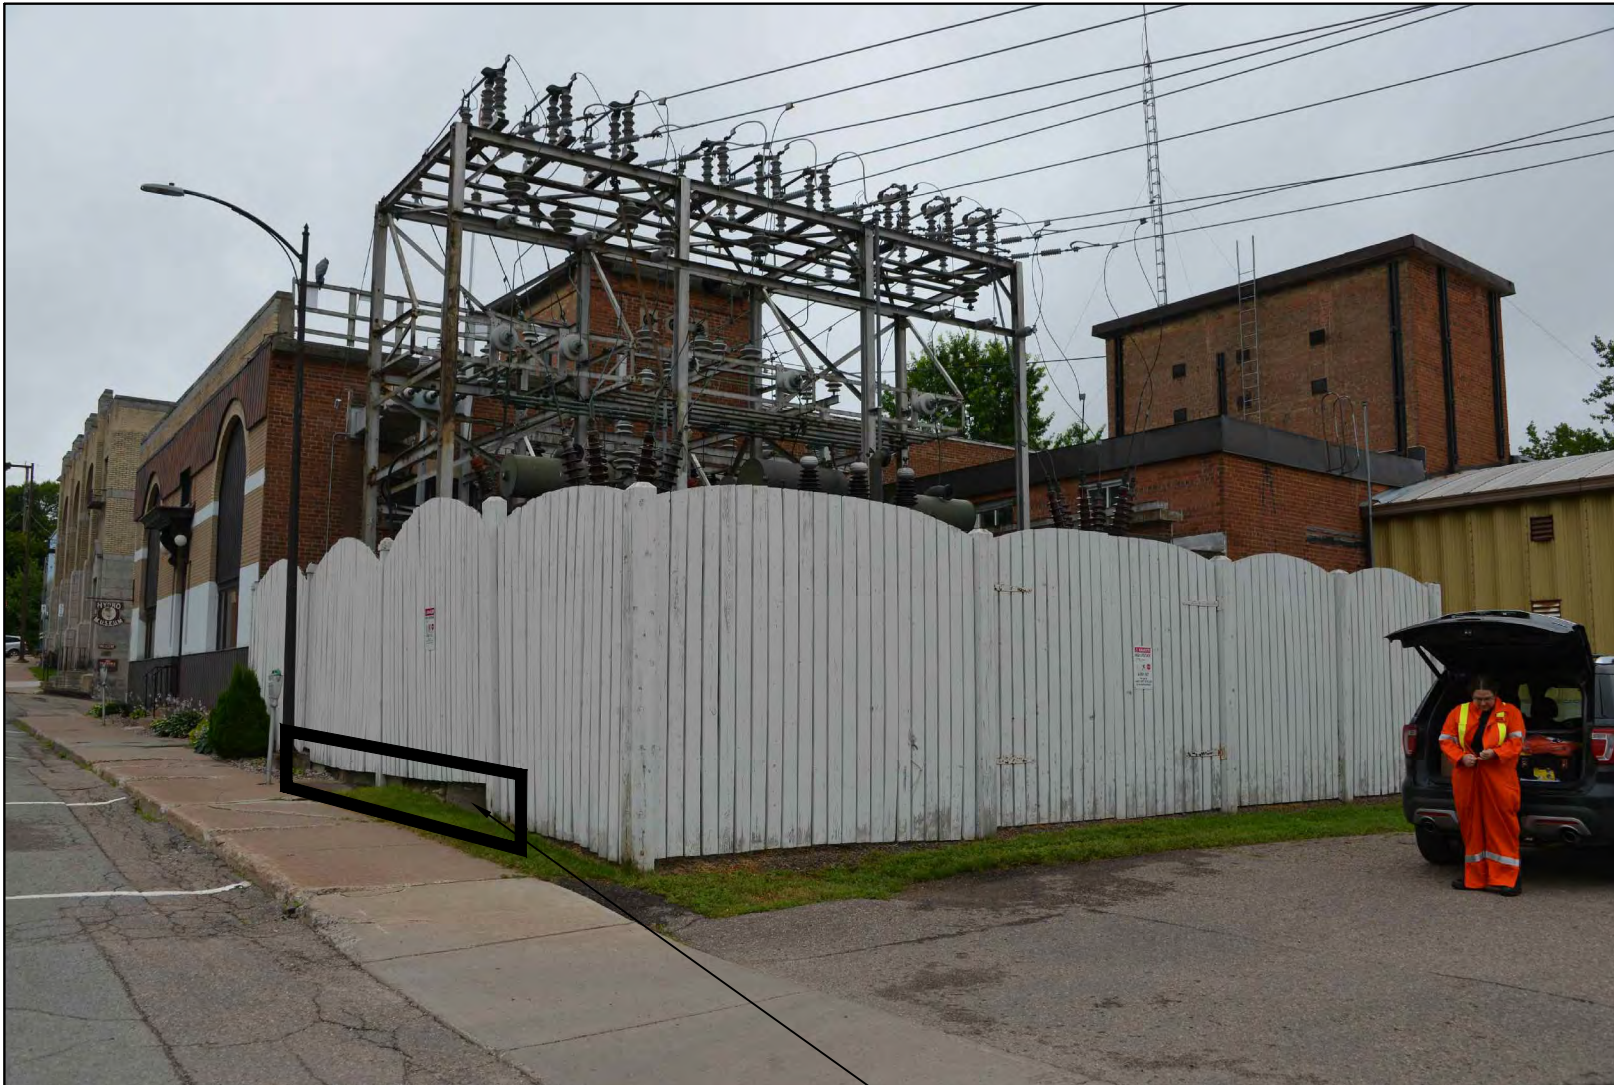
WOOD FENCE NOT TO CODE.
NO BARB WIRE AND GAPS GREATER THAN
50mm AT THE BOTTOM

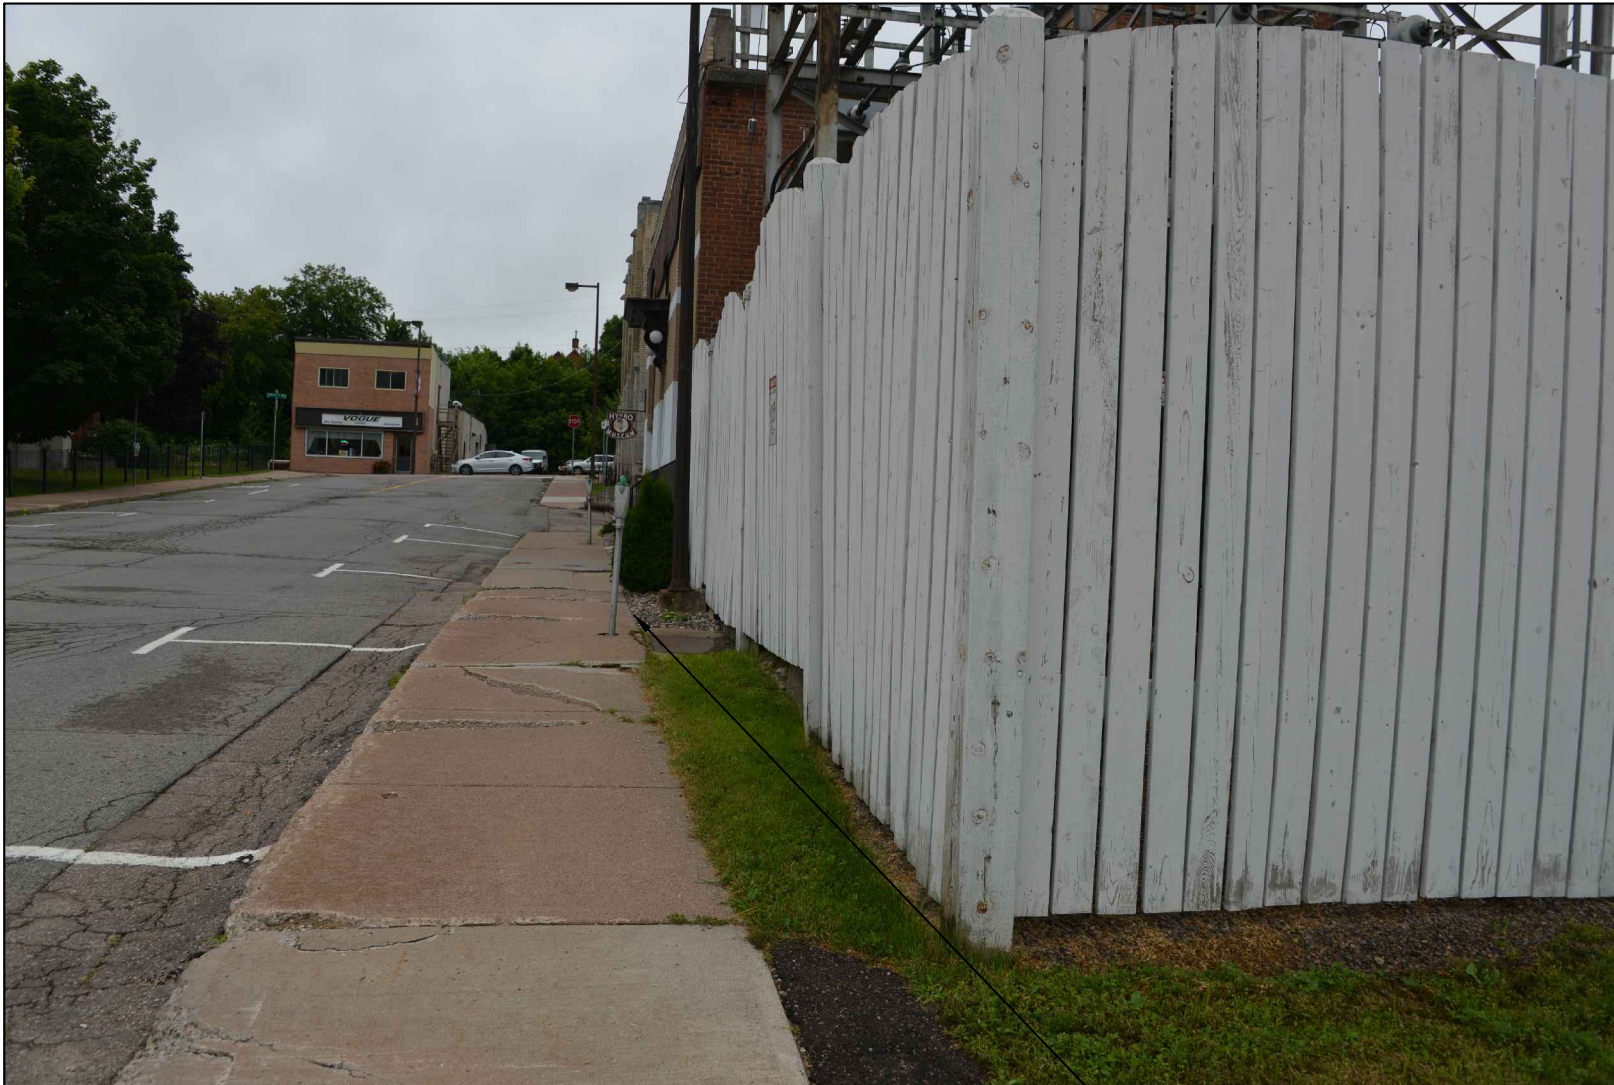
GROUNDING AND BONDING.
PARKING METER AND STREETLIGHT.

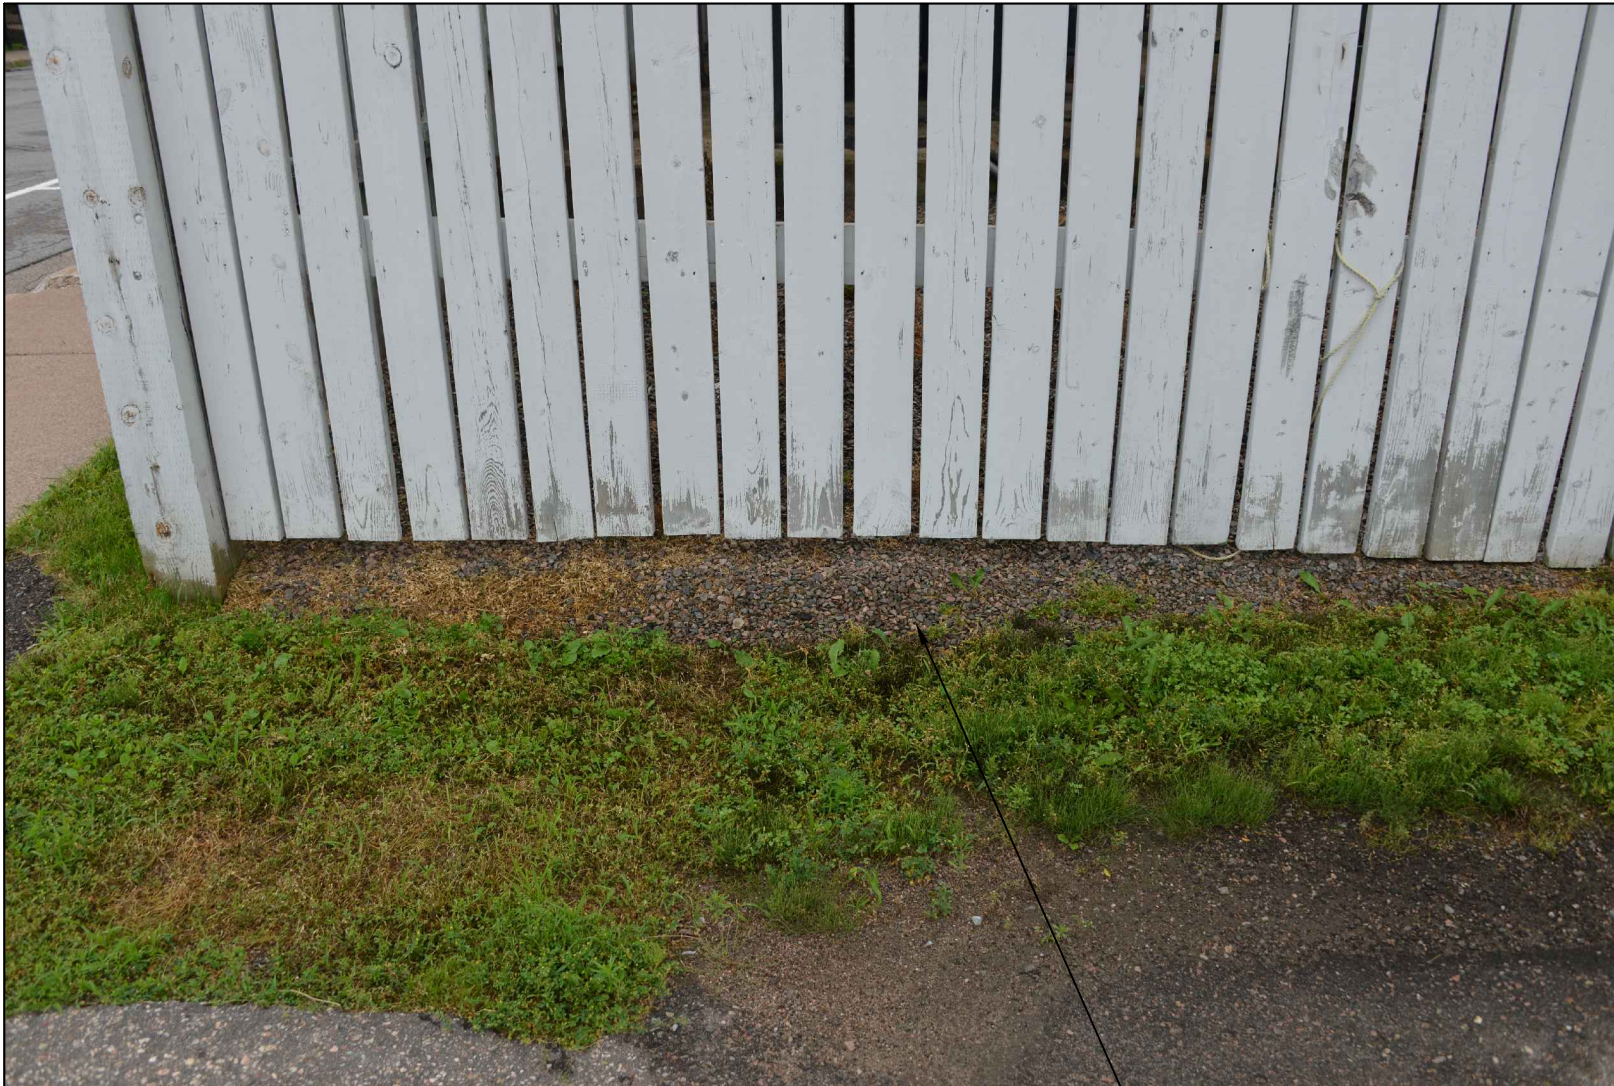
CRUSHED STONE IS TO EXTEND 1.00m
OUTSIDE OF THE FENCE.

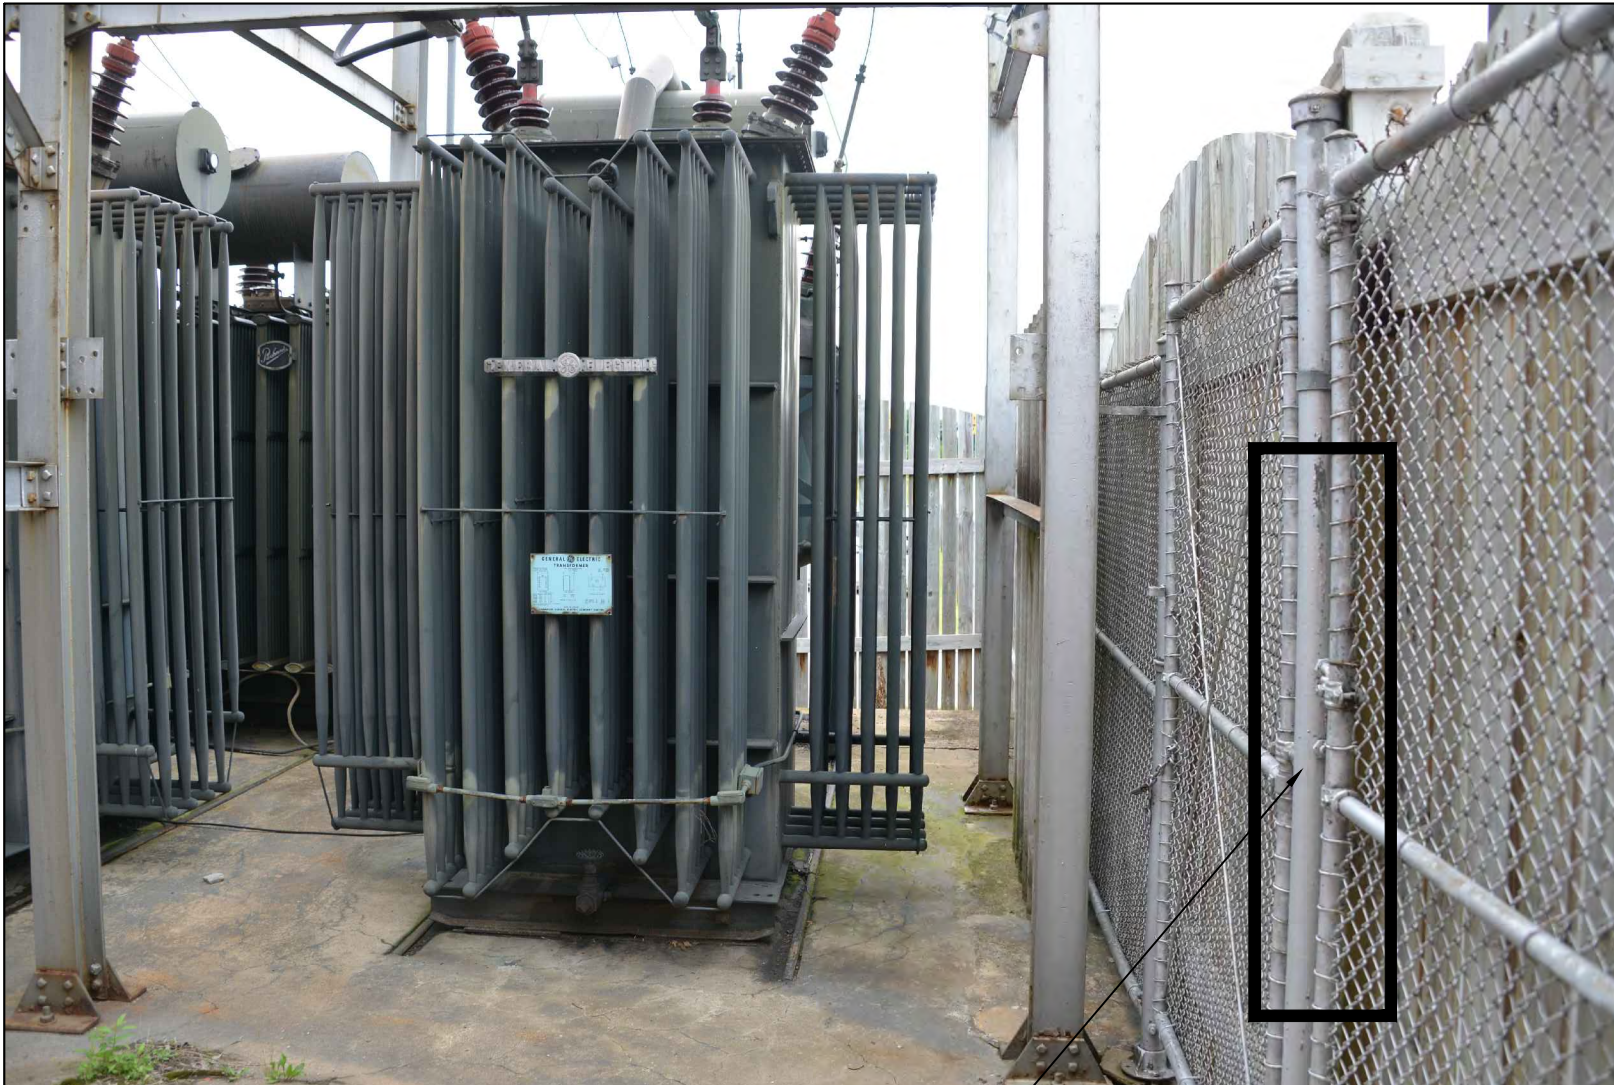
NO FENCE GROUNDING AS PER CODE

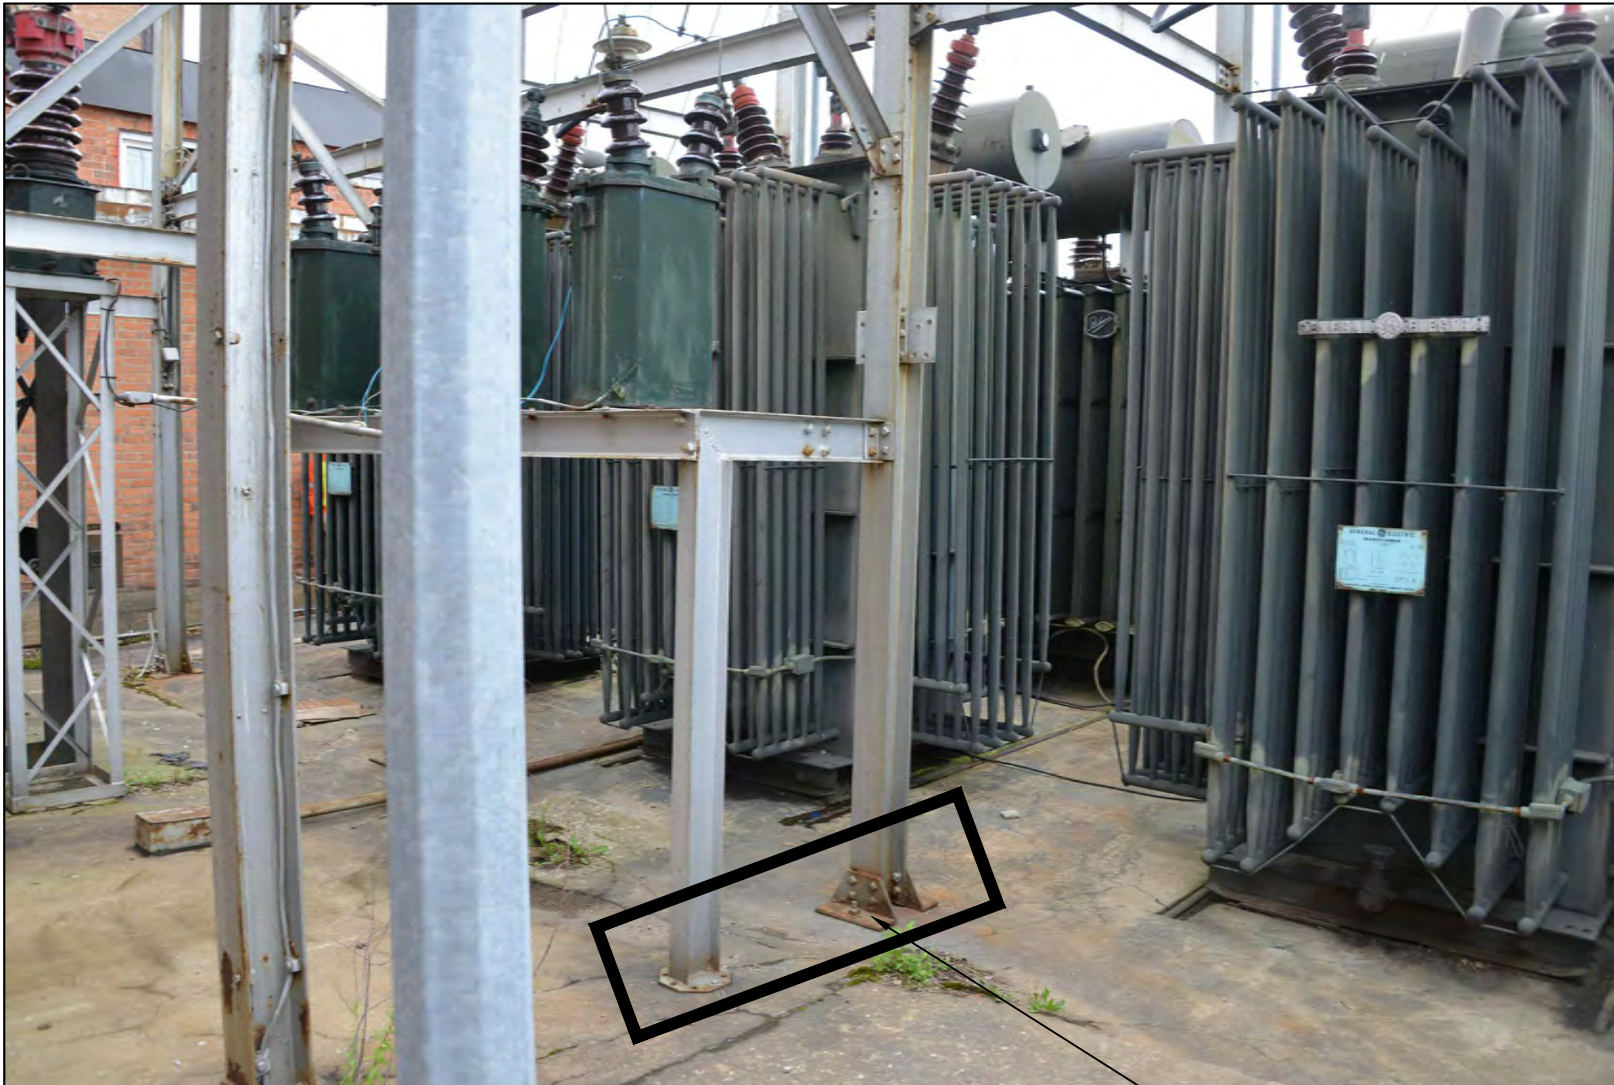
NO GROUNDING AND BONDING OF
STRUCTURES

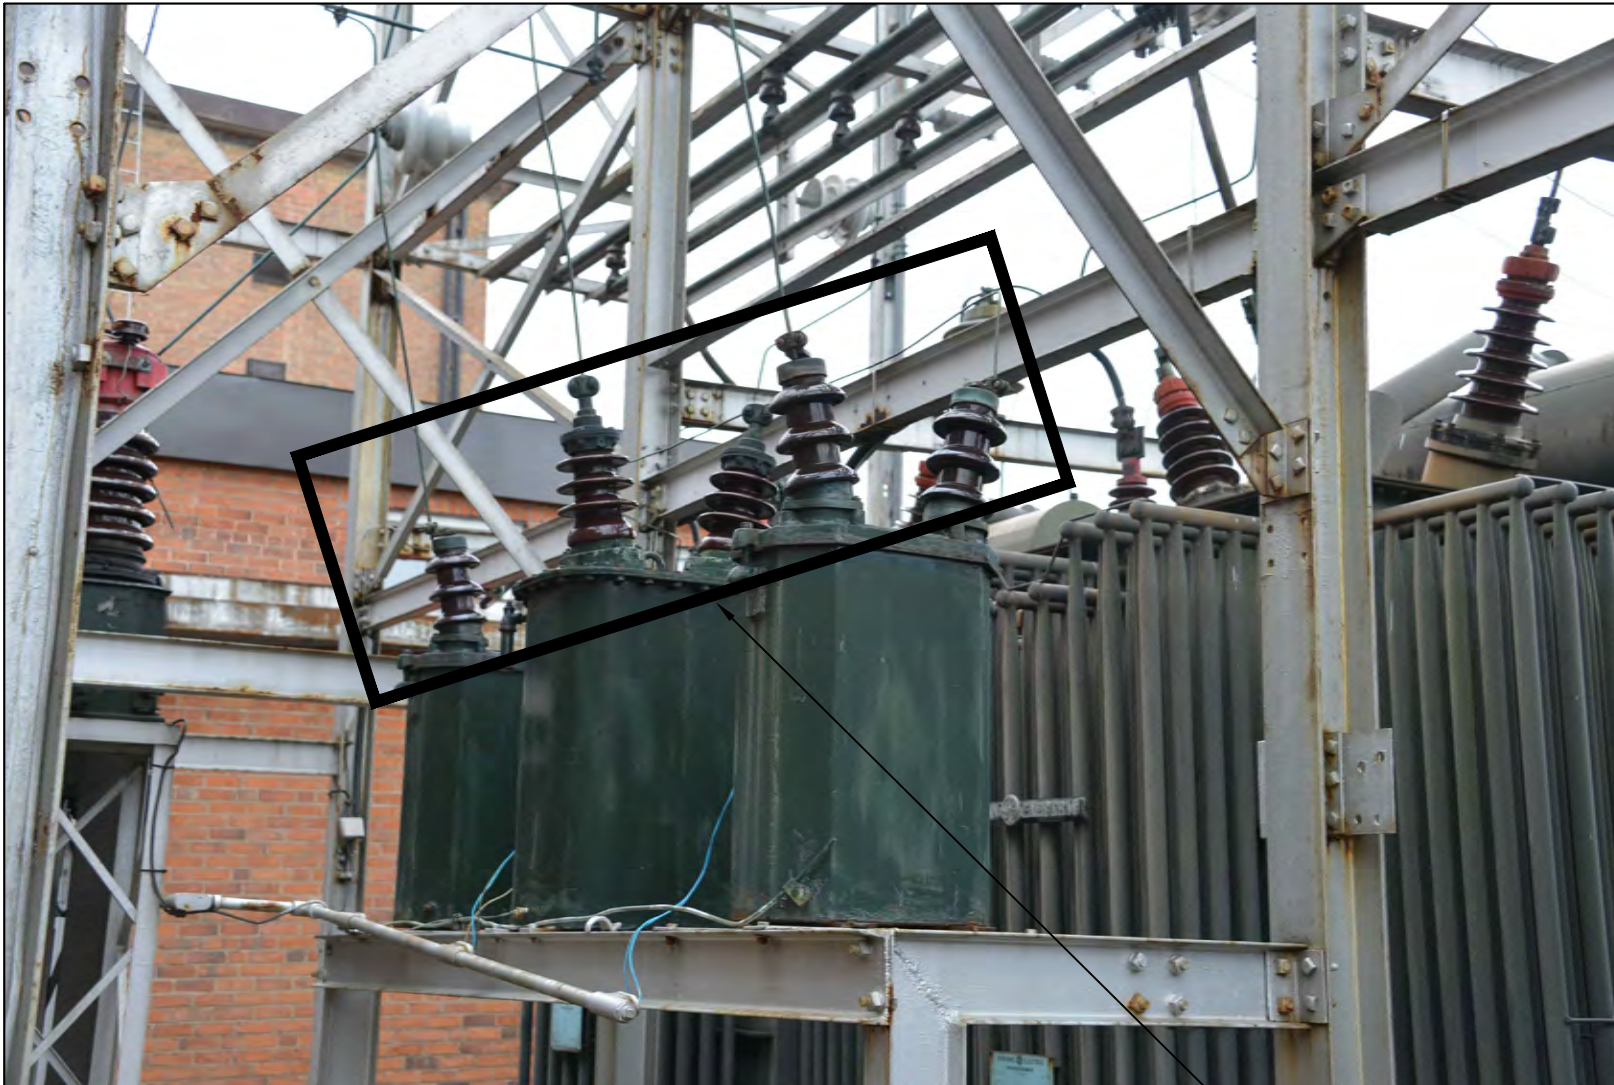
UNSAFE LIMITS OF APPROACH

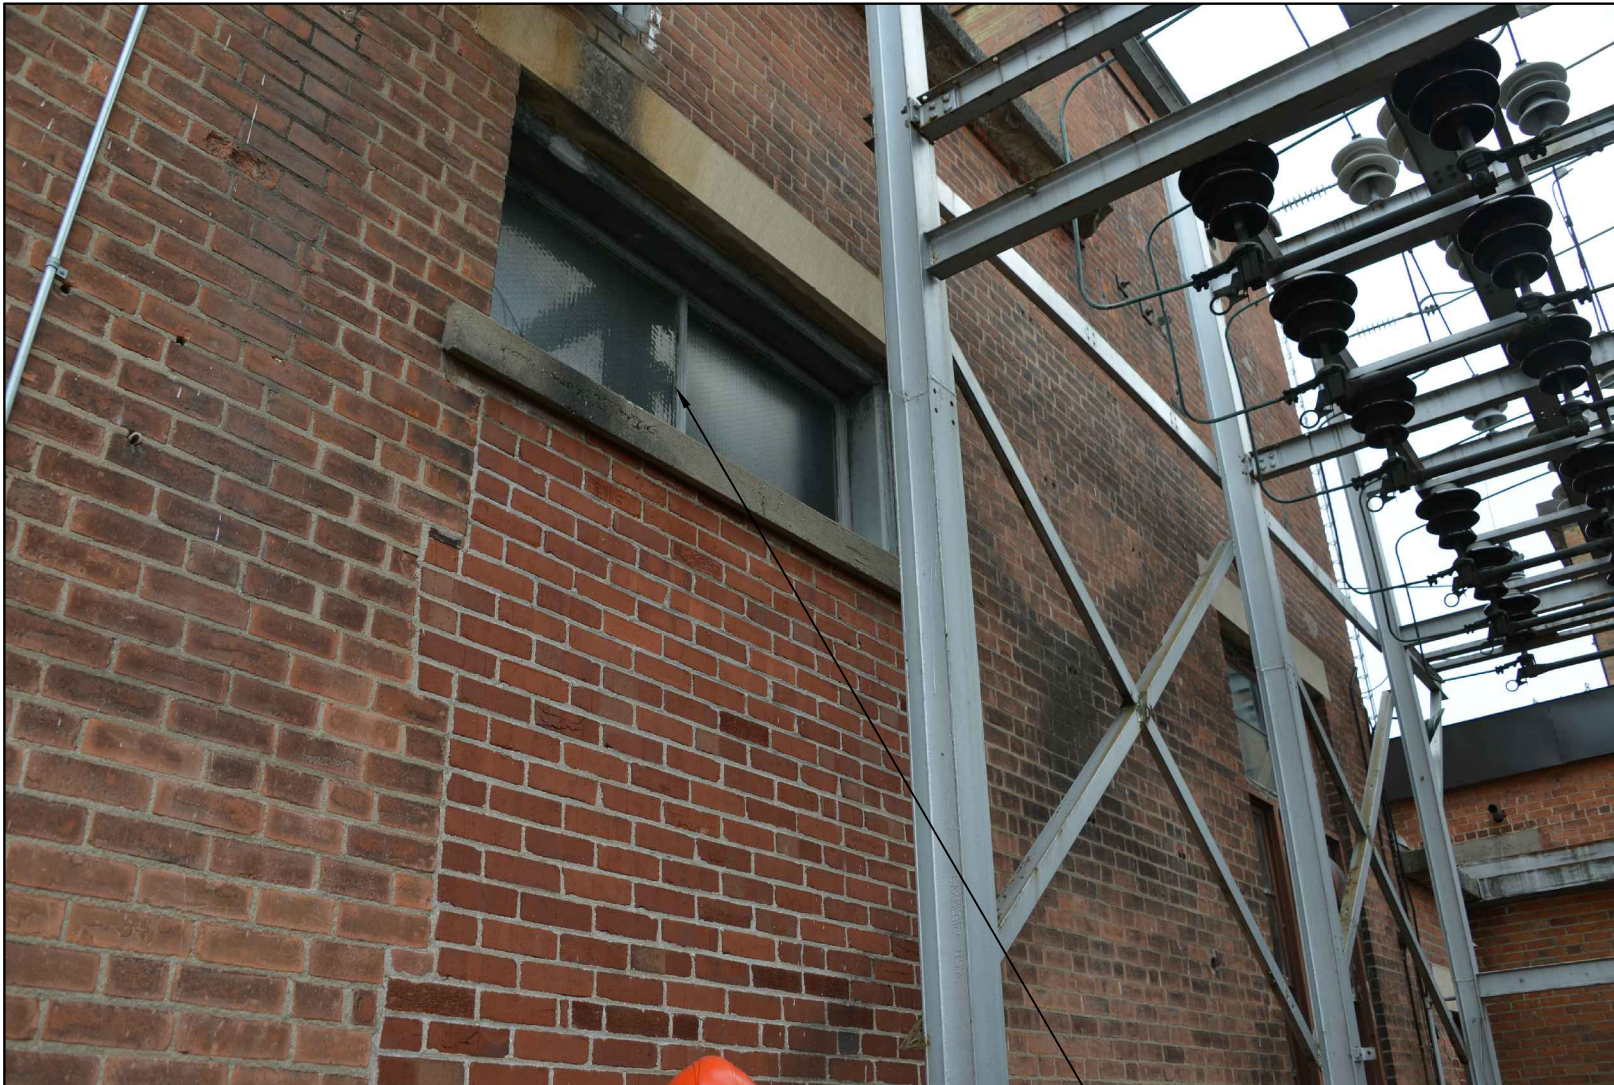
OFFICE WINDOW IS IN CLOSE PROXIMITY TO
PORCELAIN

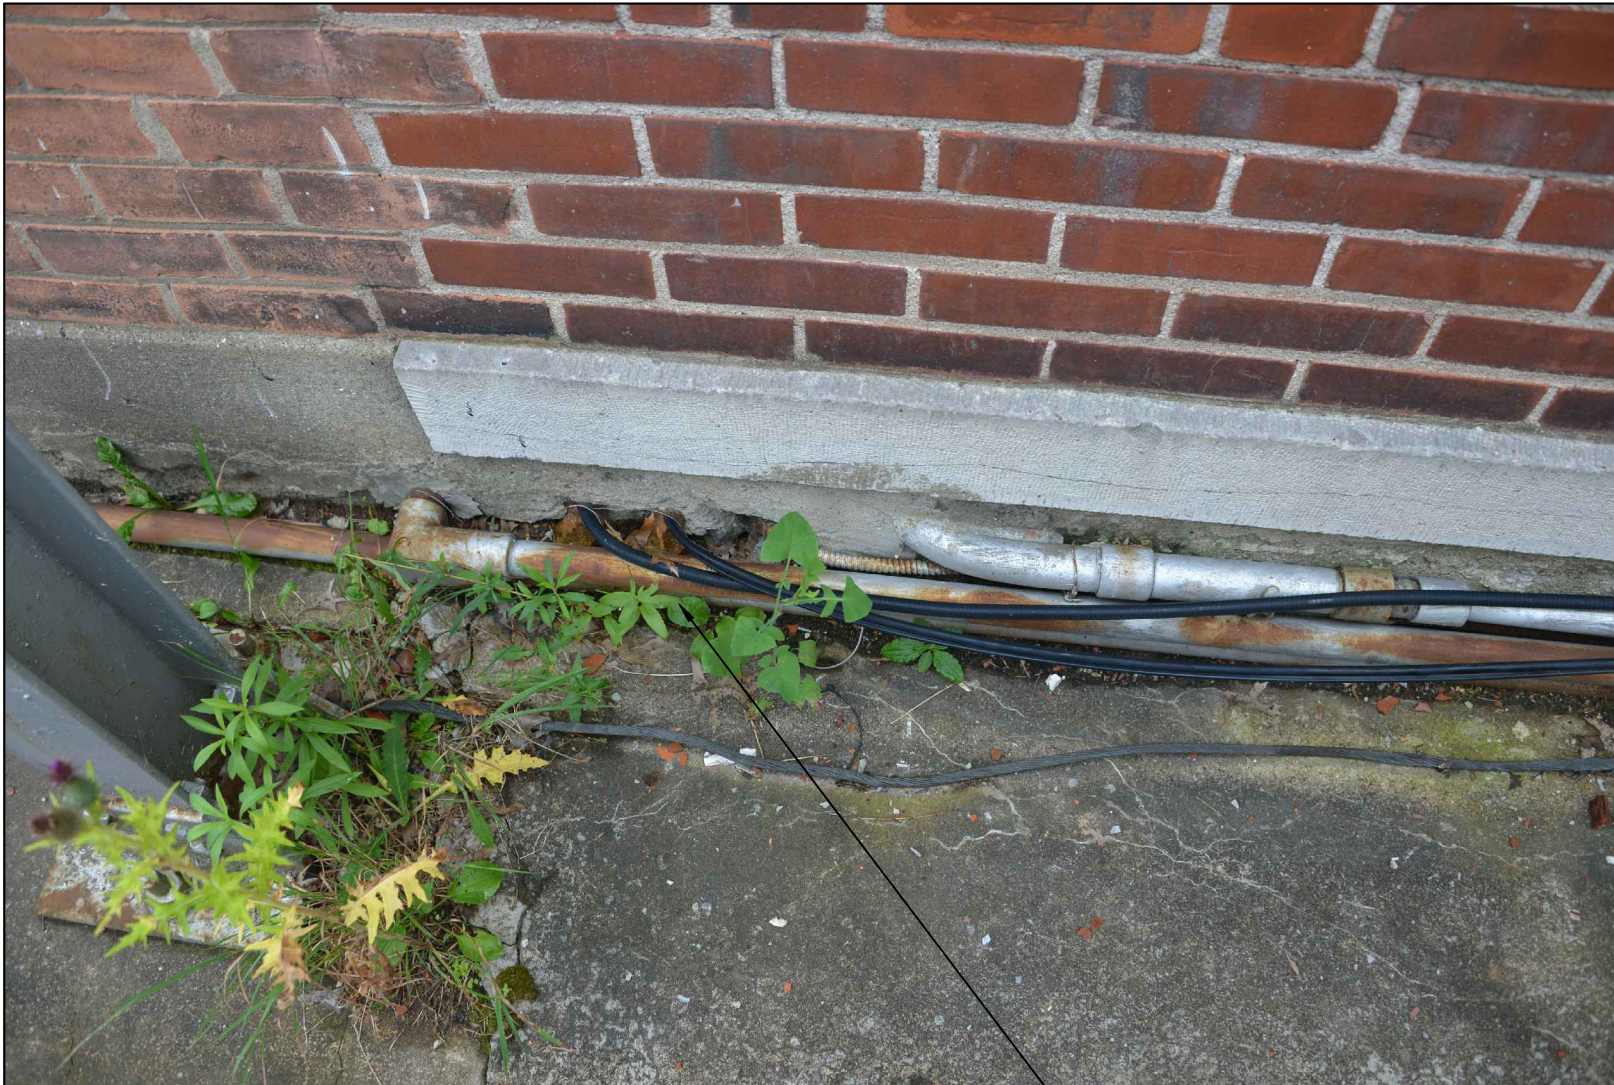
IMPROPER INSTALLATION OF
CONTROL CABLES – NOT TO CODE

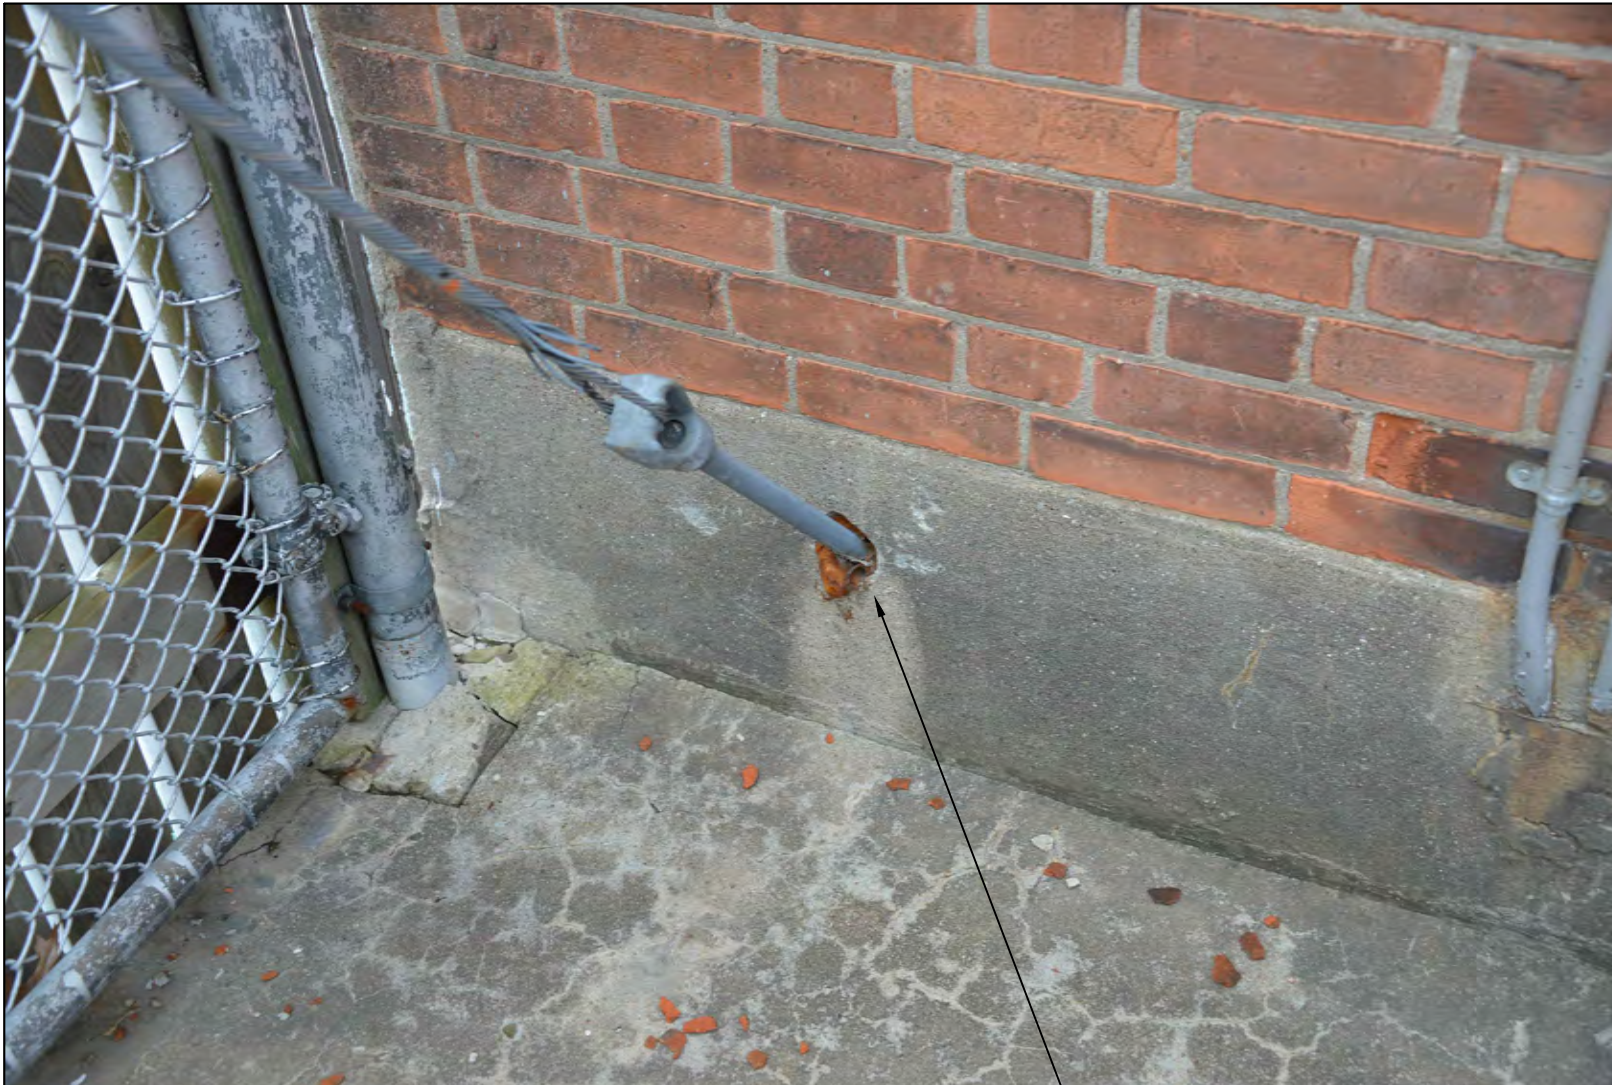
ANCHOR FOR TOWER STRUCTURE IS IN THE BASEMENT. NO WAY TO MEASURE THE STRENGTH OF THIS. STRANDS ARE FRAYING.

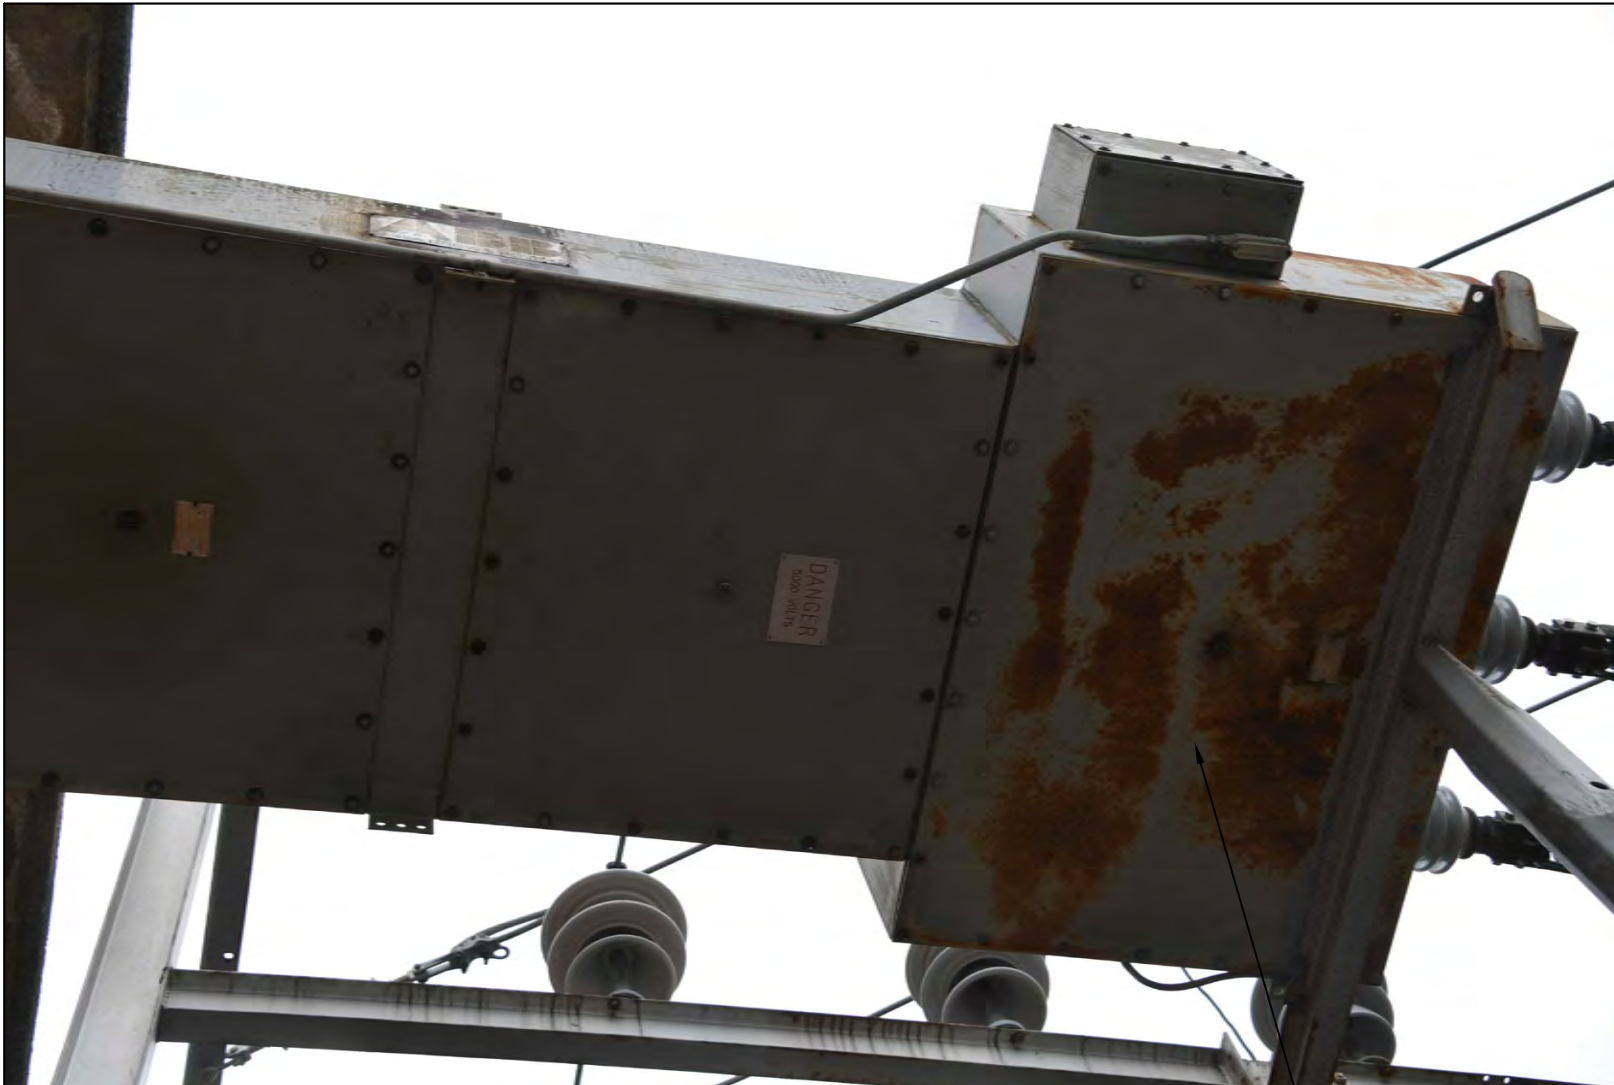
PAINT CONDITION ON BUS DUCT

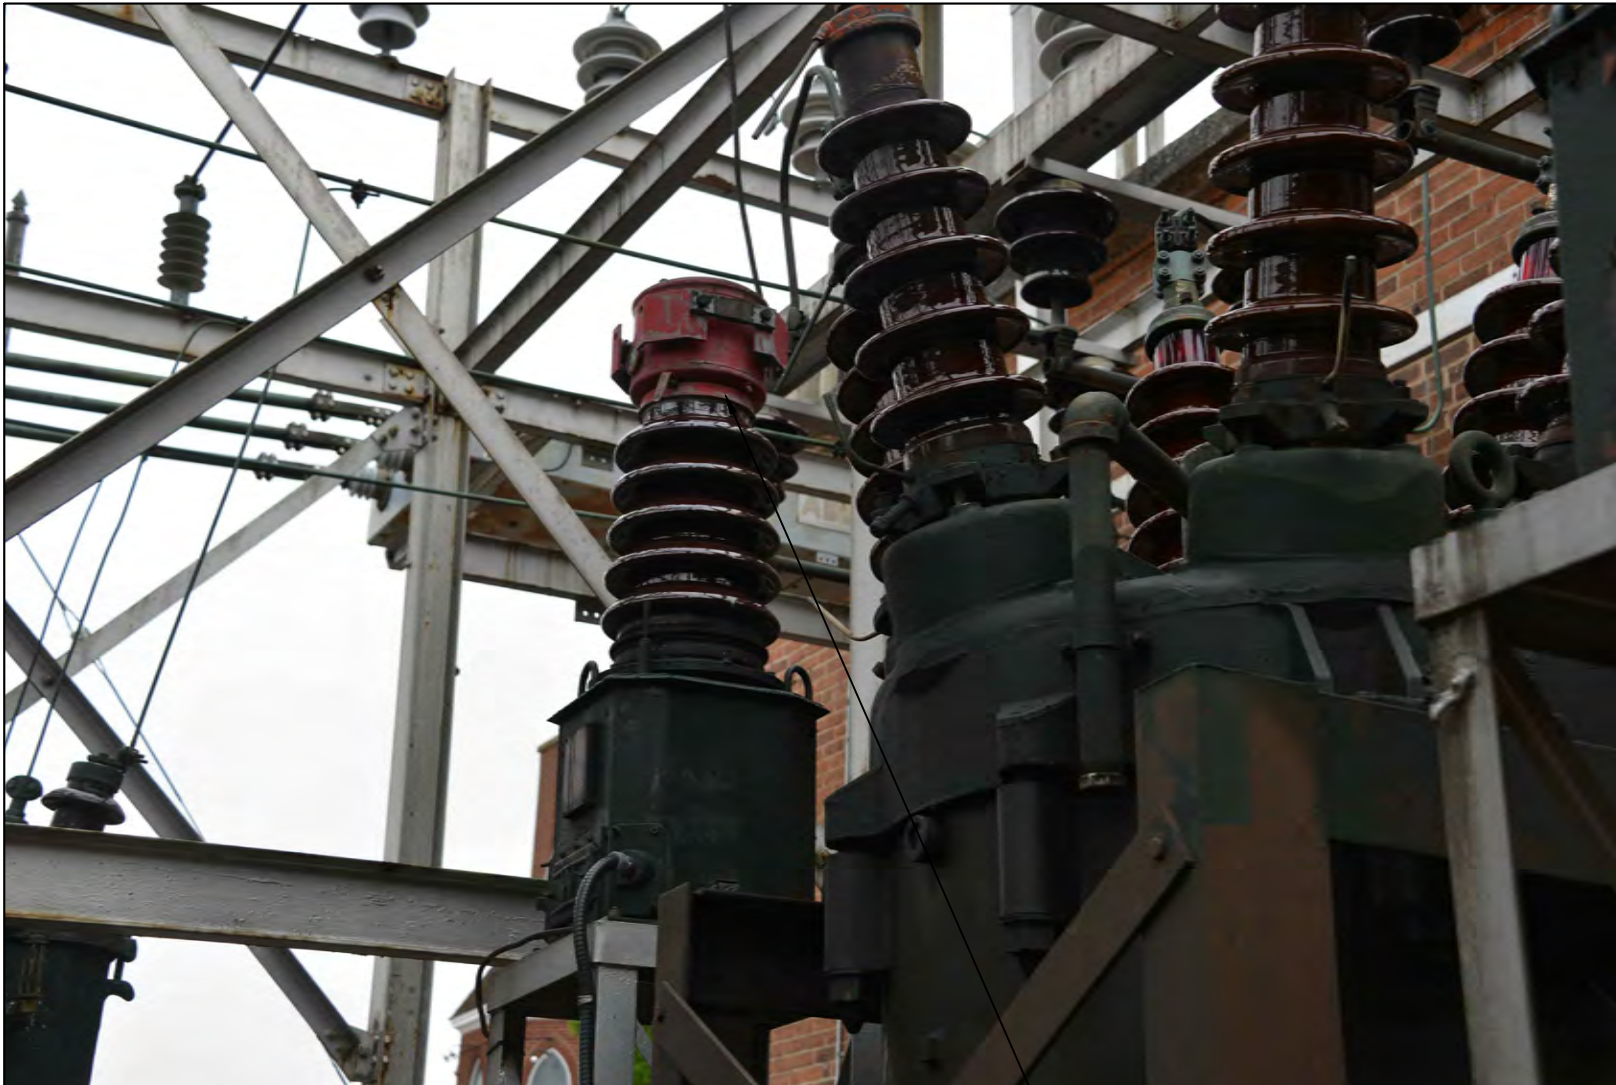
PORCELAIN INSTRUMENT TRANSFORMERS –
VERY LOW CLEARANCES FOR WORKERS

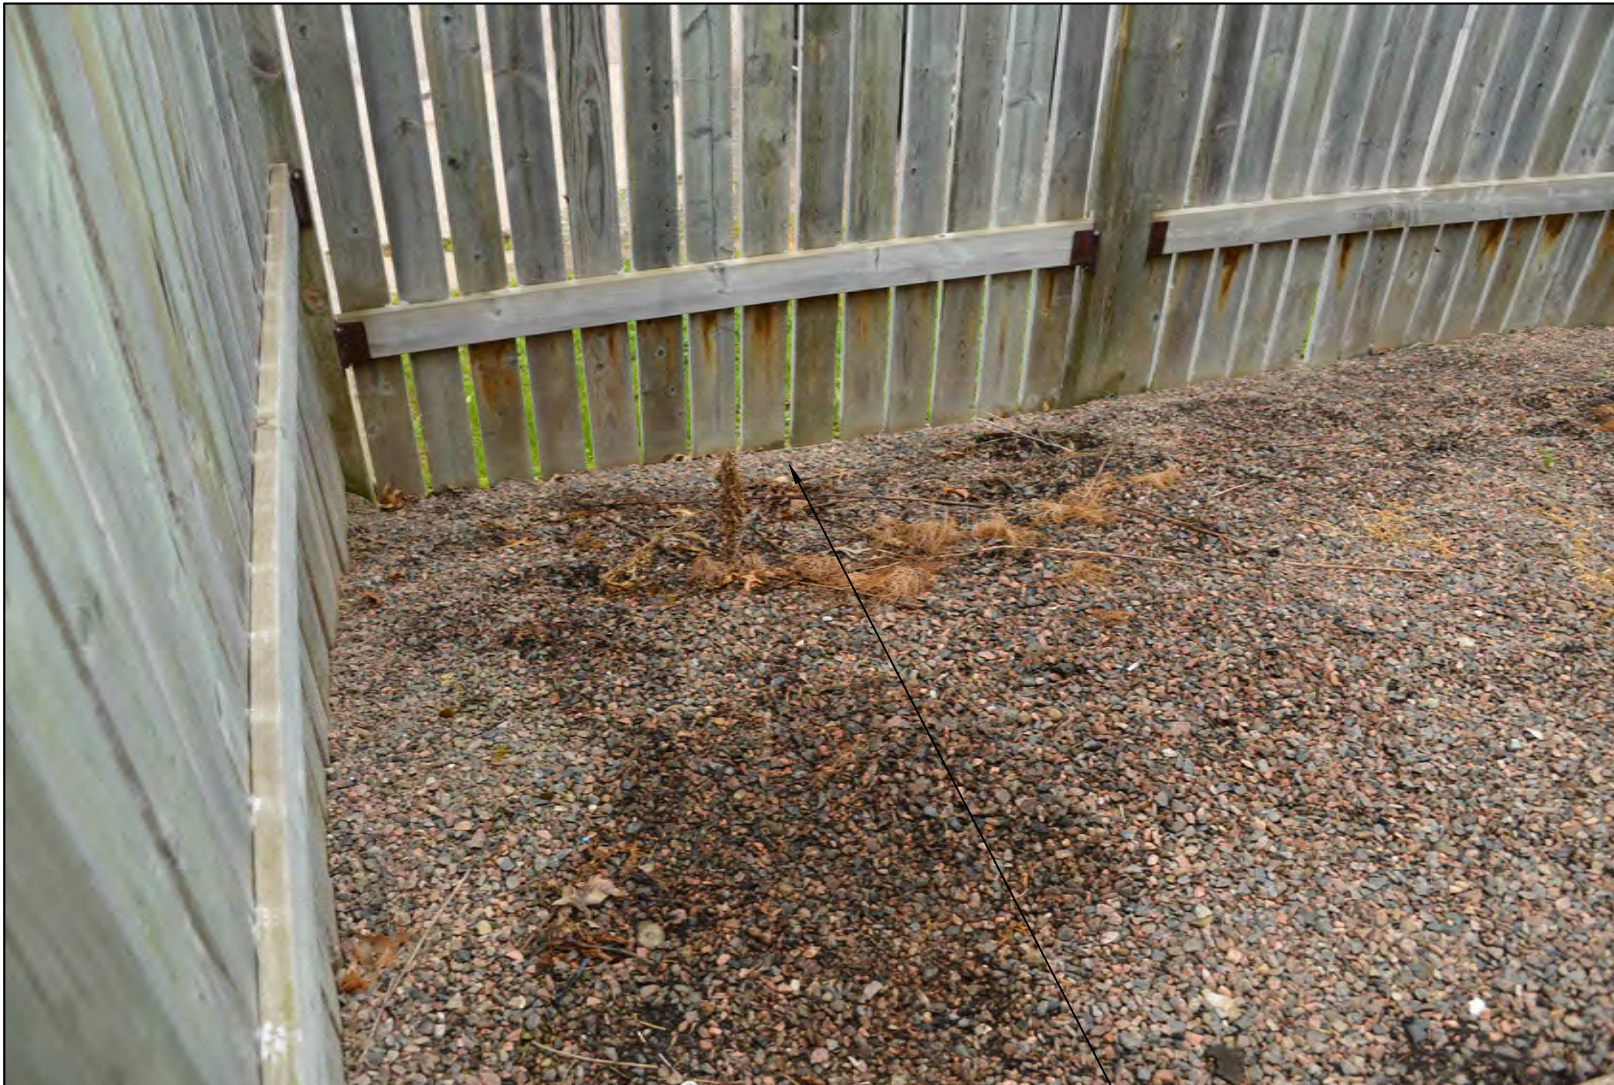
FENCE GAPS ARE LARGER THAN 50mm AND
LACK OF CRUSHED STONE

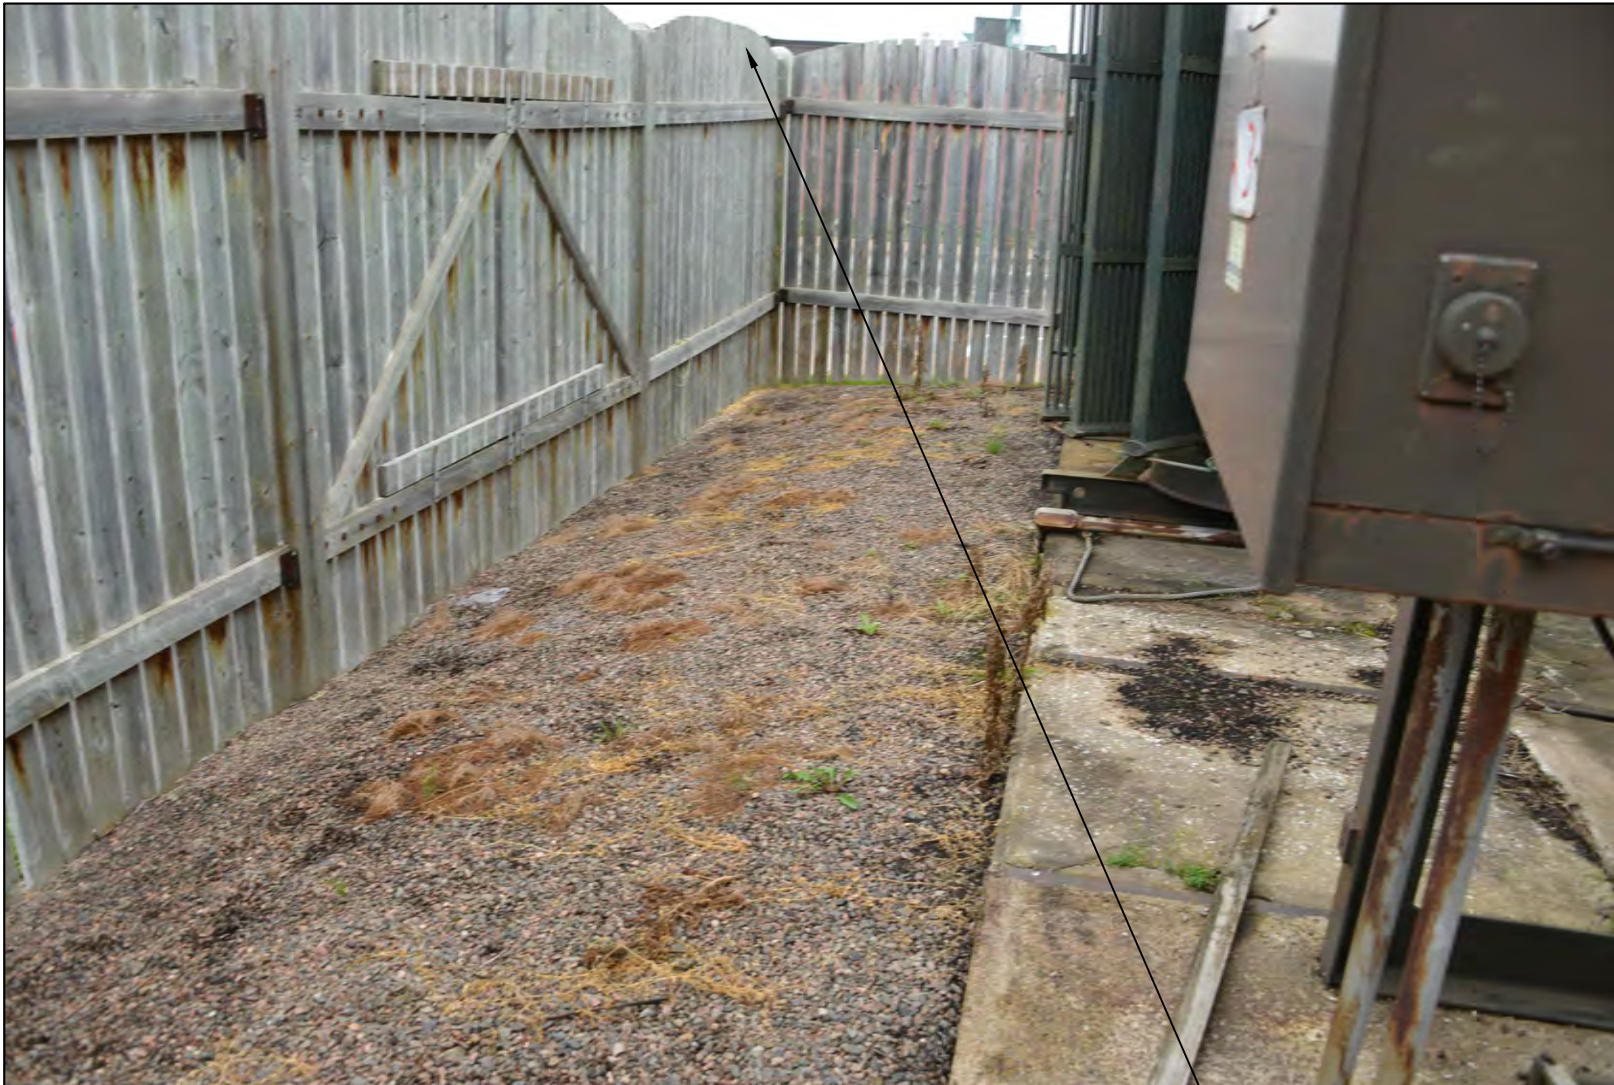
NO BARB WIRE AS PER OESC
