Ottawa River Power Corporation Substation Condition Assessment Report

Project: 17153

costello
Utility Consultants

September 2017

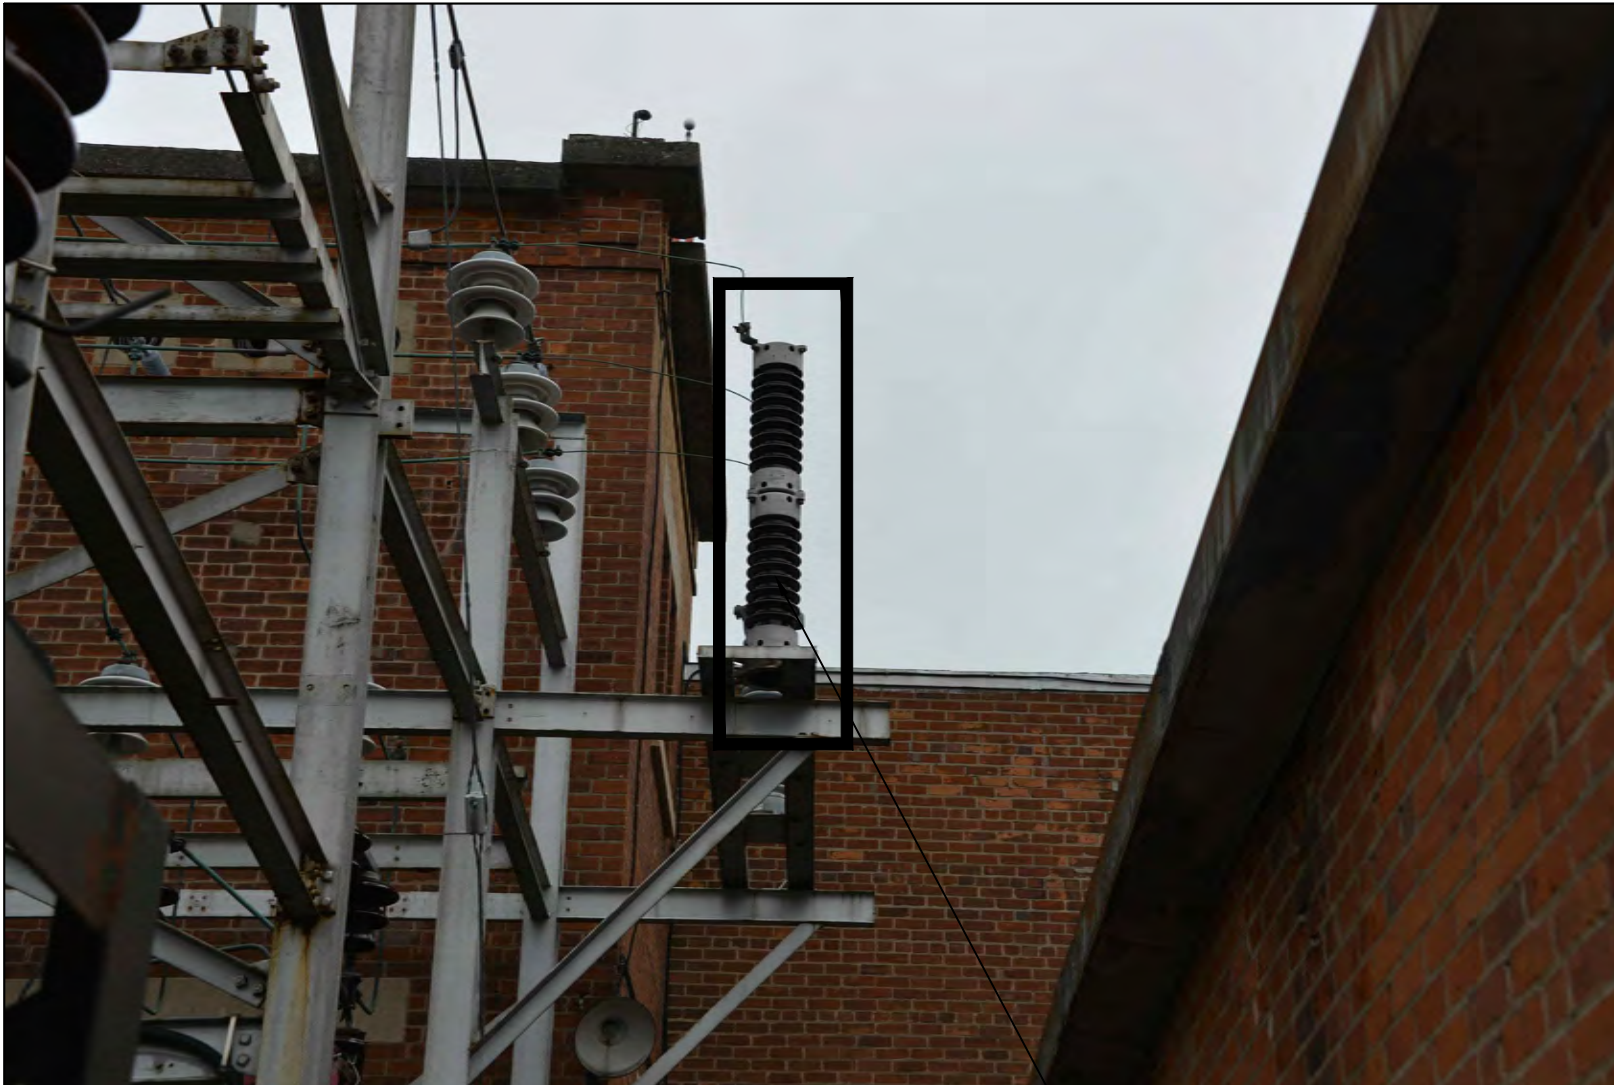
PORCELAIN ARRESTORS

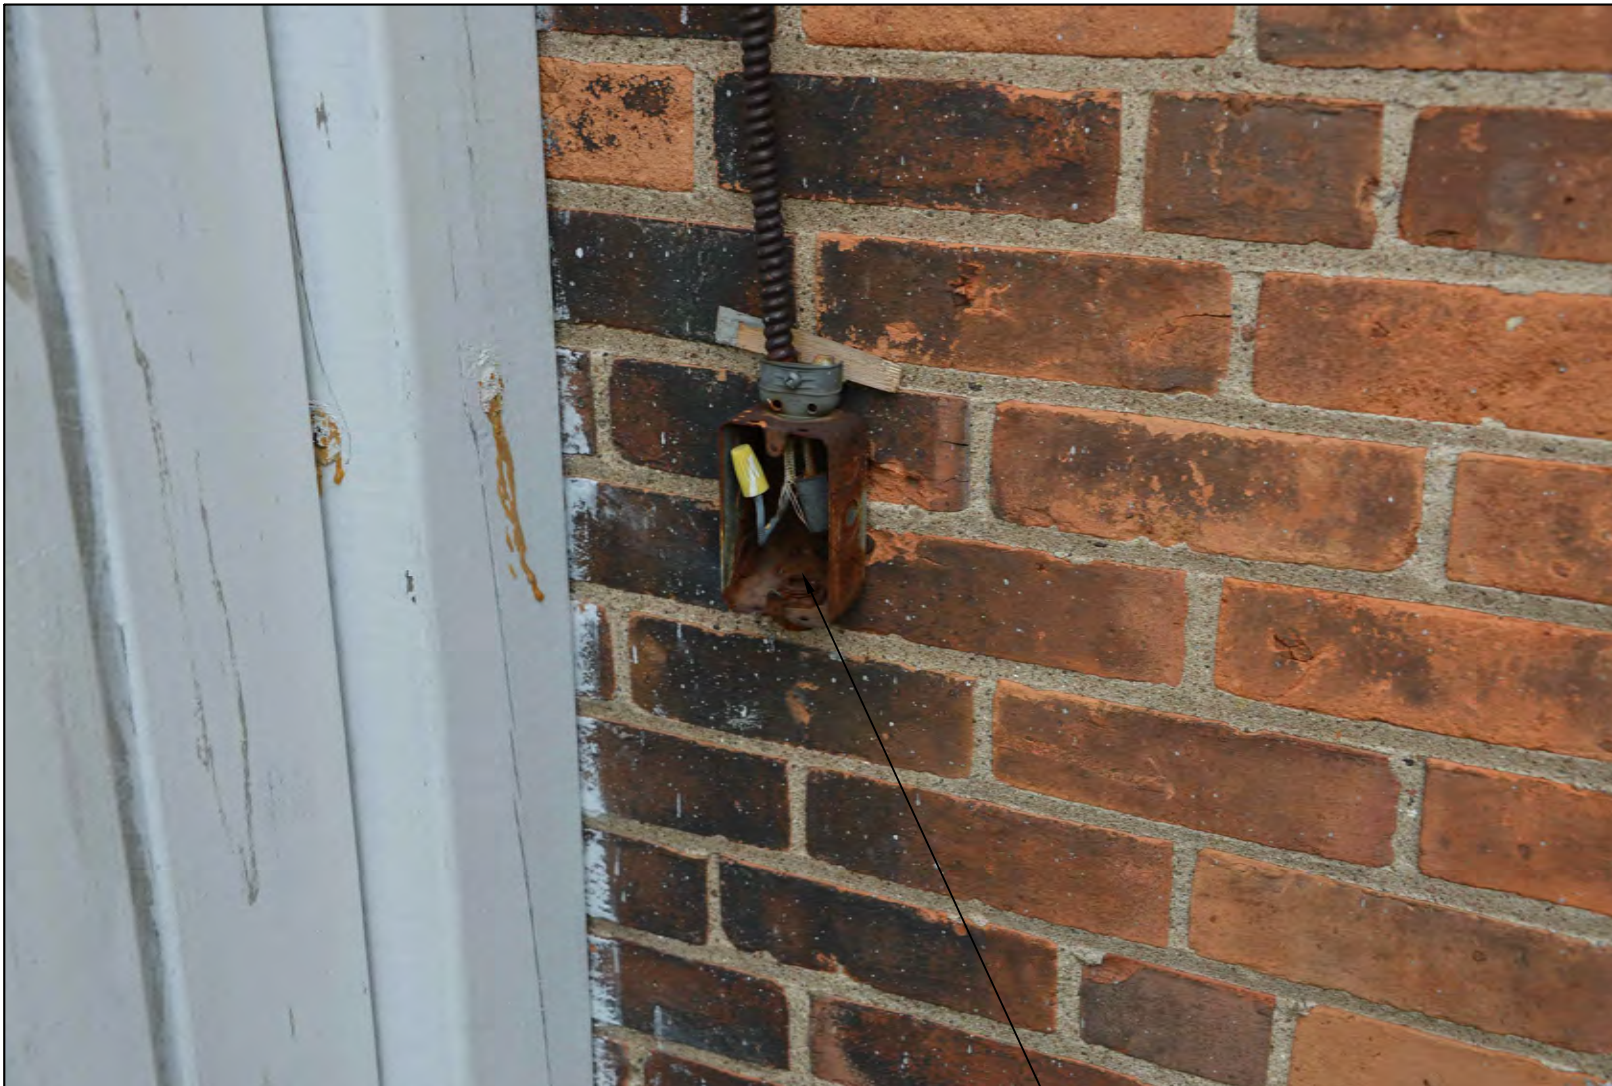
EXPOSED WIRING - CODE VIOLATION

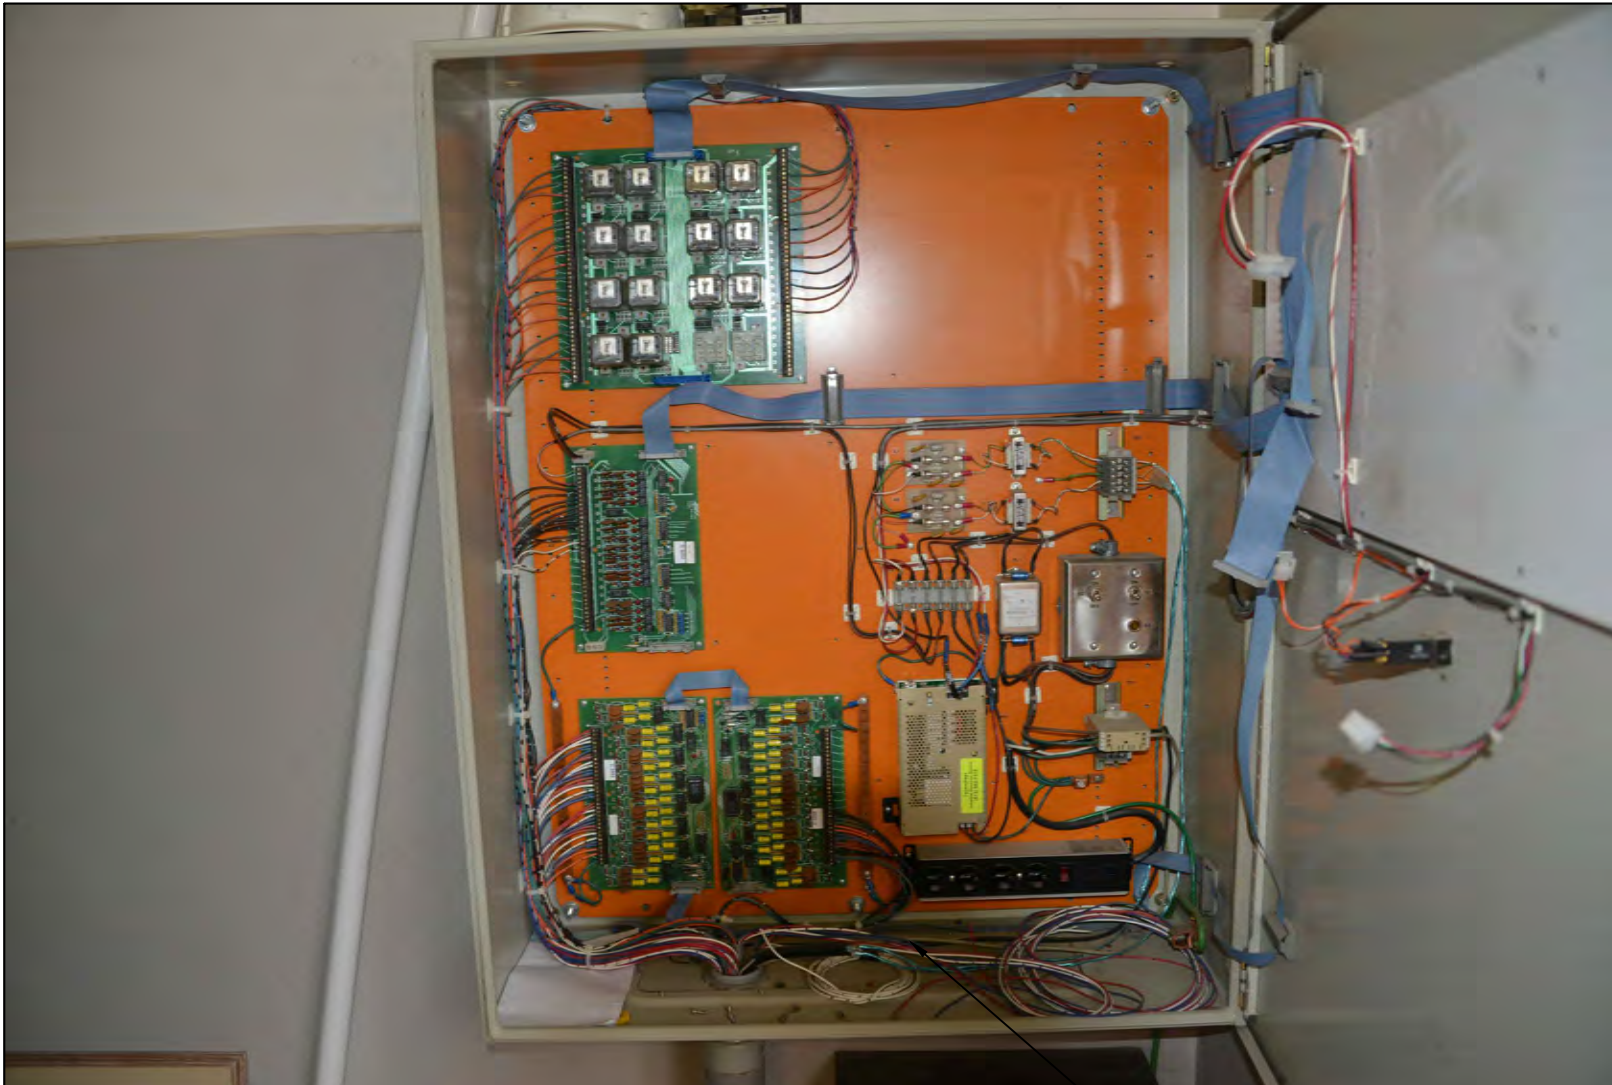
SCADA is seen by electric utilities as an invaluable tool for monitoring and measuring their system's performance. SCADA systems are installed at most Ontario LDC's. All of the Pembroke stations have SCADA equipment installed, although the MS-1 station RTU failed about two years ago. None of the Almonte stations have SCADA.

— FAILED SCADA RTU

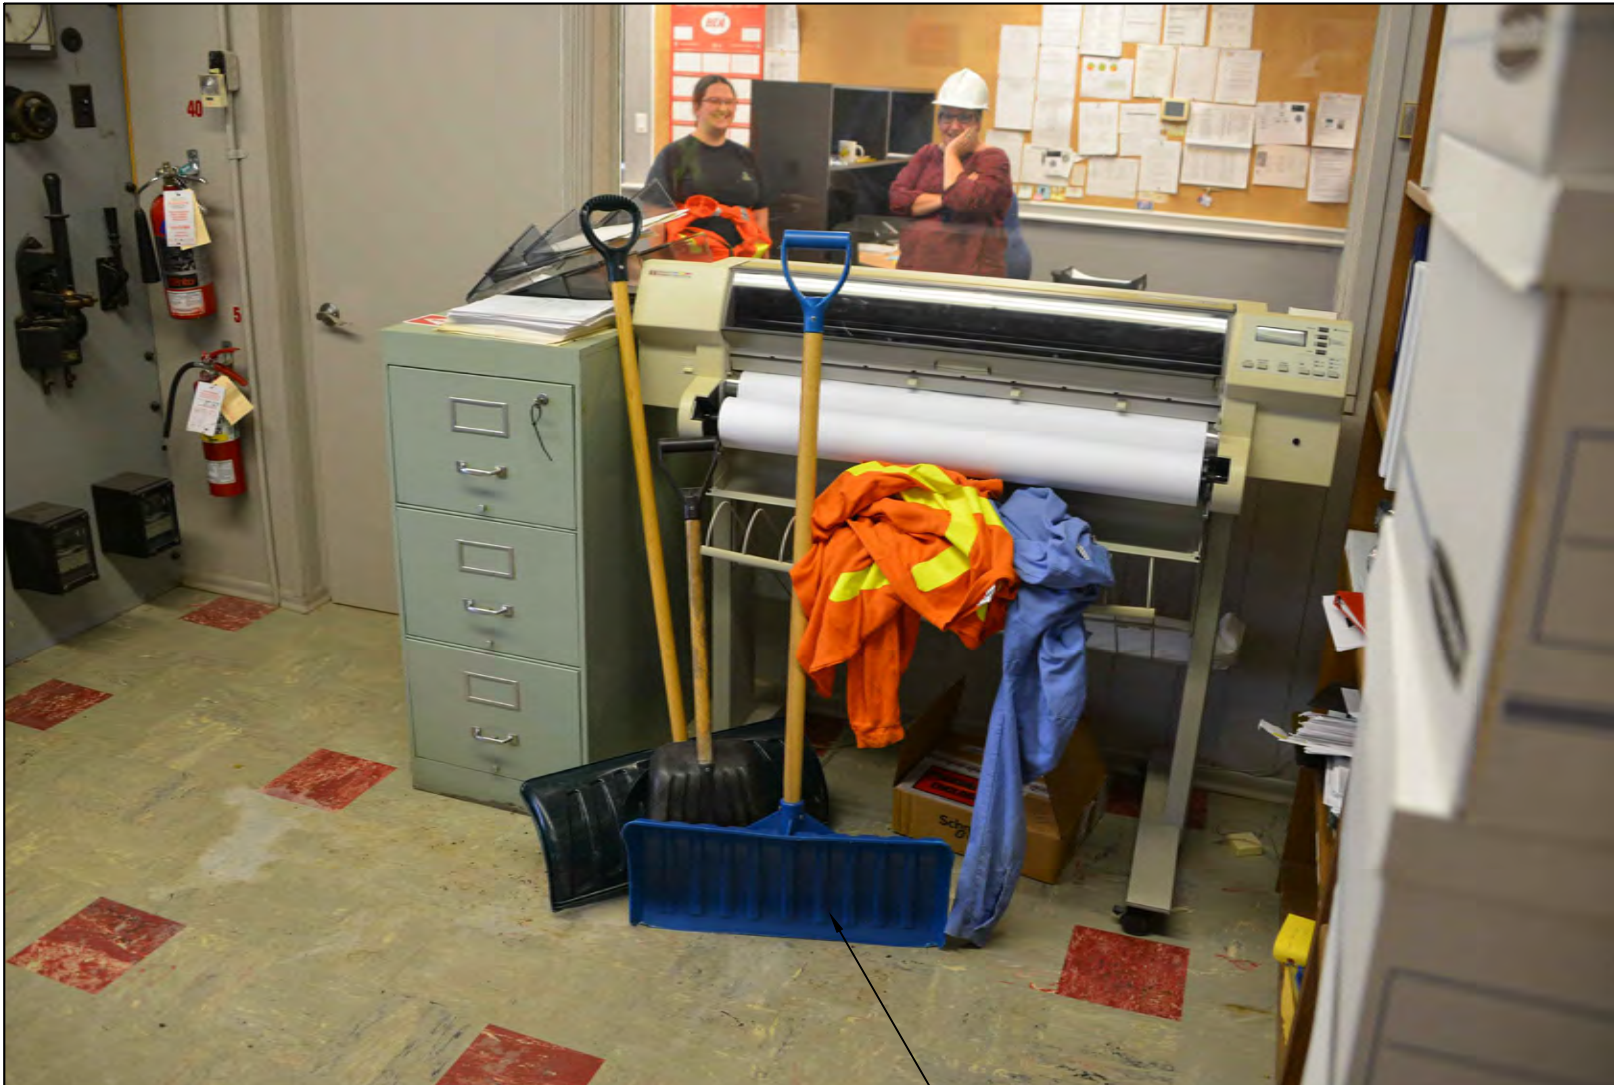
OFFICE EQUIPMENT AND STORAGE IN THE
SUBSTATION ROOM – CODE VIOLATION.
OFFICE ATTACHED TO SUBSTATION (GLASS).

The low voltage switchgear for this station is in an office environment, inside the main ORPC office. Desks, printers, and files in a switchgear room in conflict with OESC, and could cause unqualified personnel to enter the high voltage area. These obstructions should be removed from the room immediately.

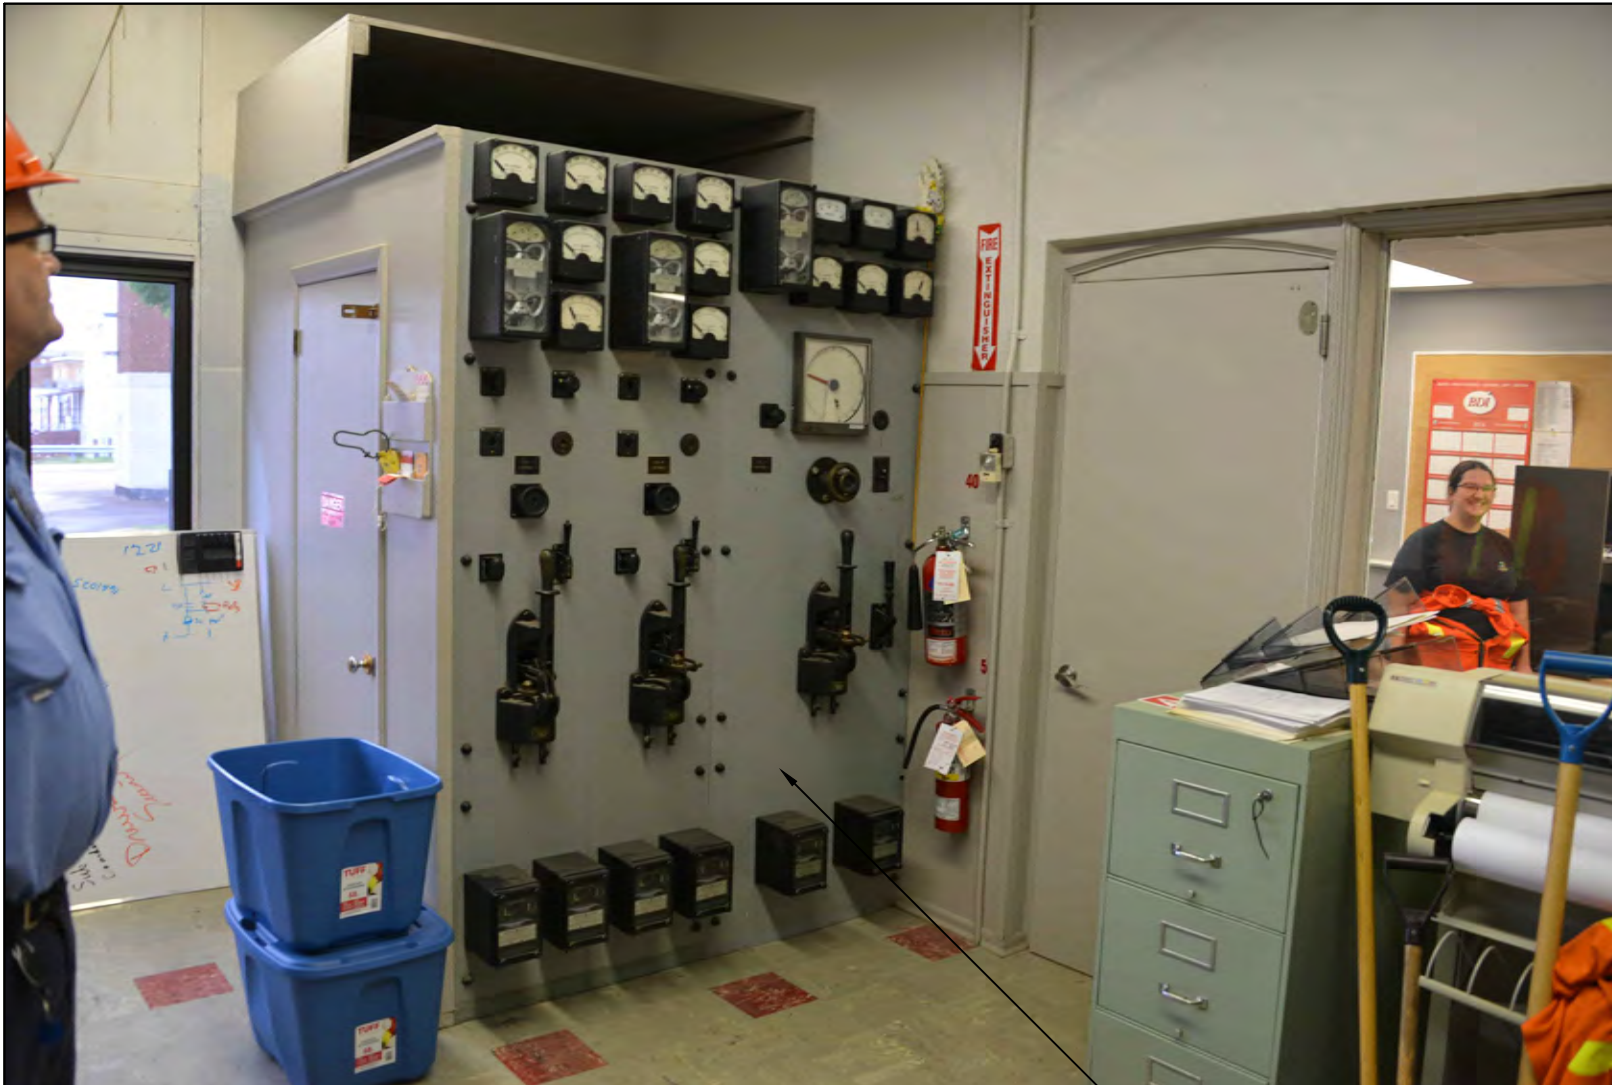
MINI OCB'S COMBUSTIBLE IN OFFICE ENVIRONMENT

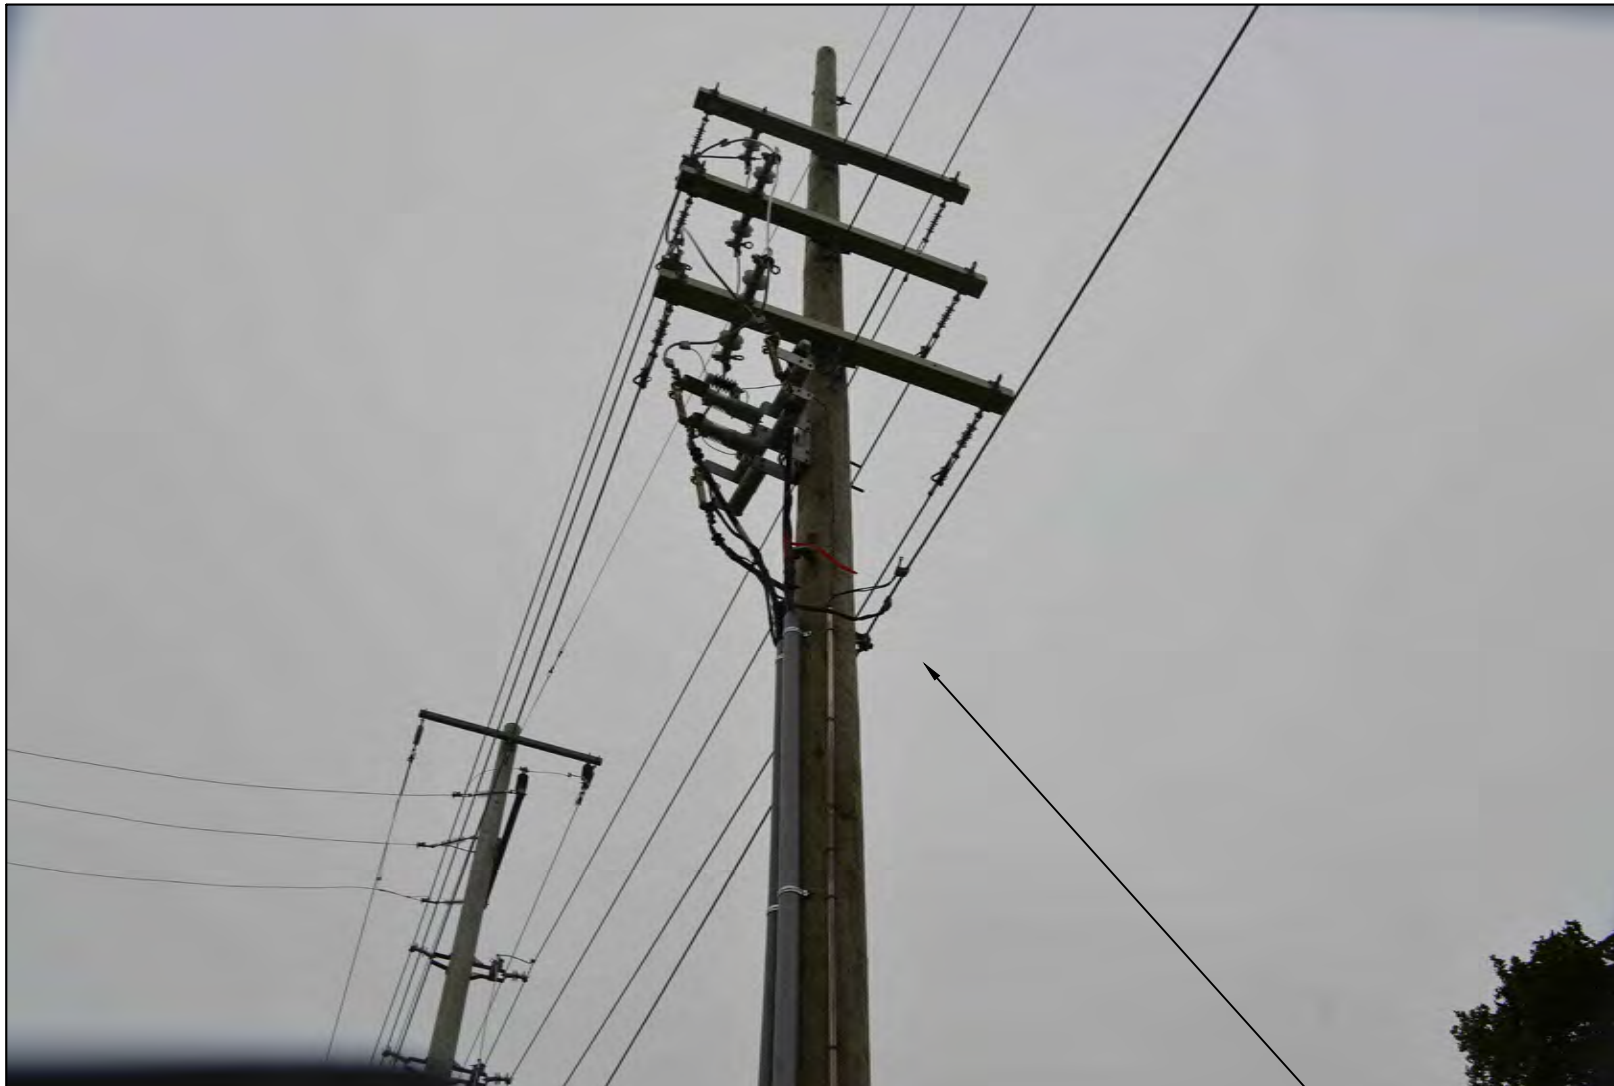
The station neutral is a direct buried bare 3/0 wire. This is not standard practice and is a hazard to public and workers. The bare copper wire makes the neutral look like most pole grounds which can cause a dangerous situation if someone were to cut into it for any reason.

STATION L.V NEUTRAL
CONNECTION IS BARE 3/0 WIRE

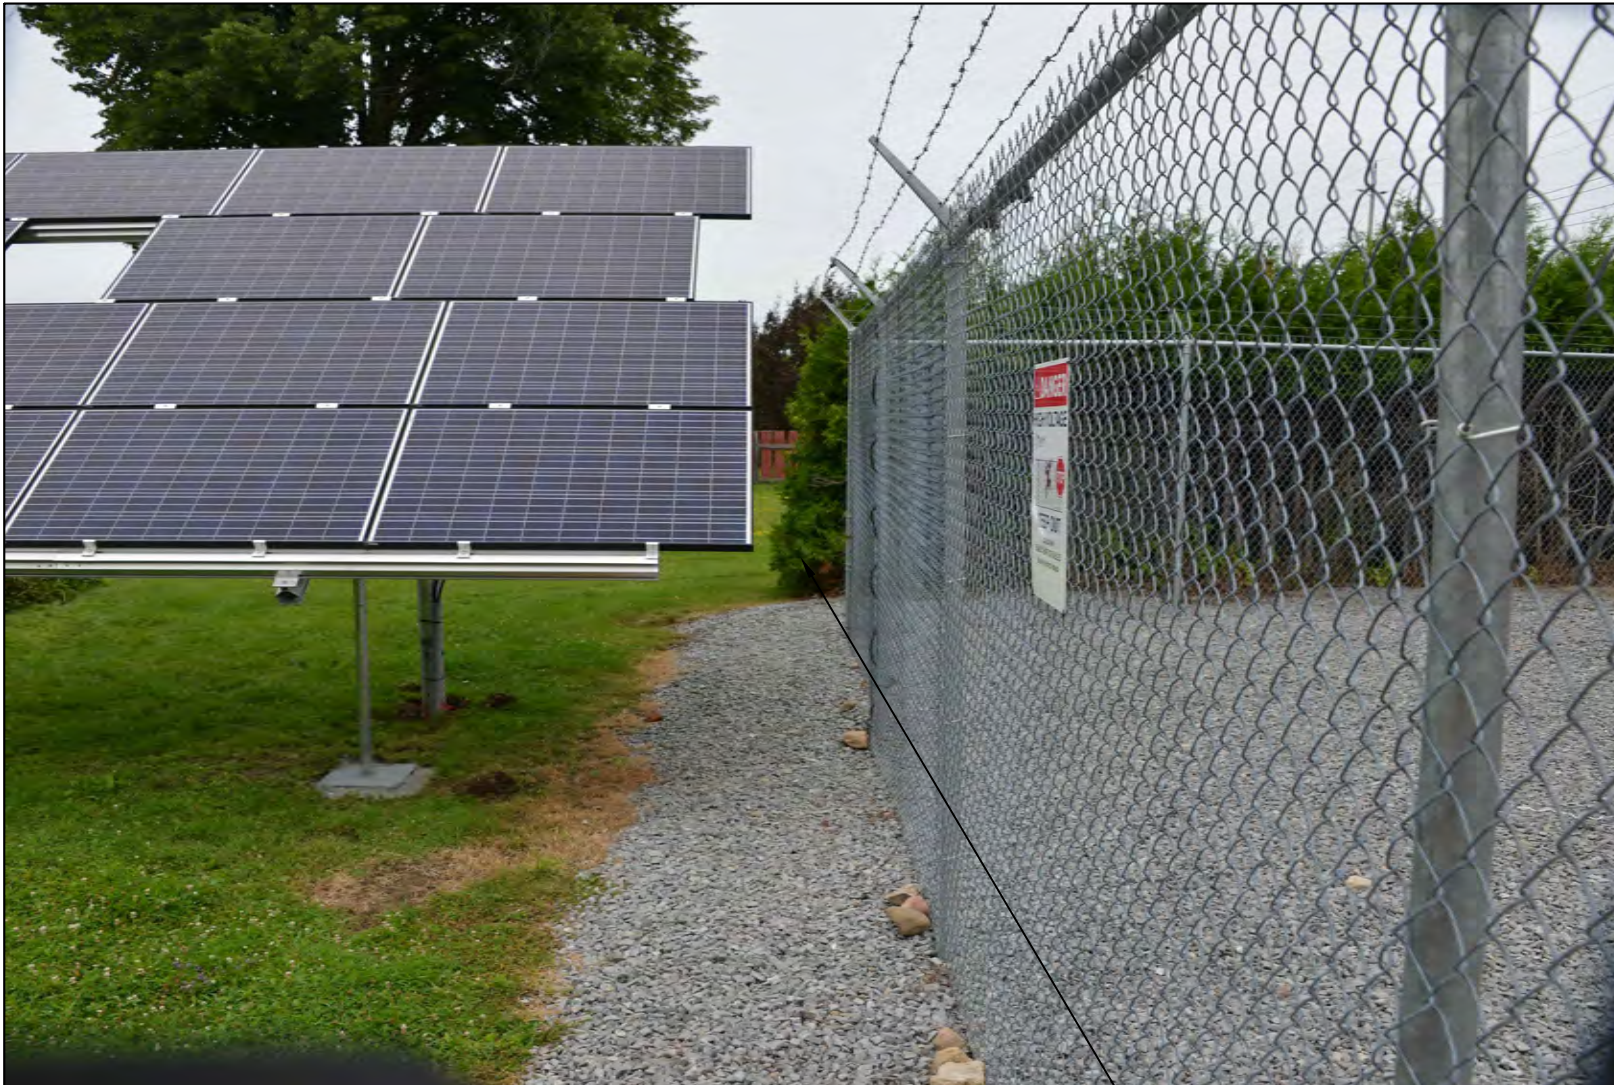
LOW CLEARANCE BETWEEN SOLAR
PANELS AND STATION FENCE.

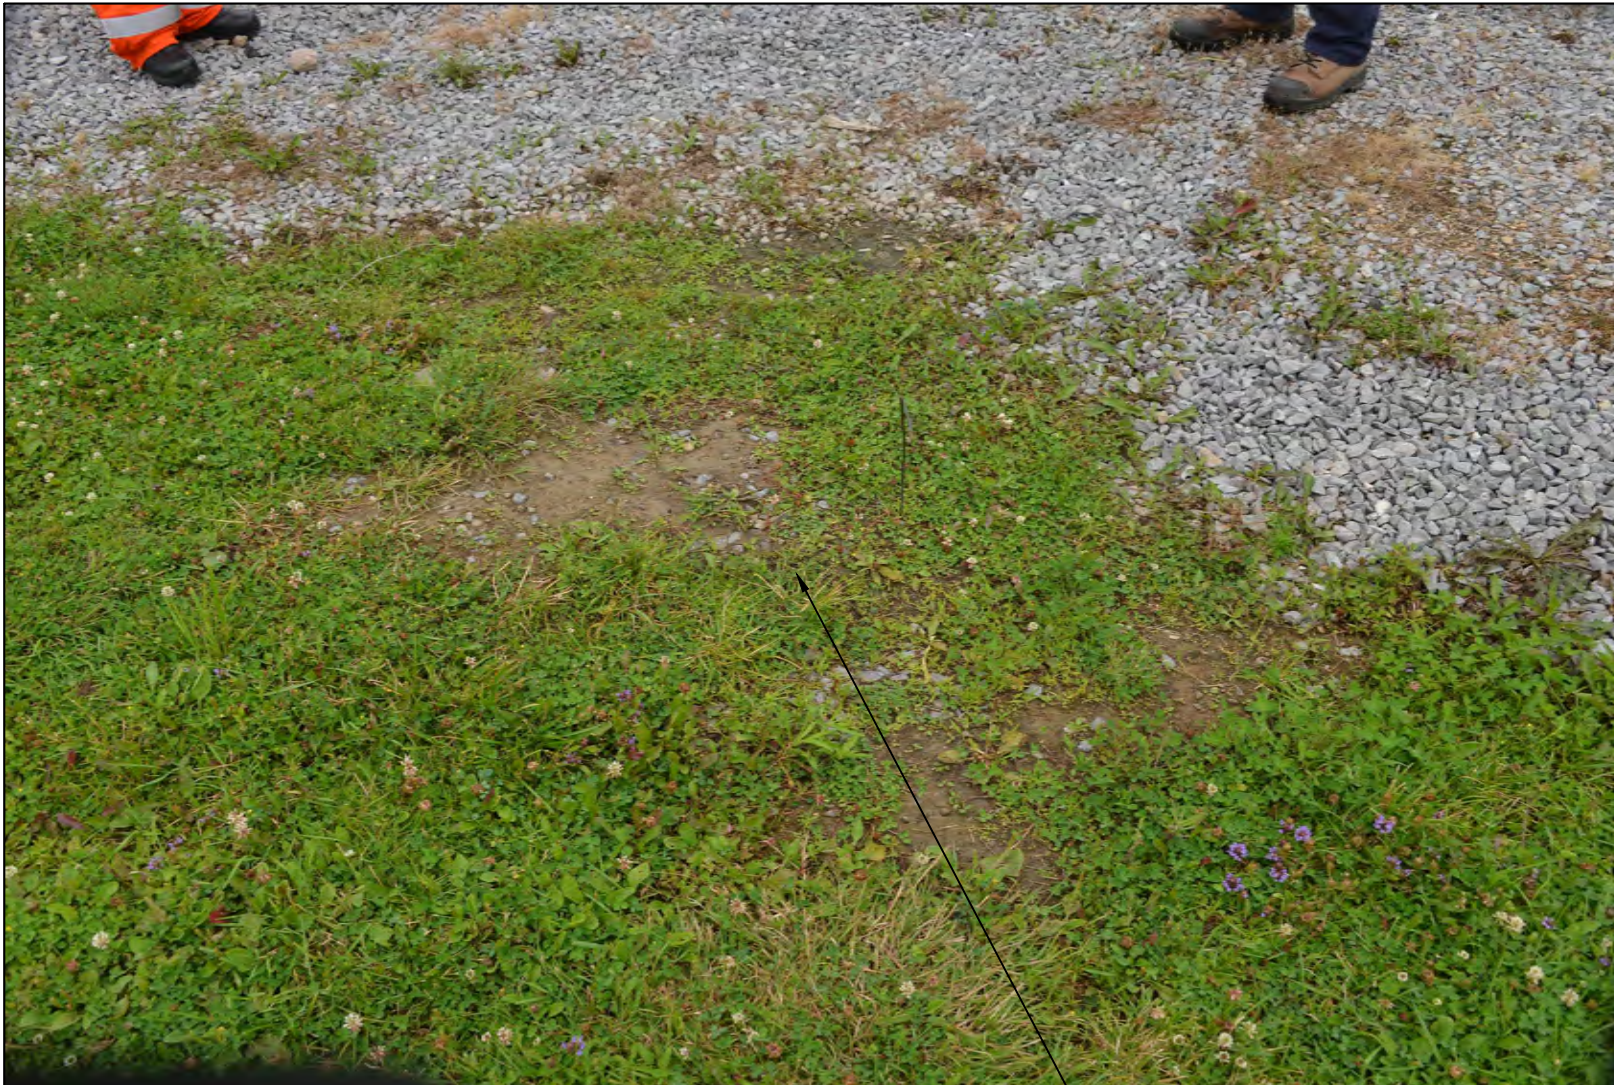
INSUFFICIENT CRUSHED
STONE

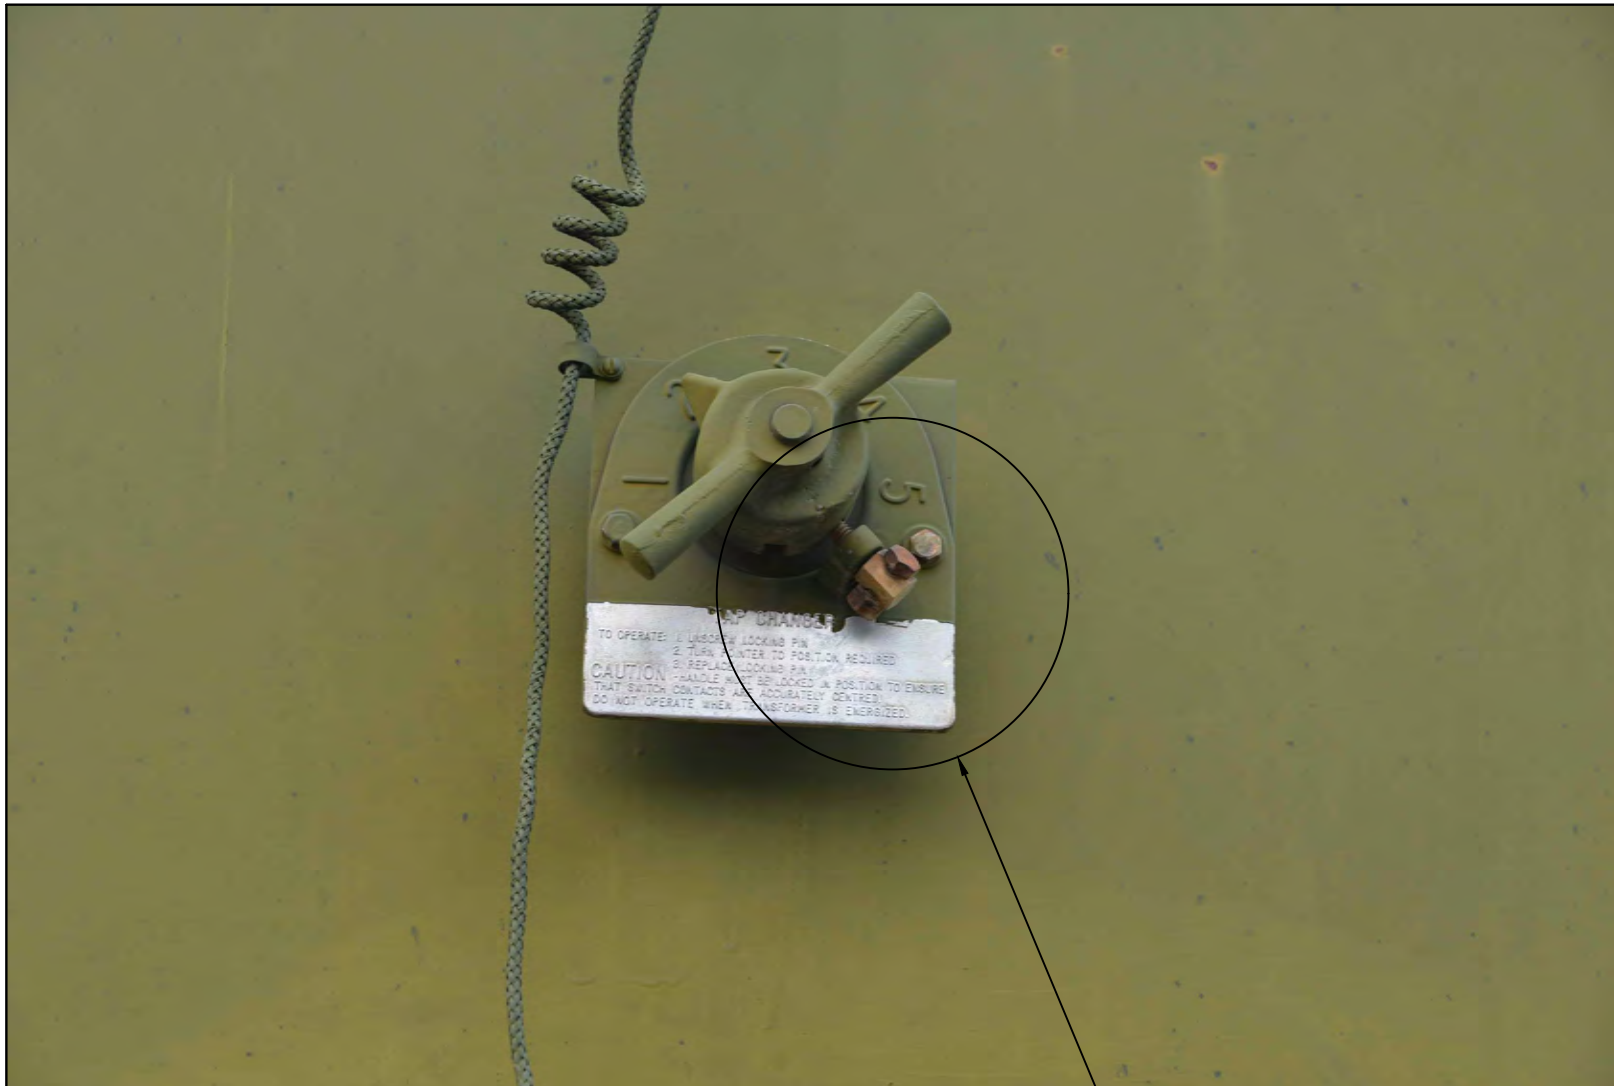
REQUIRES
PADLOCK

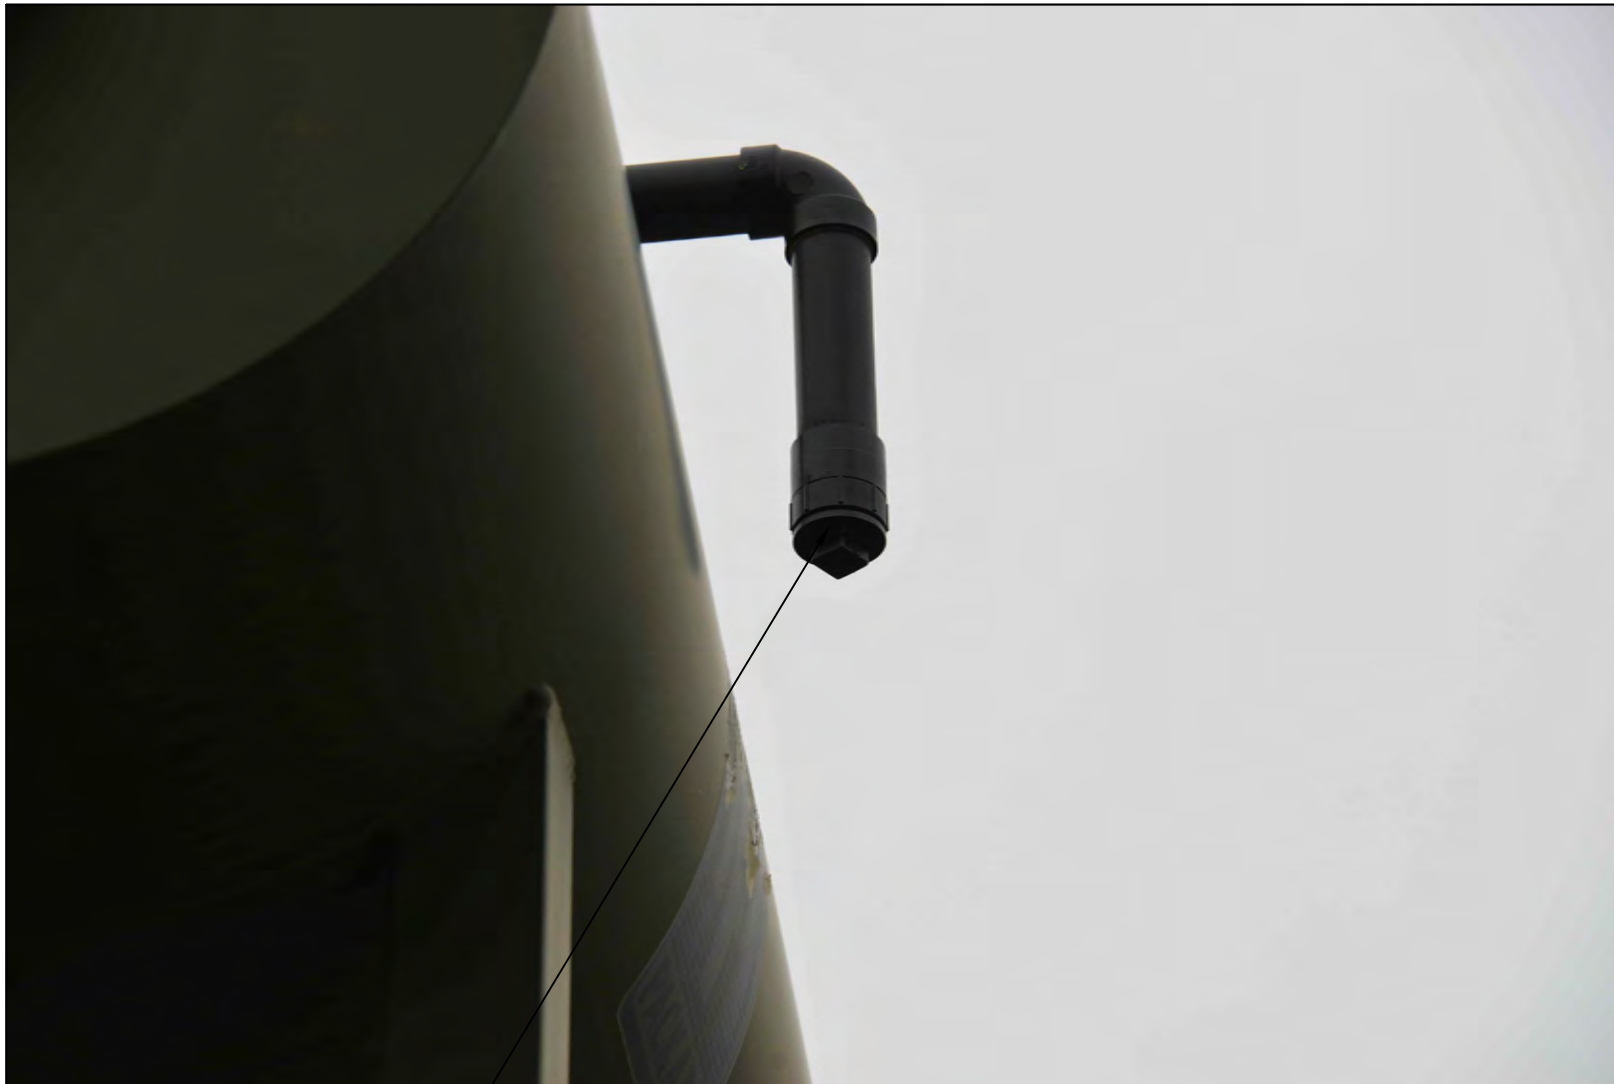
REQUIRES BREATHER

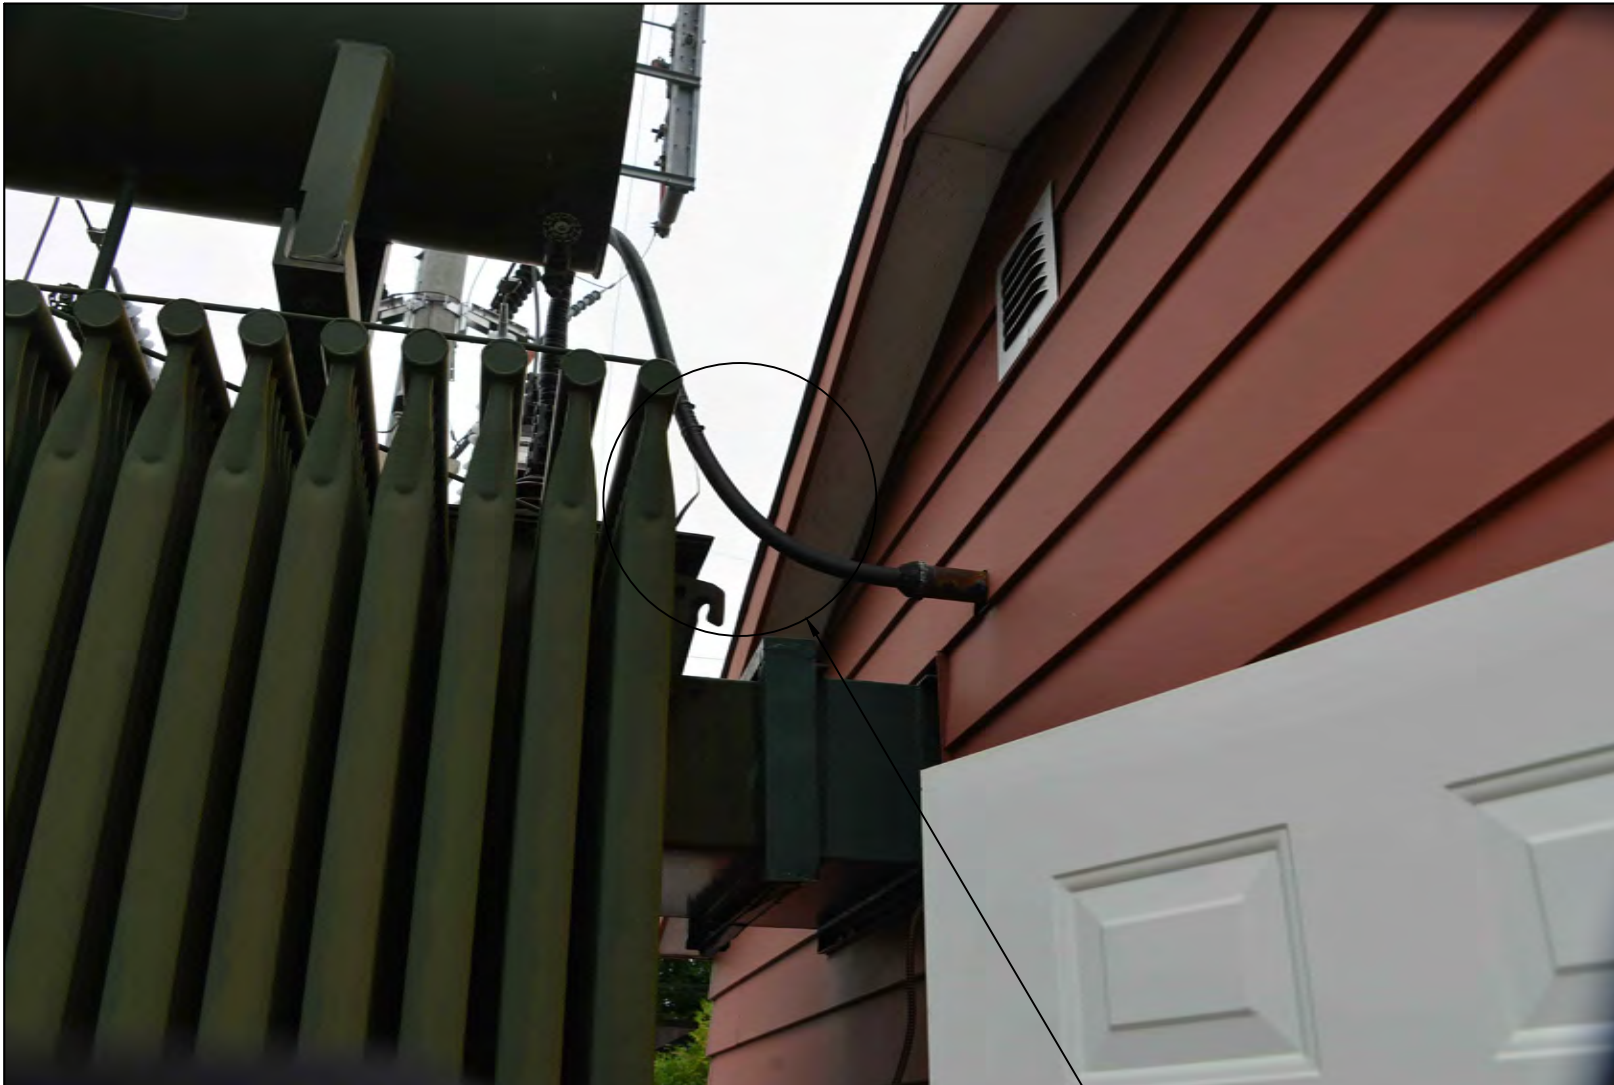
NEED TO CONFIRM STATION
NEUTRAL CONNECTIONS

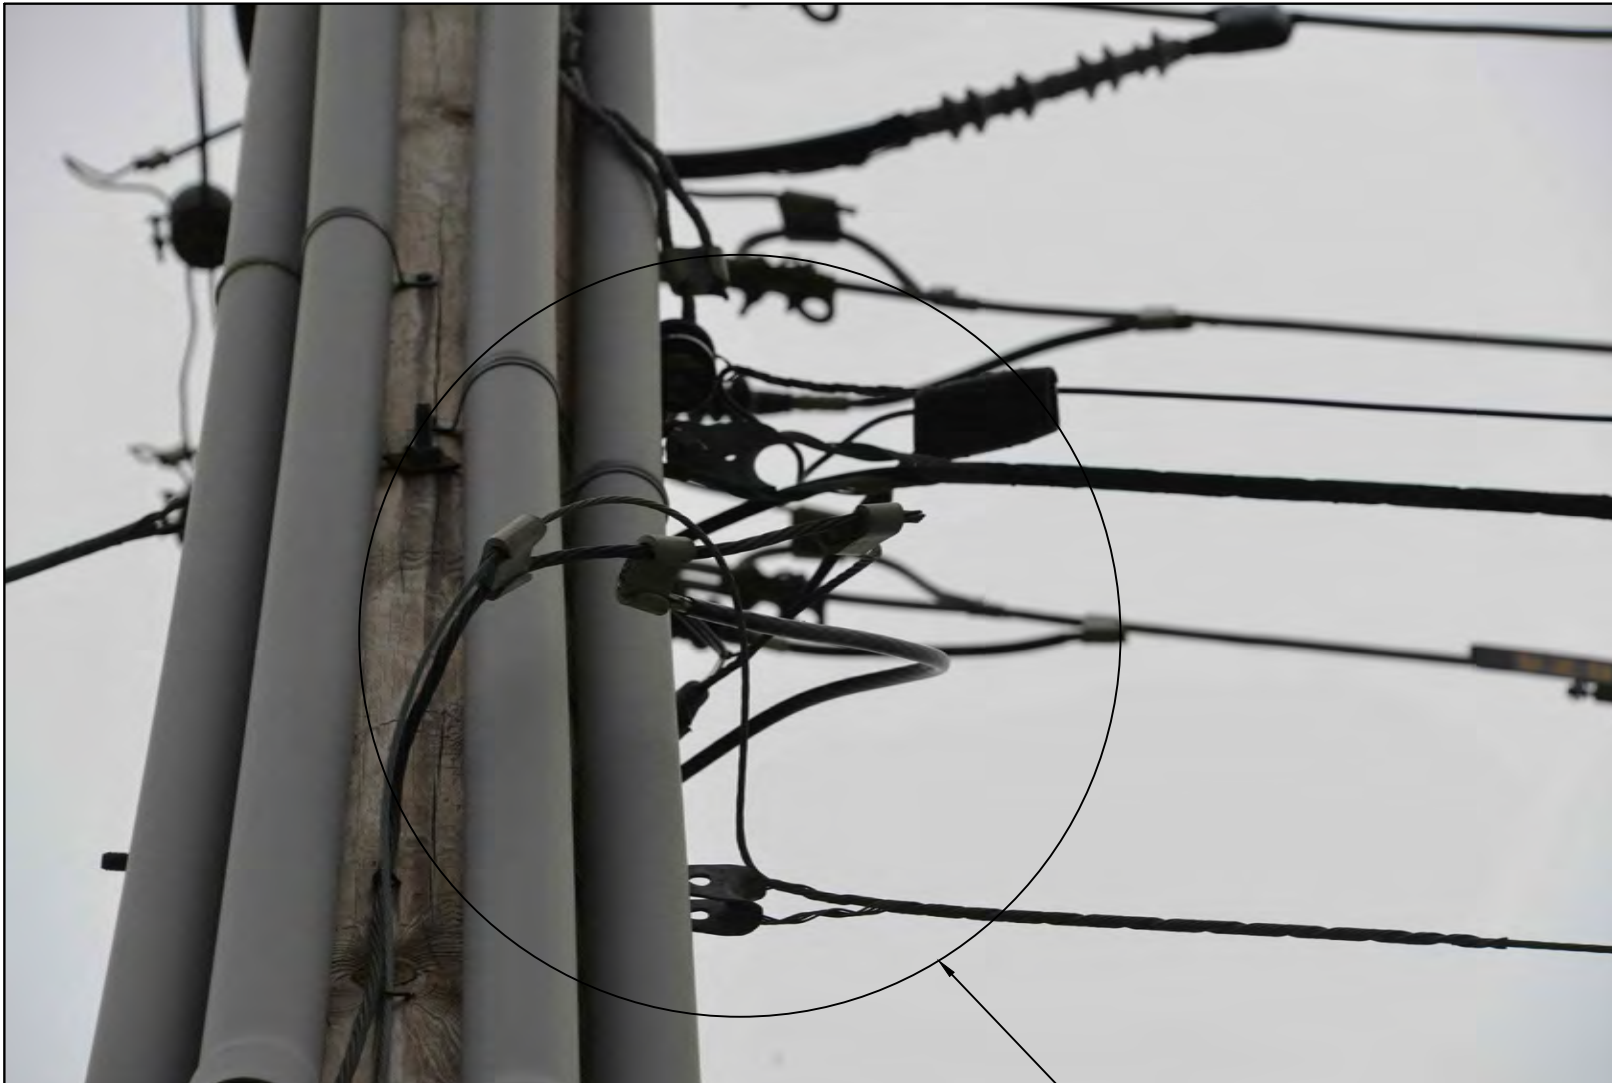
NEED TO CONFIRM STATION NEUTRAL
CONNECTIONS DURING OUTAGE

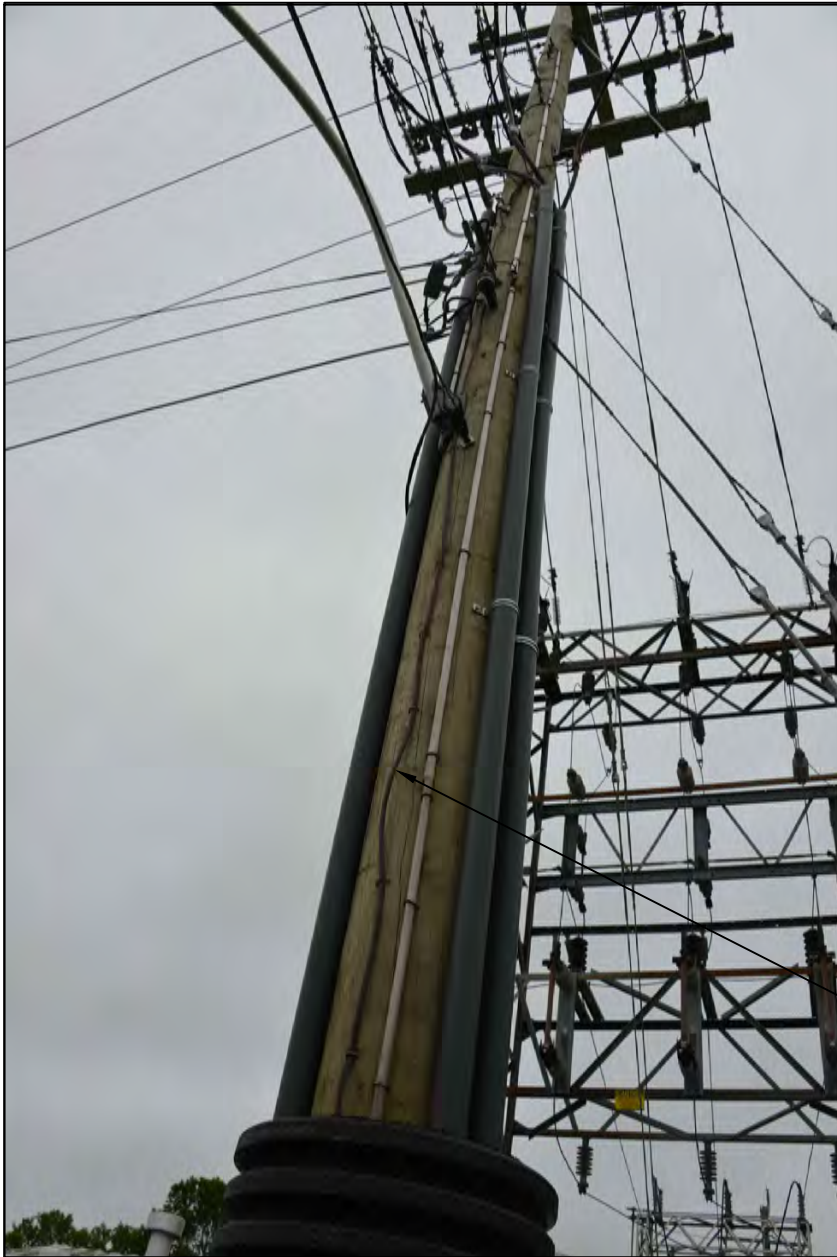
BARE STRANDED NEUTRAL CONNECTIONS RUN UP RISER POLE. THIS IS DANGEROUS.
