Ottawa River Power Corporation Substation Condition Assessment Report

Project: 17153

costello
Utility Consultants

September 2017

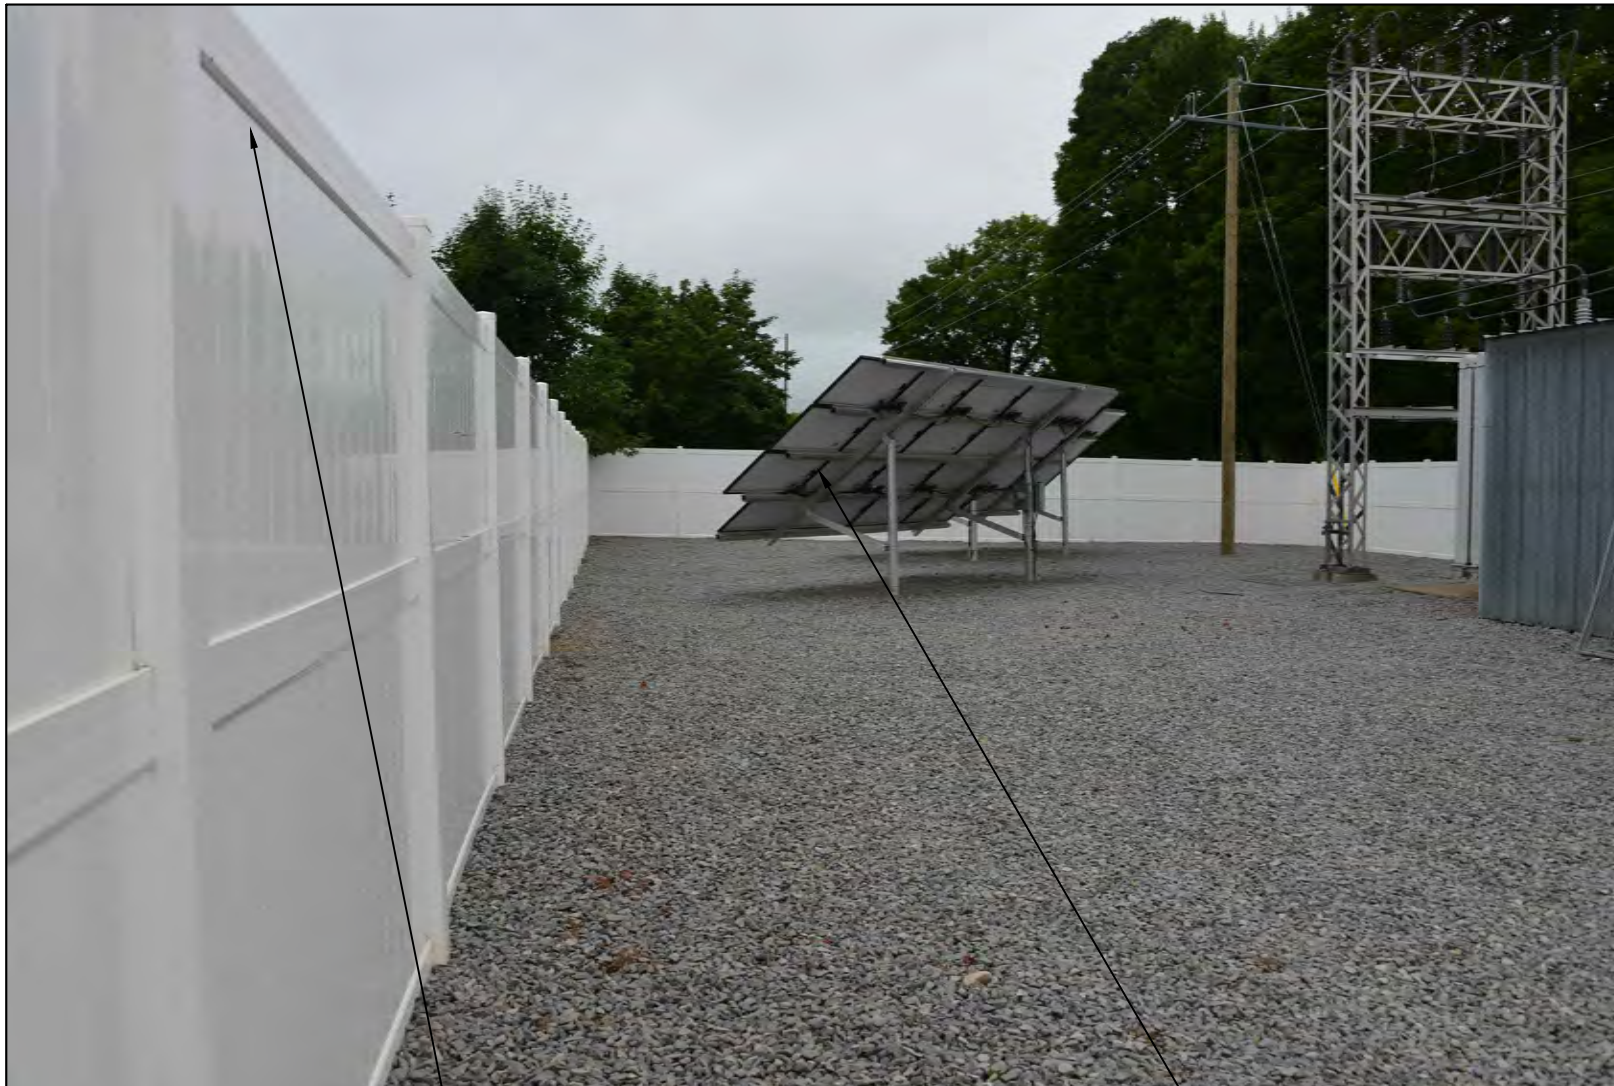
FENCE – NO BARBED WIRE AS PER CODE

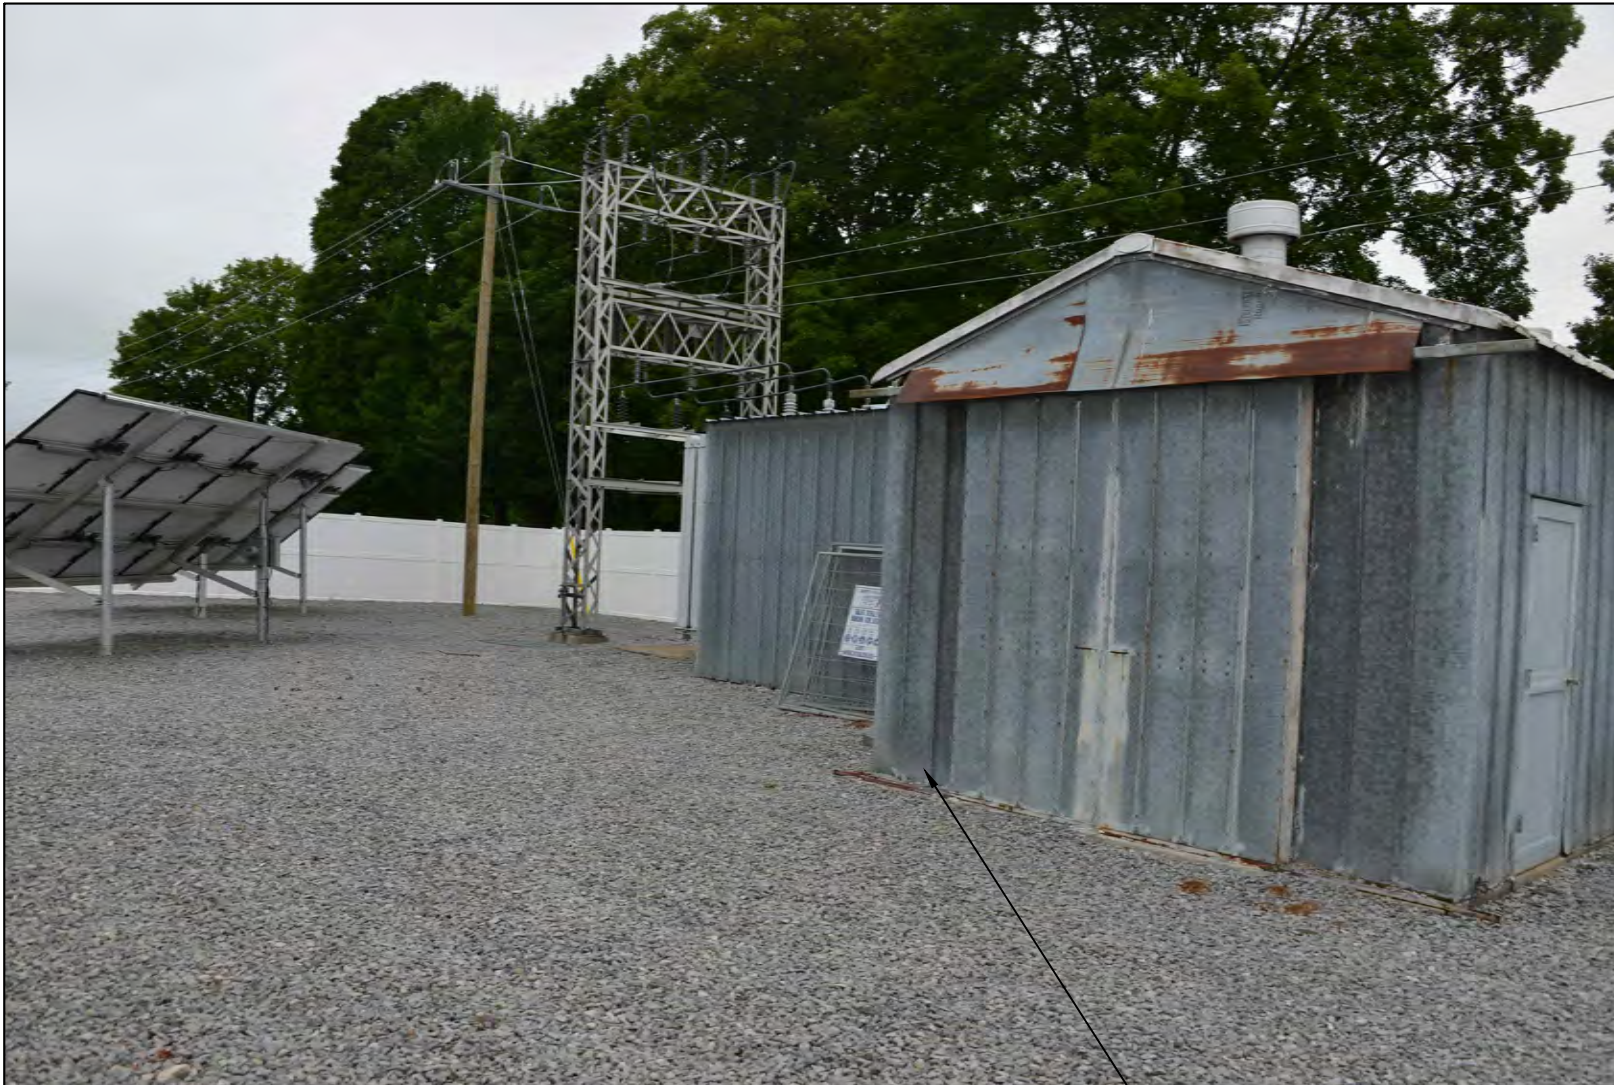
IMPROPER GROUNDING AND BONDING ON
METAL CLAD SWITCHGEAR BUILDINGS

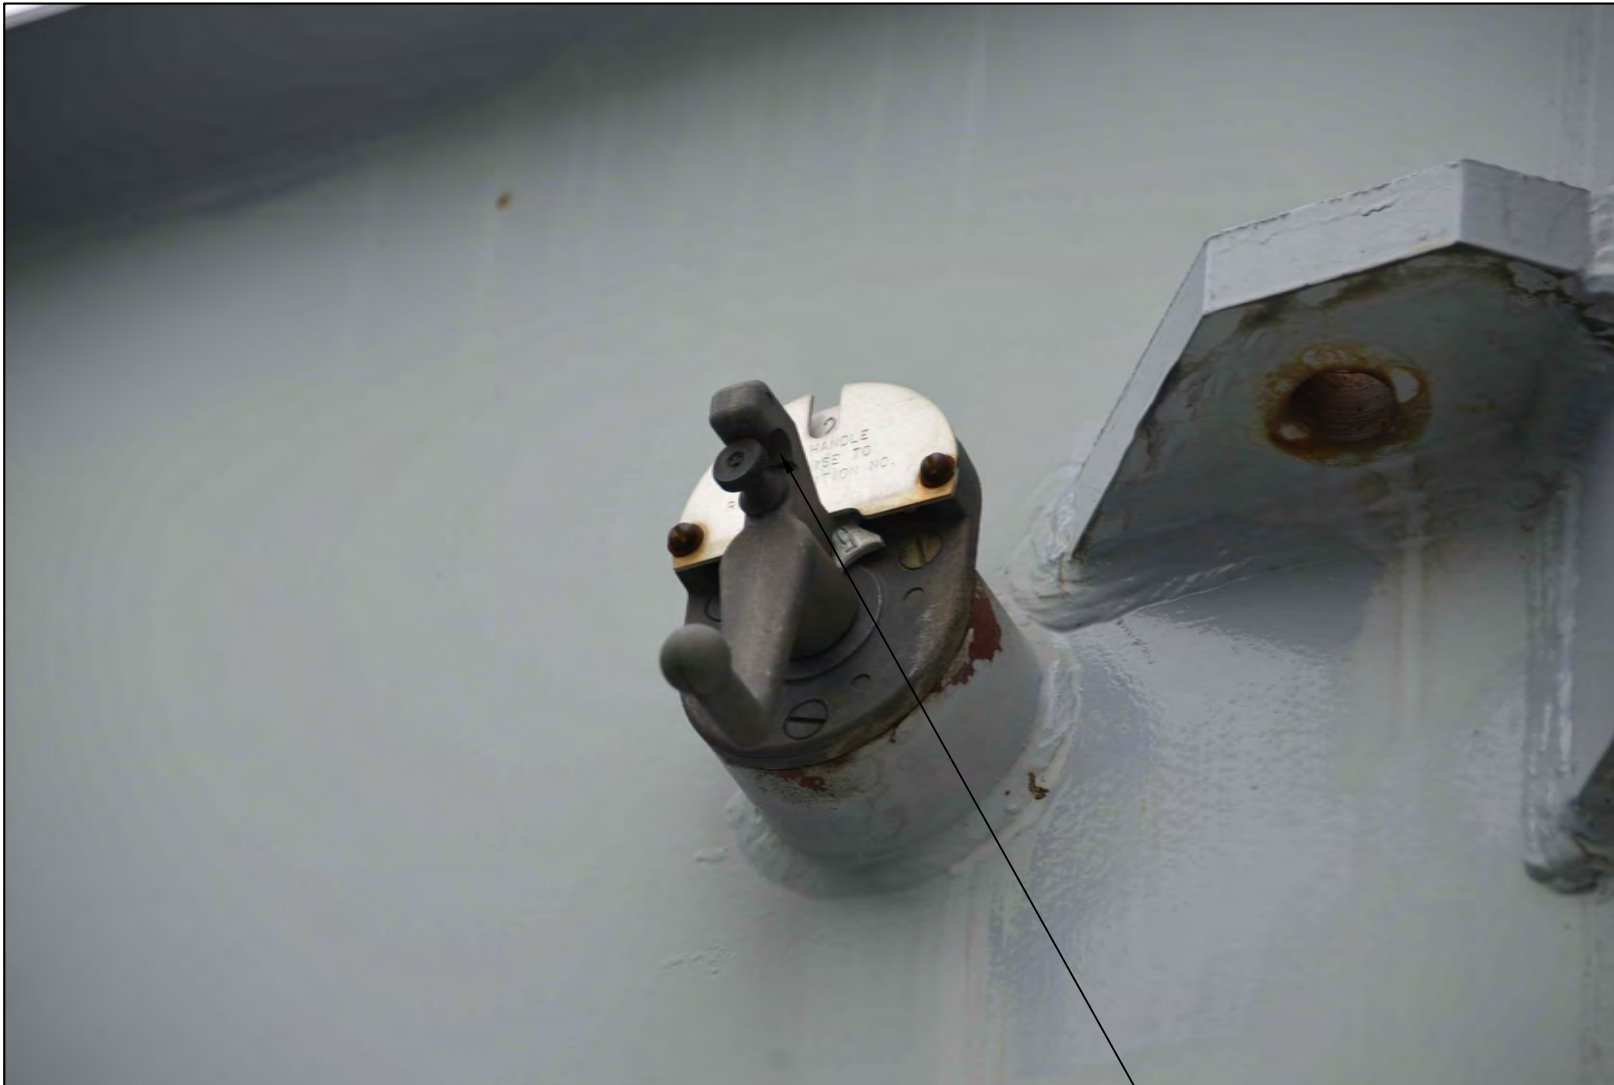
PADLOCK REQUIRED

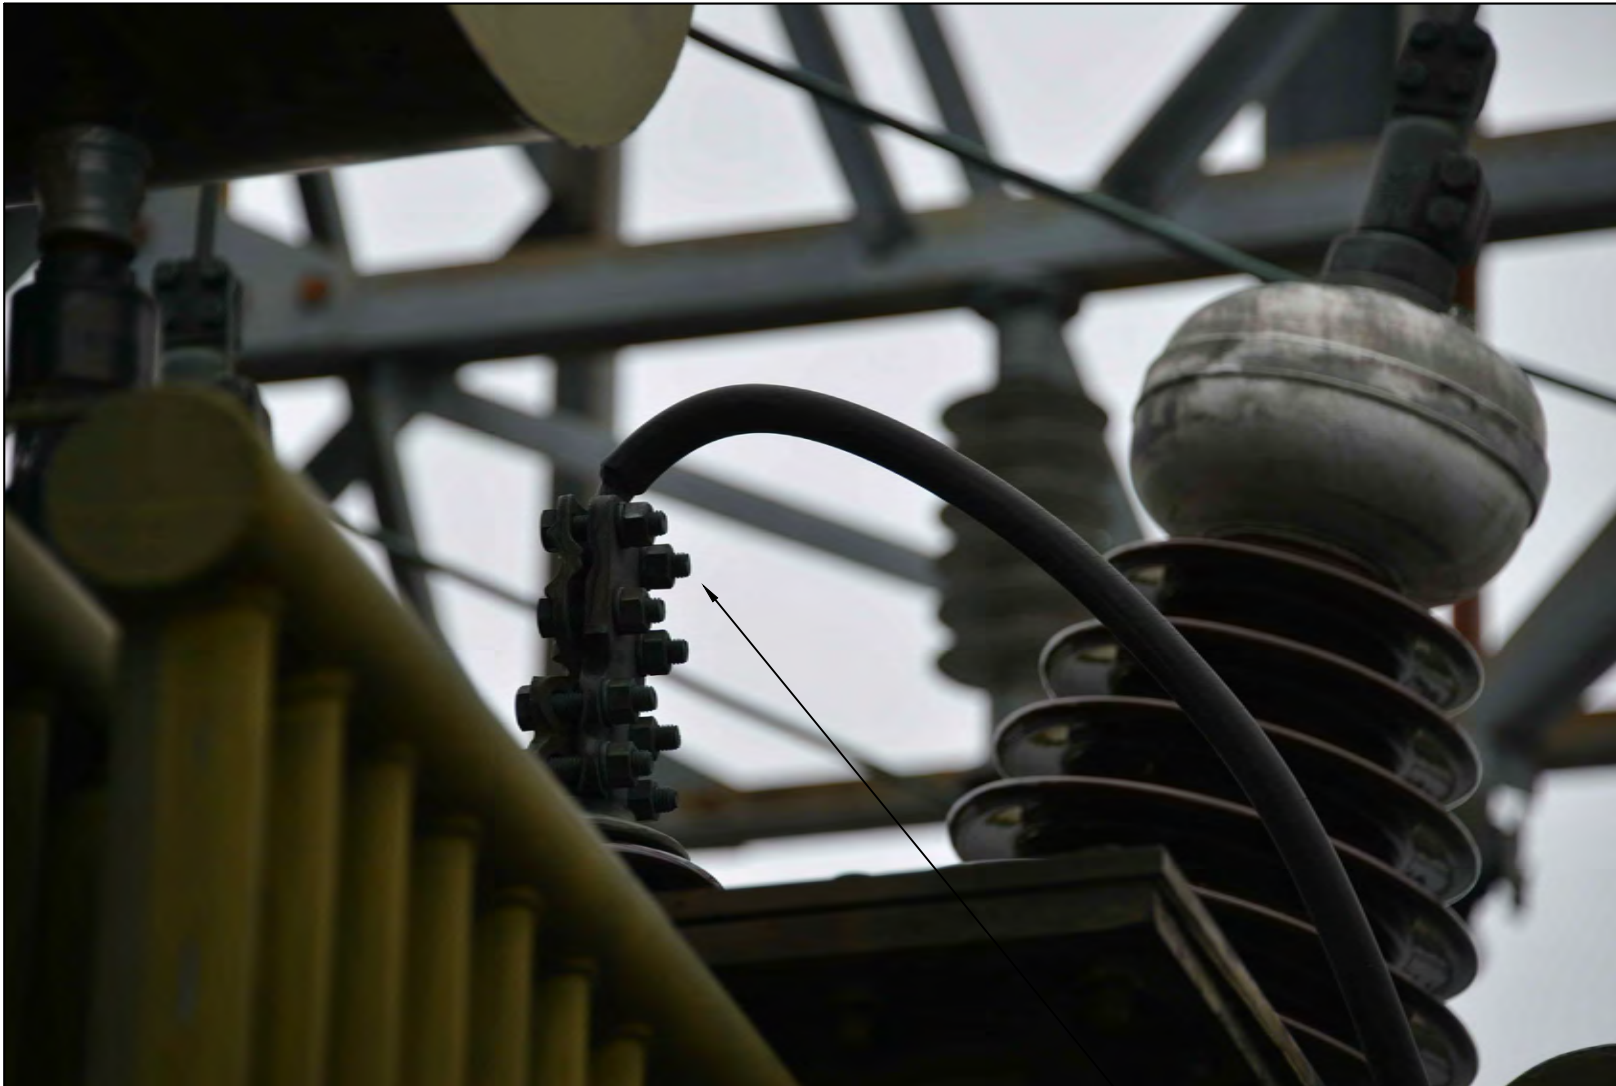
TRANSFORMER LV NEUTRAL NOT
MECHANICALLY PROTECTED

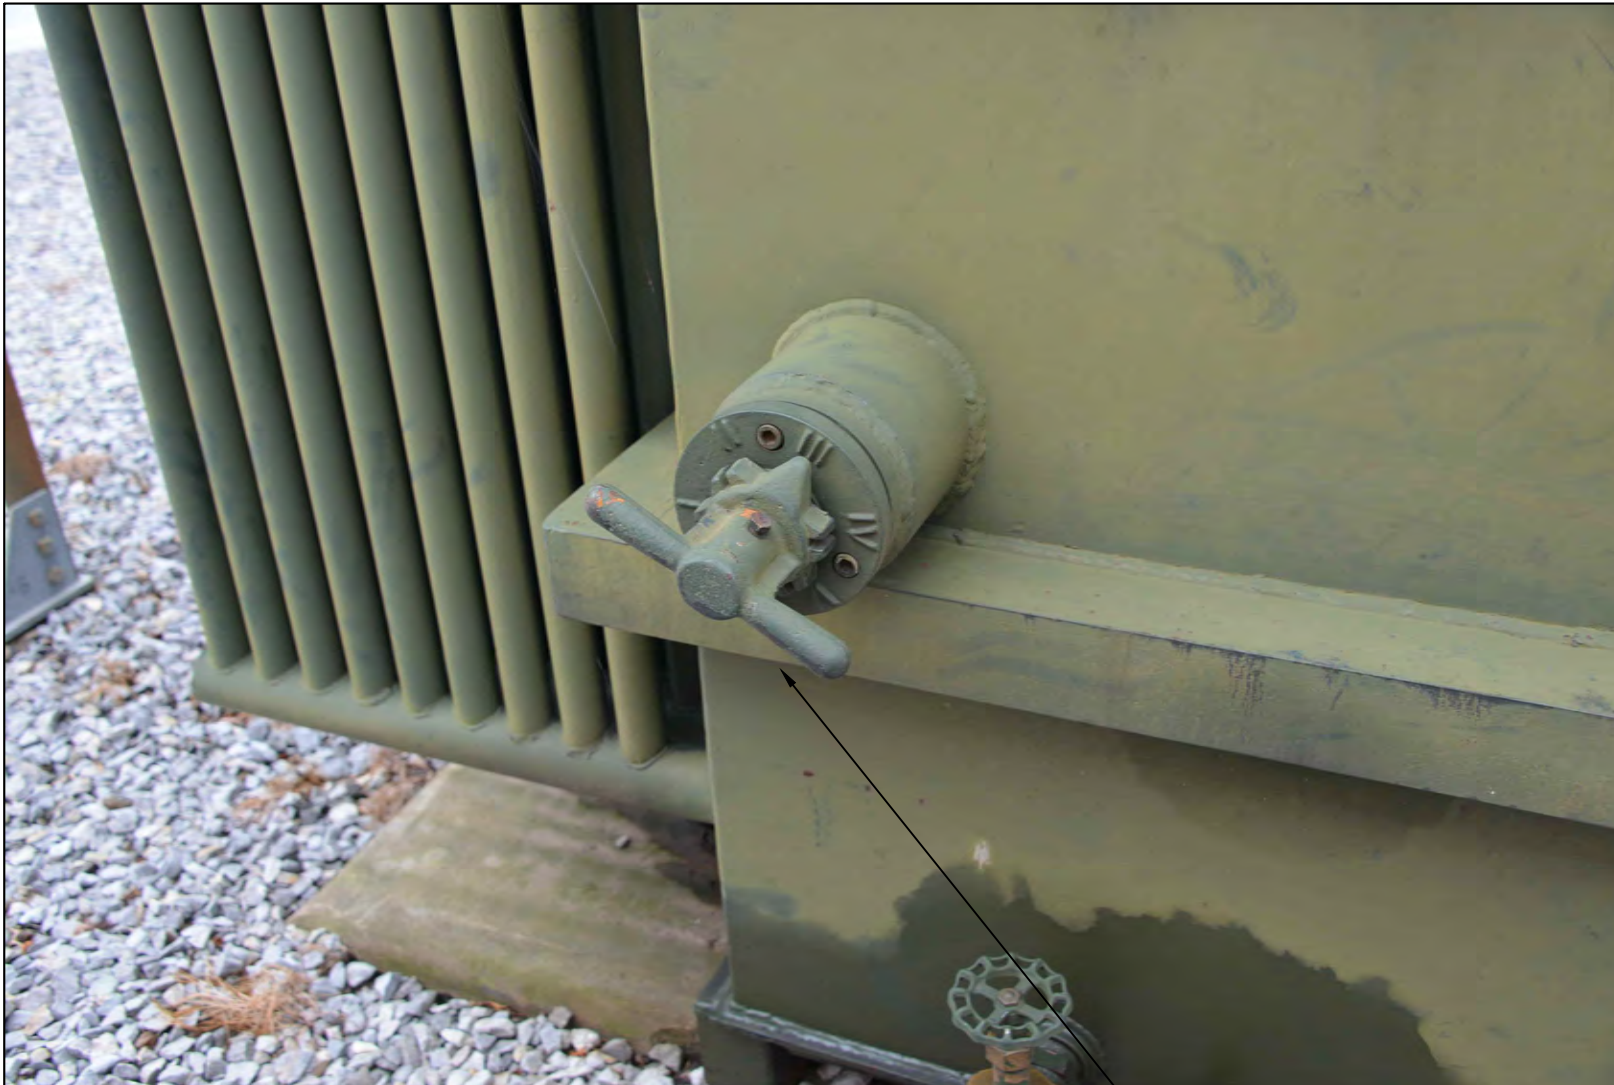
PADLOCK REQUIRED

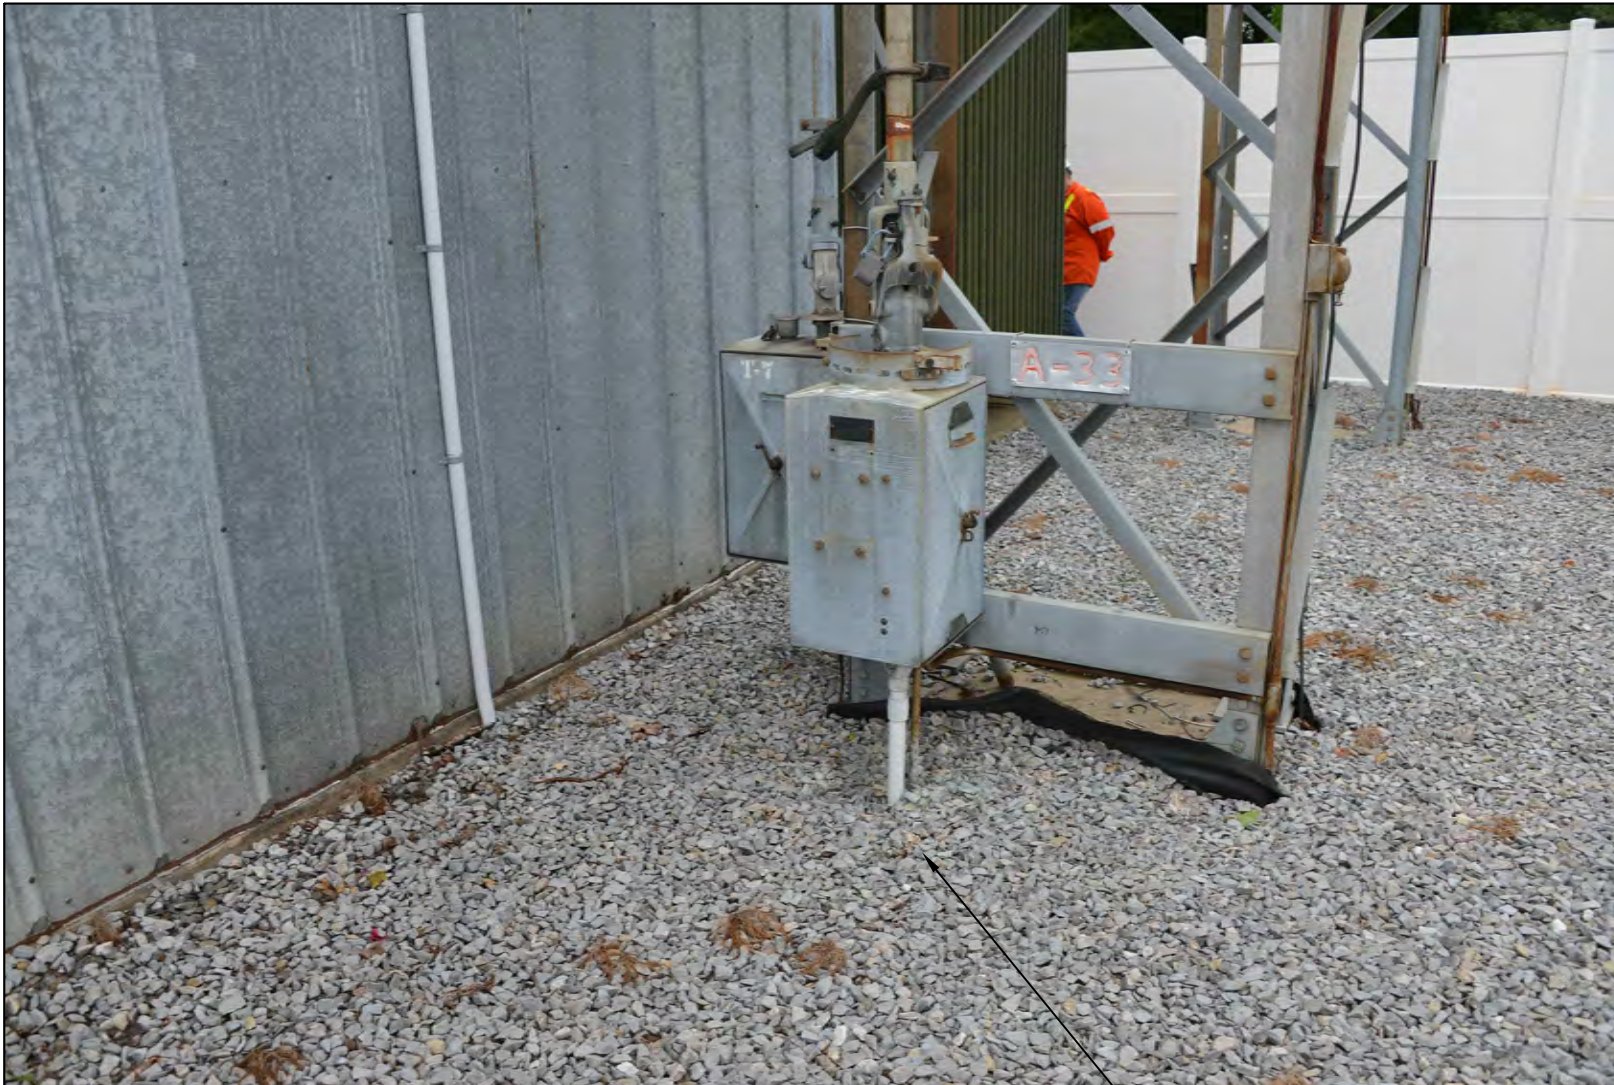
GRADIENT CONTROL MAT OR PORTABLE MAT
REQUIRED FOR SWITCHING

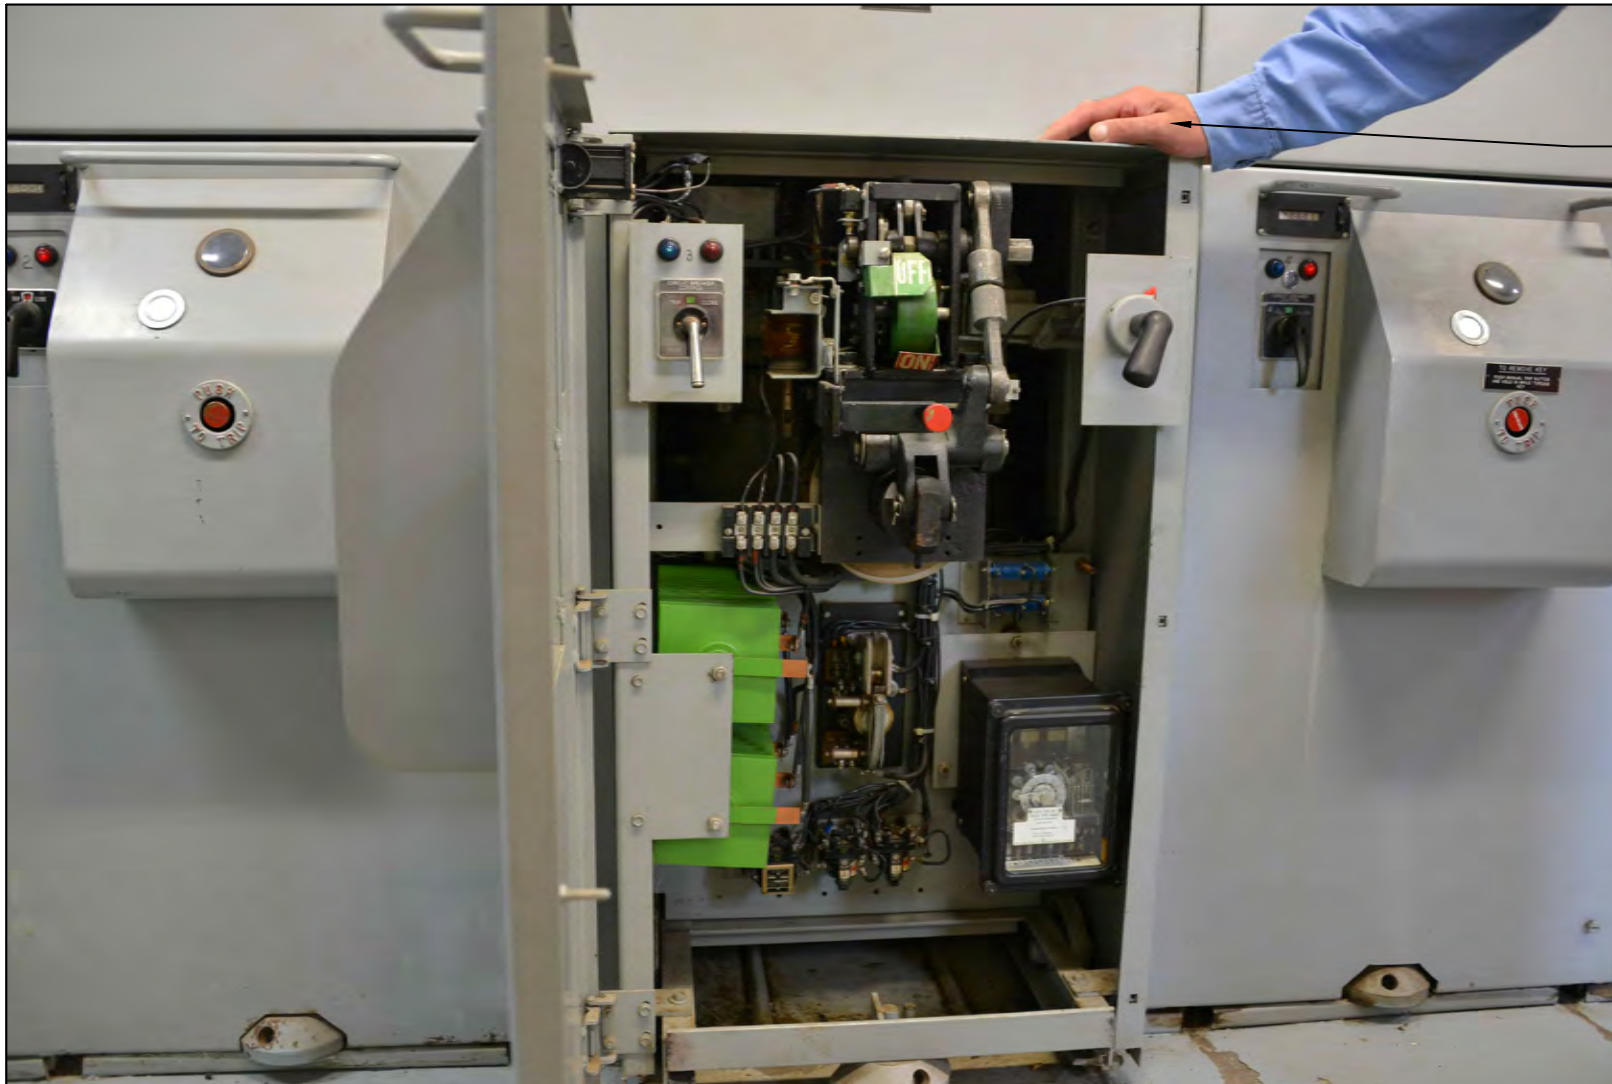
WORK PRACTICES
DRAW OUT BREAKER
PPE AND PROXIMITY

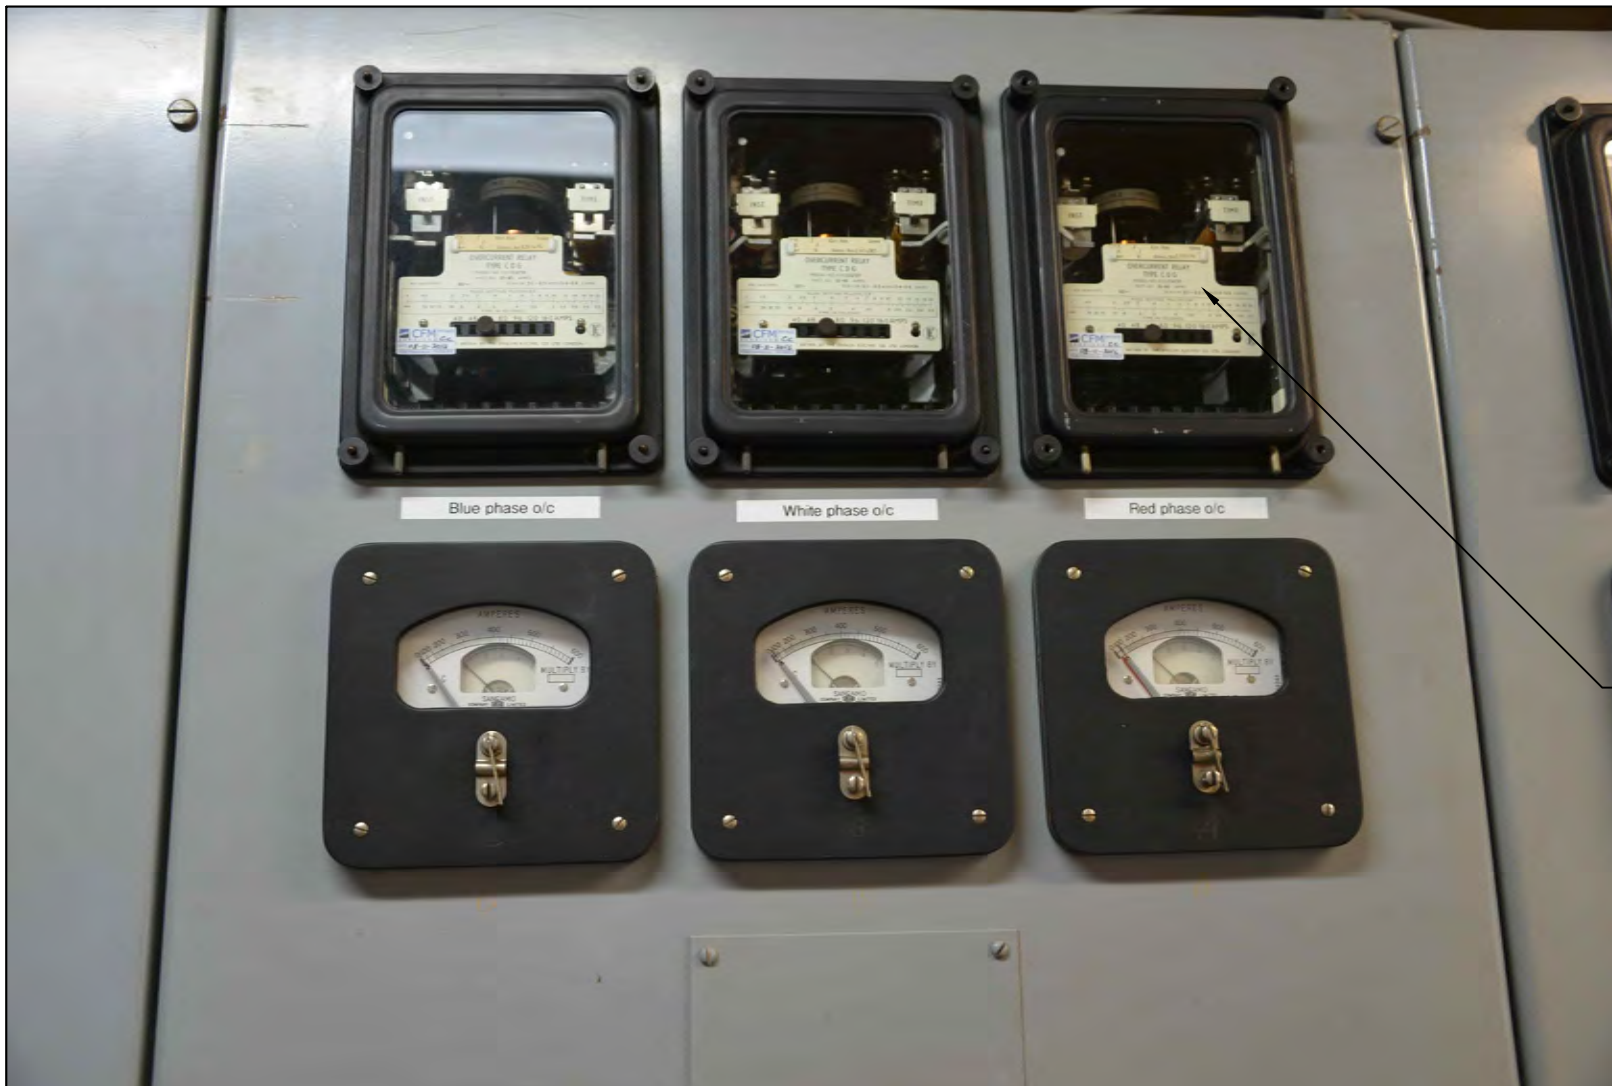
NO GROUND
FAULT
PROTECTION

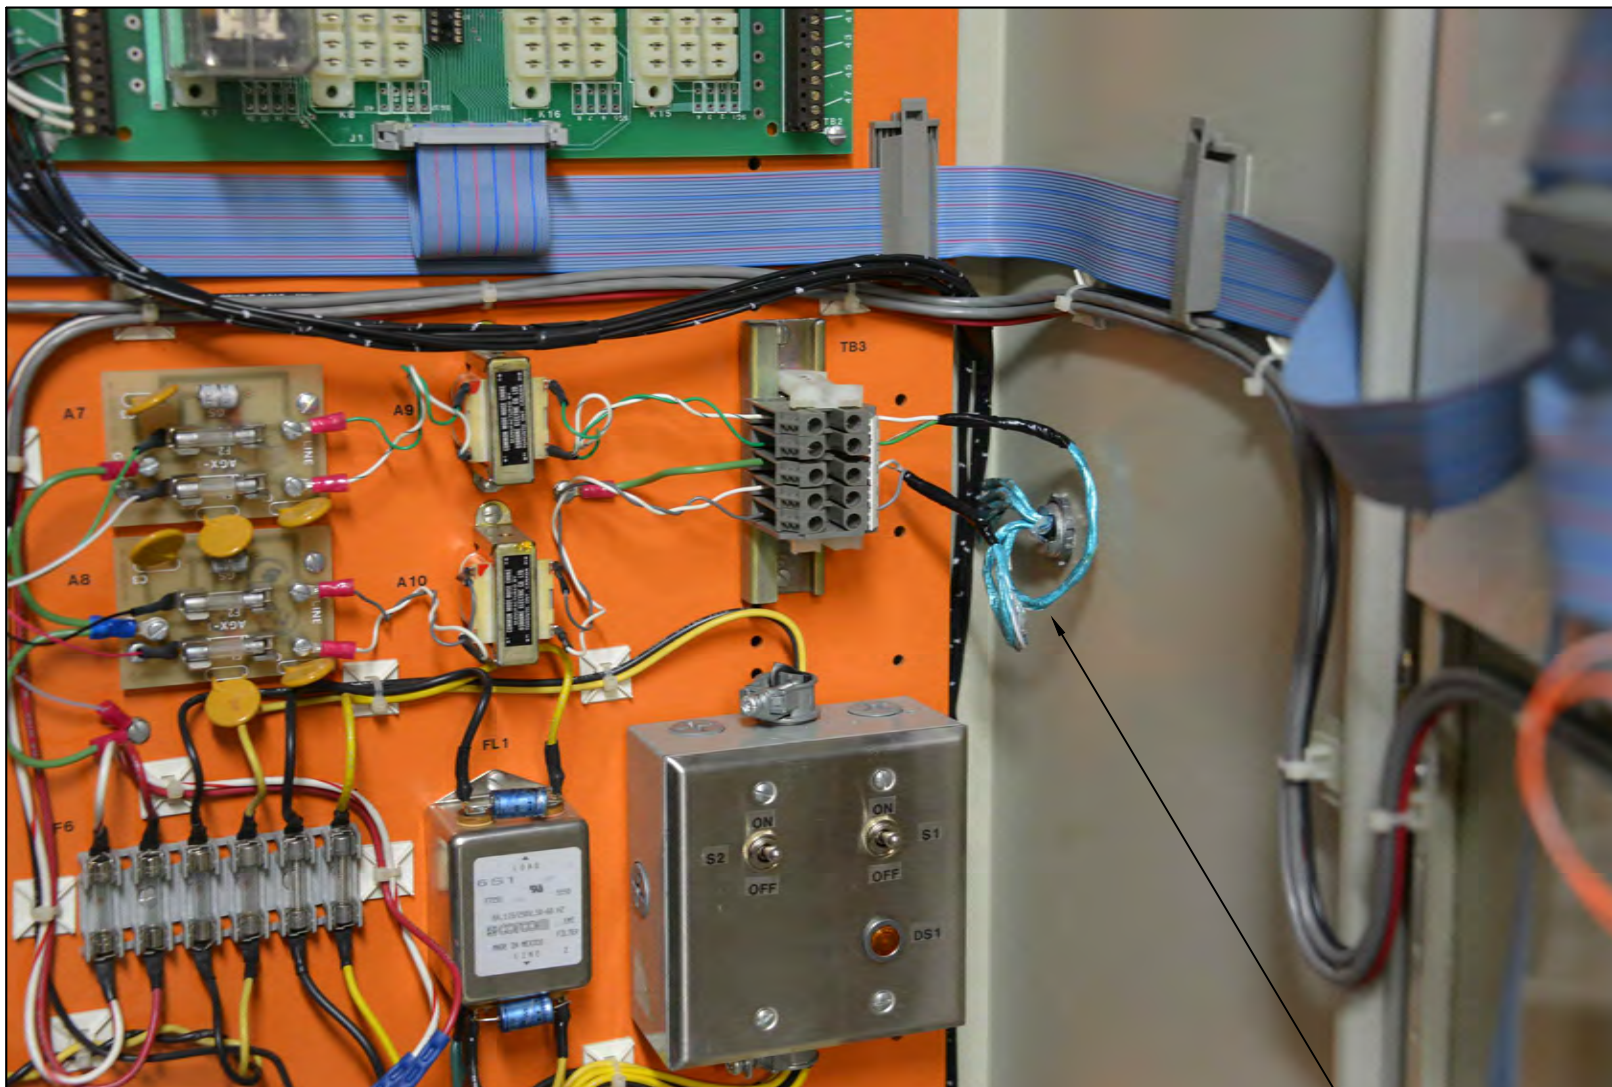
COPPER COMMUNICATION LINES
WITHOUT ELECTRICAL ISOLATION

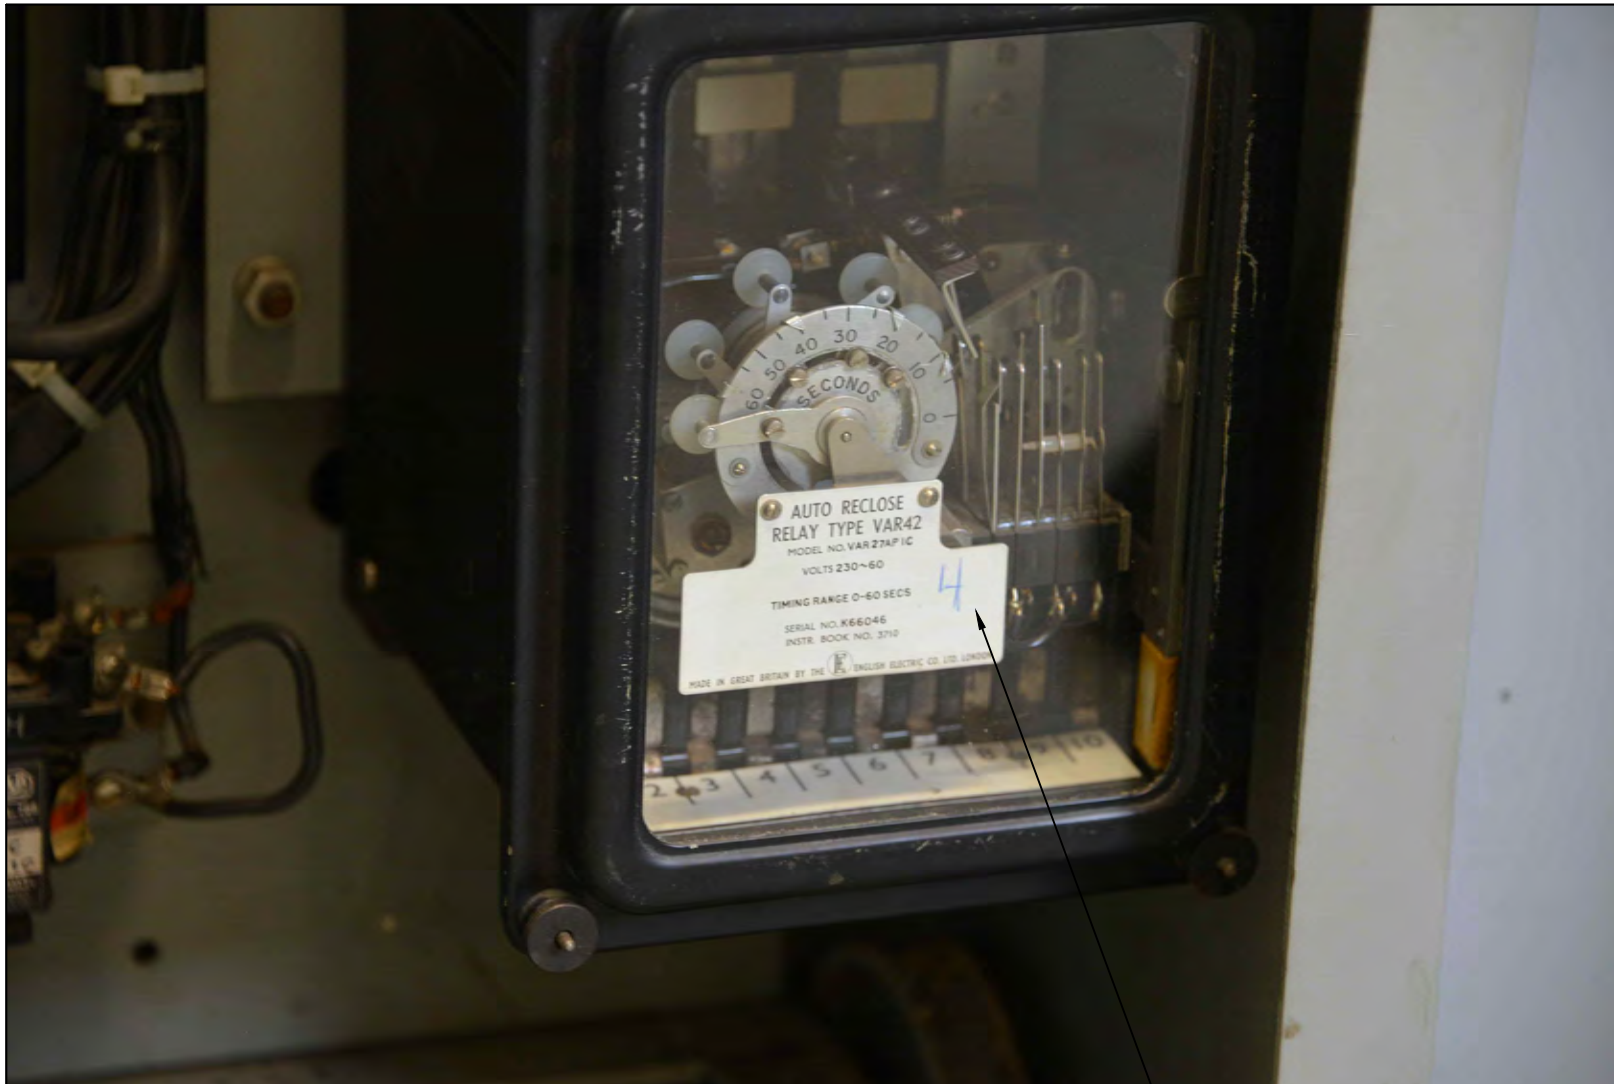
Another common issue noted in many substations is the overcurrent protection and reclosing methodology. Many stations have four reclose attempts before lockout, which is not common practice in an urban environment. Urban faults have a high probability of human interference, such as a motor vehicle accident, and it is common utility practice to have one fast and one slow reclose attempt to lockout. The first auto-reclose attempt on a few of the stations is instantaneous. The Hydro One Standard suggests 600ms as the minimum time to reclose, which helps prevent fault restrike. There is also no ground protection on many feeders, which is also a public safety concern, as low current ground faults will not be seen by the protection equipment.

FOUR (4) AUTO RECLOSURES IN URBAN ENVIRONMENT

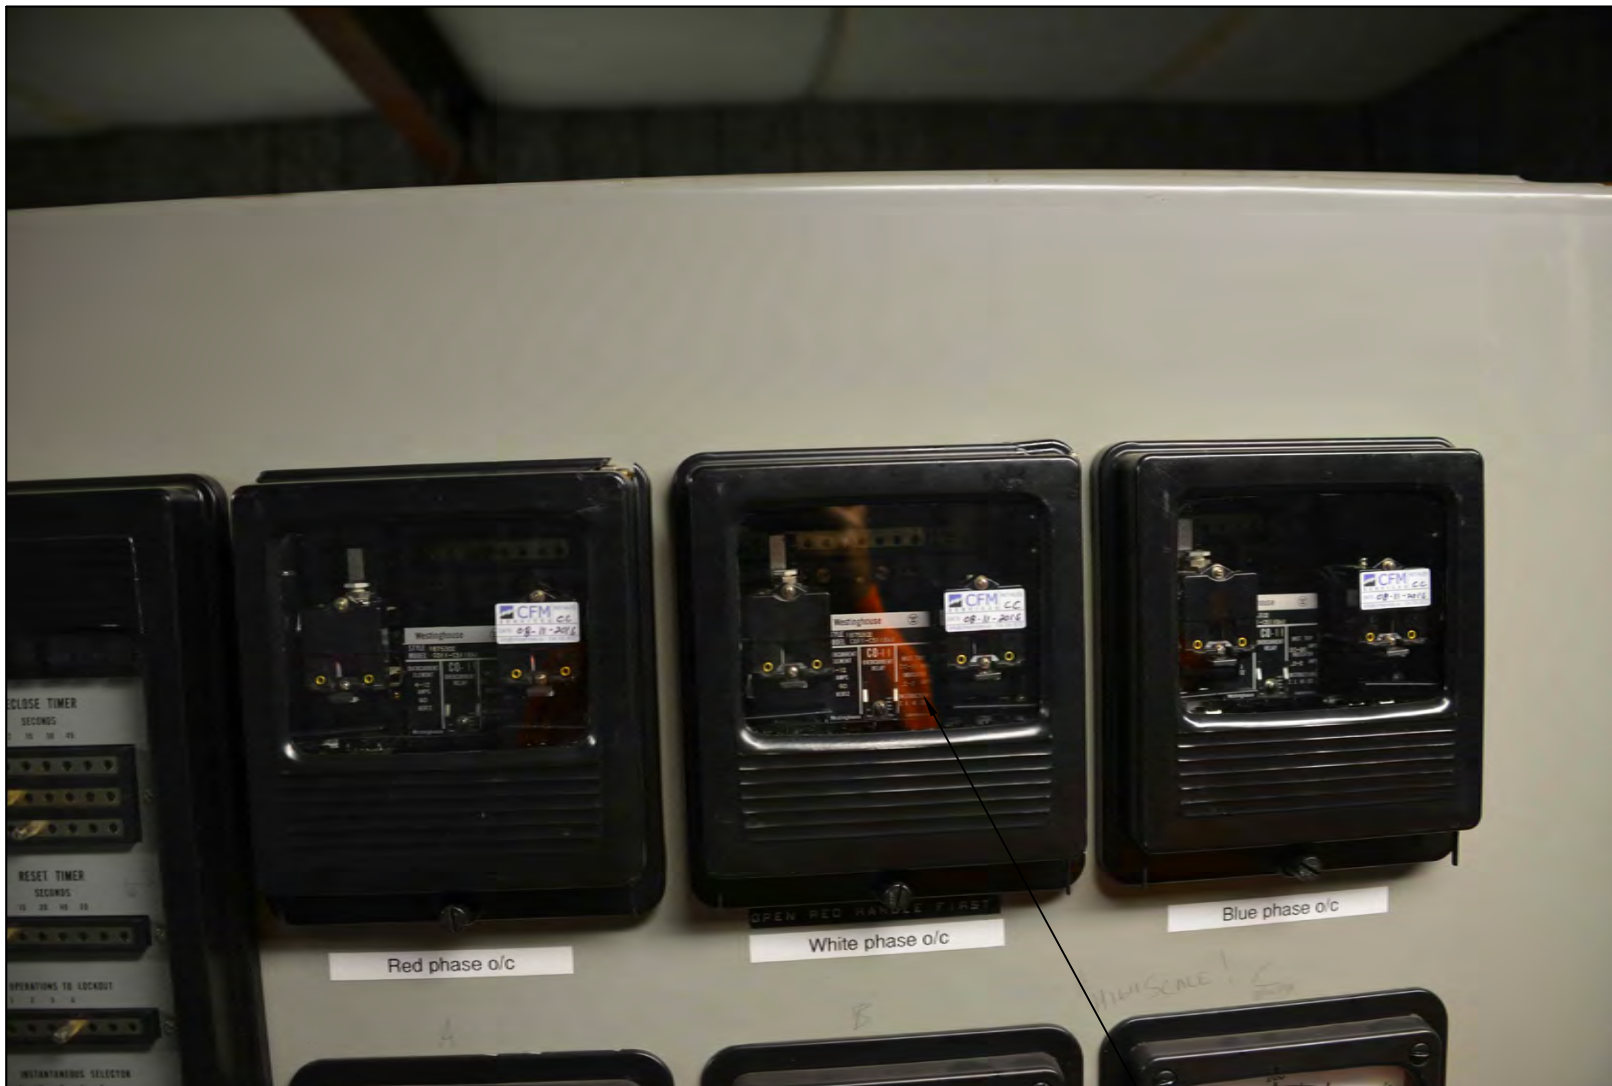
NO GROUND FAULT PROTECTION

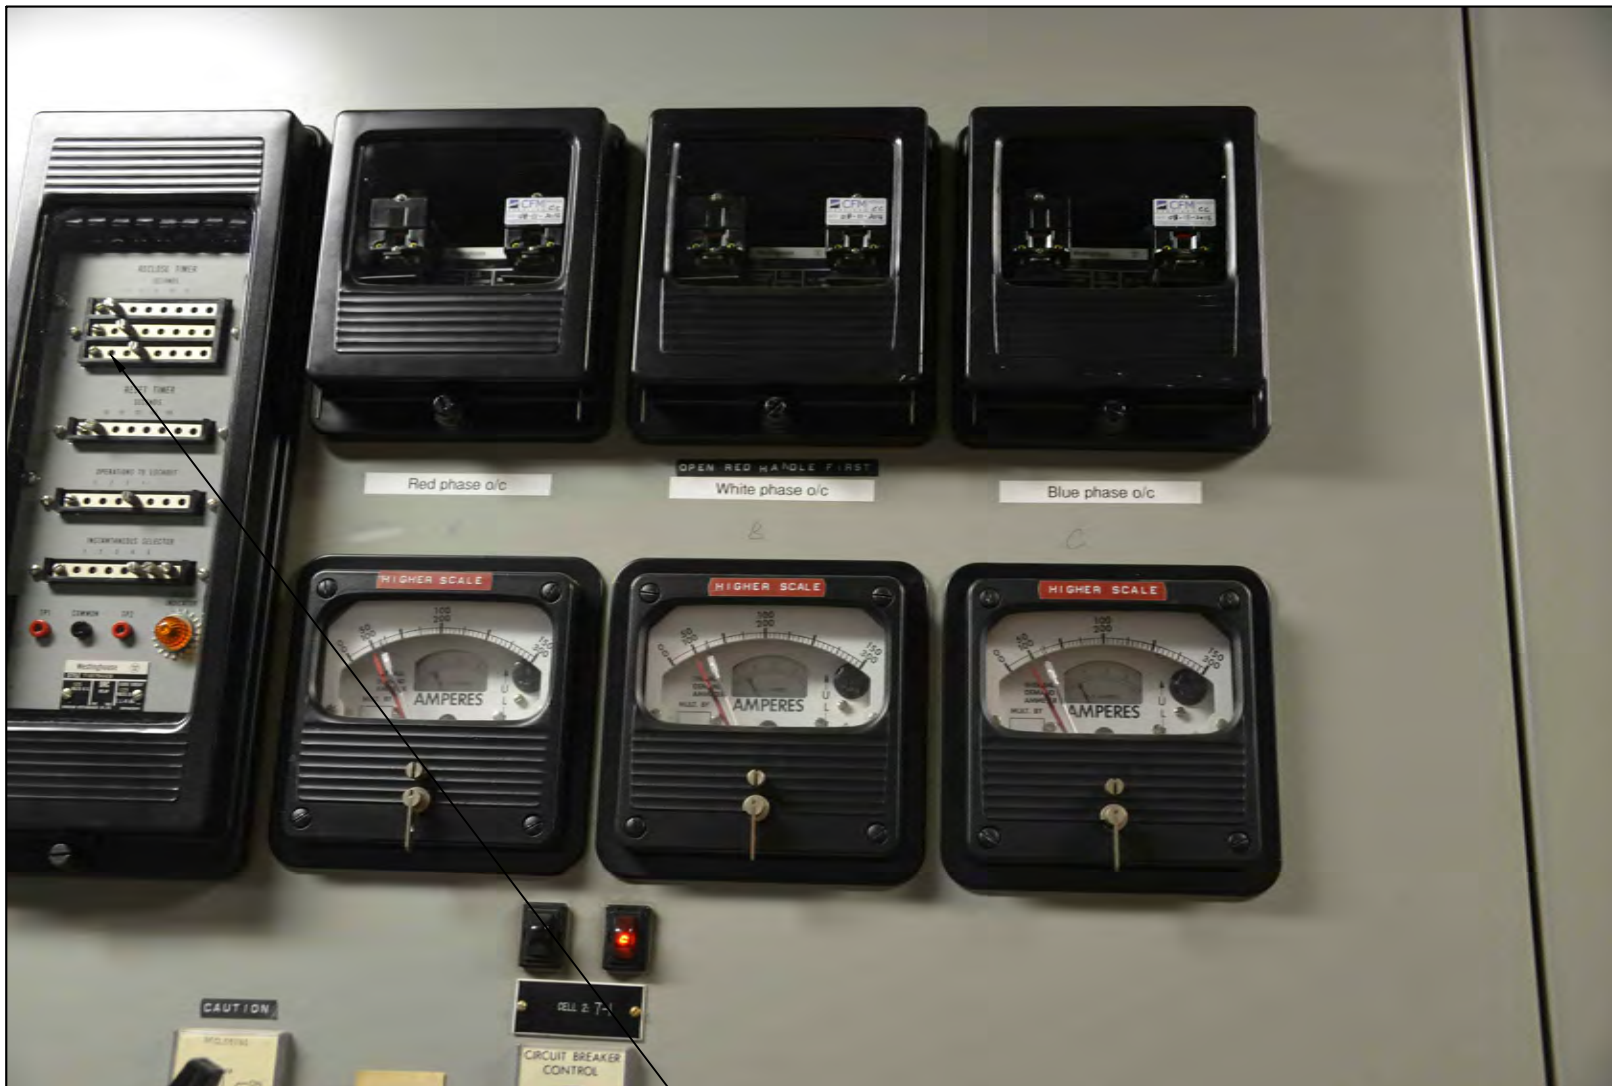
MS3 NO DELAY ON RECLOSING

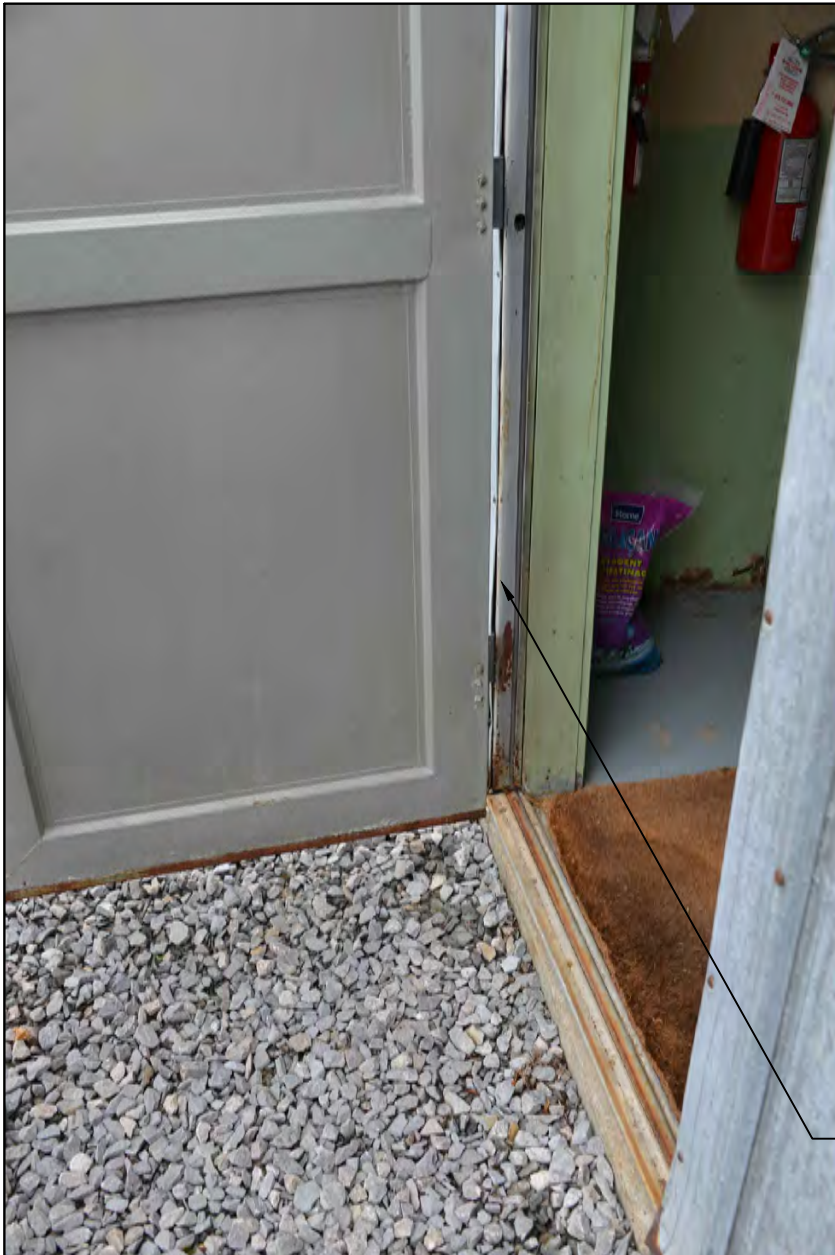
DOOR GROUNDING AND BONDING
