Ottawa River Power Corporation Substation Condition Assessment Report

Project: 17153

costello
Utility Consultants

September 2017

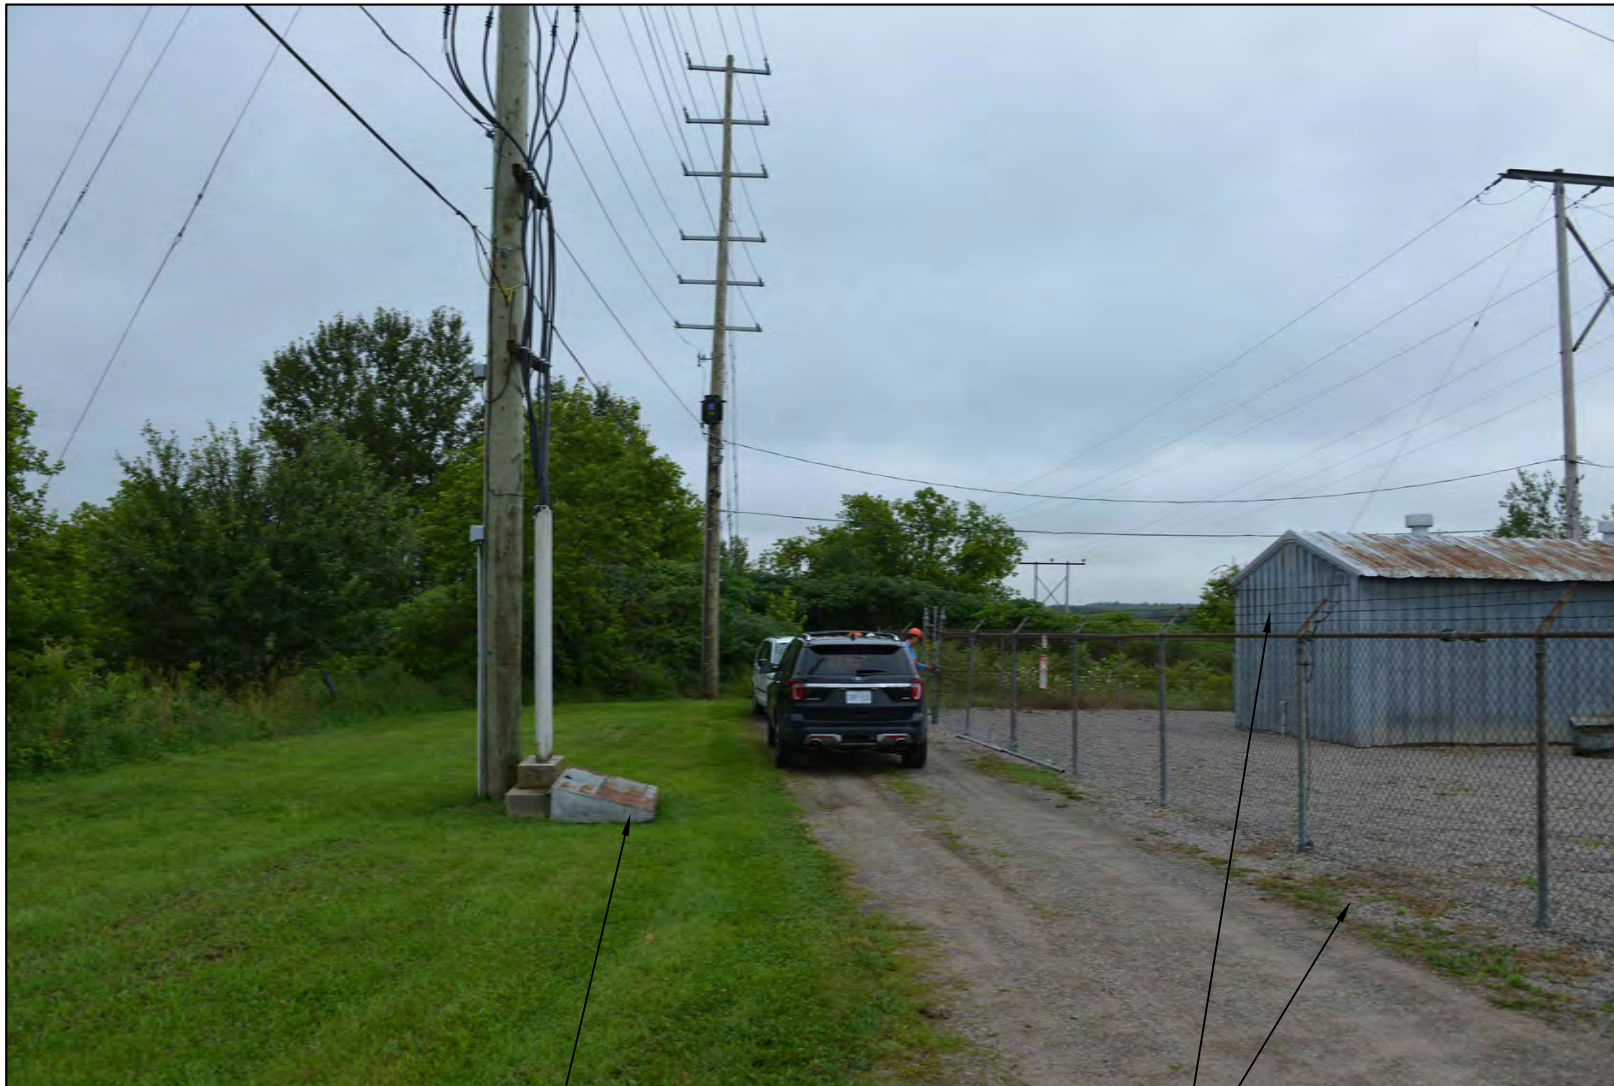
UNGROUND VOLT COVER

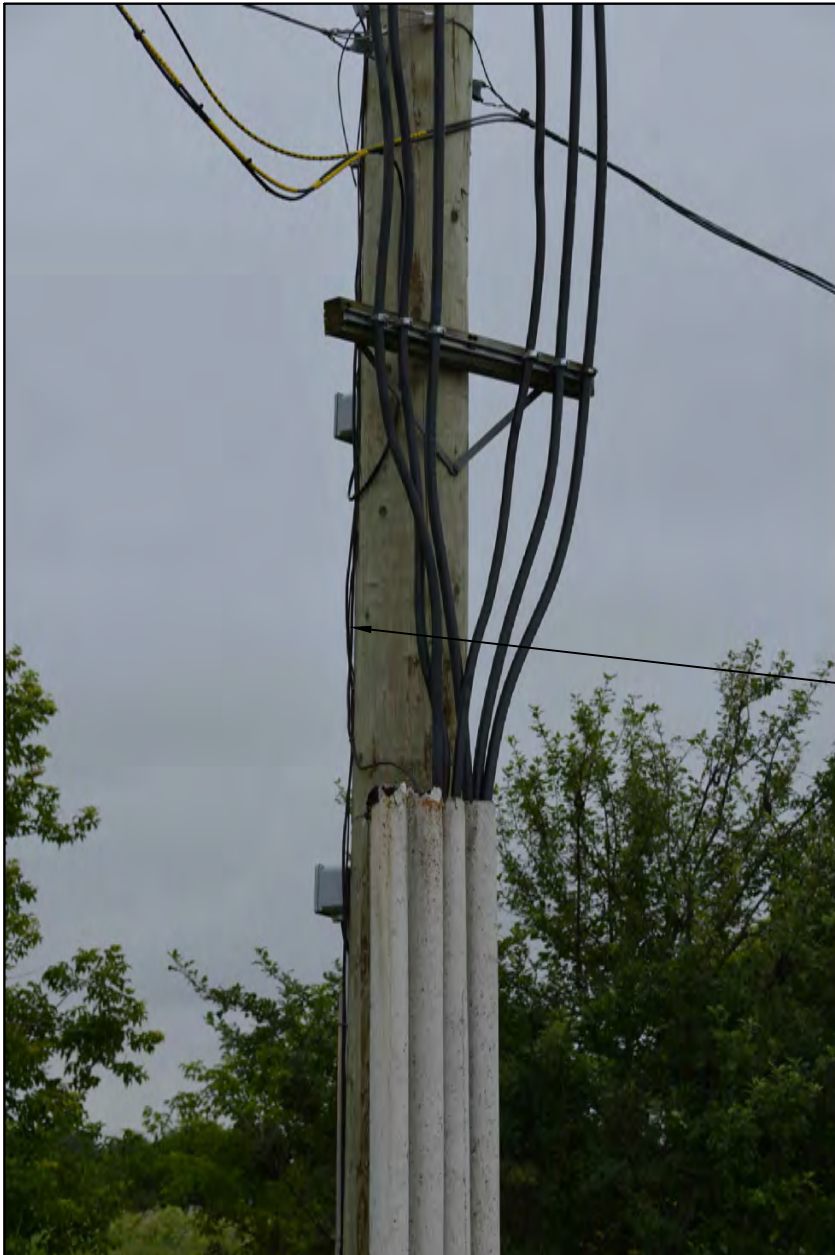
BARE SYSTEM NEUTRAL RUNS UP
THE POLE – THIS IS DANGEROUS

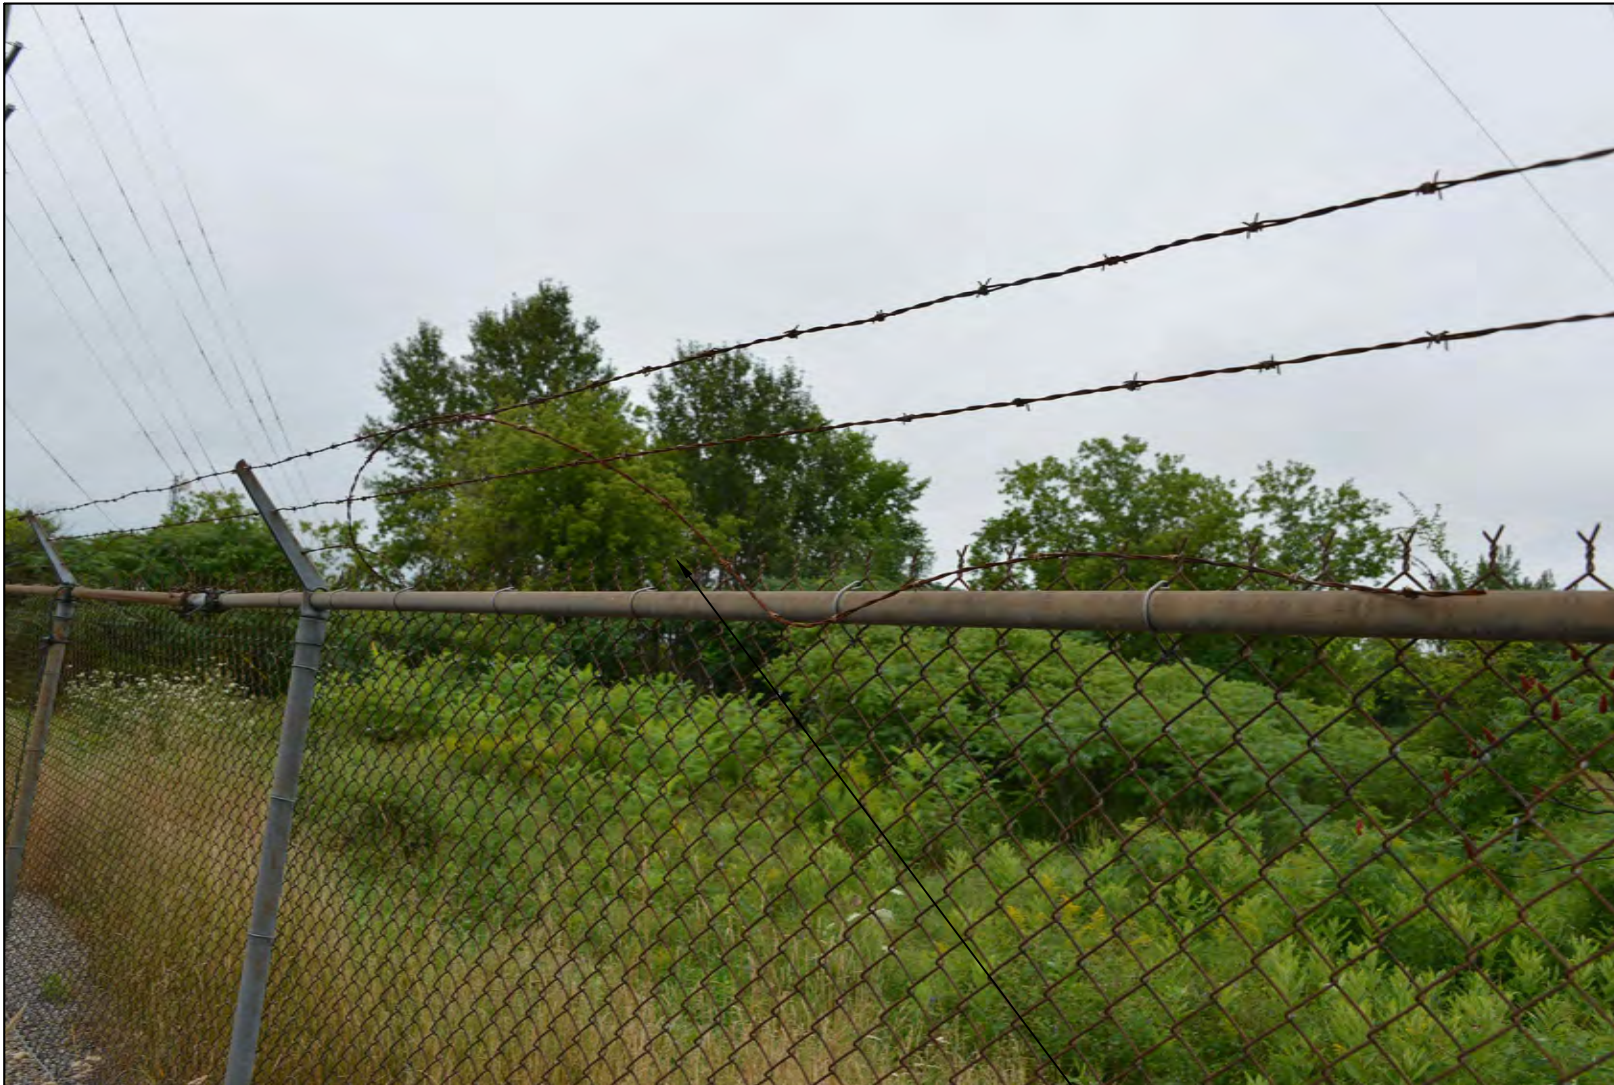
— BROKEN FENCE BARBED WIRE

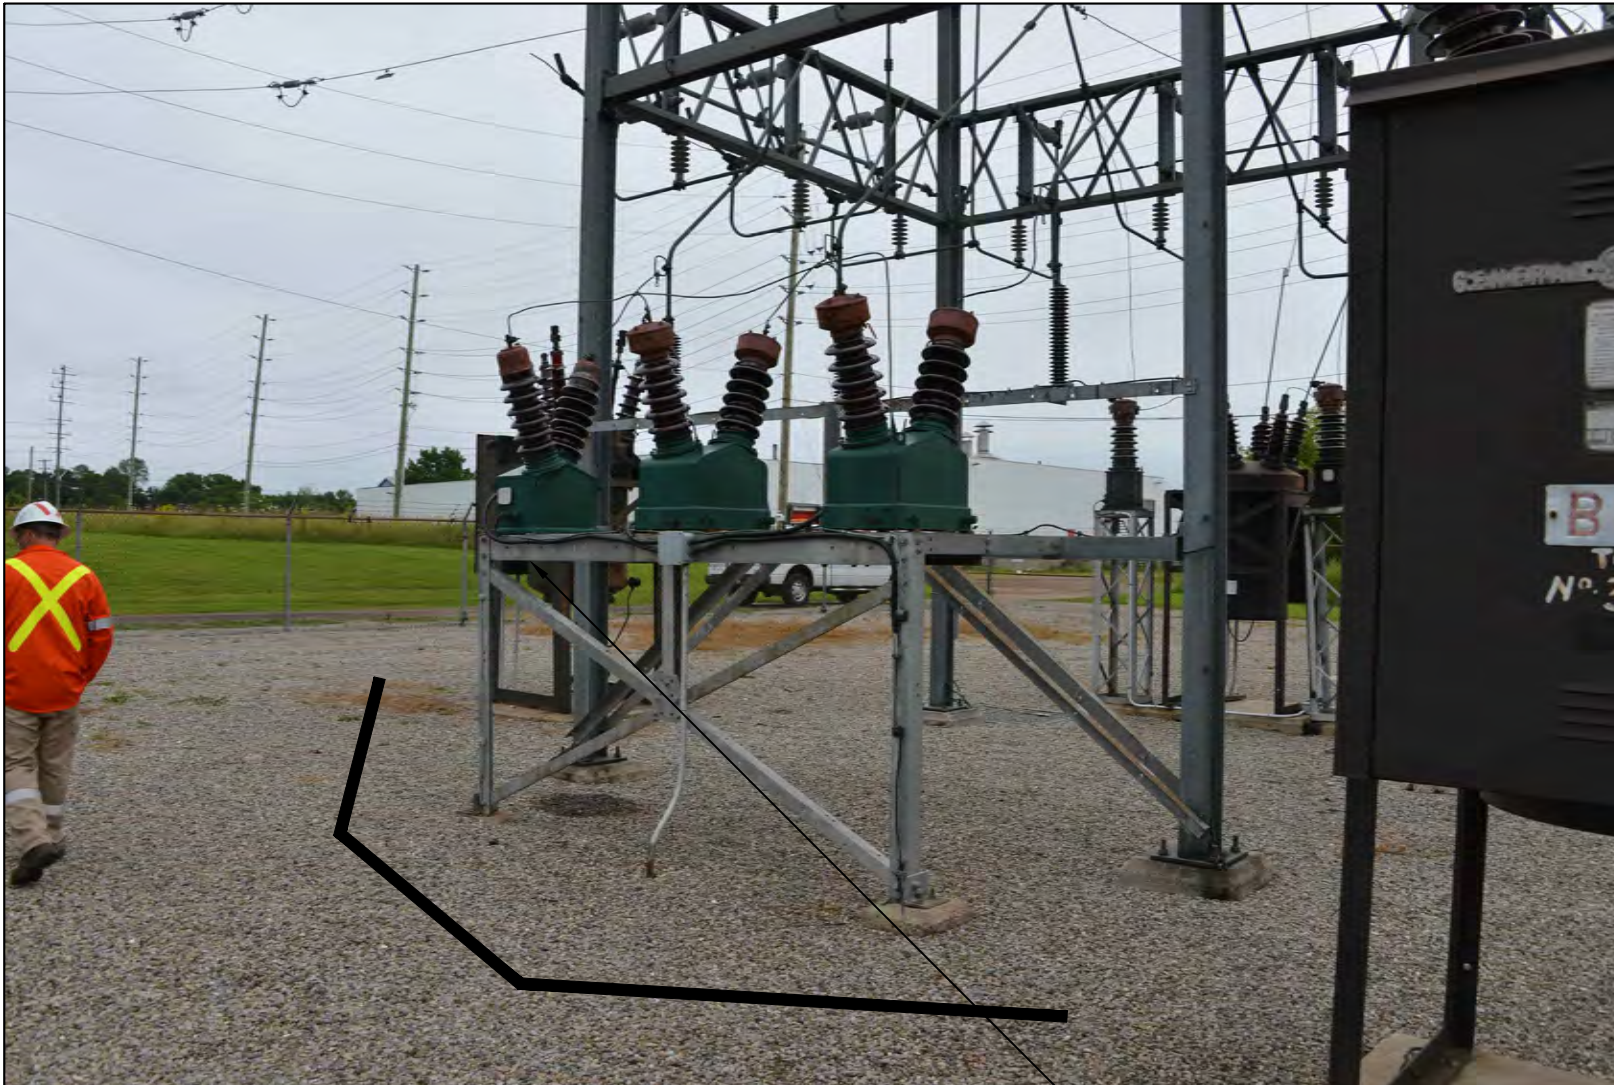
LOW LEVELS OF APPROACH.
NEW FENCE SUGGESTED.

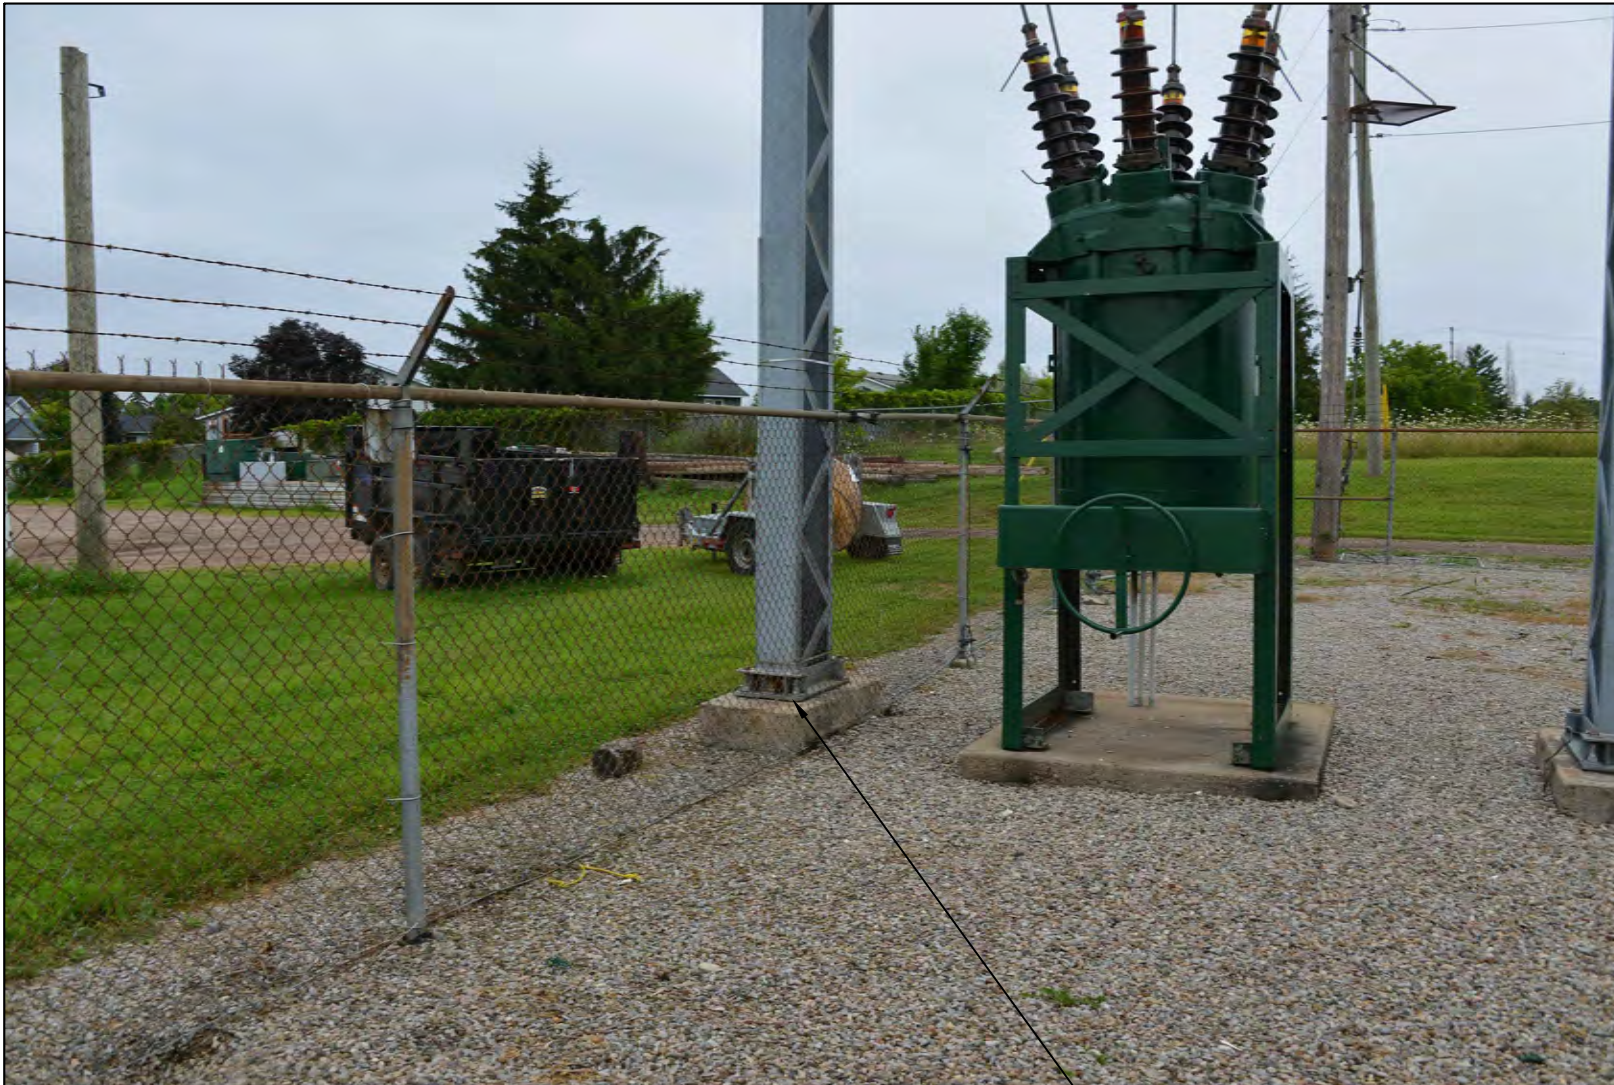
PUBLIC AREA (OUTSIDE STATION FENCE)
WITHIN LIMITS OF APPROACH.
STATION STRUCTURE IS OUTSIDE OF THE
STATION FENCE.

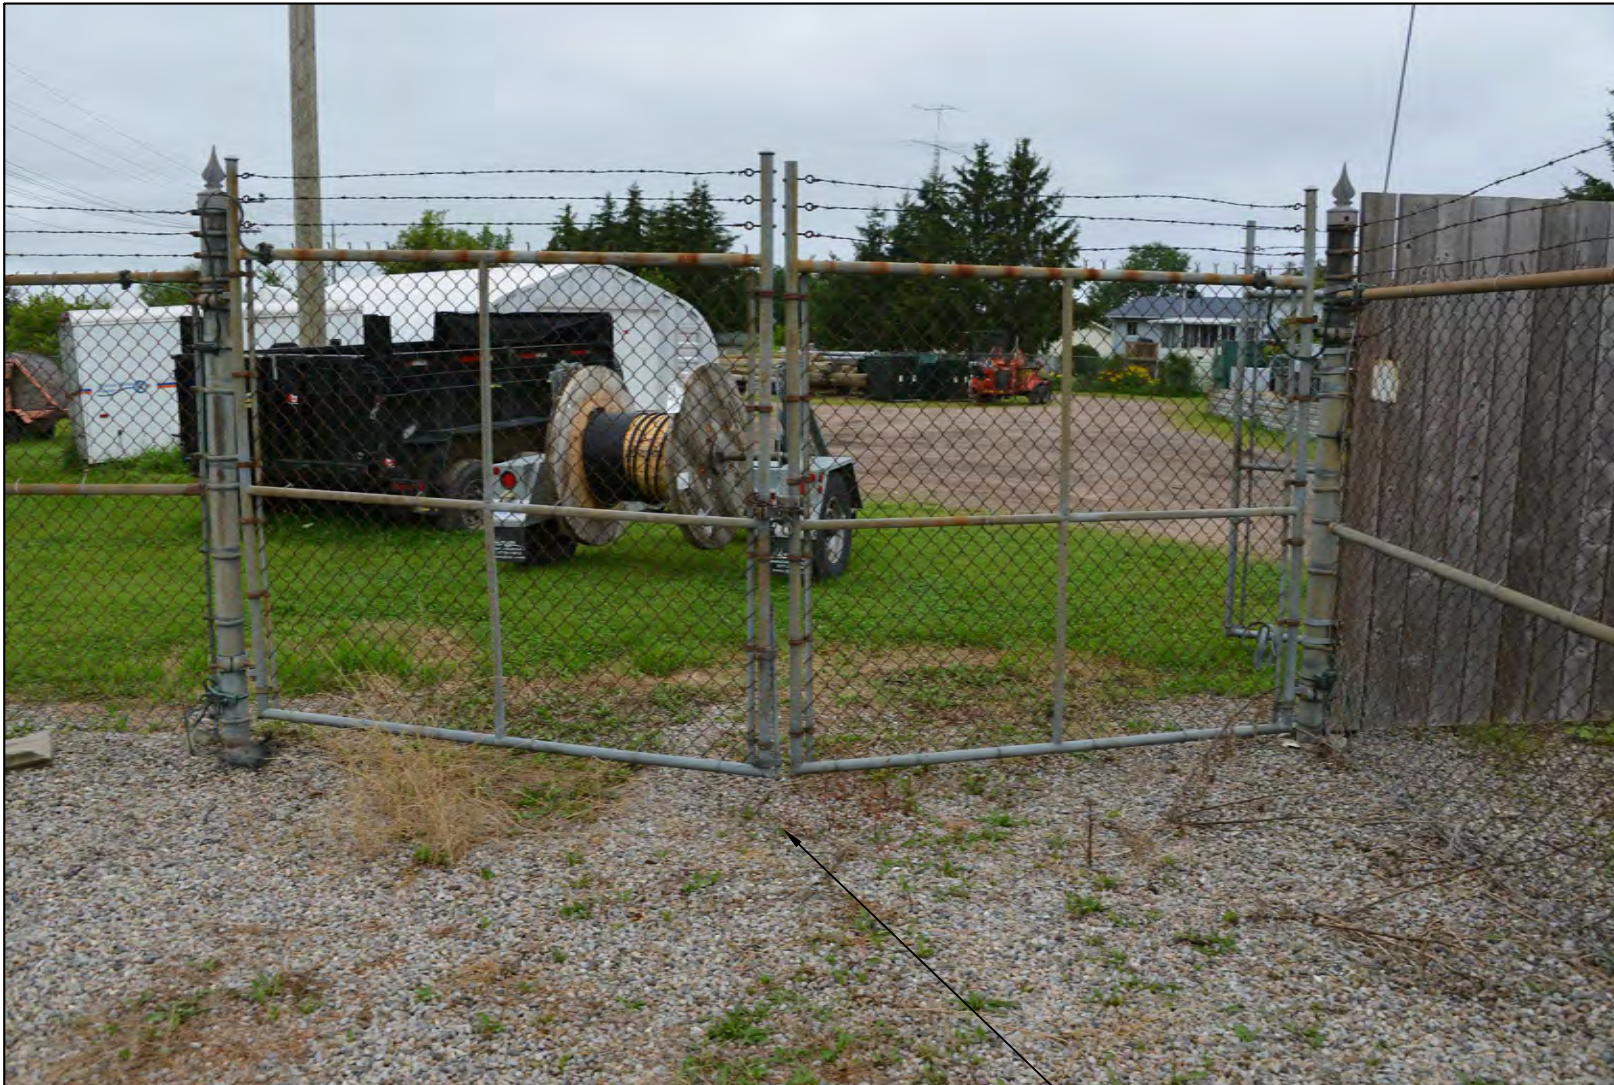
FENCE GATE SWINGS OUTSIDE OF THE
STATION GROUND GRID

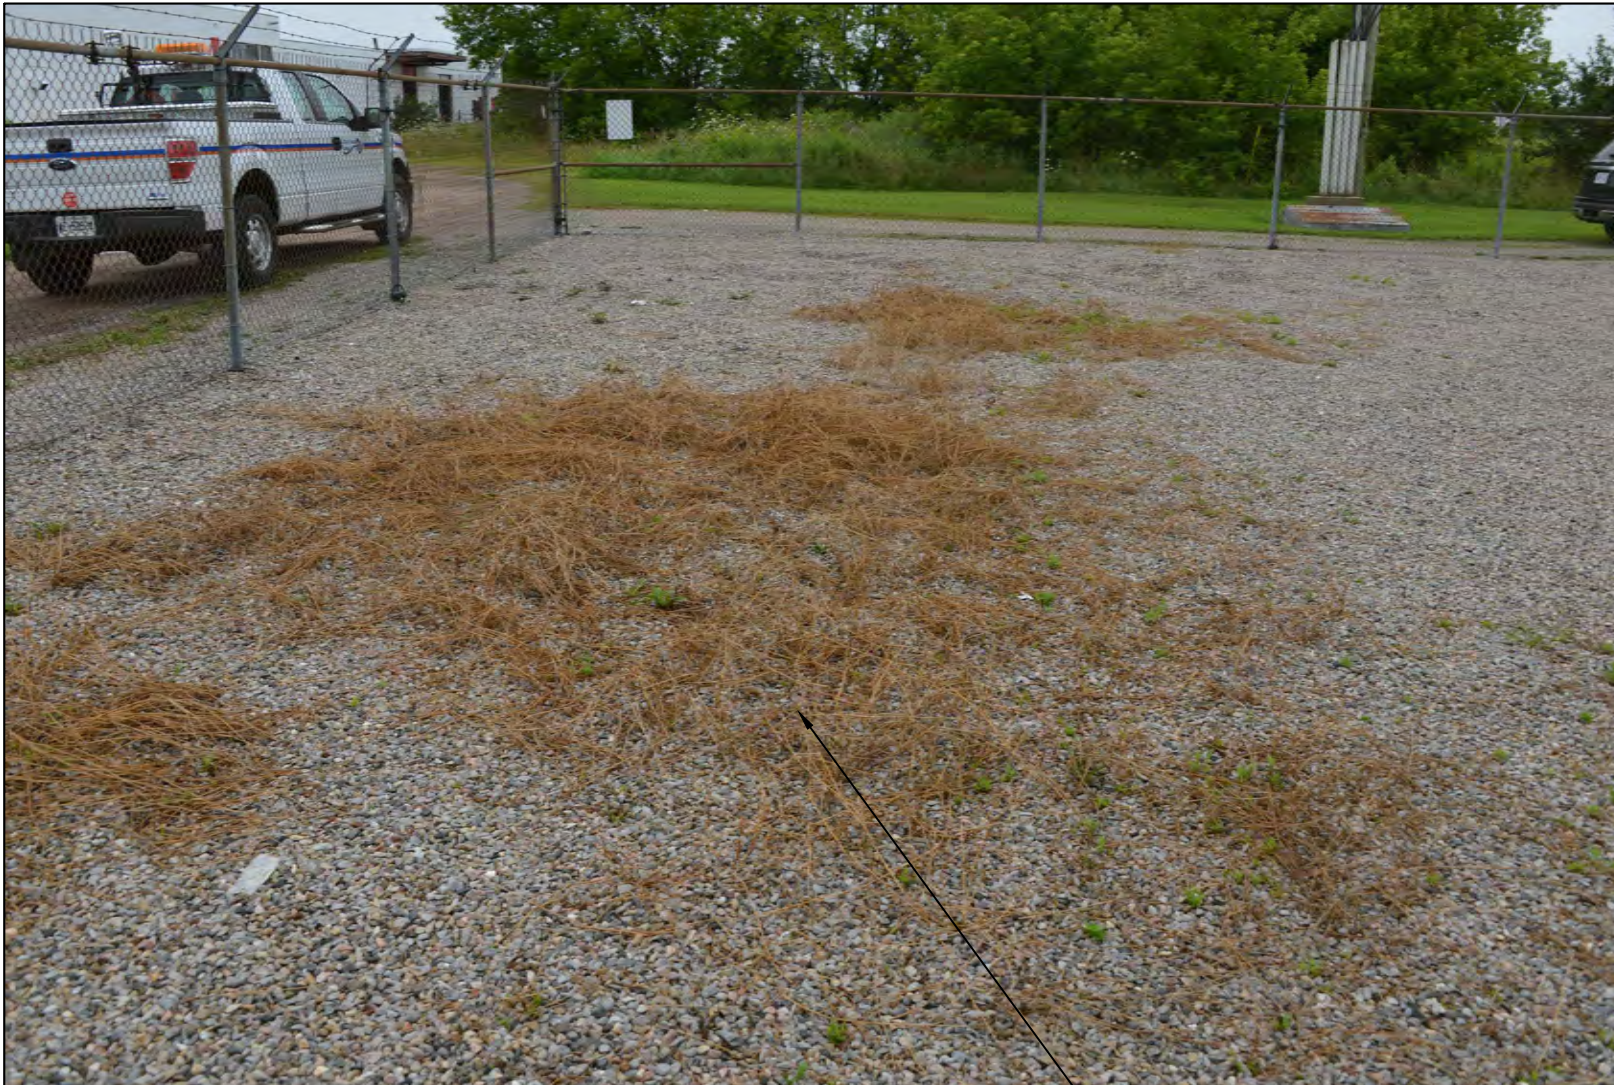
INADEQUATE CRUSHED STONE WITH
VEGETATION GROWING THROUGH IT

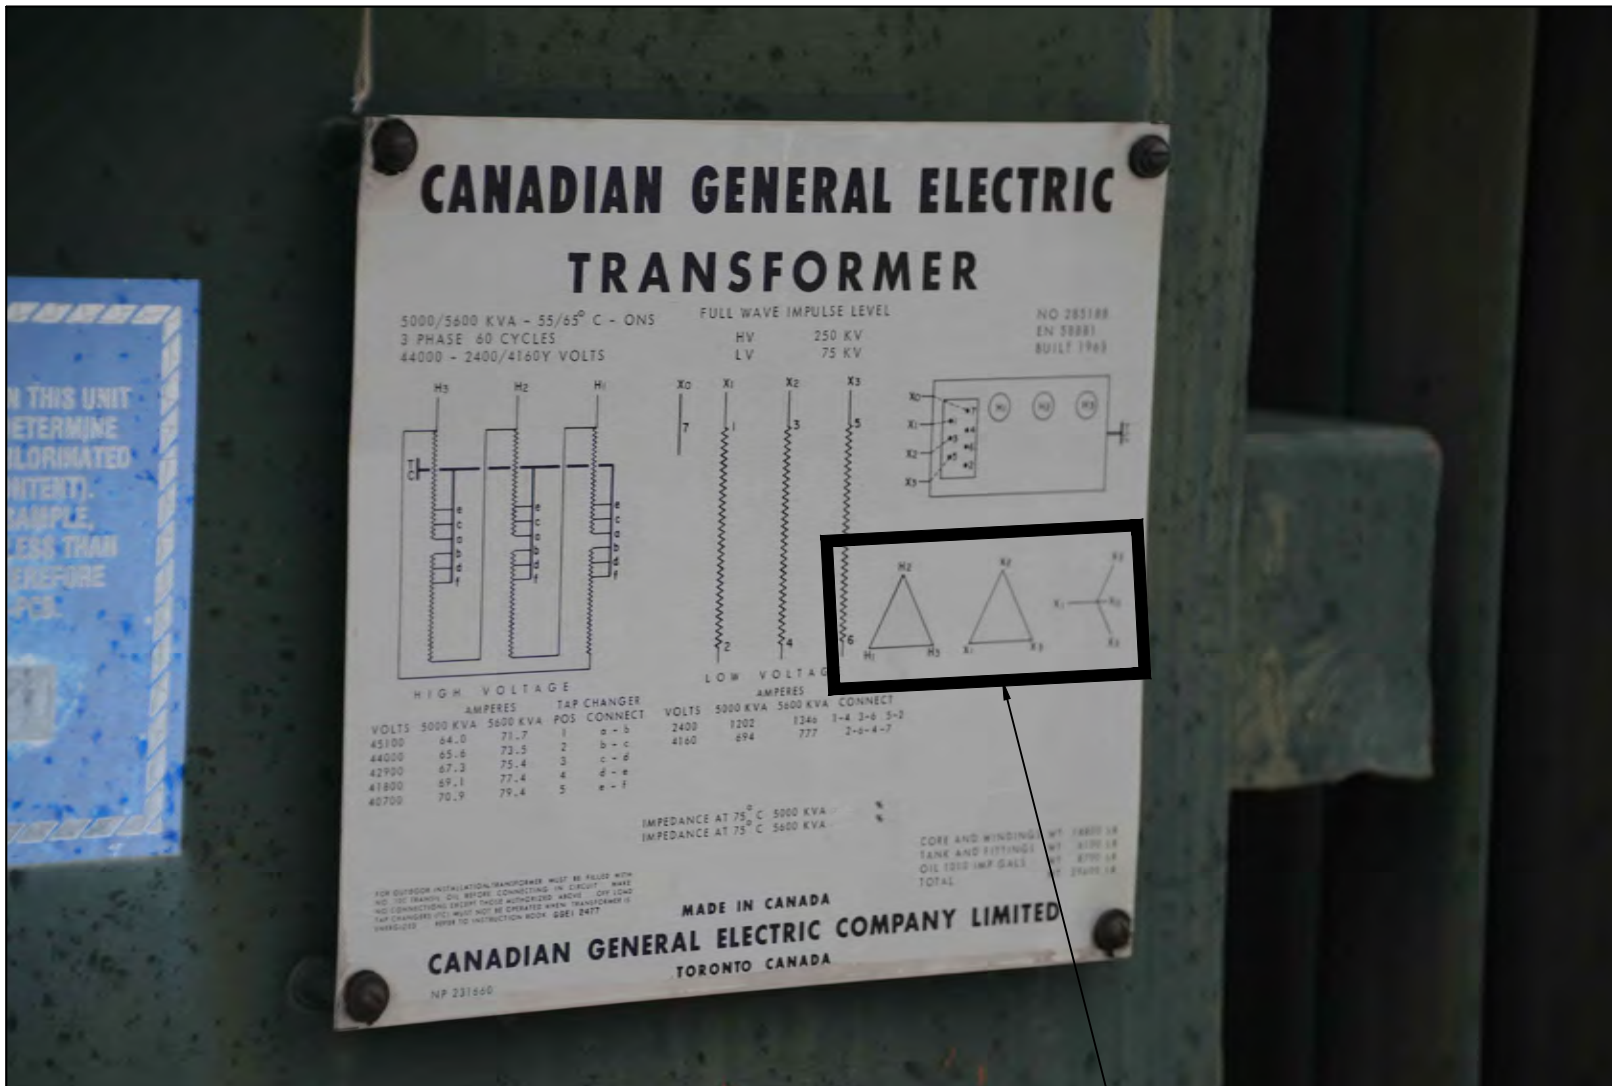
CSA DYI VECTOR NOT A PROBLEM. FOR INFORMATION PURPOSES. THIS WILL NOT PARALLEL WITH DYII TRANSFORMER

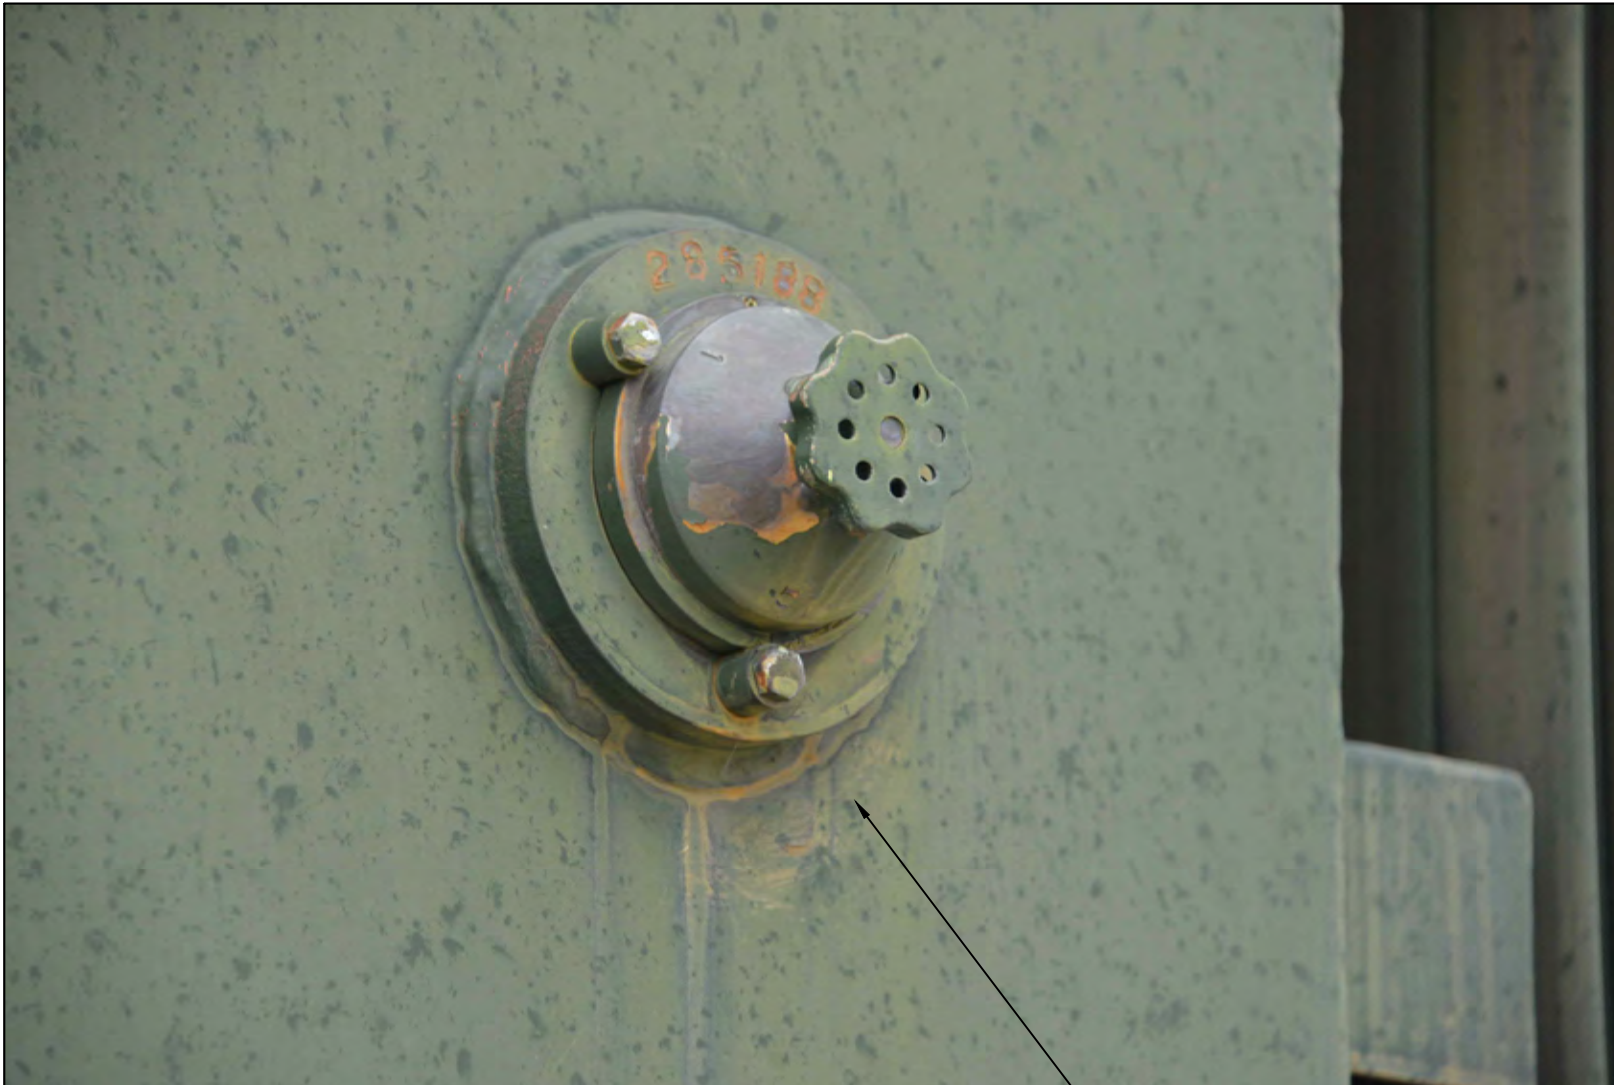
PADLOCK REQUIRED

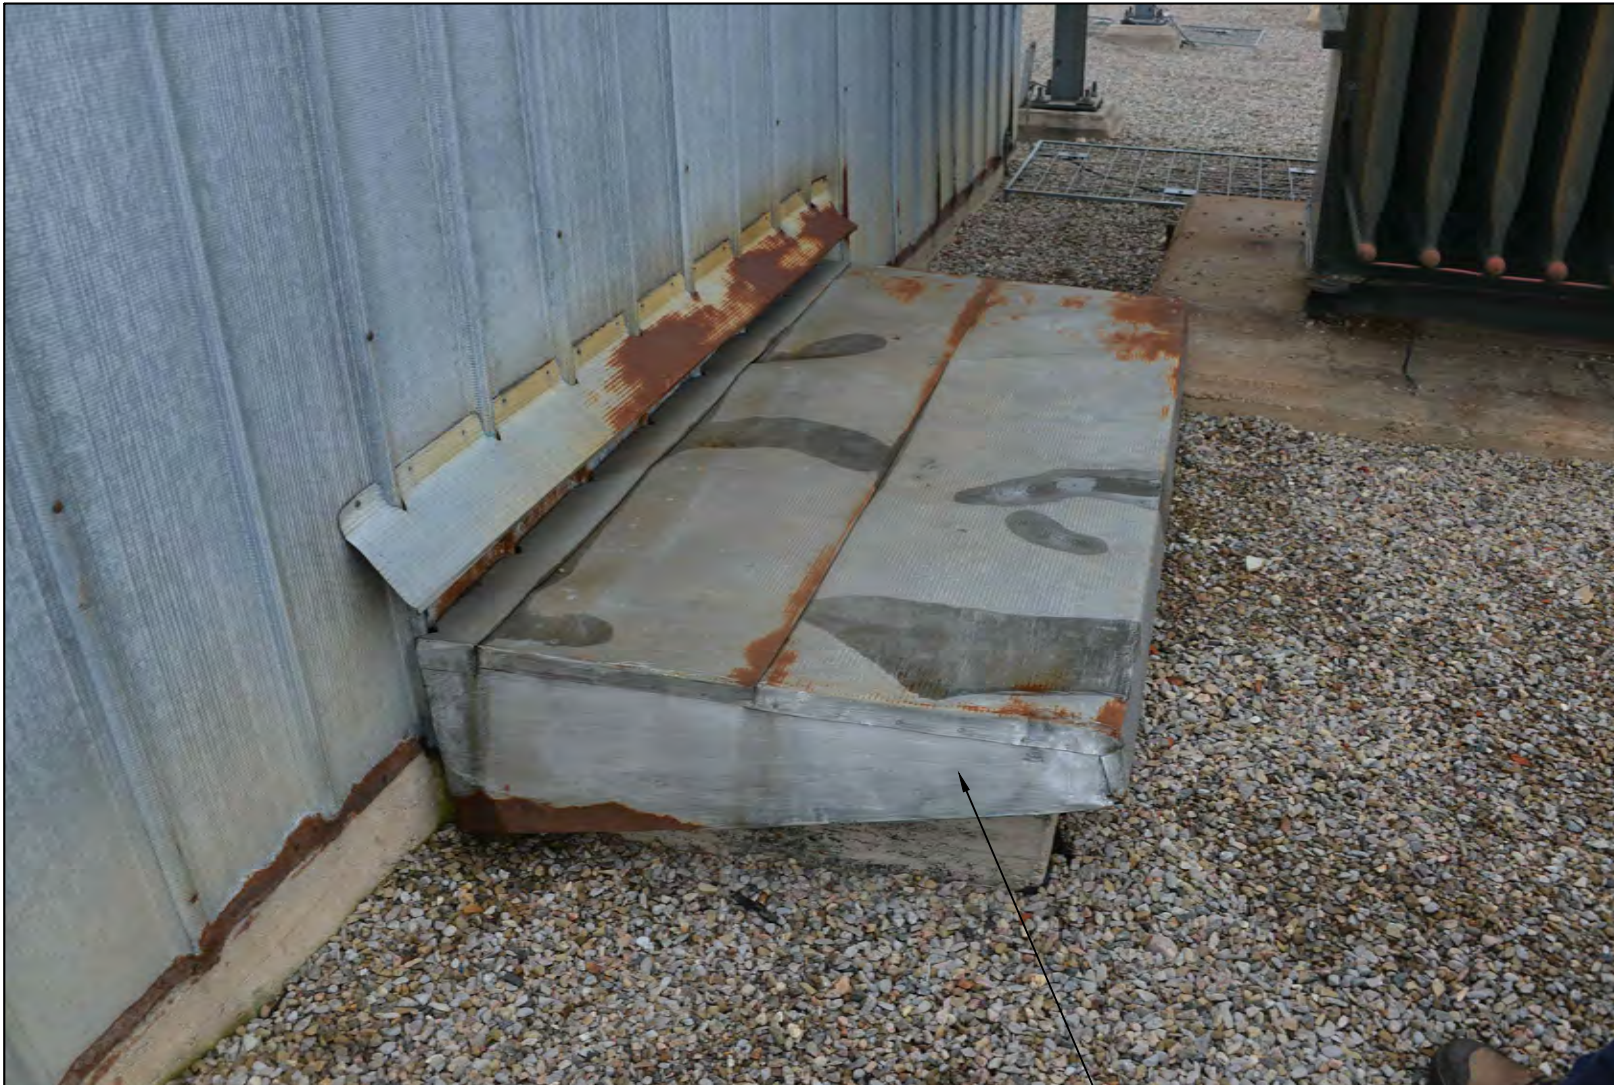
GROUNDING AND BONDING OF VAULT LID
