## **CONDITION ASSESSMENT FOR ENWIN UTILITIES' 27.6 kV ASSETS**

### EXECUTIVE SUMMARY

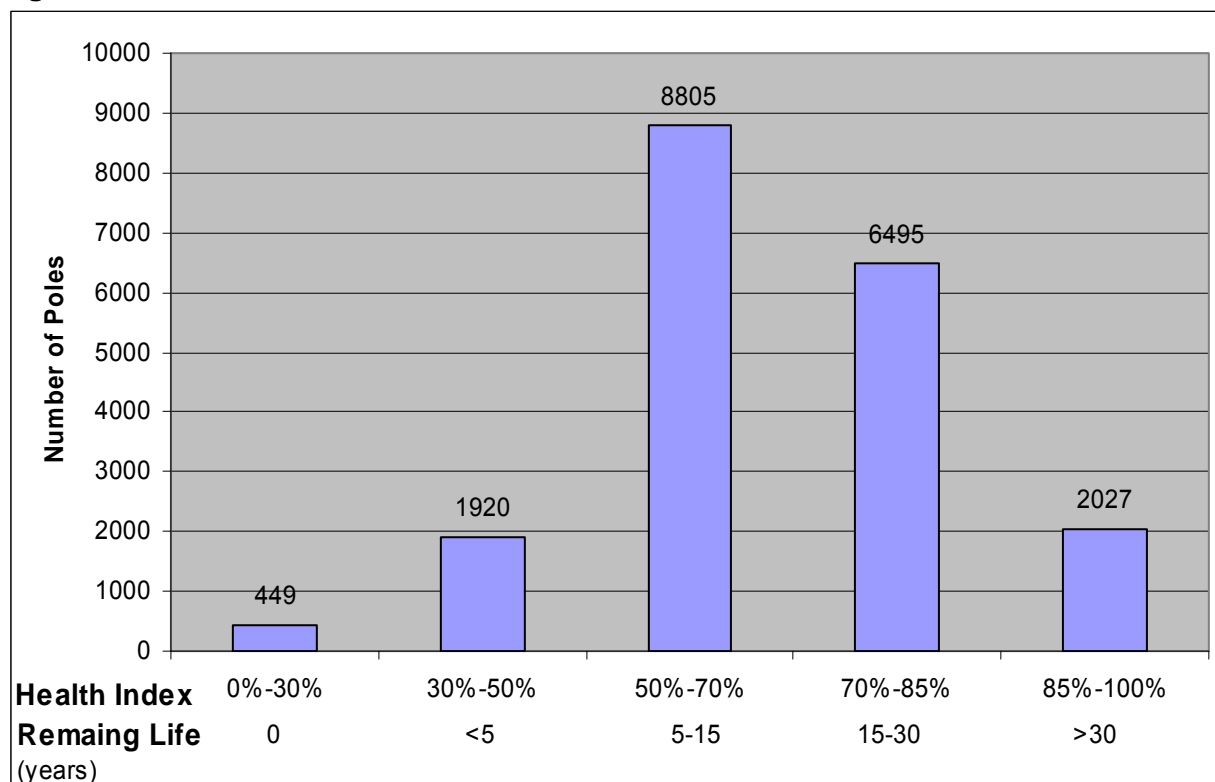
**Figure 4 Poles Health Index Results**

The wide range of condition of wood poles indicated by the health index has been confirmed by the interviews with staff. Operations staff expressed a growing concern about the number of poles in very poor condition. A recommendation for a pole replacement program has been made in section 10 of this report.

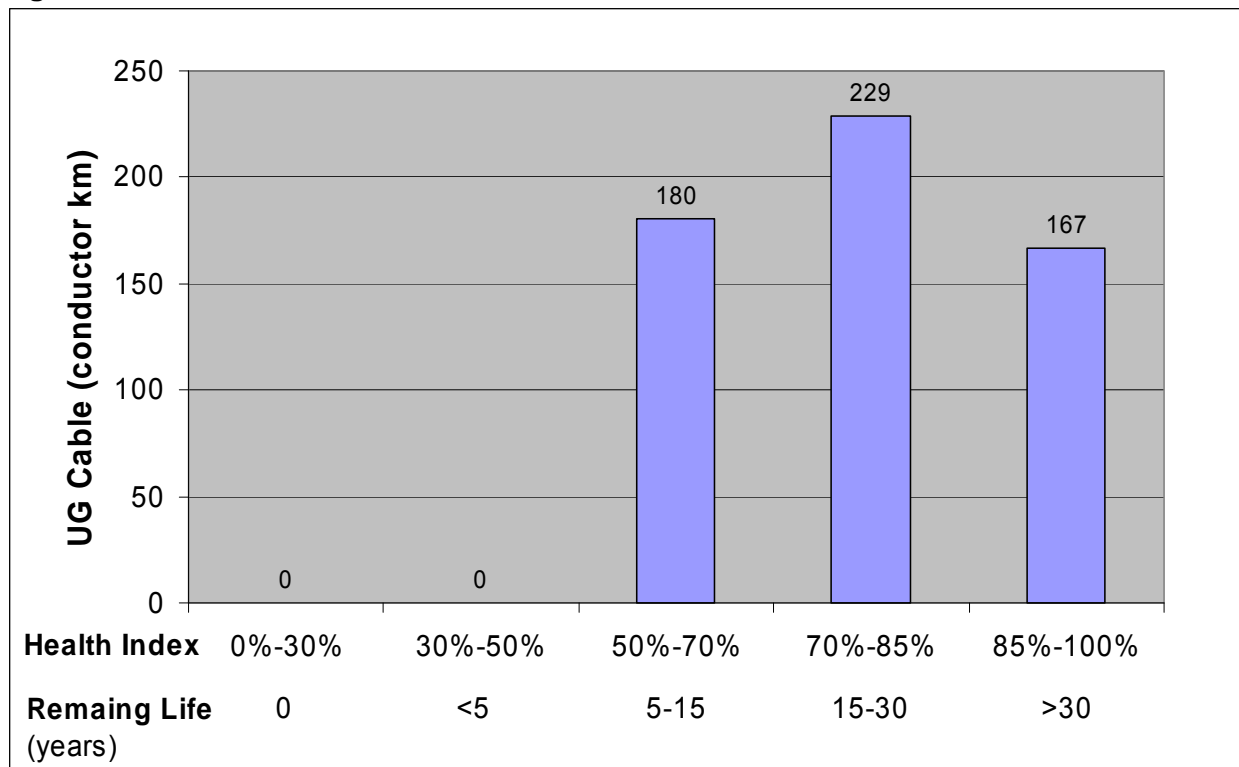
**Figure 8 UG Cable Health Index Results**

The overall good condition of underground cable indicated by the health index has been confirmed by interviews with staff and the low failure rate experienced. The staff interviews identified that there is a targeted replacement program to eliminate the direct buried XLPE cable, about 5% of the installed cable.

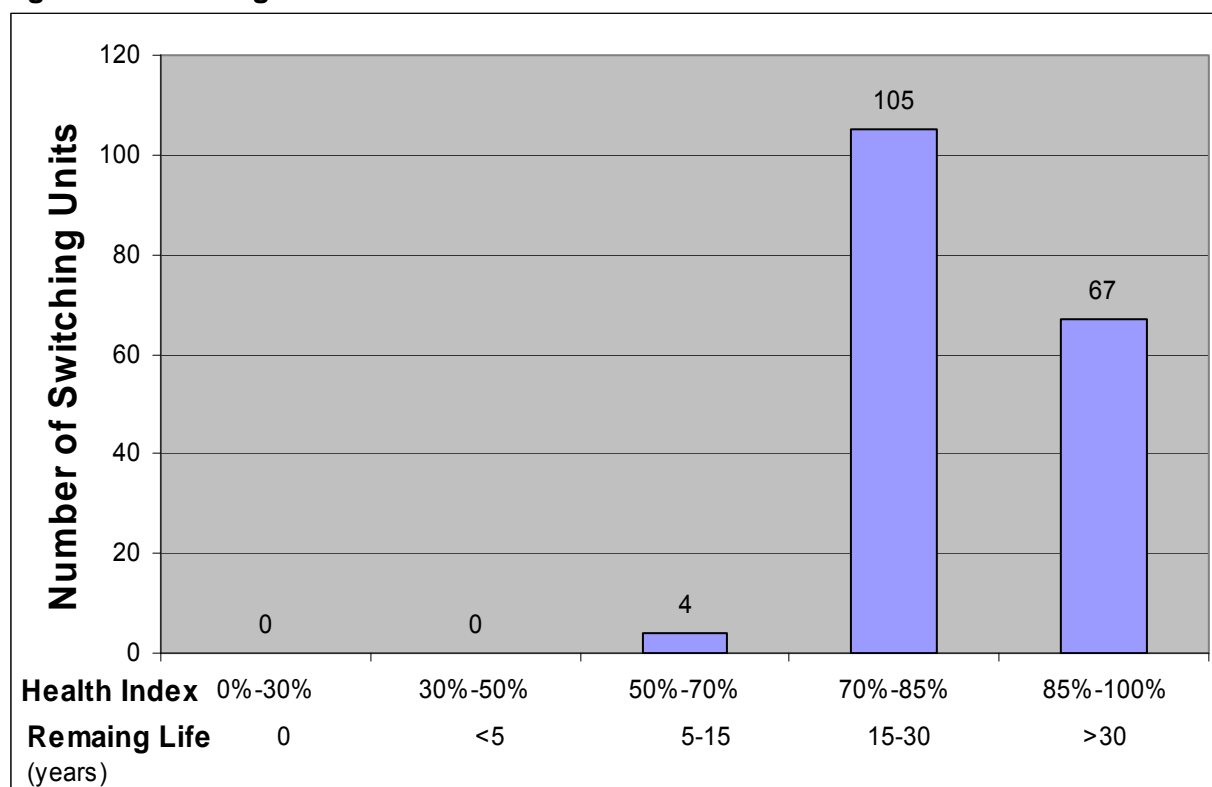
**Figure 9 Switching Unit Health Index Results**

The overall good condition of switching units indicated by the health index has been confirmed by visual inspection of a sample of units and interviews with staff. However, the staff interviews did indicate that there are a few units that are experiencing the corrosion problem caused by moisture build up that other utilities are experiencing. If the recommended visual inspection grade is added to the condition monitoring program then health indices calculated in the future will be able to reflect this condition. The present health index analysis is missing these poor condition switches because a visual condition grade was not available on all units.

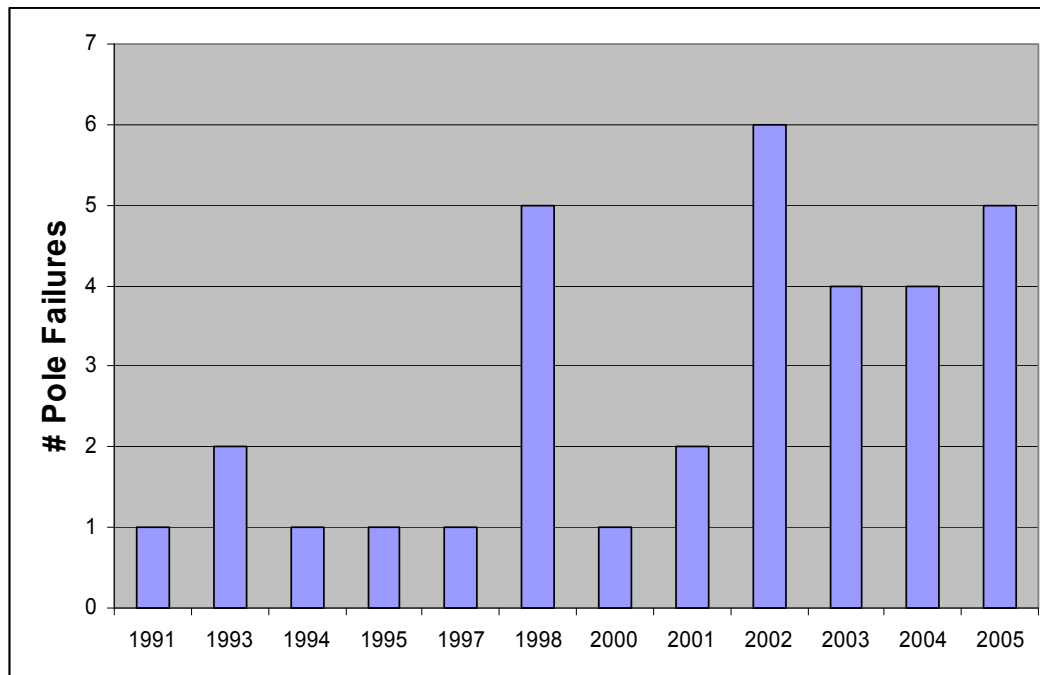
**Figure 10 Wood Pole Failure Trend**

The trend in wood pole failures is shown in Figure 10. Concrete poles have experienced no failures. The failure rate of 5/19666 (0.02%) is low but the trend is increasing. This is an indication that wood pole condition is deteriorating and may require remedial action in the future.

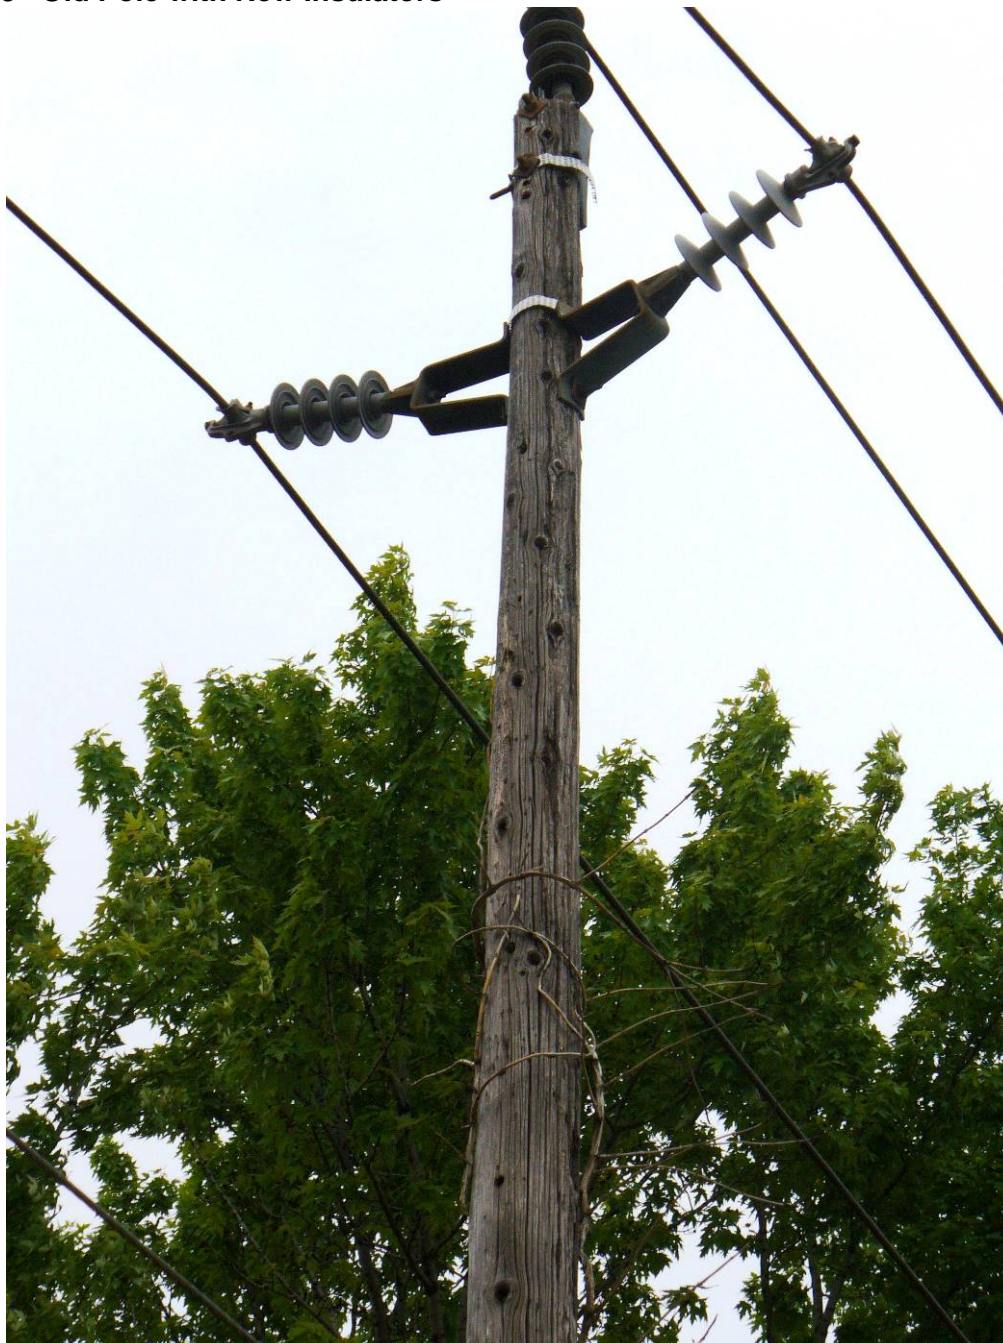
**Figure 13 Old Pole with New Insulators**

Figure 12 illustrates an old pole with new insulators and hardware. The pole will reach the end of its life before the insulator and hardware do.

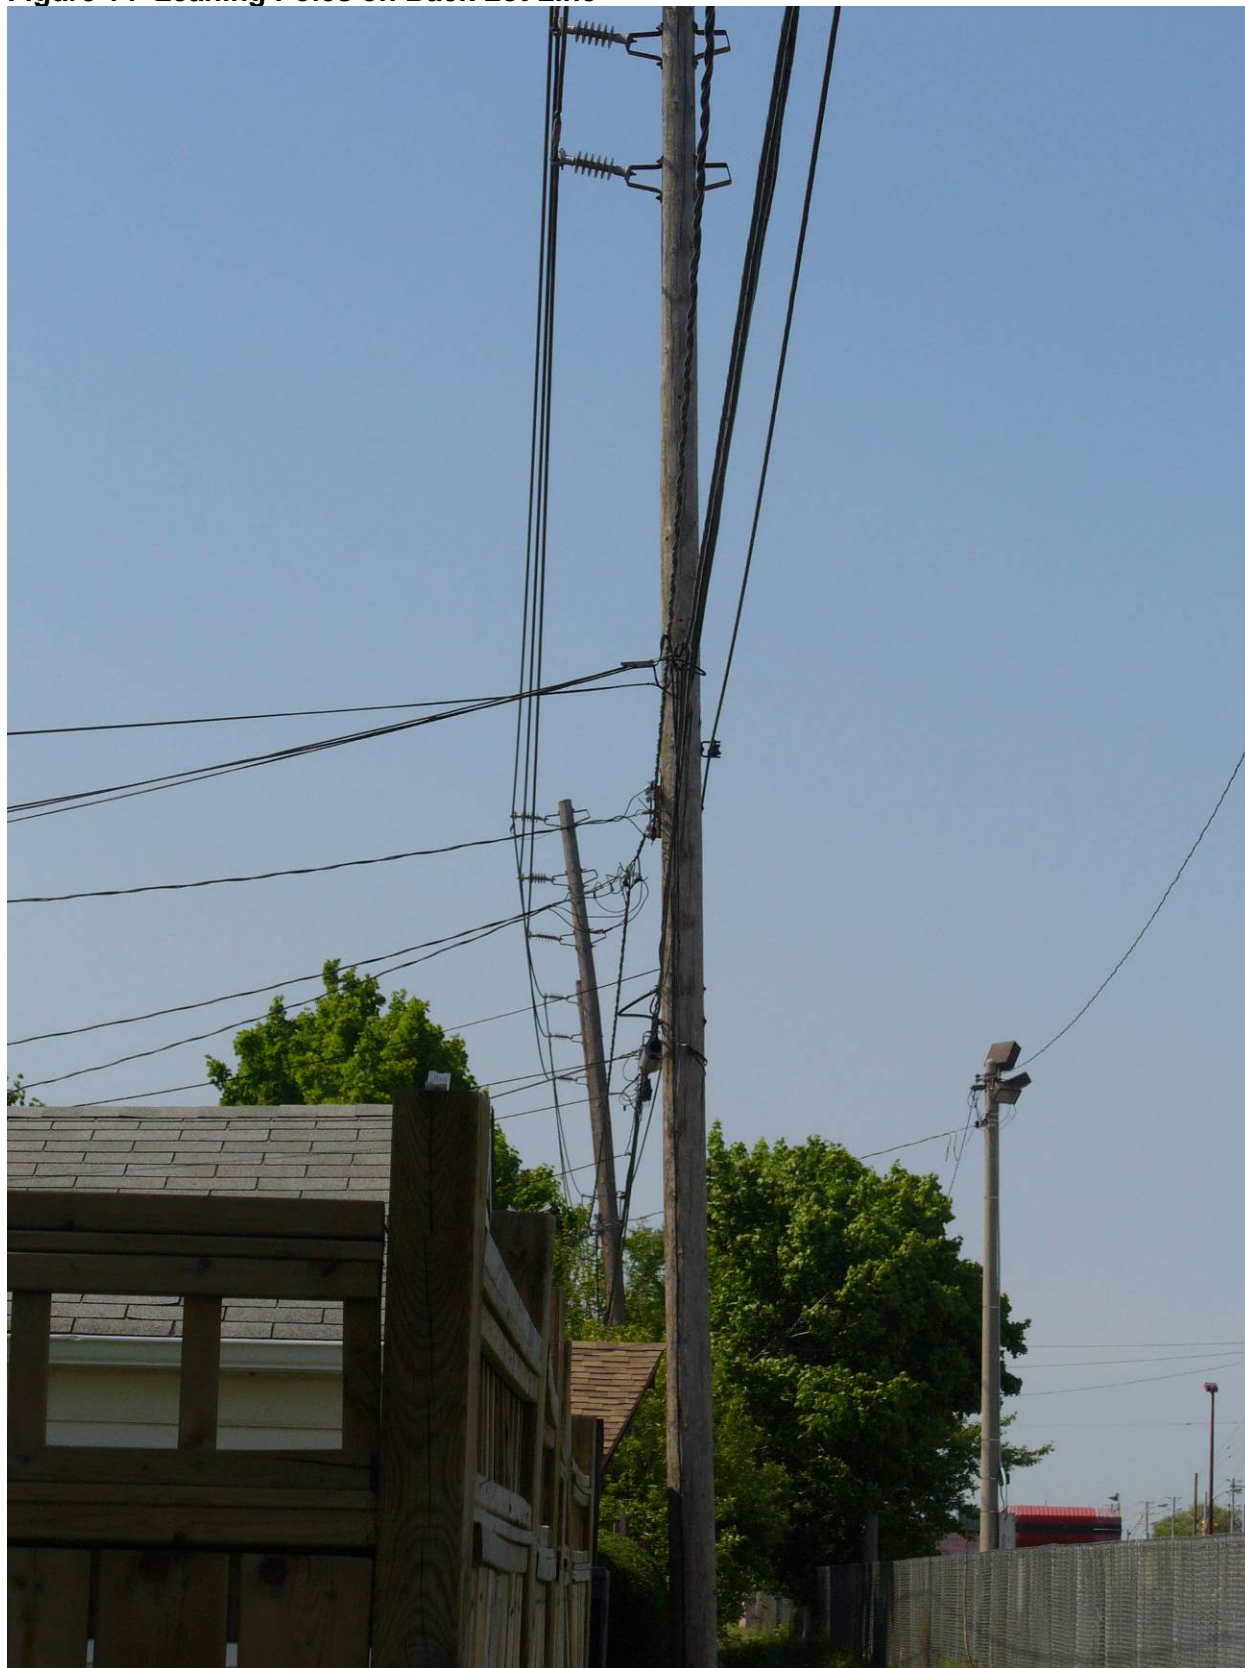
**Figure 14 Leaning Poles on Back Lot Line**

Figure 13 illustrates a problem with back lot lines. The poles in this picture are in good condition but they are inadequately guyed.

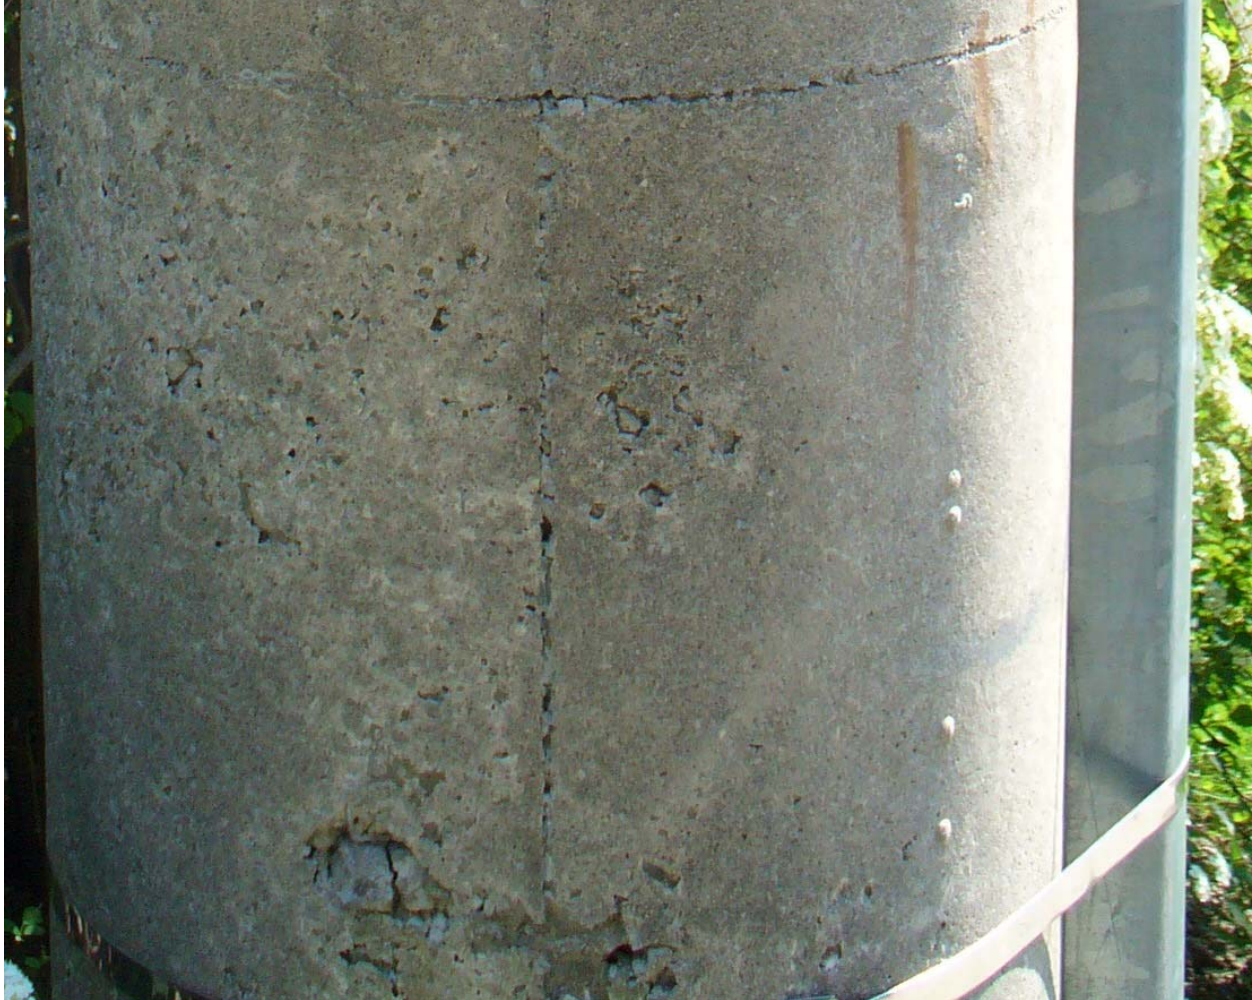
**Figure 15 Concrete Pole with Exposed Aggregate**

Figure 14 illustrates a concrete pole in poor condition. Water can corrode the exposed rebar and also freeze in the interior of the concrete, cracking the pole and weakening it.

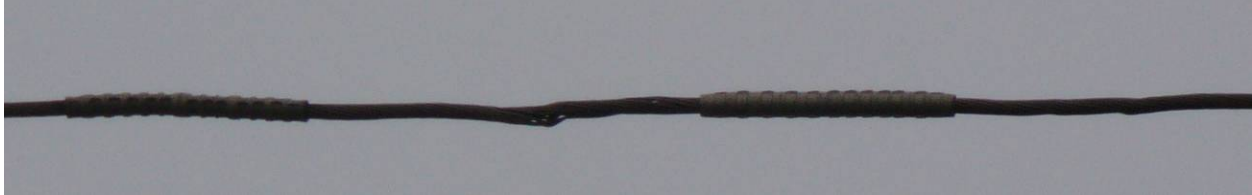
**Figure 16 Conductor in Poor Condition**

Figure 15 illustrates a conductor that may be in poor condition, but the close splices and the separation of the strands (bird caging) do not necessarily indicate poor mechanical strength. A tensile test is the only reliable condition indicator.

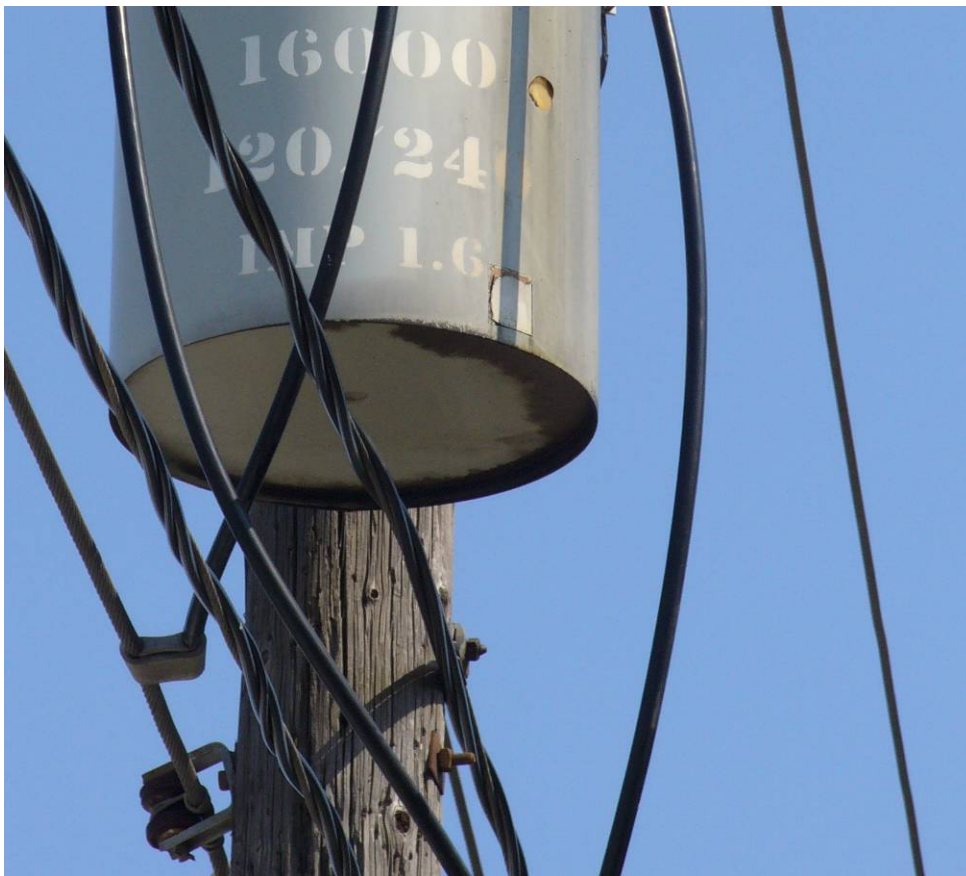
**Figure 17 Transformer with Minor Rust**

Figure 16 is an example of a transformer in fair condition. It shows signs of deterioration, but the deterioration is not extensive and does not affect its function. Even this small degree of deterioration is rare on the ENWIN system. The transformers are generally in good or excellent condition.
