**EE File No. E18002**

**Title: Buildings Condition Summary Review Suite 'B' – Phase 1**

**Project: 2 Sackville Road, ON**

## **Buildings Condition Summary Review – Phase 1**

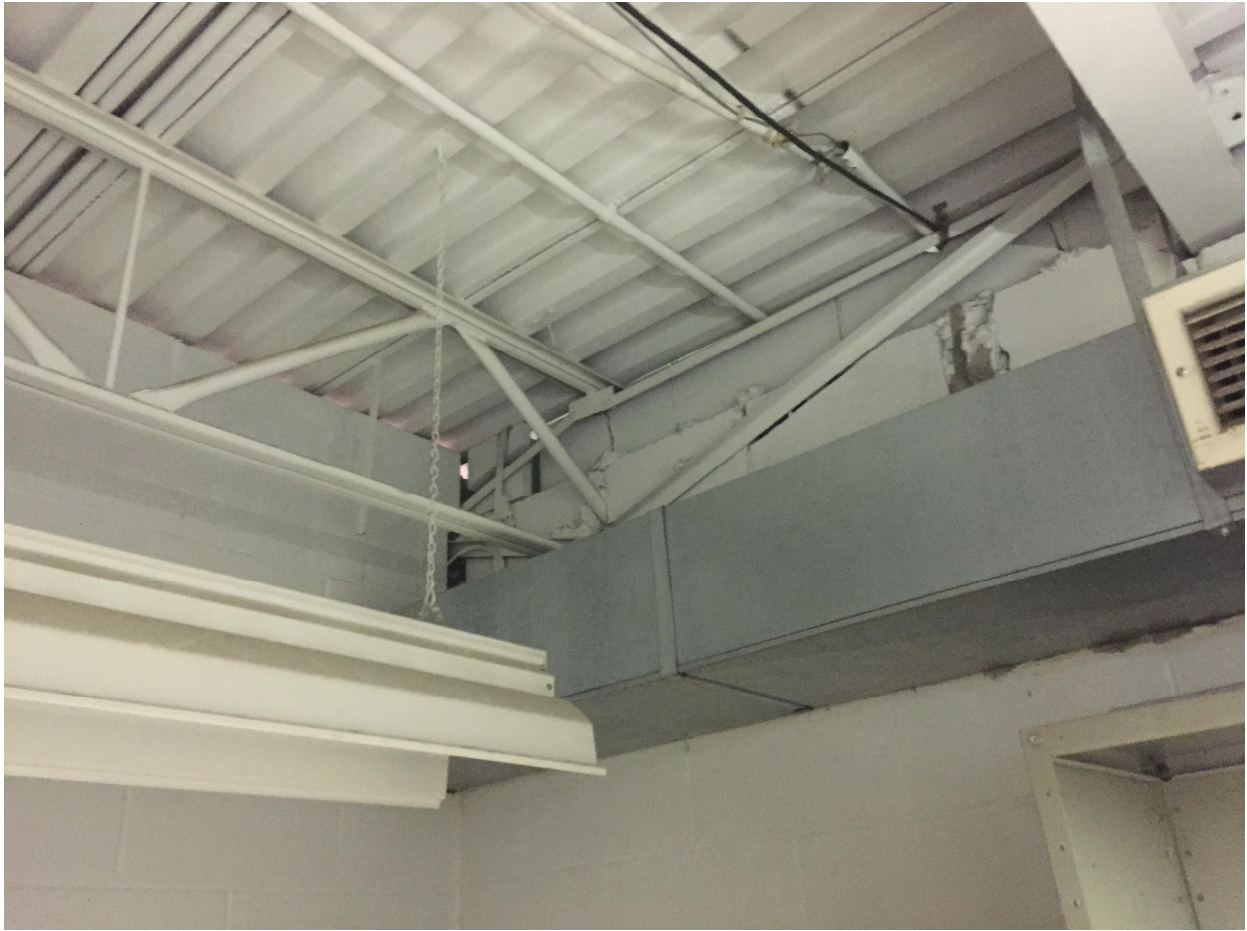
Suite 'B' Basement Photo 4 – General floor construction (first floor / basement ceiling) consisting of OWSJ and metal deck. Concrete block partition walls can also be observed.

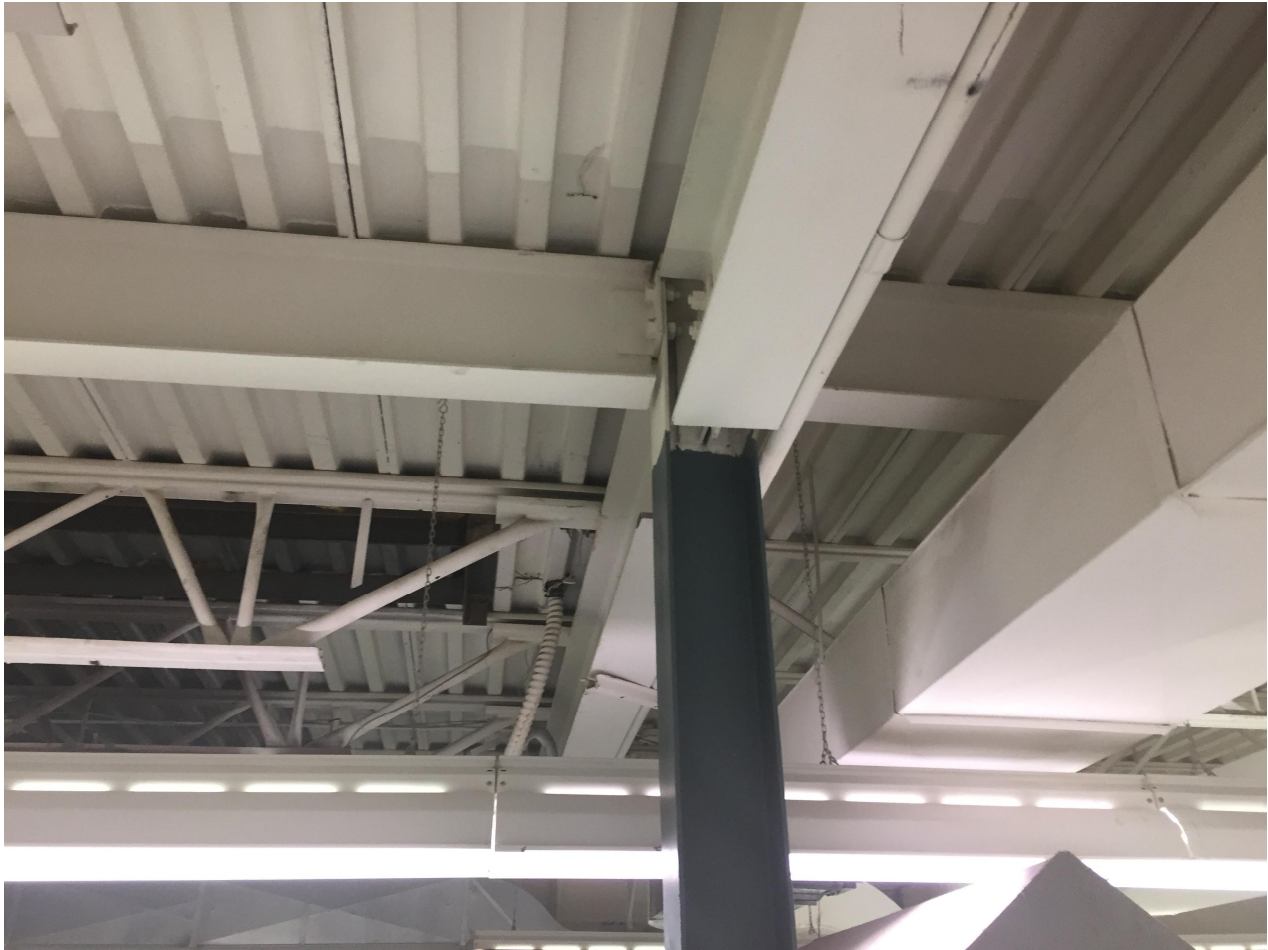
Suite 'B' Basement Photo 7 – General floor construction (first floor / basement ceiling) consisting of OWSJ and metal deck and a series of steel columns.

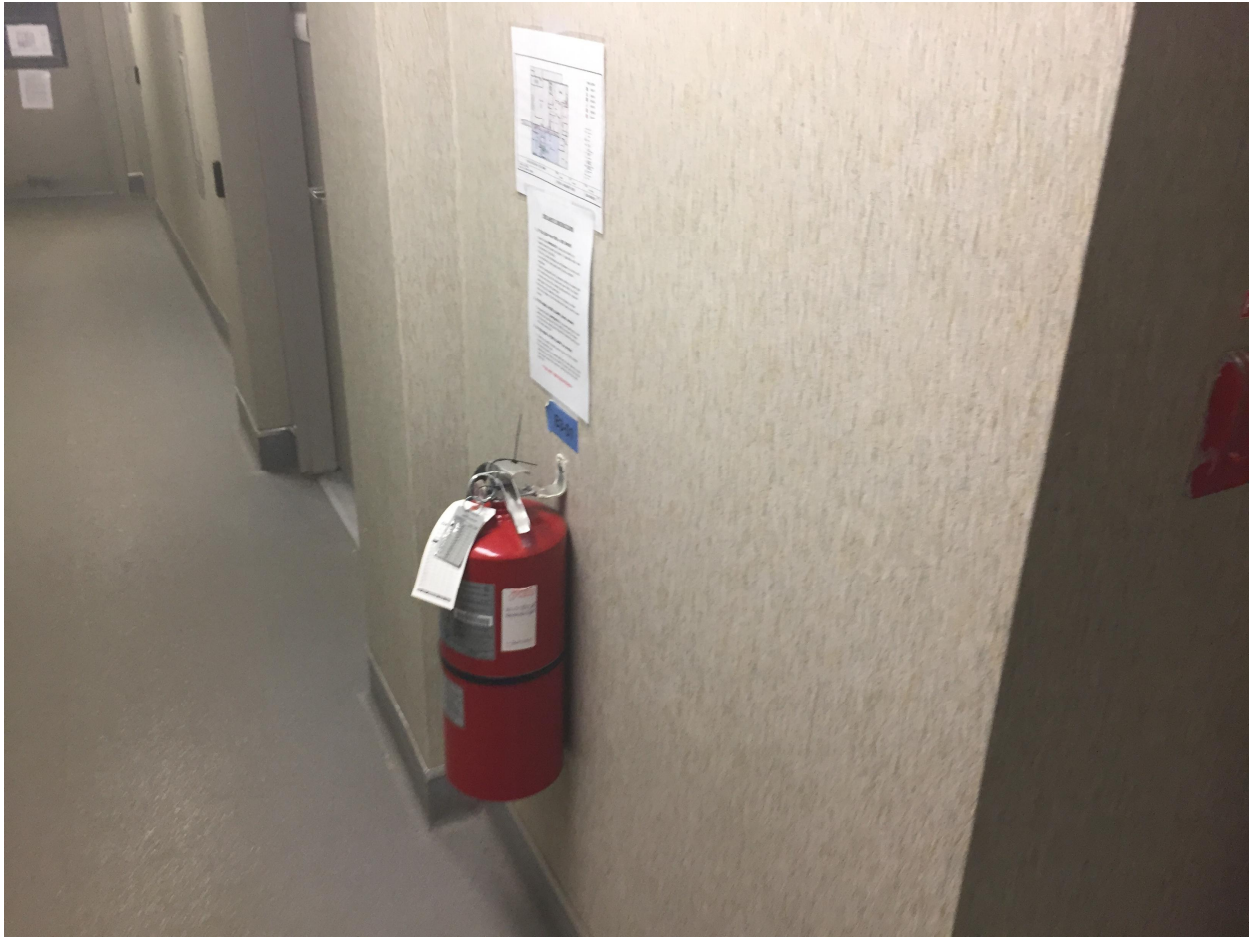
Suite 'B' Basement Photo 8 – Photo taken in the corridor of a fire extinguisher. There are extinguishers throughout the facility. Each is checked and certified annually as can be noted by the tag.

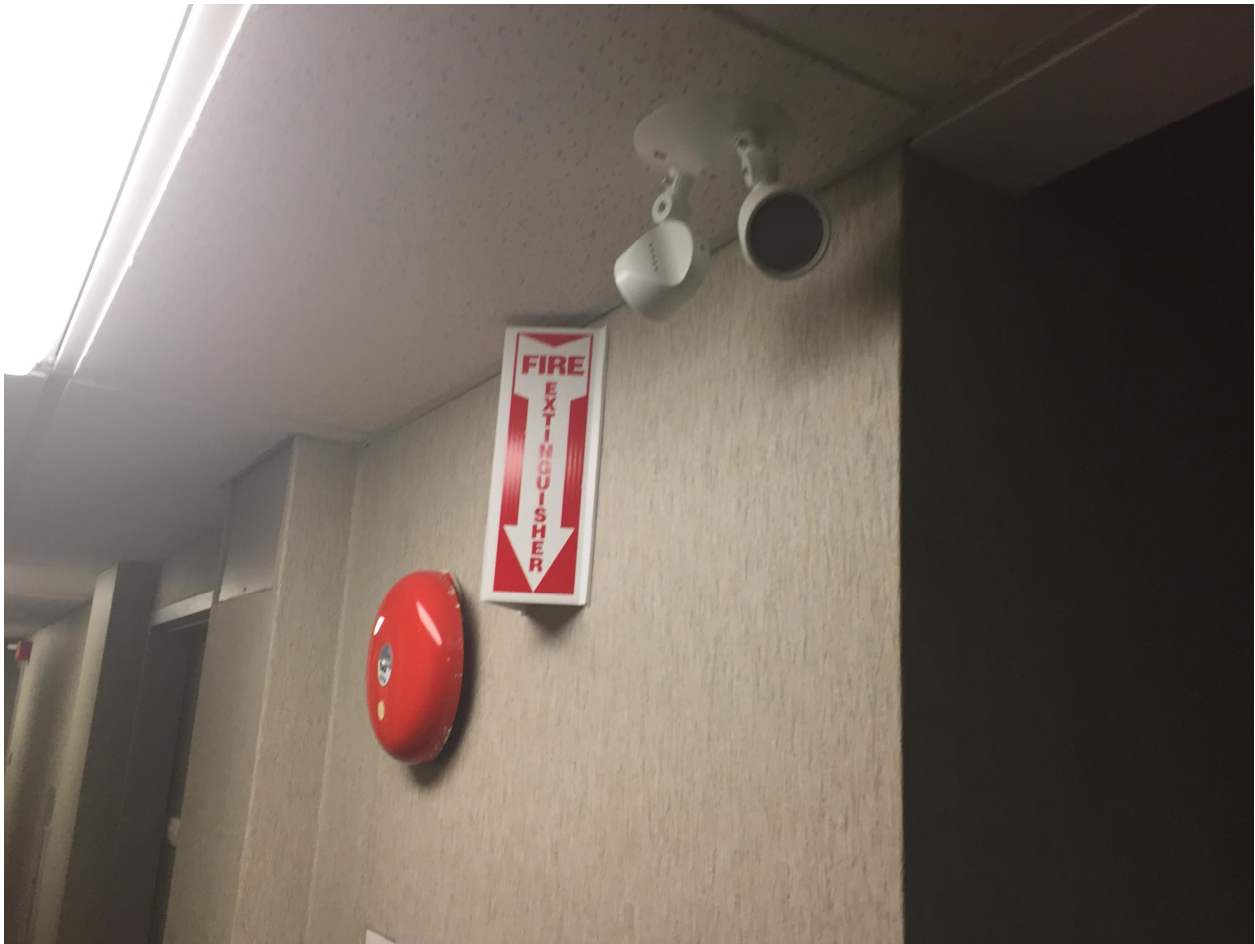
Suite 'B' Basement Photo 9 – Photo taken in the corridor of an alarm bell. There are alarm bells throughout the facility. Each is checked and certified annually.

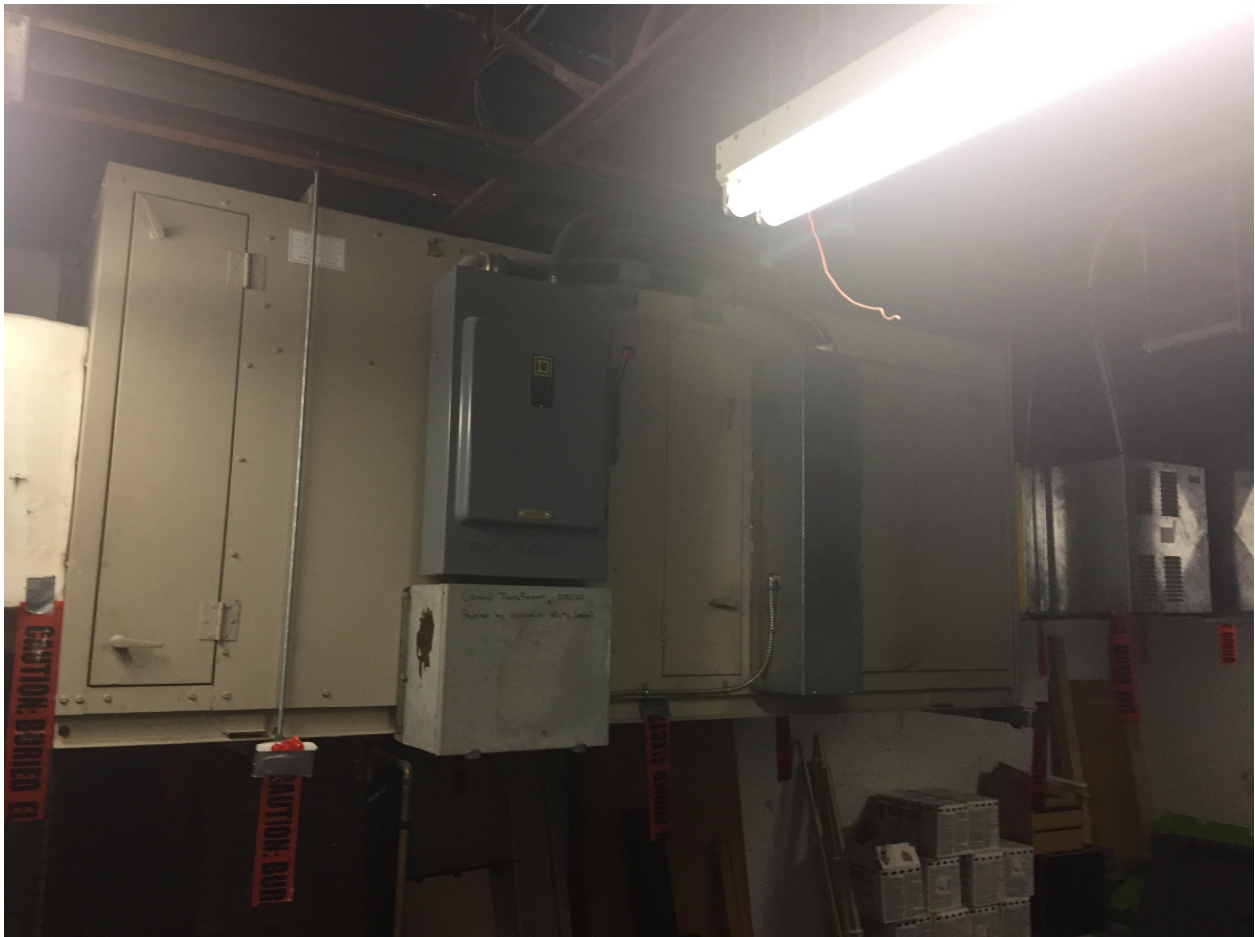
Suite 'B' Basement Photo 10 – HRU unit installed in 1994. This unit is now going on its 25 years. Presently the system is in good working order. However there can not be a determination on its life expectancy.

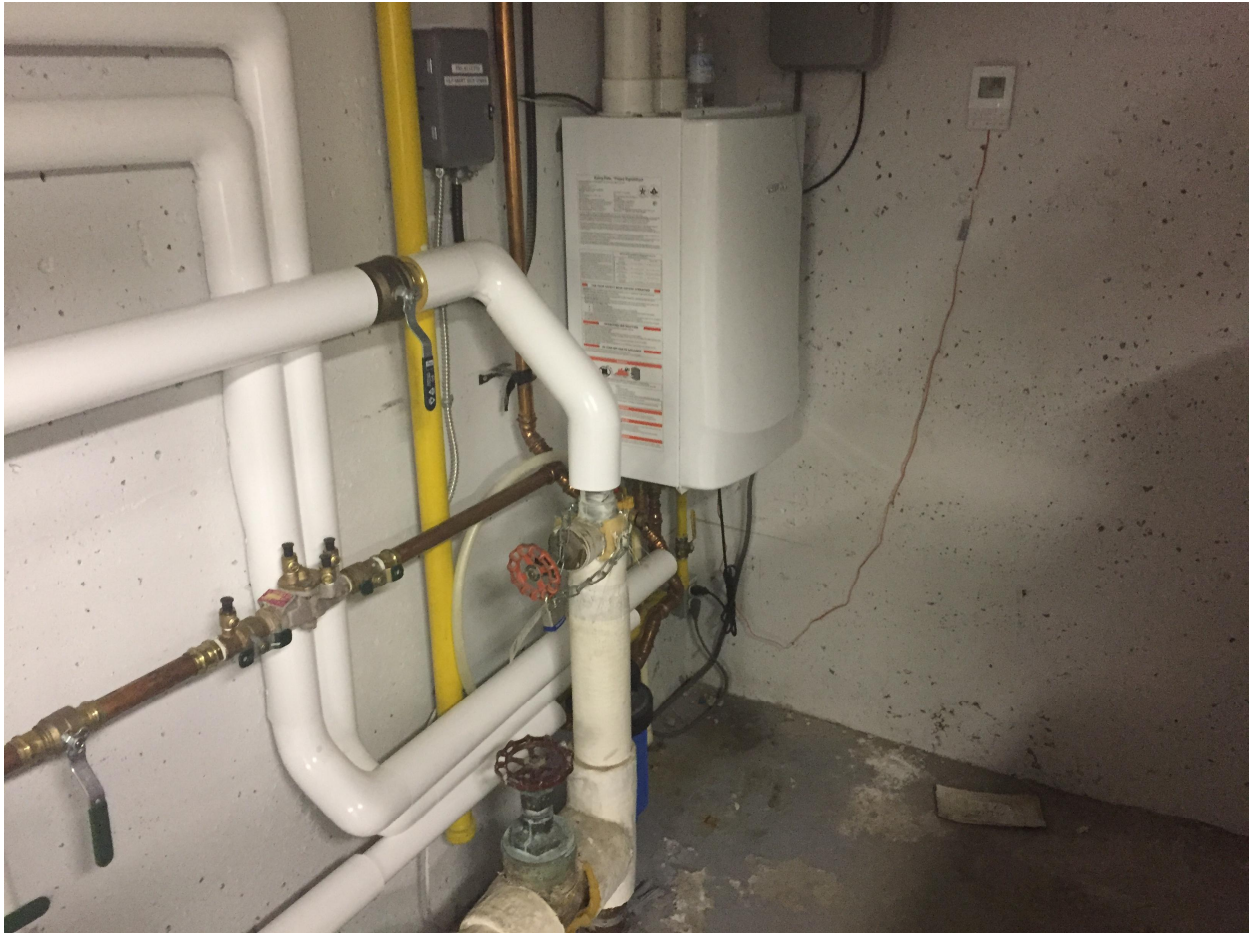
Suite 'B' Basement Photo 11 – Primary source of domestic hot water is a “On Demand” gas fired water heater manufacture by ‘NAVIEN’. Date of installation is unknown.

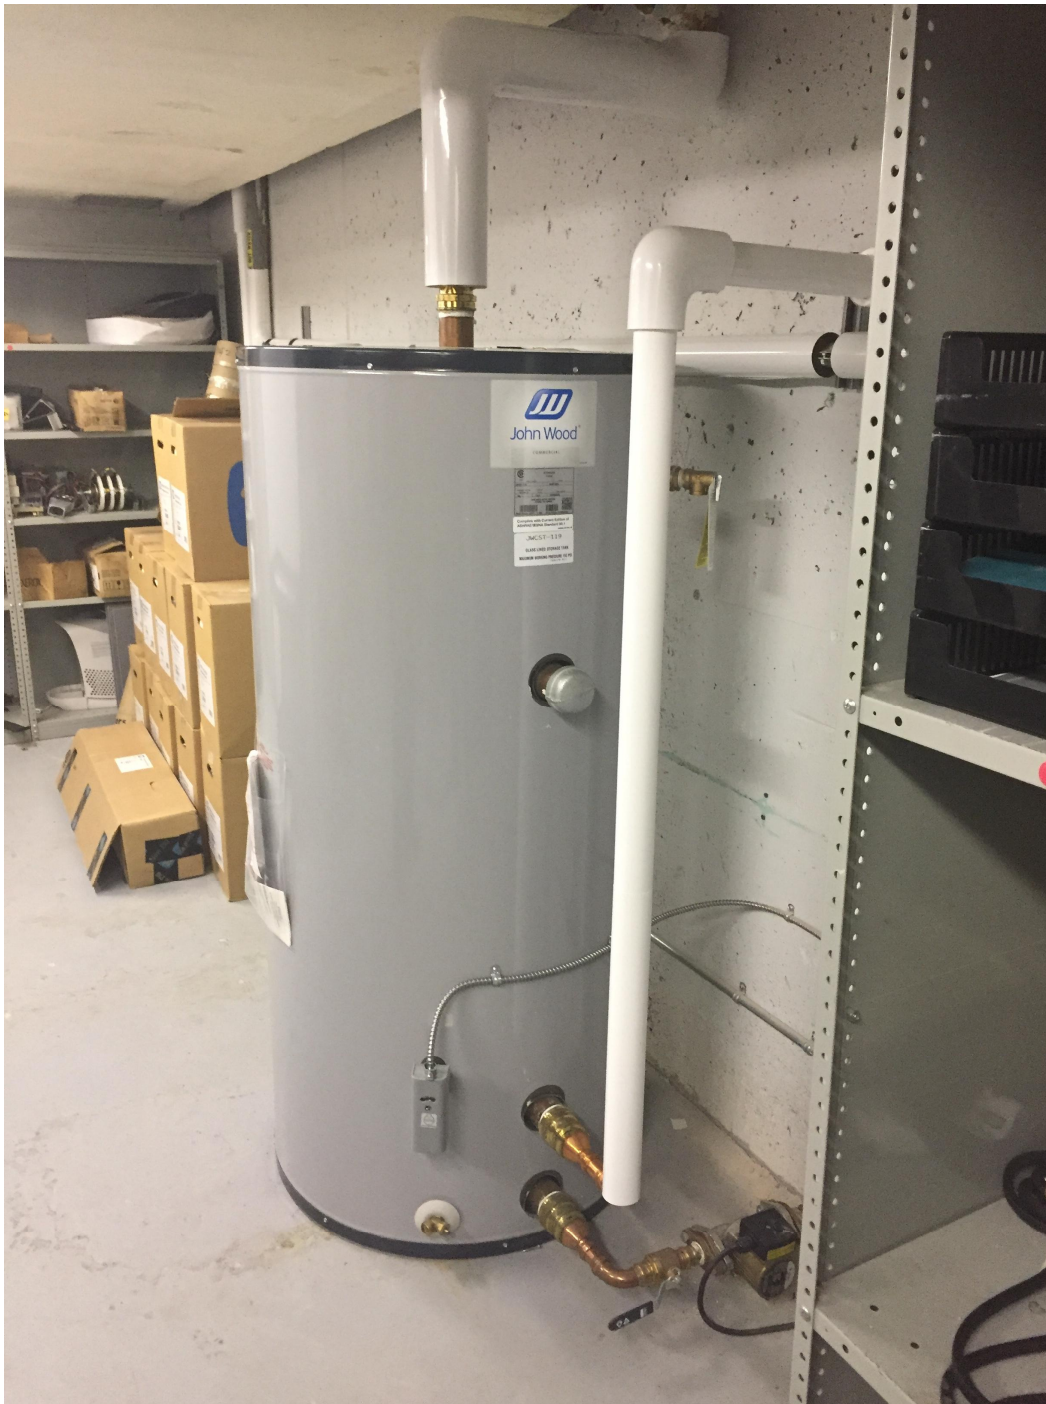
Suite 'B' Basement Photo 12 – Secondary source of domestic hot water is a traditional electric hot water tank. Date of installation is unknown.

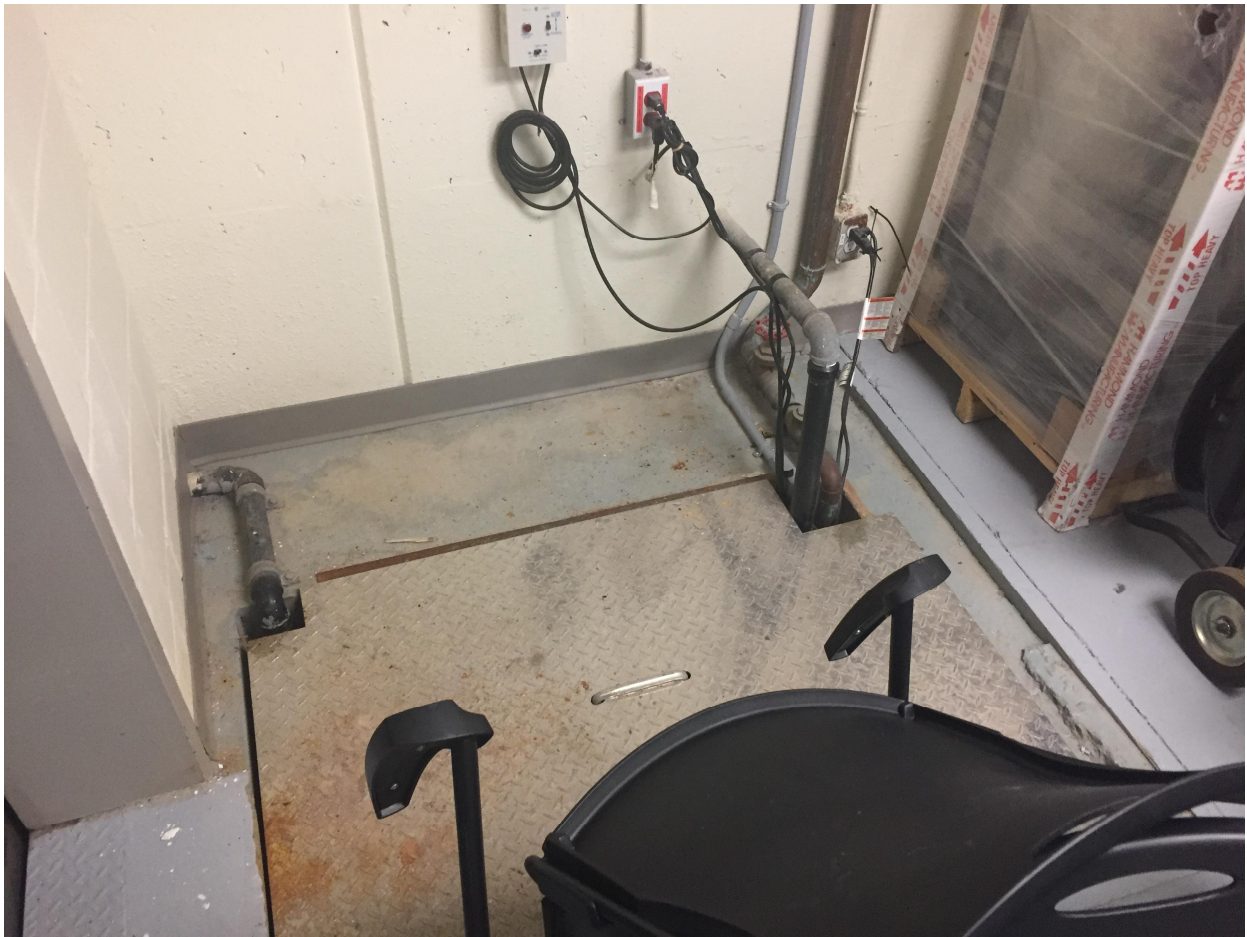
Suite 'B' Basement Photo 13 – Main sump hole complete with pump. There are two sump locations in the basement of Suite 'B'. Both are monitored and are connected into the storm water system.

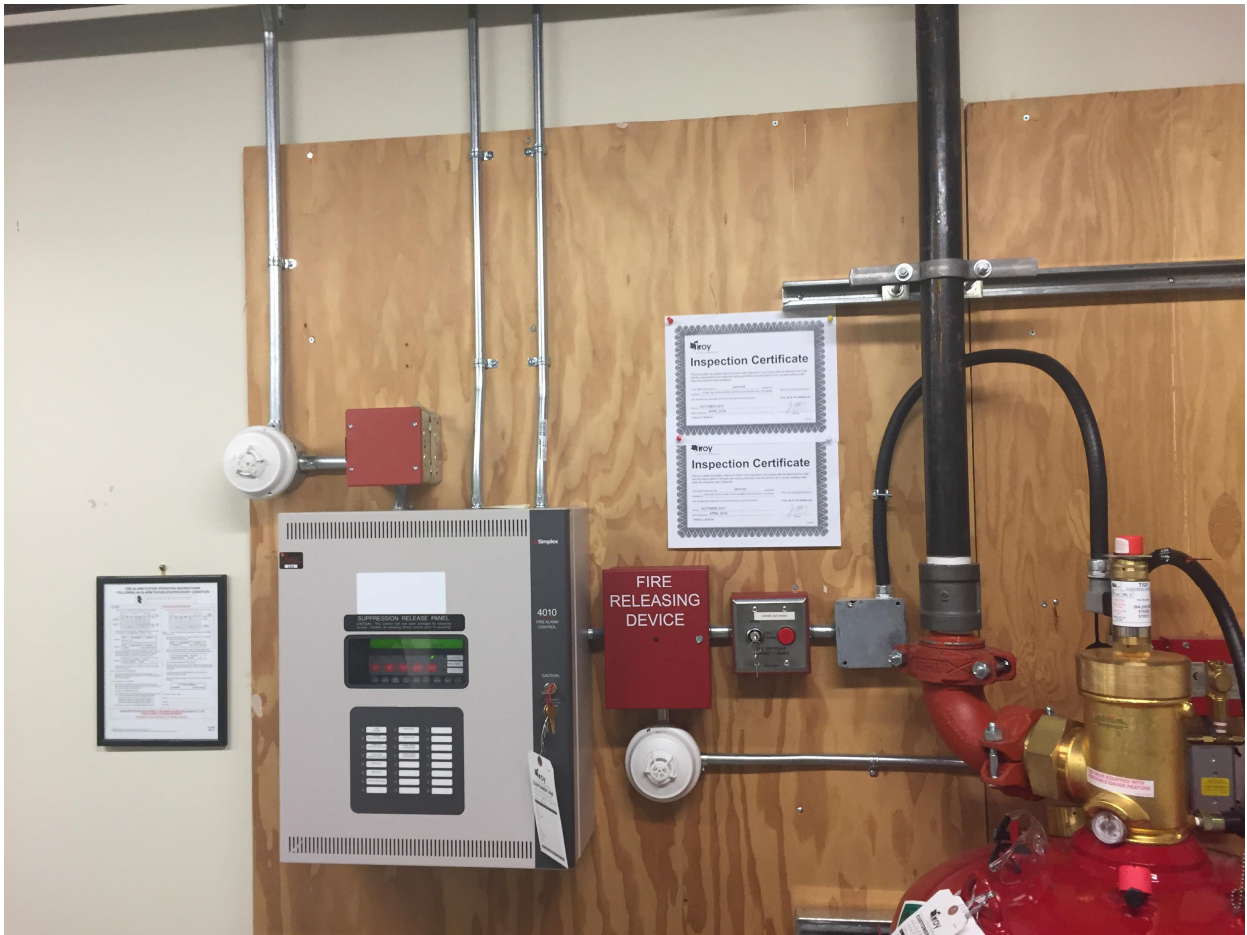
Suite 'B' Basement Photo 16 – Suite 'B' does not contain a sprinkler system, however it does contain a "Dry Chemical" suppression system located within the basement in their general server room.

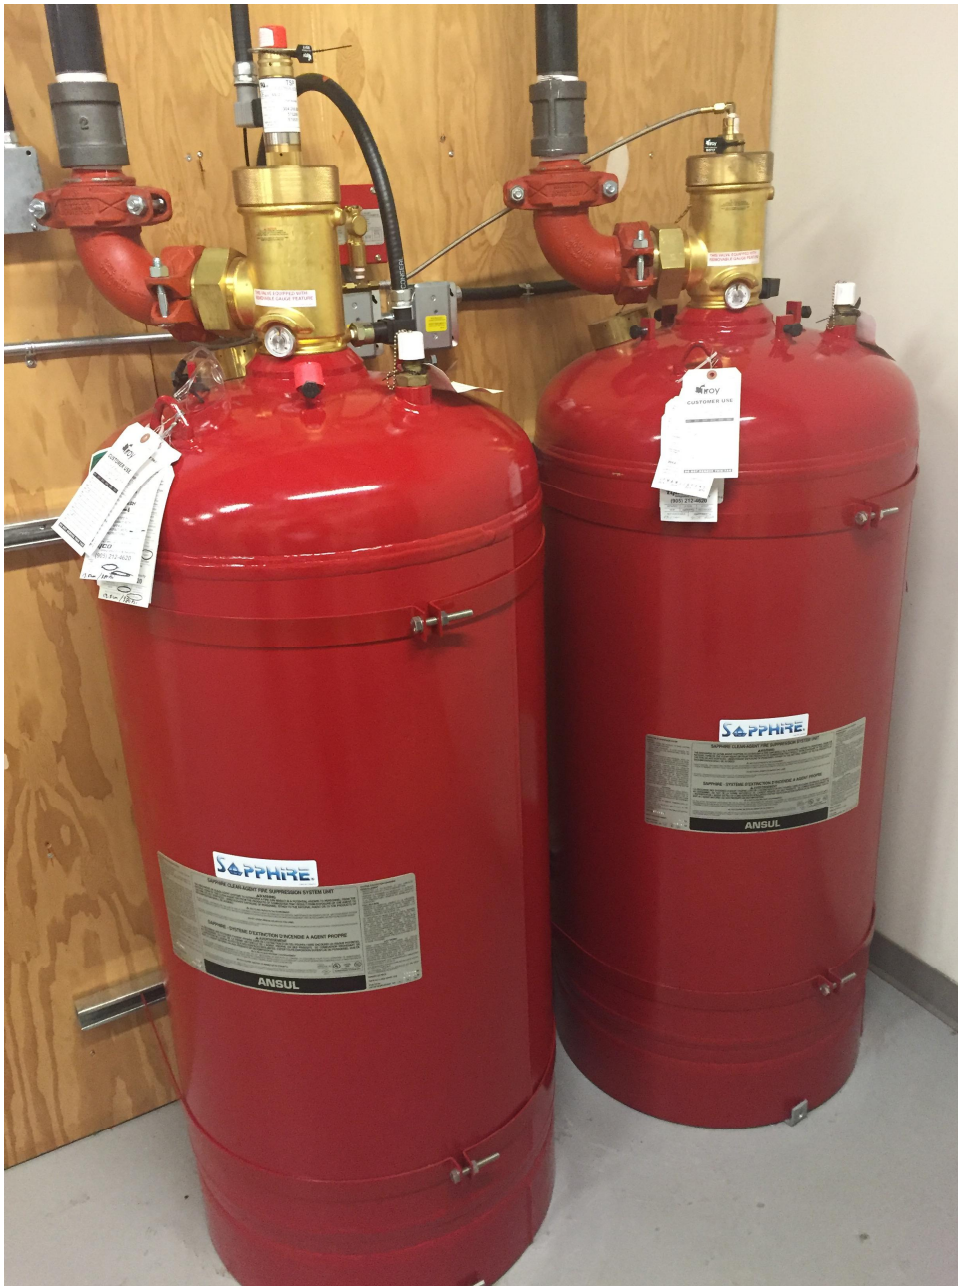
Suite 'B' Basement Photo 17 – “Dry Chemical” suppression system located within the basement in their general server room. See photo 16.

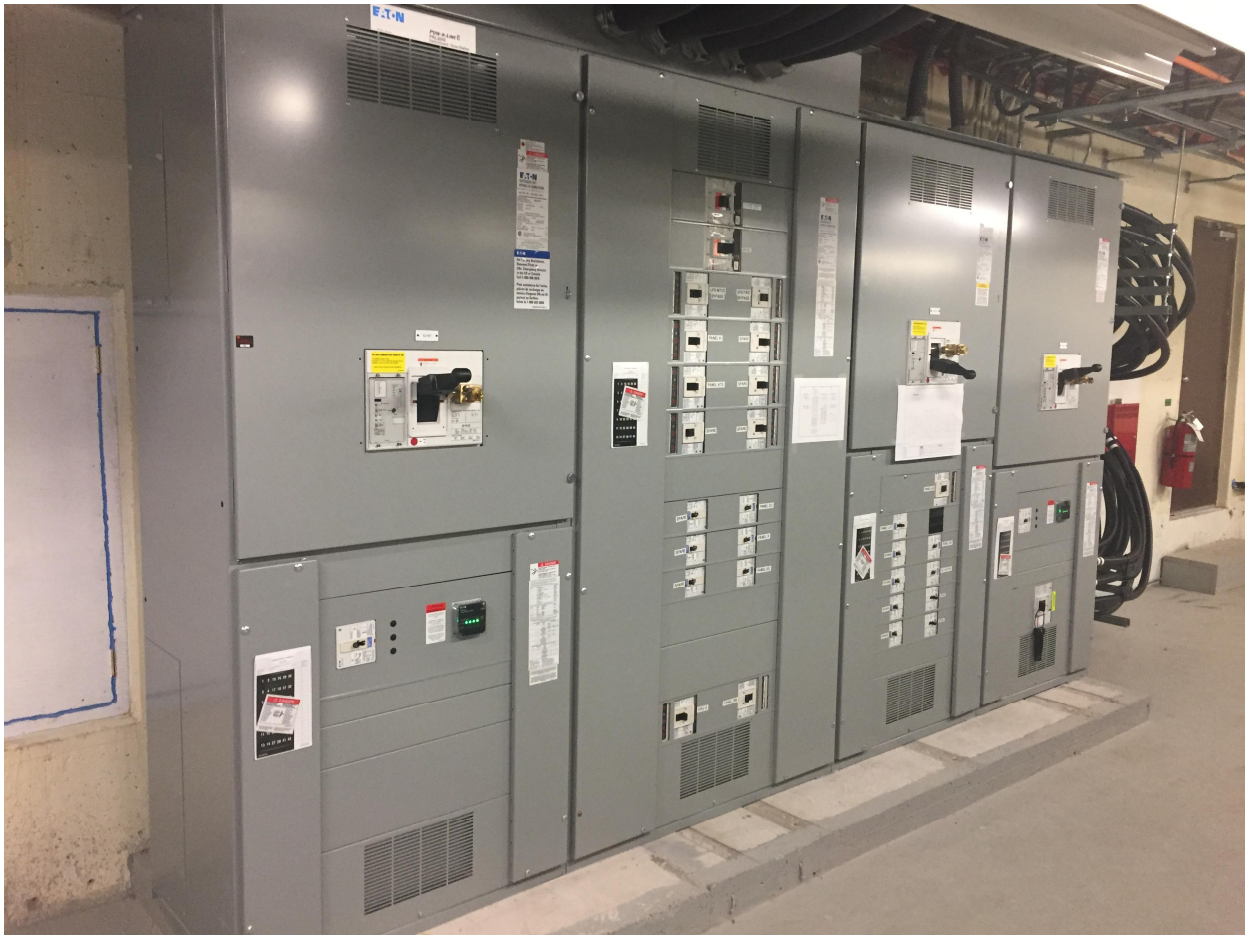
Suite 'B' Basement Photo 19 – Main electrical, switch gear and disconnects located in the server / electrical room. The power enters underground from a pad mounted transformer located on the south east of the property. 1600amp service is provided. Remainder of facility and suites are served and distributed from this main service.

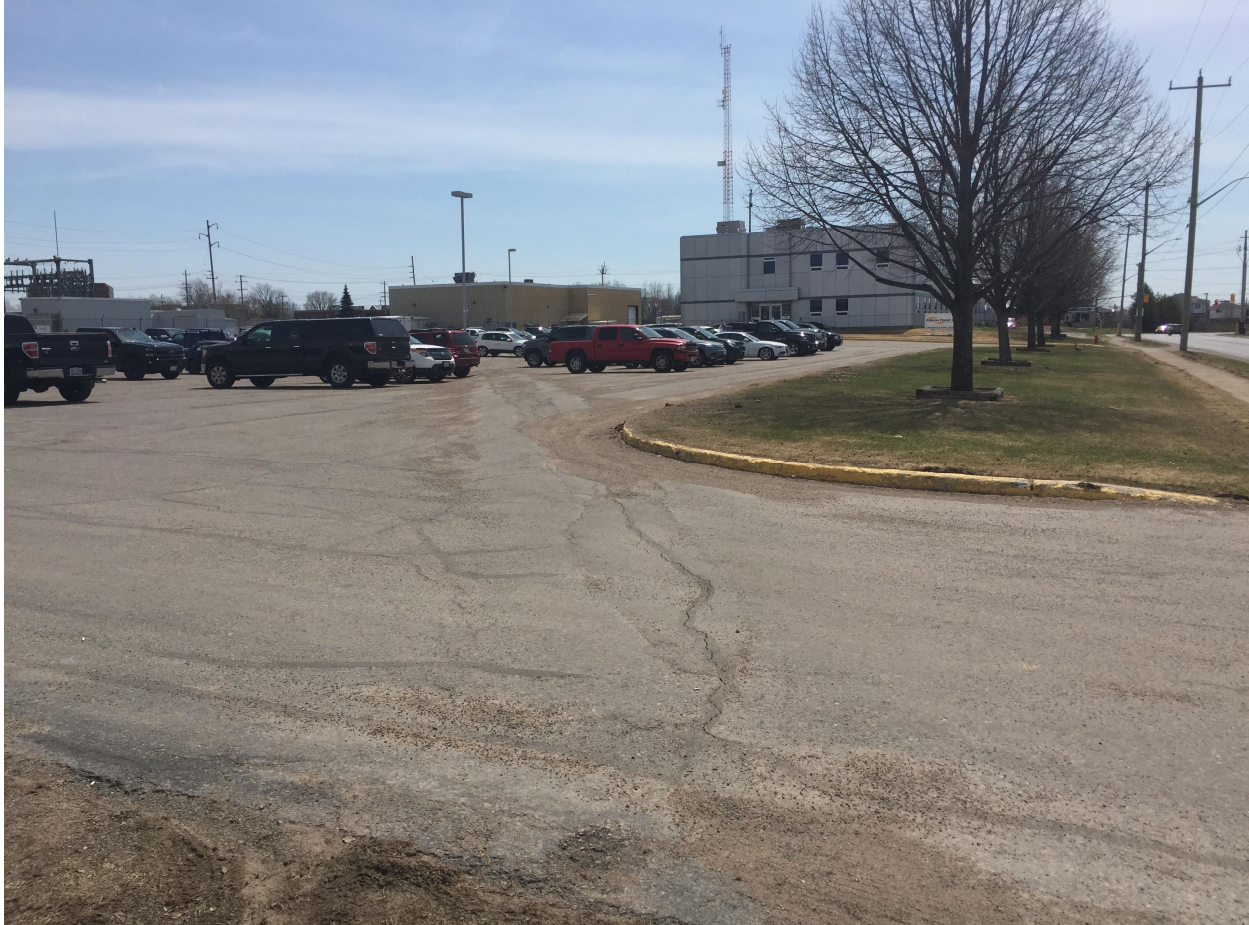
**General Site - Photo 2** – Second Entrance of Main parking area – Looking South. There is obvious settlement of the soils of the parking area around the main storm drain. There is ‘alligating’ and patches in the parking main area.

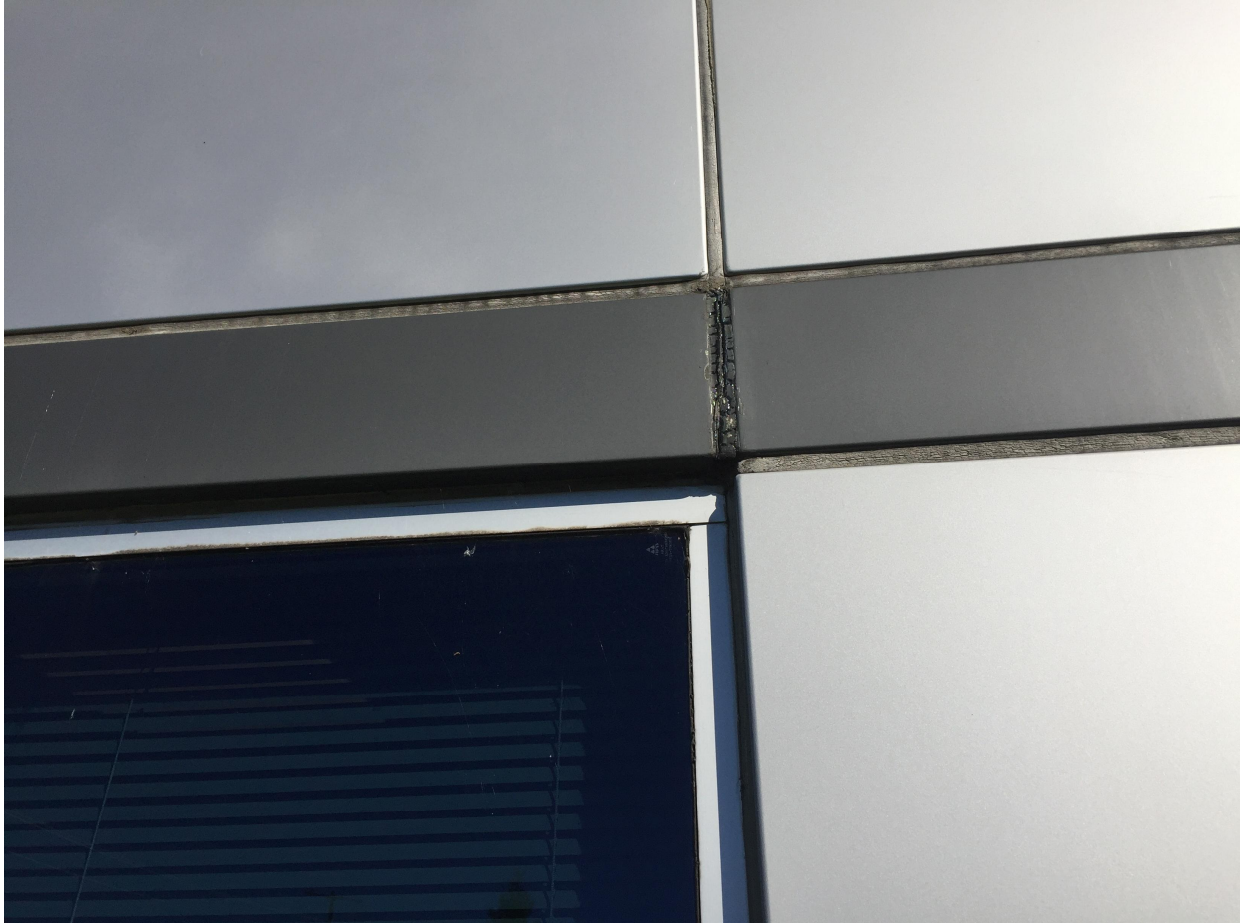
**Suite 'A' – Suite 'B' Typical Exterior – Photo No.3** - Exterior view of the exterior aluminum panel system and caulking failure. A coloration seemed to exist between the accent band (brown color panel) and the location of leaks. It may be hypothesized that the color of the caulking or its chemical makeup was not as resilient as the lighter shade of caulking.

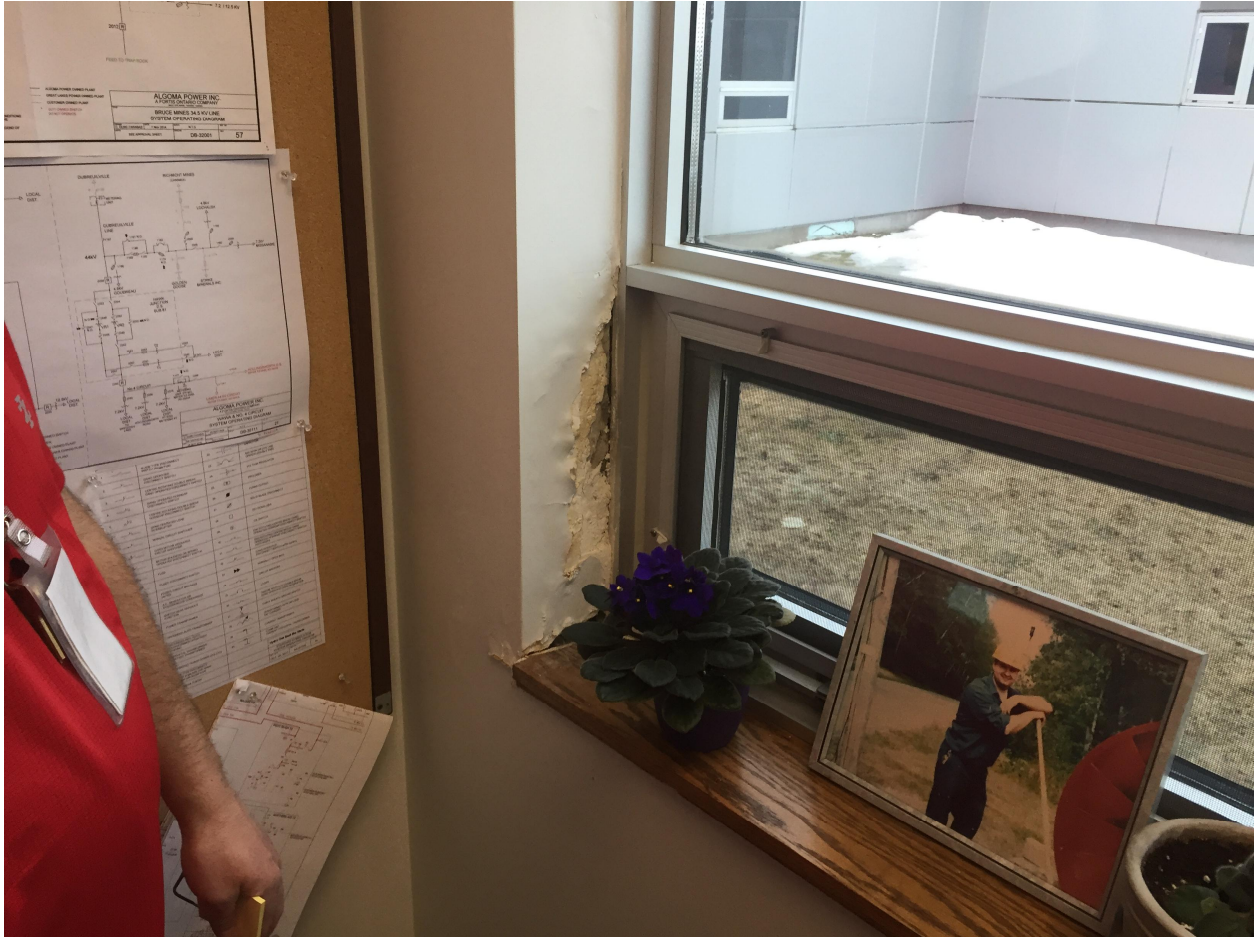
**Suite 'A' & Suite 'B' – Typical Interior Windows - Photo 4** – Water damage at window jamb. Looking south east (API). There has been an ongoing issue in regard to the exterior aluminum panels and water damage at some of the window sills, heads and jambs. A simple report had been issued to the former GLP Transmission in regard to the building envelope. The exterior wall cladding (aluminum panels) is a “WET SYSTEM”, which relies upon exterior caulking between the panels to prevent water infiltration. After years of exposure to the elements the caulking fails. The caulking has a finite life expectancy. As such water enters the building. The fix is relatively easy but is time consuming and expensive due to the repairs laborious nature. Both Suite 'A' and Suite 'B' should be schedule for rotating replacement of the caulking.

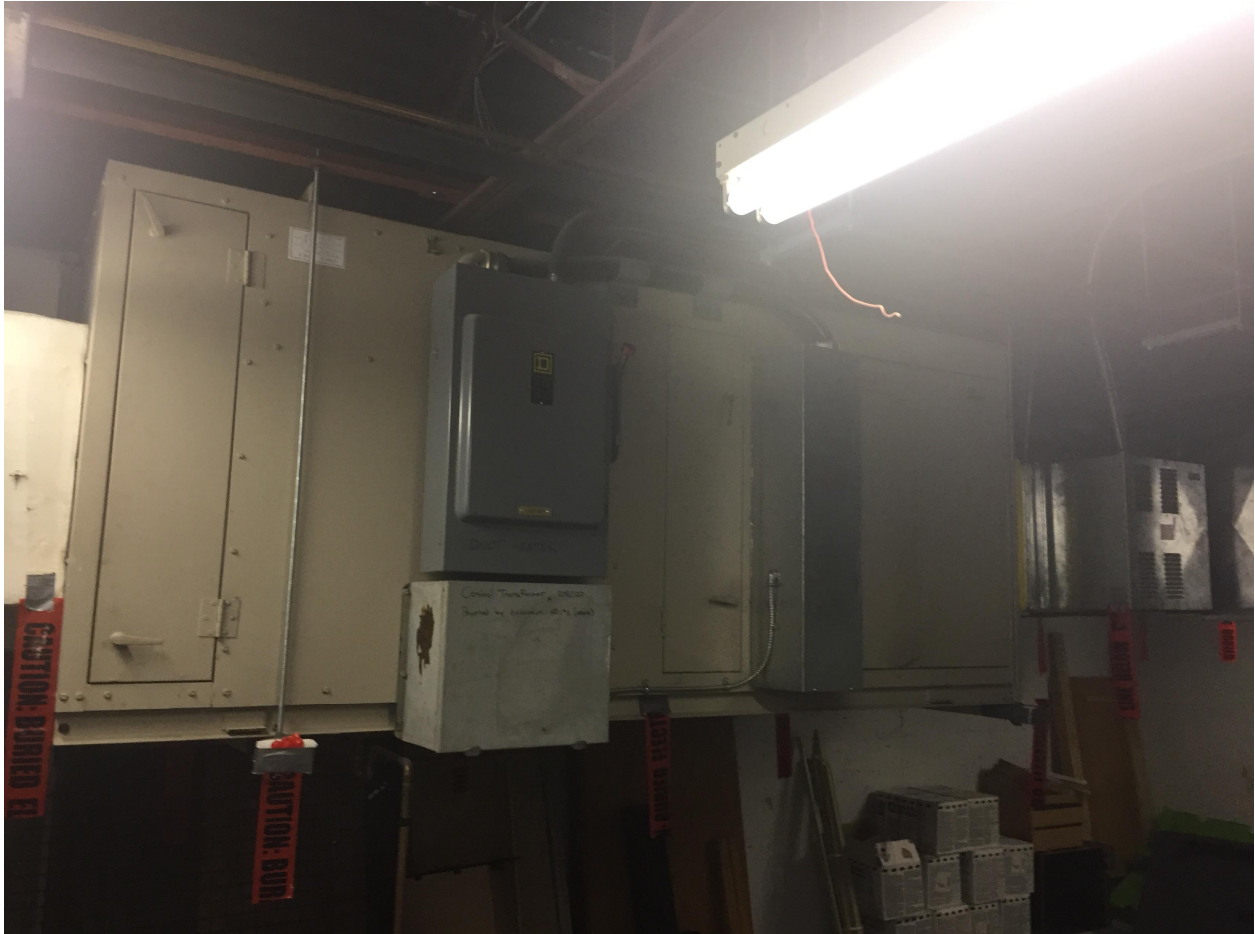
Suite 'A' & Suite 'B' Basement Photo 5 – HRU unit installed in 1994. This unit is now going on its 25 years. Presently the system is in good working order. However, there cannot be a determination on its life expectancy.

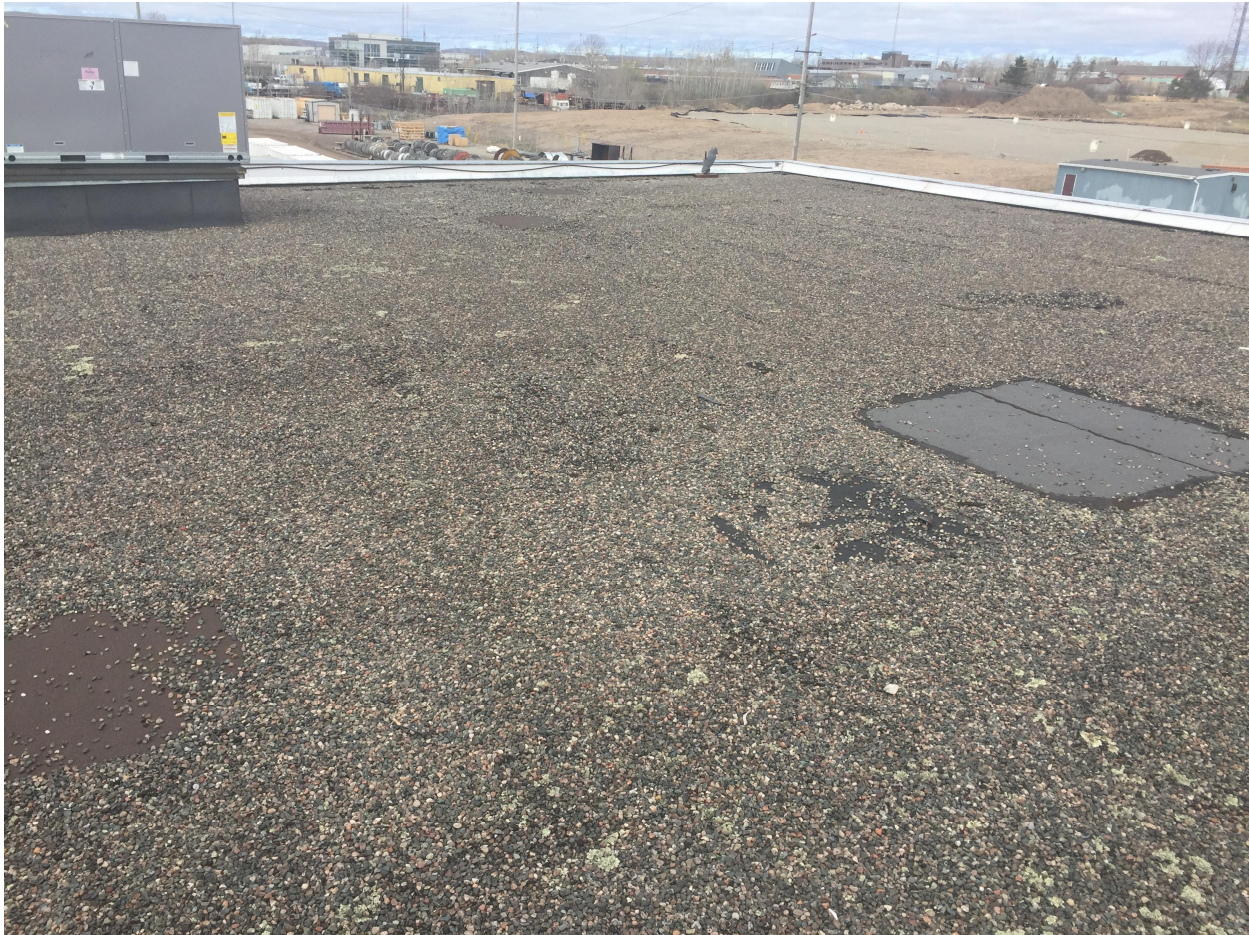
Maintenance Garage / Truck Shed Photo 6 – Exterior photo taken from the roof of the garage. The existing roof is a multi-ply hot mopped roof with gravel ballast. Several patches have been made to the roof. It is our belief that the roof could possibly be original to the building, placing it at almost 40 years old. As such given its age, condition and on-going maintenance issues it is felt that this roof needs replacement. This roof does not have an additional 5 years of acceptable performance and should be replaced when funds are available.

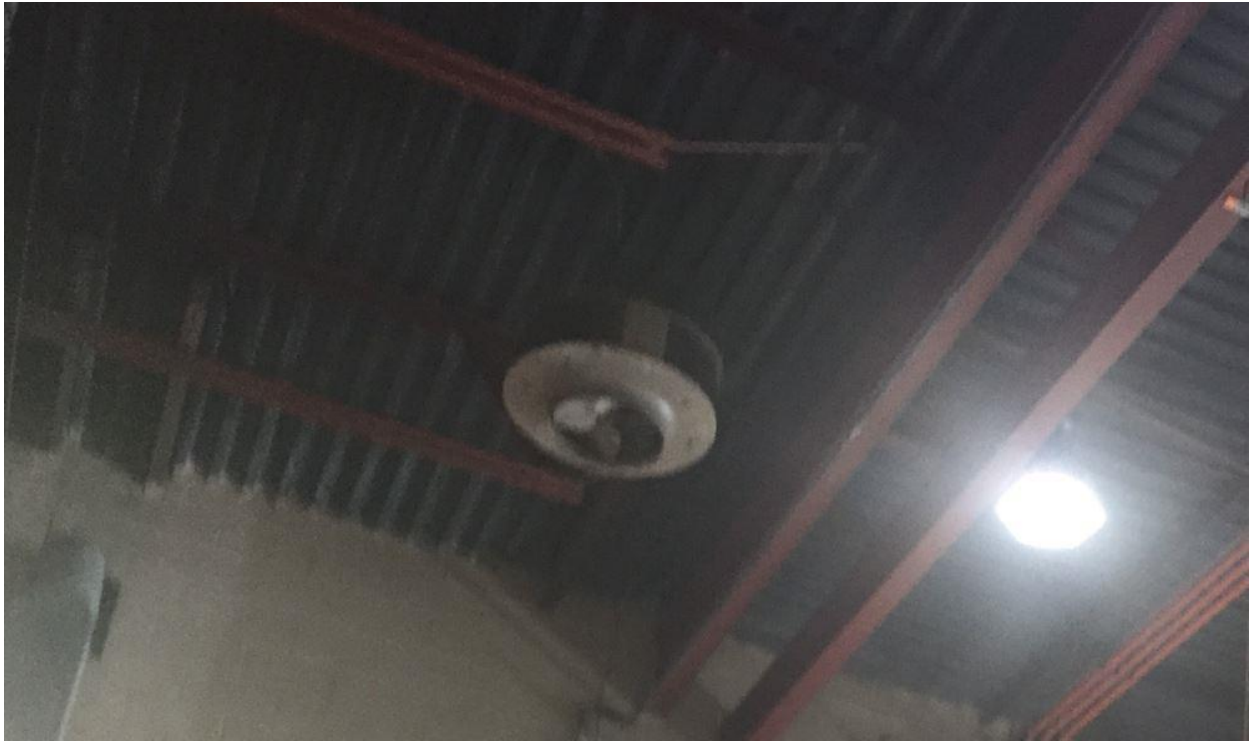
Maintenance Garage / Truck Shed Photo 7 – Interior photo taken of the interior forced air electric ceiling heater. There are approximately 6 of these units. There are approximately 6 additional unit heaters located at the O.H doors. These units are not efficient and may not operate as originally installed. They also do not provide any cooling. Date of installation may be close to the construction of the building (circa 1980).

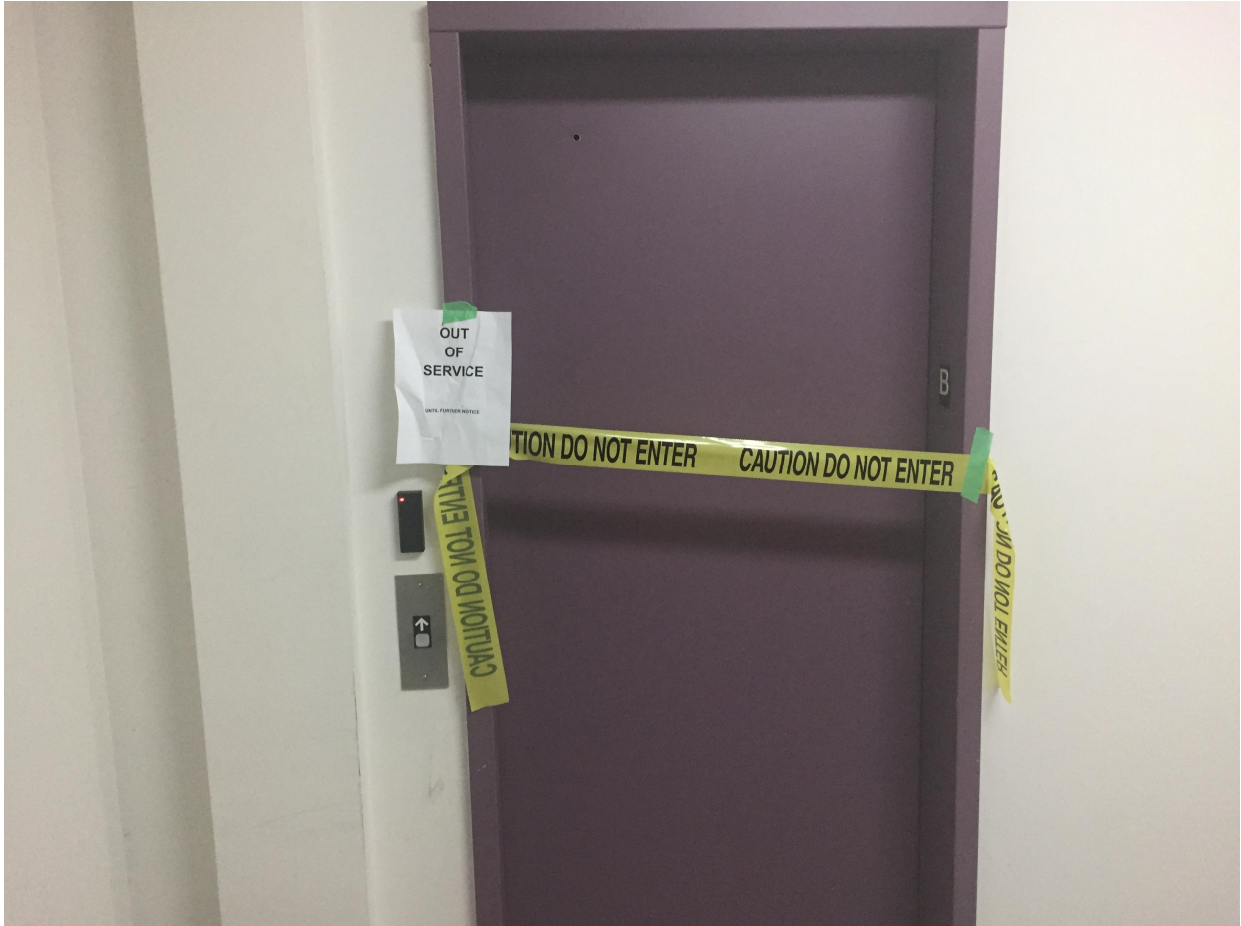
Suite 'A' Photo 9 – Passenger Elevator. Due to mechanical issues the elevator has been temporarily taken out of service.
