Building Conditions - Summary Report  
For Hydro One / API, Suite 'A'  
2 Sackville, Sault Ste. Marie, ON  
May 2018

**Title: Buildings Condition Summary Review 'Stores' – Phase 1**

**Project: 2 Sackville Road, ON**

**Title: Buildings Condition Summary Review Suite 'A' – Phase 1**

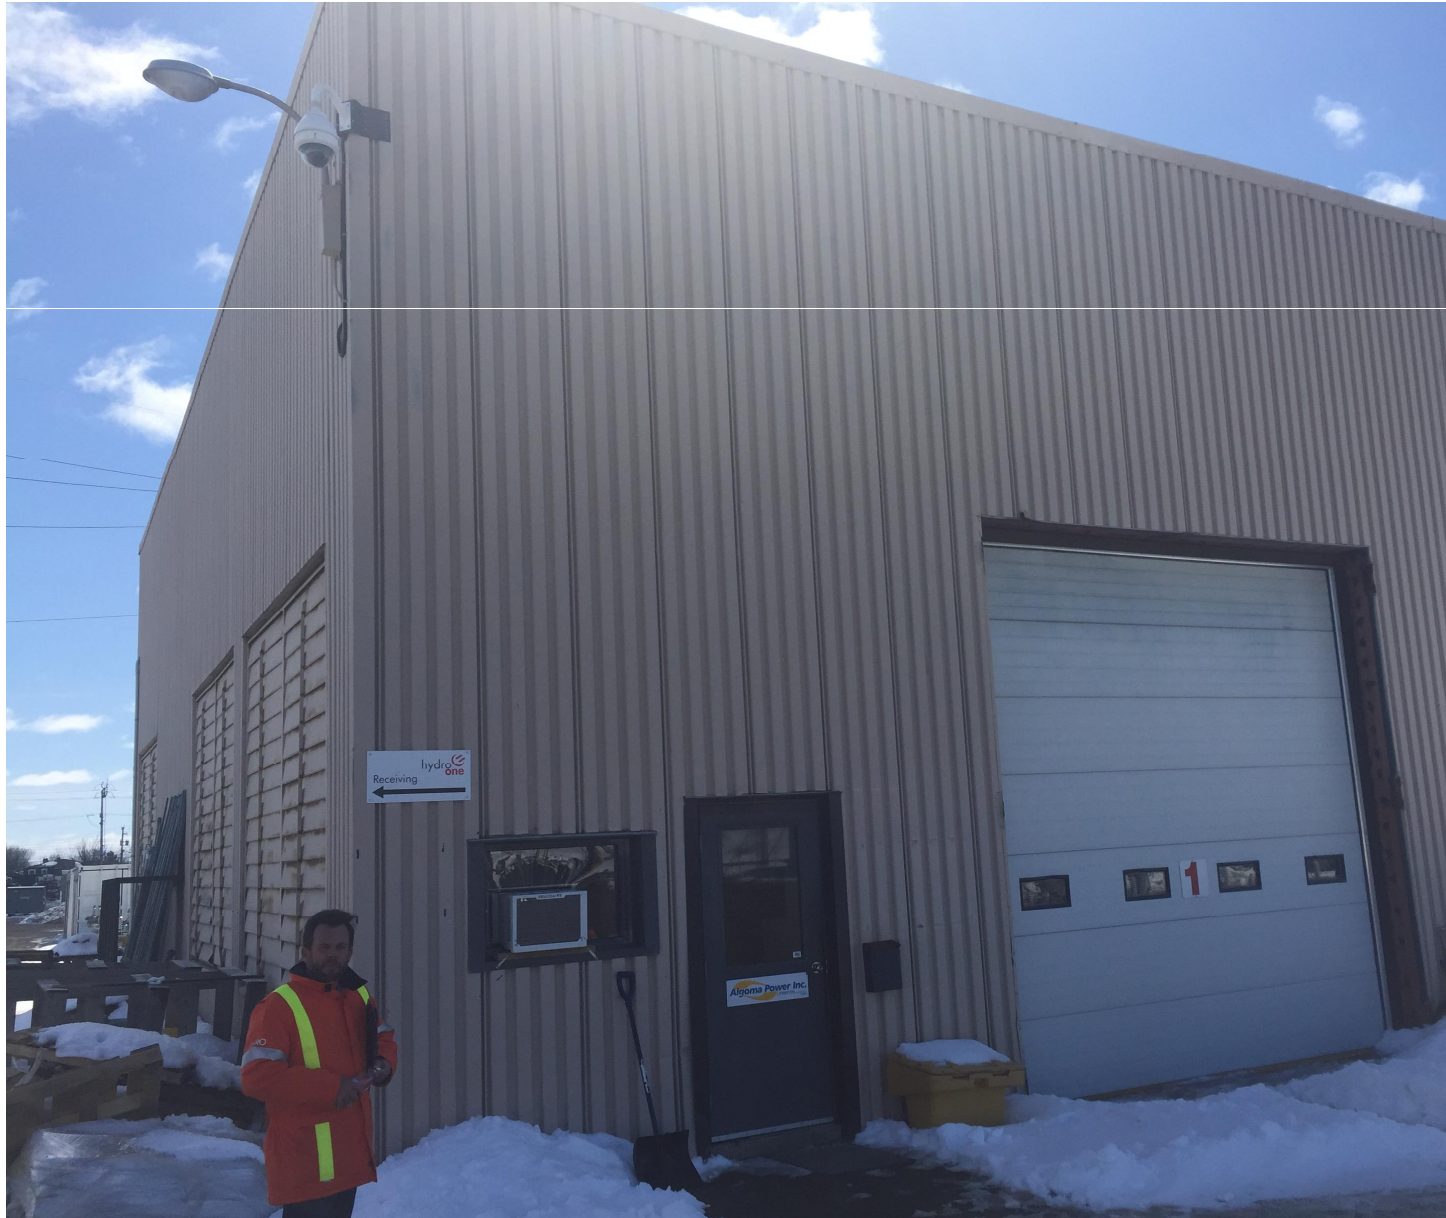
Stores Photo 2 – Front Entrance – Looking South. Door leading to interior off addition. Note window air conditioner.

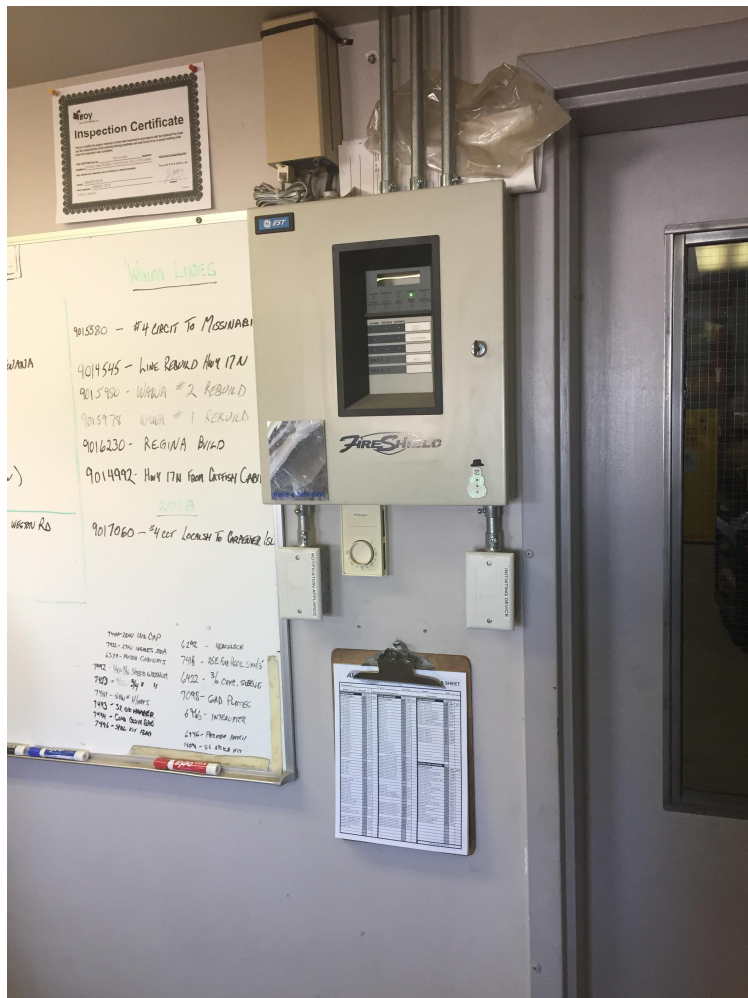
Stores Photo 3 – Entrance door from the office addition into the open storage space. Note the fire alarm and thermostat. The thermostat controls a 4' baseboard heater.

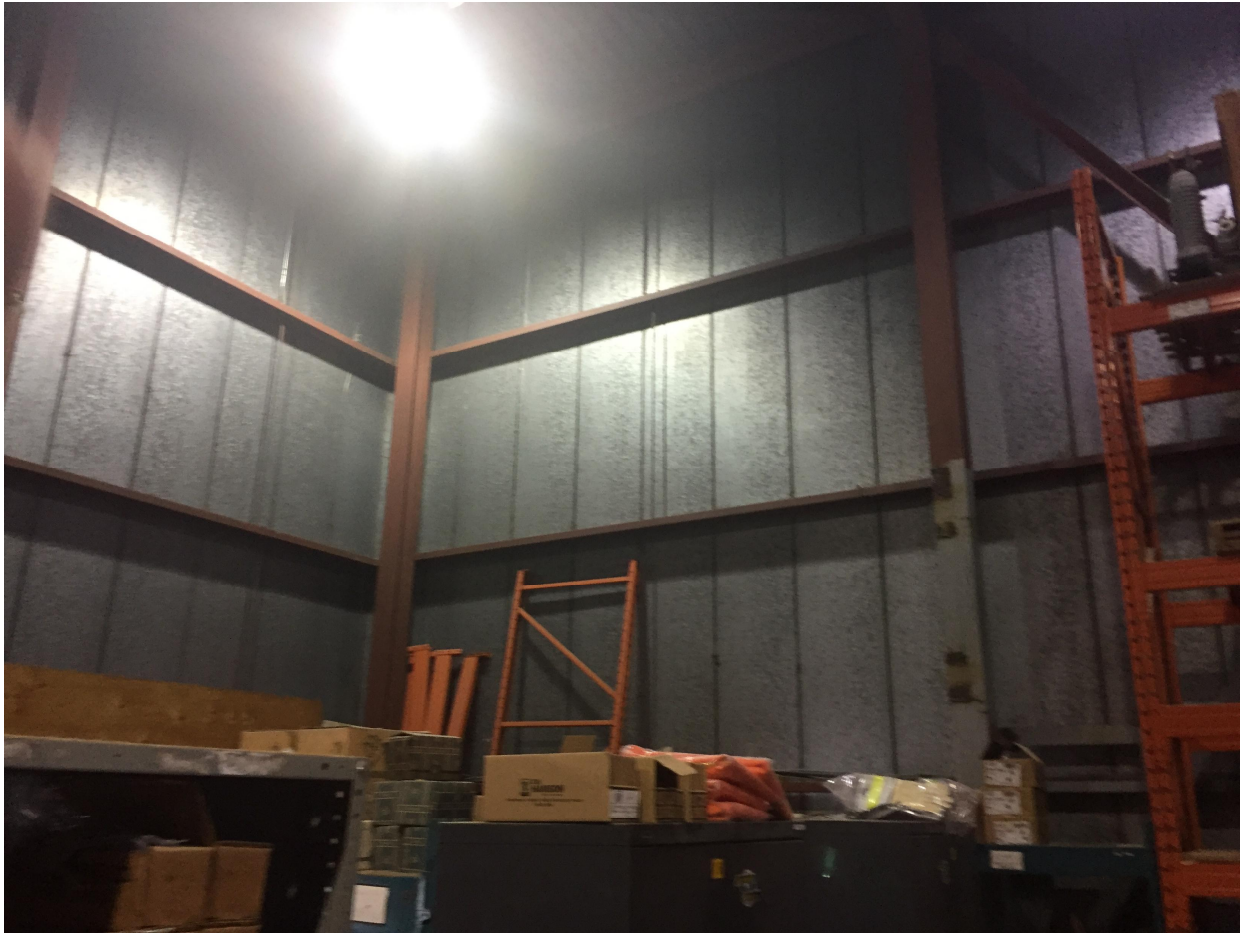
Stores Photo 4 – General structural framing and interior view of the exterior vertical metal siding, c/w channel girts.

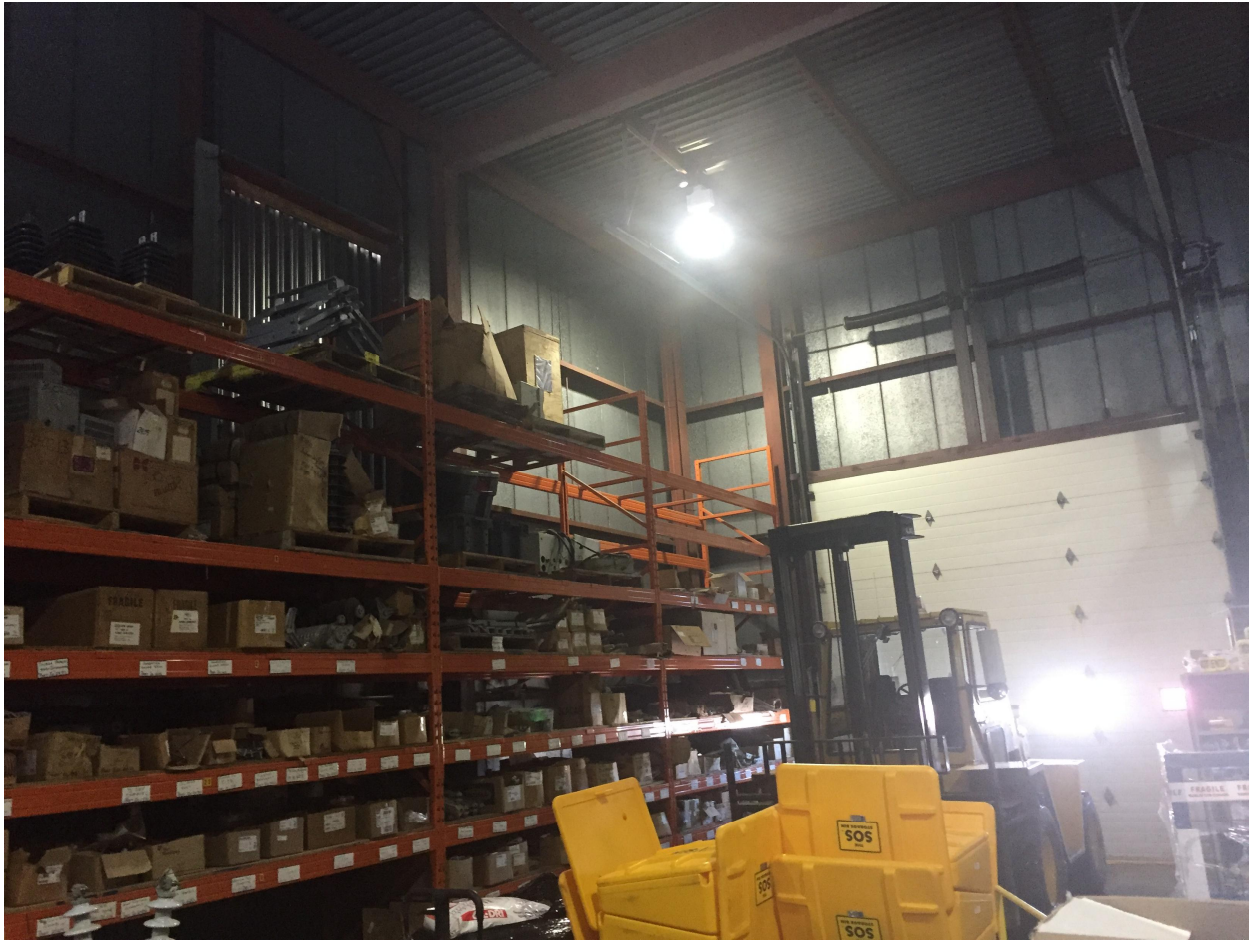
Stores Photo 5 – General structural framing and interior view of the exterior vertical metal siding, c/w channel girts as well as interior pre-engineered shelving units. OH 12'w x 14'h door complete with electric and manual operator.

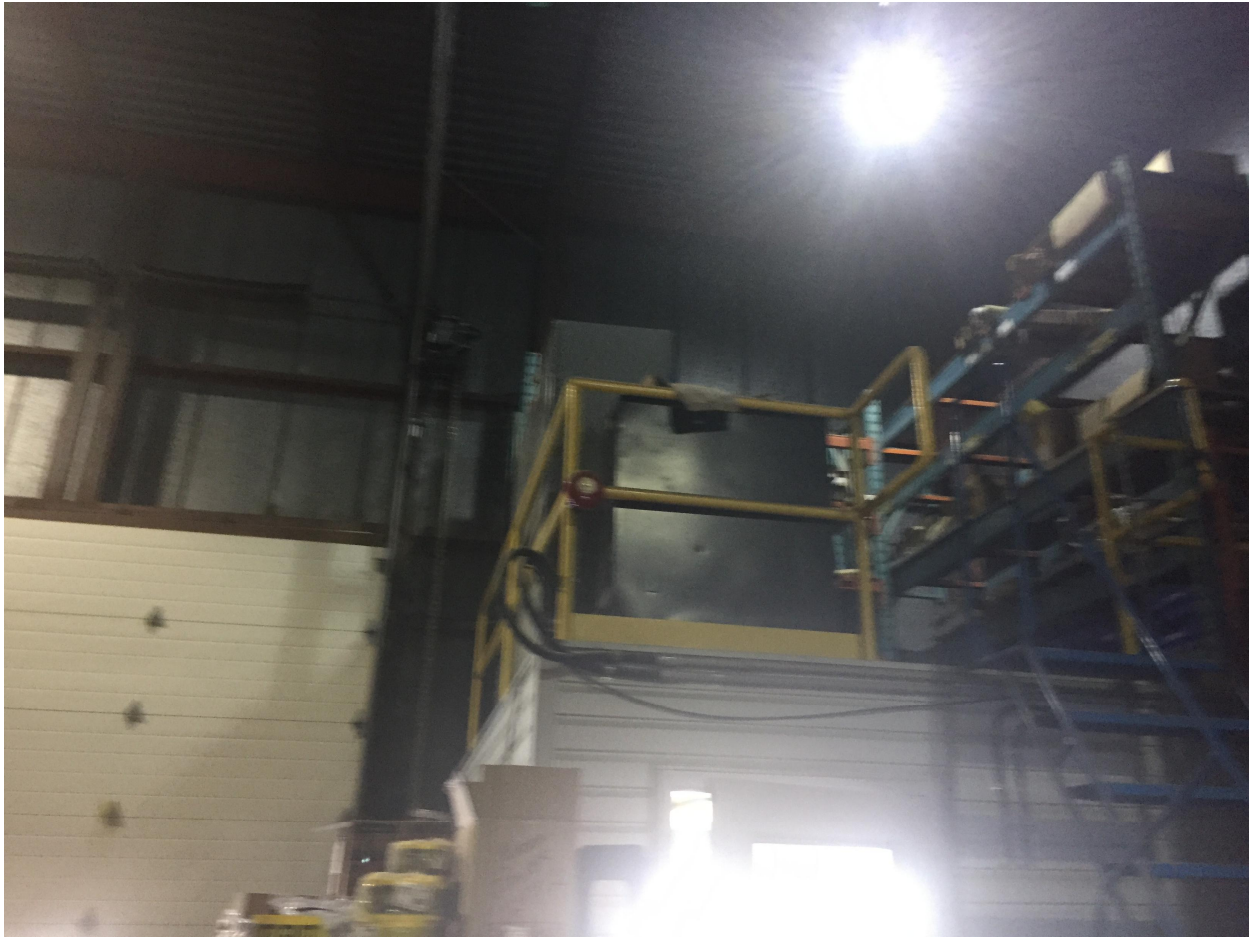
Stores Photo 6 – General view of the office addition and ladder access to mezzanine.

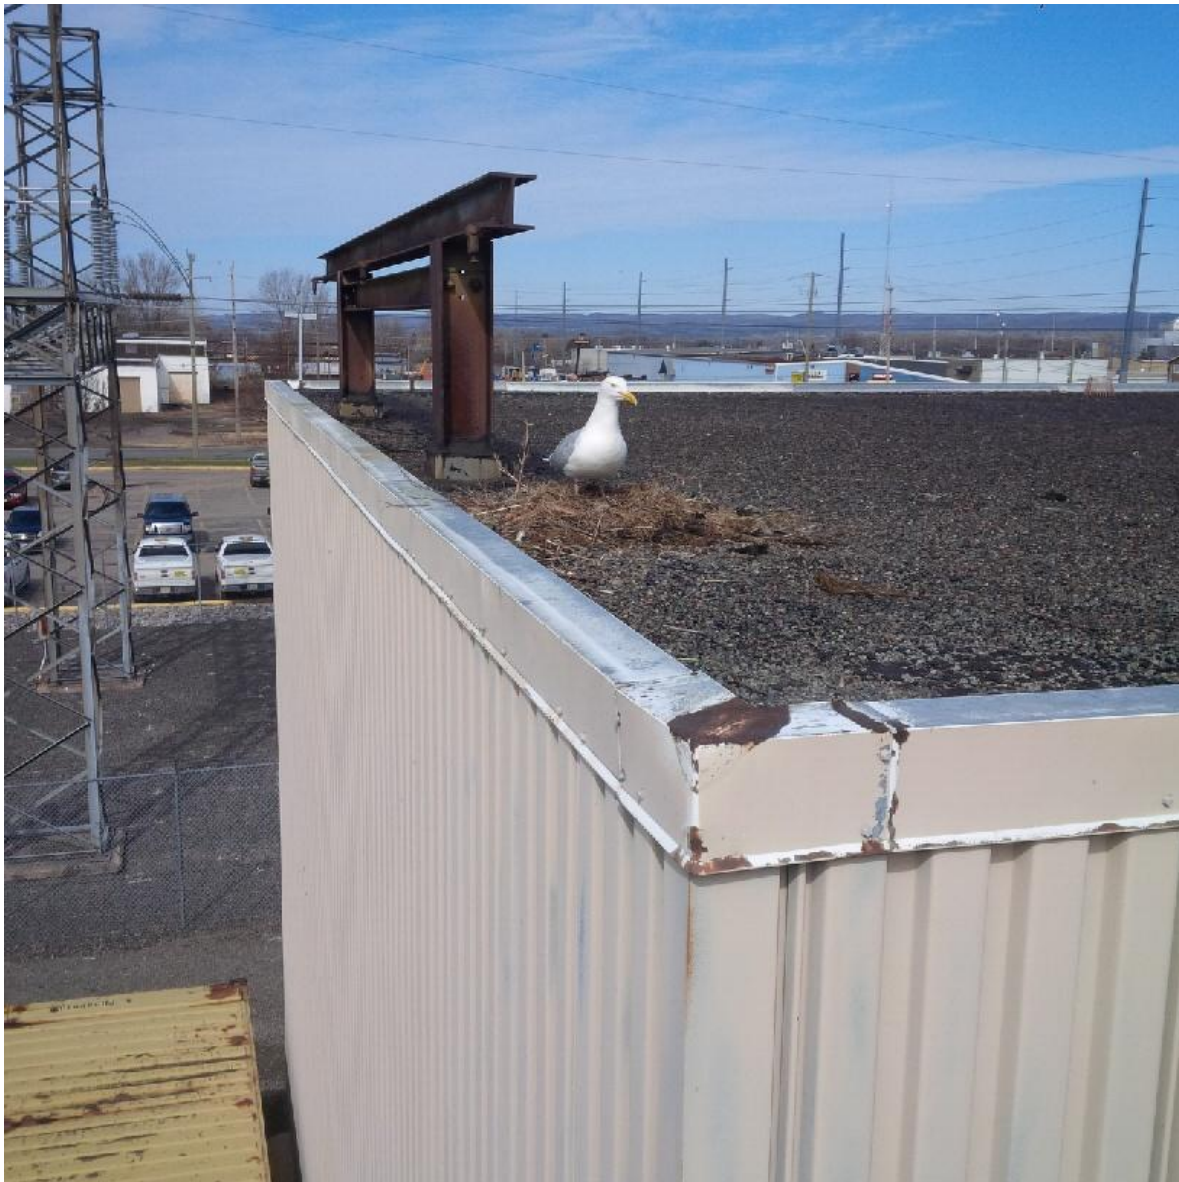
Stores Photo 8 – Photo of the Roof. The roof assembly is a built-up gravel ballast type roof. The roof appears to be original to the building construction. The roof has reached a level to which it shall require replacement within the next 2 years.

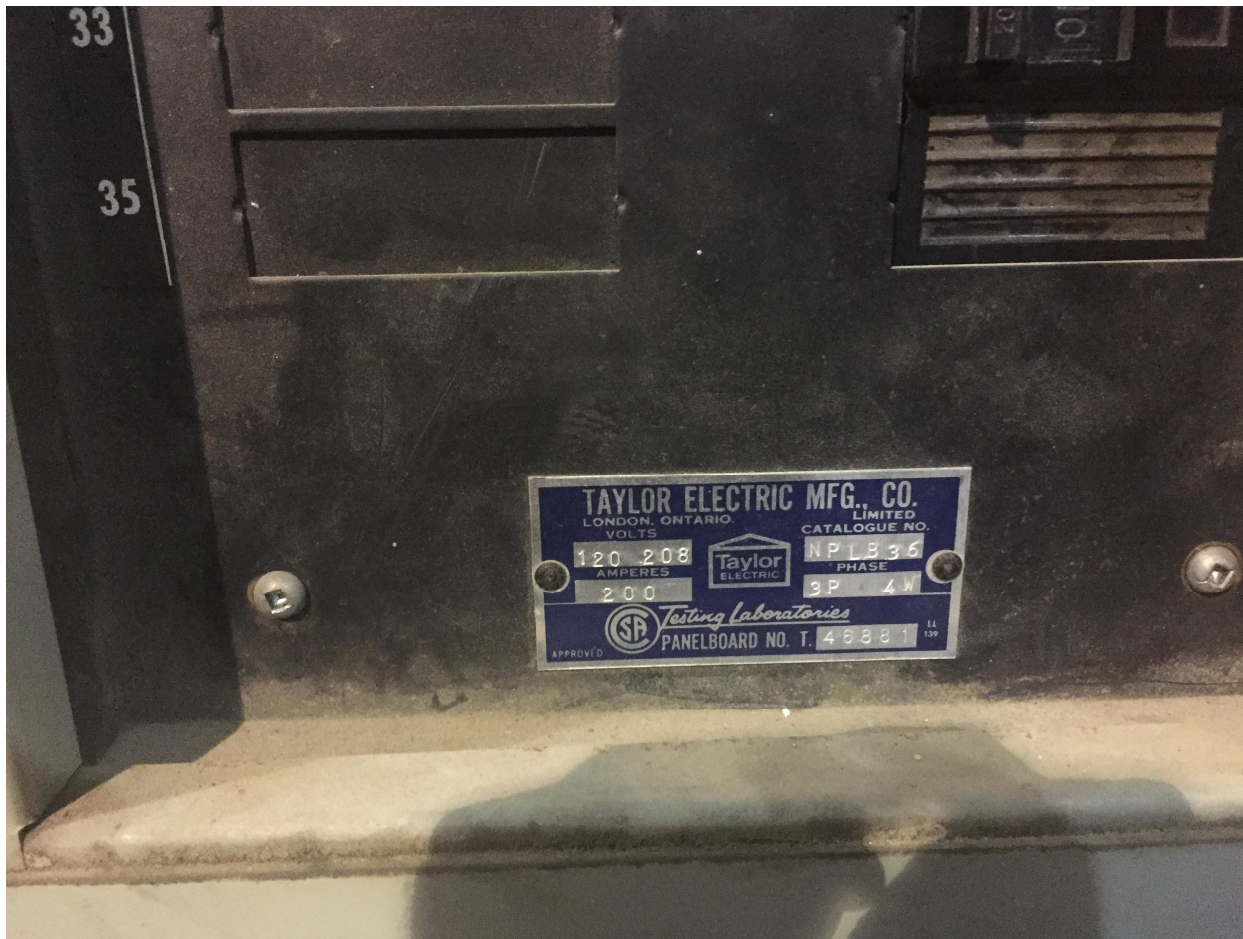
Stores Photo 9 – Photo of one of the two electrical panels. There are 2 – 200amp, 120/208v panels.

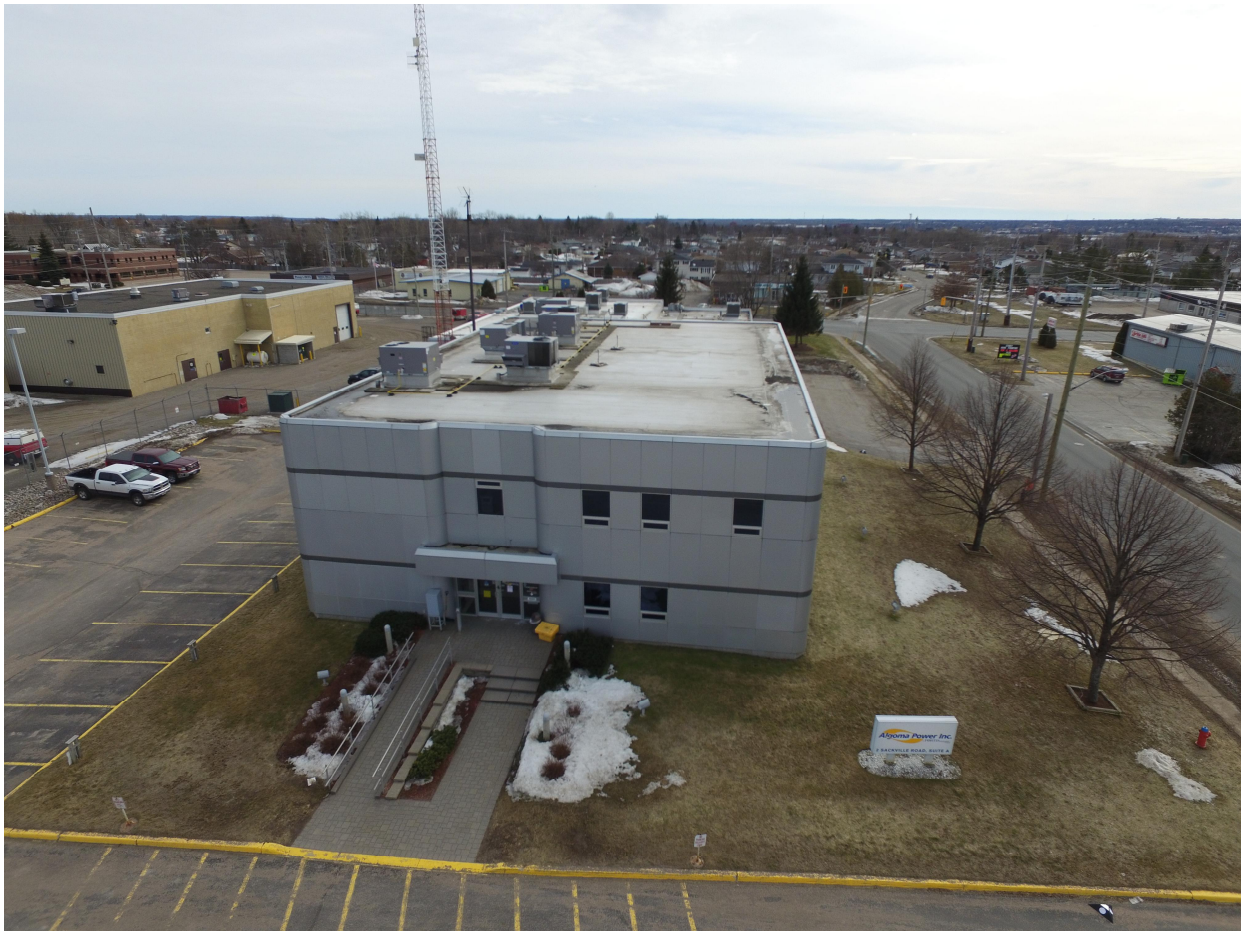
Suite 'A' Photo 2 – Aerial View looking south, prior to the re-roof that was completed in 2016.

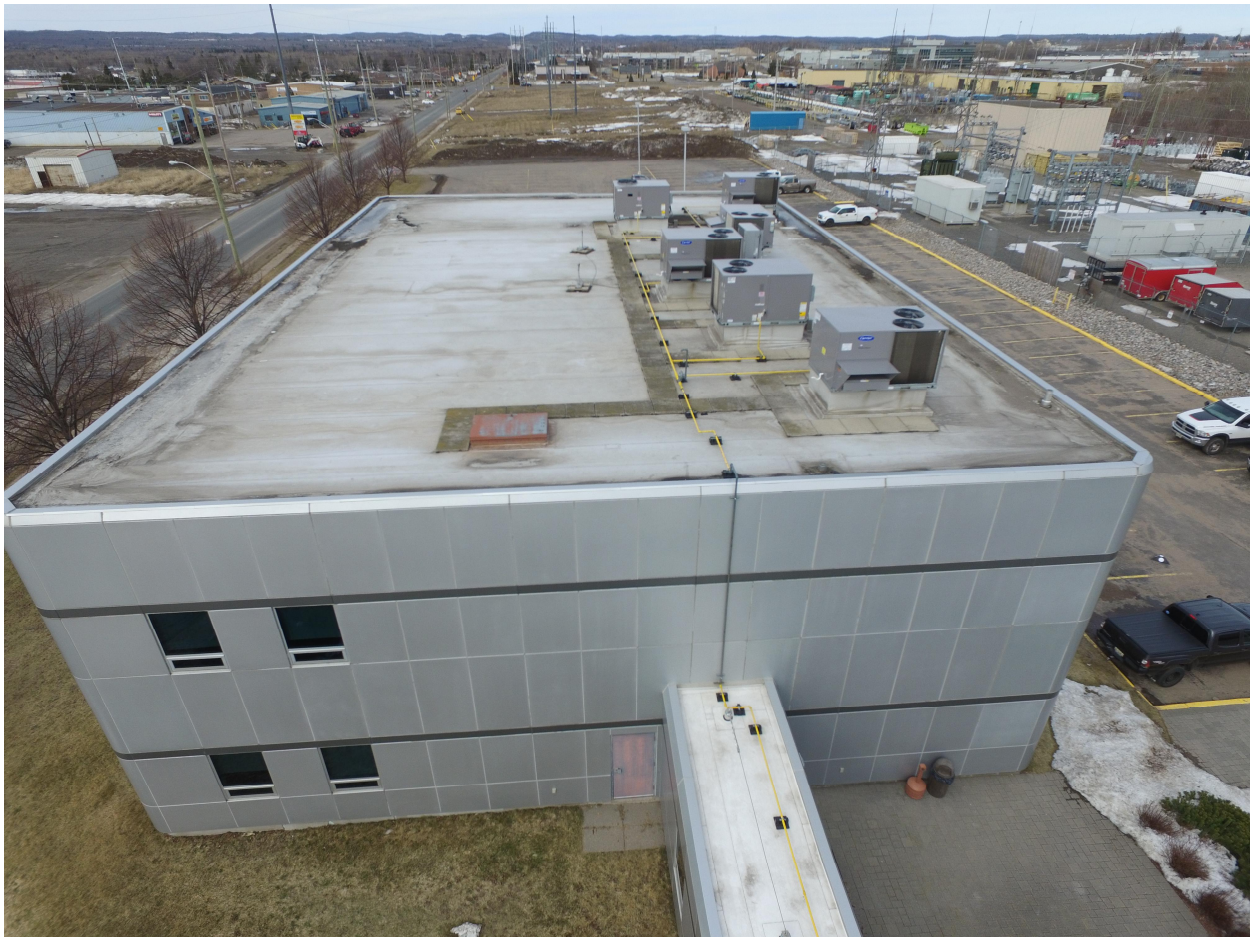
Suite 'A' Photo 3 – Aerial View looking north, prior to the re-roof that was completed in 2016.

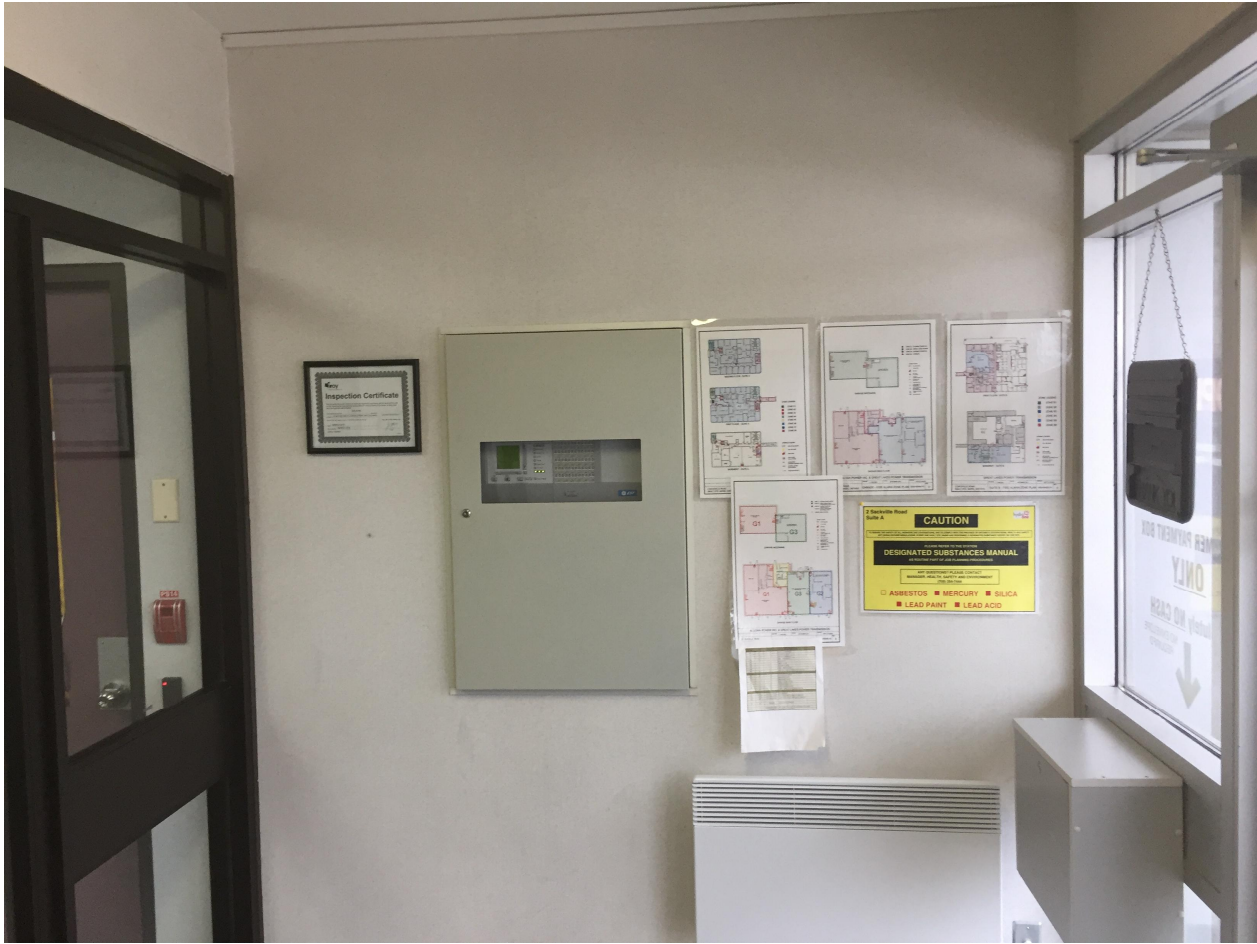
Suite 'A' Photo 6 – Main Floor Vestibule / Fire Alarm Station – Annunciator Panel. (API)

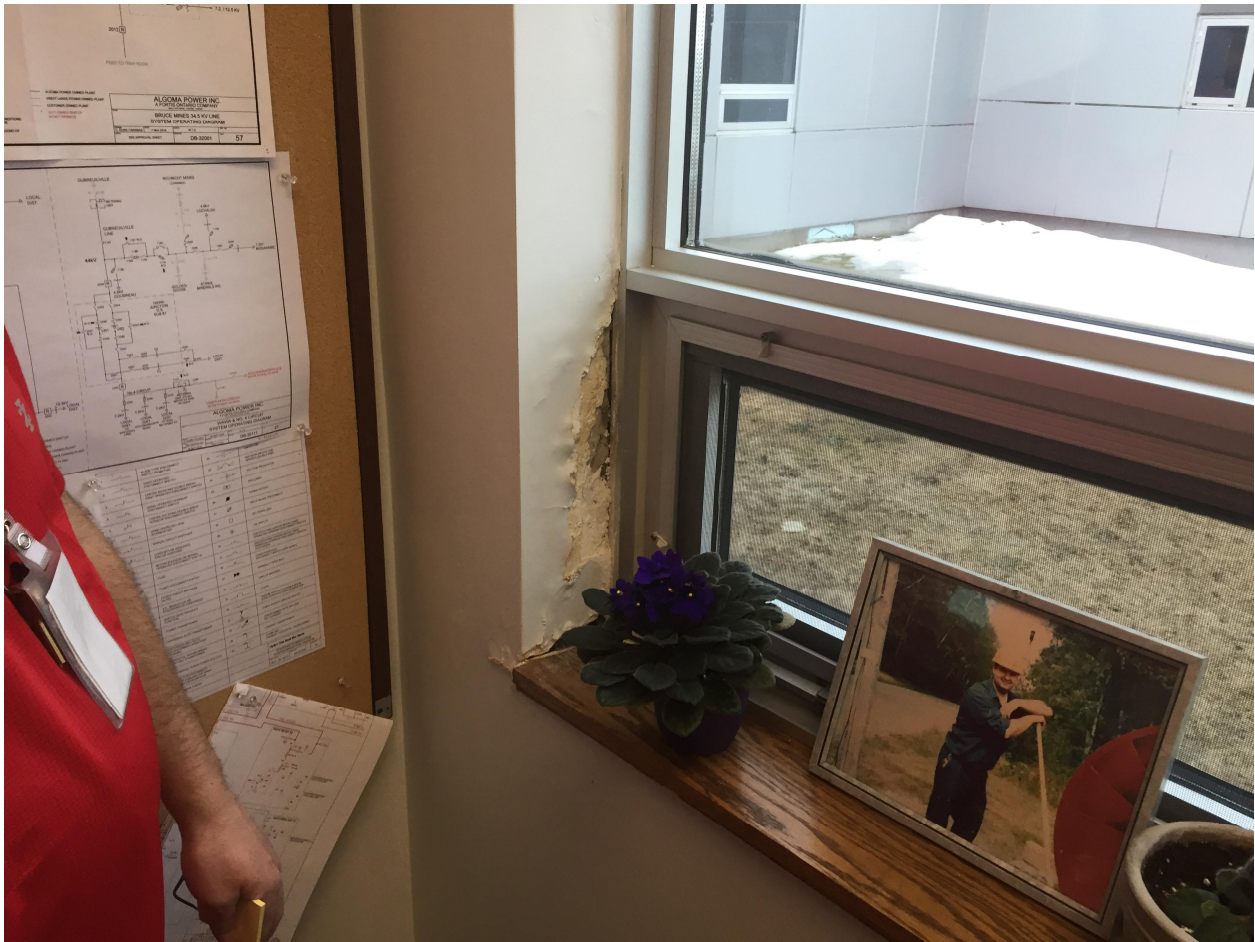
Suite 'A' Photo 8 – Water damage at window jamb. Looking south east (API). There has been an ongoing issue in regard to the exterior aluminum panels and water damage at some of the window sills, heads and jambs. A simple report had been issued to the former GLP Transmission in regard to the building envelope. The exterior wall cladding (aluminum panels) is a “WET SYSTEM”, which relies upon exterior caulking between the panels to prevent water infiltration. After years of exposure to the elements the caulking fails. The caulking has a finite life expectancy. As such water enters the building. The fix is relatively easy but is time consuming and expensive due to the repairs laborious nature. Both Suite ‘A’ and Suite ‘B’ should be schedule for rotating replacement of the caulking.

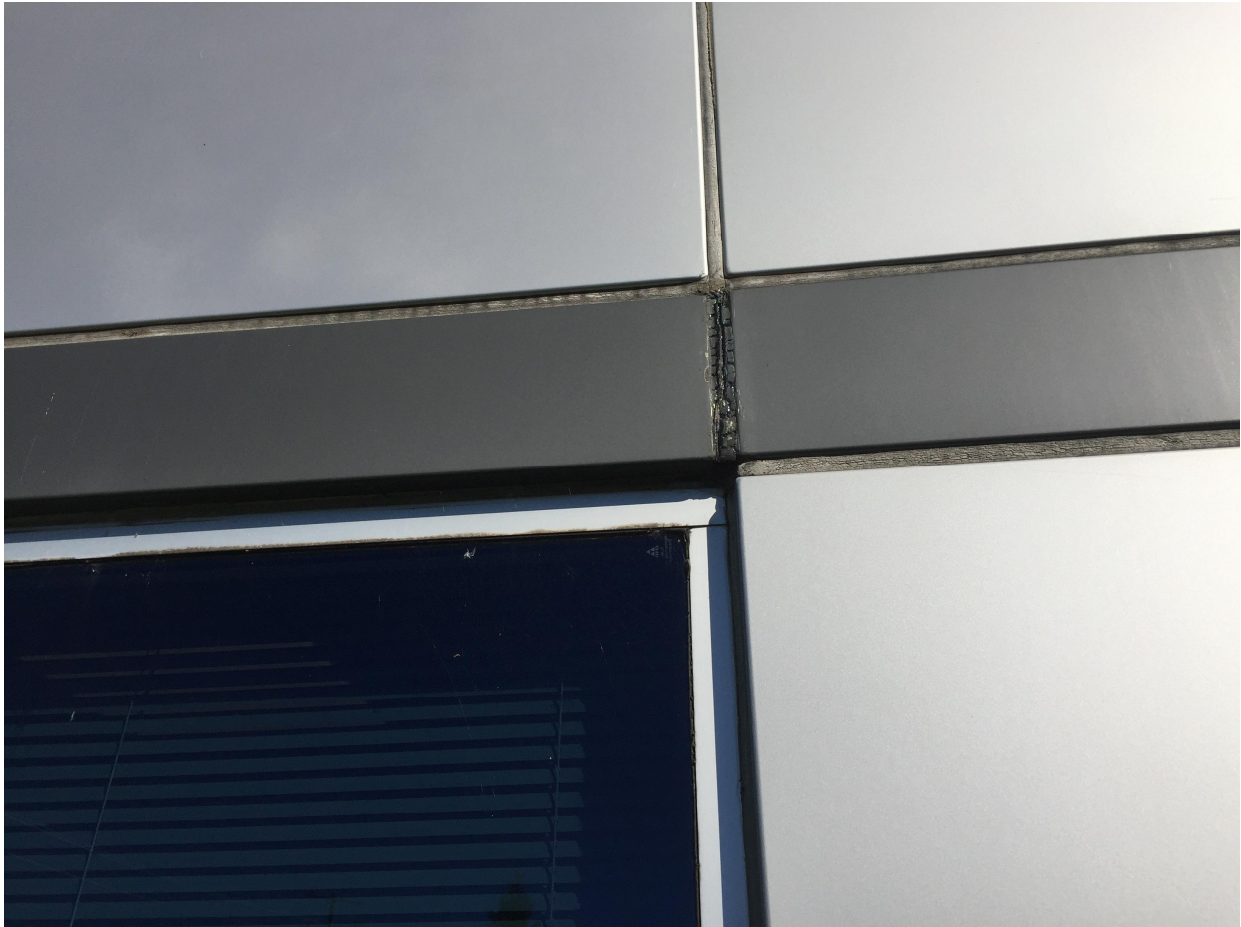
Suite 'A' Photo 8.1 – Exterior view of the exterior aluminum panel system and caulking failure. A coloration seemed to exist between the accent band (brown color panel) and the location of leaks. It may be apotheosized that the color of the caulking or its chemical makeup was not as resilient as the lighter shade of caulking.

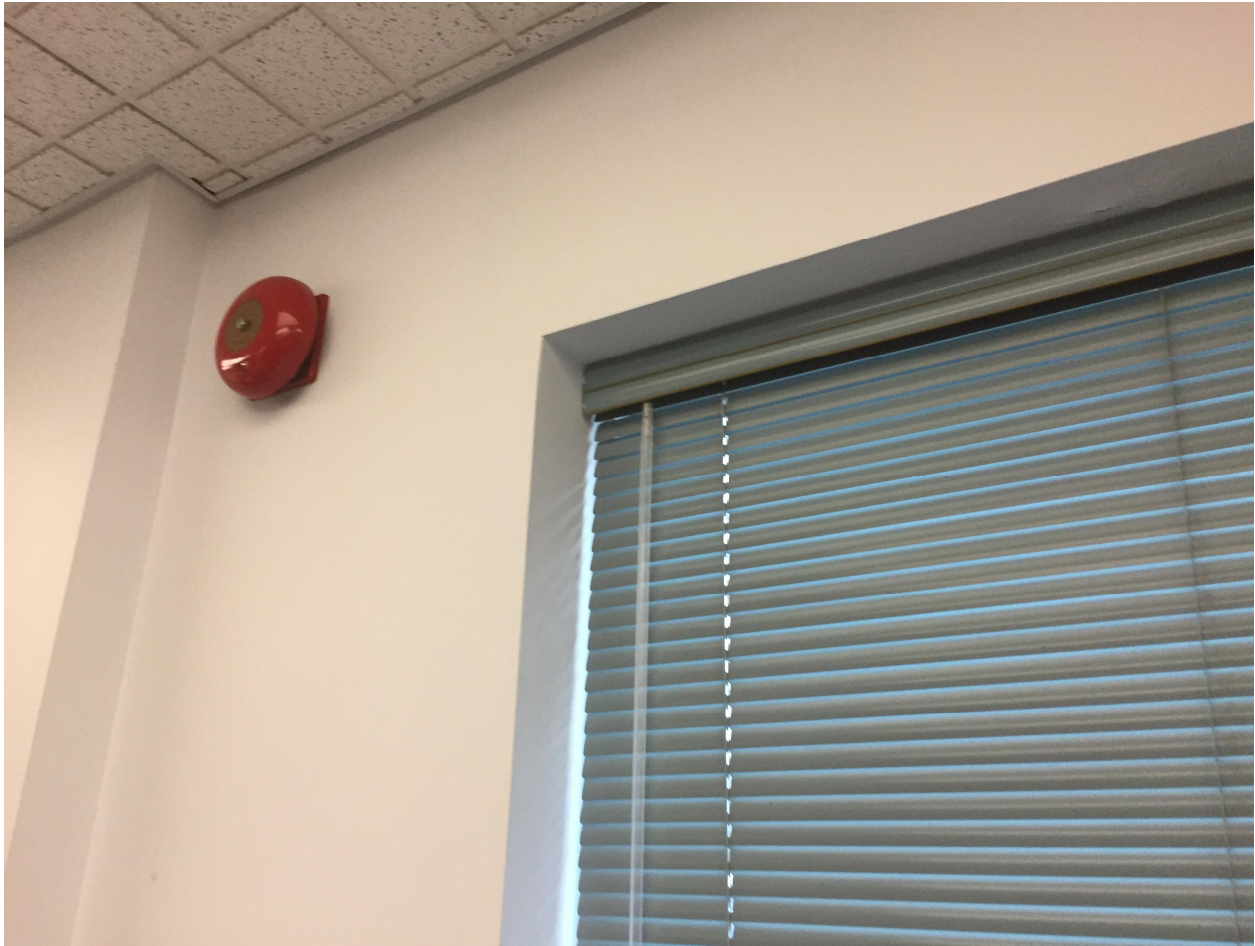
Suite 'A' Photo 13 – View of a fire alarm bell. It was noted that there were several bells located throughout all floors. As well fire extinguishers and pull stations were also noted at appropriate locations. Discussions with maintenance staff confirmed that the system is regularly tested and certified. (API)

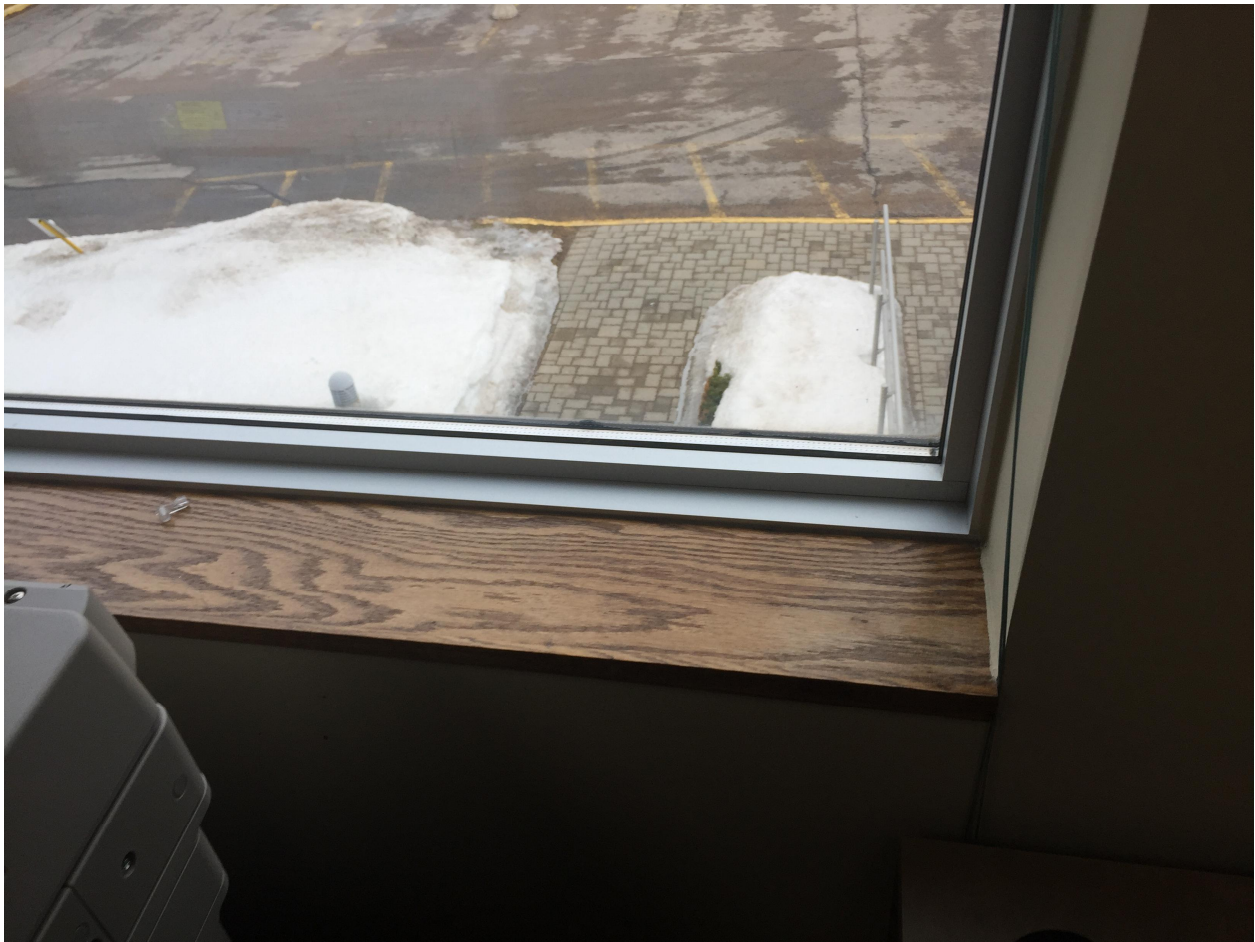
Suite 'A' Photo 15 – 2<sup>nd</sup> Floor – Looking North. The window sills, jambs and headers show little to no damage due to the earlier issues describe in Photo 8. This may be due to the amount of water on the wall or the general placement of the aluminum panels. Regardless of the lack of visible damage the protocol described in photo 8 should be carried out throughout the main and 2<sup>nd</sup> floor. (API)

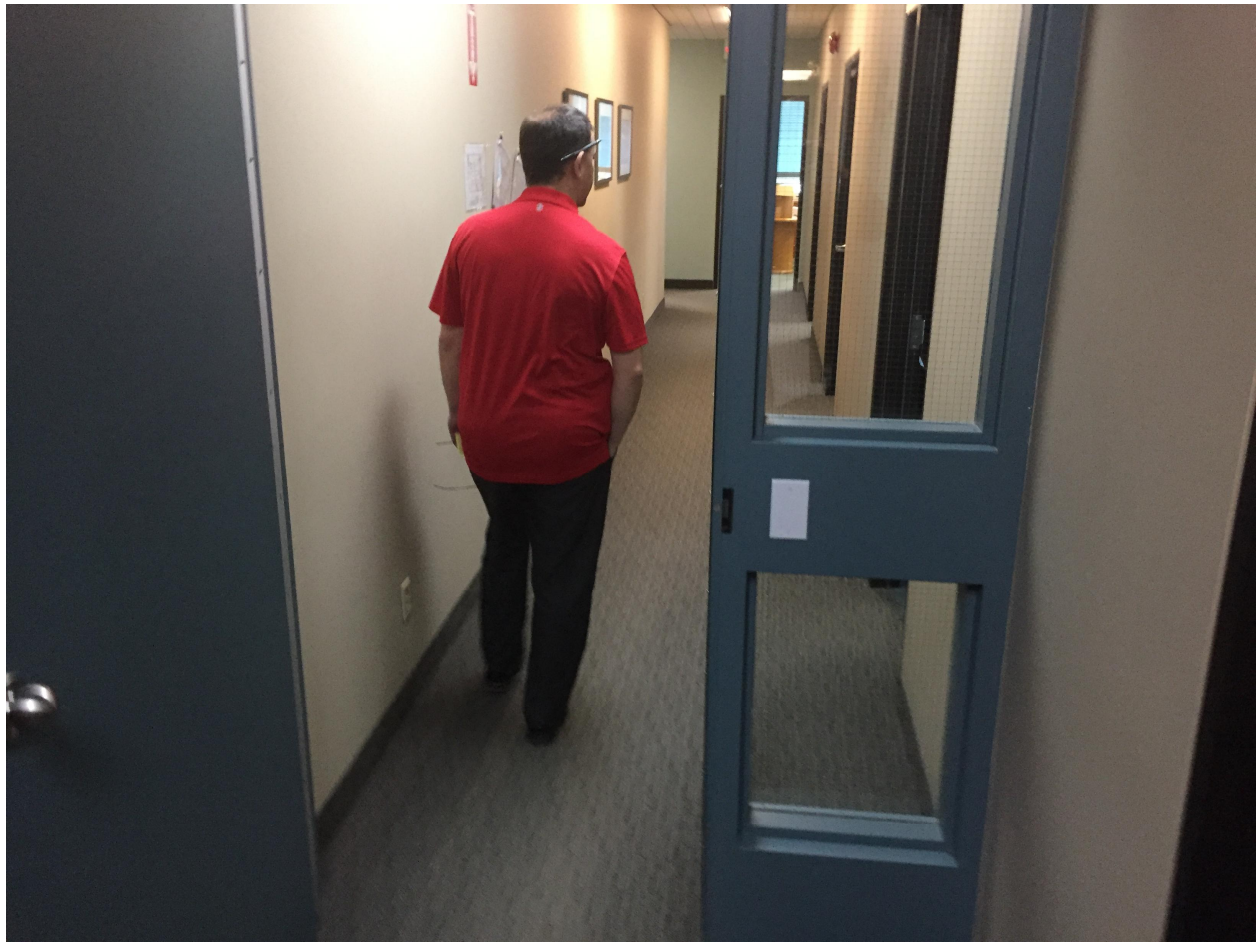
Suite 'A' Photo 17 – 2<sup>nd</sup> Floor – Corridor. It should be noted that here is a fire separation located approximately half way along the length of the primary corridor. It is presently unknown as to the requirements of this separation. A full Ontario Building Code review of the facility does not fall within the parameters of this condition survey. However, the door and its frame were rated for 20mins only.

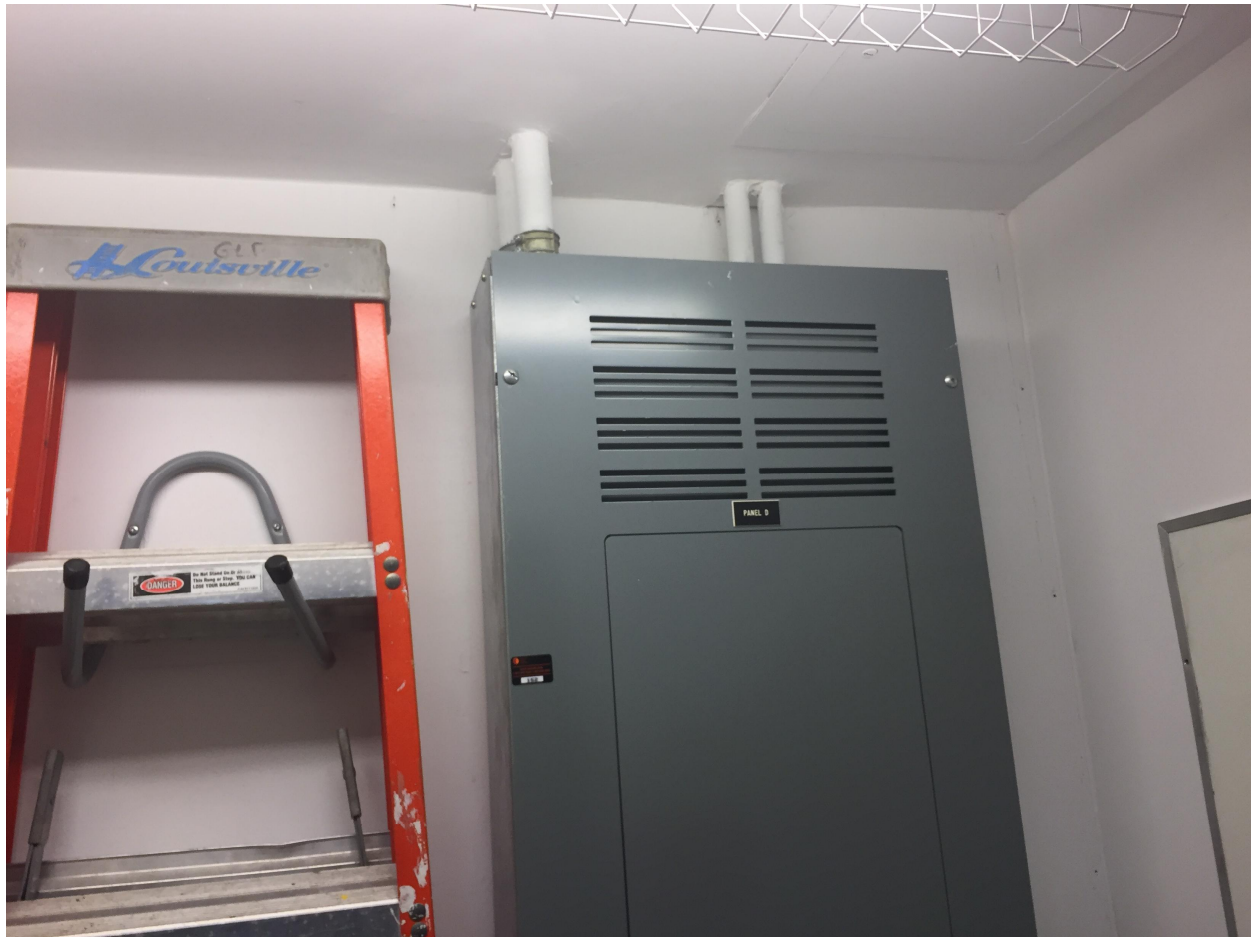
Suite 'A' Photo 18 – 2<sup>nd</sup> Floor – Electrical Closet. There are several Electrical panels located throughout the basement, main and 2<sup>nd</sup> floor. For additional information of the electrical layout refer to the electrical dwgs located within the building drawings appendix ???

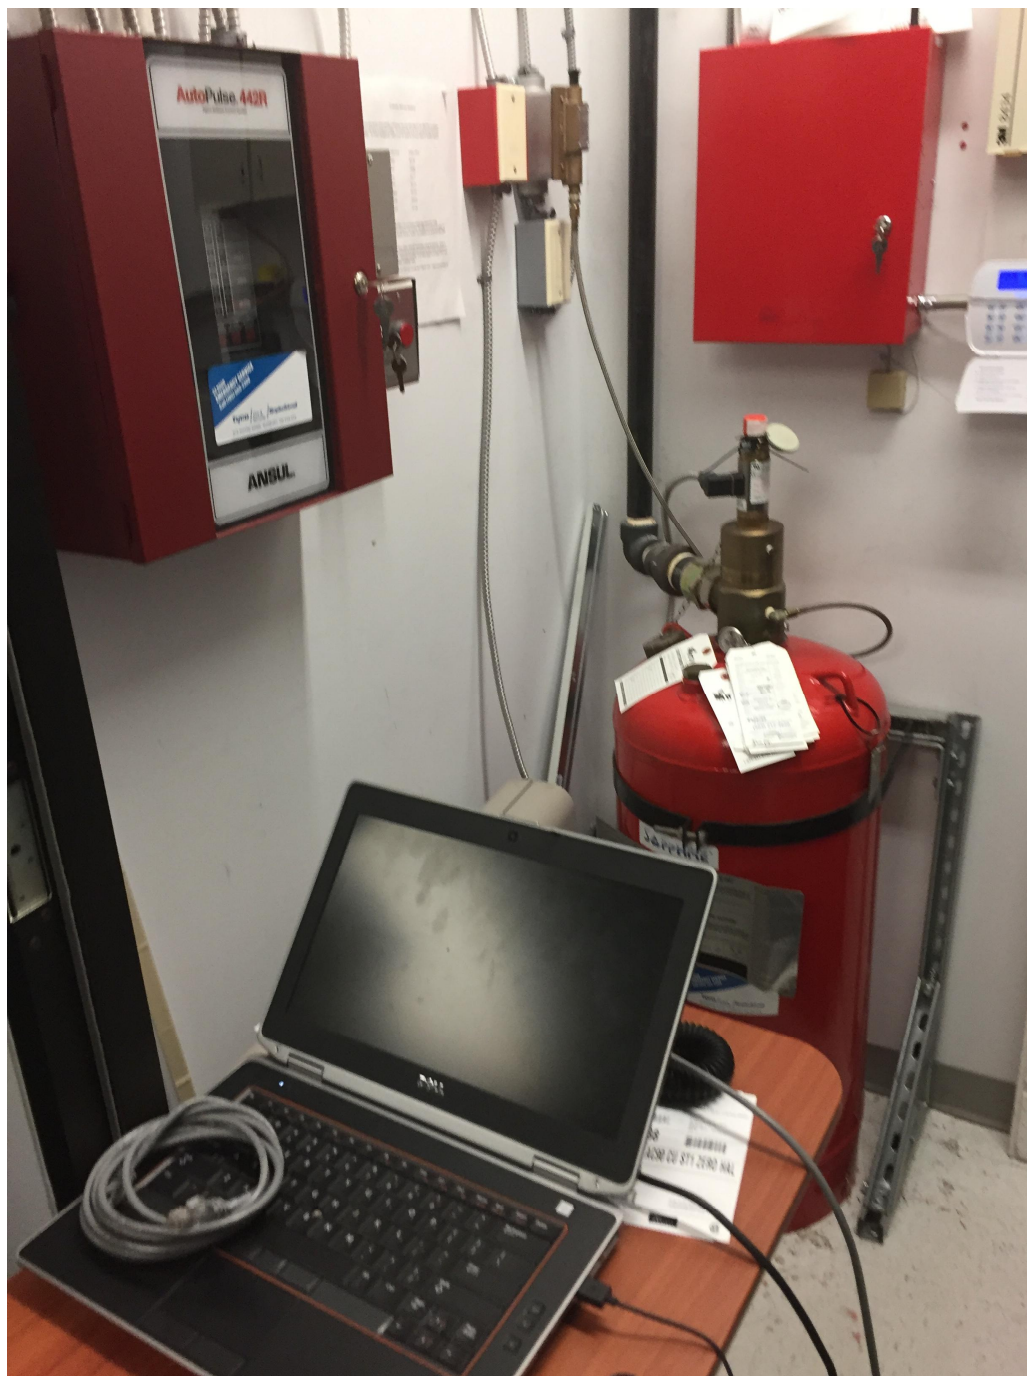
Suite 'A' Photo 19 – 2<sup>nd</sup> Floor – Computer server and IT office. The afore mentioned room is served by a Dry Chemical Suppression and alarm system. This system is regularly reviewed and certified by an approved agency.

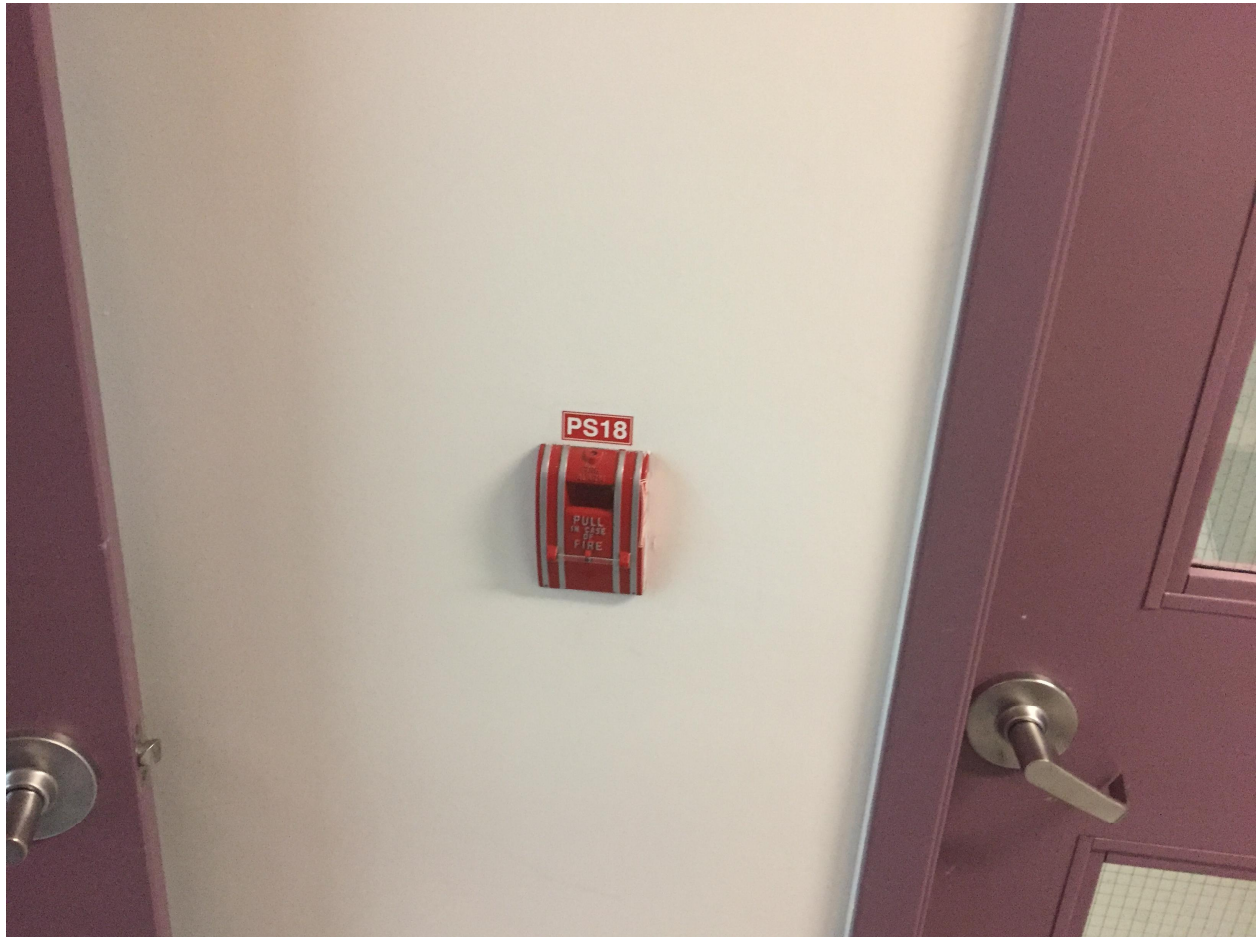
Suite 'A' Photo 20 – Basement. Typical fire alarm pull device. These items are located throughout the facility and appear to be located at the appropriate locations. All locations can be found on archived drawings from the mechanical / electrical engineer on the original building drawings. (API)
