Building Conditions - Summary Report  
For Hydro One / API, Suite 'A'  
2 Sackville, Sault Ste. Marie, ON  
May 2018

**Title: Buildings Condition Summary Review 'Stores' – Phase 1**

**Project: 2 Sackville Road, ON**

**Title: Buildings Condition Summary Review Suite 'A' – Phase 1**

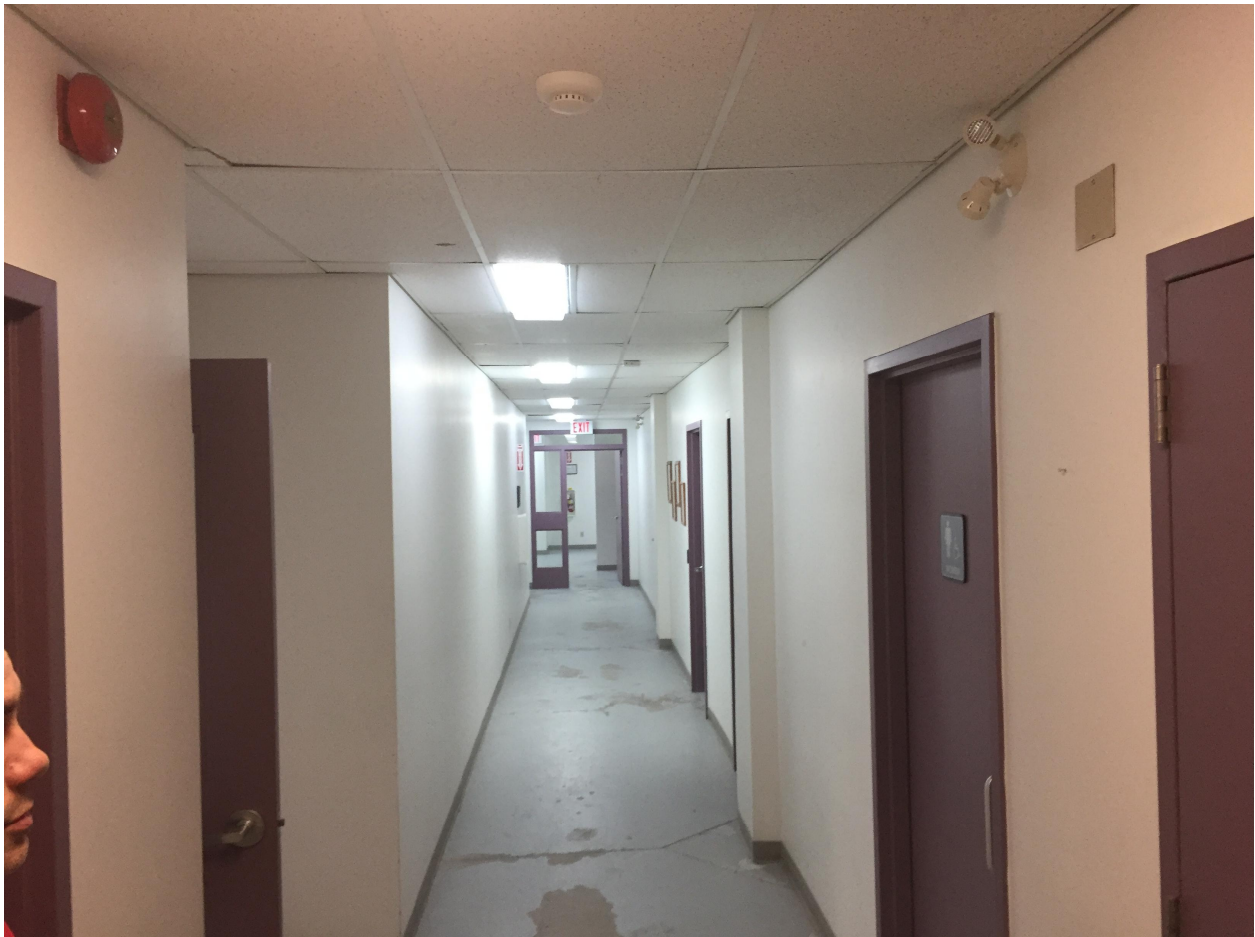
Suite 'A' Photo 21 – Basement. Typical corridor. The main floor finish is paint on concrete. Some paint is spalling due to a minor flood. After discussions with maintenance staff the floor is scheduled to receive new paint in the future.

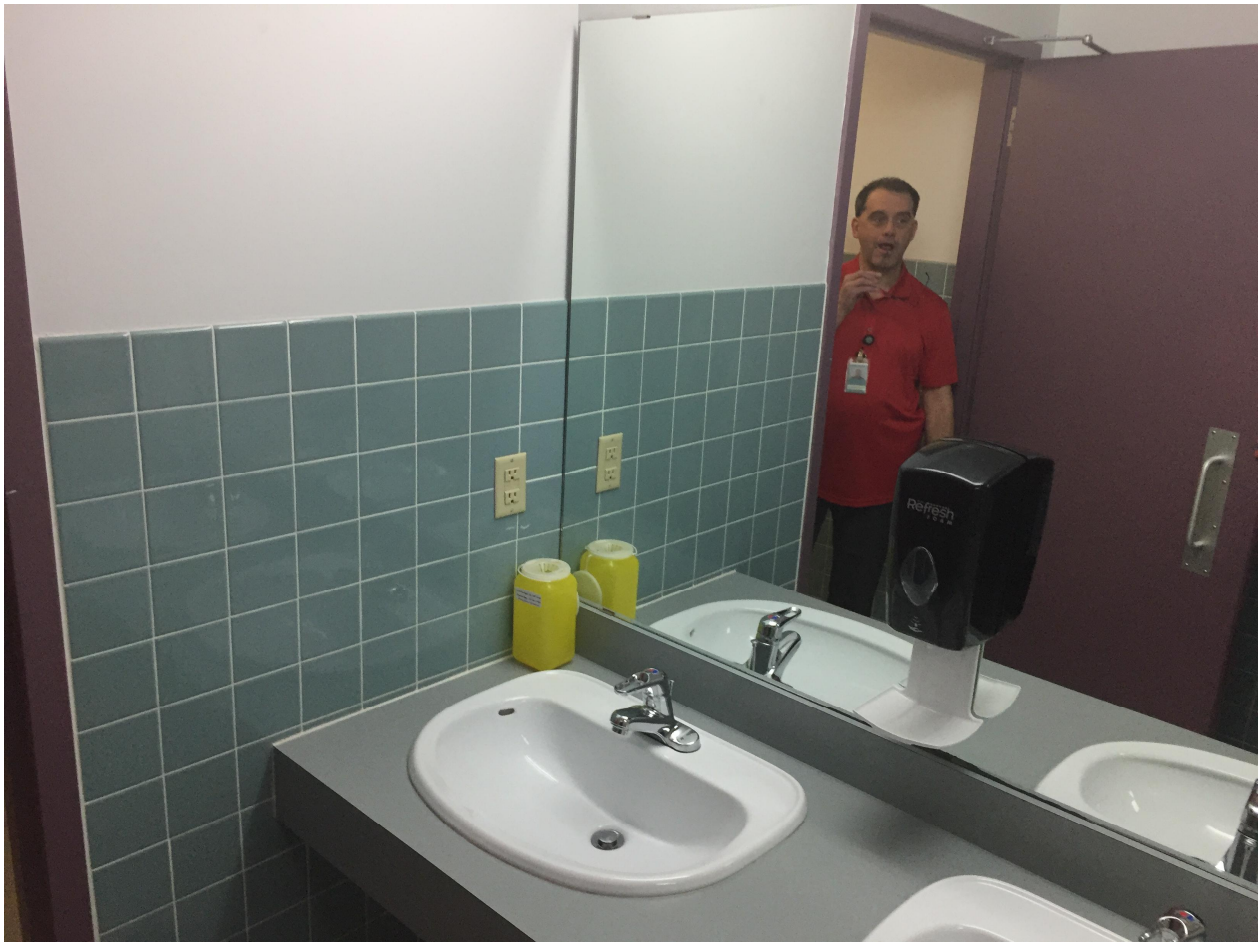
Suite 'A' Photo 22 – Basement. Typical washroom. The main floor finish is paint on concrete. Some paint is spalling due to a minor flood. After discussions with maintenance staff the floor is scheduled to receive new paint in the future.

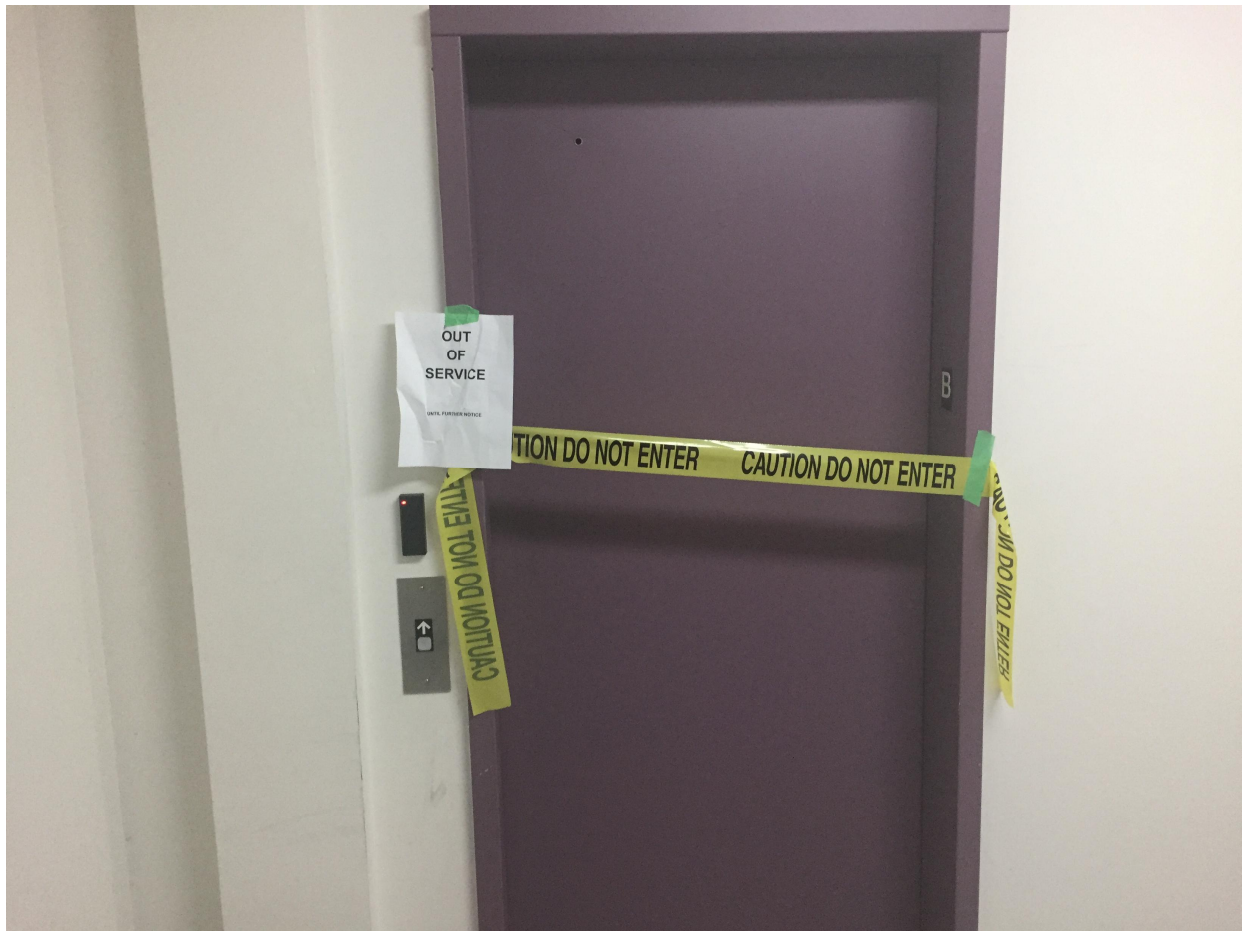
Suite 'A' Photo 26.1 – Passenger Elevator. Due to mechanical issues the elevator has been temporarily taken out of service.
