Building Conditions - Summary Report
For Hydro One / API, Suite 'A'
2 Sackville, Sault Ste. Marie, ON
May 2018

EE File No. E18002

Title: Buildings Condition Summary Review General Site Conditions – Phase 1

Project: 2 Sackville Road, ON

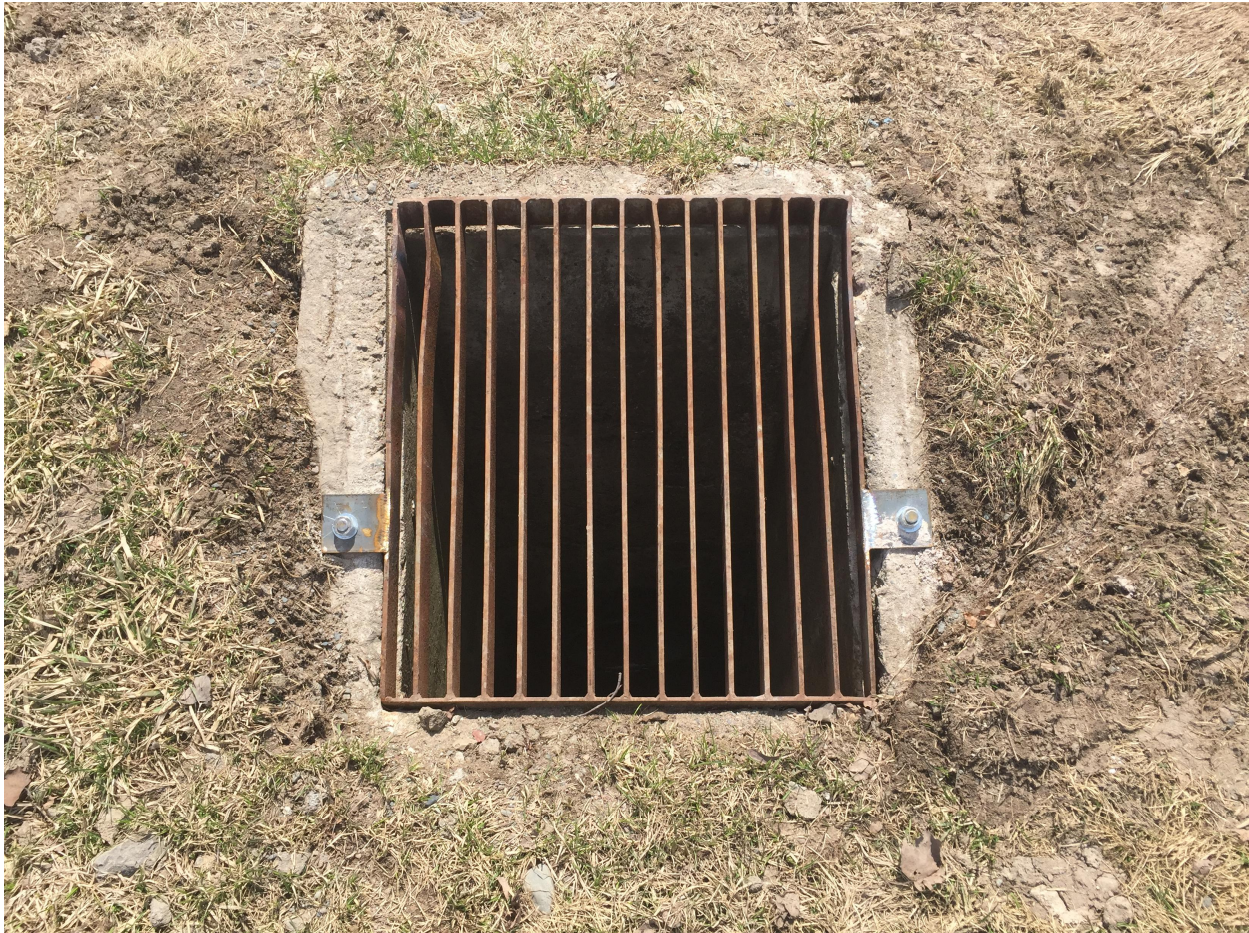
General Site, Photo 4 – Ditch Inlet Catch Basin – This structure is located at north side of the second entrance to the main parking area. The main parking area catch basins drain to this basin. It then is fully entered into the City of SSM storm water system.

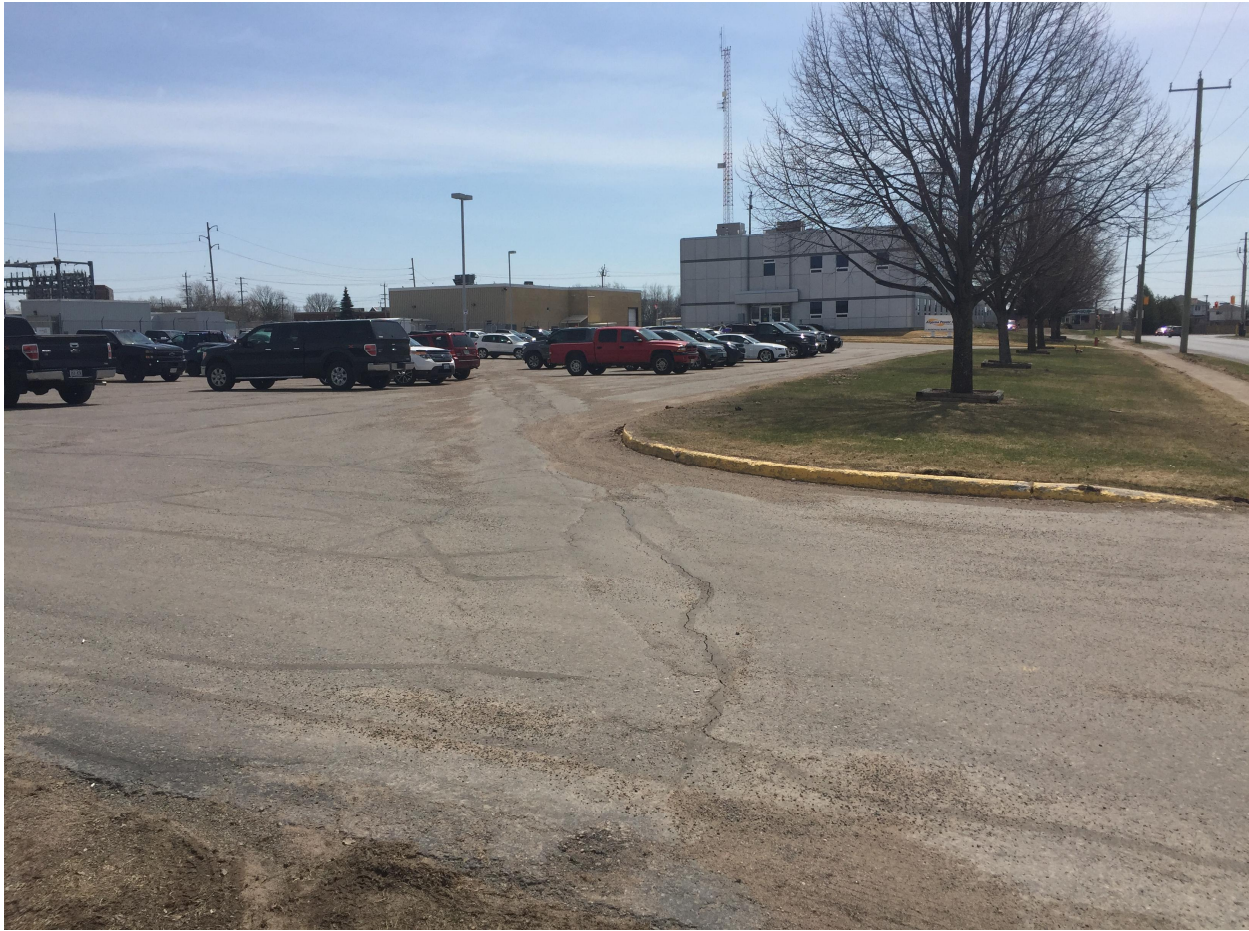
General Site, Photo 6 – Second Entrance of Main parking area – Looking South. There is obvious settlement of the soils of the parking area around the main storm drain.

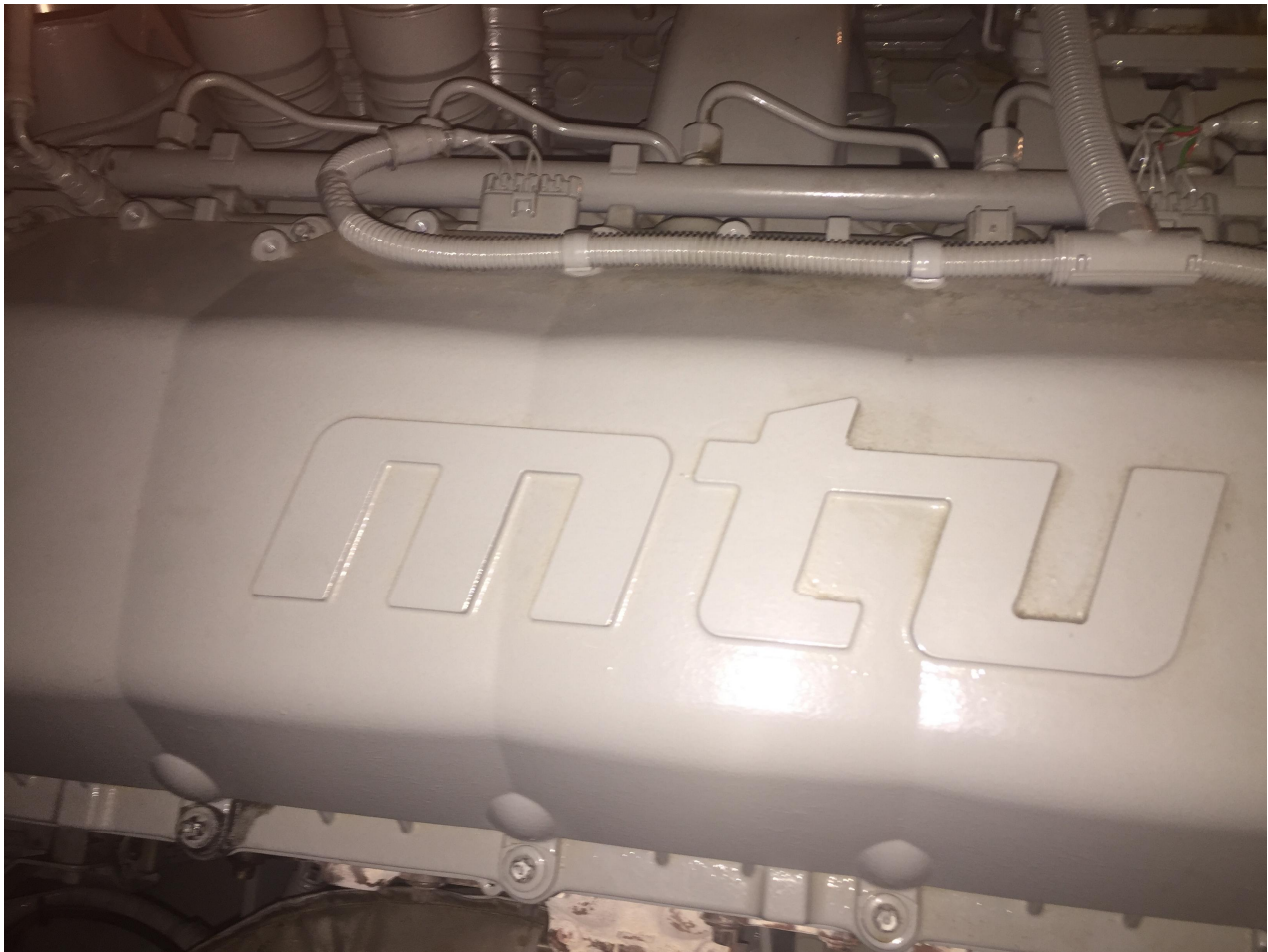
General Site, Photo 17 – Interior view of Stand-By power (Generator) - Due to the confines of the building, overall photos were not able to be taken..

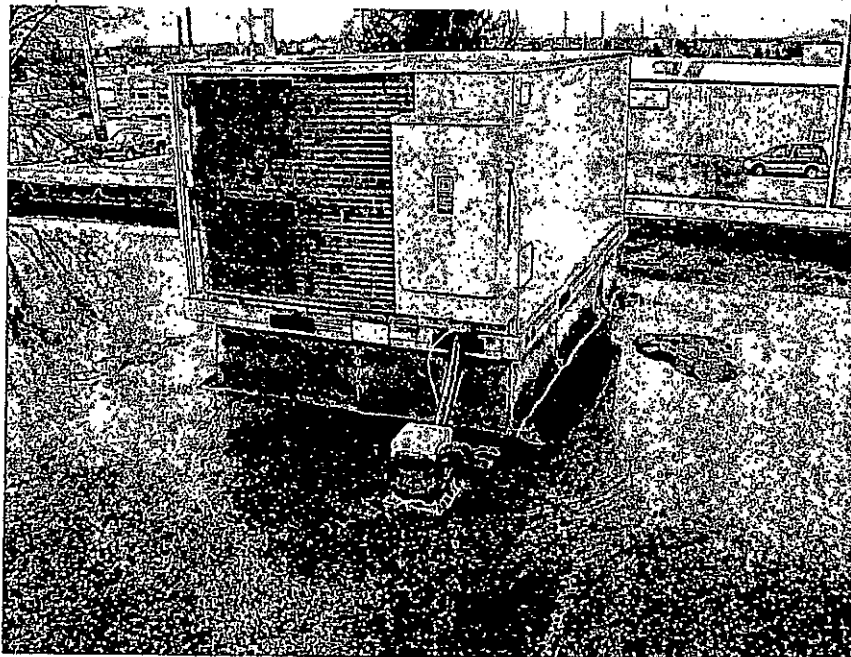
Photograph 5: Roofing materials presumed to contain asbestos.

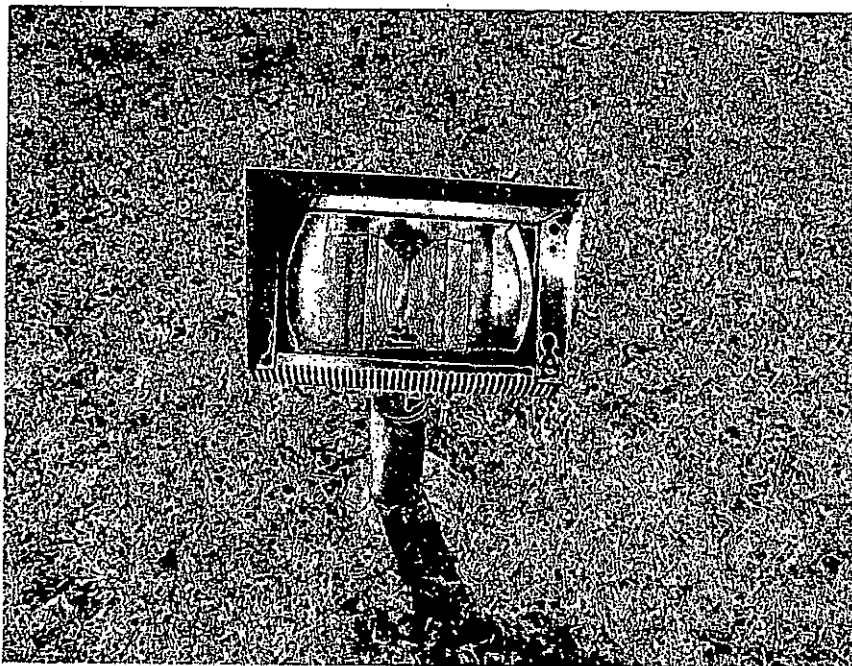
Photograph 6: A HID bulb on the lawn of the Building.

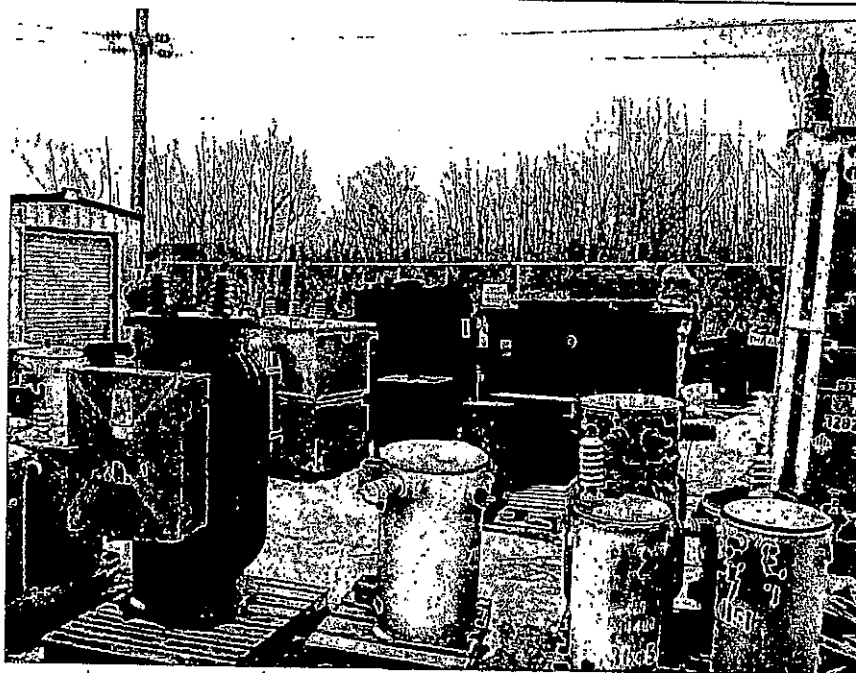
Photograph 2: De-energized electrical equipment stored in the yard.

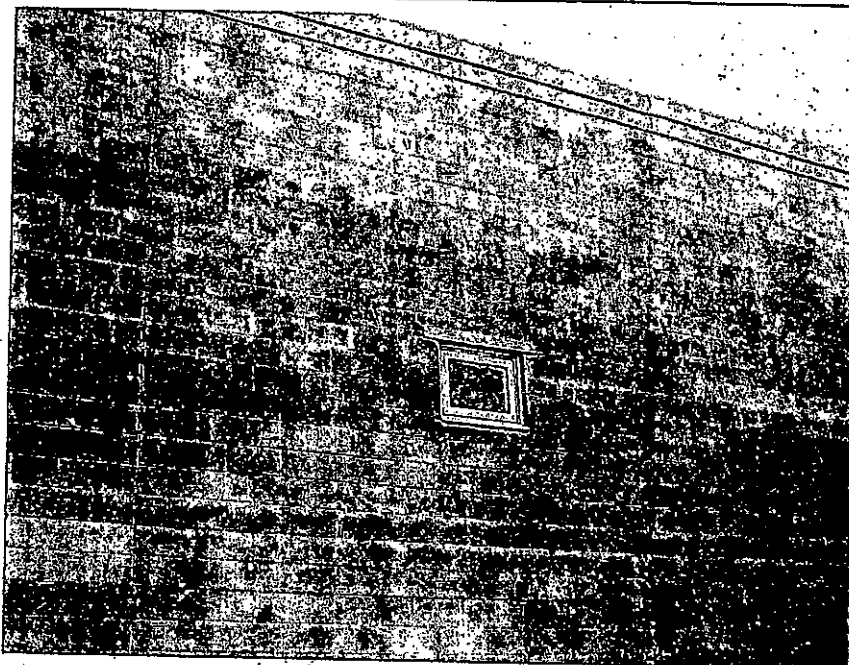
Photograph 3: Window caulking presumed to contain asbestos.

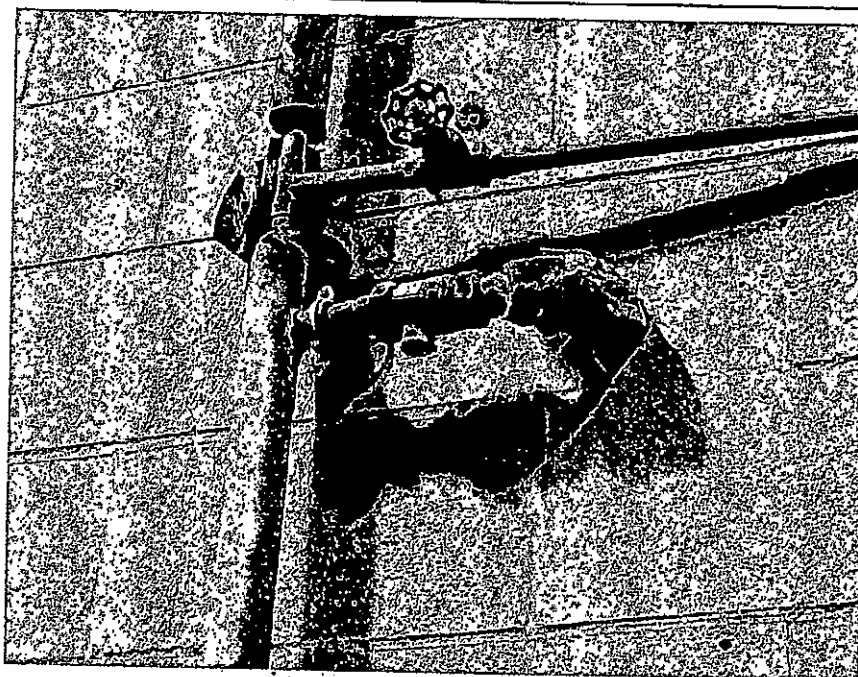
Photograph 4: Non-asbestos pipe parging in the wash bay.
