**Imperial Oil Limited
Construction of the Waterdown to Finch Project**

**Application under section 90(1) of the *Ontario Energy Board Act, 1998*
OEB File Number EB-2019-0007**

City of Toronto – Evidence

Pipeline Accident Report

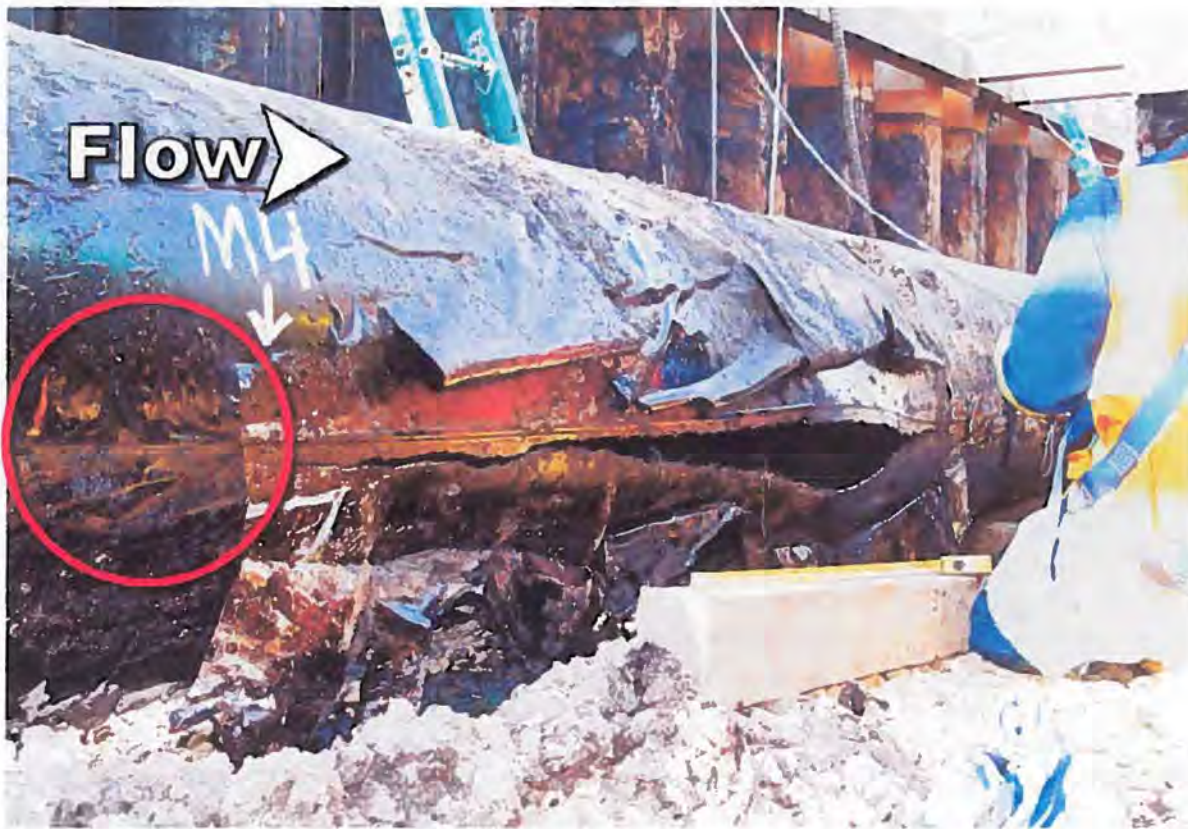
The fracture in the ruptured segment measured 6 feet 8.25 inches long and up to 5.32 inches wide. (See figure 2.) External corrosion was present along the longitudinal weld seam and in areas where the adhesive bond between the pipe and its protective polyethylene tape coating had deteriorated (disbonded). The coating was wrinkled and had separated from the pipe surface as shown in the red circle in figure 2.

Figure 2. The ruptured segment of Line 6B in the trench following the July 25, 2010, rupture. The fracture face measured about 6 feet 8.25 inches long and was 5.32 inches wide at the widest opening. The fracture ran just below the seam weld that was oriented just below the 3 o'clock position. A red circle shows a location where the coating was wrinkled and had separated from the pipe surface.

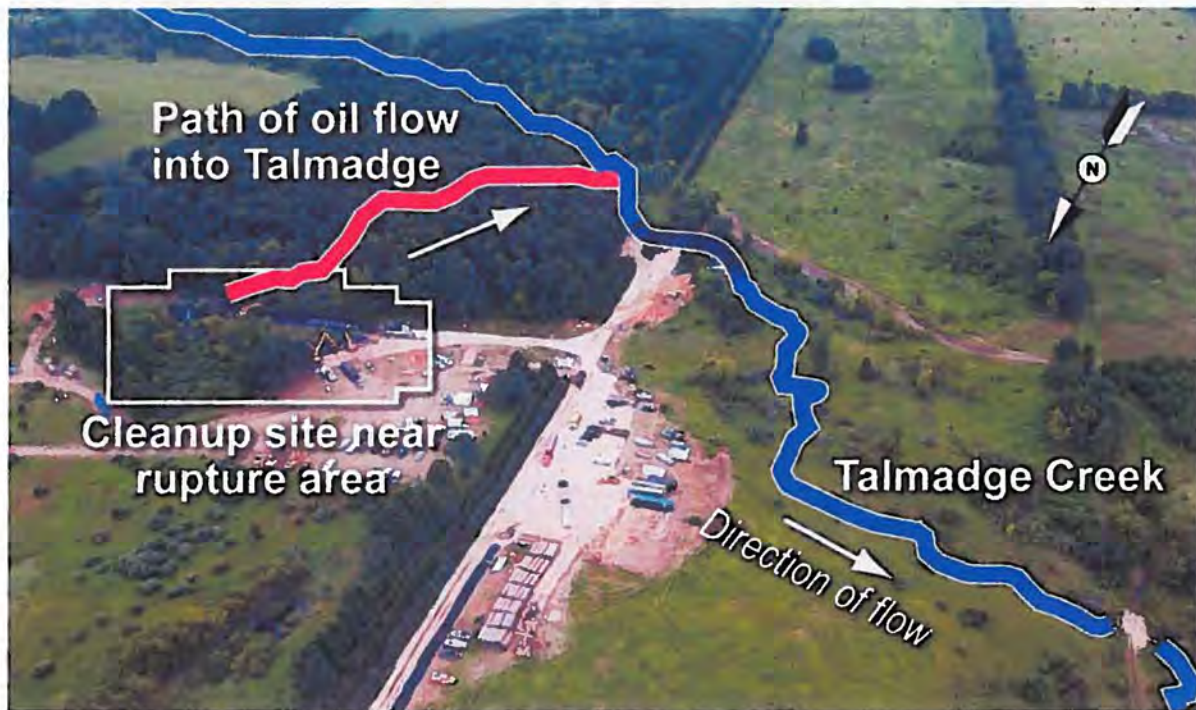
The crude oil release soaked the rupture site and the surrounding wetlands, eventually spreading to the Talmadge Creek and the Kalamazoo River. Enbridge's early response efforts were focused downstream of the rupture. Recent heavy rainfall had increased the flow of the Talmadge Creek and the Kalamazoo River, which spread the oil faster, hindering the response efforts. (See figure 3.)

Figure 3. Aerial view of the accident location showing the rupture site to the left and the Talmadge Creek flowing west toward the Kalamazoo River.

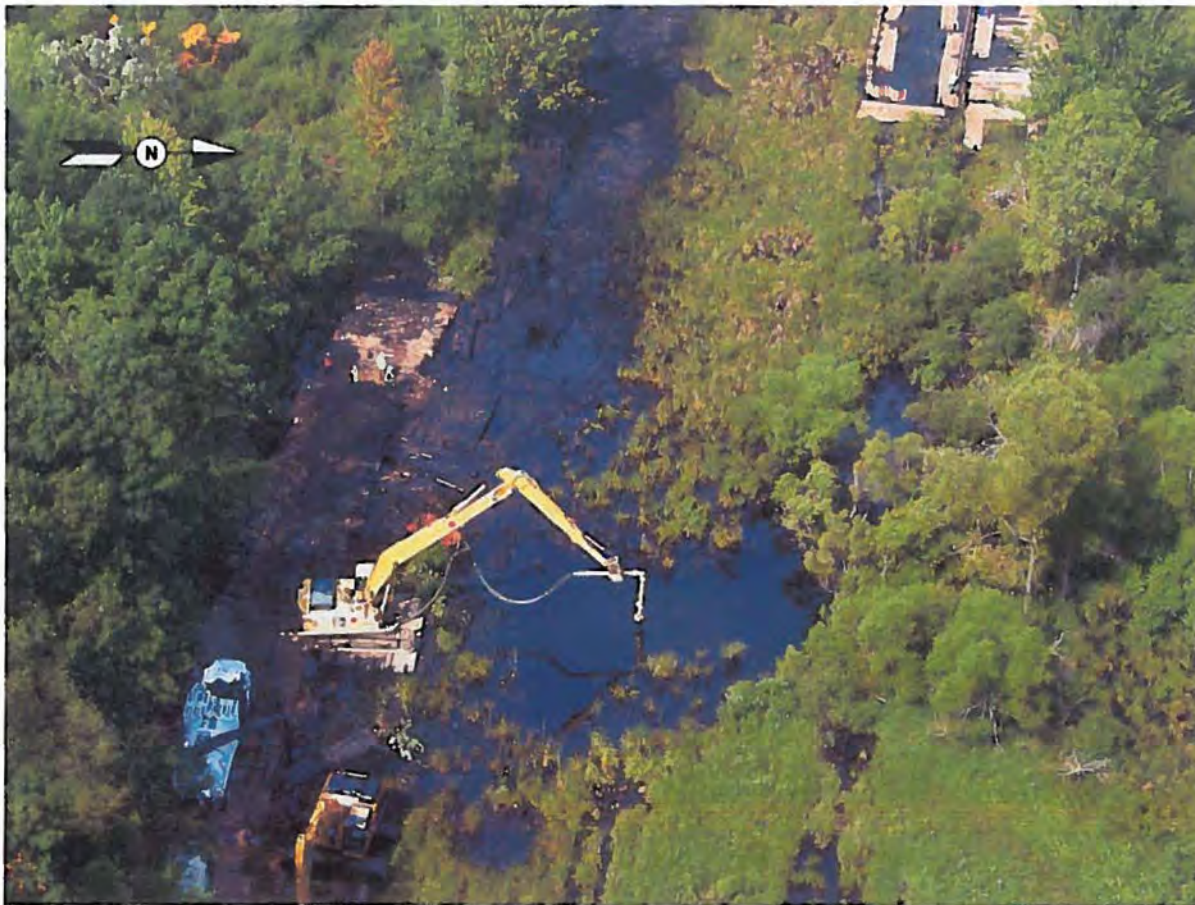
The wetland conditions in addition to the crude oil release made it difficult for vacuum trucks and excavators to get near the rupture location. Large wooden matting had to be placed around the rupture location to bring heavy equipment close to the release. (See figure 4.) The conditions at the accident site also delayed efforts to extract the pipe and to contain the oil near the rupture source.

Figure 4. Cleanup efforts in an oil-soaked wetland near the rupture site. Saturated soil complicated the cleanup and excavation efforts. An excavator with a vacuum attachment is shown situated on wooden matting near the rupture site.

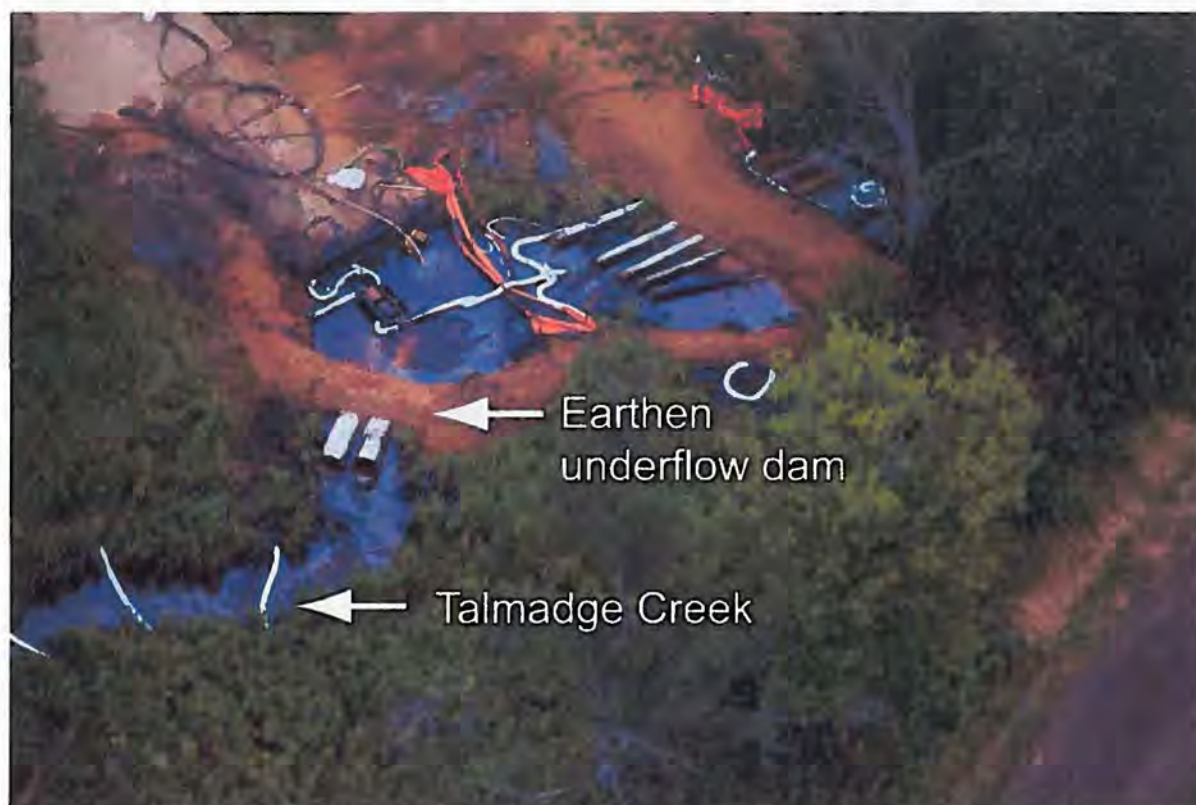
Working with a six-person crew, the Marshall PLM supervisor constructed an earthen underflow dam, which consists of a mound of soil holding back oil-contaminated water with pipes submerged on the dam side and rising toward the discharge end. The angle of the pipe allows the deeper water in the dam to flow downstream, preventing the contaminated surface waters from flowing into Talmadge Creek. (See figure 10.)

Figure 10. Underflow dam on Talmadge Creek on July 30, 2010.

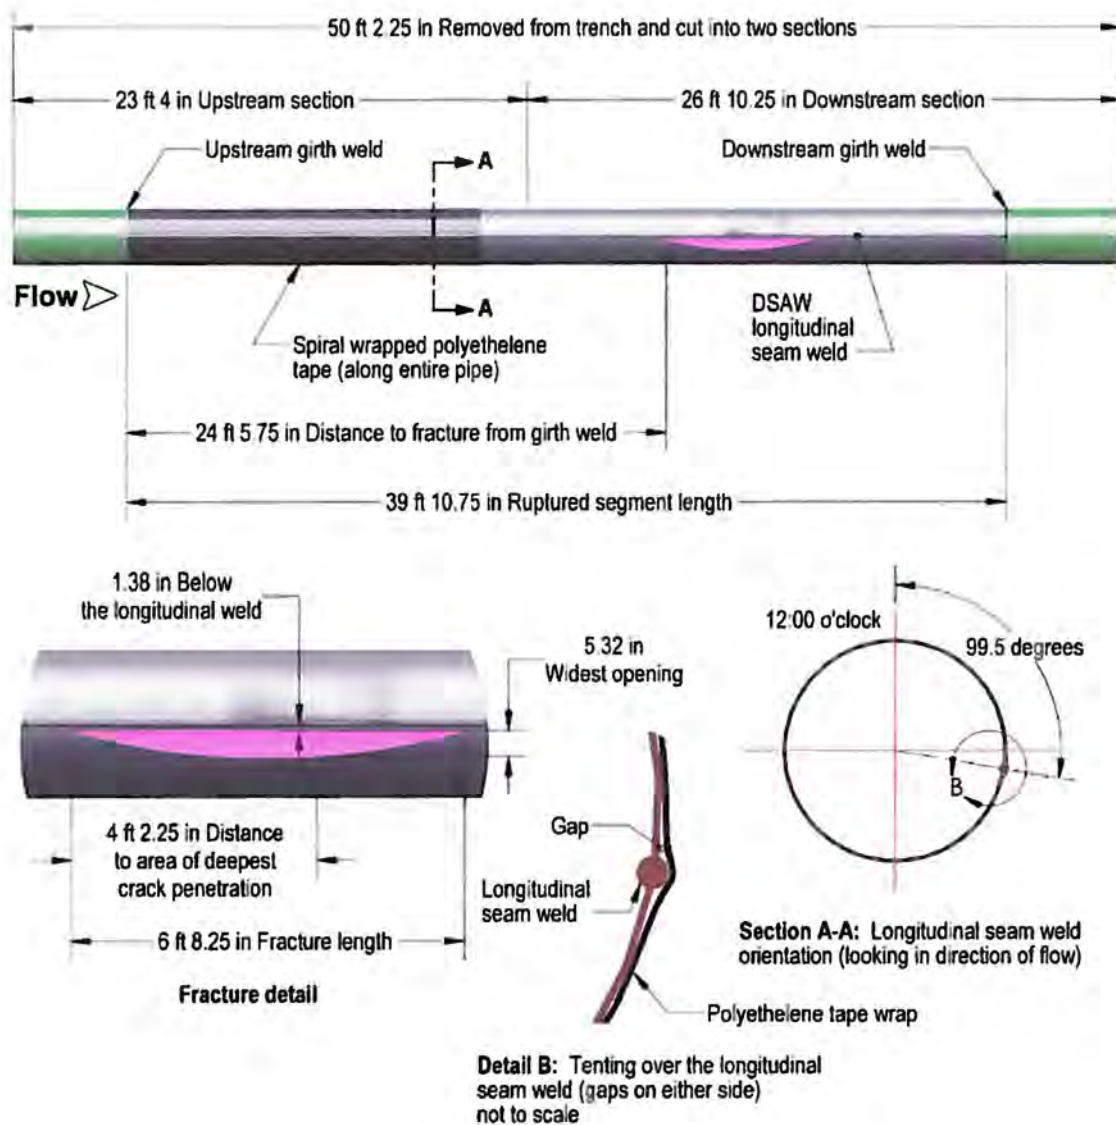
The ruptured pipe segment was 39 feet 10.75 inches long. The longitudinal seam was oriented at 99.5° clockwise.⁴³ A 50-foot length of pipe that included the rupture was removed and cut into two sections for shipping to the NTSB's Materials Laboratory for examination. The upstream section measured 23 feet 4 inches. The downstream section measured 26 feet 10.25 inches. (See figure 11.)

Figure 11. Line 6B ruptured segment showing upstream and downstream sections used for Materials Laboratory examination. Detail B shows tented coating over the longitudinal seam weld.

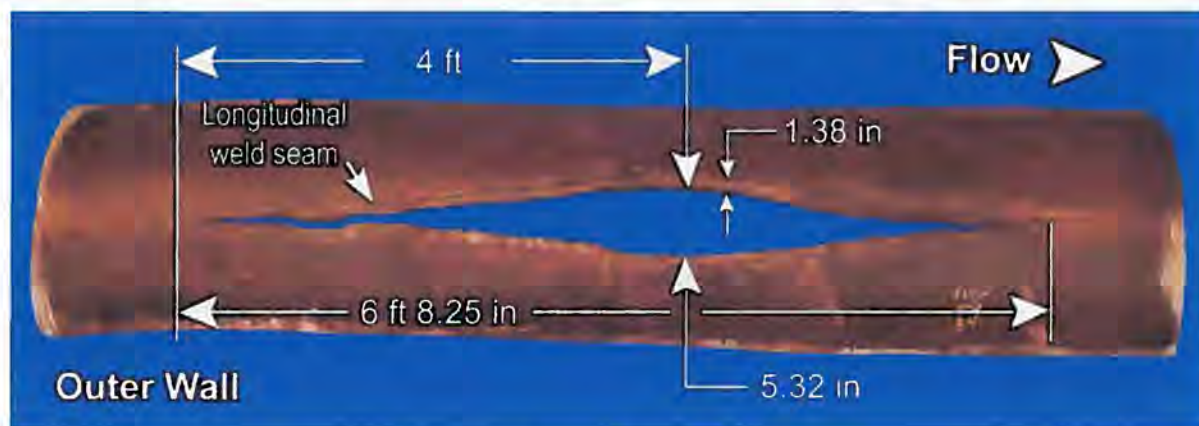
The fracture measured 6 feet 8.25 inches in length with the upstream end of the fracture located 24 feet 5.75 inches away from the upstream girth weld. The widest point along the fracture measured 5.32 inches and was about 4 feet from the upstream end of the rupture. The upper fracture face at the widest opening was measured at 1.38 inches below the longitudinal seam weld away from the heat-affected zone, with this offset ranging from 0.5 to 1.5 inches below the longitudinal weld seam for the length of the fracture face. (See figure 12.)

Figure 12. The outside surface of the pipe looking at the fracture area cut for lab examination.

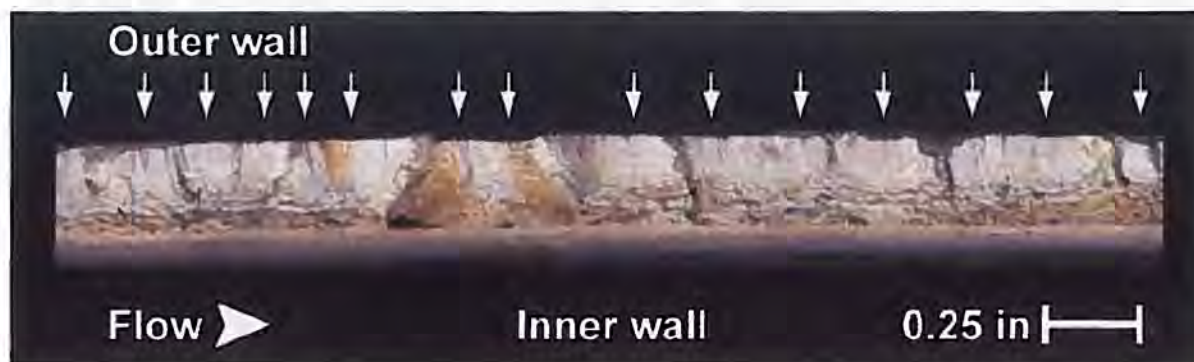
observed on the preexisting crack portion of the fracture consistent with oxidation in an oxygen-poor environment.

Figure 13. Curving arrest lines of preexisting cracks along the upper fracture face shown after cleaning to remove oxides. White arrows indicate multiple origin areas of preexisting cracks.

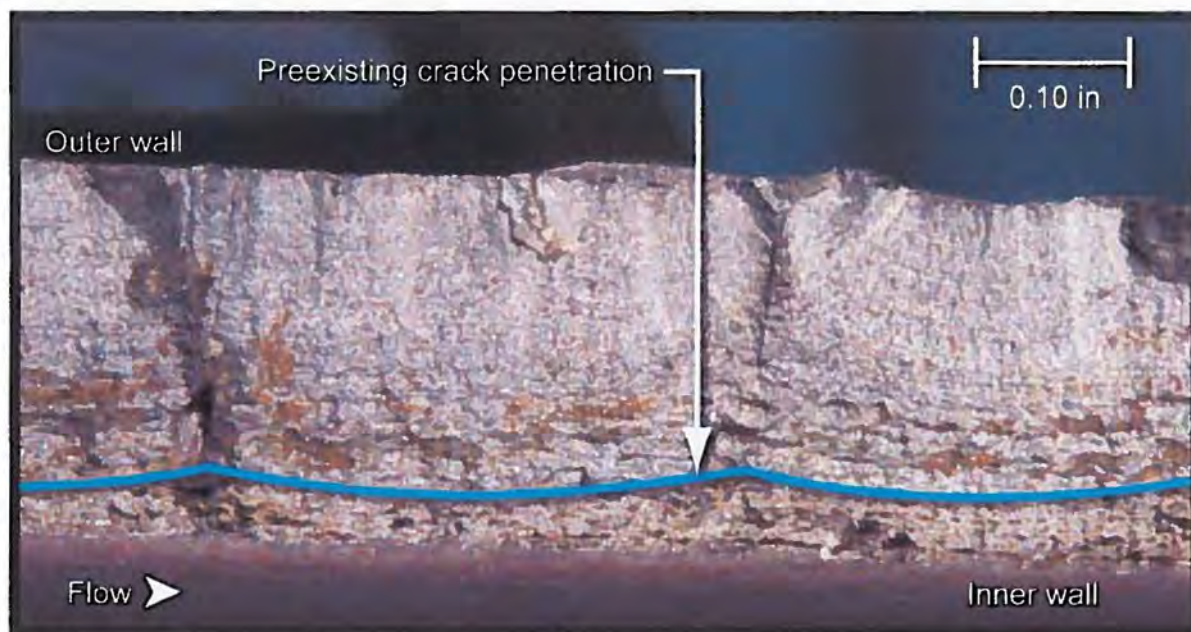
Figure 14. Close view of fracture surface area in the area of deepest crack penetration. The solid blue line indicates the extent of the preexisting crack penetration.

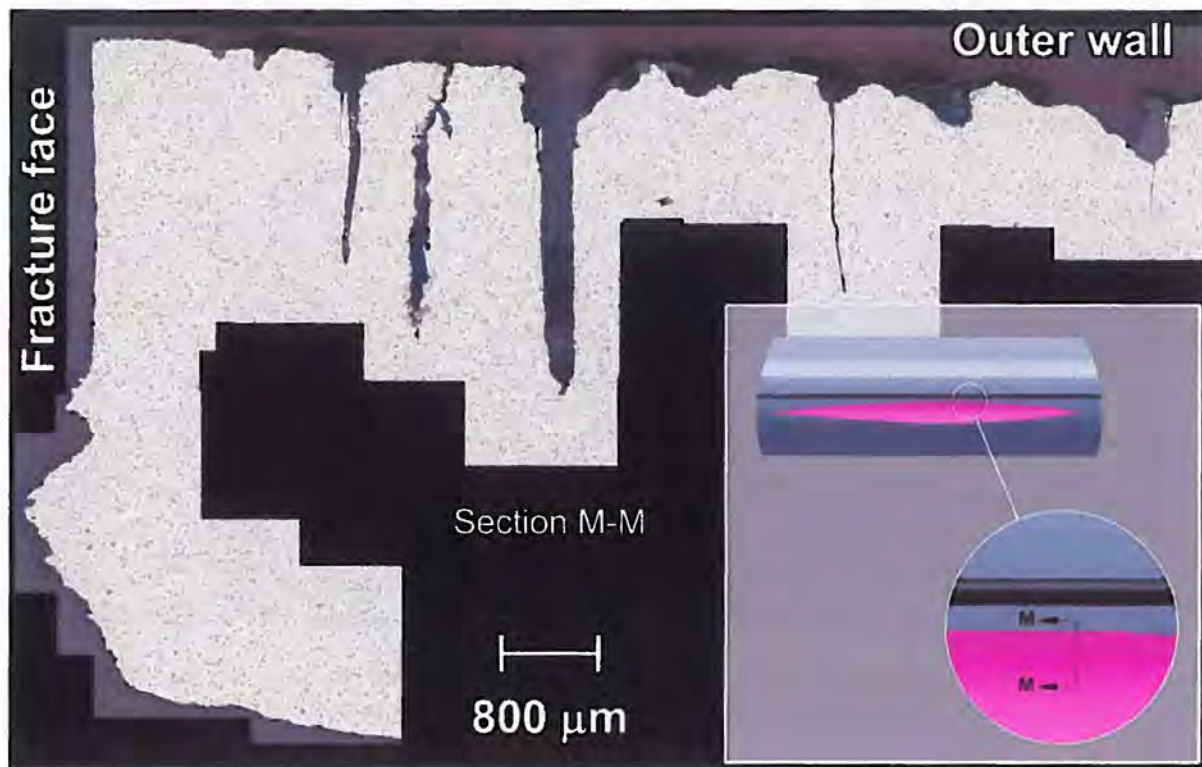
Figure 15. Transverse section through the top of the fracture showing multiple parallel cracks emanating from corrosion pits on the outside surface.

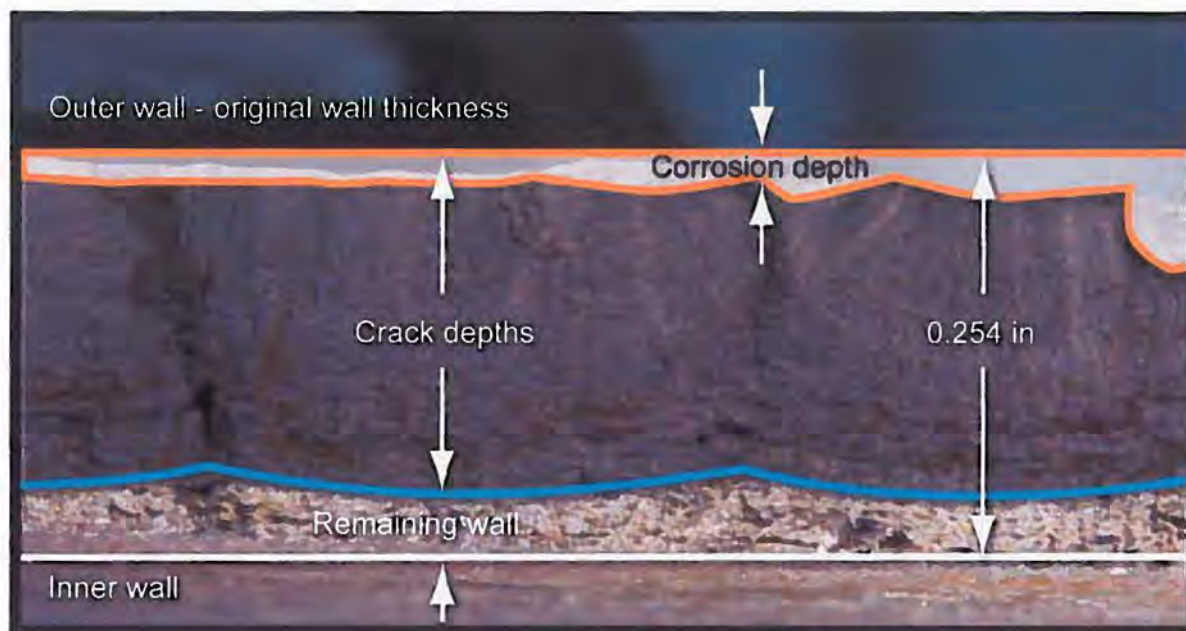
Figure 16. Lab measurements of crack and corrosion depths along the fracture face measured from images similar to figure 14 near area of deepest penetration (about 344 inches from upstream girth weld).

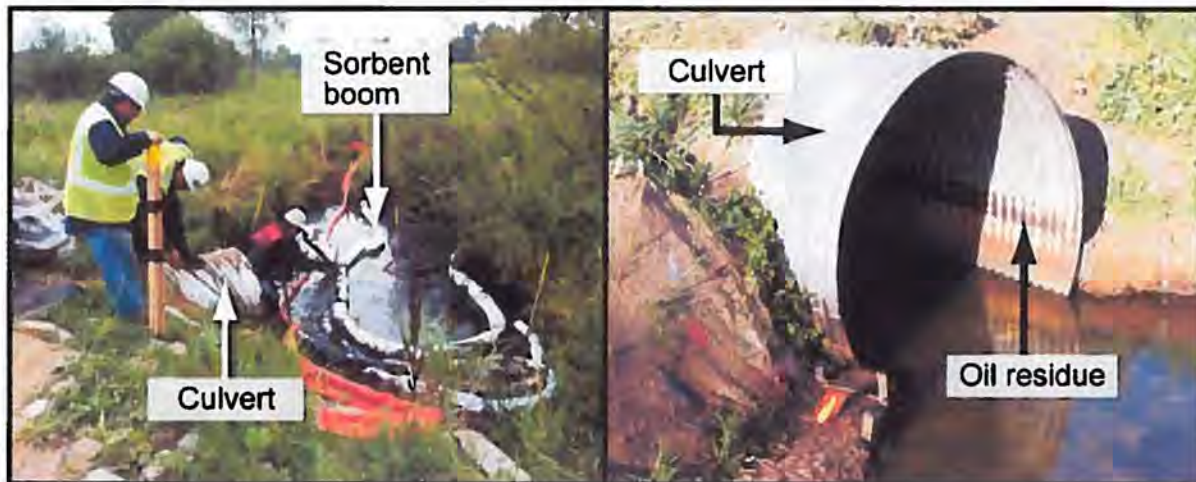
Figure 21. (Left) Enbridge employees install sorbent boom in front of a culvert at Division Drive. (Right) Oil residue marks the level of the oil carried through this culvert following the Enbridge release from Line 6B.
