**Bathurst Reinforcement Project:**

**Post-Construction Interim  
Monitoring Report**

**EB-2018-0097**

Company: Enbridge Gas Inc.

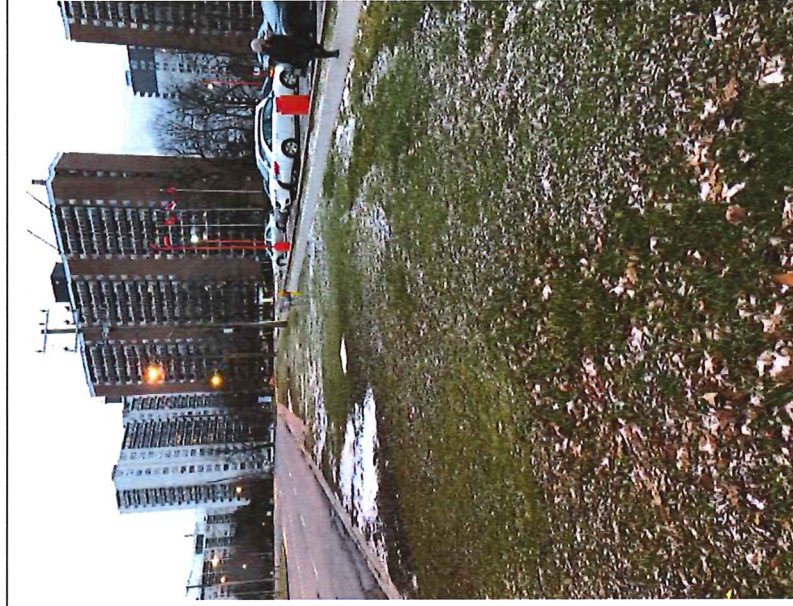
PHOTO #	LOCATION	CURRENT CONDITION	ACTION
<b>Photo 1</b>	Tie-in at South West corner of Steeles Ave. W. and Bathurst St. (looking south east)	Temporary restoration has been completed.	Permanent asphalt, sidewalk, curbs and boulevard planned for Spring/Summer 2020.
<b>Photo 2</b>	Entry/Exit Pit on West Side of Bathurst St., South of Steeles Ave. W. (looking north)	Complete. Boulevard was hydroseeded and restored to pre-construction condition.	None required.
<b>Photo 3</b>	West Side of Bathurst St., South of Fisherville Rd. (looking south)	Partial restoration was completed, boulevard was hydroseeded and restored to pre-construction condition. Temporary restoration completed to pattern concrete apron at curb.	Permanent restoration of pattern concrete apron will be completed in Spring/Summer 2020.
<b>Photo 4</b>	West Side of Bathurst St. South of Carpenter Rd. (looking north)	Partial restoration was completed in boulevard with hydroseed as well as partial temporary restoration of sidewalks.	Permanent restoration, including hydroseed and concrete sidewalks to be completed in Spring/Summer 2020.

<p>Photo 1: Tie-in at South West corner of Steeles Ave. W. and Bathurst St. (looking south east)</p>
 	<p>Photo 2: Entry/Exit Pit on West Side of Bathurst St., South of Steeles Ave. W. (looking north)</p>

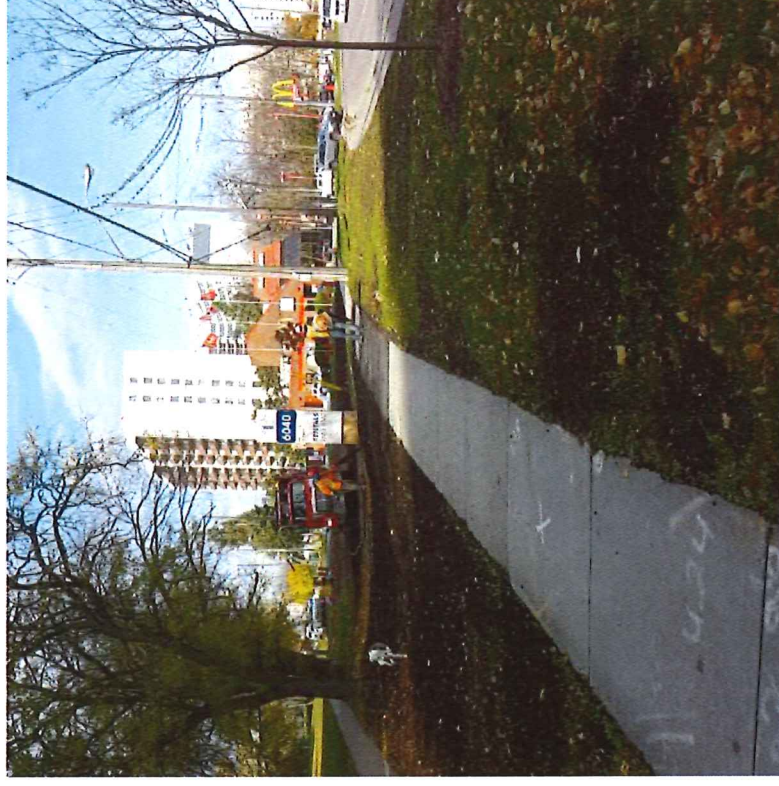
Photo 3: West Side of Bathurst St., South of Fisherville Rd. (looking south)

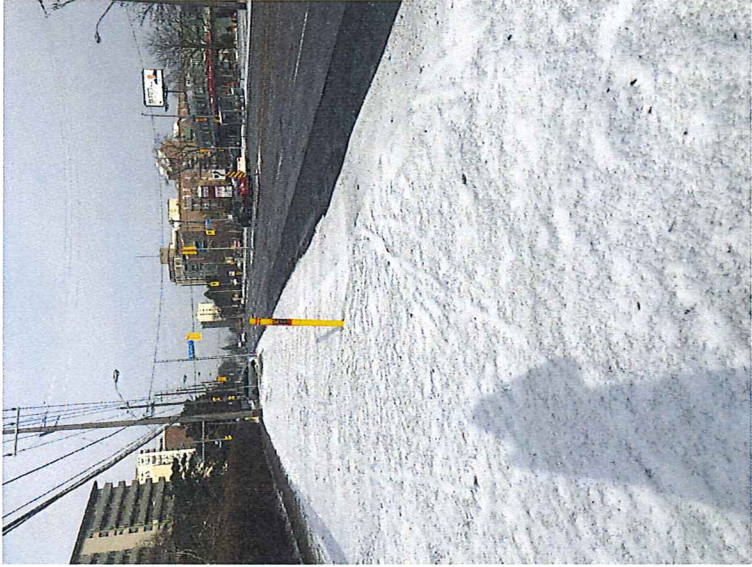
Photo 4: West Side of Bathurst St. South of Carpenter Rd. (looking north)

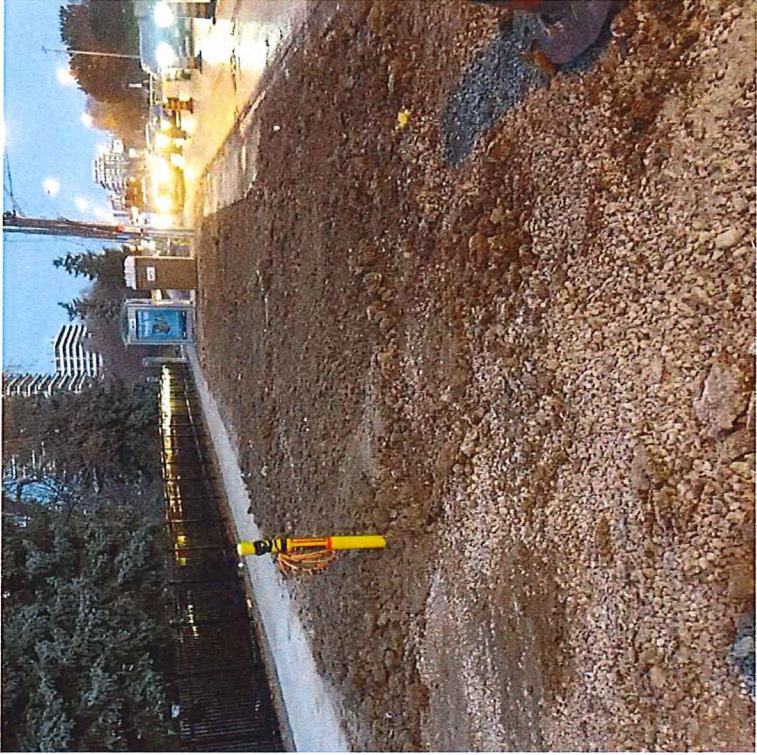
<b>Photo 5</b>	West Side of Bathurst St., South of Rockford Rd. (looking north)	Boulevard was hydroseeded and restored to pre-construction condition.	Permanent restoration, including road asphalt, pattern concrete apron and curbs is planned for Spring/Summer 2020.
<b>Photo 6</b>	West Side of Bathurst St., South of Kenton Dr. (looking north)	Temporary restoration has been completed.	Permanent restoration, including hydroseed, is planned for Spring/Summer 2020.
<b>Photo 7</b>	West Side of Bathurst St., South of Kenton Dr. (looking north)	Temporary restoration has been completed.  Large mounds in picture was confirmed to be snow/ice buildup from plowing.	Permanent restoration, including hydroseed, is planned for Spring/Summer 2020.

<p>Photo 5: West Side of Bathurst St., South of Rockford Rd. (looking north)</p>	<p>Photo 6: West Side of Bathurst St., South of Kenton Dr. (looking north)</p>
