Appendix L: Building Condition Assessment

Baseline Property Condition Assessment

100-102 Simcoe Street South,
Oshawa, Ontario

May 1, 2020

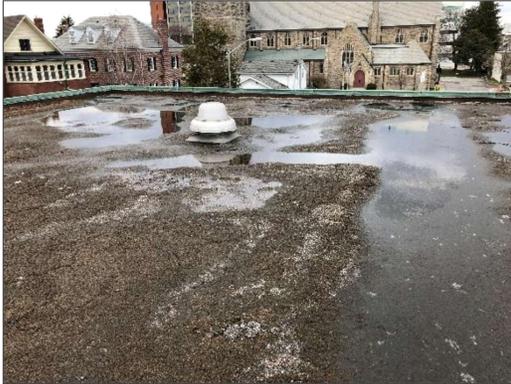
Active leaking within the roof system atop the original phase of construction of the garage portion of Site Building C was reported during the assessment. No active leaking within the remainder of the roof systems was reported, although evidence of moisture infiltration was noted on ceilings in various locations.

View of the roof system atop the original phase of construction of the garage portion of Site Building C.

Pinchin has included an allowance for replacement of the BUR system atop the second phase of construction of the garage portion of Site Building C in year one and allowances to replace the remaining roof systems in the latter portion of the of the analysis. Pinchin recommends that regular annual maintenance be performed on the roof systems throughout the term of the analysis.

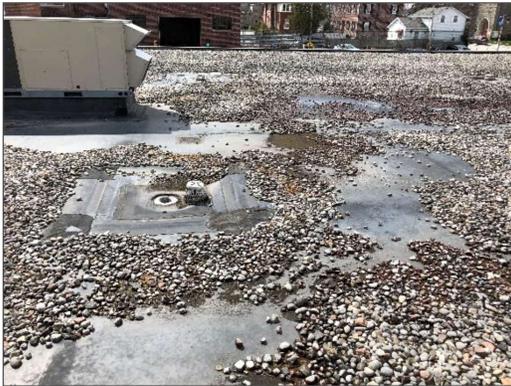
<ul style="list-style-type: none"> Site Building B –Membrane exposed with insufficient ballast cover . 	<ul style="list-style-type: none"> Ensure sufficient ballast cover is in place over the entire membrane.
<ul style="list-style-type: none"> Site Building B – Roof drain ballast guard was noted to be displaced atop. 	<ul style="list-style-type: none"> Ensure ballast guard covers remain secured in place.
<ul style="list-style-type: none"> Debris blocking s roof drain in various locations. 	<ul style="list-style-type: none"> Ensure ballast guards remain clear and free of debris.

View of areas of membrane with insufficient ballast cover noted atop Site Building B.

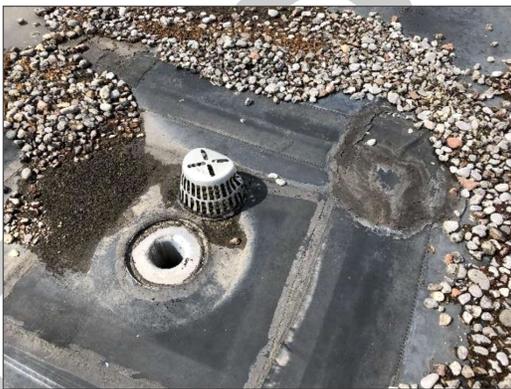
View of typical displaced internal roof drain ballast guard cover noted atop Site Buildings B and C.

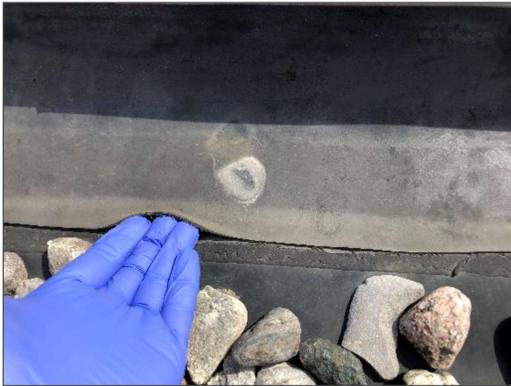
View of typical debonded seams noted on the EPDM membrane atop Site Building B.

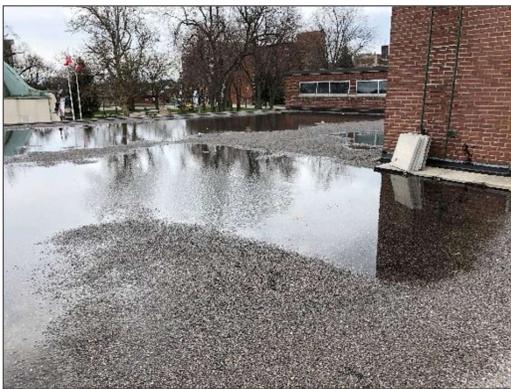
View of large areas of ponding water noted atop Site Building C.

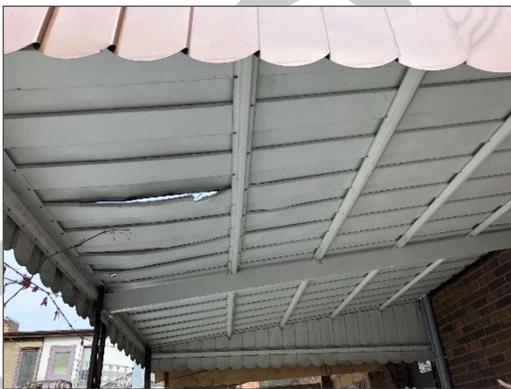
View of a damaged section noted on the sloped metal canopy on the north elevation of Site Building A.

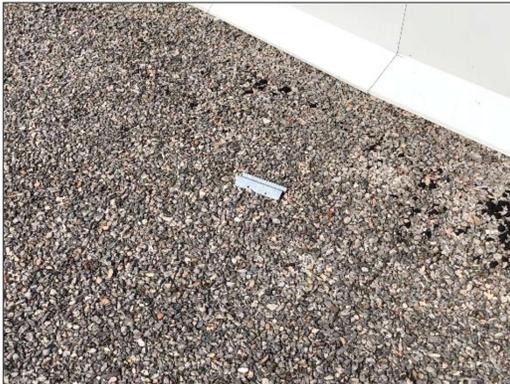
View of loose metal debris noted atop Site Building A.

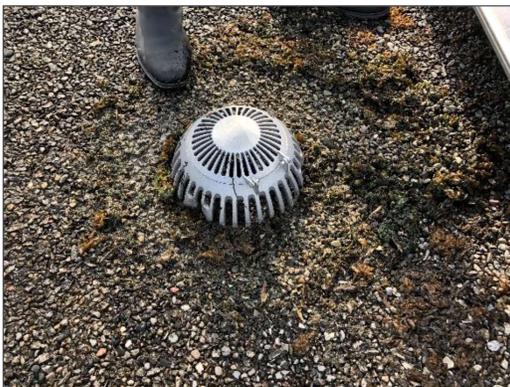
View of a typical internal roof drain ballast guard blocked by debris.

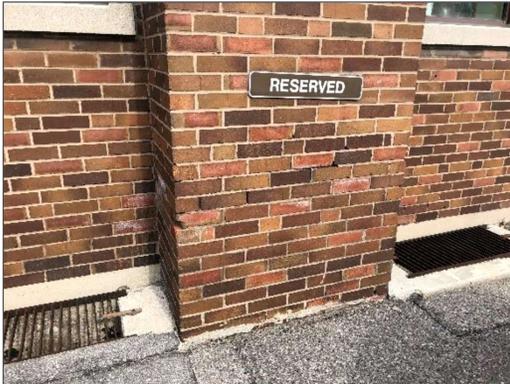
View of typical deteriorated mortar joints noted on the brick masonry veneer in various locations on the north elevation of Site Building A.

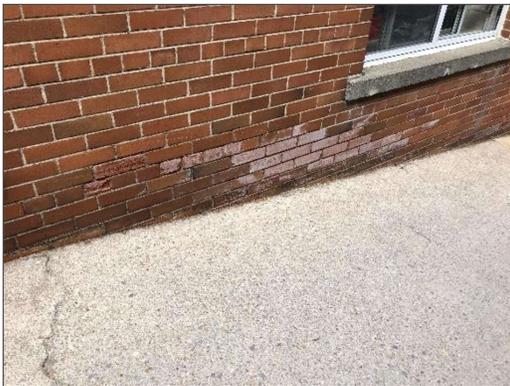
View of typical efflorescence noted on the brick masonry veneer in various locations.

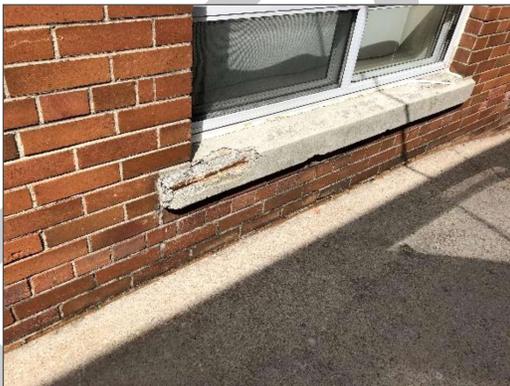
View of deterioration noted on concrete windowsills in various locations on Site Building B.

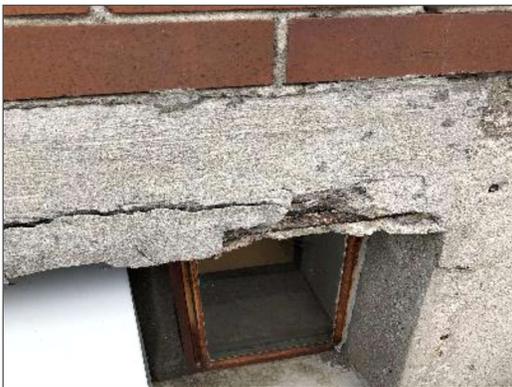
<ul style="list-style-type: none"> Cracking and deterioration noted on the cast-in-place concrete foundation walls around the window units on the south elevation of Site Building C. 	<ul style="list-style-type: none"> Repair cracking and deteriorated concrete.

Cracking and deterioration noted on the cast-in-place concrete foundation walls around the window units on the south elevation of Site Building C.

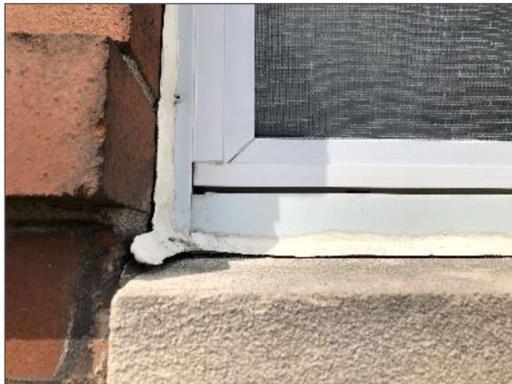
View of typical failing perimeter sealant noted on the window units in various locations.

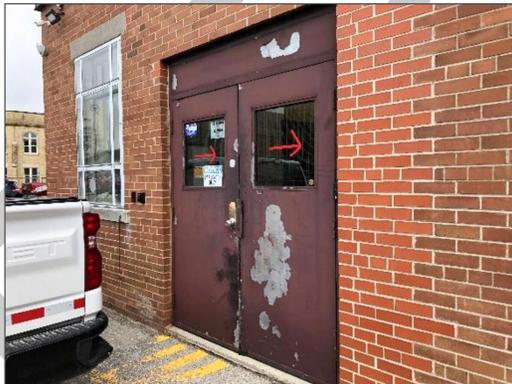
View of typical peeling paint noted on various hollow metal doors serving the Site Buildings.

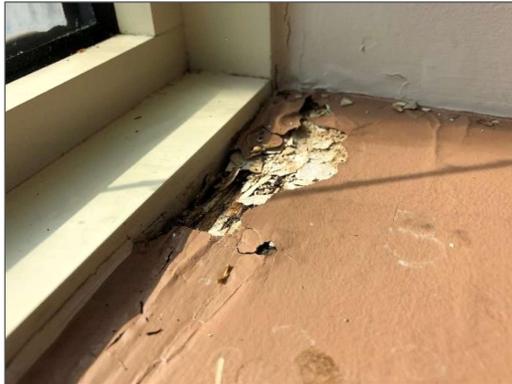
View of moisture damage noted on a window sill
in an office space on the second floor of Site
Building A.

Pinchin recommends and has included allowances to perform a mould survey of the building due to the presence of the moisture damaged materials and to assess where the moisture is infiltrating. The extent or possible cost of mould remediation cannot be estimated without performing this intrusive mould survey. Depending on the extent of the mould detected the cost of remediation may be significant. Pinchin has attempted to identify and quantify the deficiencies associated with the wall, window and door systems however an investigation of the components should be completed prior to the repair work and to ensure the extent of deterioration is fully understood. It is noted that the cost estimates provided in this report are preliminary and provided only as an indication of the order of magnitude of the remedial work. More precise cost estimates would require more detailed investigation to define the scope of work. Superficial or visual signs of concrete or structural deterioration may indicate the need for extensive repairs which can only be estimated by performing a detailed investigation of the structure and the structural design.

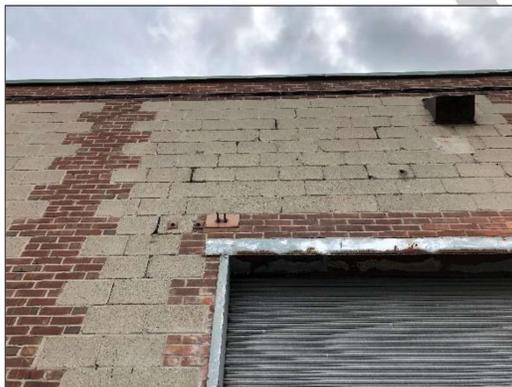
View of typical deteriorated mortar joints and step cracking noted on the concrete block masonry on Site Building C.

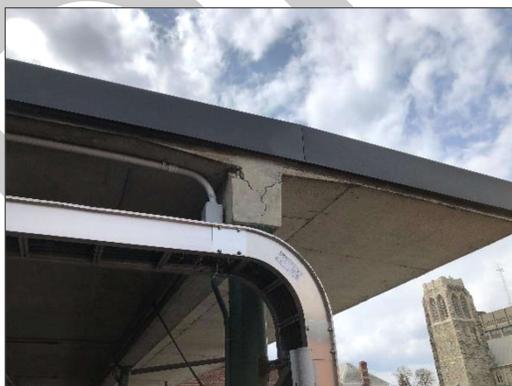
Cracking noted on a structural concrete beam supporting the roof on the north elevation of Site Building C.

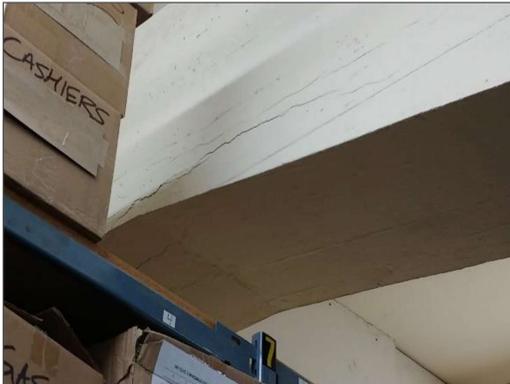
Cracking noted in concrete beam of Site Building C.

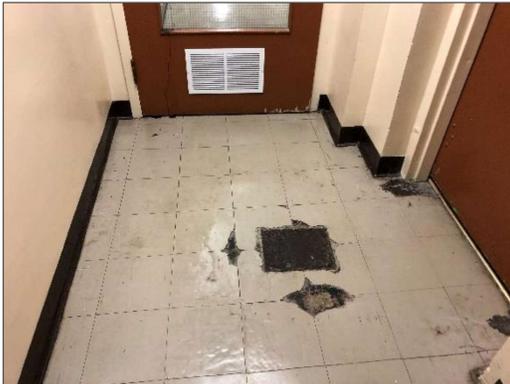
View of damaged vinyl floor tiles noted in the basement level of Site Building A.

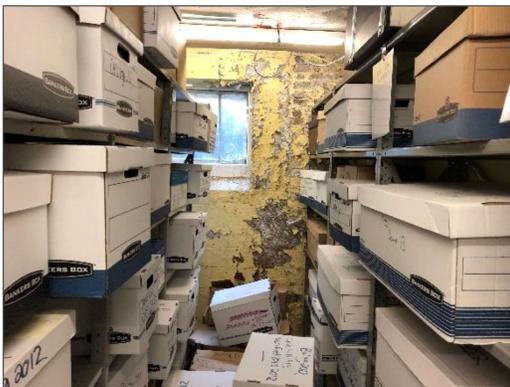
<ul style="list-style-type: none"> Peeling paint noted on various wall finishes within Site Building A. 	<ul style="list-style-type: none"> Prep and repaint the wall finishes.
<ul style="list-style-type: none"> Cracking plaster wall finishes noted in various locations within Site Building A. 	<ul style="list-style-type: none"> Repair the cracking plaster.
<ul style="list-style-type: none"> Damaged gypsum board noted in various locations within the office spaces of Site Building A. 	<ul style="list-style-type: none"> Repair damaged gypsum board.

View of typical peeling paint noted on various wall finishes within Site Building A.

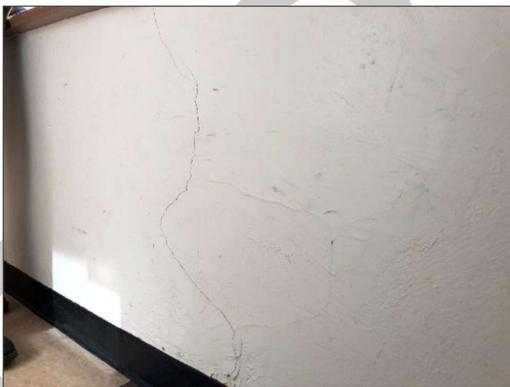
View of typical cracking plaster noted in various locations within Site Building A.

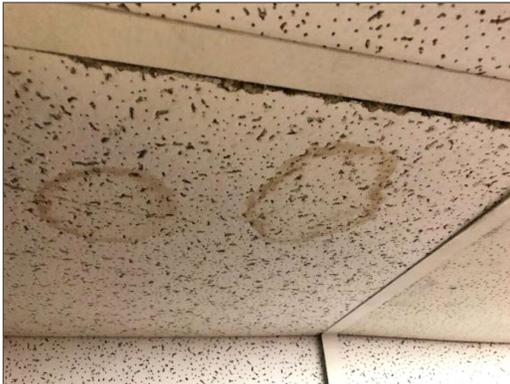
View of typical moisture staining noted on lay-in ceiling tiles in various locations throughout the Site Buildings.

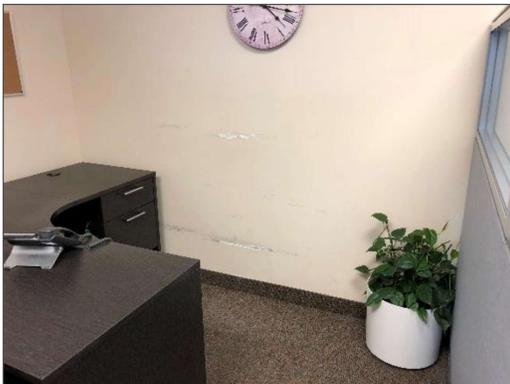
View of typical damaged gypsum board noted within the office spaces of Site Building A.

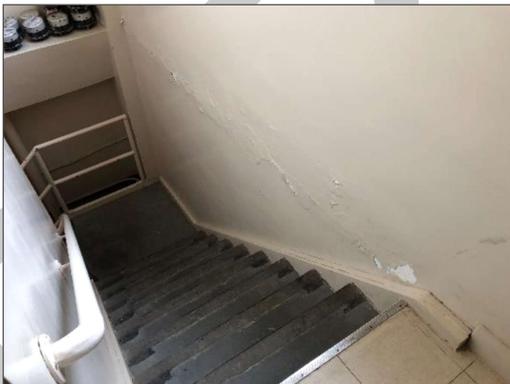
View of moisture damaged plaster noted on the exterior walls in various locations within the office spaces of Site Building A.

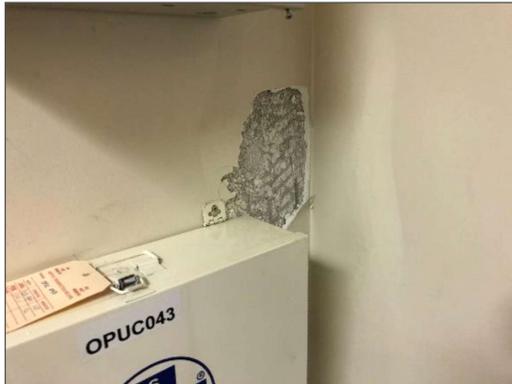
View of typical plaster damage noted in various locations within Site Building C.

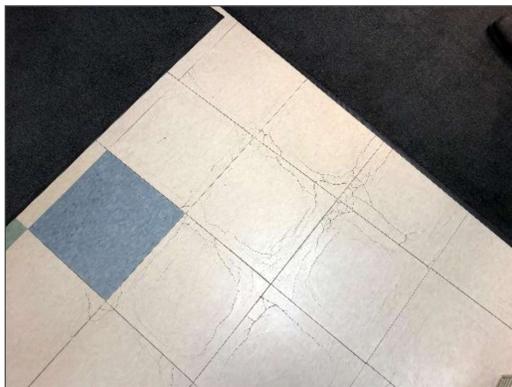
View of cracking vinyl floor tiles noted in various locations within Site Building C.

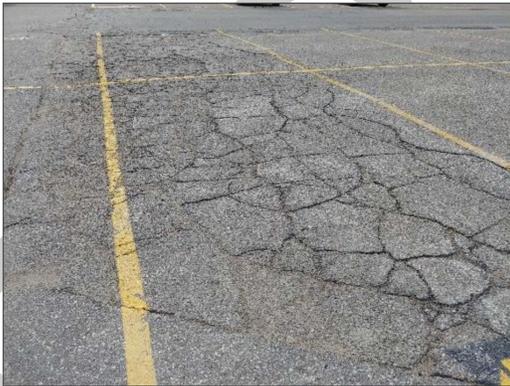
View of typical cracking and shifting asphalt noted throughout the Site.

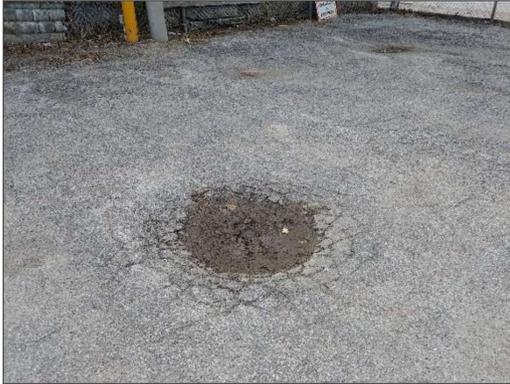
View of typical a depression noted on the asphalt pavement in various locations.

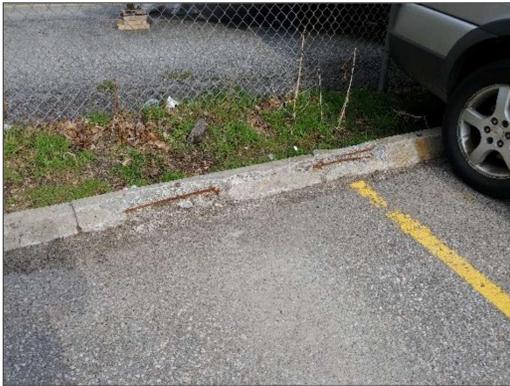
View of typical deteriorated concrete curbing noted in various locations.

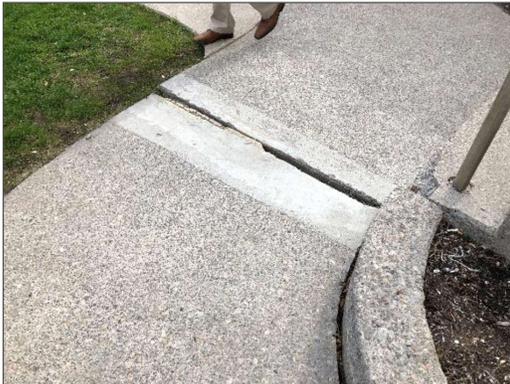
View of a shifting section of cast-in-place concrete walkway posing a potential trip and fall hazard adjacent to the south elevation of Site Building A.

An immediate cost of \$3,000 has been identified for the concrete walkway repairs that currently pose a potential trip hazard adjacent to the south and east elevations of Site Building A. Repair requirements (under replacement reserves) over the term of the analysis (i.e., 10 years) of \$872,696 have been identified. As noted during the Site visit, deficiencies relating to roof systems, wall systems, elevator systems, interior finishes, Site features and mechanical/electrical systems were noted. Of particular note, recommendations, repairs and replacements for the following items are included throughout the term of the analysis:

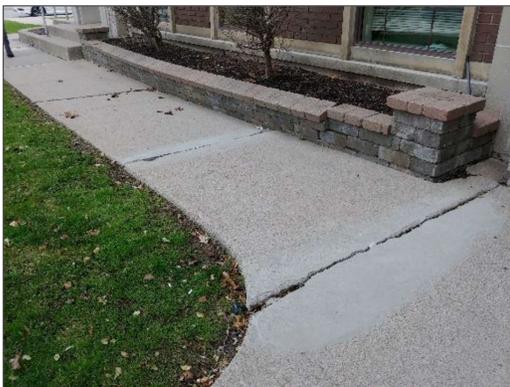
View of a shifting and cracking in the cast-in-place concrete walkway posing a potential trip and fall hazard adjacent to the east elevation of Site Building A.

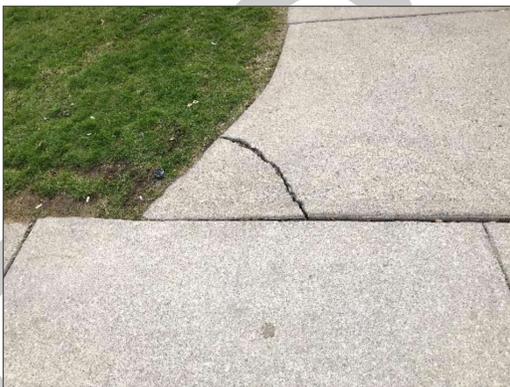
View of typical cracking noted in the cast-in-place concrete walkways in various locations.

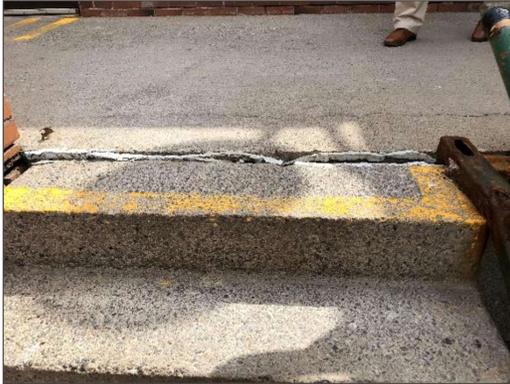
View of cracking and shifting concrete steps leading to the loading docks adjacent to the north elevation of Site Building C.

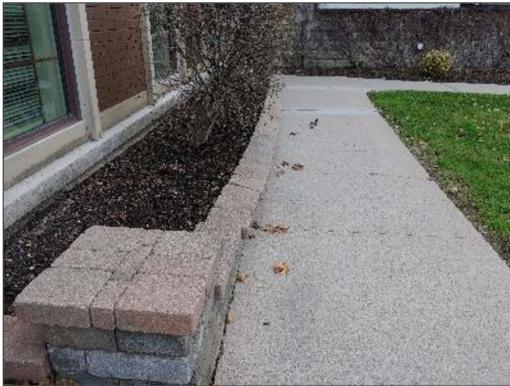
<ul style="list-style-type: none"> Shifting concrete block masonry planter retaining wall surrounding soft landscaping noted on the east elevation of Site Building A. 	<ul style="list-style-type: none"> Repair the concrete block masonry.

View of shifting concrete block masonry planter retaining wall surrounding soft landscaping on the east elevation of Site Building A.

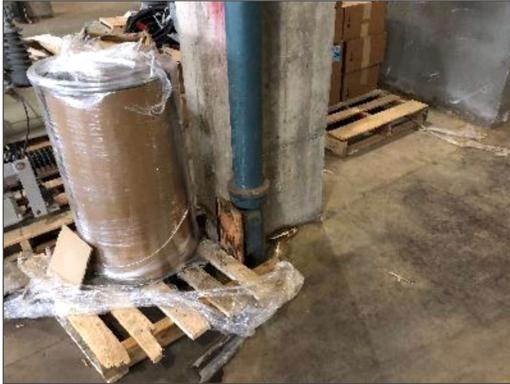
View of a leaking rainwater leader pipe noted in the basement of Site Building C.
