Scugog Island Natural Gas Pipeline Project:

Post-Construction Interim Monitoring Report

EB-2017-0261

To: Sarah Kingdon-Benson
From: Sean Robinson
Date: June 26, 2020
Subject: Highway 7A Interim Reclamation Report
Our File: 19-9834

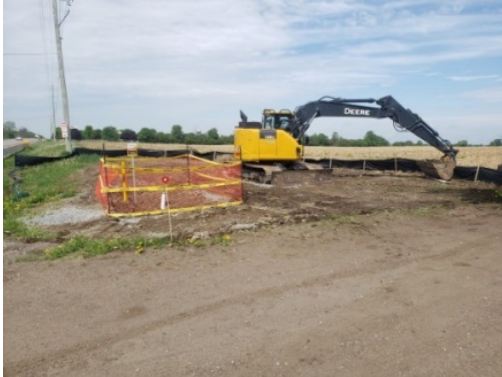
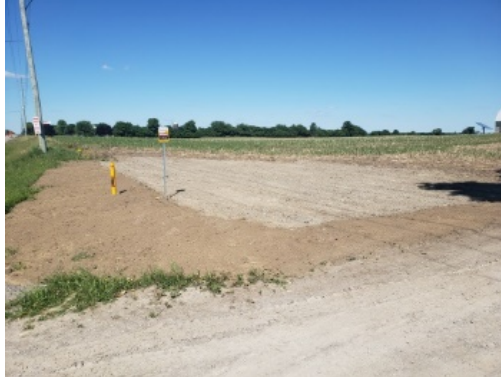
Location	Site Condition	Additional Work Recommended	Comments/ Recommendations	Representative Photo (May 29 and June 1, 2020)	Representative Photo (June 15, 2020)
3291 Hwy 7A (E12)	Reclaimed	N	Disturbed area is located west of a gravel laneway at the south end of a cultivated agricultural field. No signs of erosion. ESC measures have been removed. Pictures facing Northwest.

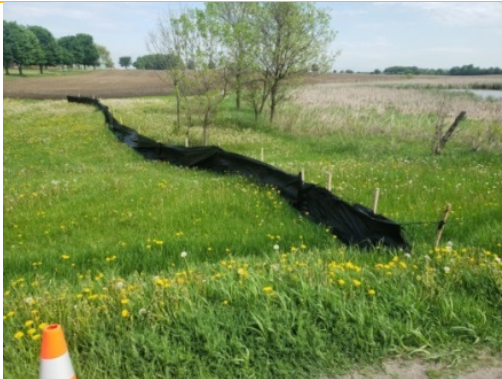
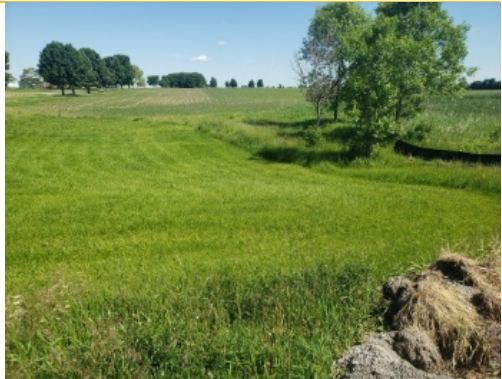
3291 Hwy 7A (E12)	Undisturbed	N	Silt fencing at this location was installed as exclusion fencing for wildlife and has been subsequently removed. Pictures facing Northeast.

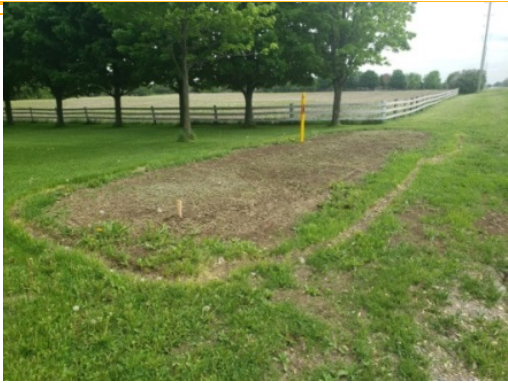
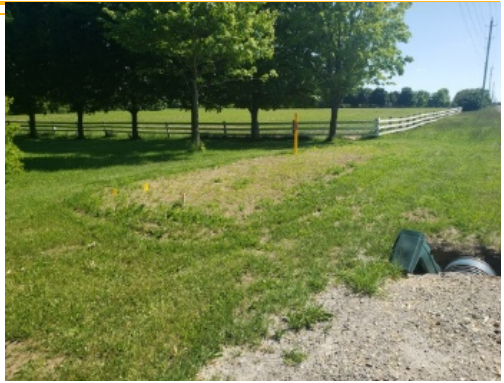
Location	Site Condition	Additional Work Recommended	Comments/ Recommendations	Representative Photo (May 29 and June 1, 2020)	Representative Photo (June 15, 2020)
3191 Hwy7A (E11)	Reclaimed	N	Disturbed area is located within a maintained lawn. Evidence of seeding observed, seed germination not yet observed. No signs of erosion. ESC measures have been removed. Pictures facing Northeast.

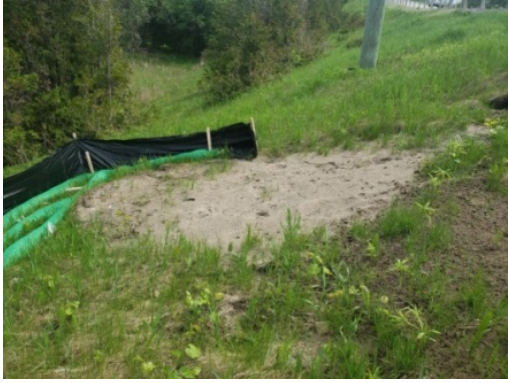
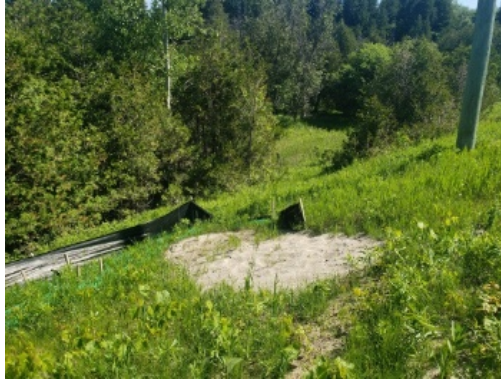
3191 Hwy7A (PPR-2 Watercourse)	Not reclaimed	Y	Three sand piles observed along the vegetated road shoulder in proximity to a watercourse. Removal of excess sand, dressing with topsoil and subsequent seeding is recommended. ESC measures currently installed at these locations can be removed upon stabilization through vegetative growth. Pictures facing Northeast.

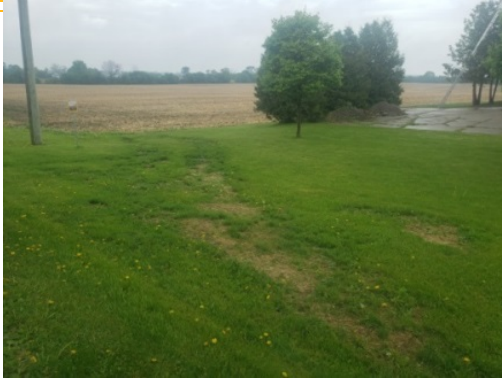
Location	Site Condition	Additional Work Recommended	Comments/ Recommendations	Representative Photo (May 29 and June 1, 2020)	Representative Photo (June 15, 2020)
3091 Hwy 7A (E7)	Reclaimed	N	Disturbed area is located within a maintained lawn. Evidence of seeding observed, seed germination observed to be uneven. No signs of erosion. ESC measures have been removed. Pictures facing Northwest.

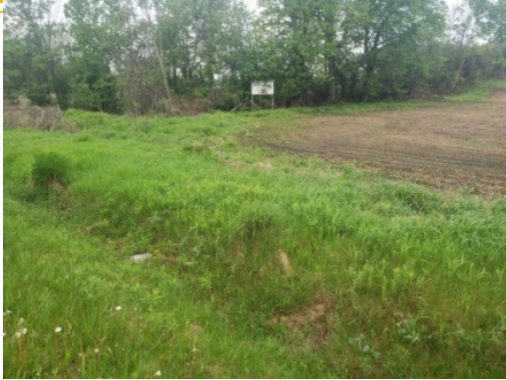
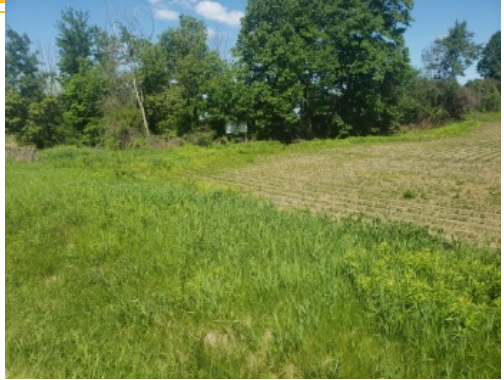
Location	Site Condition	Additional Work Recommended	Comments/ Recommendations	Representative Photo (May 29 and June 1, 2020)	Representative Photo (June 15, 2020)
Cartwright West ¼ Line and Hwy 7A (E5)	Reclaimed	N	Disturbed area is located on the southern edge of a cultivated field. No signs of erosion. ESC measures have been removed. Pictures facing Northwest.

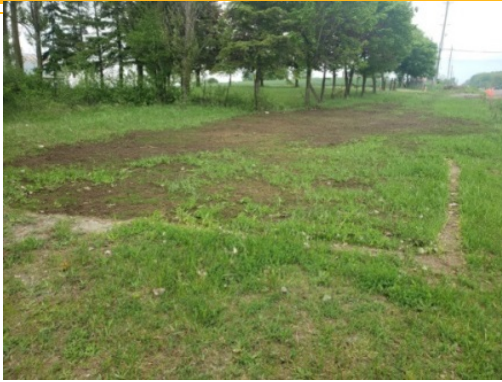
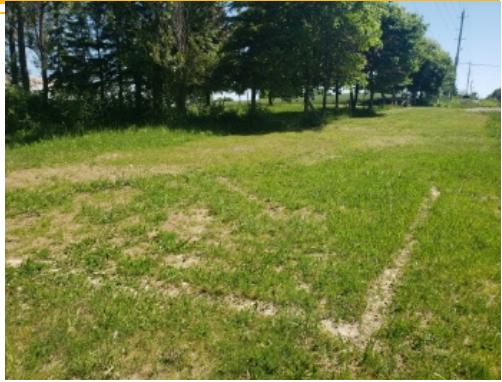
Location	Site Condition	Additional Work Recommended	Comments/ Recommendations	Representative Photo (May 29 and June 1, 2020)	Representative Photo (June 15, 2020)
2951 Hwy 7A (E3)	Reclaimed	N	Disturbed area is located within a maintained lawn area. Signs of early seed germination observed. No signs of erosion. ESC measures have been removed. Pictures facing Northwest.	 	 
2895 Hwy 7A (E2)	Partially reclaimed	Y	Disturbed area is located within a maintained lawn area. Evidence of seeding observed, however, seed application appears to be uneven and additional seed may be required. Signs of early seed germination observed. No signs of erosion. An open excavation with shoring box and fencing remains at

Location	Site Condition	Additional Work Recommended	Comments/ Recommendations	Representative Photo (May 29 and June 1, 2020)	Representative Photo (June 15, 2020)
			the east end of the work area due to ongoing conditioning of the pipe, which is surrounded by silt soxx. Silt soxx can be removed once surrounding area has been reclaimed and is stabilized through vegetation growth. Pictures facing Northeast.

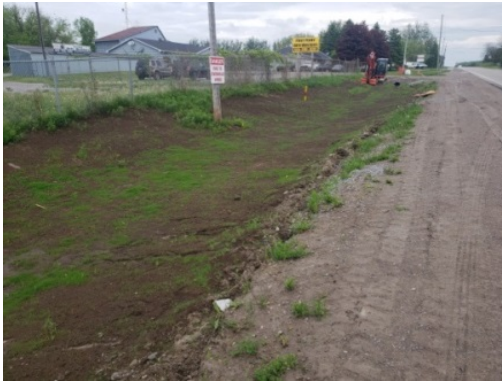
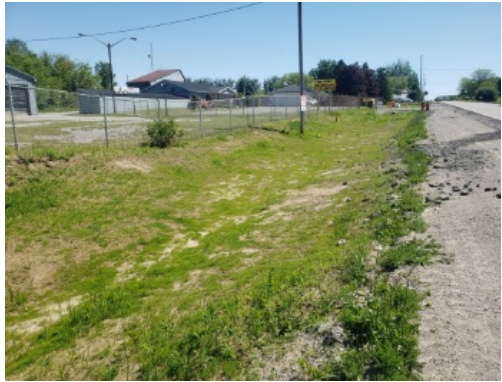
2831 Hwy 7A (E1)	Reclaimed	N	Disturbed area is located within a maintained lawn area. Evidence of seeding and early seed germination observed. Early signs of erosion (shallow rilling) observed, however, continued observation over 3 weeks has not revealed any progression of the erosion. ESC measures have been removed. Pictures facing Northeast.

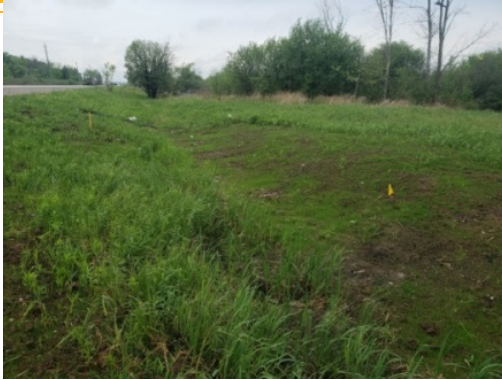
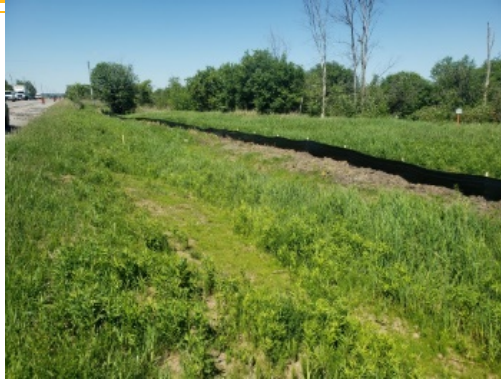
Location	Site Condition	Additional Work Recommended	Comments/ Recommendations	Representative Photo (May 29 and June 1, 2020)	Representative Photo (June 15, 2020)
2831 Hwy 7A (W7)	Reclaimed	Y	Disturbed area is located within meadow habitat north of the vegetated road shoulder. Evidence of seeding and early seed germination observed. No signs of erosion observed. Silt soxx remain in place west of the work area and can be removed. Pictures facing Northwest.

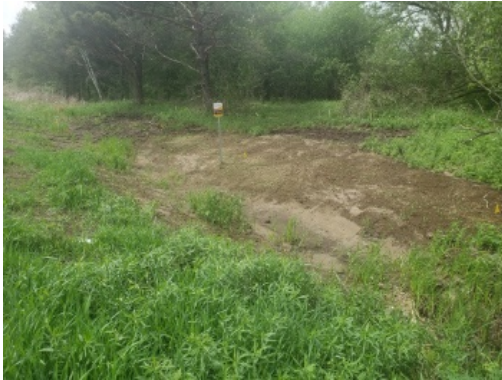
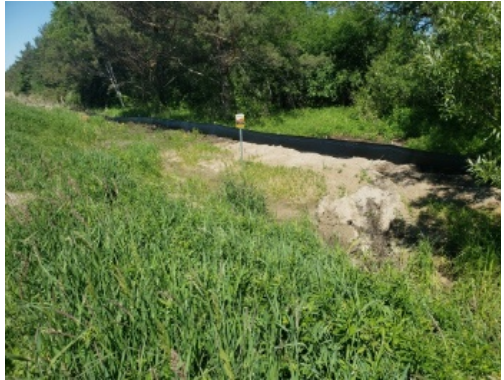
2831 Hwy 7a (W6)	Reclaimed	Y	Disturbed area is located within wet meadow habitat north of the vegetated road shoulder. Evidence of seeding observed, however, application appears to be uneven and additional seed may be required. Areas of sand have been left in place and require removal. Recommend leaving silt soxx containment in place until disturbed areas have become stabilized through vegetative growth. Pictures facing Northwest.

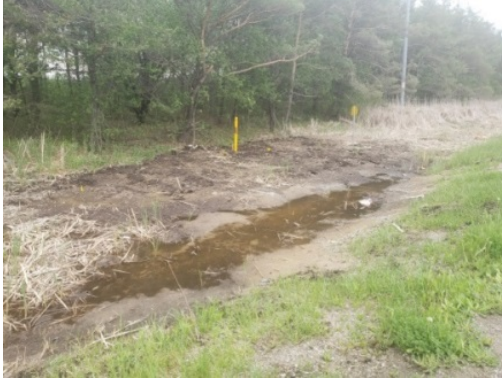
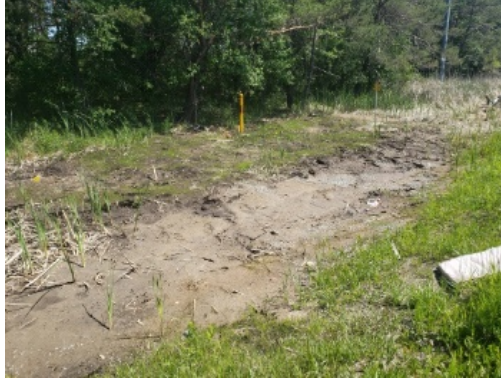
Location	Site Condition	Additional Work Recommended	Comments/ Recommendations	Representative Photo (May 29 and June 1, 2020)	Representative Photo (June 15, 2020)
2505 Hwy 7A (W5.5)	Reclaimed	Y	<p>Disturbed area is located within wetland habitat north of the vegetated road shoulder. Evidence of seeding observed, however, vegetative growth appears to be uneven and additional seed may be required. Small piles of sand, gravel and areas of pooling water observed within work area. Recommend removal of excess sand/gravel and subsequent addition of topsoil/seed. Recommend leaving silt soxx containment in place until disturbed areas have become stabilized through vegetative growth.</p> <p>Pictures facing Northeast.</p>

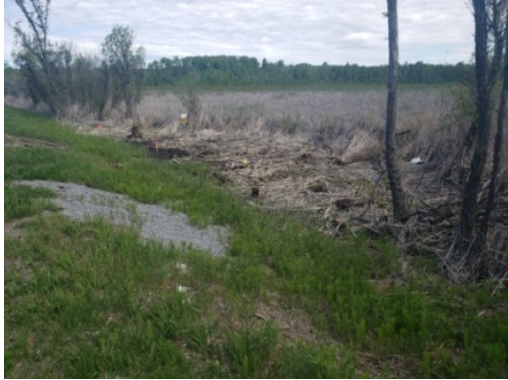
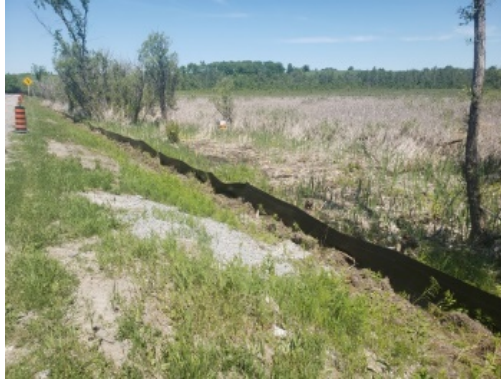
Location	Site Condition	Additional Work Recommended	Comments/ Recommendations	Representative Photo (May 29 and June 1, 2020)	Representative Photo (June 15, 2020)
Approx. 650 m east of intersection of Reader Road and Highway 7A (W4)	Reclaimed	Y	<p>Disturbed area is located within wetland habitat north of the vegetated road shoulder. Areas of exposed soil within the disturbed area were observed to be minimal and the work area is expected to naturally revegetate. Recommend leaving silt soxx containment in place until disturbed areas have become stabilized through vegetative growth. A small pile of gravel has been left on the vegetated road shoulder south of the work area and its removal is recommended.</p> <p>Pictures facing Northwest.</p>

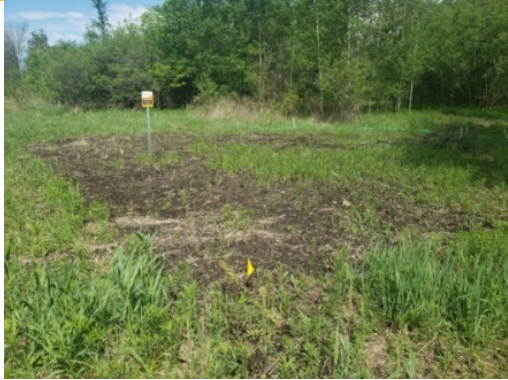
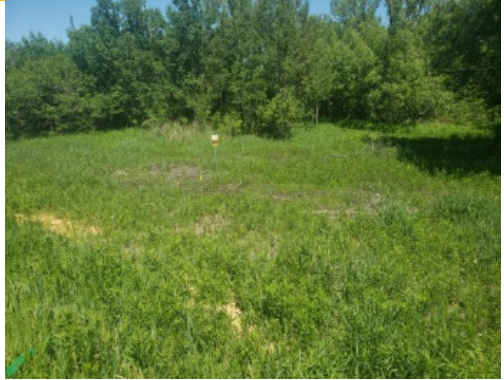
2431 Hwy 7A (W3)	Reclaimed	Y	<p>Disturbed area is located within wet meadow habitat north of the vegetated road shoulder. Evidence of seeding and early seed germination observed. Recommend leaving silt soxx containment in place until disturbed areas have become stabilized through vegetative growth. Minor rutting observed north of the</p>

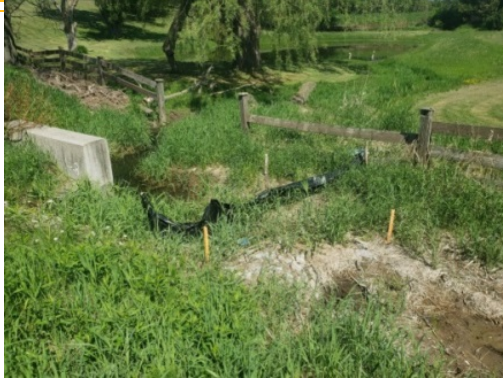
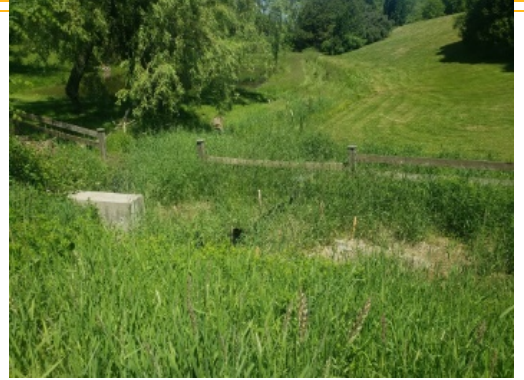
Location	Site Condition	Additional Work Recommended	Comments/ Recommendations	Representative Photo (May 29 and June 1, 2020)	Representative Photo (June 15, 2020)
Reader Road and Hwy 7a (PPR-6 Watercourse)	Not reclaimed	Y	ESC measures were installed east of the watercourse to contain drilling fluid during HDD activities and can now be removed. Small areas of exposed soil are expected to naturally revegetate. Pictures facing North.

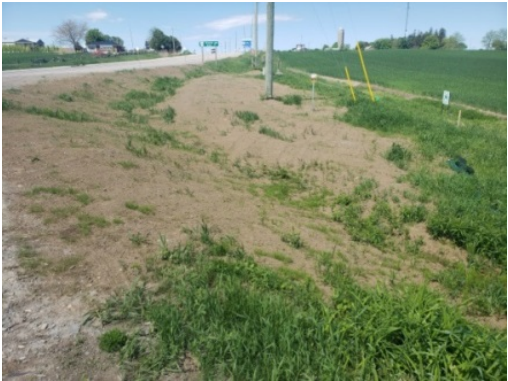
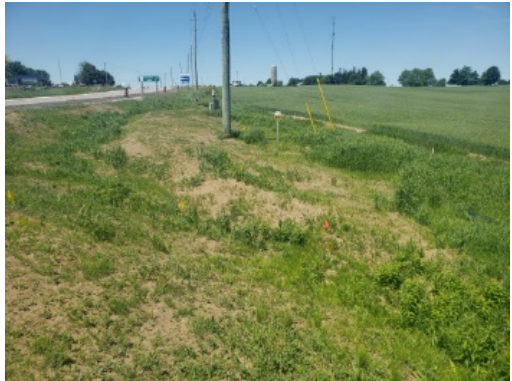
Location	Site Condition	Additional Work Recommended	Comments/ Recommendations	Representative Photo (May 29 and June 1, 2020)	Representative Photo (June 15, 2020)
Reader Road and Hwy 7A (W2-1)	Reclaimed	Y	Disturbed area is located within meadow habitat north of the vegetated road shoulder. Evidence of seeding observed, however, vegetative growth appears to be uneven and additional seed may be required. No signs of erosion observed. Recommend leaving silt soxx containment in place until disturbed areas have become stabilized through vegetative growth. Pictures facing West.

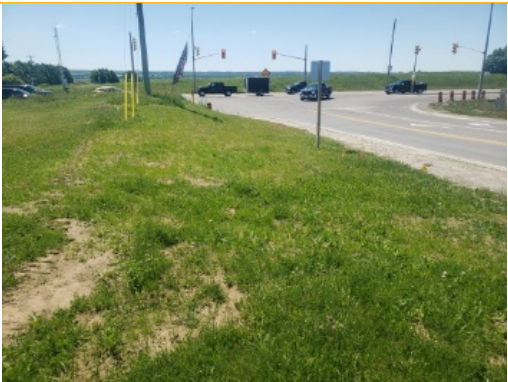
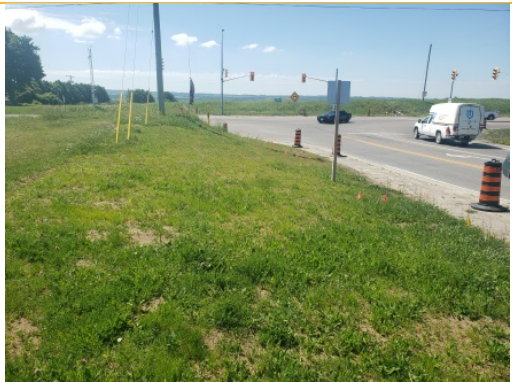
Island Road and Hwy 7A (W1)	Reclaimed	N	Disturbed area is located within a maintained lawn area east of Island Road. Evidence of seeding and even seed germination observed. No signs of erosion. ESC measures have been removed. Pictures facing South.
