**Re: Enbridge Gas Inc. (“Enbridge Gas”)
Ontario Energy Board (“Board”) File No.: EB-2019-0006
St. Laurent Pipeline Project (“Project”)**

St. Laurent Pipeline Project:
Post-Construction Report
EB-2019-0006

Company: Enbridge Gas Inc.

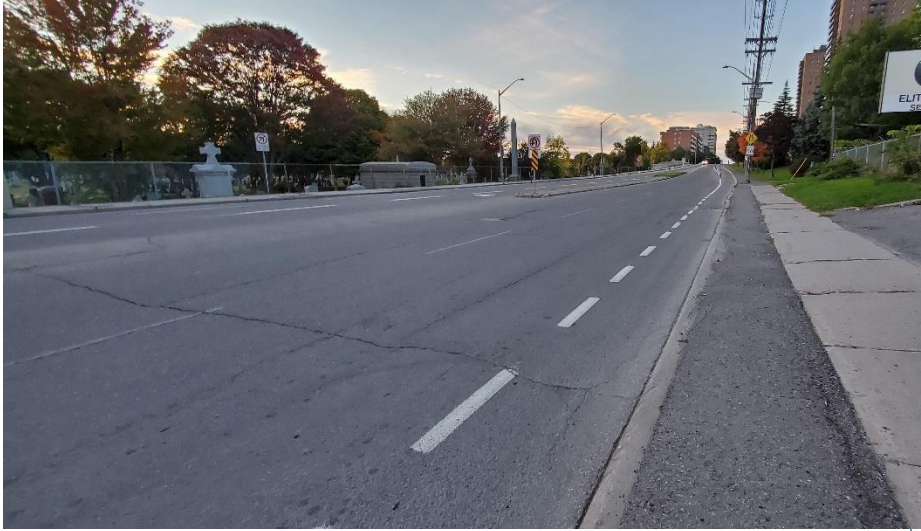
<p>Facing north at St. Laurent Boulevard from the northbound St. Laurent Boulevard sidewalk, north of Montreal Road.</p> <p>Mainline replacement area.</p>	<p>Reclaimed</p>	<p>None required.</p>

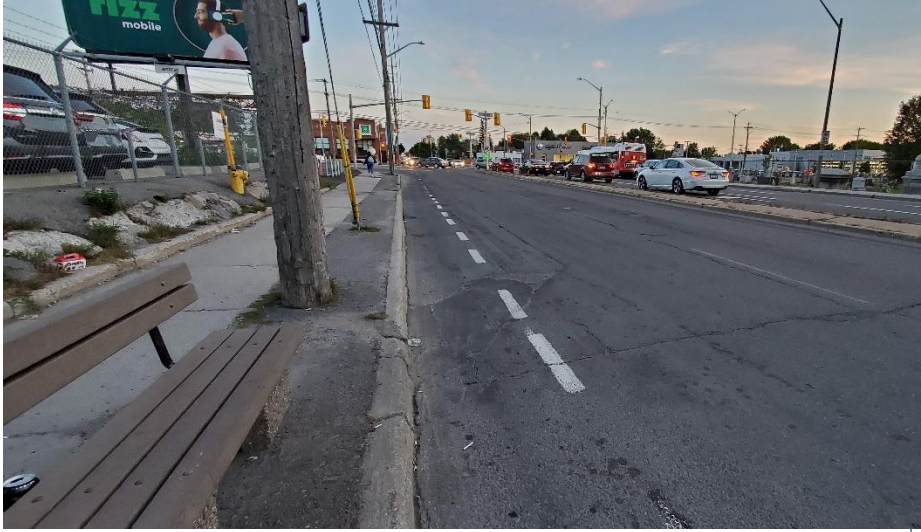
<p>Facing southwest at St. Laurent Boulevard from the northbound St. Laurent Boulevard sidewalk, north of Montreal Road</p> <p>Mainline replacement area.</p>	<p>Reclaimed</p>	<p>None required.</p>

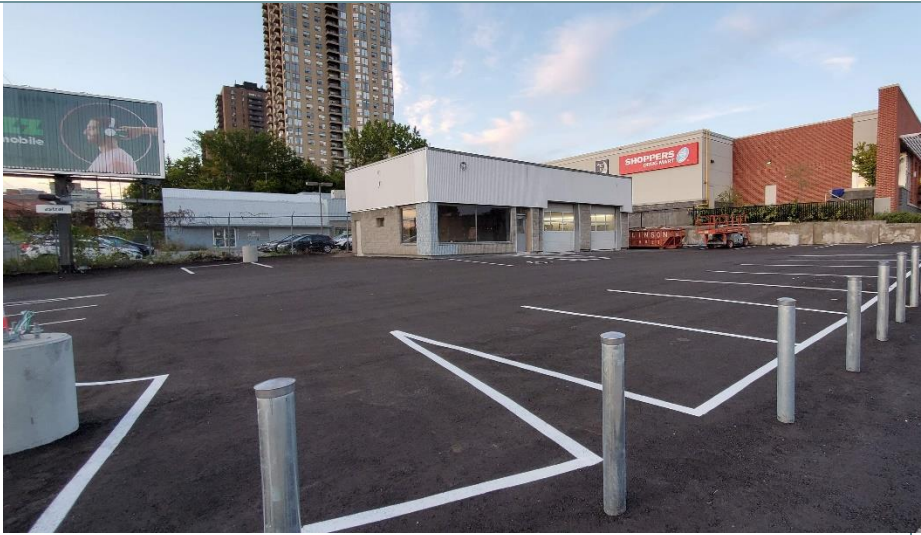
<p>Facing northeast at commercial parking lot from the intersection of St. Laurent Boulevard and Montreal Road.</p> <p>Past equipment staging area as well as sand and gravel storage area.</p>	<p>Reclaimed. Previously used as a staging area for equipment and gravel/sand piles.</p>	<p>None required.</p>

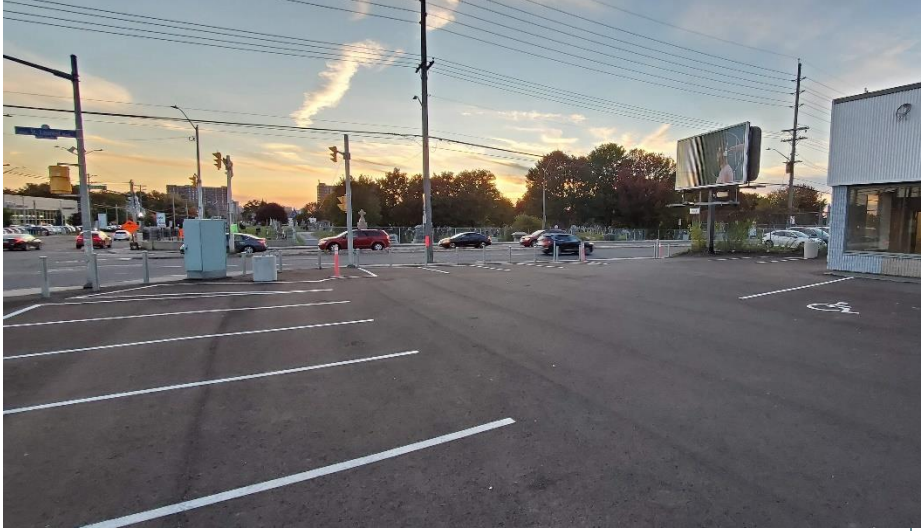
<p>Facing northwest at commercial parking lot from westbound Montreal Road sidewalk, east of the intersection of St. Laurent Boulevard and Montreal Road.</p> <p>Past equipment staging area as well as sand and gravel storage area.</p>	<p>Reclaimed. Previously used as a staging area for equipment and gravel/sand piles.</p>	<p>None required.</p>

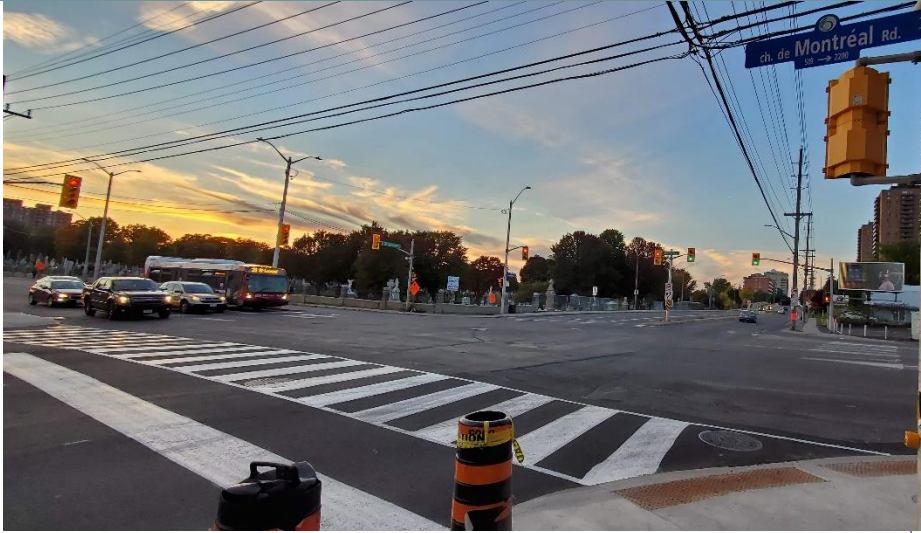
<p>Facing northwest at the intersection of St. Laurent Boulevard and Montreal Road from the northbound lane sidewalk of St. Laurent Boulevard.</p> <p>Mainline replacement area.</p>	<p>Reclaimed.</p>	<p>None required</p>

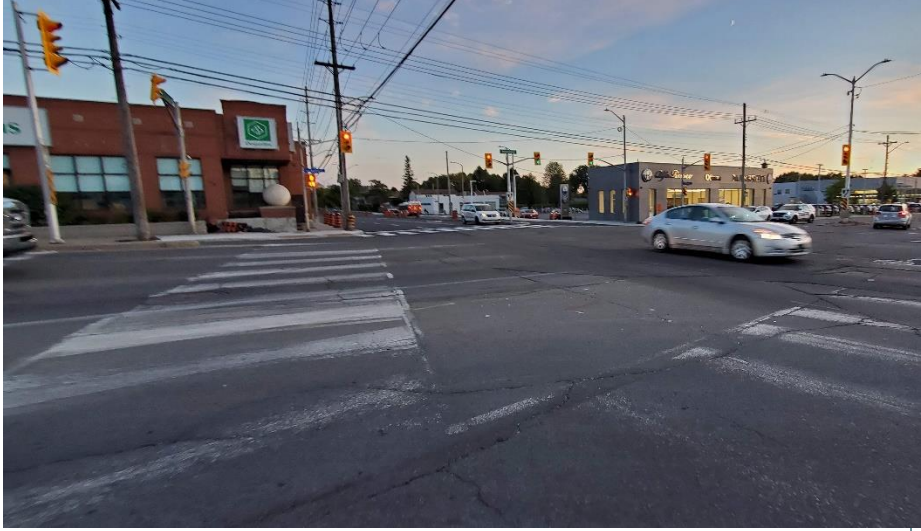
<p>Facing southwest at the intersection of St. Laurent Boulevard and Montreal Road from the northbound lane sidewalk of St. Laurent Boulevard.</p> <p>Mainline replacement area.</p>	<p>Reclaimed</p>	<p>None required</p>

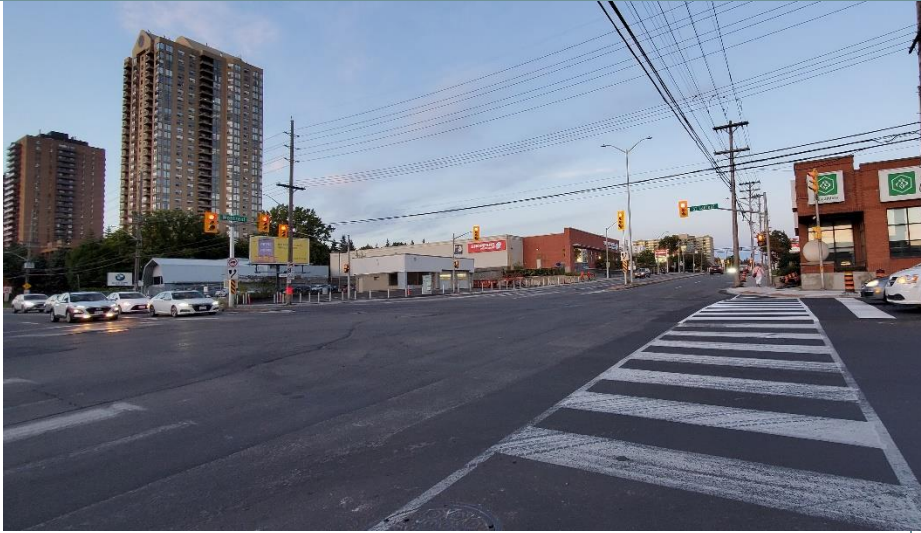
<p>Facing northwest at the intersection of St. Laurent Boulevard and Montreal Road from the southbound lane sidewalk of St. Laurent Boulevard.</p> <p>Mainline replacement area.</p>	<p>Reclaimed</p>	<p>None required</p>

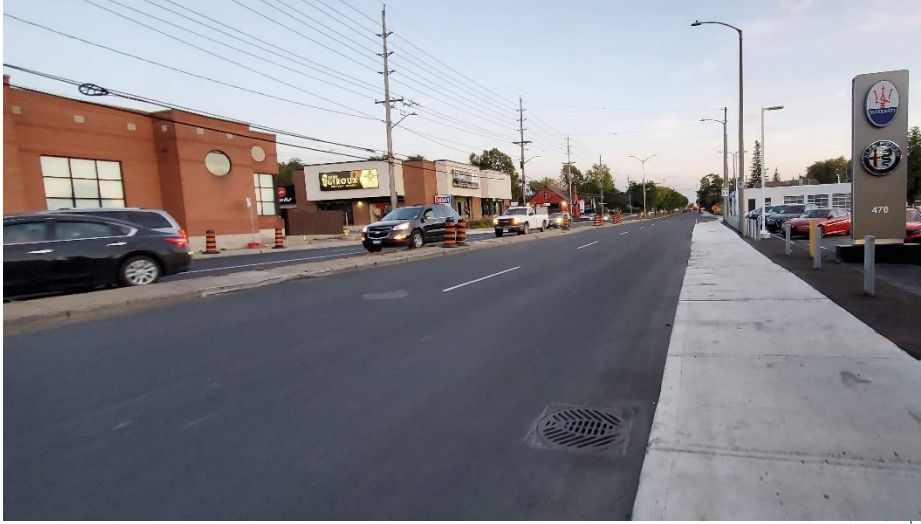
<p>Facing south at southbound land of St. Laurent Boulevard.</p> <p>Upgraded service connection area.</p>	<p>Reclaimed</p>	<p>None required</p>

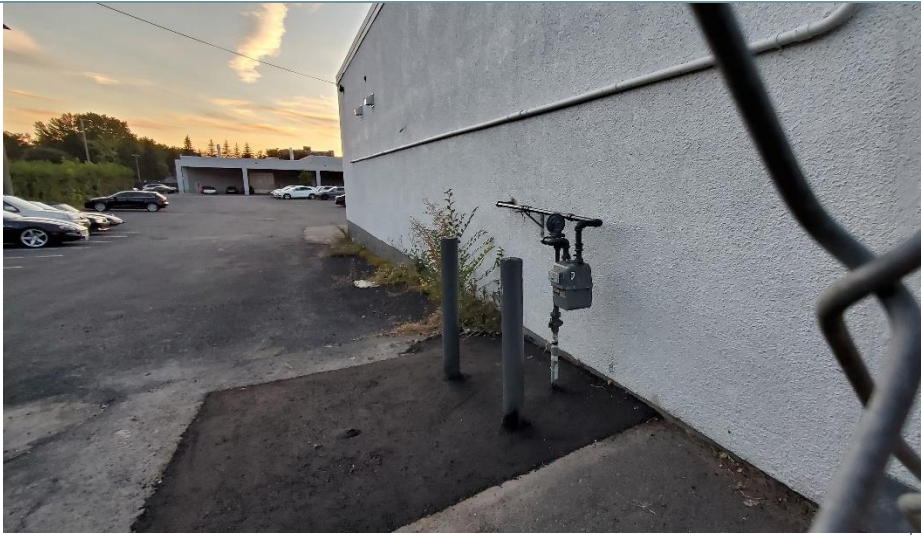
<p>Facing northwest at completed service connection for Maserati of Ottawa (616 St. Laurent Boulevard) from the sidewalk of the southbound lane of St. Laurent Boulevard.</p> <p>Upgraded service connection area.</p>	<p>Reclaimed</p>	<p>None required</p>

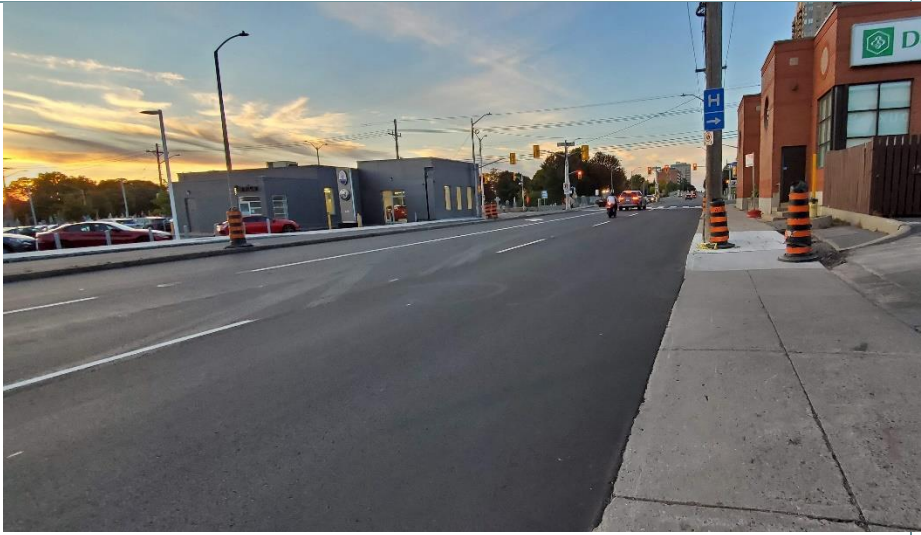
<p>Facing northwest at St. Laurent Boulevard from the northbound lane sidewalk of St. Laurent Boulevard south of Centre de Services Desjardins Montfort (520 Montreal Road).</p> <p>Mainline replacement area.</p>	<p>Reclaimed</p>	<p>None required</p>

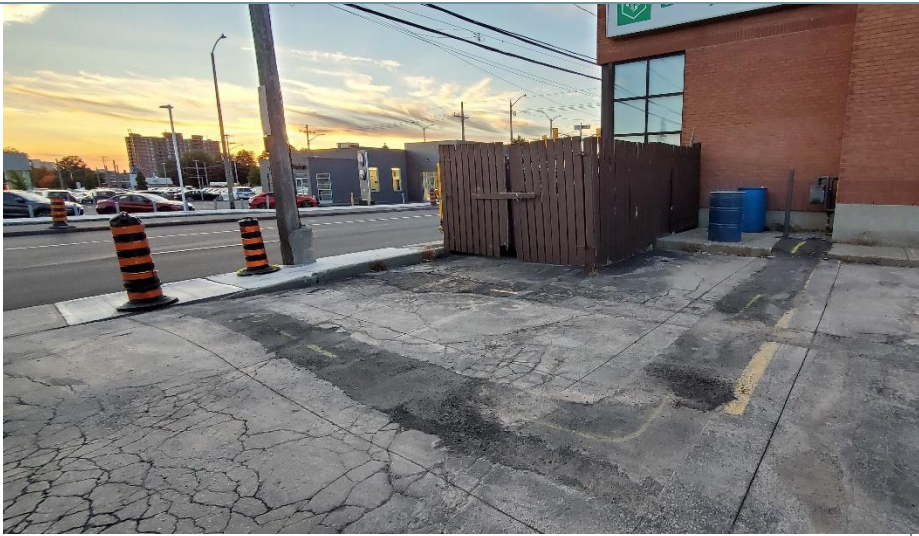
<p>Facing northwest at south wall of Centre de Services Desjardins Montfort (520 Montreal Road) from southern section of shared business/commercial parking lot.</p> <p>Upgraded service connection area.</p>	<p>Reclaimed</p>	<p>None required.</p>

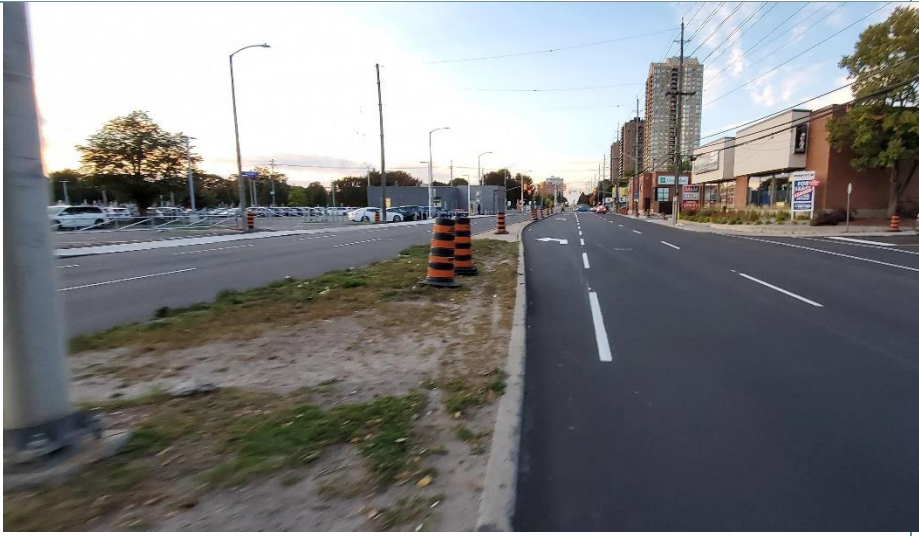
<p>Facing north at St. Laurent Boulevard from northernmost St. Laurent Boulevard median south of the intersection of Camil Street and St. Laurent Boulevard.</p> <p>Mainline replacement area (St. Laurent Boulevard) and Upgraded service connection area (median).</p>	<p>Partially Reclaimed</p>	<p>The median requires topsoil and reseeded.</p>

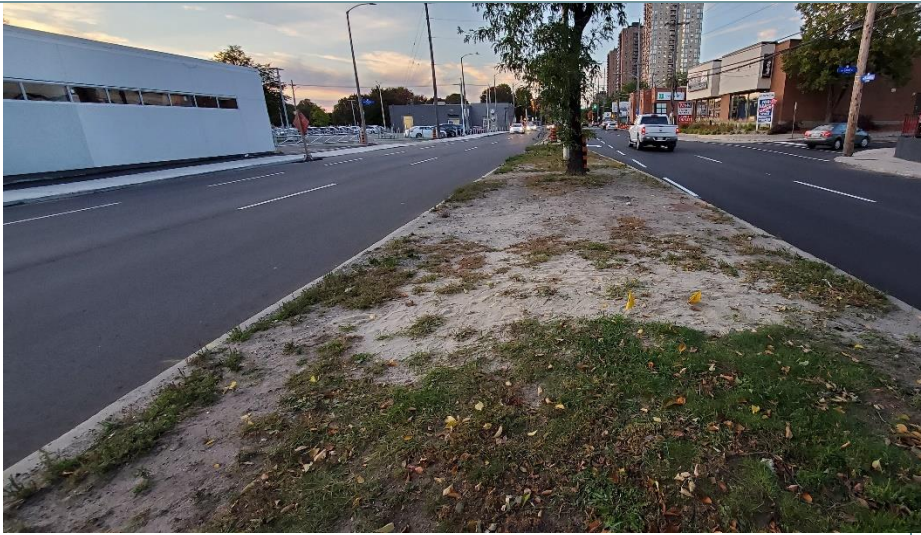
<p>Facing north at St. Laurent Boulevard from northernmost St. Laurent Boulevard median south of the intersection of Camil Street and St. Laurent Boulevard.</p> <p>Mainline replacement area (St. Laurent Boulevard) and Upgraded service connection area (median).</p>	<p>Partially reclaimed</p>	<p>The median requires topsoil and reseeded.</p>

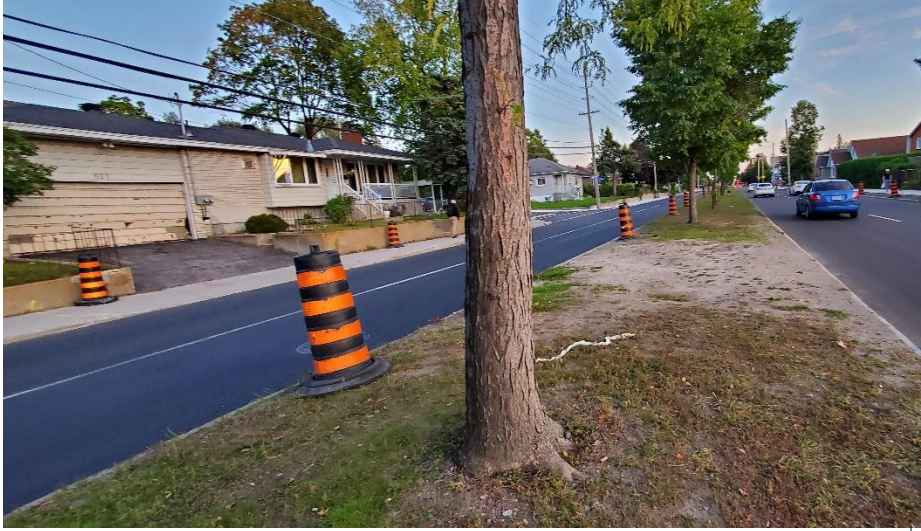
<p>Facing south at St. Laurent Boulevard from northernmost St. Laurent Boulevard median south of the intersection of Camil Street and St. Laurent Boulevard.</p> <p>Mainline replacement area (St. Laurent Boulevard) and Upgraded service connection area (median).</p>	<p>Partially reclaimed</p>	<p>The median requires topsoil and reseeded.</p>

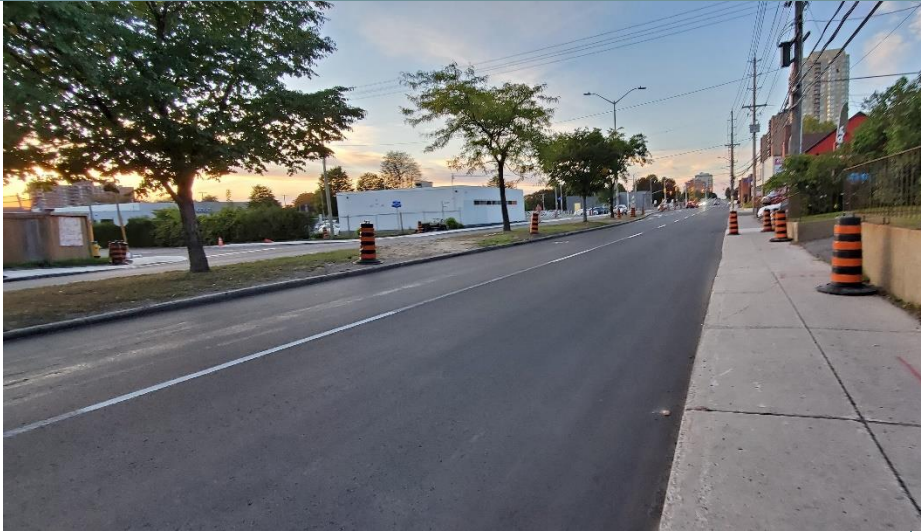
<p>Facing north at St. Laurent Boulevard from the northbound St. Laurent Boulevard sidewalk south of the intersection of Camil Street and St. Laurent Boulevard.</p> <p>Mainline replacement area (St. Laurent Boulevard) and Upgraded service connection area (median).</p>	<p>Partially Reclaimed</p>	<p>The median requires topsoil and reseeded.</p>

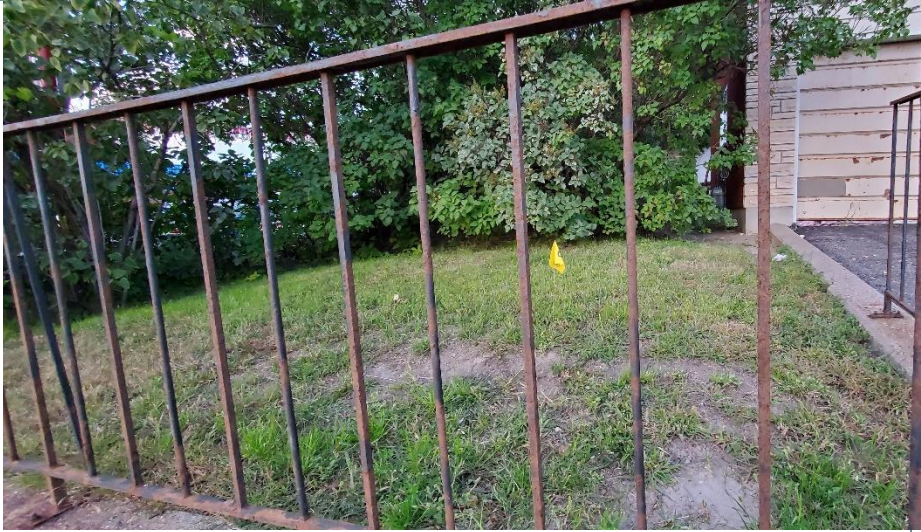
<p>Facing east at lawn of 621 St. Laurent Boulevard from northbound St. Laurent Boulevard sidewalk.</p> <p>Upgraded service connection area.</p>	<p>Reclaimed</p>	<p>None required.</p>

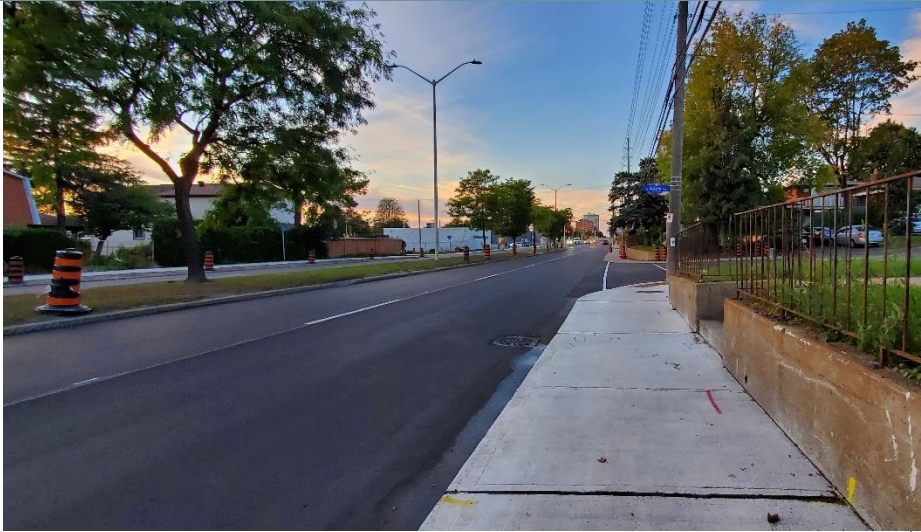
<p>Facing north at St. Laurent Boulevard from the northbound St. Laurent Boulevard sidewalk, south of the intersection of Malartic Avenue and St. Laurent Boulevard.</p> <p>Mainline replacement area</p>	<p>Reclaimed</p>	<p>None required.</p>

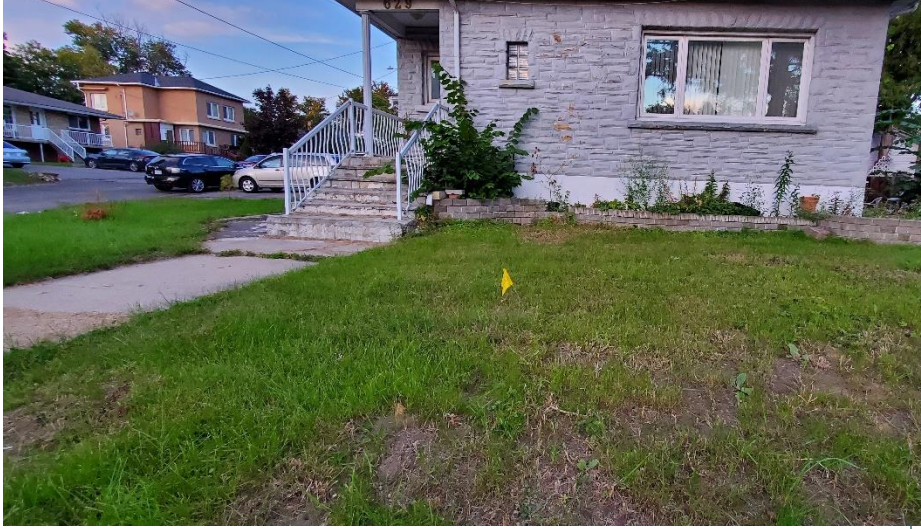
<p>Facing east at lawn of 629 St. Laurent Boulevard from northbound St. Laurent Boulevard sidewalk.</p> <p>Upgraded service connection area.</p>	<p>Reclaimed</p>	<p>None required.</p>

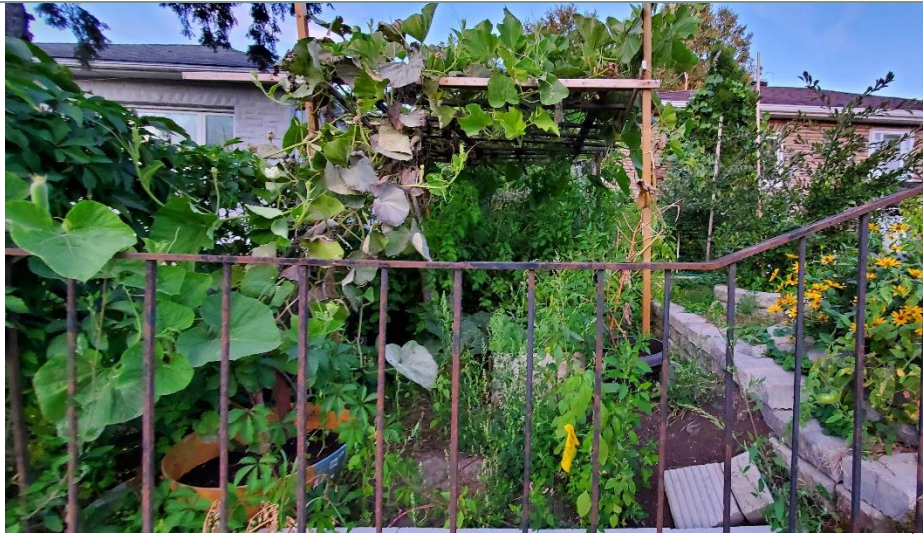
<p>Facing east at lawn of 637 St. Laurent Boulevard from northbound St. Laurent Boulevard sidewalk.</p> <p>Upgraded service connection area.</p>	<p>Reclaimed</p>	<p>None required.</p>

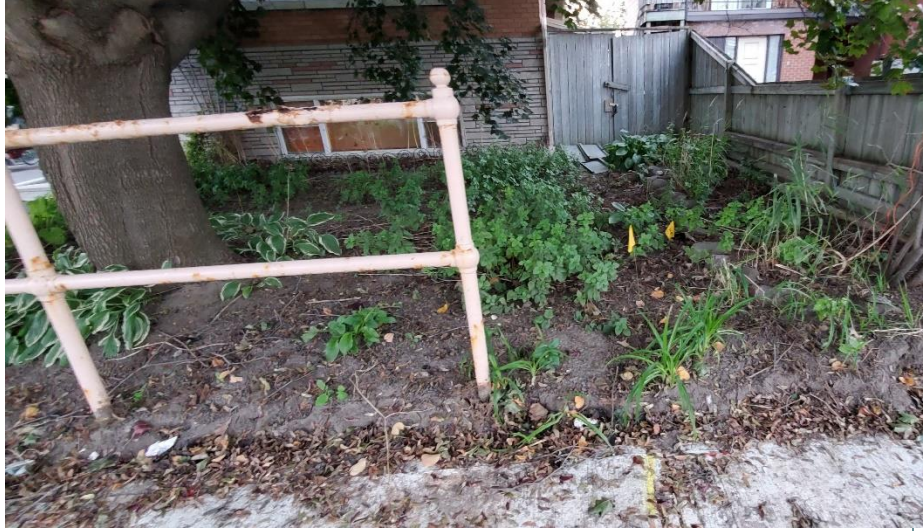
<p>Facing west at front yard of 708 St. Laurent Boulevard from northbound St. Laurent Boulevard sidewalk.</p> <p>Upgraded service connection area.</p>	<p>Reclaimed</p>	<p>None required.</p>

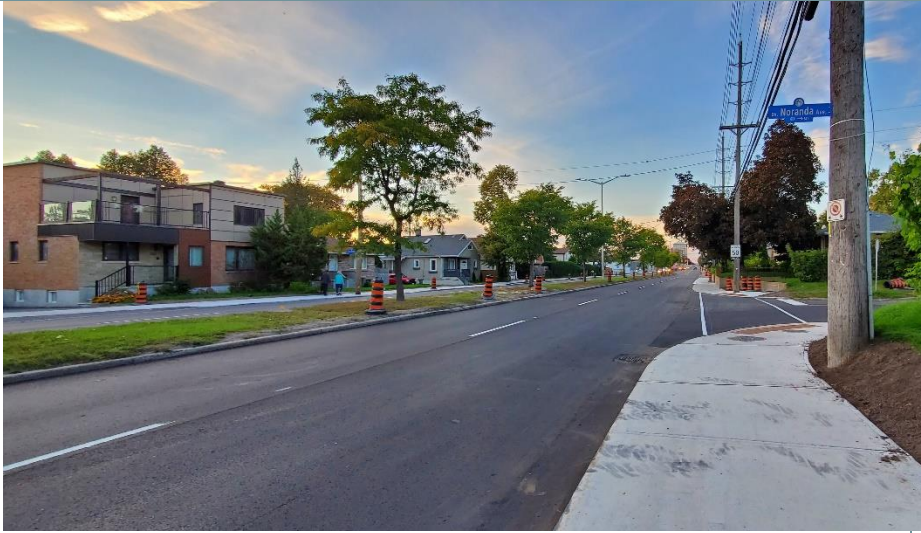
<p>Facing north at St. Laurent Boulevard from the northbound St. Laurent Boulevard sidewalk south of the intersection of Noranda Avenue and St. Laurent Boulevard.</p> <p>Mainline replacement area.</p>	<p>Reclaimed</p>	<p>None required.</p>

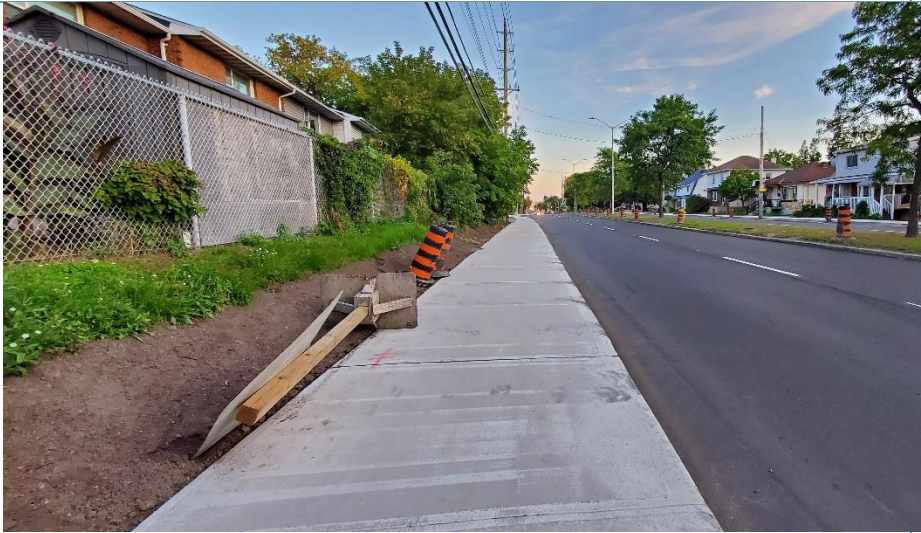
<p>Facing south at St. Laurent Boulevard from the northbound St. Laurent Boulevard sidewalk south of the intersection of Noranda Avenue and St. Laurent Boulevard.</p> <p>Mainline replacement area.</p>	<p>Reclaimed</p>	<p>None required.</p>

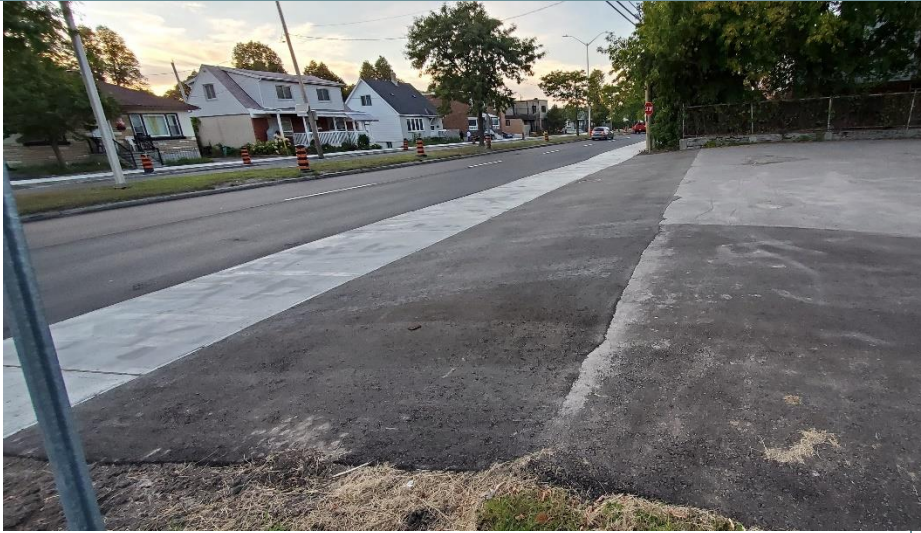
<p>Facing northwest at northbound end of St. Laurent Boulevard from the exit of Queen Elizabeth Public School.</p> <p>Past temporary parking and equipment staging area.</p>	<p>Reclaimed</p>	<p>None required.</p>

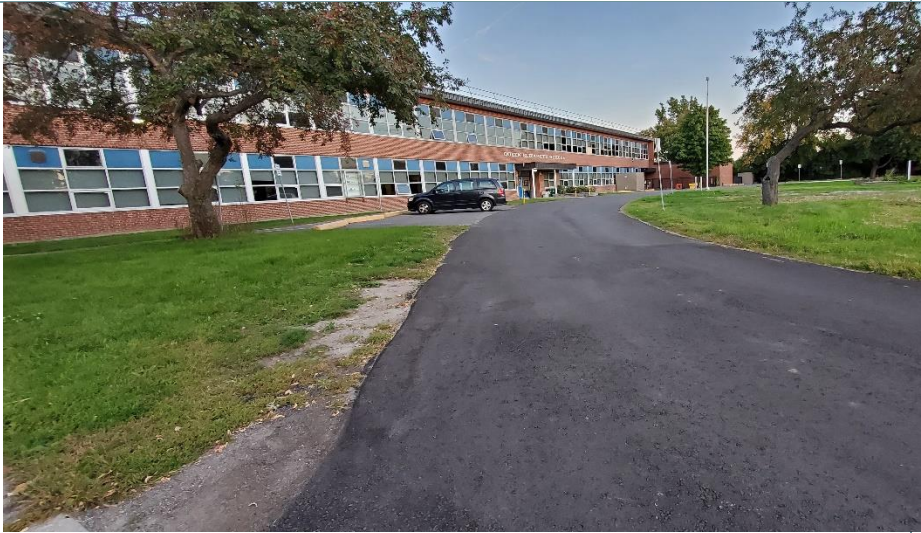
<p>Facing southeast at Queen Elizabeth Public School from school exit onto St. Laurent Boulevard.</p> <p>Past temporary parking and equipment staging area.</p>	<p>Reclaimed</p>	<p>None required.</p>

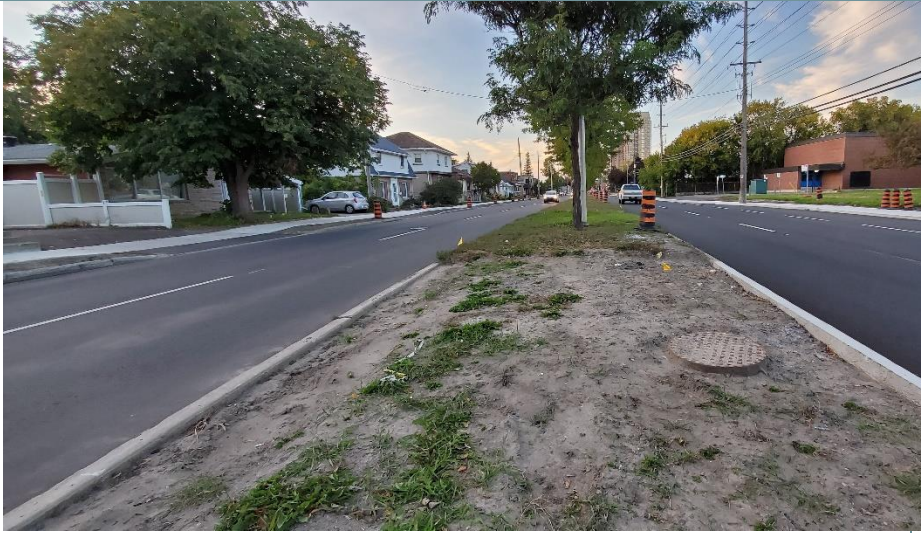
<p>Facing north at both lanes of St. Laurent Boulevard from the St. Laurent Boulevard median near Queen Elizabeth Public School.</p> <p>Mainline replacement area (St. Laurent Boulevard) and upgraded service connection area (median).</p>	<p>Partially reclaimed</p>	<p>The median requires topsoil and reseeded.</p>

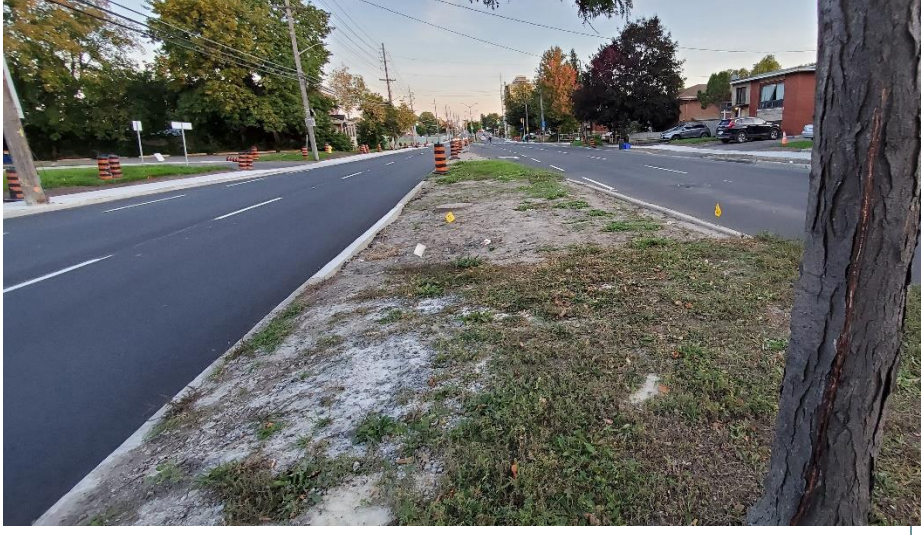
<p>Facing south at both lanes of St. Laurent Boulevard from the St. Laurent Boulevard median near Queen Elizabeth Public School.</p> <p>Mainline replacement area (St. Laurent Boulevard) and upgraded service connection area (median).</p>	<p>Partially reclaimed</p>	<p>The median requires topsoil and reseeded.</p>

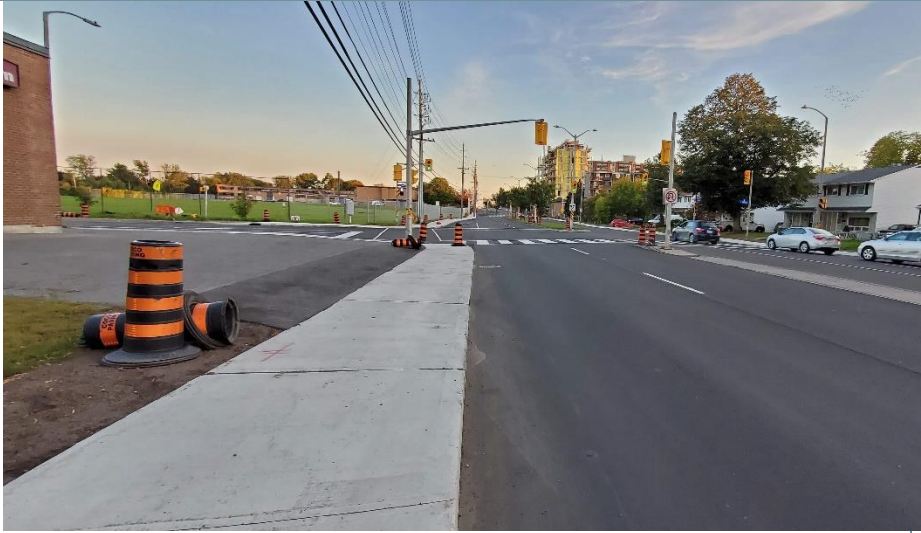
<p>Facing southeast at St. Laurent Boulevard from the northbound St. Laurent Boulevard sidewalk, north of Clarke Avenue.</p> <p>Mainline replacement area.</p>	<p>Reclaimed</p>	<p>None required.</p>

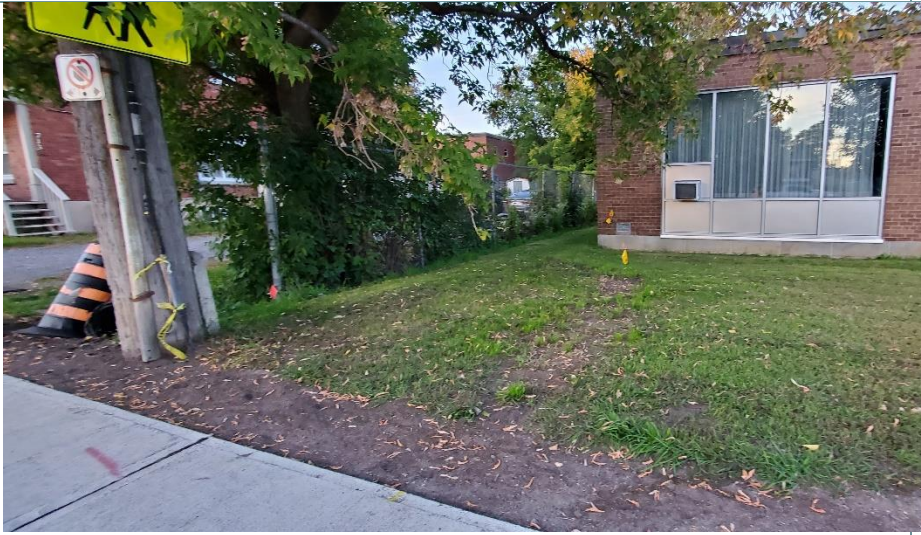
<p>Facing east at front yard of Mount Zion Church of the Firstborn (715 St. Laurent Boulevard) from northbound St. Laurent Boulevard sidewalk.</p>	<p>Reclaimed</p>	<p>None required.</p>

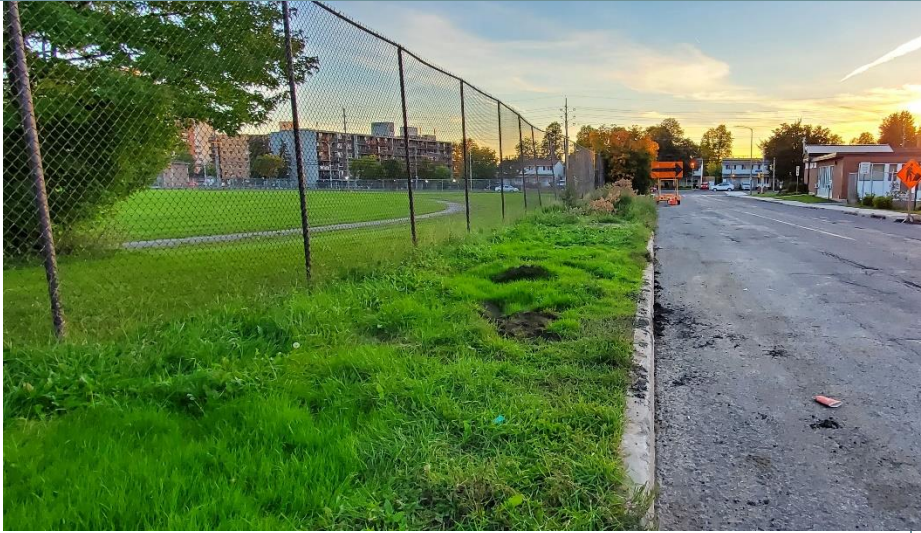
<p>Facing west at vegetated road shoulder of Clark Avenue, north of Rideau High School recreation fields.</p> <p>Past equipment storage area</p>	<p>Reclaimed</p>	<p>None required.</p>

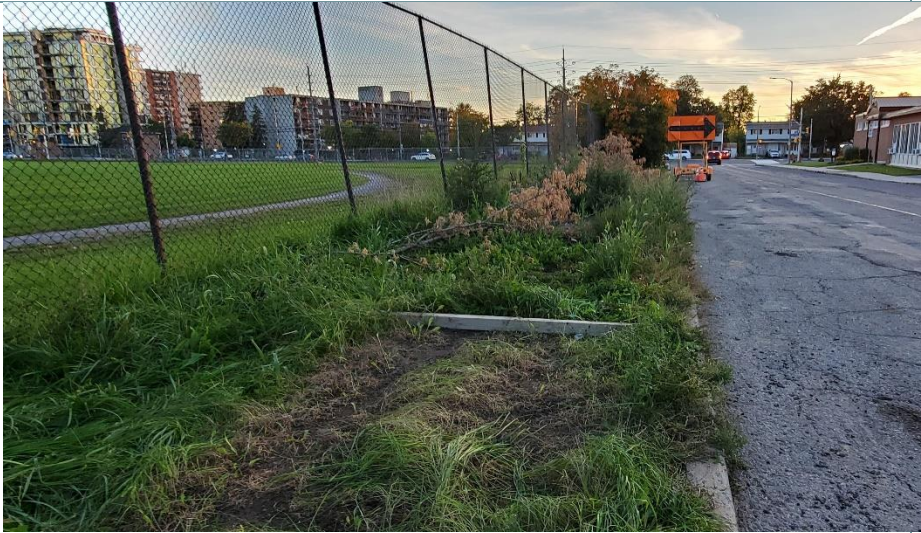
<p>Facing west at vegetated road shoulder of Clark Avenue, north of Rideau High School recreation fields.</p> <p>Past equipment storage area.</p>	<p>Reclaimed</p>	<p>None required.</p>

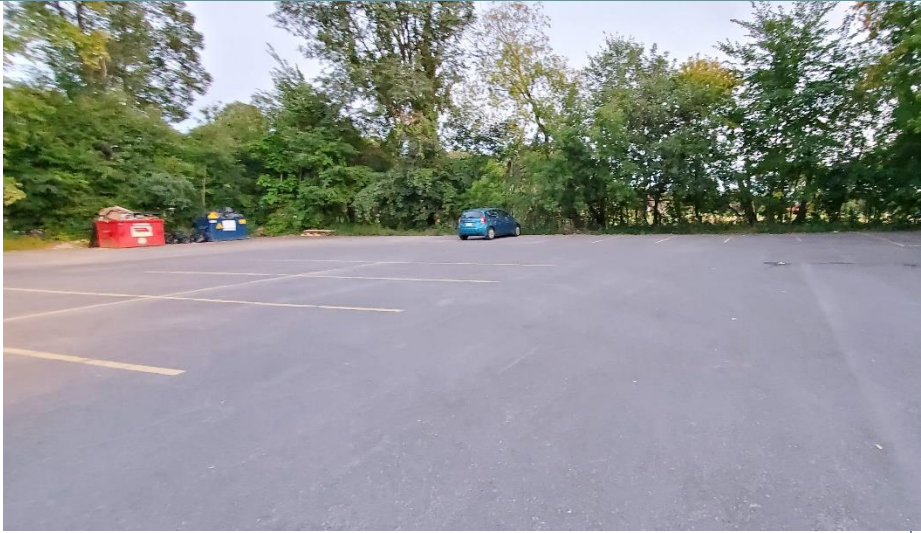
<p>Facing southeast at parking lot of St. Laurent Academy Ottawa Private School from Noranda Avenue.</p> <p>Past equipment staging area as well as sand and gravel storage area.</p>	<p>Reclaimed</p>	<p>None required.</p>

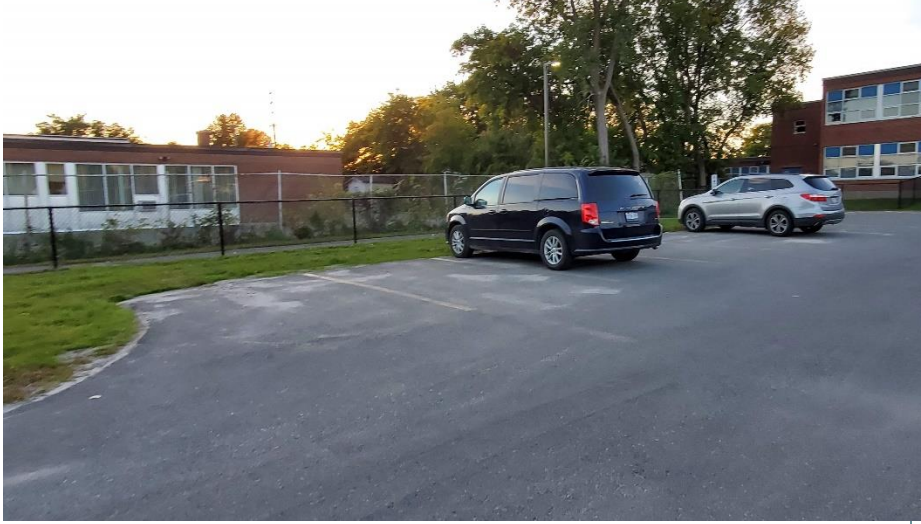
<p>Facing northwest at parking lot of Queen Elizabeth Public School from westbound Clarke Avenue sidewalk.</p> <p>Past temporary parking area sand and gravel storage area.</p>	<p>Reclaimed</p>	<p>None required.</p>

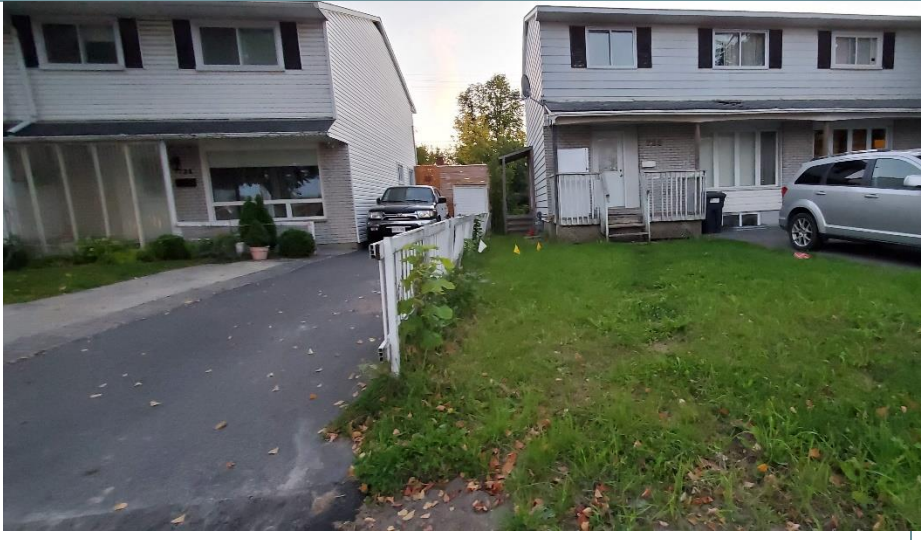
<p>Facing west at front yard of 722 St. Laurent Boulevard from southbound St. Laurent Boulevard sidewalk.</p> <p>Upgraded service connection area.</p>	<p>Reclaimed</p>	<p>None required.</p>

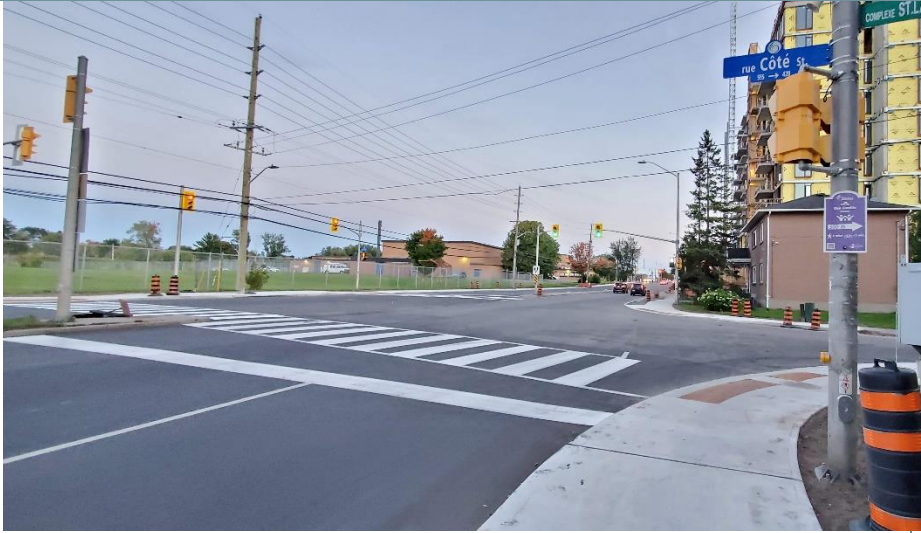
<p>Facing south at the intersection of Cote Street and St. Laurent Boulevard from the southbound St. Laurent Boulevard sidewalk.</p> <p>Mainline replacement area.</p>	<p>Reclaimed</p>	<p>None required.</p>

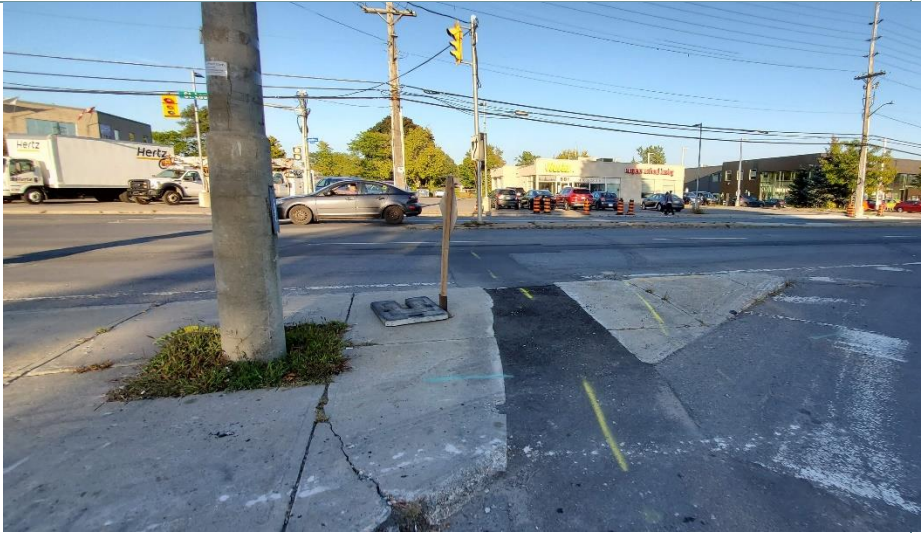
<p>Facing east at the intersection of McArthur Avenue and St. Laurent Boulevard from the southbound St. Laurent Boulevard sidewalk.</p> <p>Mainline replacement area and upgraded service connection area.</p>	<p>Reclaimed</p>	<p>None required.</p>

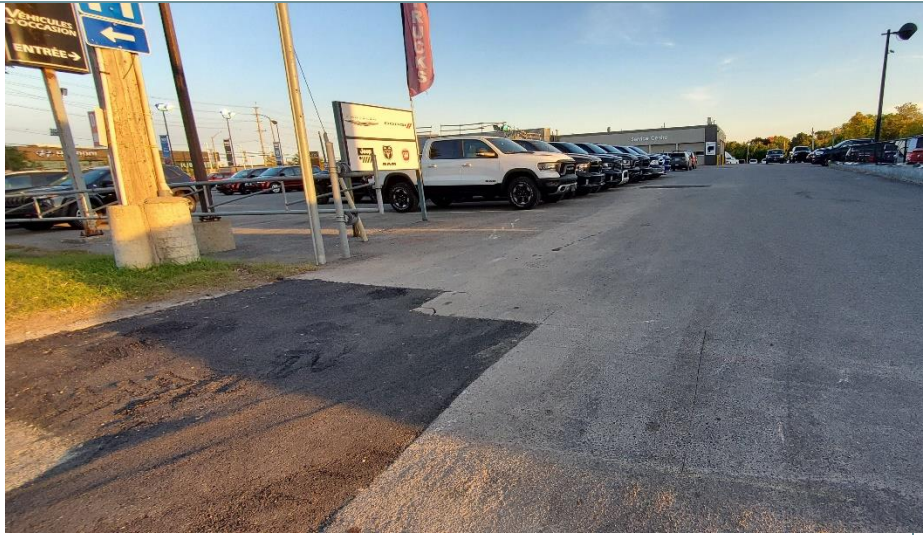
<p>Facing west at front yard of 708 St. Laurent Boulevard from northbound St. Laurent Boulevard sidewalk.</p> <p>Upgraded service connection area.</p>	<p>Reclaimed</p>	<p>None required.</p>

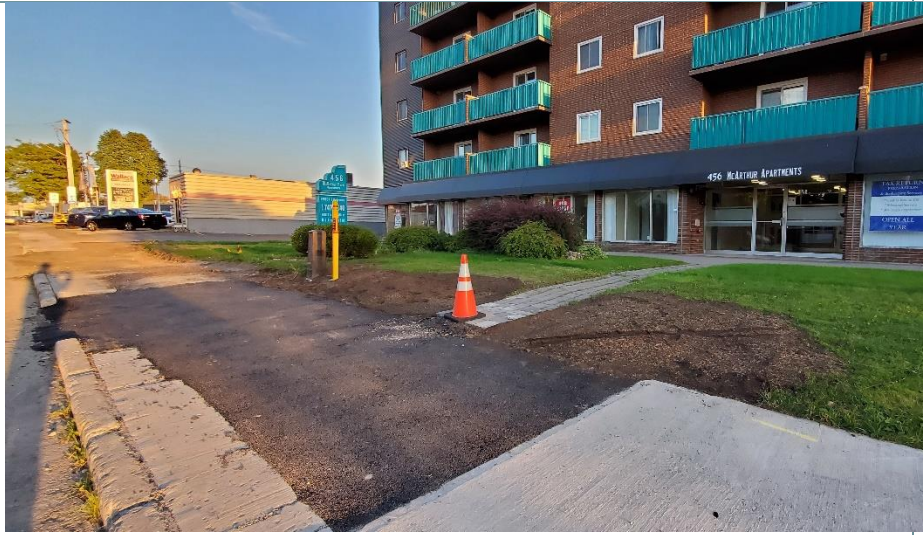
<p>Facing southeast at manicured lawn of 456 McArthur Avenue Apartments from eastbound McArthur Avenue sidewalk.</p> <p>Upgraded service connection area.</p>	<p>Partially reclaimed – Topsoil has been applied</p>	<p>Concrete sidewalk requires reclamation and reseeding is required for manicured lawn.</p>

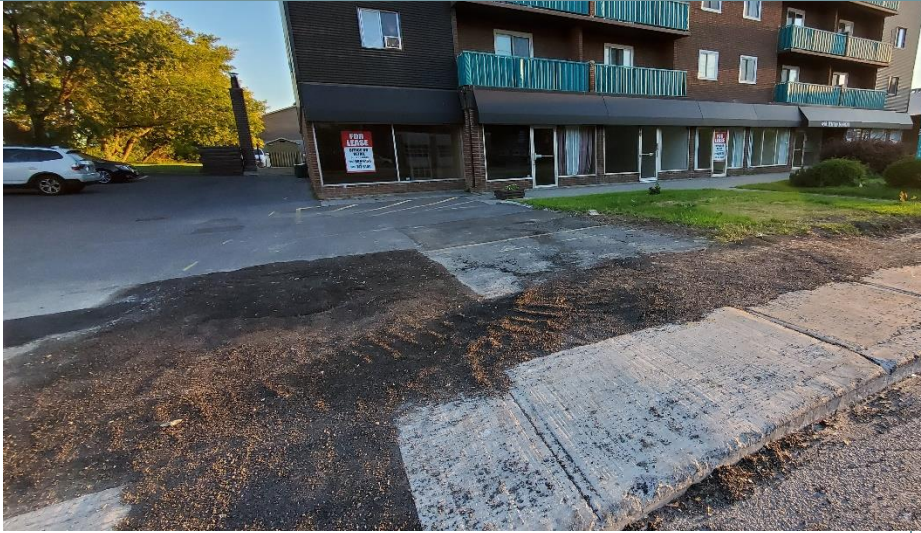
<p>Facing southwest at entrance/manicured lawn of 456 McArthur Avenue Apartments from eastbound McArthur Avenue sidewalk.</p> <p>Upgraded service connection area.</p>	<p>Partially reclaimed – topsoil has been applied.</p>	<p>Concrete sidewalk requires reclamation and reseedling is required for manicured lawn.</p>

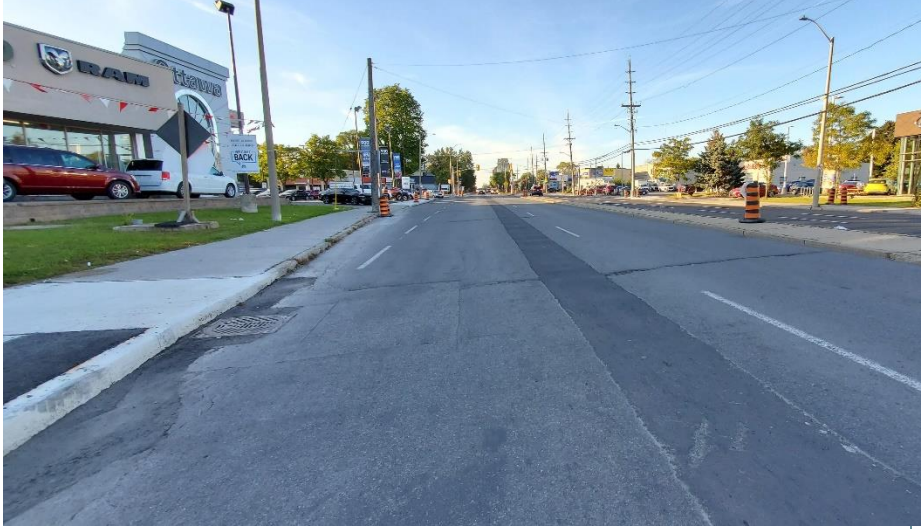
<p>Facing northeast at St. Laurent Boulevard from the southbound St. Laurent Boulevard sidewalk, north of Donald Street.</p> <p>Mainline replacement area.</p>	<p>Reclaimed</p>	<p>None required.</p>

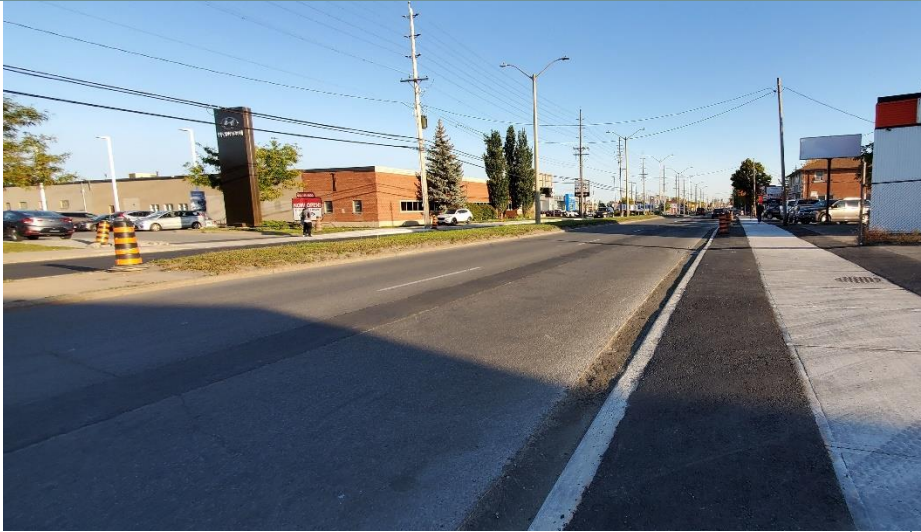
<p>Facing southeast at St. Laurent Boulevard from the southbound St. Laurent Boulevard sidewalk, north of Donald Street.</p> <p>Mainline replacement area.</p>	<p>Reclaimed</p>	<p>None required.</p>

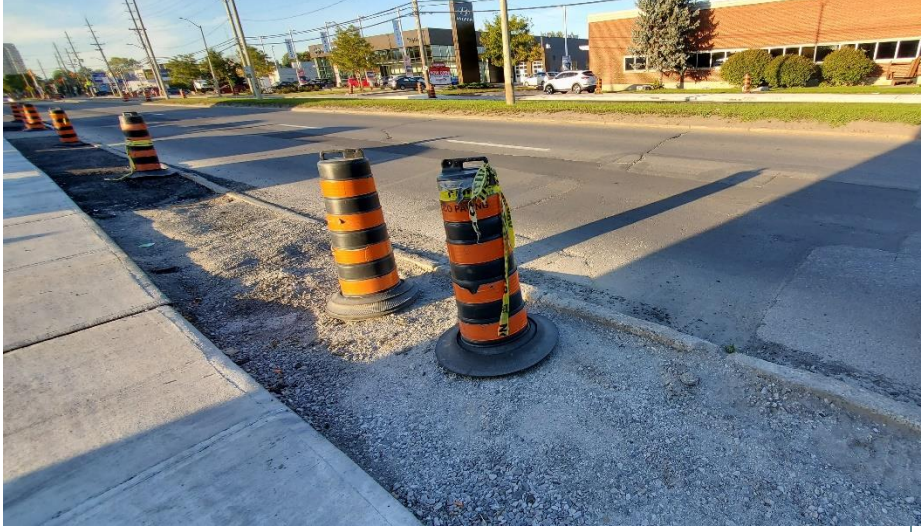
<p>Facing northeast at St. Laurent Boulevard from the southbound St. Laurent Boulevard sidewalk, north of Donald Street.</p> <p>Mainline replacement area.</p>	<p>Reclaimed</p>	<p>None required.</p>
