**Re: Enbridge Gas Inc. (“Enbridge Gas”)
Ontario Energy Board (“Board”) File No.: EB-2019-0006
St. Laurent Pipeline Project (“Project”)**

St. Laurent Pipeline Project:
Post-Construction Report
EB-2019-0006

Company: Enbridge Gas Inc.

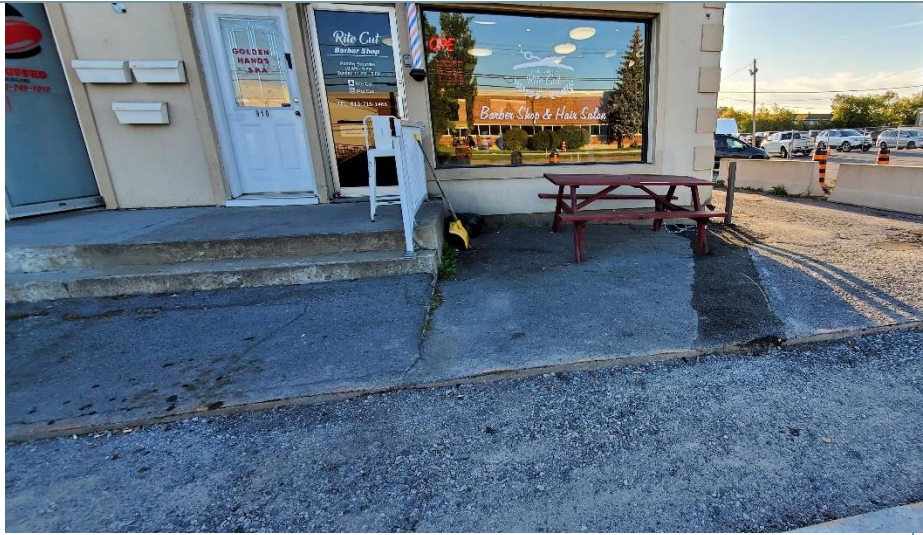
<p>Facing west at entrance to Rite Cut Barber Shop and Hair Salon (908 St. Laurent Boulevard) from southbound St. Laurent Boulevard sidewalk.</p> <p>Upgraded service connection area.</p>	<p>Reclaimed</p>	<p>None required.</p>

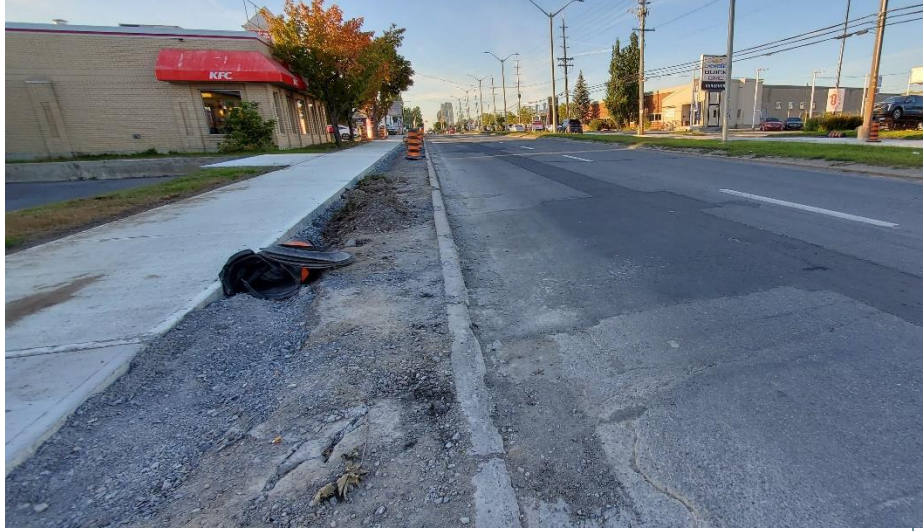
<p>Facing northeast at St. Laurent Boulevard from the southbound St. Laurent Boulevard sidewalk, north of Donald Street.</p> <p>Mainline replacement area.</p>	<p>Reclaimed</p>	<p>None required.</p>

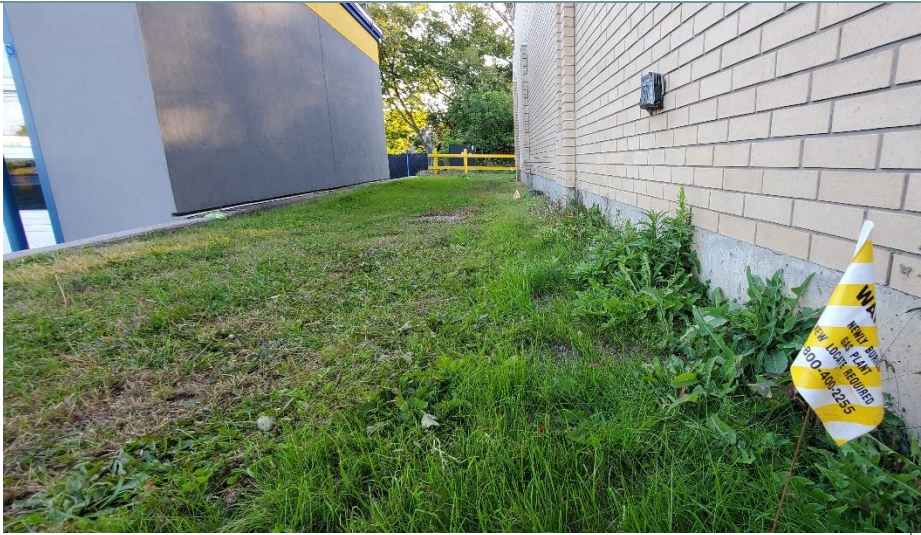
<p>Facing west at manicured lawn of Kentucky Fried Chicken (732 St. Laurent Boulevard) from southbound St. Laurent Boulevard sidewalk.</p> <p>Upgraded service connection area.</p>	<p>Reclaimed</p>	<p>None required.</p>

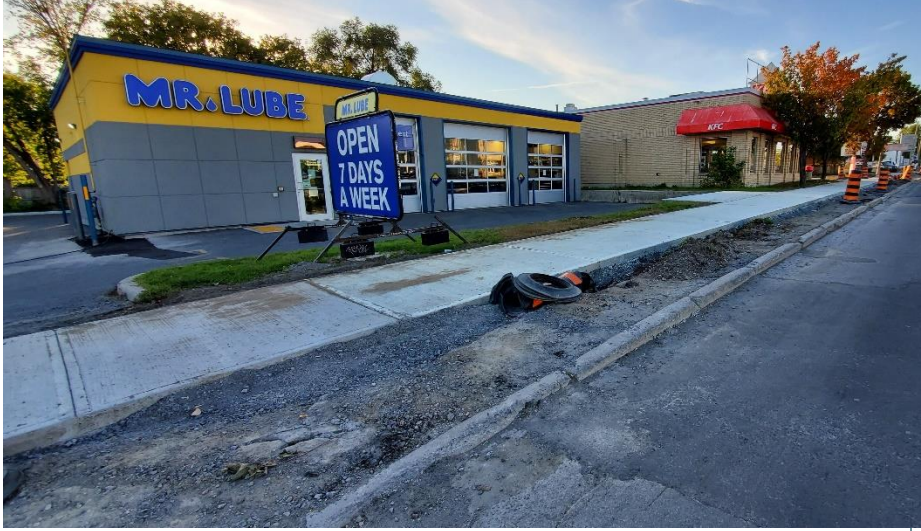
<p>Facing west at Mr. Lube (738 St. Laurent Boulevard) from southbound St. Laurent Boulevard sidewalk.</p> <p>Mainline replacement area.</p>	<p>Reclaimed</p>	<p>None required.</p>

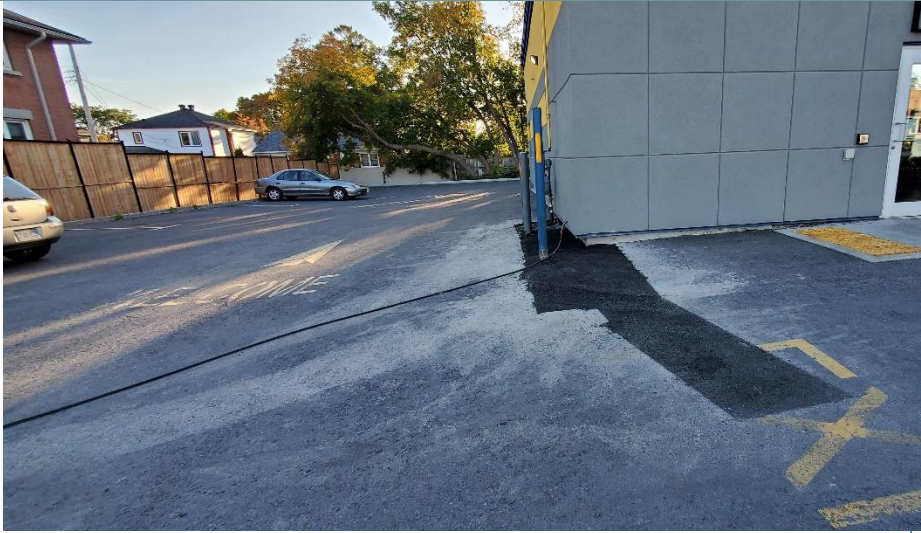
<p>Facing west at entrance to Mr. Lube (738 St. Laurent Boulevard) from southbound St. Laurent Boulevard sidewalk.</p> <p>Upgraded service connection area.</p>	<p>Reclaimed</p>	<p>None required.</p>

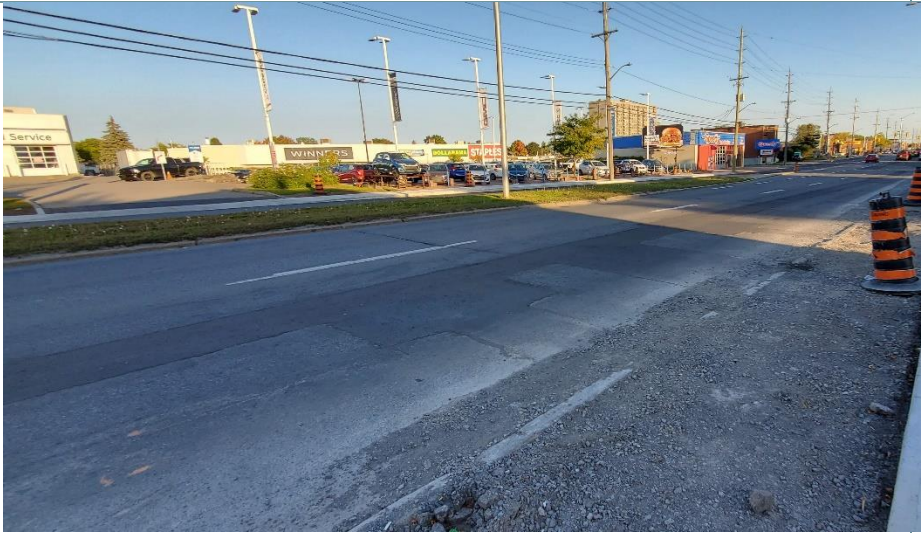
<p>Facing southeast at St. Laurent Boulevard from the southbound St. Laurent Boulevard sidewalk, north of Donald Street.</p> <p>Mainline replacement area.</p>	<p>Reclaimed</p>	<p>None required.</p>

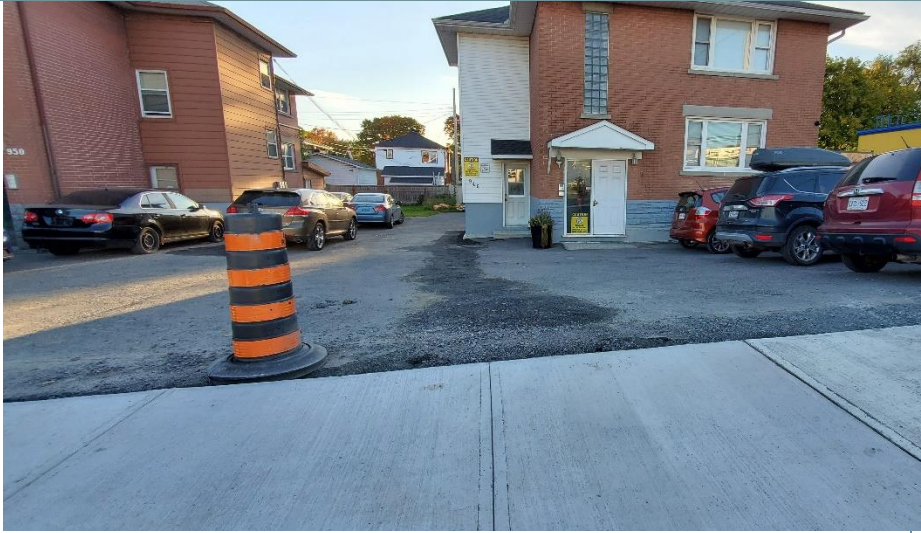
<p>Facing west at entrance to 946 St. Laurent Boulevard from southbound St. Laurent Boulevard sidewalk.</p> <p>Upgraded service connection area.</p>	<p>Reclaimed</p>	<p>None required.</p>

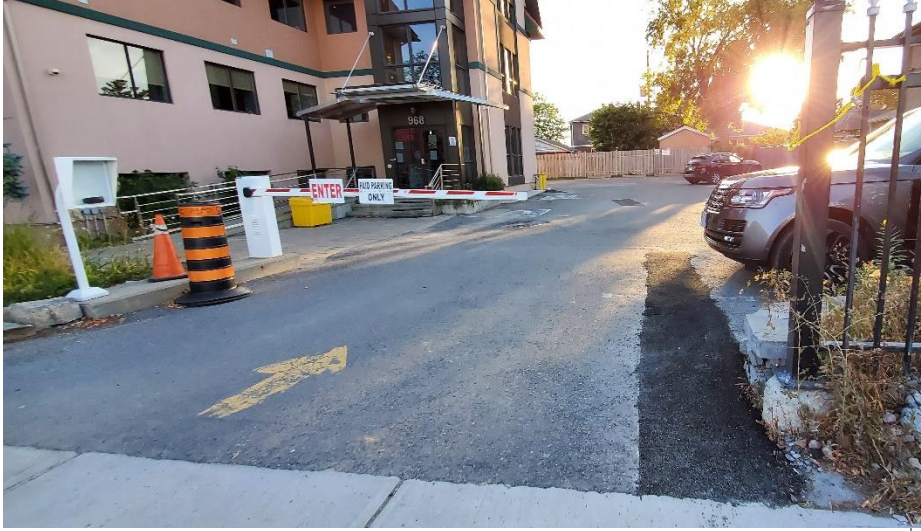
<p>Facing west at entrance to 708 St. Laurent Boulevard from southbound St. Laurent Boulevard sidewalk.</p> <p>Upgraded service connection area.</p>	<p>Reclaimed</p>	<p>None required.</p>

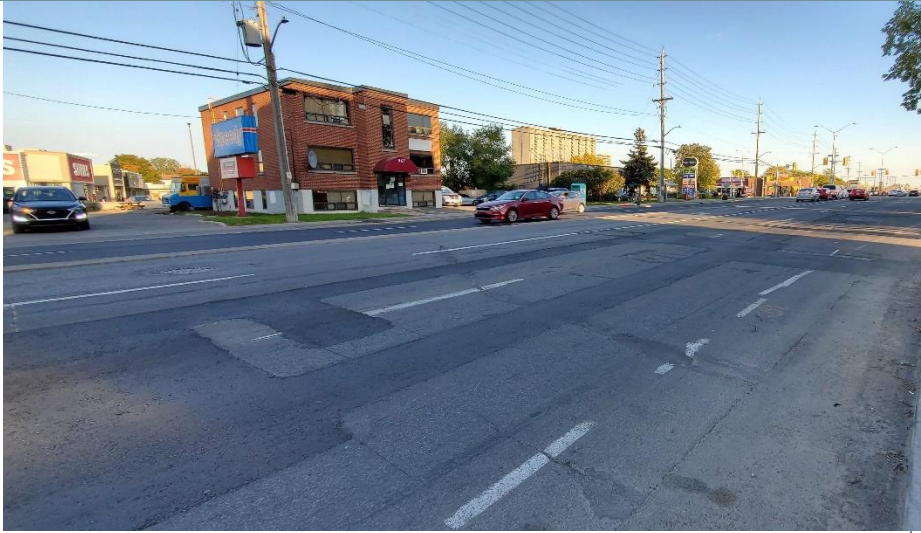
<p>Facing southeast at St. Laurent Boulevard from the southbound St. Laurent Boulevard sidewalk, north of Donald Street.</p> <p>Mainline replacement area.</p>	<p>Reclaimed</p>	<p>None required.</p>

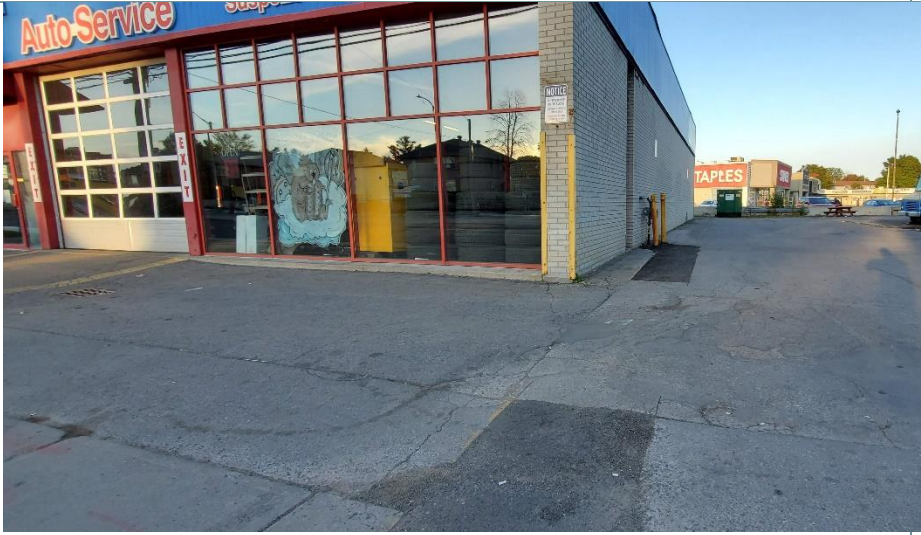
<p>Facing east at entrance to Speedy Auto Service Ottawa East Branch (963 St. Laurent Boulevard) from northbound St. Laurent Boulevard sidewalk.</p> <p>Upgraded service connection area.</p>	<p>Reclaimed</p>	<p>None required.</p>

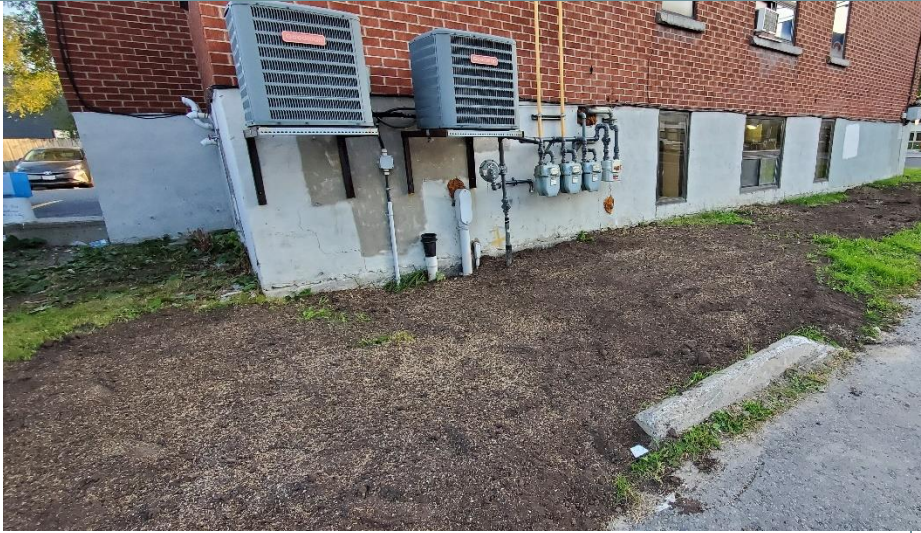
<p>Facing southwest at manicured lawn of East Ottawa Masjid and Community Centre (967 St. Laurent Boulevard) from parking lot.</p> <p>Upgraded service connection area.</p>	<p>Reclaimed</p>	<p>None required.</p>

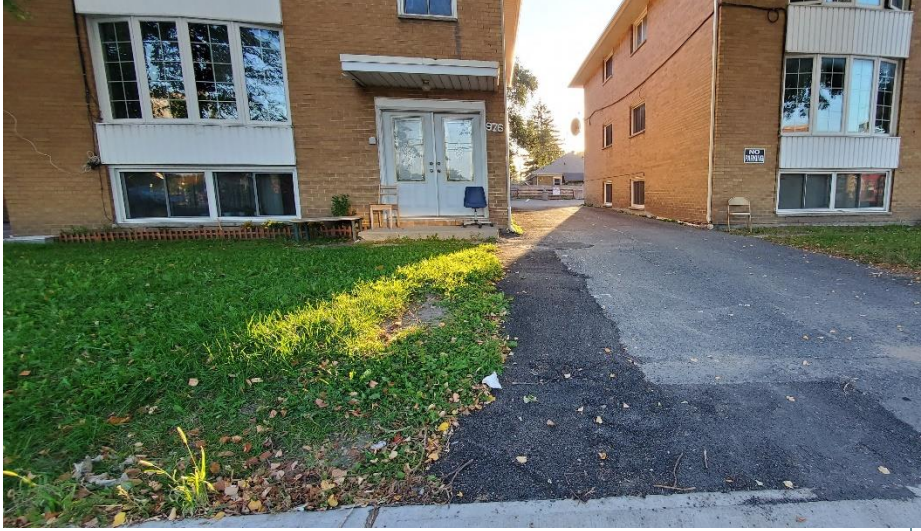
<p>Facing west at front yard of 976 St. Laurent Boulevard from southbound St. Laurent Boulevard sidewalk.</p> <p>Upgraded service connection area.</p>	<p>Reclaimed</p>	<p>None required.</p>

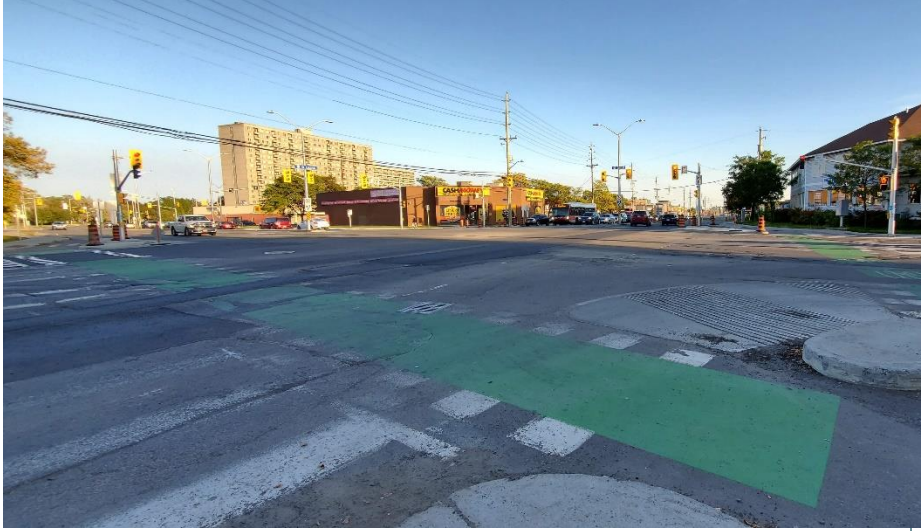
<p>Facing southeast at intersection of St. Laurent Boulevard and Donald Street from the southbound St. Laurent Boulevard sidewalk, north of Donald Street.</p> <p>Mainline replacement area.</p>	<p>Reclaimed</p>	<p>None required.</p>

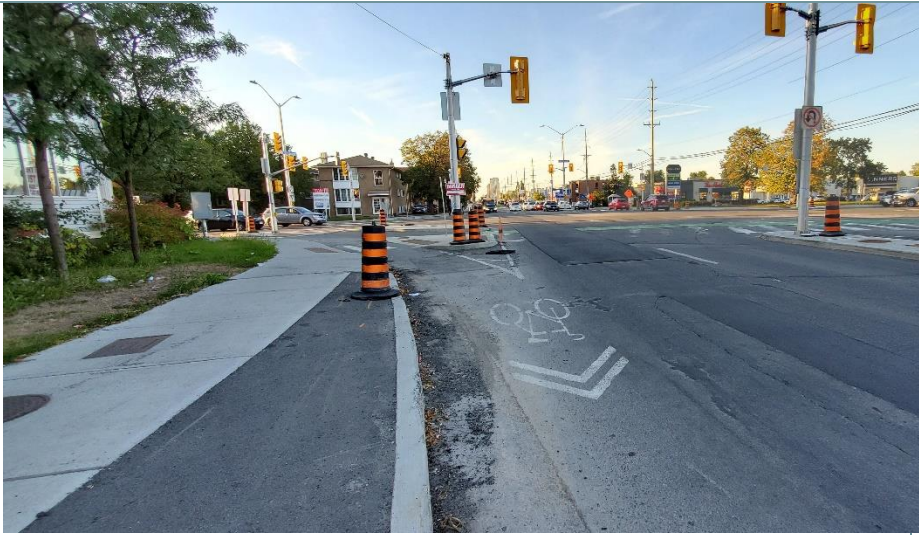
<p>Facing north at St. Laurent Boulevard from the southbound St. Laurent Boulevard sidewalk, south of Donald Street.</p> <p>Mainline replacement area.</p>	<p>Reclaimed</p>	<p>None required.</p>
