**Re: Enbridge Gas Inc. (Enbridge Gas)
Ontario Energy Board (OEB) File No.: EB-2018-0097
Bathurst Reinforcement Project**

**Bathurst Reinforcement Project:
Post-Construction Final Monitoring
Report**

EB-2018-0097

Company: Enbridge Gas Inc.

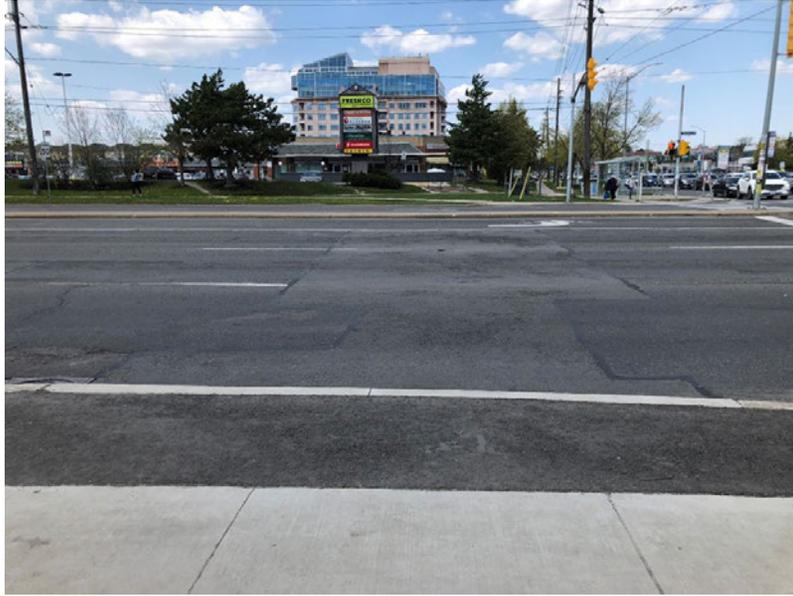
PHOTO #	LOCATION	CURRENT CONDITION
Photo 1	Tie-in at South West corner of Steeles Ave. W. and Bathurst St. (looking north)	Permanent asphalt, sidewalk, curbs, and boulevard complete. No further action required.
Photo 2	Entry/Exit Pit on West Side of Bathurst St., South of Steeles Ave. West (looking north)	Boulevard was hydroseeded and restored. No further action required.
Photo 3	West Side of Bathurst St., South of Fisherville Rd. (looking south)	Boulevard was hydroseeded and restored to pre-construction condition. Permanent restoration of pattern concrete apron complete. No further action required.
Photo 4	West Side of Bathurst St. South of Carpenter Rd. (looking north)	Permanent restoration, including hydroseed and concrete sidewalks complete. No further action required.
Photo 5	West Side of Bathurst St., South of Rockford Rd. (looking north)	Boulevard was hydroseeded and restored to pre-construction condition. Permanent restoration, including road asphalt, pattern concrete apron and curbs complete. No further action required.

Photo 1: Tie-in at South West corner of Steeles Ave. W. and Bathurst St. (looking north)

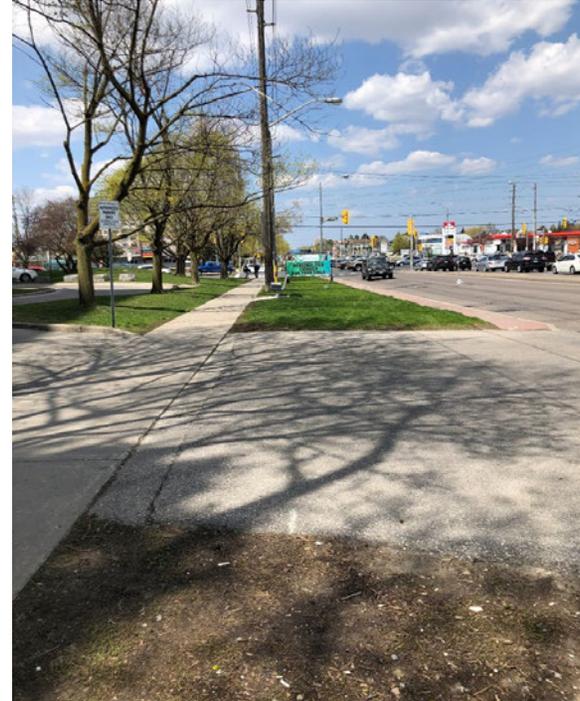
Photo 2: Entry/Exit Pit on West side of Bathurst St., South of Steeles Ave West (looking north)

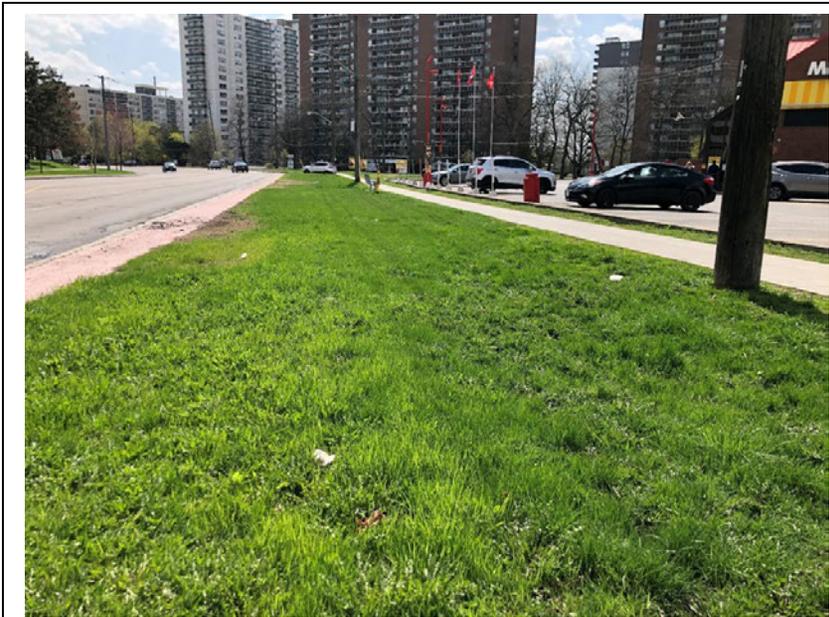
Photo 3: West Side of Bathurst St., South of Fisherville Rd. (looking south)

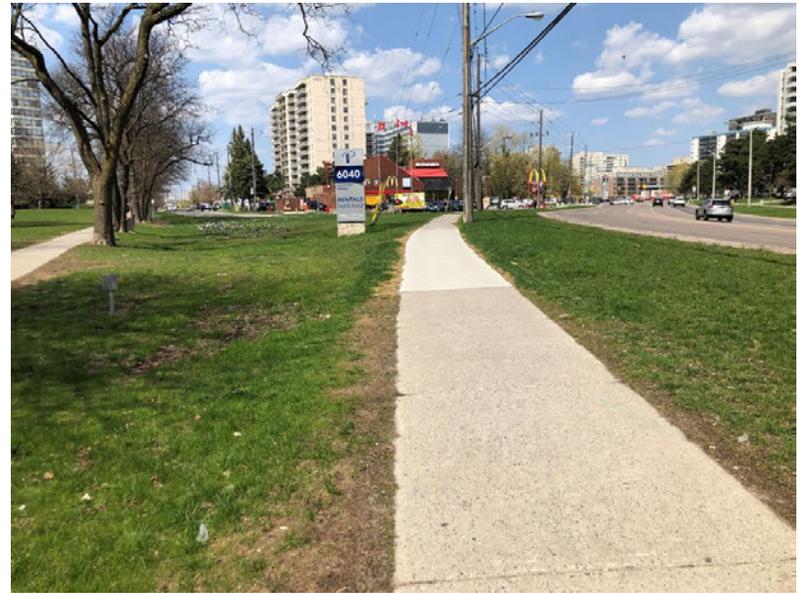
Photo 4: West Side of Bathurst St., South of Carpenter Rd. (looking north)

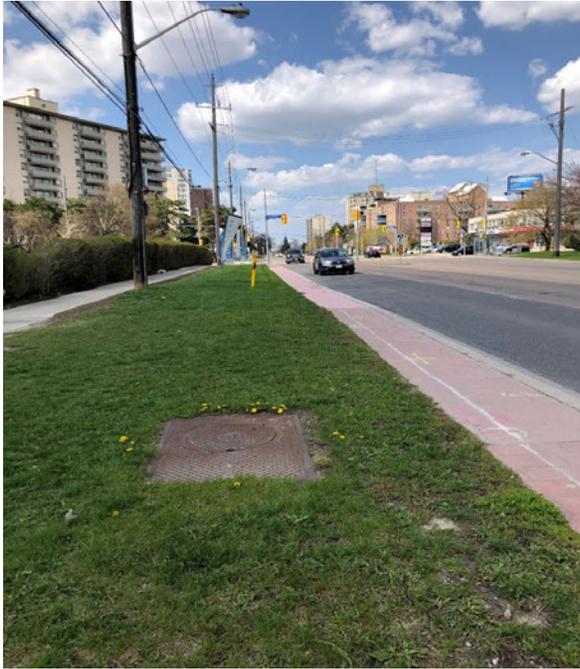
Photo 5: West Side of Bathurst St., South of Rockford Rd. (looking north)

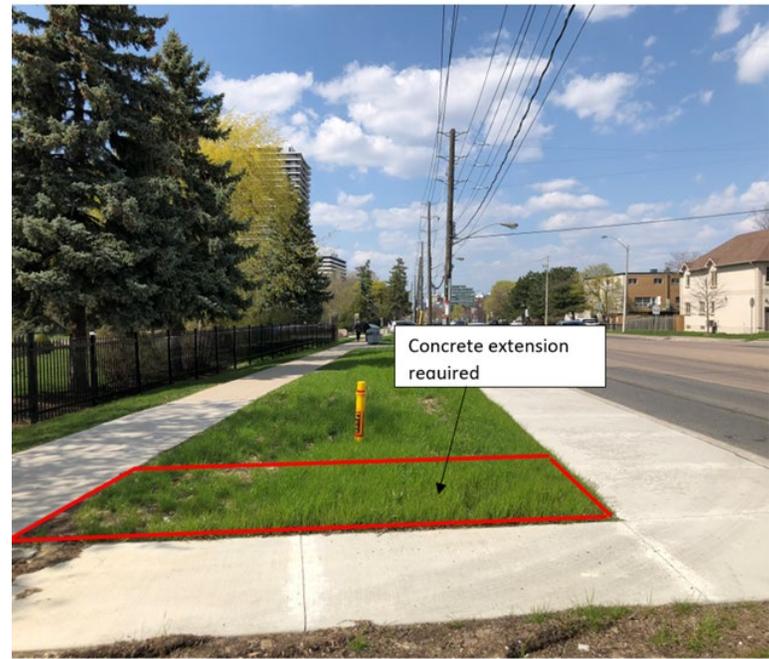
Photo 6	West Side of Bathurst St., South of Kenton Dr. (looking north)	Permanent restoration, including hydroseed, is complete. TTC bus stop pad requires repair, which is anticipated to be completed in mid-May.
Photo 7	Tie-in and District Station on East Side of Bathurst St., South of Ellerslie Ave (looking north)	Boulevard was hydroseeded, sidewalk and pattern concrete apron restored. No further action required.
Photo 8	West side of Bathurst St., South of Greenwin Village Rd. (looking north)	All visible settlements along Bathurst St. boulevard were identified and repaired. Final restoration (i.e. fill placement, installation of final road asphalt, curbs, sidewalks and hydroseed) complete. No further action required.
Photo 9	West side of Bathurst St., North of Cedarcroft Blvd. at 5998 Bathurst St. (looking southwest).	All visible settlements along Bathurst St. boulevard were identified and repaired. Final restoration (i.e. fill placement, installation of final road asphalt, curbs, sidewalks, and hydroseed/sod) complete. No further action required.

There is one unresolved issue that remains at the time of completion of this Final Report. As documented in Photo 6 and Appendix D, the TTC repairs related to a bus stop are scheduled for completion in mid-May 2021.

Photo 6: West Side of Bathurst St., South of Kenton Dr. (looking north). TTC bus stop pad requires repair.

DATE RECEIVED	CONTACT NAME	LANDOWNER TYPE	COMMENT	RESOLUTION
2021-Jan-05	Sohrab Kiani	Toronto Transit Commission (TTC)	TTC completed a site visit and noticed that the new pad that was built as part of the Project restoration was only 2.2 meters (m) deep vs. the original depth of 2.4m. Also, the concrete connection to the existing sidewalk was less than 2.0m vs. the original depth of 2.0m. The TTC requested these deficiencies be repaired as they have made this bus stop inaccessible.	<p>City of Toronto advising the fence was removed.</p> <p>Enbridge sent an email to Contractor (BevCon Construction) January 5, 2021 to investigate the concern. Enbridge emailed the TTC on January 13th to inquire how Enbridge can meet the TTC requirements. Enbridge received an email back from TTC on January 19, 2021 advising how to meet the TTC requirements. BevCon Construction to complete repairs in Spring 2021.</p>

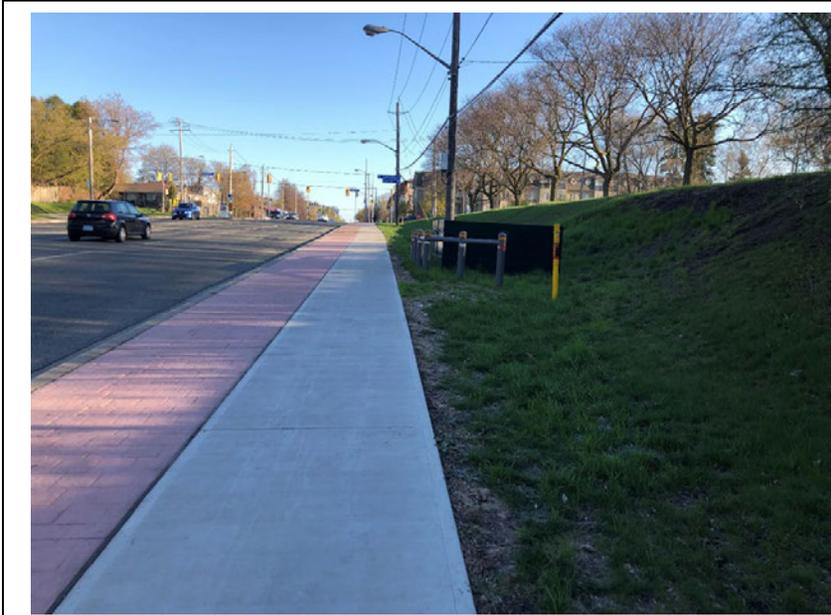
Photo 7: Tie-in and District Station on East Side of Bathurst St., South of Ellerslie Ave (looking north)

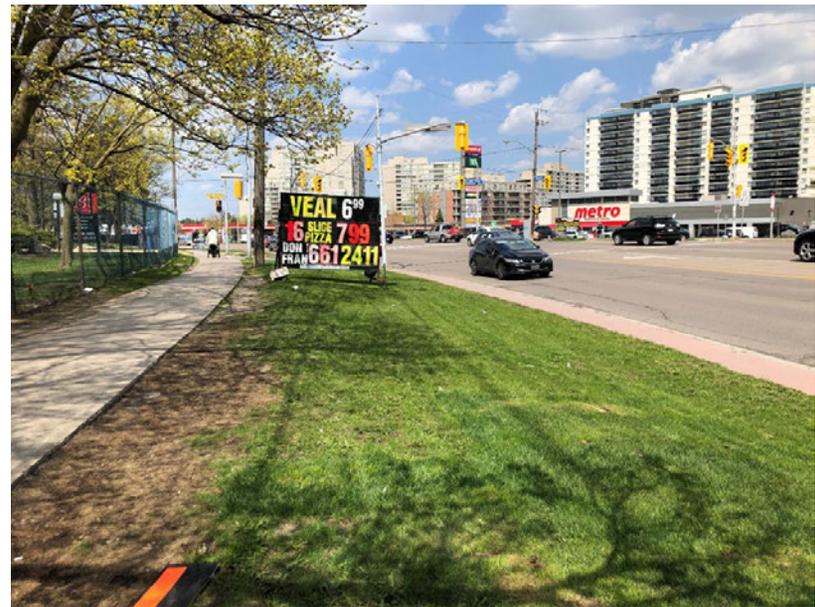
Photo 8: West side of Bathurst St., South of Greenwin Village Rd. (looking north)

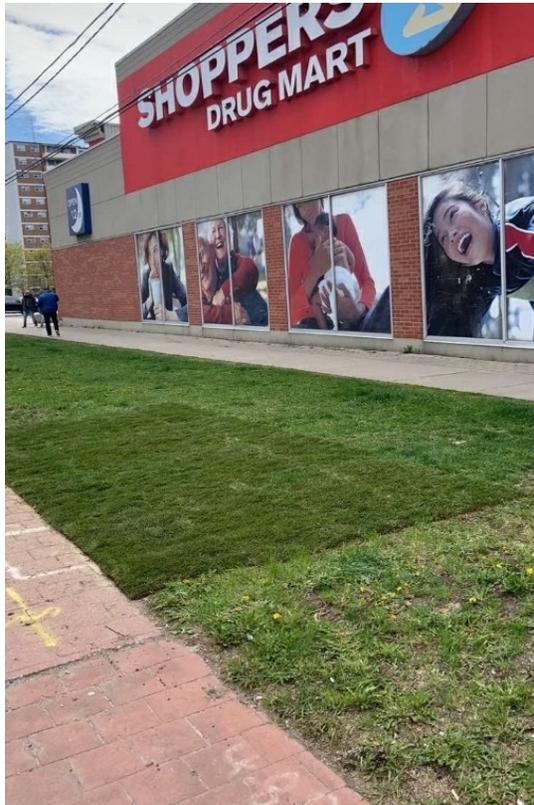
Photo 9: West side of Bathurst St., North of Cedarcroft Blvd. at 5998 Bathurst St. (looking southwest).
