Scugog Island Natural Gas Pipeline Project:

Post-Construction Final Monitoring Report

EB-2017-0261

To: Sarah Kingdon-Benson
From: Michael Tredree
Date: July 6, 2021
Subject: Highway 7A Interim Reclamation Report
Our File: 19-9834

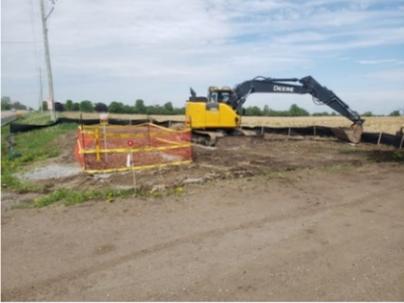
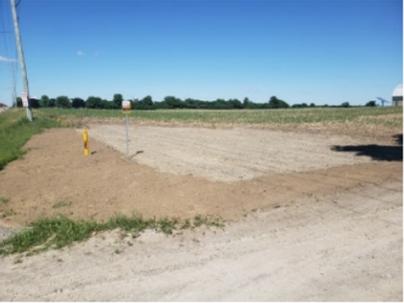
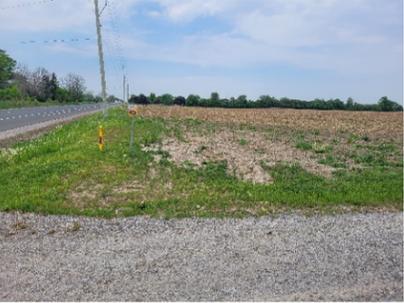
Location	Site Condition	Additional Work Recommended (Y/N)?	Comments/Recommendations	Representative Photo (May 29 and June 1, 2020)	Representative Photo (June 15, 2020)	Representative Photo (May 25, 2021)
3291 Hwy 7A (E12)	Reclaimed	N	<p>Disturbed area is located west of a gravel laneway at the south end of a cultivated agricultural field. No signs of erosion. ESC measures removed.</p> <p>Area re-disturbed by roadwork contractor.</p> <p>Pictures facing Northwest.</p>

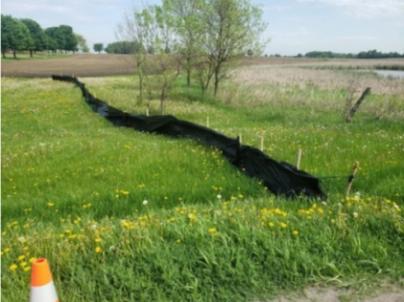
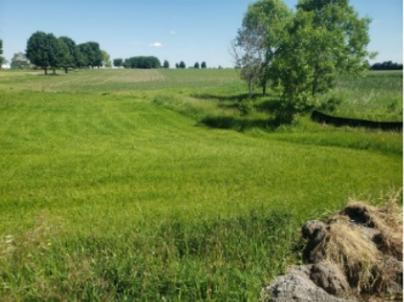
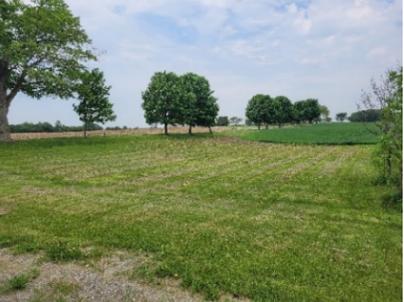
3291 Hwy 7A (E12)	Undisturbed	N	<p>Silt fencing at this location was installed as exclusion fencing for wildlife and has been subsequently removed.</p> <p>Pictures facing Northeast to Northwest.</p>

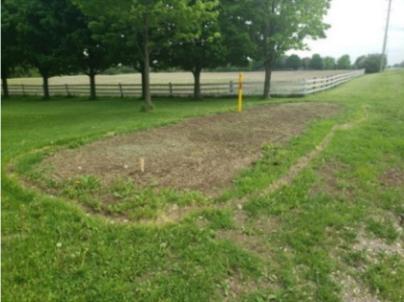
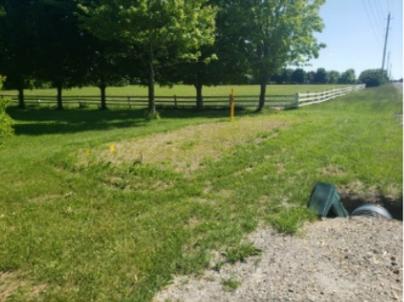
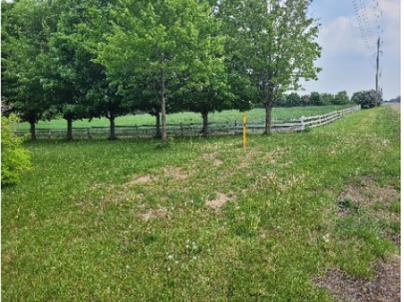
3191 Hwy7A (E11)	Reclaimed	N	<p>Disturbed area is located within a maintained lawn. Evidence of seeding observed, seed germination not yet observed. No signs of erosion. ESC measures have been removed.</p> <p>Pictures facing Northeast.</p>

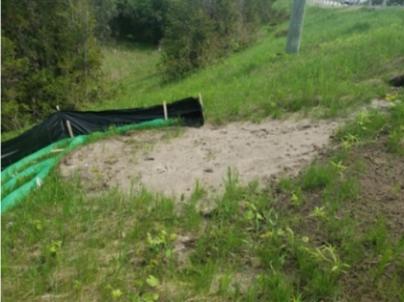
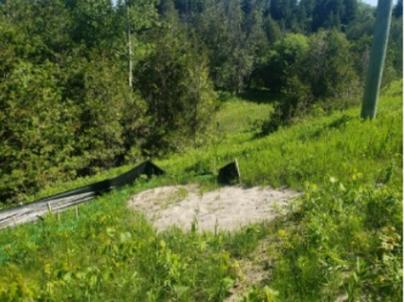
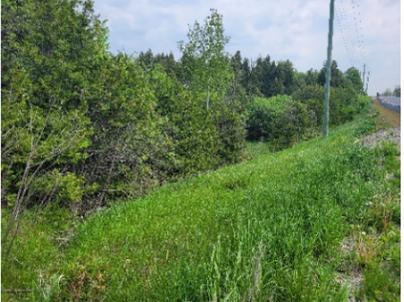
3191 Hwy7A (PPR-2 Watercourse)	Reclaimed	N	<p>Disturbed area is vegetated and stable.</p> <p>Gravel remains from roadwork contractor.</p> <p>Pictures facing Northeast.</p>

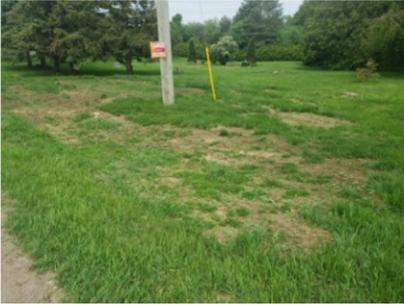
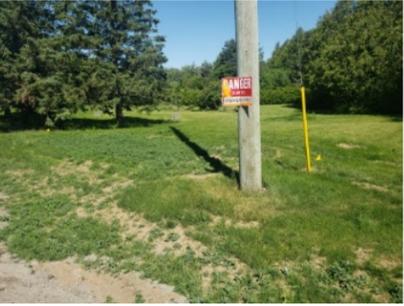
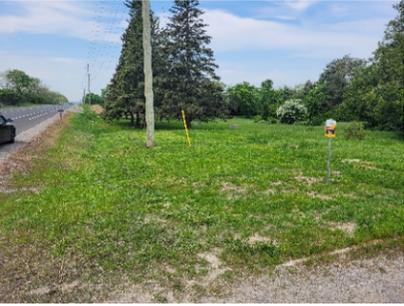
Location	Site Condition	Additional Work Recommended (Y/N)?	Comments/Recommendations	Representative Photo (May 29 and June 1, 2020)	Representative Photo (June 15, 2020)	Representative Photo (May 25, 2021)
3131 Hwy 7A (E10)	Reclaimed	N	Disturbed area is located within a maintained lawn. No signs of erosion. ESC measures have been removed. Pictures facing Northwest.

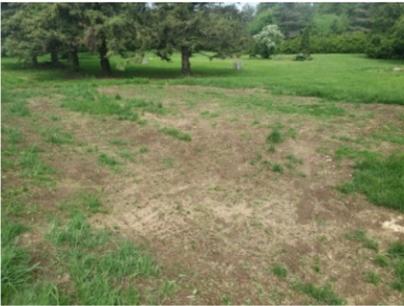
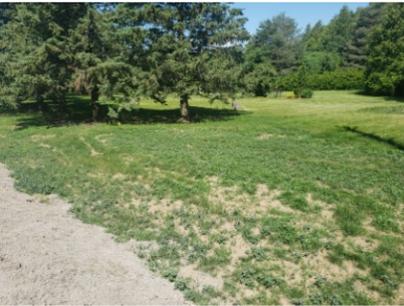
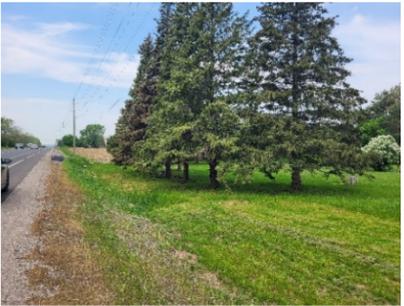
3131 Hwy 7A (E9)	Reclaimed	N	Disturbed area is located adjacent to E10 location within a maintained lawn. No signs of erosion. ESC measures have been removed. Pictures facing Northwest.

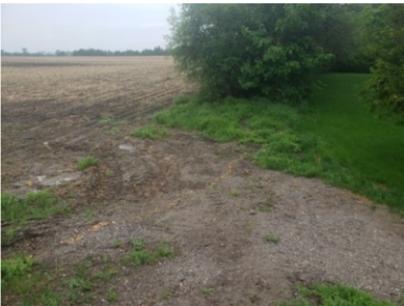
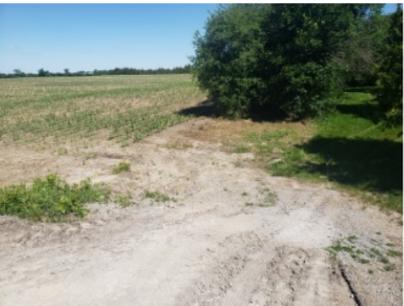
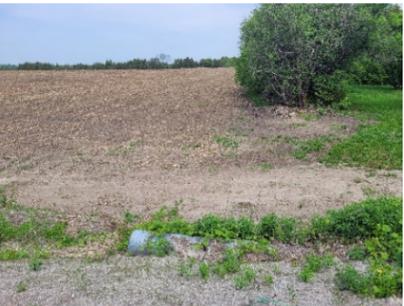
3131 Hwy 7A (E8)	Reclaimed	N	Area has not been seeded due to its proximity to a cultivated field and its location within the point of entry to the field. Evidence of machinery use within the area observed (tire tracks/shallow rutting). No signs of erosion observed. ESC measures have been removed. Pictures facing North.

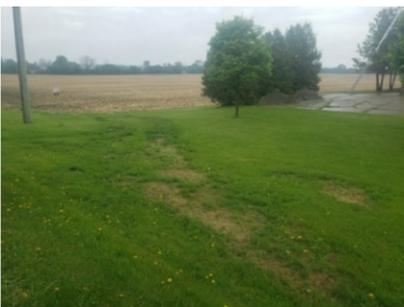
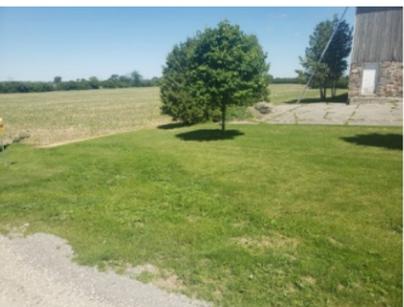
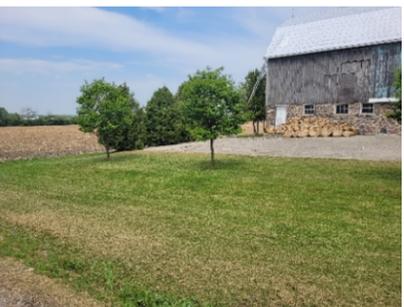
3091 Hwy 7A (E7)	Reclaimed	N	Disturbed area is located within a maintained lawn. Evidence of seeding observed, seed germination successful in the majority of the impacted area. No signs of erosion. ESC measures have been removed. Pictures facing Northwest.

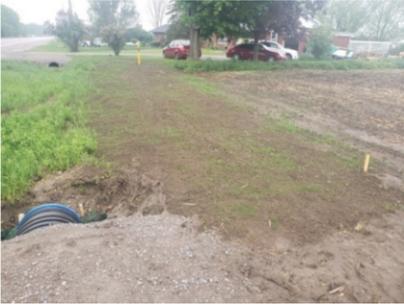
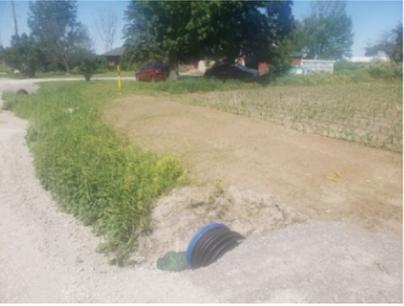
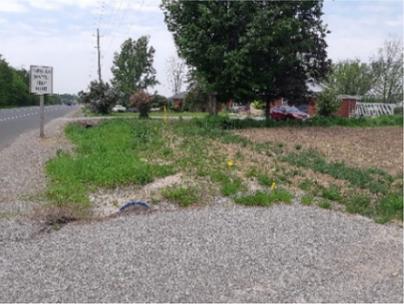
Location	Site Condition	Additional Work Recommended (Y/N)?	Comments/Recommendations	Representative Photo (May 29 and June 1, 2020)	Representative Photo (June 15, 2020)	Representative Photo (May 25, 2021)
3041 Hwy 7A (E6)	Reclaimed	N	<p>Disturbed area is located within a maintained lawn area south of a cultivated field. Evidence of seeding observed, seed germination observed to be progressing well. No signs of erosion. ESC measures have been removed. Note – new vegetative growth not easily visible in June 15 photo due to lighting.</p> <p>Pictures facing Northwest.</p>

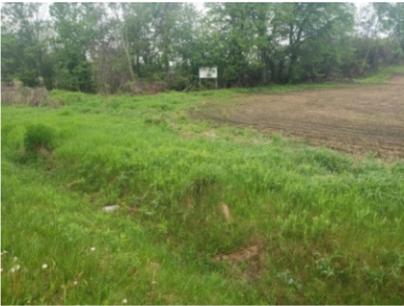
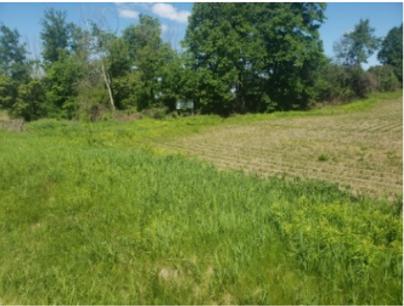
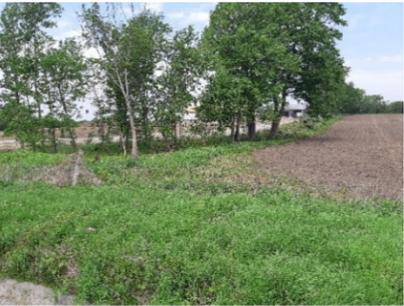
Cartwright West ¼ Line and Hwy 7A (E5)	Reclaimed	N	<p>Disturbed area is located on the southern edge of a cultivated field. No signs of erosion. ESC measures have been removed.</p> <p>Pictures facing Northwest.</p>

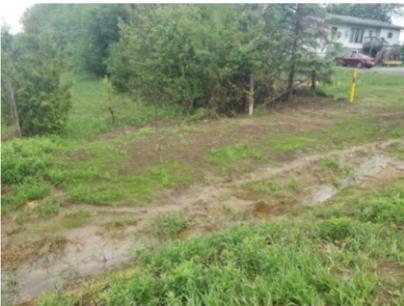
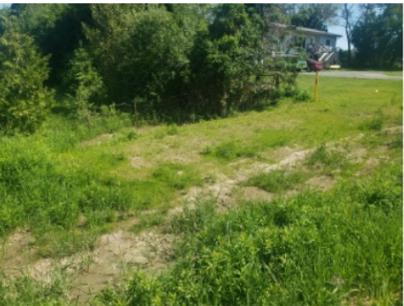
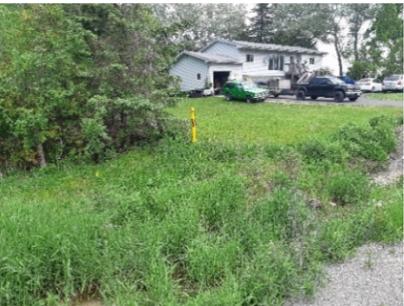
2981 Hwy 7A (E4)	Reclaimed	N	<p>Disturbed area is located north of the vegetated road shoulder of Highway 7A, north of a ditch line. ESC measures have been removed.</p> <p>Gravel remains from roadwork contractor.</p> <p>Pictures facing Northeast.</p>

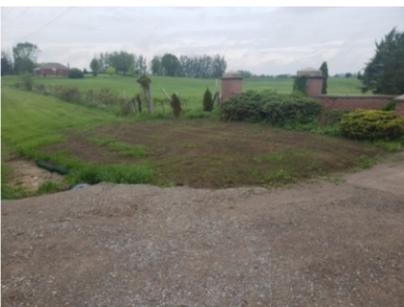
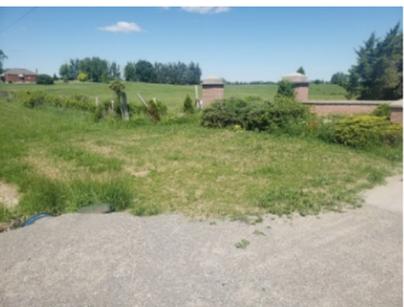
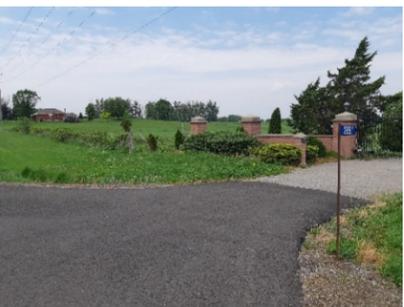
2951 Hwy 7A (E3)	Reclaimed	N	<p>Disturbed area is located within a maintained lawn area. Signs of early seed germination observed. No signs of erosion. ESC measures have been removed.</p> <p>Pictures facing Northwest.</p>

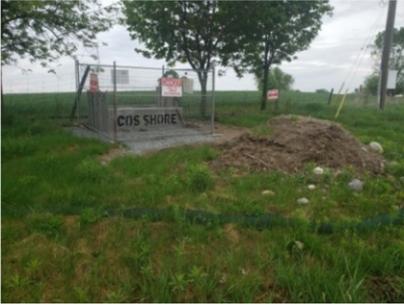
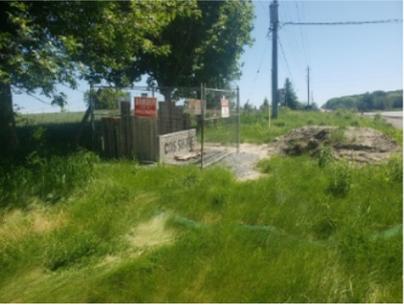
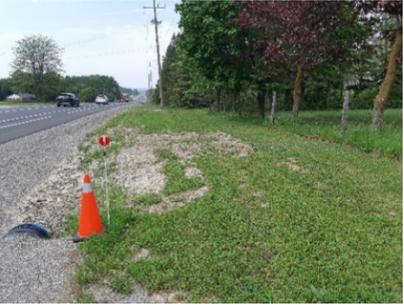
Location	Site Condition	Additional Work Recommended (Y/N)?	Comments/Recommendations	Representative Photo (May 29 and June 1, 2020)	Representative Photo (June 15, 2020)	Representative Photo (May 25, 2021)
2895 Hwy 7A (E2)	Reclaimed	N	<p>Disturbed area is located within a maintained lawn area. No signs of erosion.</p> <p>Area re-disturbed by roadwork contractor.</p> <p>Pictures facing Northeast to due East.</p>

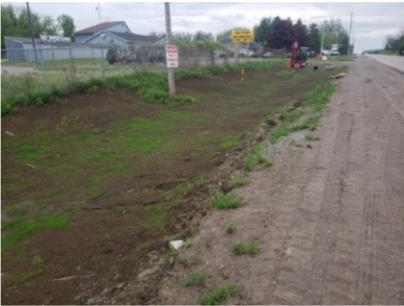
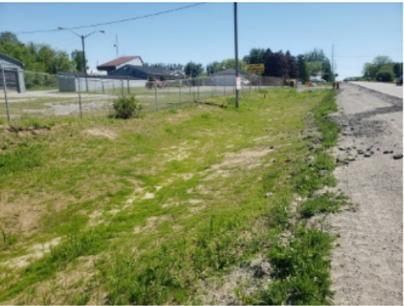
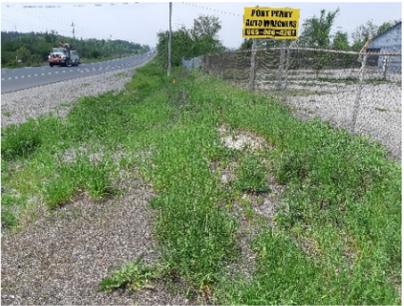
2831 Hwy 7A (E1)	Reclaimed	N	<p>Disturbed area is located within a maintained lawn area. ESC measures removed.</p> <p>Gravel remains from roadwork contractor.</p> <p>Pictures facing Northeast to Northwest.</p>

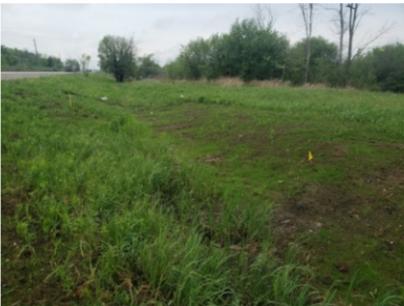
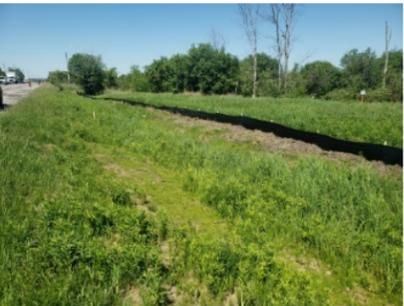
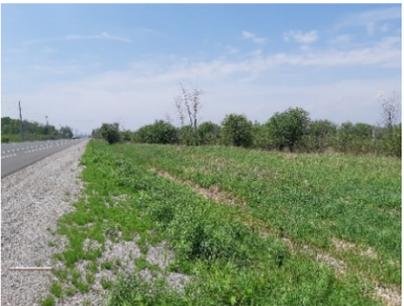
2831 Hwy 7A (W7)	Reclaimed	N	<p>Disturbed area is located within meadow habitat north of the vegetated road shoulder. No signs of erosion observed. ESC removed.</p> <p>Gravel remains from roadwork contractor.</p> <p>Pictures facing Northwest.</p>

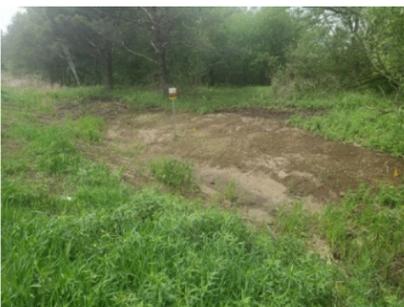
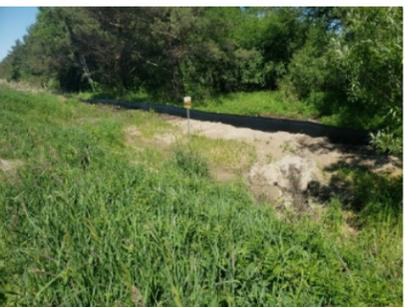
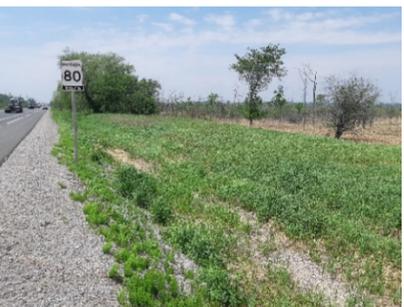
2831 Hwy 7a (W6)	Reclaimed	N	<p>Disturbed area is located within wet meadow habitat north of the vegetated road shoulder.</p> <p>Gravel remains from roadwork contractor.</p> <p>Pictures facing Northwest.</p>

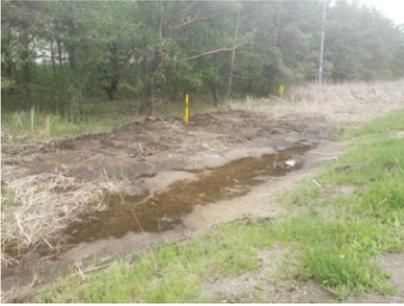
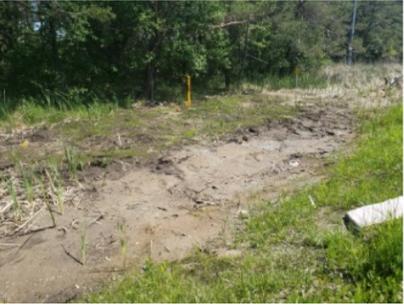
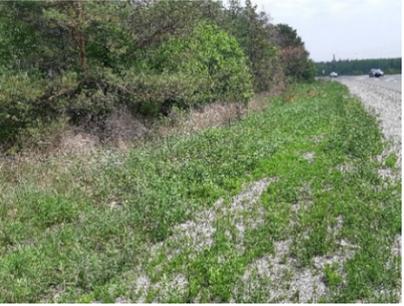
Location	Site Condition	Additional Work Recommended (Y/N)?	Comments/Recommendations	Representative Photo (May 29 and June 1, 2020)	Representative Photo (June 15, 2020)	Representative Photo (May 25, 2021)
2505 Hwy 7A (W5.5)	Reclaimed	N	Disturbed area is located within wetland habitat north of the vegetated road shoulder. ESC removed. Gravel remains from roadwork contractor. Pictures facing Northeast.

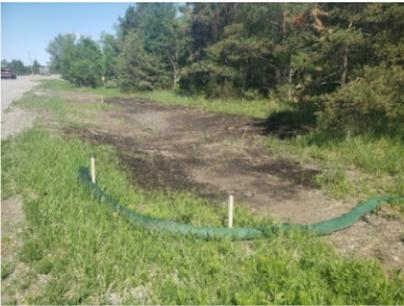
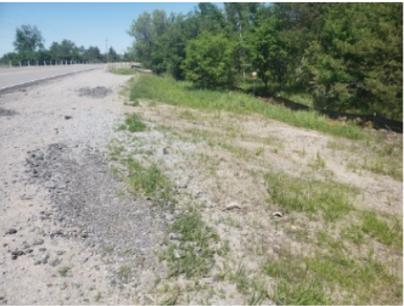
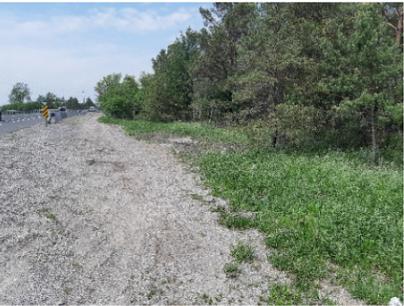
2505 Hwy 7A (W5)	Reclaimed	N	Disturbed area is located within wet meadow habitat north of the vegetated road shoulder. ESC removed. Area re-disturbed by roadwork contractor. Pictures facing West.

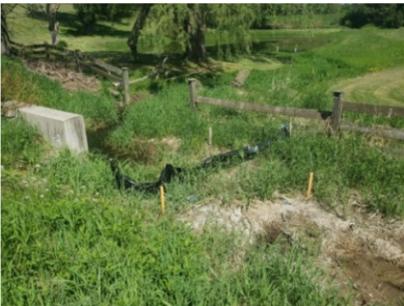
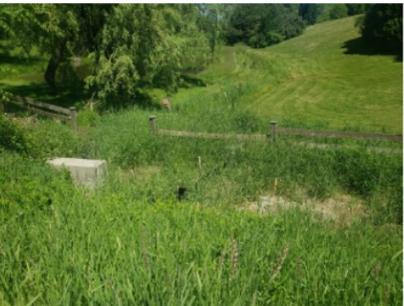
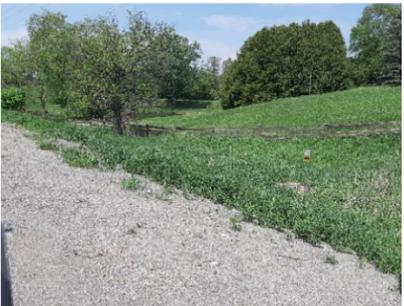
Reader Road and Hwy 7a (PPR-6 Watercourse)	Reclaimed	N	Area revegetated and stabilized. ESC removed. Gravel shoulder extended by roadwork contractor. Pictures facing North.

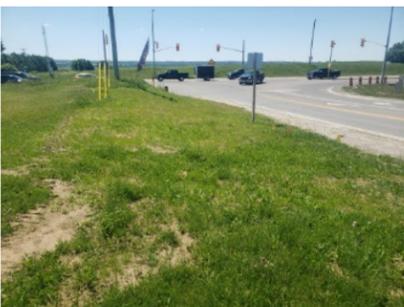
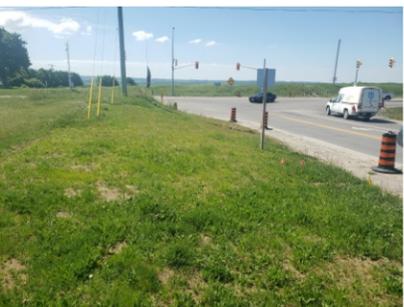
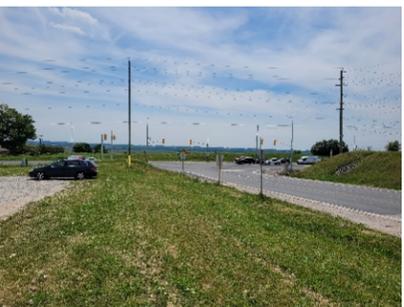
Island Road and Hwy 7A (W1)	Reclaimed	N	Disturbed area is located within a maintained lawn area east of Island Road. No signs of erosion. ESC measures have been removed. Pictures facing South.
