Final Monitoring Report

St. Laurent Pipeline Project (EB-2019-0006)

ENBRIDGE GAS INC.
ST LAURENT PHASE 2 OEB
FINAL MONITORING REPORT

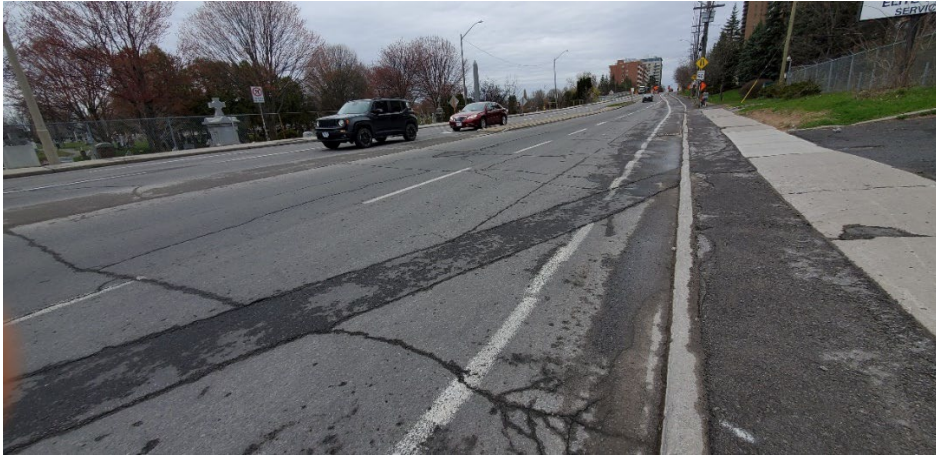
Facing north at St. Laurent Boulevard from the northbound St. Laurent Boulevard sidewalk, north of Montreal Road. Mainline replacement area.	Reclaimed	None required
2

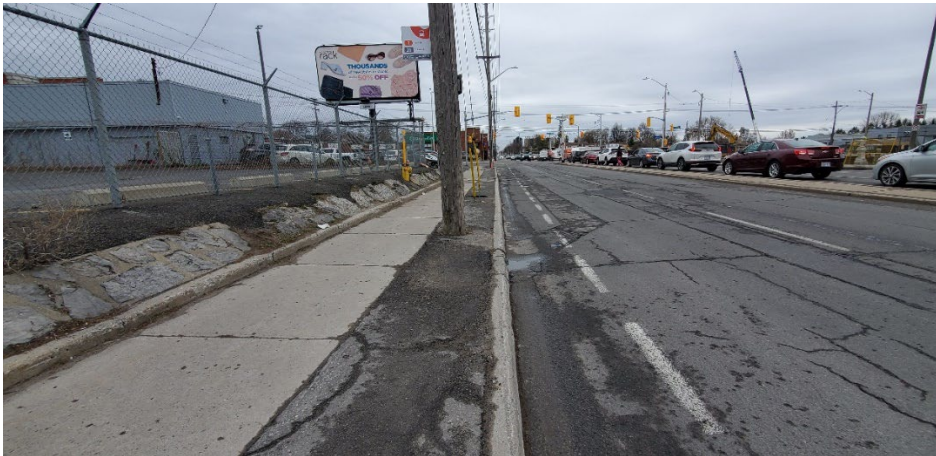
Facing southwest at St. Laurent Boulevard from the northbound St. Laurent Boulevard sidewalk, north of Montreal Road. Mainline replacement area.	Reclaimed	None required

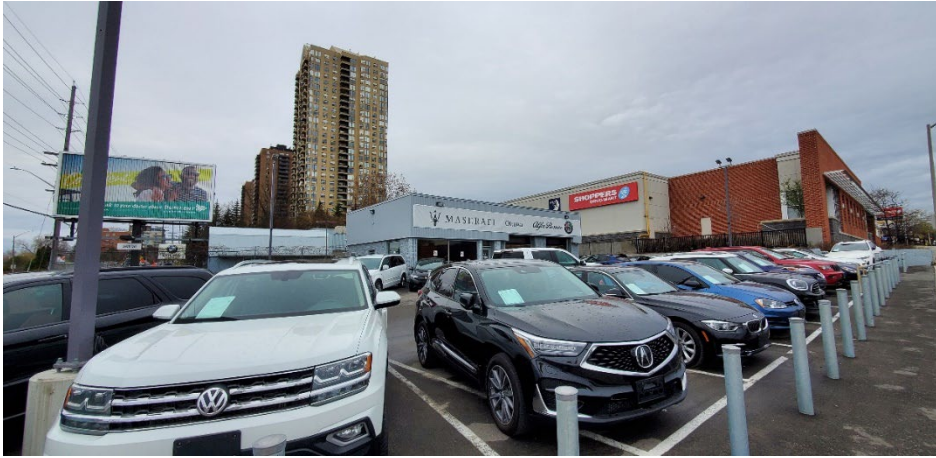
<p>Facing northeast at commercial parking lot from the intersection of St. Laurent Boulevard and Montreal Road.</p> <p>Past equipment staging area as well as sand and gravel storage area.</p>	<p>Reclaimed. Previously used as a staging area for equipment and gravel/sand piles.</p>	None required
4

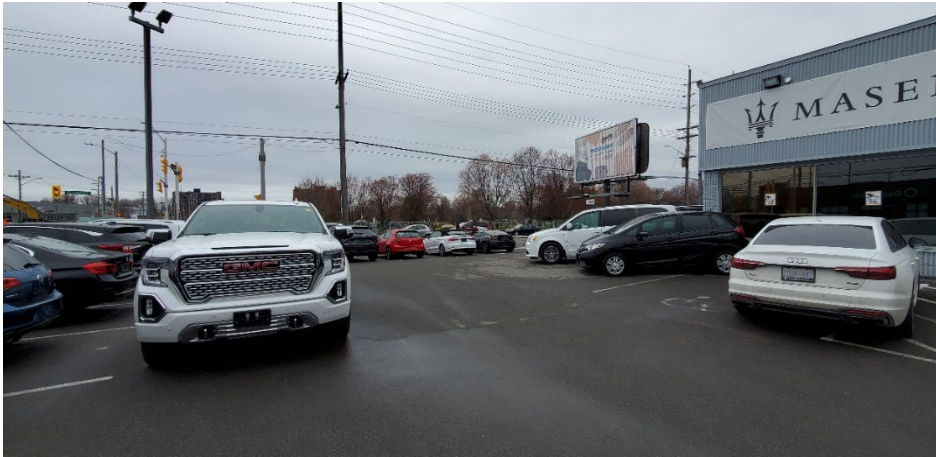
<p>Facing northwest at commercial parking lot from westbound Montreal Road sidewalk, east of the intersection of St. Laurent Boulevard and Montreal Road.</p> <p>Past equipment staging area as well as sand and gravel storage area.</p>	<p>Reclaimed. Previously used as a staging area for equipment and gravel/sand piles.</p>	None required

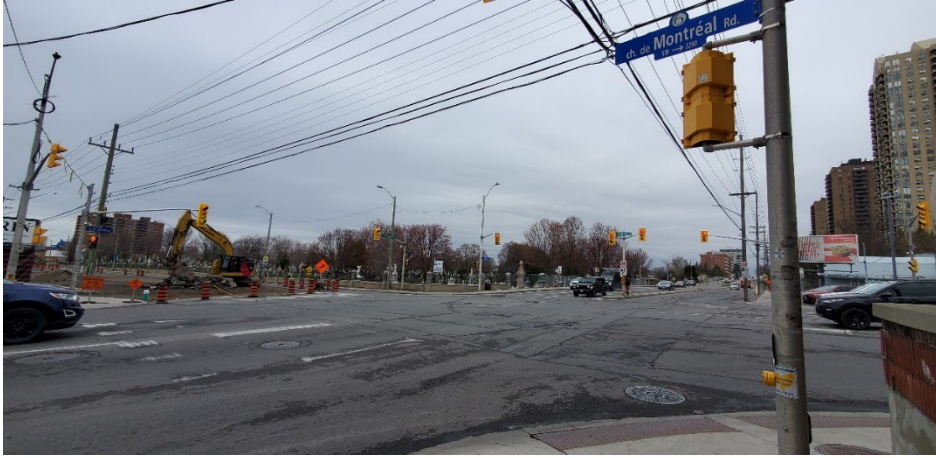
Facing northwest at the intersection of St. Laurent Boulevard and Montreal Road from the northbound lane sidewalk of St. Laurent Boulevard. Active construction related to the City of Ottawa Montreal Road Revitalization Project can be seen. Mainline replacement area.	Reclaimed	None required
6

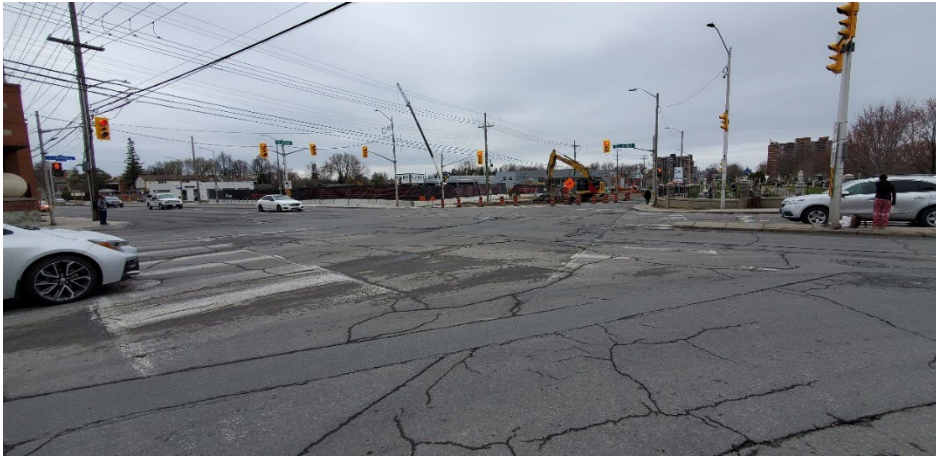
Facing southwest at the intersection of St. Laurent Boulevard and Montreal Road from the northbound lane sidewalk of St. Laurent Boulevard. Active construction related to the City of Ottawa Montreal Road Revitalization Project and a development by Laurin Group can be seen. Mainline replacement area.	Reclaimed	None required

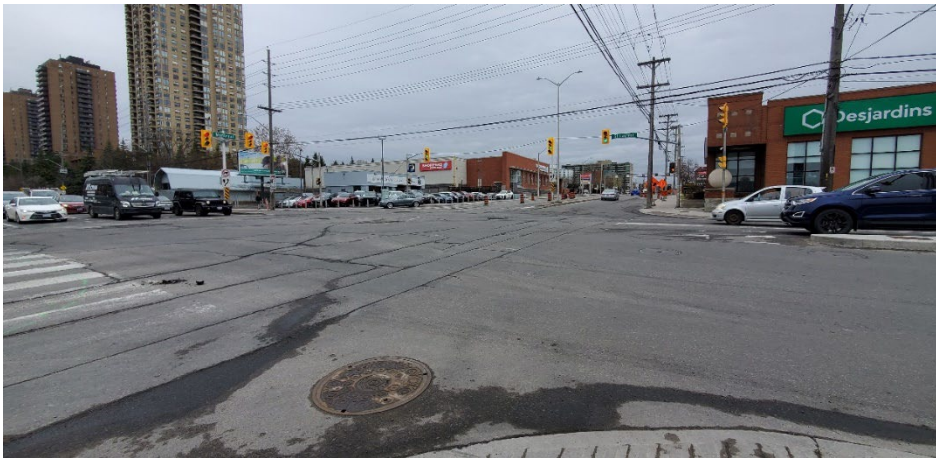
Facing northwest at the intersection of St. Laurent Boulevard and Montreal Road from the southbound lane sidewalk of St. Laurent Boulevard. Mainline replacement area.	Reclaimed	None required
8

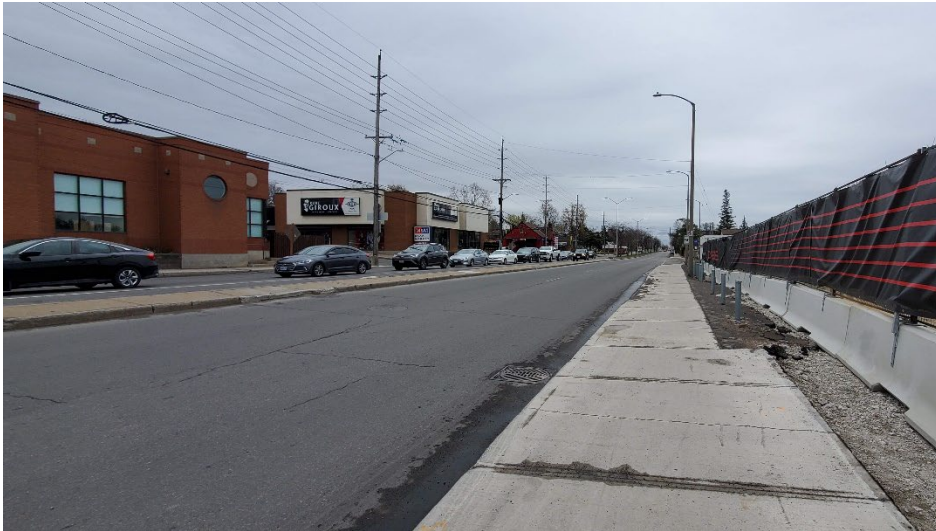
Facing south at southbound lane of St. Laurent Boulevard. Development by Laurin Group can be seen to the right. Upgraded service connection area.	Reclaimed	None required

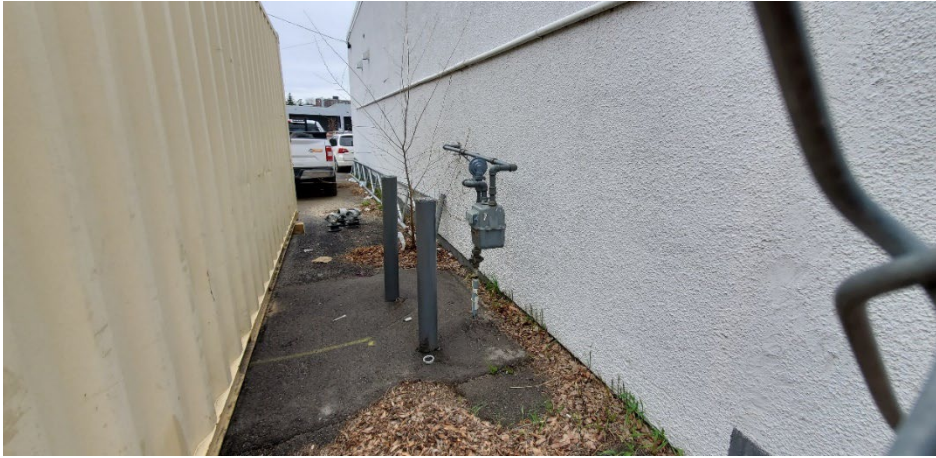
Facing northwest at completed service connection for Maserati of Ottawa (616 St. Laurent Boulevard) from the sidewalk of the southbound lane of St. Laurent Boulevard. Upgraded service connection area.	Reclaimed	None required
10

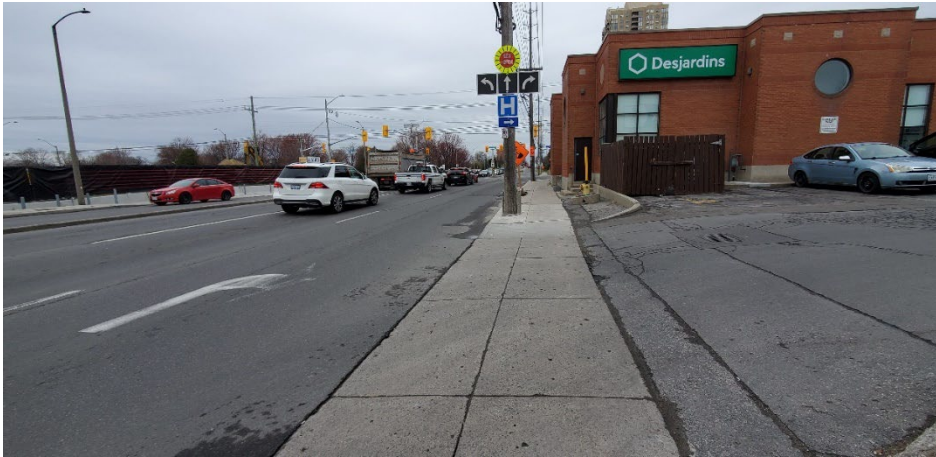
Facing northwest at St. Laurent Boulevard from the northbound lane sidewalk of St. Laurent Boulevard south of Centre de Services Desjardins Montfort (520 Montreal Road). Mainline replacement area.	Reclaimed	None required

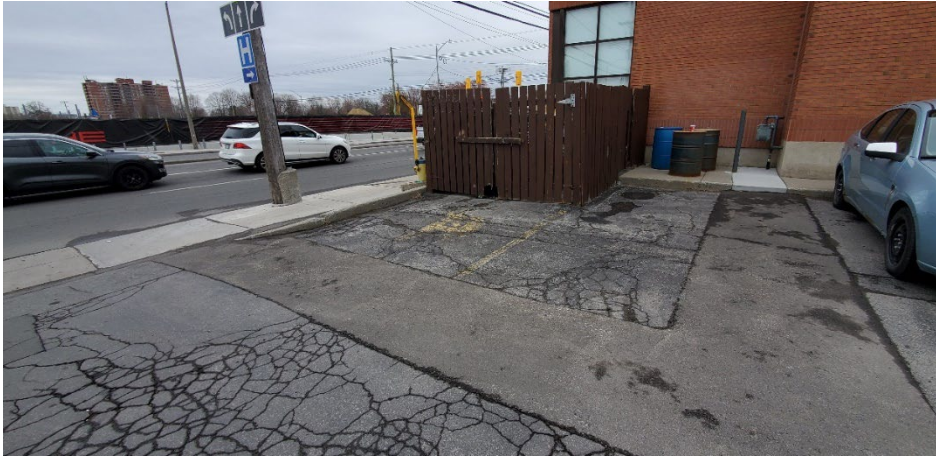
Facing northwest at south wall of Centre de Services Desjardins Montfort (520 Montreal Road) from southern section of shared business/commercial parking lot. Upgraded service connection area.	Reclaimed	None required
12

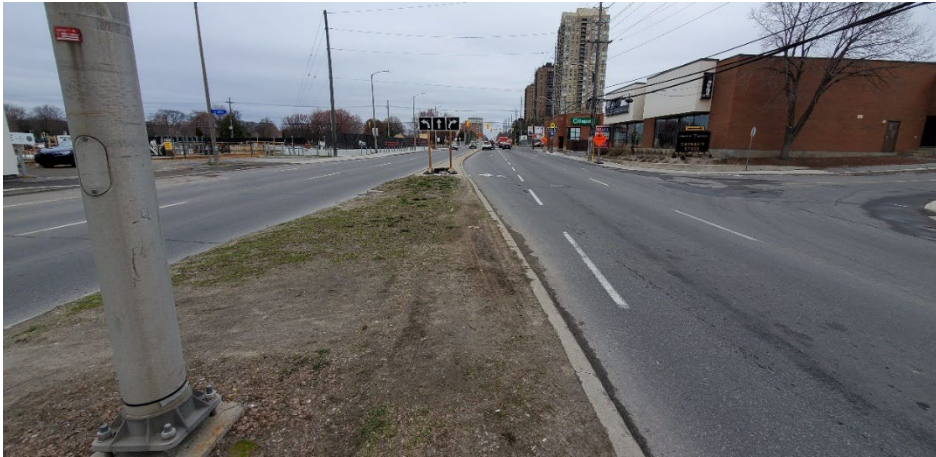
Facing north at St. Laurent Boulevard from northernmost St. Laurent Boulevard median south of the intersection of Camil Street and St. Laurent Boulevard. Mainline replacement area (St. Laurent Boulevard) and Upgraded service connection area (median).	Partially Reclaimed	The median requires topsoil and reseeding.

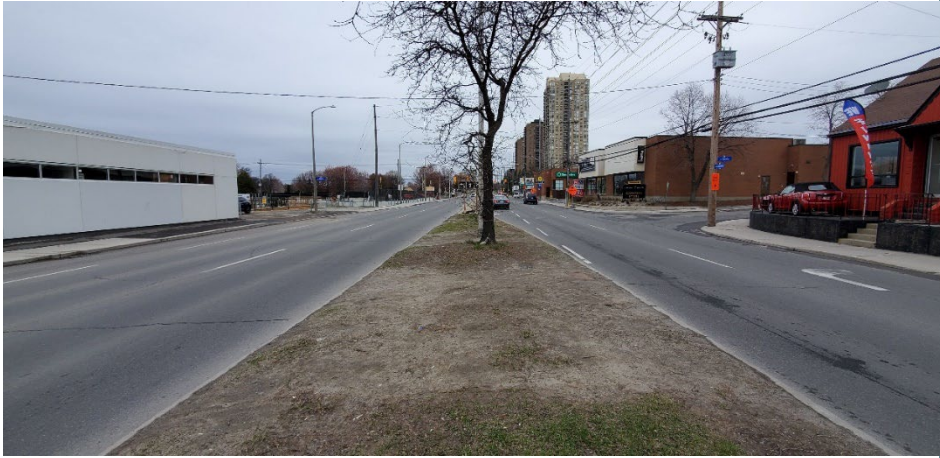
Facing north at St. Laurent Boulevard from northernmost St. Laurent Boulevard median south of the intersection of Camil Street and St. Laurent Boulevard. Mainline replacement area (St. Laurent Boulevard) and Upgraded service connection area (median).	Partially reclaimed	The median requires topsoil and reseeding.
14	 	Facing south at St. Laurent Boulevard from northernmost St. Laurent Boulevard median south of the intersection of Camil Street and St. Laurent Boulevard. Mainline replacement area (St. Laurent Boulevard) and Upgraded service connection area (median).	Reclaimed	None required

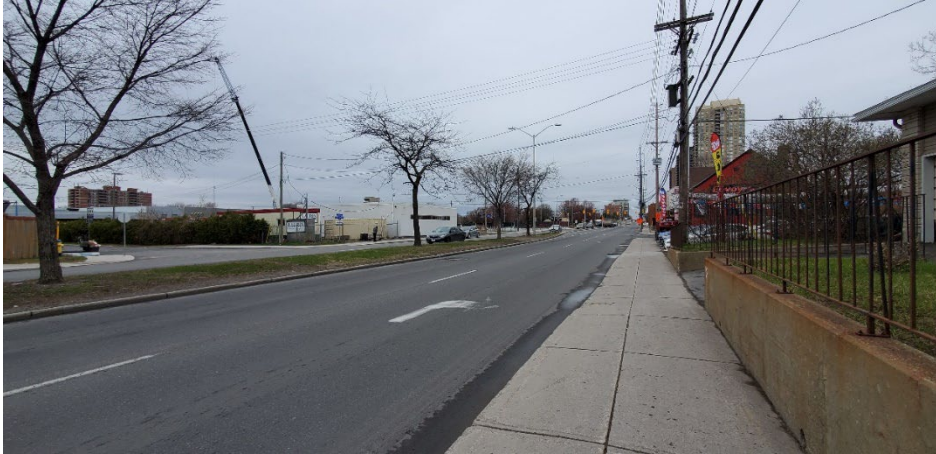
<p>Facing north at St. Laurent Boulevard from the northbound St. Laurent Boulevard sidewalk south of the intersection of Camil Street and St. Laurent Boulevard.</p> <p>Mainline replacement area (St. Laurent Boulevard) and Upgraded service connection area (median).</p>	Reclaimed	None required
16

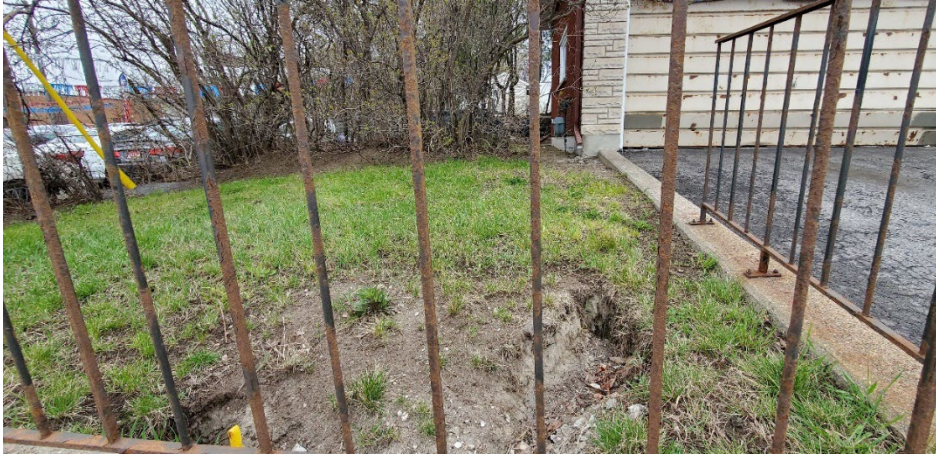
<p>Facing east at lawn of 621 St. Laurent Boulevard from northbound St. Laurent Boulevard sidewalk. Disturbed lawn area has experienced sinkholes where excavation occurred.</p> <p>Upgraded service connection area.</p>	Partially reclaimed	Fill with topsoil and reseed.

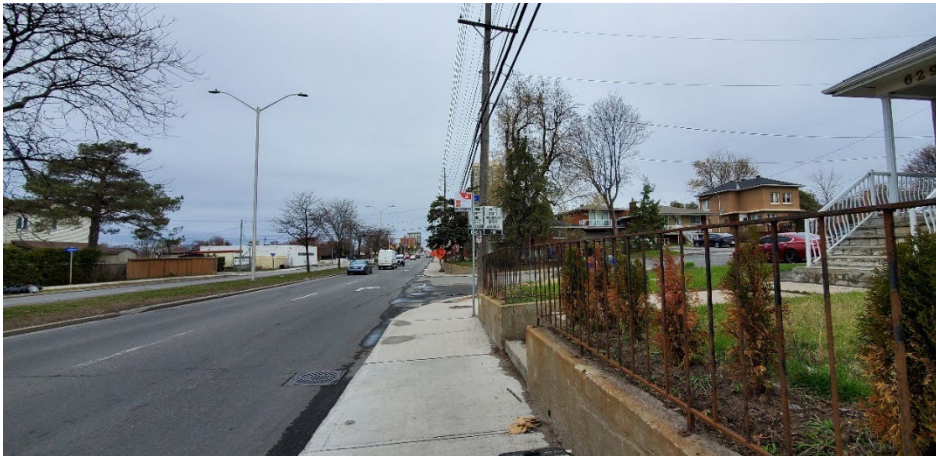
Facing north at St. Laurent Boulevard from the northbound St. Laurent Boulevard sidewalk, south of the intersection of Malartic Avenue and St. Laurent Boulevard. Mainline replacement area.	Reclaimed	None required
18	 	Facing east at lawn of 629 St. Laurent Boulevard from northbound St. Laurent Boulevard sidewalk. Upgraded service connection area.	Reclaimed	None required

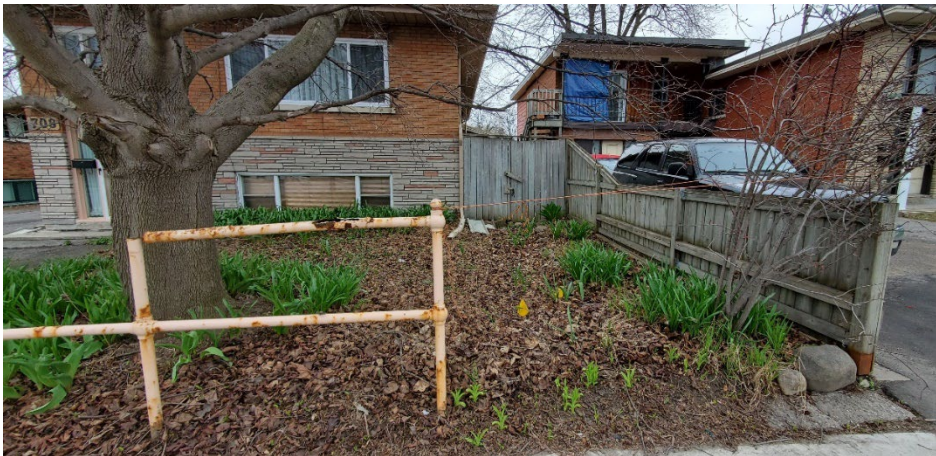
Facing west at front yard of 708 St. Laurent Boulevard from northbound St. Laurent Boulevard sidewalk. Upgraded service connection area.	Reclaimed	None required

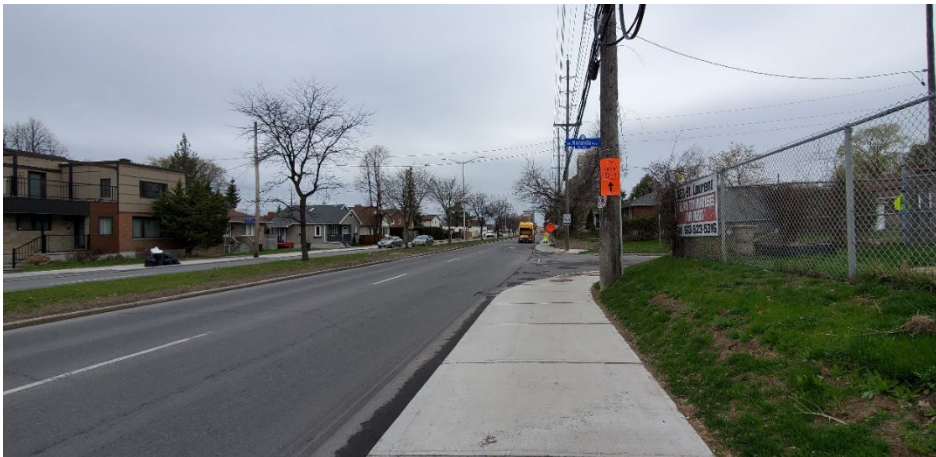
Facing north at St. Laurent Boulevard from the northbound St. Laurent Boulevard sidewalk south of the intersection of Noranda Avenue and St. Laurent Boulevard. Mainline replacement area.	Reclaimed	None required
22

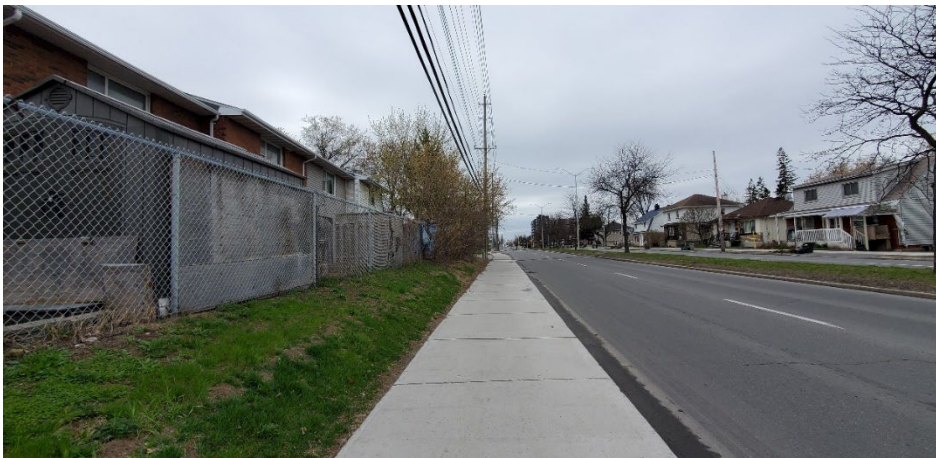
Facing south at St. Laurent Boulevard from the northbound St. Laurent Boulevard sidewalk south of the intersection of Noranda Avenue and St. Laurent Boulevard. Mainline replacement area.	Reclaimed	None required

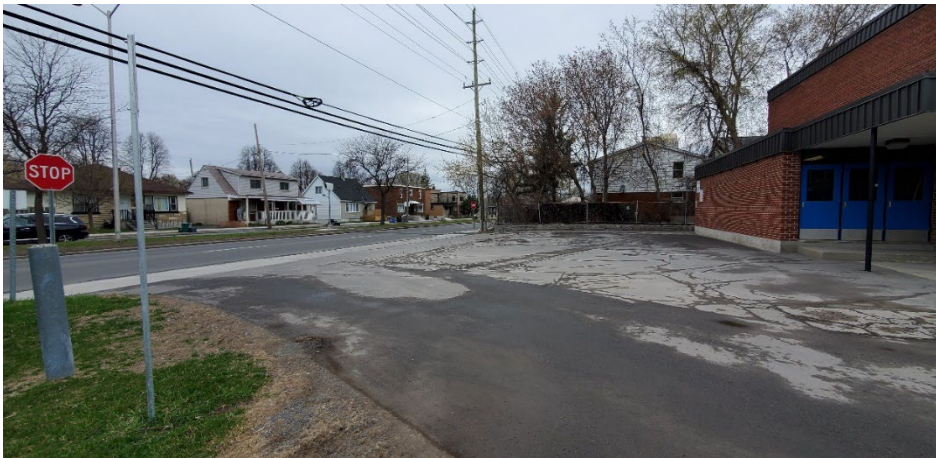
Facing northwest at northbound lane of St. Laurent Boulevard from the exit of Queen Elizabeth Public School. Past temporary parking and equipment staging area (asphalt areas only). Lawn areas were in good condition during 2020 visit. Current state likely from road salt or school activities.	Reclaimed	None required
24

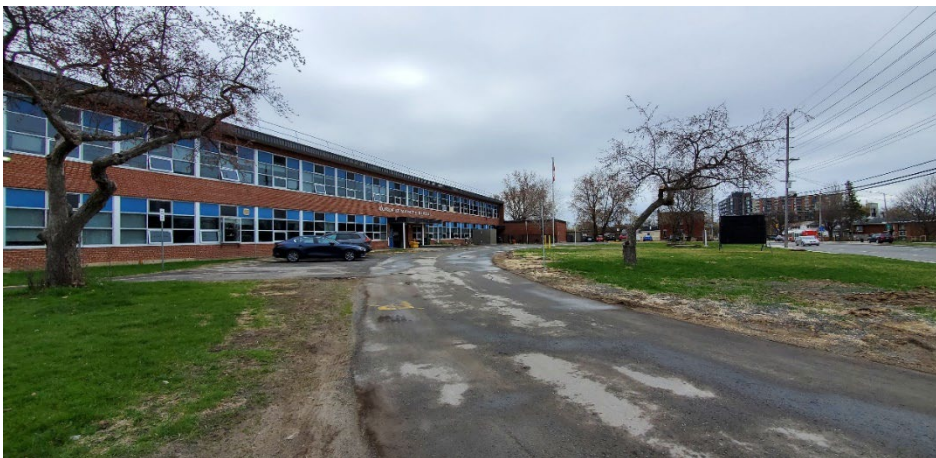
Facing southeast at Queen Elizabeth Public School from school exit onto St. Laurent Boulevard. Past temporary parking and equipment staging area (asphalt areas only). Lawn areas were in good condition during 2020 visit. Current state likely from road salt or school activities.	Reclaimed	None required

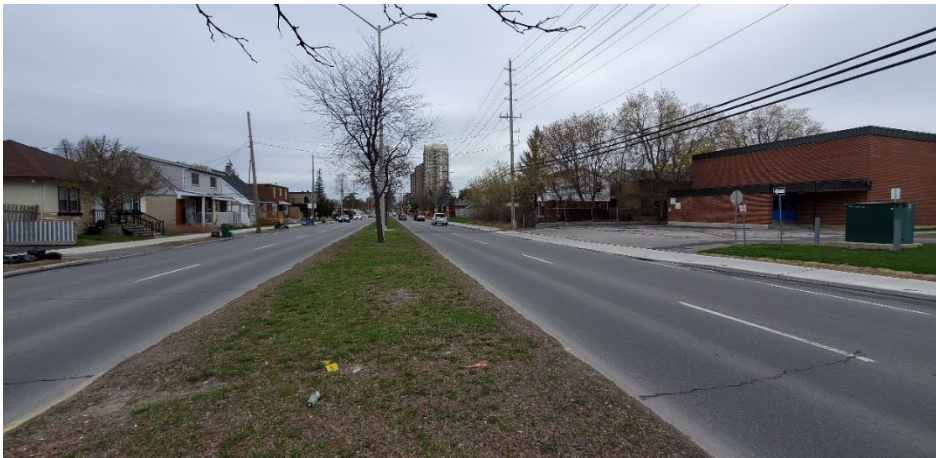
Facing north at both lanes of St. Laurent Boulevard from the St. Laurent Boulevard median near Queen Elizabeth Public School. Mainline replacement area (St. Laurent Boulevard) and upgraded service connection area (median).	Reclaimed	None required
26

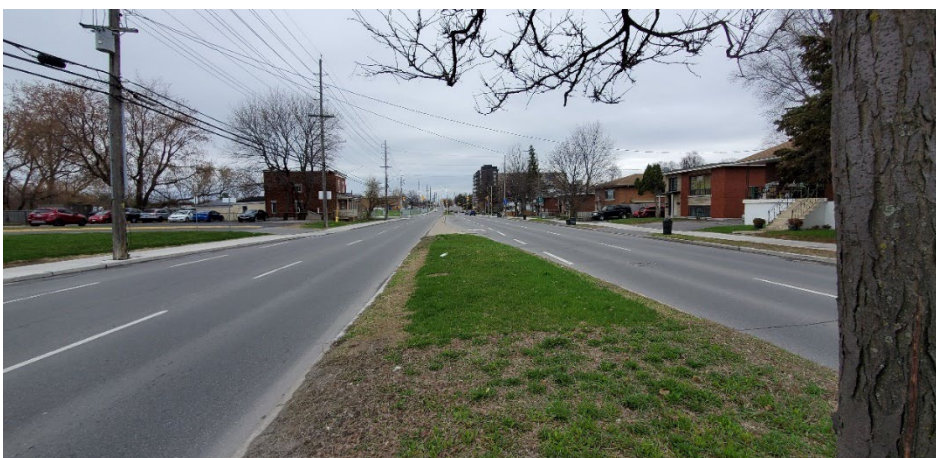
Facing south at both lanes of St. Laurent Boulevard from the St. Laurent Boulevard median near Queen Elizabeth Public School. Mainline replacement area (St. Laurent Boulevard) and upgraded service connection area (median).	Reclaimed	None required

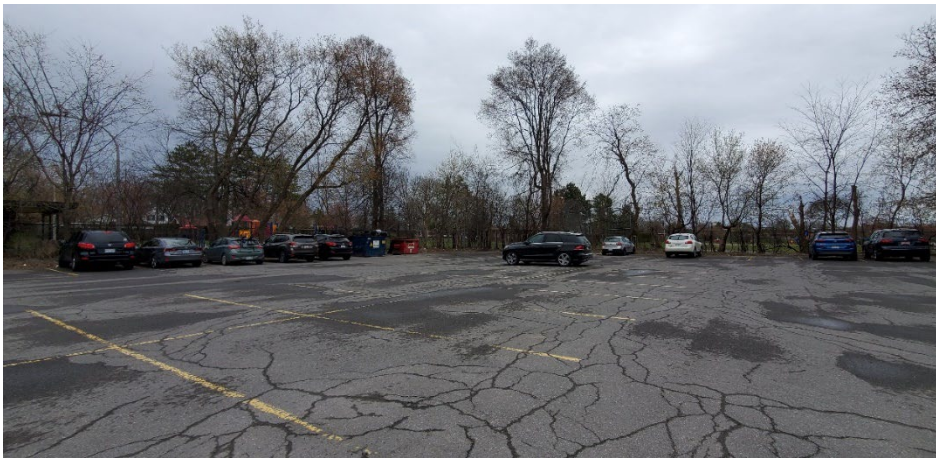
Facing southeast at parking lot of St. Laurent Academy Ottawa Private School from Noranda Avenue. Past equipment staging area as well as sand and gravel storage area.	Reclaimed	None required
34

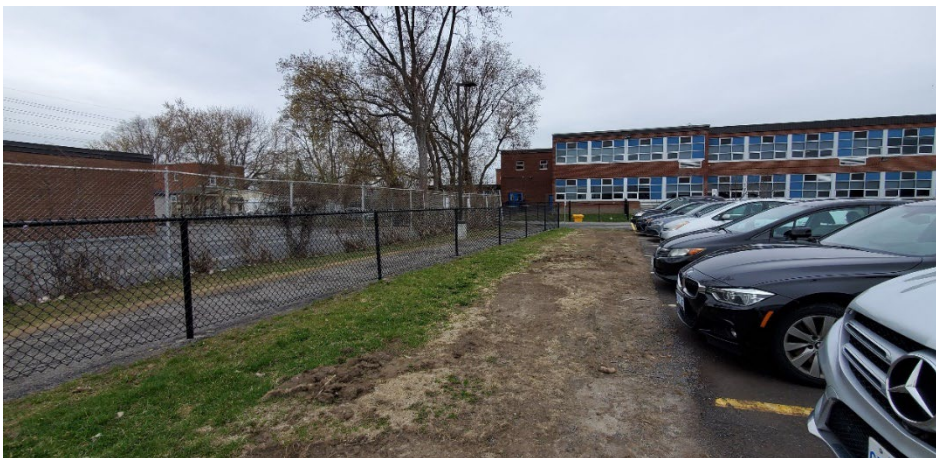
Facing north at parking lot of Queen Elizabeth Public School from westbound Clarke Avenue sidewalk. Lawn area was in good condition during 2020 visit. Current state likely from snow storage. Past temporary parking area sand and gravel storage area.	Reclaimed	None required

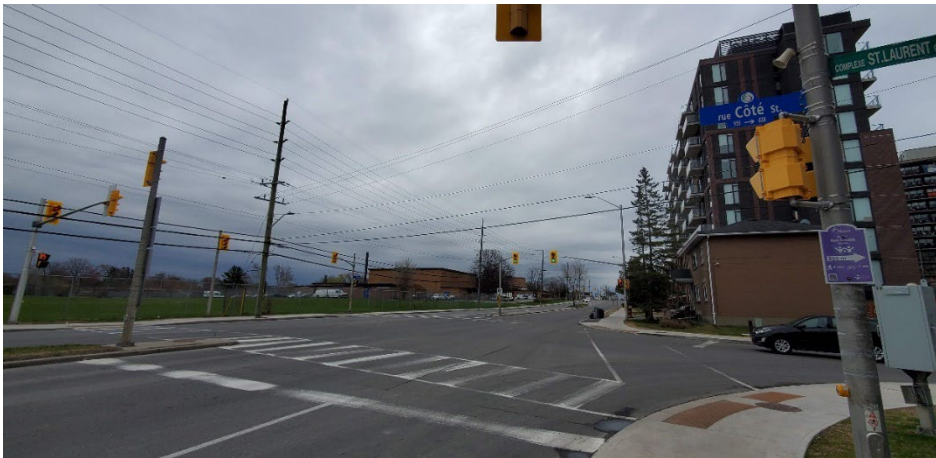
Facing southeast at the intersection of Cote Street and St. Laurent Boulevard from the southbound St. Laurent Boulevard sidewalk. Mainline replacement area.	Reclaimed	None required
38

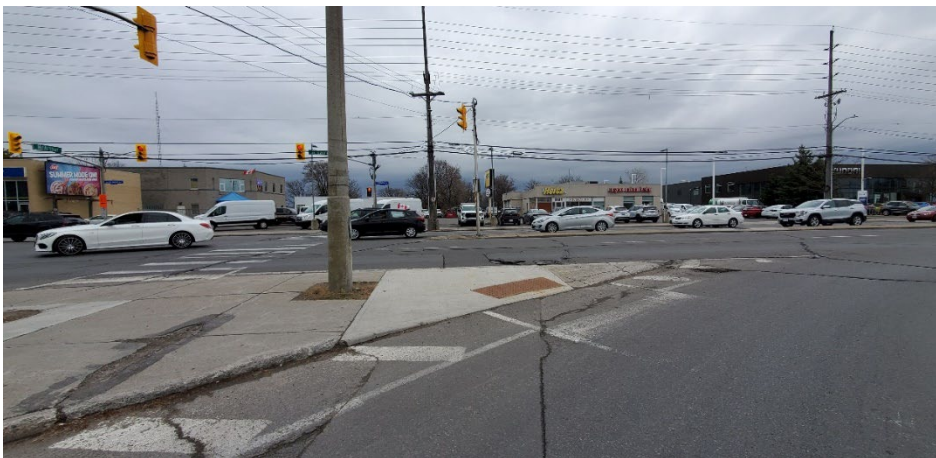
Facing east at the intersection of McArthur Avenue and St. Laurent Boulevard from the southbound St. Laurent Boulevard sidewalk. Mainline replacement area and upgraded service connection area.	Reclaimed	None required

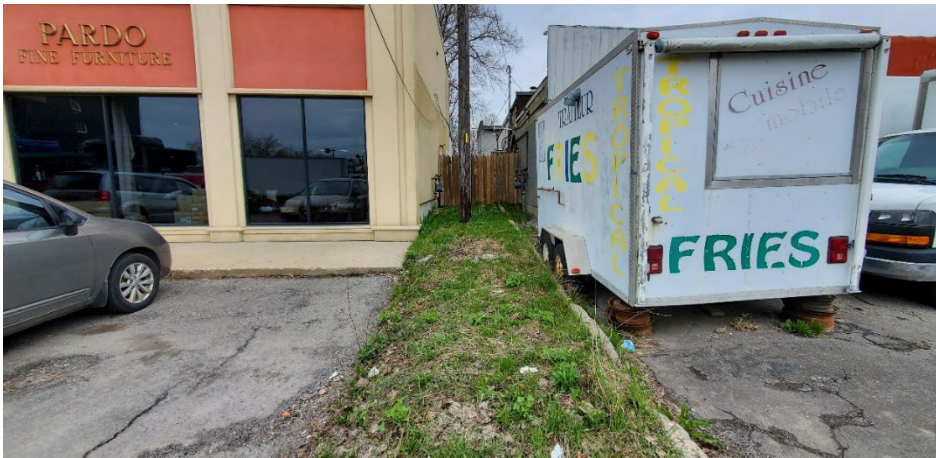
Facing north at manicured lawn of 573 McArthur Avenue from westbound McArthur Avenue sidewalk. Upgraded service connection area.	Reclaimed	None required
40

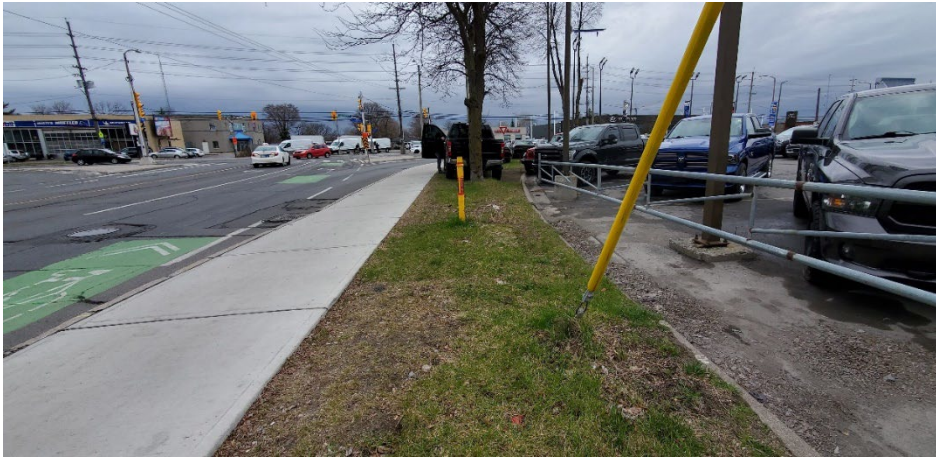
Facing east at manicured lawn of Ottawa St. Laurent Jeep and RAM (900 St. Laurent Boulevard) from east bound McArthur Avenue sidewalk. Upgraded service connection area.	Reclaimed	None required

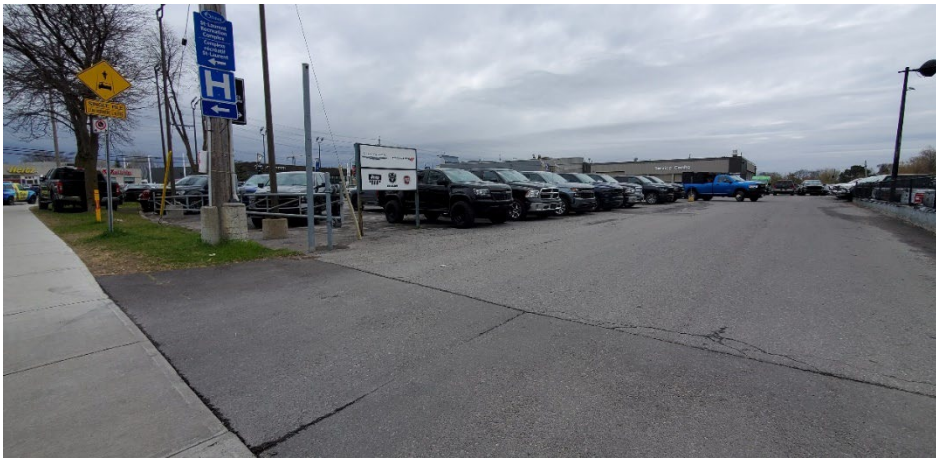
Facing southeast at front yard of 708 St. Laurent Boulevard from northbound St. Laurent Boulevard sidewalk. Upgraded service connection area.	Reclaimed	None required
42

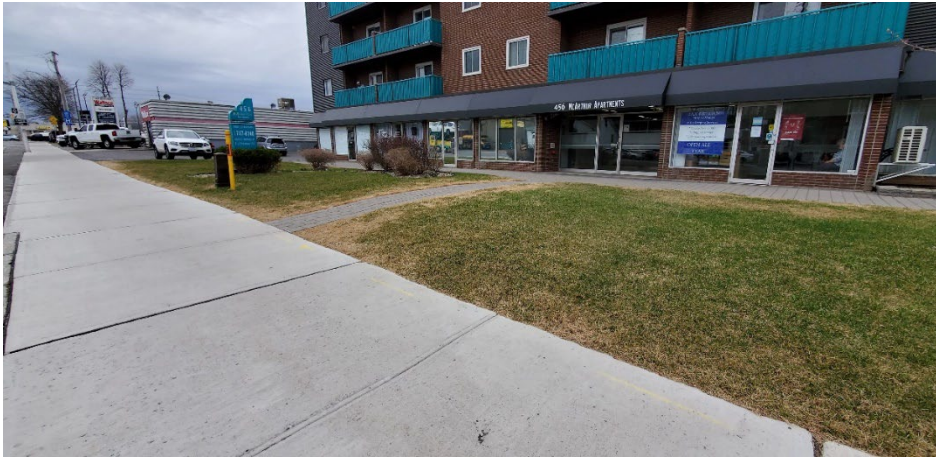
Facing southeast at manicured lawn of 456 McArthur Avenue Apartments from eastbound McArthur Avenue sidewalk. Upgraded service connection area.	Reclaimed	None required

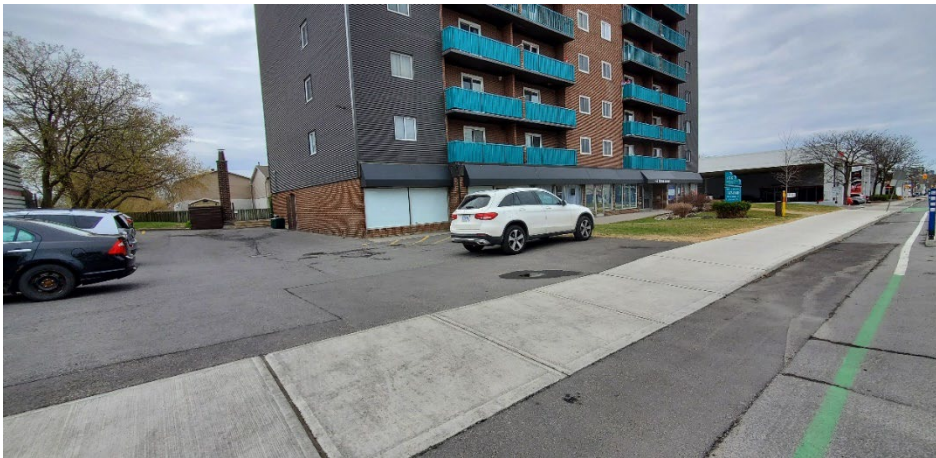
Facing southwest at entrance and manicured lawn of 456 McArthur Avenue Apartments from eastbound McArthur Avenue sidewalk. Upgraded service connection area.	Reclaimed	None required
44

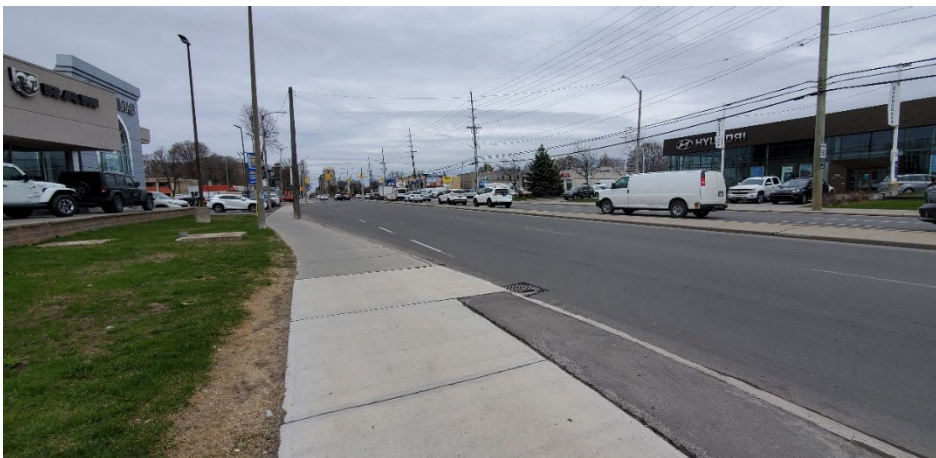
Facing north at St. Laurent Boulevard from the southbound St. Laurent Boulevard sidewalk, north of Donald Street. Mainline replacement area.	Reclaimed	None required

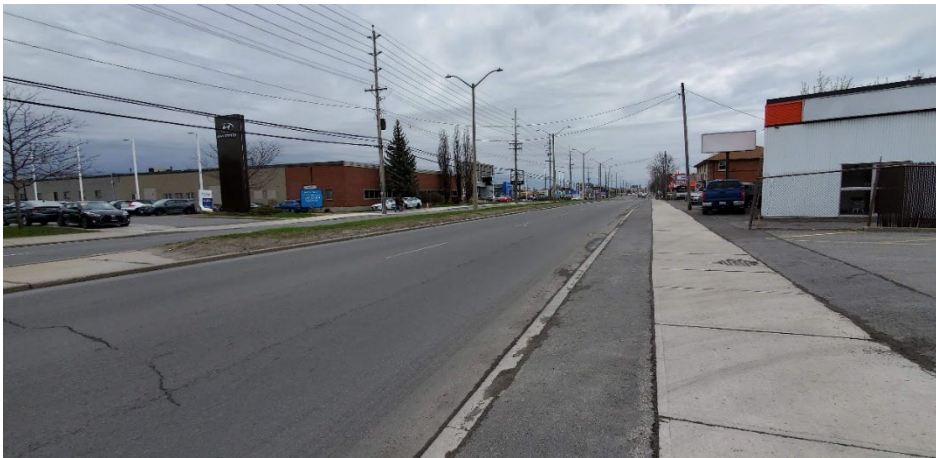
Facing southeast at St. Laurent Boulevard from the southbound St. Laurent Boulevard sidewalk, north of Donald Street. Mainline replacement area.	Reclaimed	None required
46

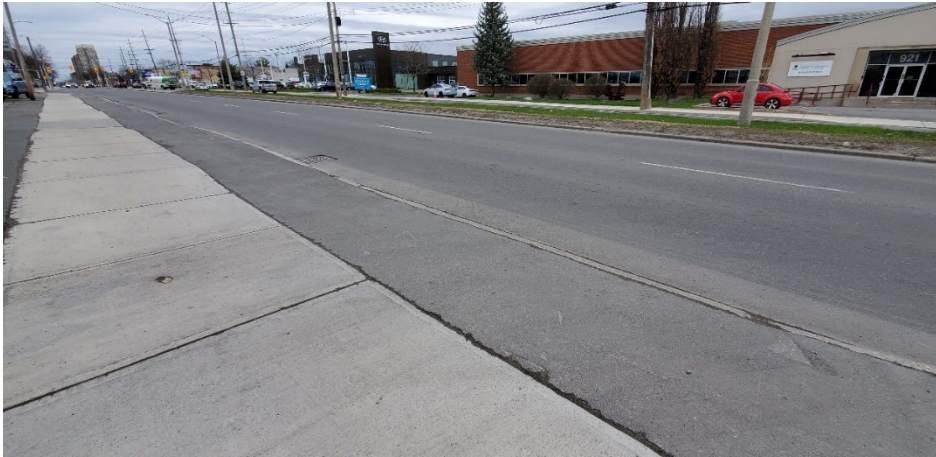
Facing northeast at St. Laurent Boulevard from the southbound St. Laurent Boulevard sidewalk, north of Donald Street. Mainline replacement area.	Reclaimed	None required

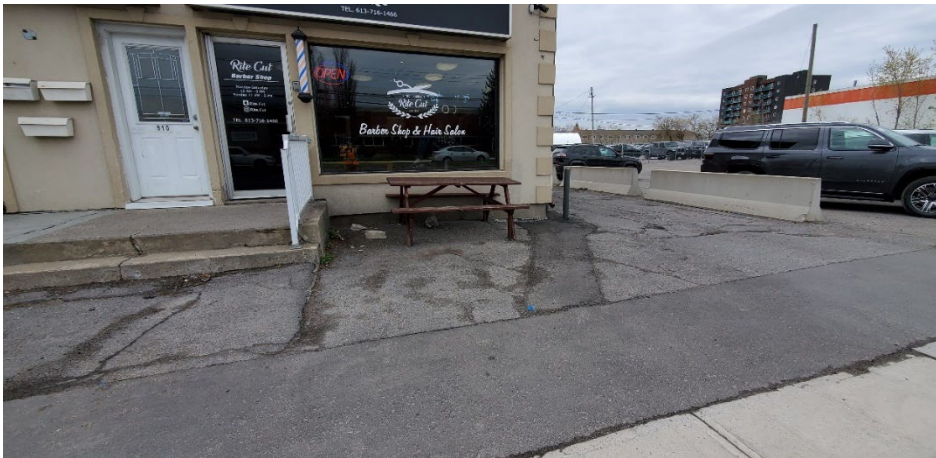
A photograph showing the entrance to the Rite Cut Barber Shop and Hair Salon. The building is a single-story structure with a white door and a large glass window. A wooden picnic table is in front of the entrance. The sidewalk is paved and shows some wear.	Facing west at entrance to Rite Cut Barber Shop and Hair Salon (908 St. Laurent Boulevard) from southbound St. Laurent Boulevard sidewalk. Upgraded service connection area.	Reclaimed	None required
48

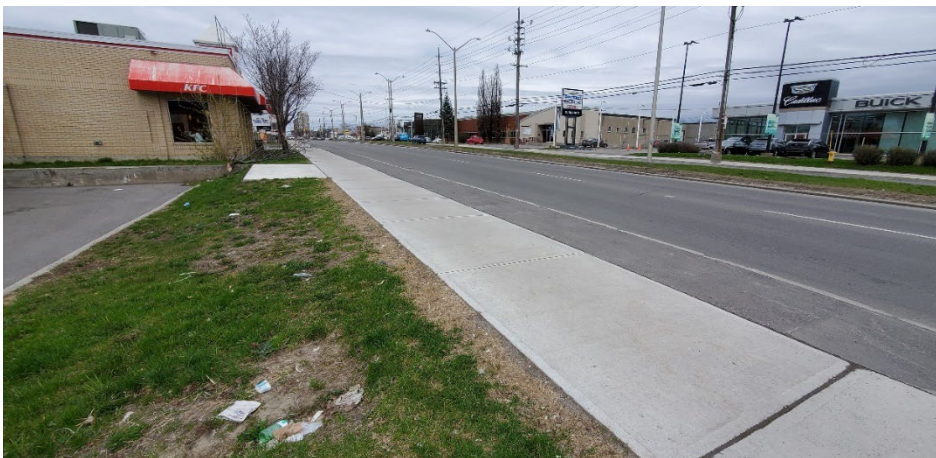
A photograph showing a view of St. Laurent Boulevard from the southbound sidewalk. The road is paved and has a concrete curb. There are utility poles and wires along the road. In the background, there are commercial buildings, including a Buick dealership.	Facing northeast at St. Laurent Boulevard from the southbound St. Laurent Boulevard sidewalk, north of Donald Street. Mainline replacement area.	Reclaimed	None required

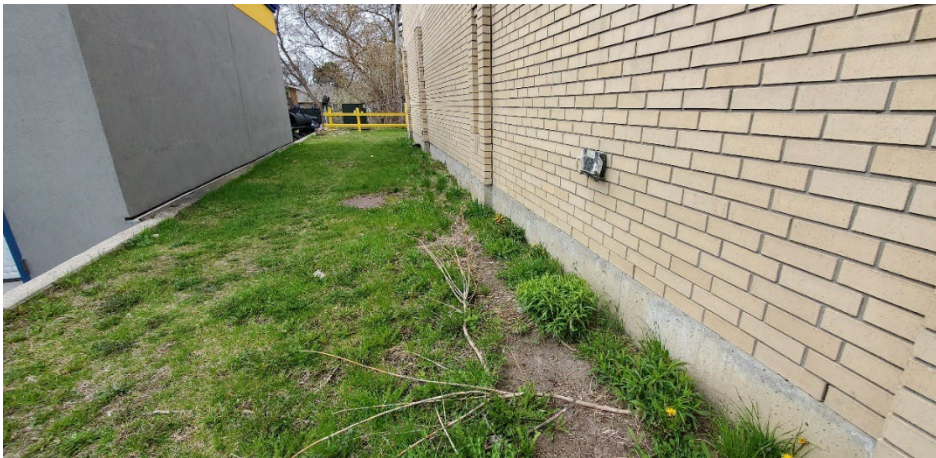
Facing west at manicured lawn of Kentucky Fried Chicken (732 St. Laurent Boulevard) from southbound St. Laurent Boulevard sidewalk. Upgraded service connection area.	Reclaimed	None required
50

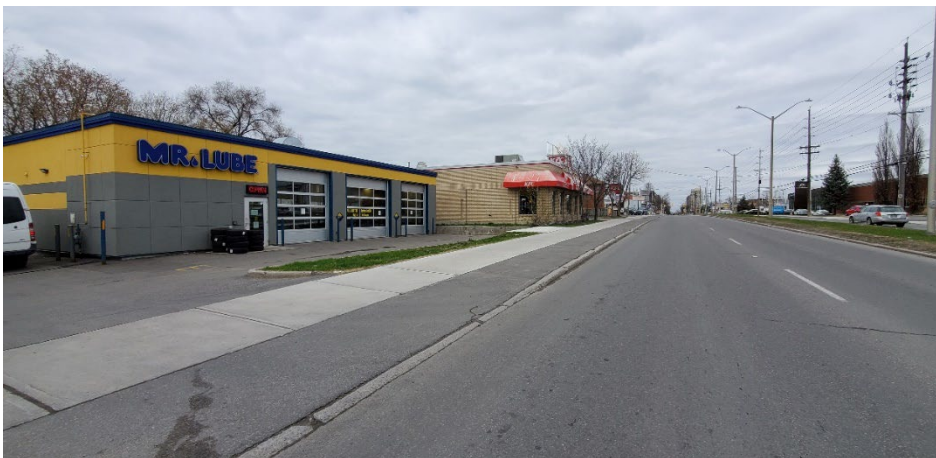
Facing west at Mr. Lube (738 St. Laurent Boulevard) from southbound St. Laurent Boulevard sidewalk. Mainline replacement area.	Reclaimed	None required

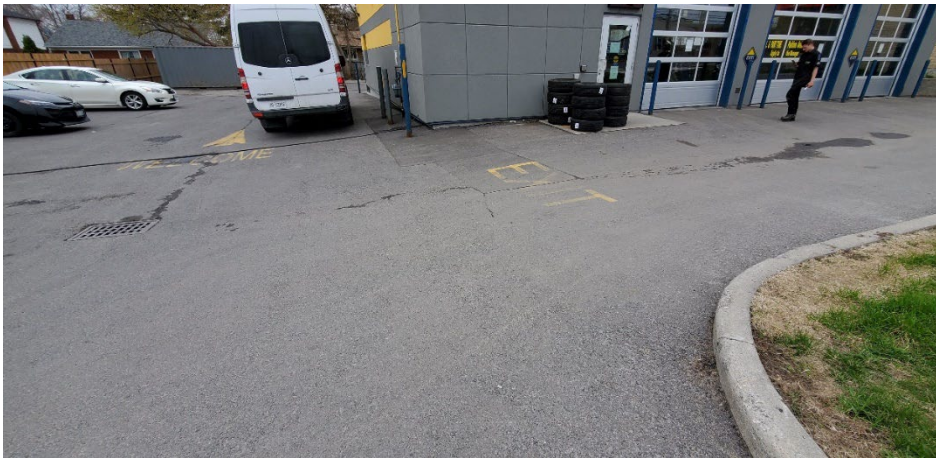
Facing west at entrance to Mr. Lube (738 St. Laurent Boulevard) from southbound St. Laurent Boulevard sidewalk. Upgraded service connection area.	Reclaimed	None required
52

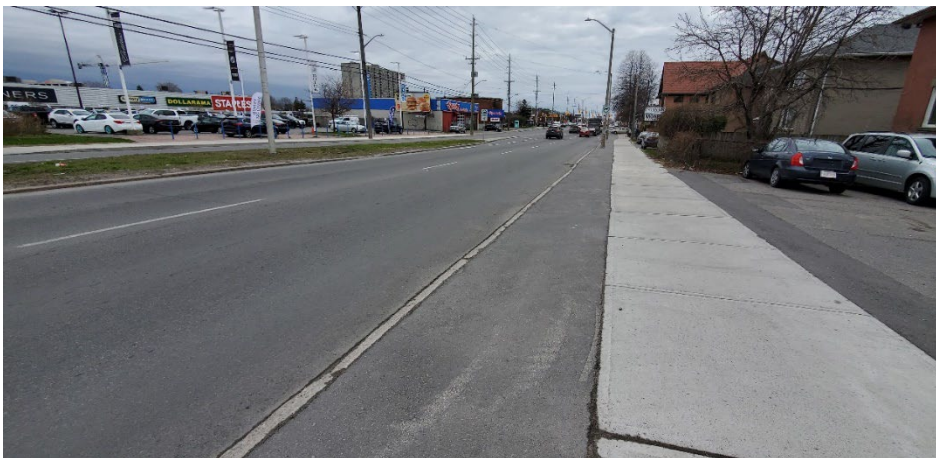
Facing southeast at St. Laurent Boulevard from the southbound St. Laurent Boulevard sidewalk, north of Donald Street. Mainline replacement area.	Reclaimed	None required

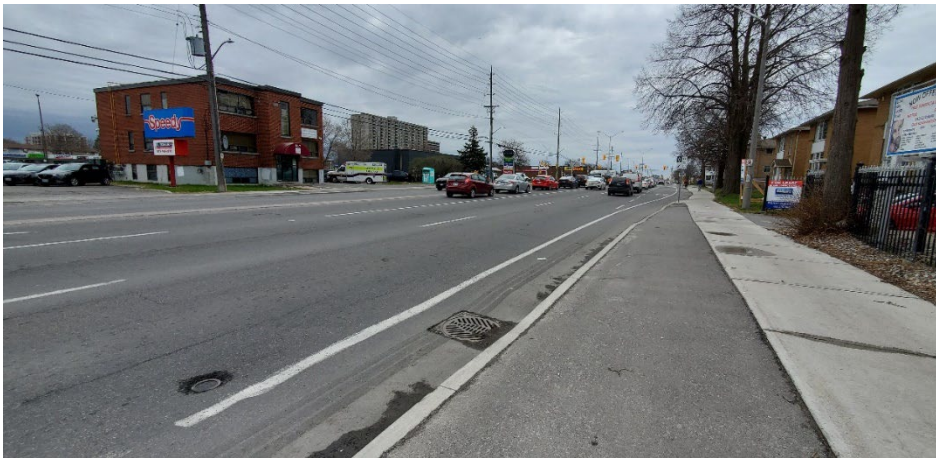
Facing southeast at St. Laurent Boulevard from the southbound St. Laurent Boulevard sidewalk, north of Donald Street. Mainline replacement area.	Reclaimed	None required
56

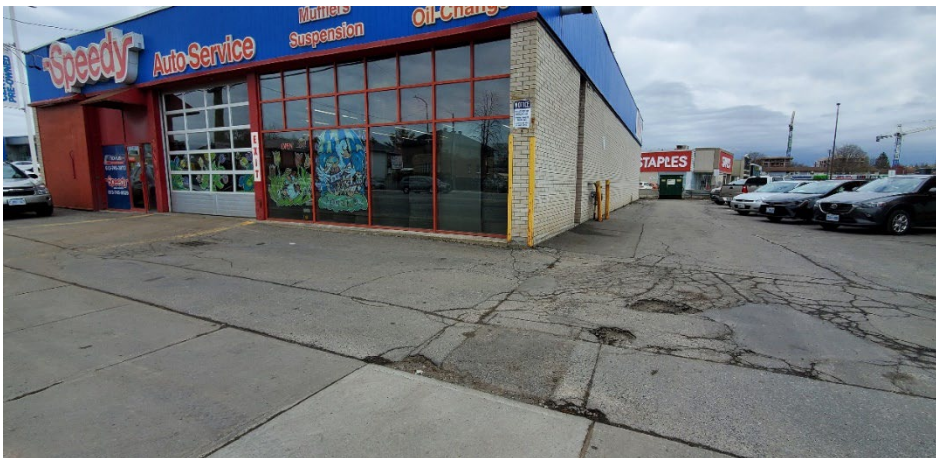
Facing east at entrance to Speedy Auto Service Ottawa East Branch (963 St. Laurent Boulevard) from northbound St. Laurent Boulevard sidewalk. Upgraded service connection area.	Reclaimed	None required

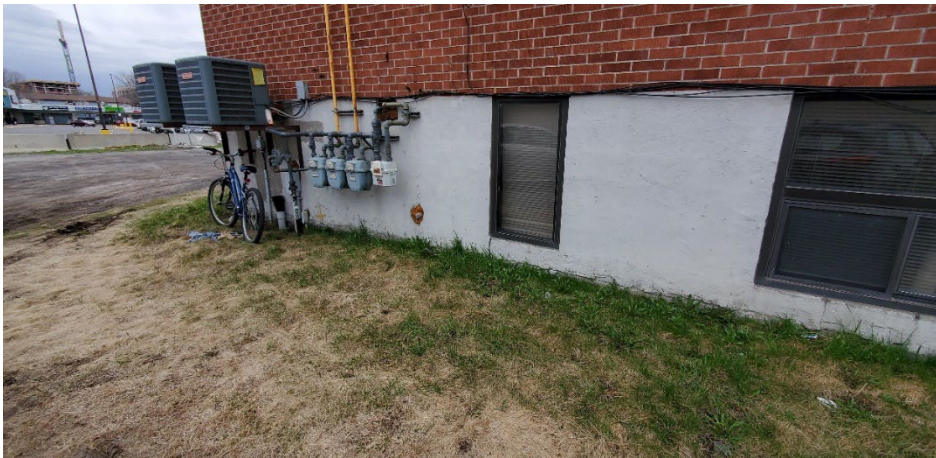
Facing southwest at manicured lawn of East Ottawa Masjid and Community Centre (967 St. Laurent Boulevard) from parking lot. Lawn area was in good condition during incidental May 2021 visit. Current state likely from snow storage. Upgraded service connection area.	Reclaimed	None required
58

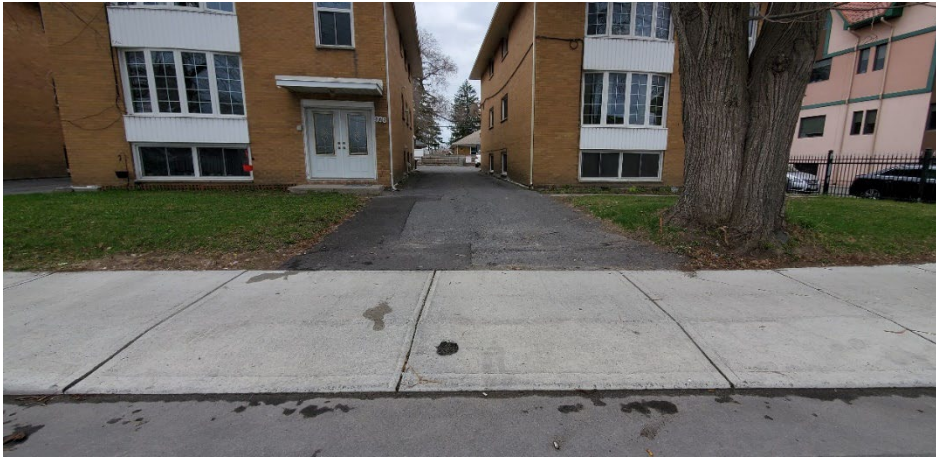
Facing west at front yard of 976 St. Laurent Boulevard from southbound St. Laurent Boulevard sidewalk. Upgraded service connection area.	Reclaimed	None required

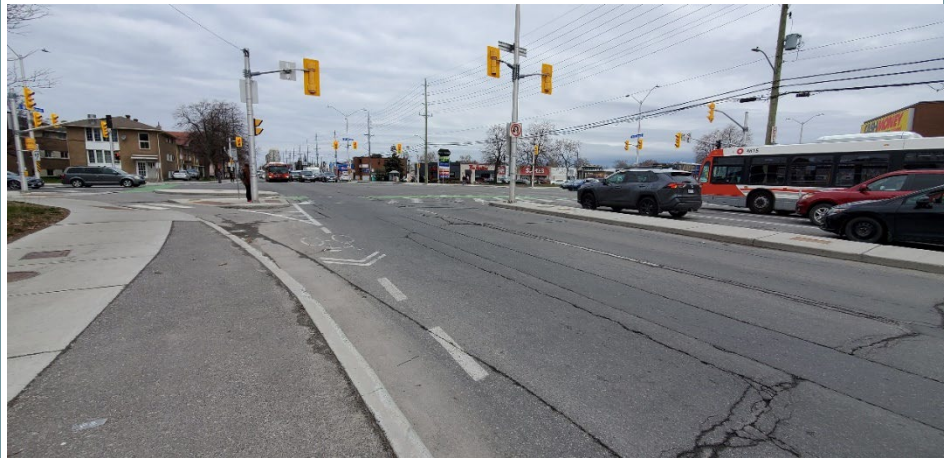
Facing north at St. Laurent Boulevard from the southbound St. Laurent Boulevard sidewalk, south of Donald Street. Mainline replacement area.	Reclaimed	None required
62
