Final Monitoring Report

St. Laurent Pipeline Project (EB-2019-0006)

ENBRIDGE GAS INC.
ST LAURENT PHASE 2 OEB
FINAL MONITORING REPORT

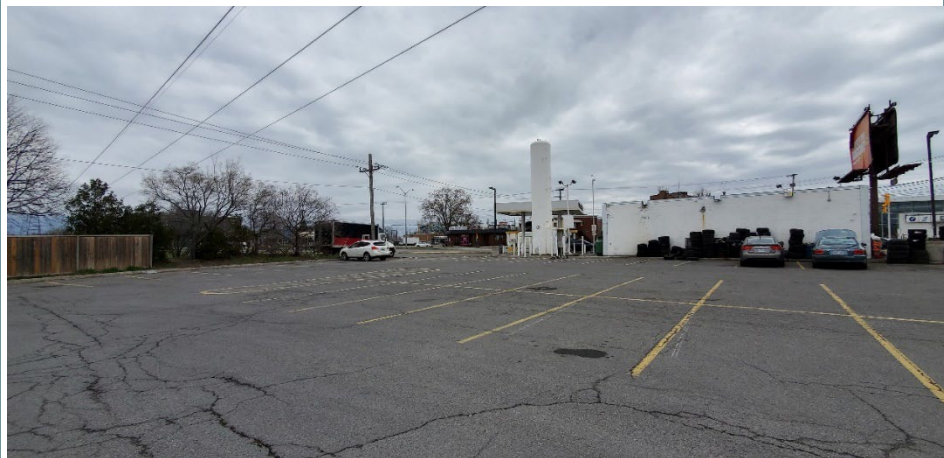
Facing southeast within shared business / commercial parking lot located adjacent to and north of Carlsbad Auto Service (1057 Cyrville Road). Past equipment staging area as well as sand and gravel storage area.	Reclaimed	None required

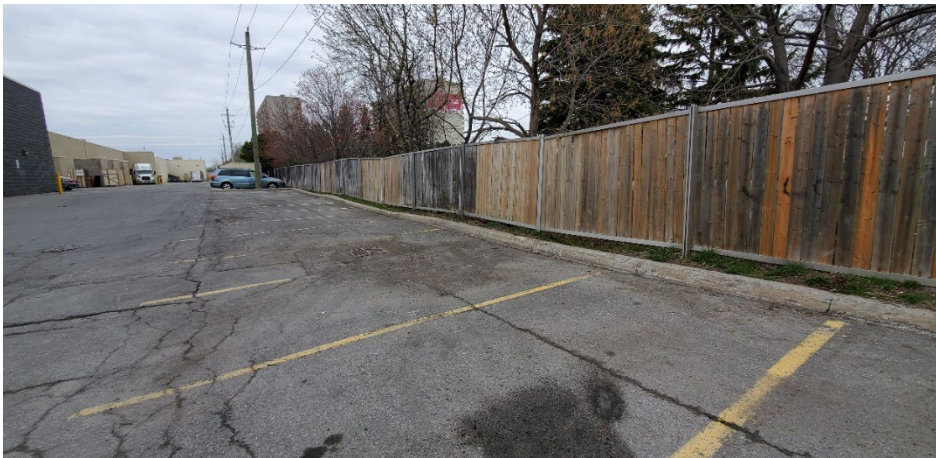
Facing northwest within shared business / commercial parking lot located adjacent to and north of Carlsbad Auto Service (1057 Cyrville Road). Past equipment staging area as well as sand and gravel storage area.	Reclaimed	None required
64

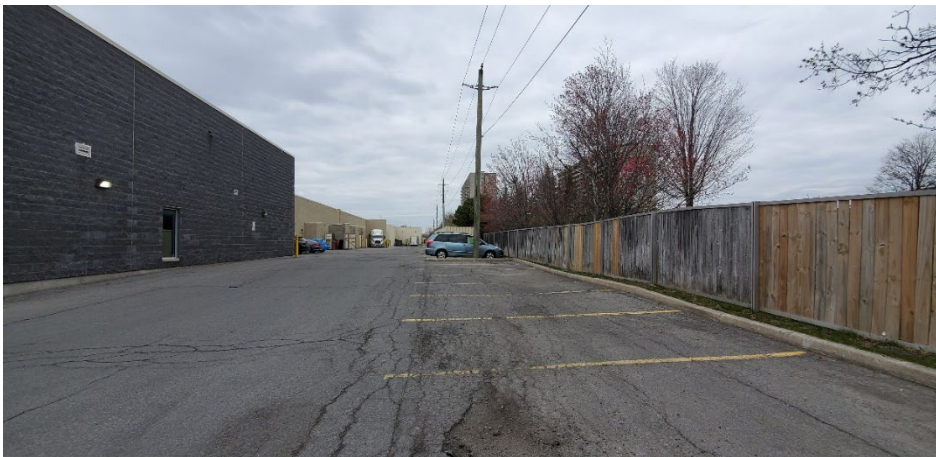
Facing north within shared business / commercial parking lot located adjacent to and north of Carlsbad Auto Service (1057 Cyrville Road). Past equipment staging area as well as sand and gravel storage area.	Reclaimed	None required
