DILLON
CONSULTING

IMPERIAL OIL LIMITED

Post-Construction (Interim) Report

Waterdown to Finch Project (EB-2019-0007)

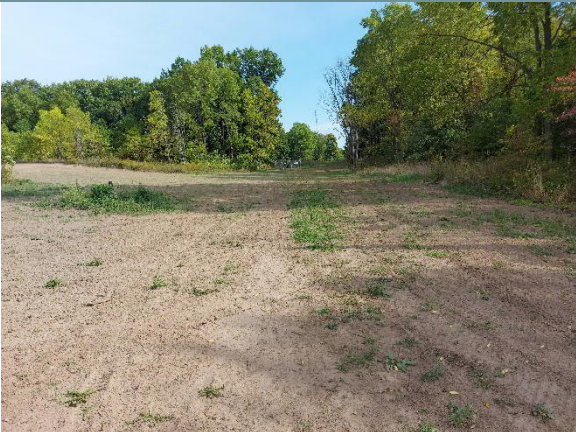
Location (Tract No.)	Site Condition	Additional Work Recommended (Y/N)	Comments/Recommendations	Representative Photo (Date)
WTFN0001	The ROW is mostly bare soil.	Y	Confirm revegetation success in 2023. Seed if required.

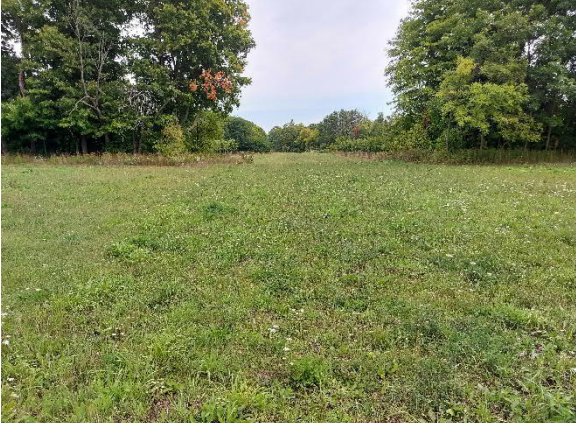
WTFN0003	Site restored.	N	No issues documented at the time of inspection.

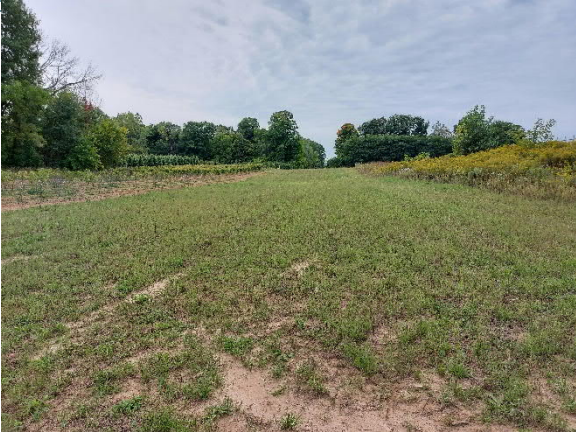
Location (Tract No.)	Site Condition	Additional Work Recommended (Y/N)	Comments/Recommendations	Representative Photo (Date)
WTFN0004	Site restored, but areas of bare soil and higher weed density (Annual Ragweed) observed.	Y	Site to be re-assessed in 2023.

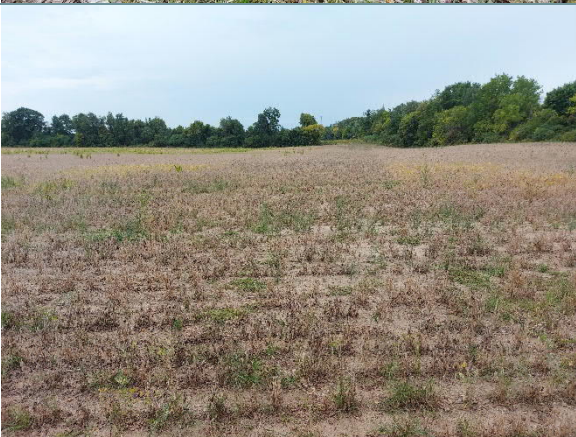
WTFN0013	Crop height is lower than off-ROW.	Y	Site to be re-assessed in 2023.

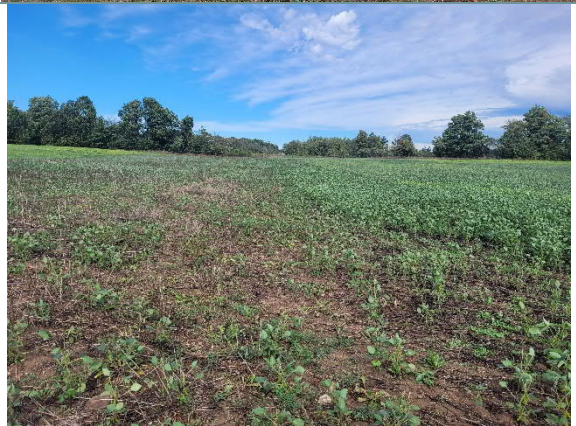
WTFN0038	Reduced crop density at KP 7.4.	Y	Confirm revegetation success in 2023.

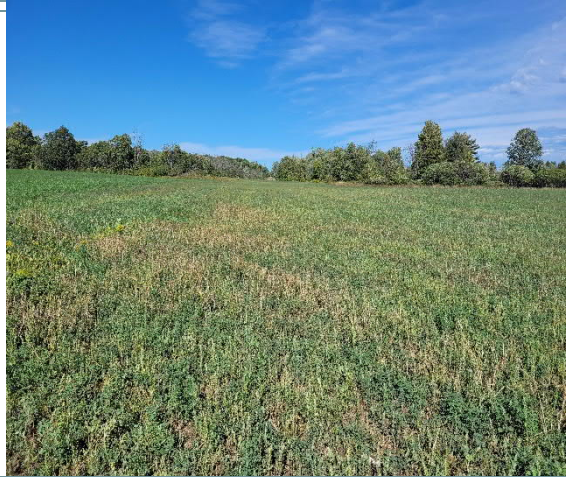
Location (Tract No.)	Site Condition	Additional Work Recommended (Y/N)	Comments/Recommendations	Representative Photo (Date)
WTFN0039	Crop height is lower than off-ROW.	Y	Site to be re-assessed in 2023.

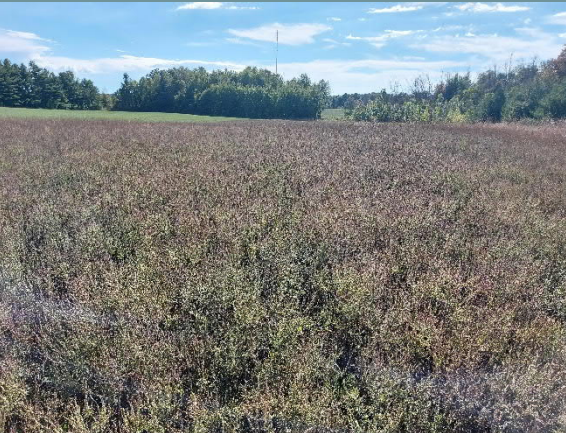
WTFN0040	Higher weed density than adjacent land (Annual Ragweed).	Y	Site to be re-assessed in 2023. Control weeds and seed if required.

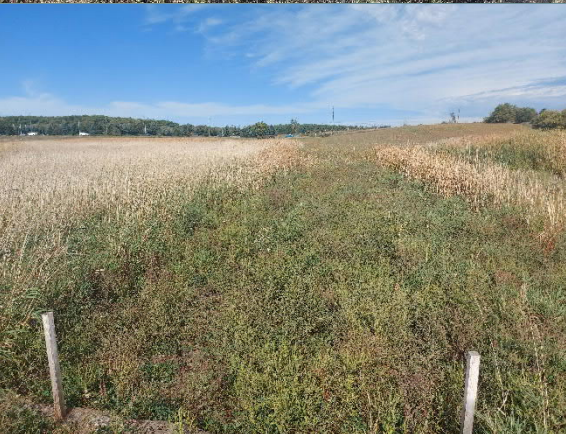
WTFN0041	Site restored, but areas of bare ground and higher weed density (Annual Ragweed) observed. WC_6.1 within wetland may require re-contouring to promote flow across the ROW.	Y	Site to be re-assessed in 2023. Re-contour wetland if required.

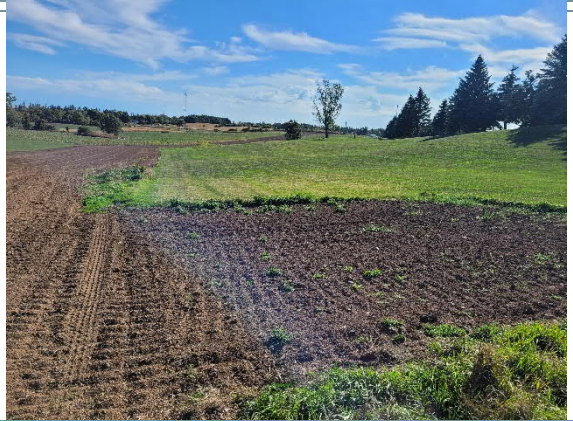
Location (Tract No.)	Site Condition	Additional Work Recommended (Y/N)	Comments/Recommendations	Representative Photo (Date)
WTFN0045	The ROW is mostly bare soil at the west end of the tract.	Y	Site to be re-assessed in 2023.

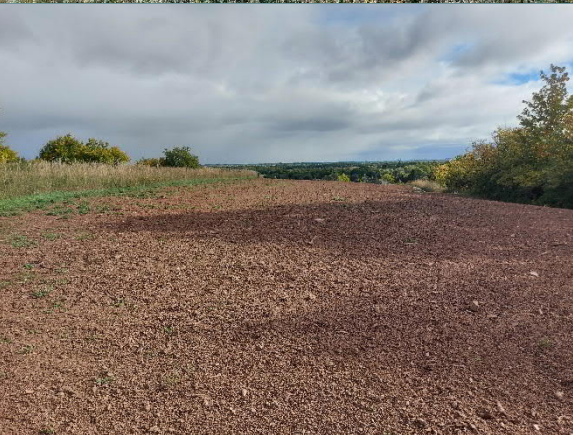
WTFN1000	The ROW is mostly bare soil.	Y	Confirm revegetation success in 2023.

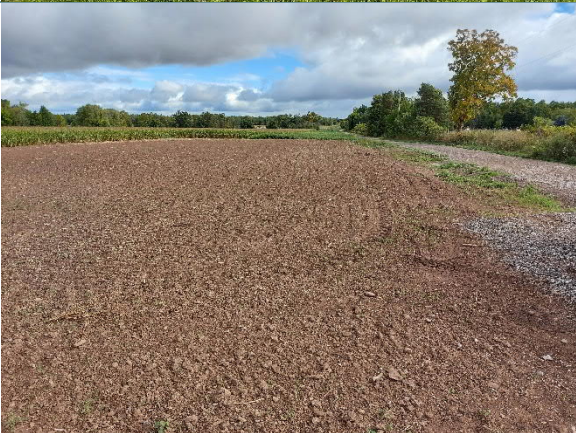
WTFN1003	The ROW is mostly bare soil.	Y	Confirm revegetation success in 2023.

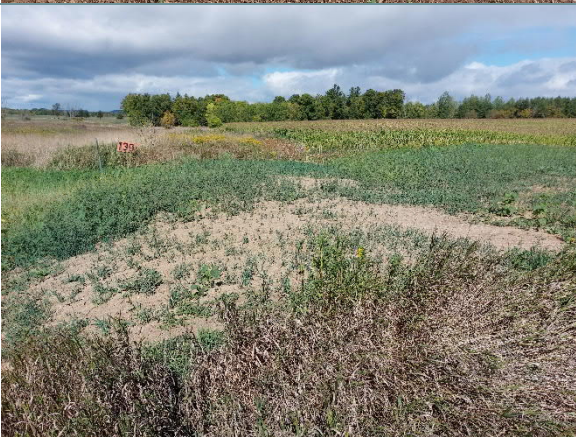
WTFN1004	Site restored, but areas of bare ground observed.	Y	Site to be re-assessed in 2023.

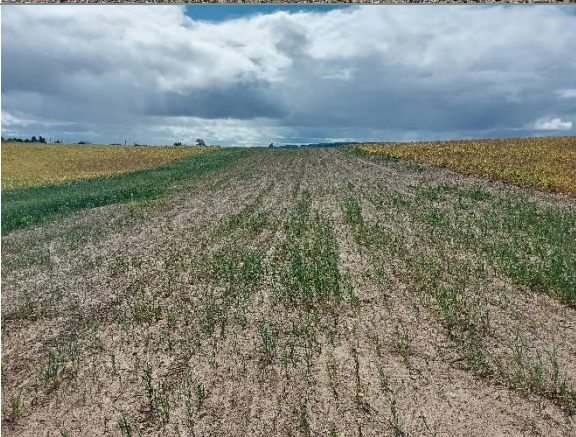
WTFN1017	The ROW is mostly bare soil.	Y	Confirm revegetation success in 2023.

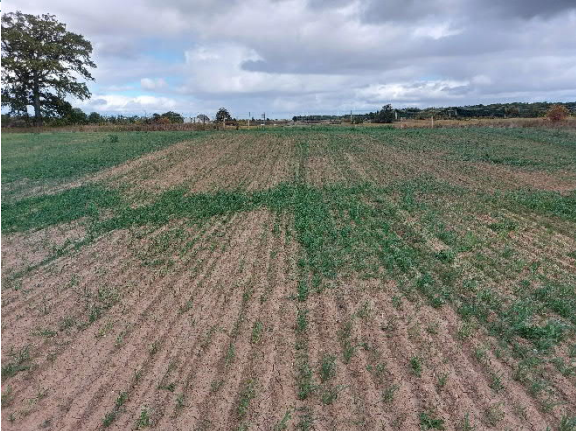
Location (Tract No.)	Site Condition	Additional Work Recommended (Y/N)	Comments/Recommendations	Representative Photo (Date)
WTFN1018	The ROW is mostly bare soil.	Y	Confirm revegetation success in 2023.

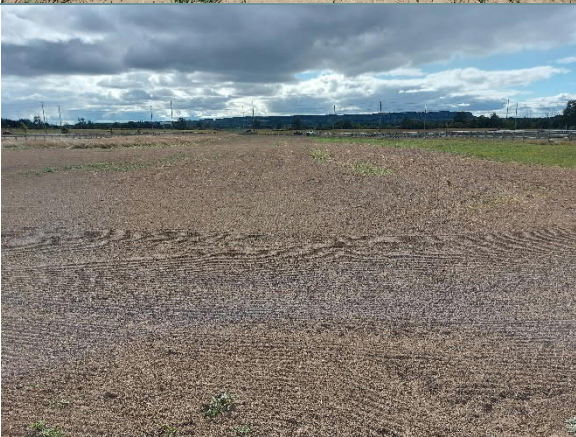
WTFN1022	The ROW is mostly bare soil.	Y	Confirm revegetation success in 2023.

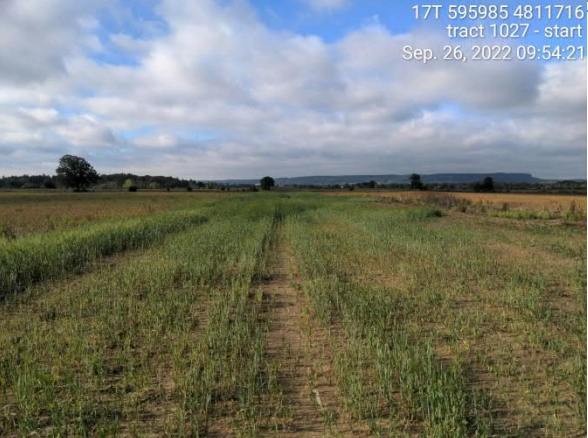
Location (Tract No.)	Site Condition	Additional Work Recommended (Y/N)	Comments/Recommendations	Representative Photo (Date)
WTFN1027	Crop establishment not equal on- and off-ROW.	Y	Site to be reassessed in 2023.

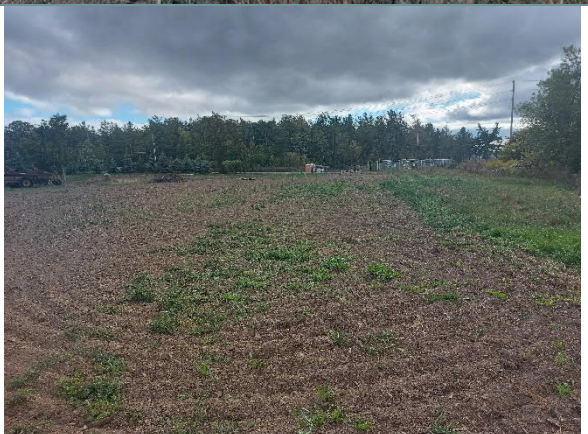
WTFN1032	The ROW is mostly bare soil. Small areas of higher weed abundance (Annual Ragweed and Bull Thistle) observed.	Y	Confirm revegetation success in 2023.

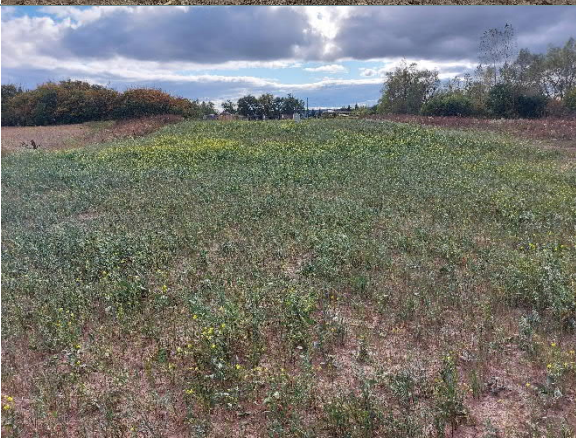
WTFN1035	Site restoring, but higher abundance of weeds (Field Mustard and Annual Ragweed) abundance observed on-ROW.	Y	Site to be re-assessed in 2023. Control weeds as needed.

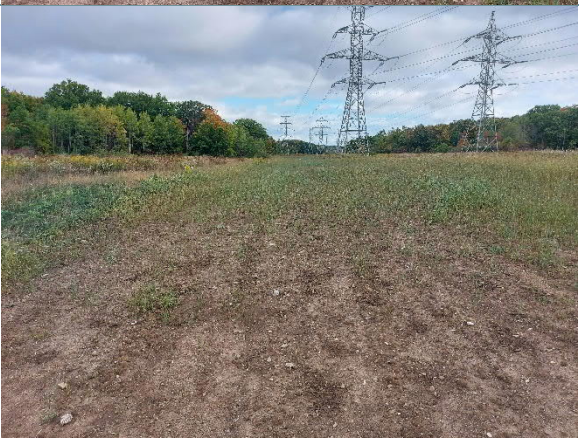
WTFN1045	The ROW is mostly bare soil. Areas of higher weed abundance (Annual Ragweed) observed on-ROW.	Y	Site to be reassessed in 2023.

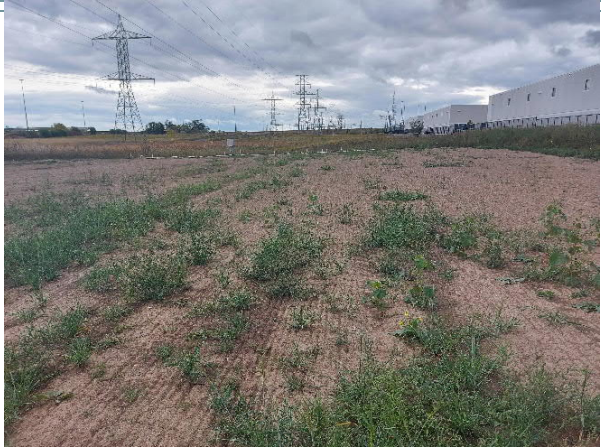
Location (Tract No.)	Site Condition	Additional Work Recommended (Y/N)	Comments/Recommendations	Representative Photo (Date)
WTFN2045	Areas of bare ground, higher Canada Thistle density and higher Annual Ragweed density observed.	Y	Site to be re-assessed in 2023. Control weeds and seed if required.

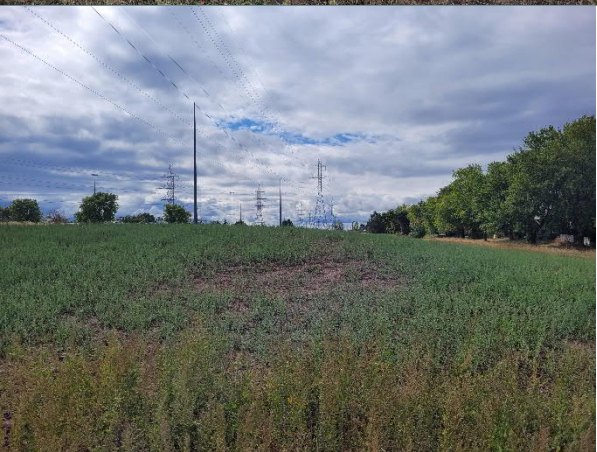
WTFN3029	Bare soil and higher weed density (Annual Ragweed) observed.	Y	Control weeds and seed if required.

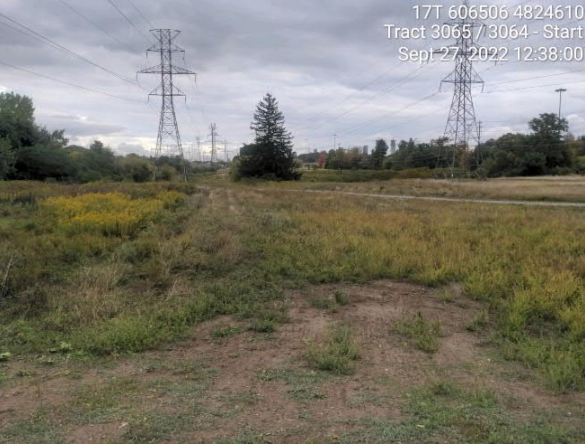
Location (Tract No.)	Site Condition	Additional Work Recommended (Y/N)	Comments/Recommendations	Representative Photo (Date)
WTFN3064	Higher weed density observed on-ROW. Large areas of bare soil between KP 33.3 and 33.4.	Y	Site to be re-assessed in 2023.

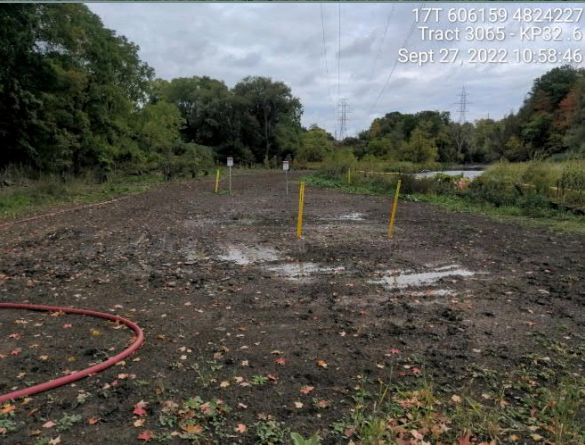
WTFN3065	KP 32.6 to KP 32.7 does not appear to be seeded. Valley Slope crop cover observed to be healthy.	Y	Site to be re-assessed in 2023.

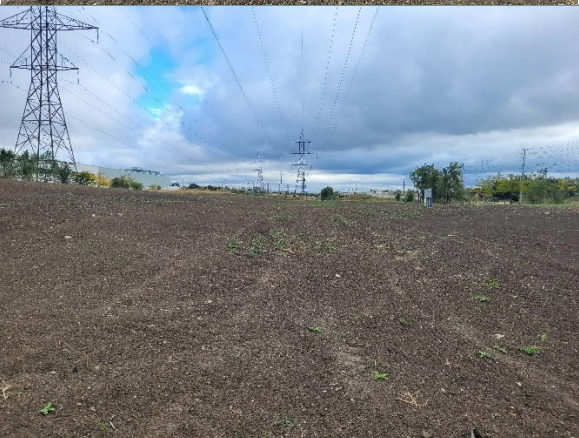
WTFN4036	Bare soil observed.	Y	Site to be re-assessed in 2023.

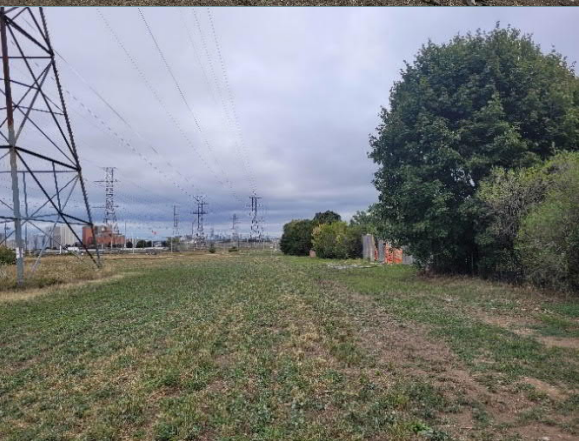
WTFN4047	Vegetation on the west is not as well-established compared to the east side. Portions of the tract remain unseeded/bare.	Y	Site to be re-assessed in 2023. Seed if required.

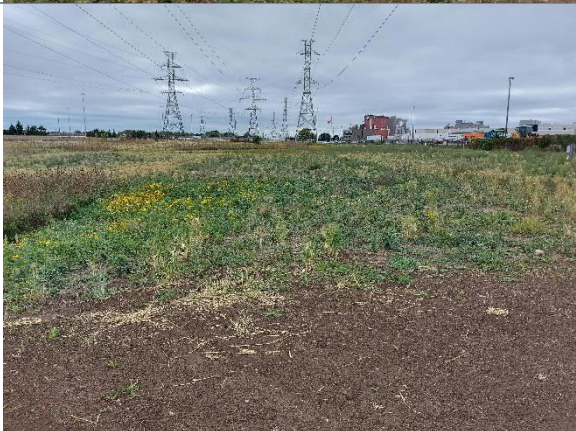
WTFN4071	Areas of bare ground, higher weed density (Canada Thistle, Bull Thistle) observed.	Y	Site to be re-assessed in 2023.

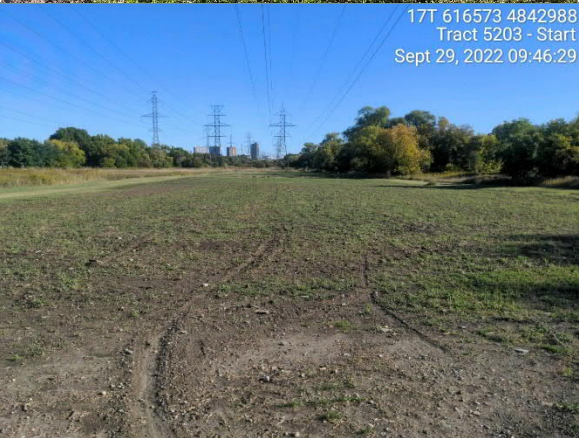
WTFN5203	Minor erosion/sedimentation off-site observed at entrance to parcel. Multiple areas of bare ground observed.	Y	Site to be re-assessed in 2023. Seed if required.
