# EB-2023-0144 – Hydro One Networks Inc. – Chapleau Public Utilities Corporation – Observation Report

## HYDRO ONE'S OBSERVATION REPORT ON OPERATION OF CHAPLEAU PUBLIC UTILITIES CORPORATION (EB-2023-0144)

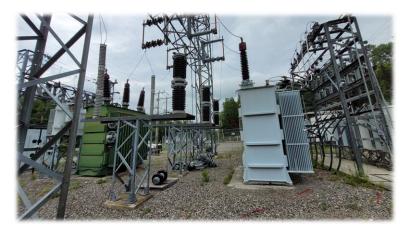
The transformers at the station are more than 50 years old and diagnostic testing has confirmed that they are at their expected service life. In addition, the manufacturer, General Electric, has released a bulletin indicating that certain transformer components, as contained in the transformers at the CPUC station, are defective.

Side View of Both Transformers

Although the transformers can back each other up most of the year, there are likely certain periods during the peak winter season where the failure of one unit may result in rotating blackouts for the community. The transformers are a non-Hydro One standard voltage (115kV-4kV) and therefore neither CPUC nor Hydro One have any spares. An appropriate contingency plan to restore power to customers in the event of a transformer failure during peak winter season would be to utilize a Mobile Unit Substation. This is not currently available to CPUC customers however, in the interim, this contingency plan could be addressed via Hydro One Mobile Unit Substations in conjunction with another temporary transformer, to be delivered and set up in Chapleau during the event of a failure.

Given the above reasons, Hydro One believes that a large-scale investment to address the station assets' age and safety related deficiencies will be required within the next few years. Planning for this should begin immediately such that the Town's reliability and quality of service do not deteriorate.

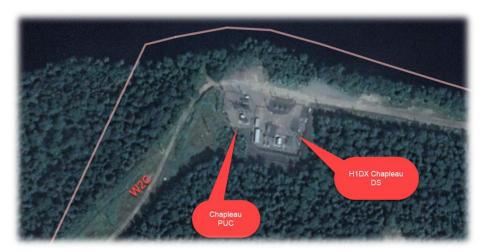
Finally, the station is located next to a body of water often used by the community. In the event of a catastrophic transformer failure, oil may be released into the water.

**Overhead View of Hydro One & Chapleau Stations**

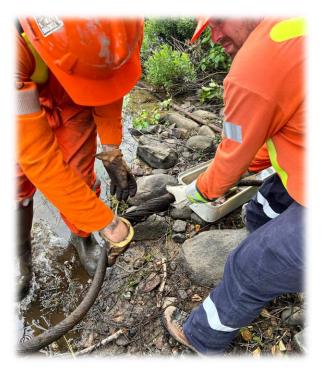
CPUC has a submarine feeder (4 separate cables) that leaves the station and supplies the northern part of the town. Earlier this year, Hydro One assisted CPUC field staff with a temporary assessment and repair of several exposed cables. Based on observations made at that time, Hydro One believes that these cables have reached their expected service life and will need to be replaced within the next few years. Hydro One recommends testing to validate the remaining expected service life of these cables.

Hydro One and Chapleau PUC Staff Repairing Sub Cable
