**Re: Imperial Oil Incorporate ("Imperial")
Ontario Energy Board ("OEB") File No. EB-2019-0007
Waterdown to Finch Project ("Project")**

Final Monitoring Report

Waterdown to Finch Project (EB-2019-0007)

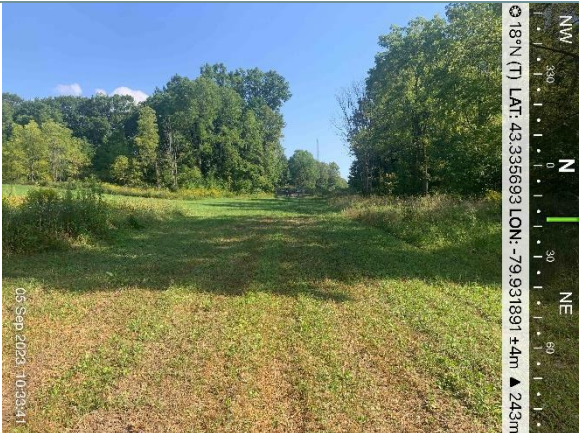
WTFN0002	Site restored.	N	No issues documented at the time of inspection.

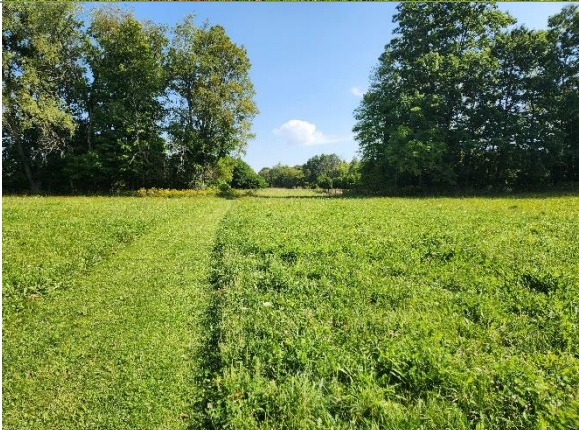
Location (Tract No.)	Site Condition	Additional Work Recommended (Y/N)	Comments/Recommendations	Representative Photo (Sept. 2023)
WTFN0004	Vegetation height is lower than adjacent land. Higher weed density (Annual Ragweed) than adjacent lands observed.	Y	Control weeds as needed.

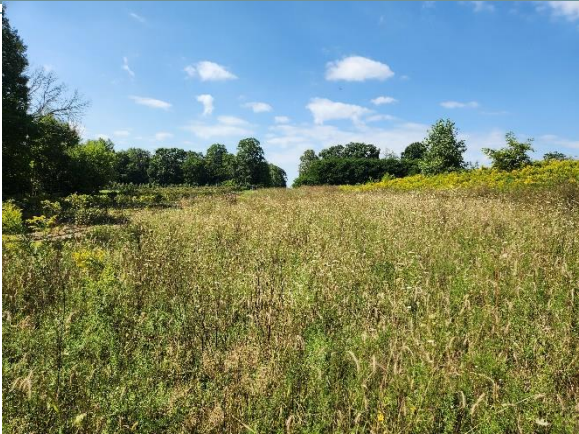
WTFN0012	Site restored, but a small area with wood chips inside wetland boundaries is slowing revegetation.	Y	Remove wood chips.

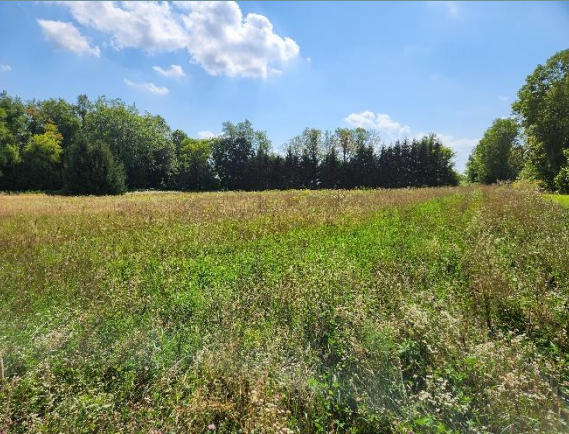
WTFN0038	Area of bare soil at KP7.475 (not planted with crop by land owner)	Y	Site to be re-assessed in 2024.

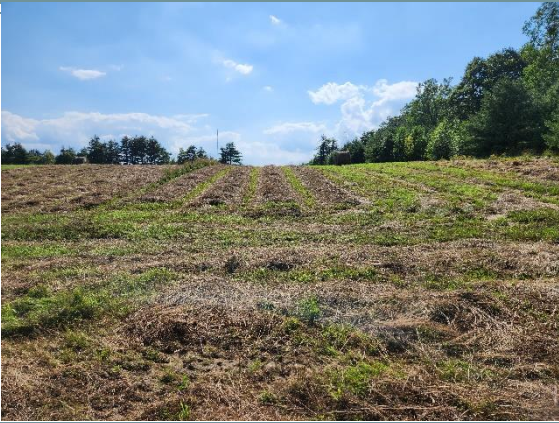
WTFN0041	Areas of bare soil and higher weed density (Annual Ragweed) than adjacent lands observed.	Y	Control weeds and seed as needed.

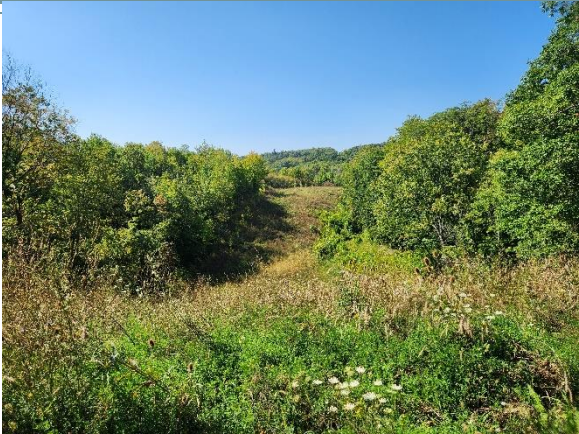
WTFN1000	Minor rill in ROW observed. Higher density of weeds (White Sweet-clover) than adjacent lands observed.	Y	Control weeds as needed. Further assess and repair erosion.

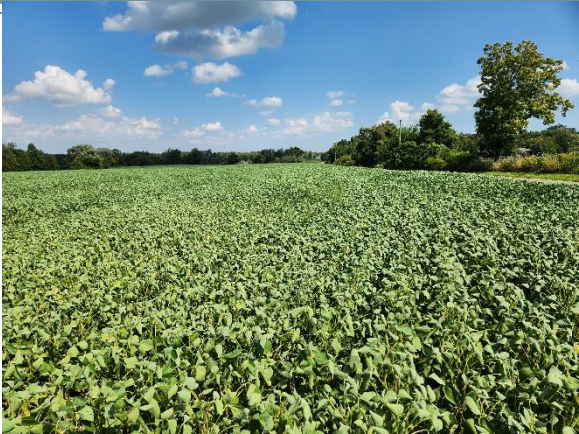
WTFN1004	Higher weed density (Annual Ragweed) in ROW than adjacent lands. Areas of bare soil and soil cracking observed along flow path of surface water at KP11.64.	Y	Site to be re-assessed in 2024. Seed and control weeds as needed. Repair area impacted by water pooling.

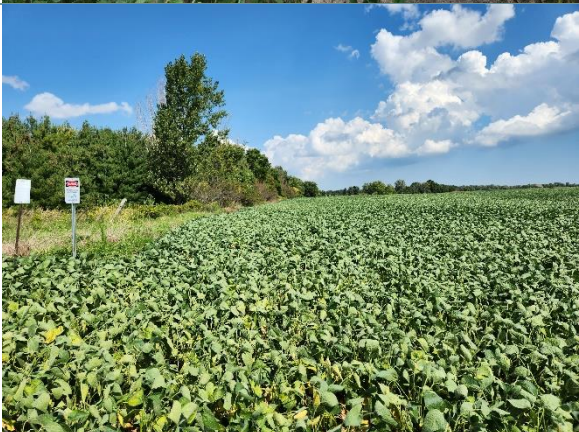
Location (Tract No.)	Site Condition	Additional Work Recommended (Y/N)	Comments/Recommendations	Representative Photo (Sept. 2023)
WTFN1014	Site restored.	N	No issues documented at the time of inspection.	 
WTFN1017	Areas of bare soil. Soil cracking and pooling of water observed at KP14.	N	Pooling of water consistent with pre-construction conditions, site resolved.	 
WTFN1018	Higher weed density (Annual Ragweed and Thistle species) than adjacent lands.	Y	Control weeds as needed.

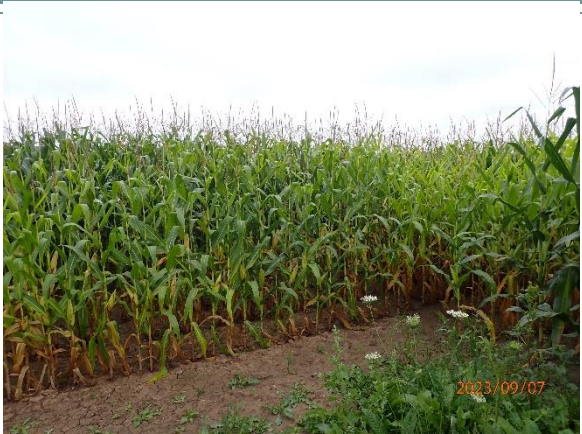
WTFN1022	Higher weed density (Annual Ragweed and Thistle species) than adjacent lands observed.	Y	Control weeds as needed.

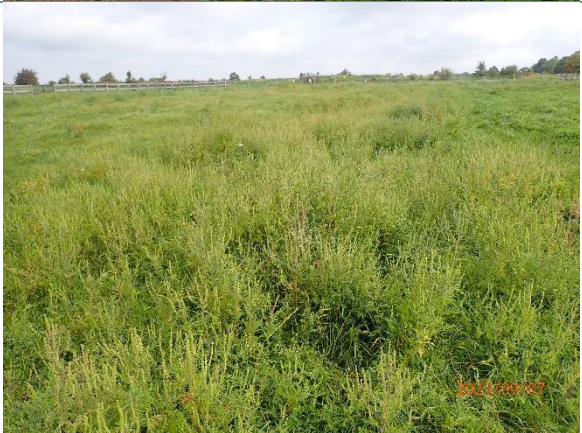
WTFN1024	Higher weed density (Annual Ragweed and Thistle species) than adjacent lands observed.	Y	Control weeds as needed.

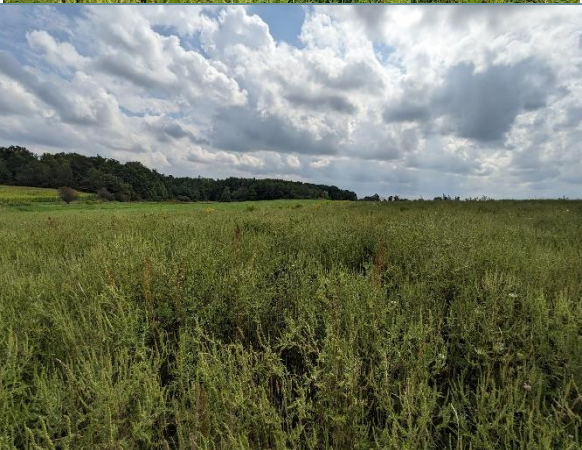
Location (Tract No.)	Site Condition	Additional Work Recommended (Y/N)	Comments/Recommendations	Representative Photo (Sept. 2023)
WTFN1025	Site restored, but patch of stunted growth observed in ROW at KP 15.6.	Y	Site to be re-assessed in 2024.

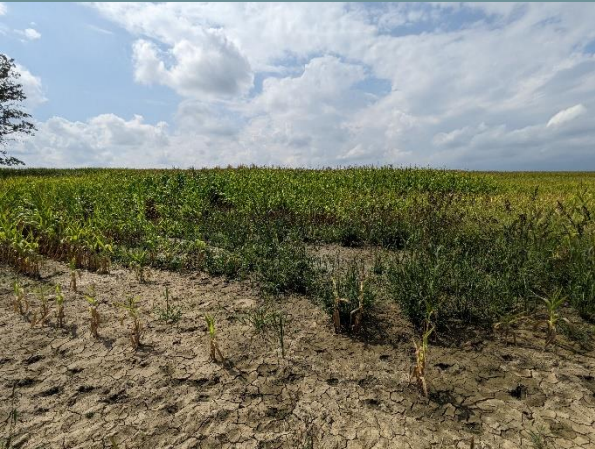
WTFN1026	Site restored, but small patch of stunted crop growth observed in ROW at KP16.	Y	Site to be re-assessed in 2024.

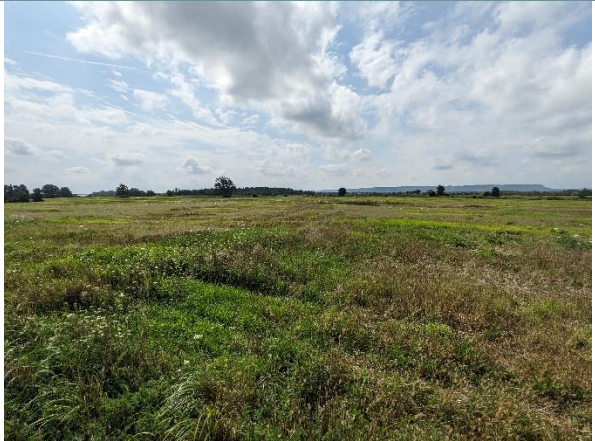
Location (Tract No.)	Site Condition	Additional Work Recommended (Y/N)	Comments/Recommendations	Representative Photo (Sept. 2023)
WTFN1029	Crops are establishing at lower height and health than adjacent lands. Areas of bare soil, soil cracking, and geotextile debris within soil. Pooling of water, and weed density (Thistle species) higher than adjacent land observed.	Y	Site to be re-assessed in 2024. Control weeds as needed. Repair area impacted by water pooling.

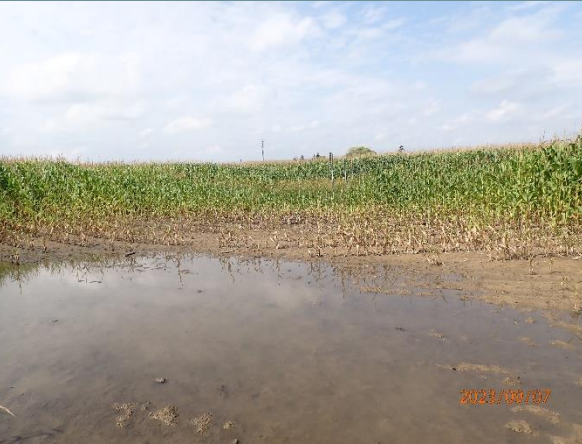
WTFN1032	Areas of bare soil between KP33.7 and KP33.9. Higher weed density (Ragweed and Thistle) than adjacent lands observed.	Y	Seed and control weeds as needed.

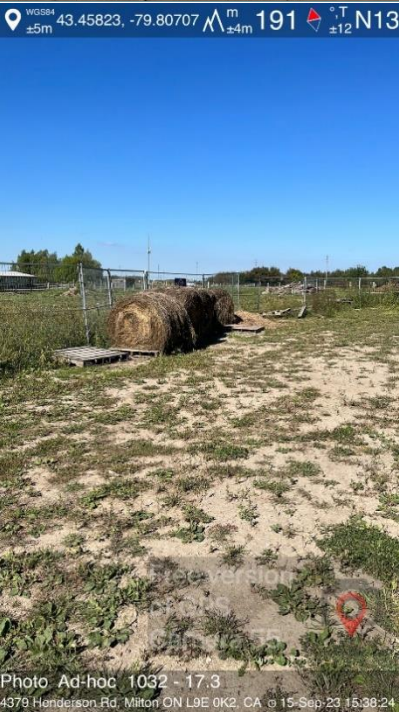
WTFN1033	Site restored, but small areas of bare soil and water pooling at KP17.4.	Y	Seed as needed. Repair area impacted by water pooling.

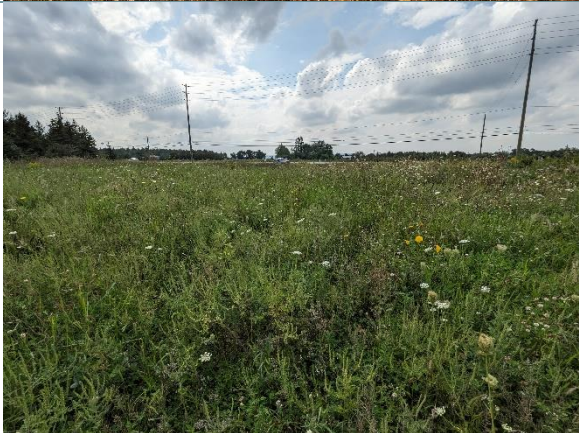
WTFN1041	Higher weed density (Annual Ragweed and Thistle species) than adjacent lands.	Y	Control weeds as needed.

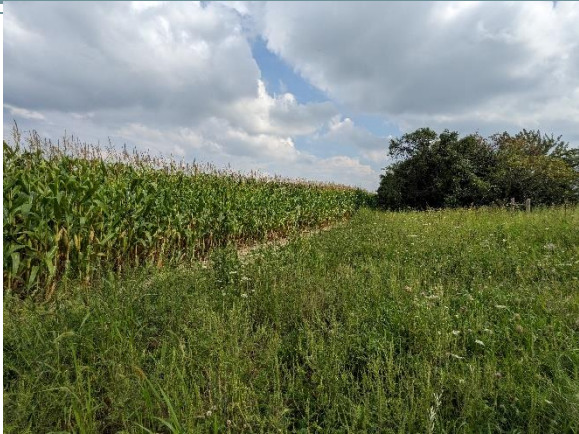
WTFN1043	Site restored, but area of low crop health and height at KP18.4.	Y	Site to be re-assessed in 2024.

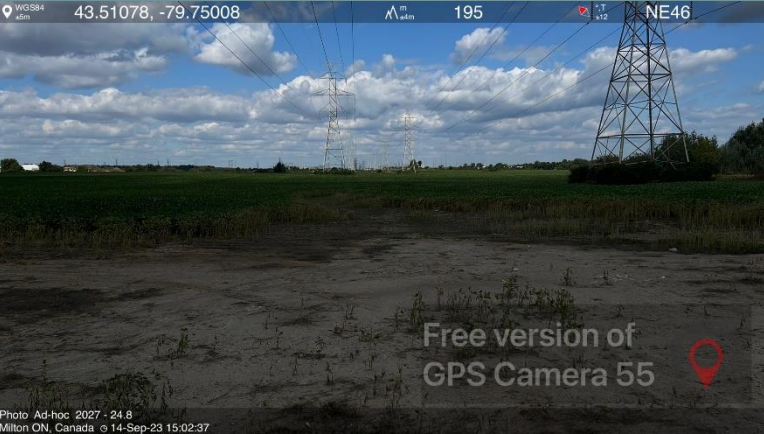
<p>A photograph showing a large area of bare, light-colored soil in a field. In the background, there are green fields and several tall metal power line towers under a blue sky with scattered white clouds. The photo includes a GPS overlay at the top with coordinates 43.51078, -79.75008 and a red location pin.</p>
WTFN2027	Area of bare soil observed at KP 24.8.	Y	Seed as needed.

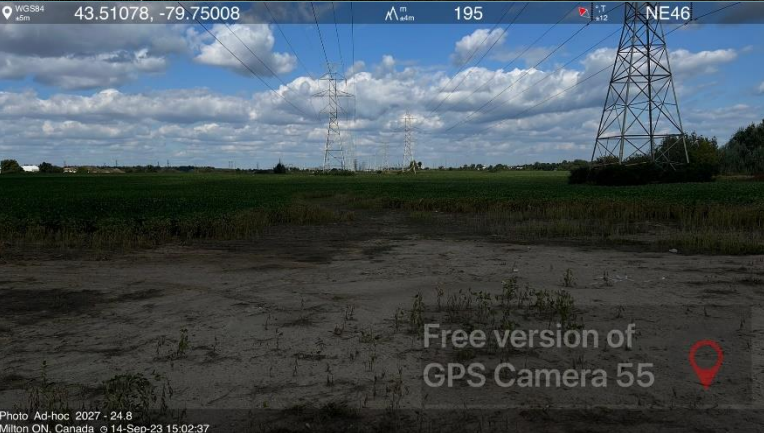
<p>A photograph showing a large area of bare, light-colored soil in a field. In the background, there are green fields and several tall metal power line towers under a blue sky with scattered white clouds. The photo includes a GPS overlay at the top with coordinates 43.51078, -79.75008 and a red location pin.</p>
WTFN2030A	Crop establishment issue in soy field between KP25.5 and KP25.6.	Y	Site to be re-assessed in 2024.

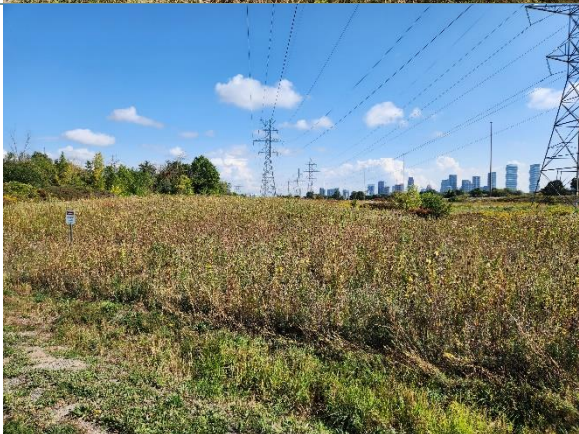
Location (Tract No.)	Site Condition	Additional Work Recommended (Y/N)	Comments/Recommendations	Representative Photo (Sept. 2023)
WTFN3213	Areas of bare soil and higher weed density (Thistle species) than adjacent land.	Y	Seed and control weeds as needed.

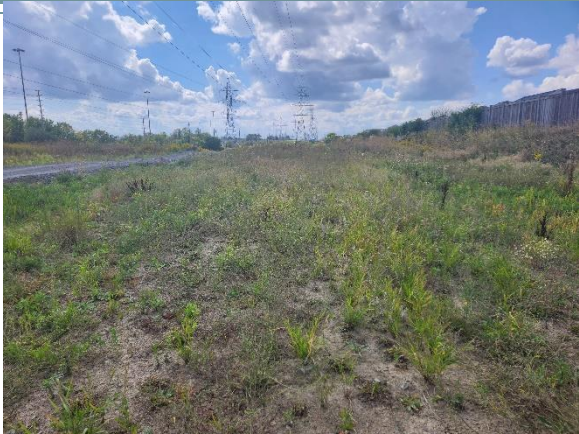
WTFN3285	Higher weed density (Thistle species) than adjacent land observed.	Y	Control weeds as needed.

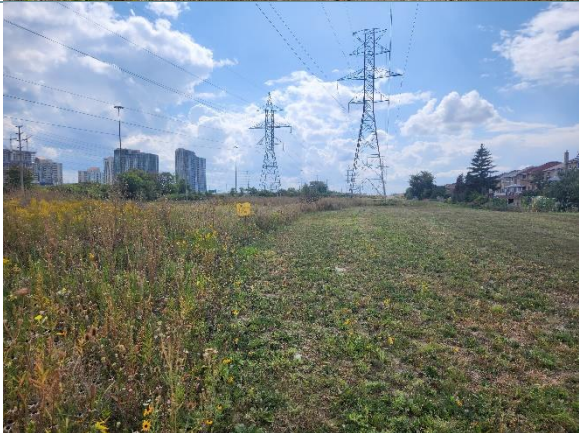
WTFN3319	Higher weed density (Thistle species) than adjacent land.	Y	Control weeds as needed.

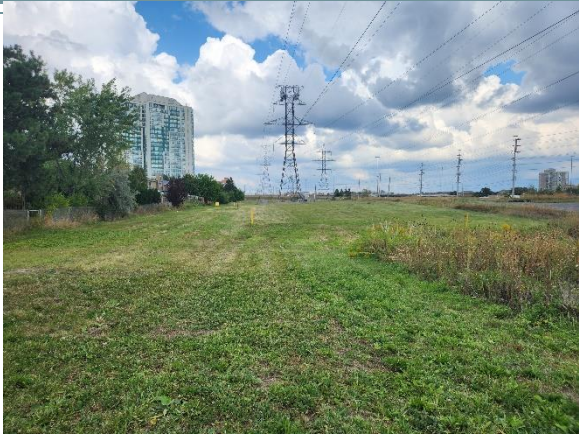
WTFN3369	Higher weed density (Thistle species) than adjacent land.	Y	Control weeds as needed.

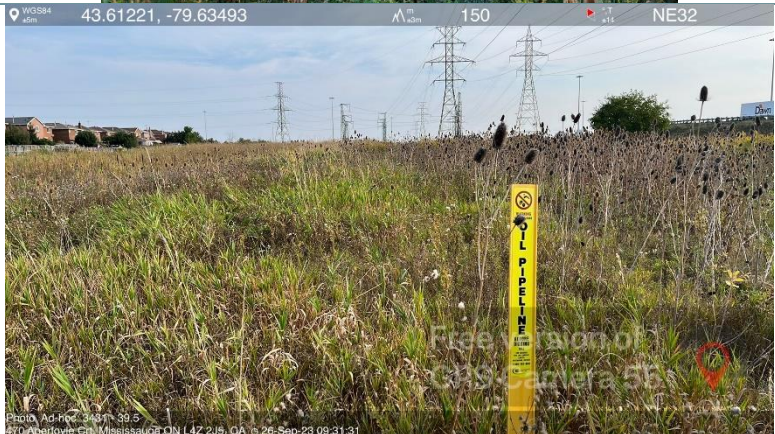
Location (Tract No.)	Site Condition	Additional Work Recommended (Y/N)	Comments/Recommendations	Representative Photo (Sept. 2023)
WTFN4001	Site restored, but area of bare soil at KP40.45-40.8.	Y	Seed as needed.
