**Re: 2009 Cost of Service Rate Application  
EB-2008-0227**

### EXECUTIVE SUMMARY

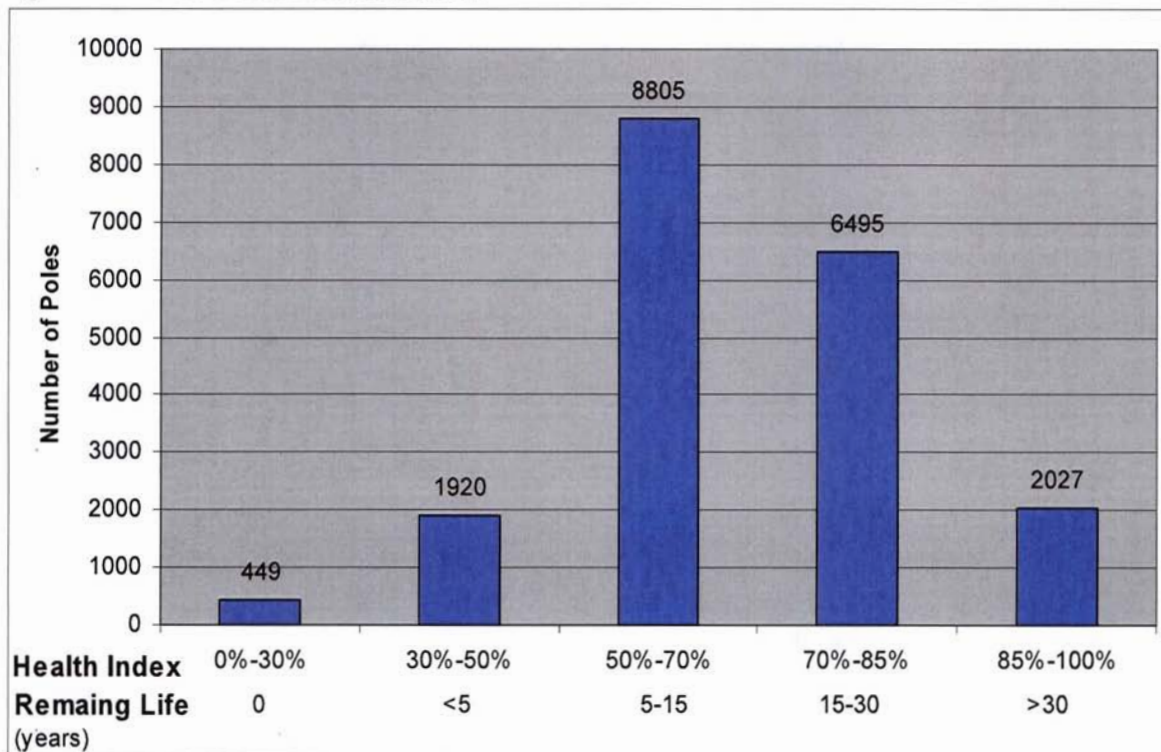
**Figure 4 Poles Health Index Results**

The wide range of condition of wood poles indicated by the health index has been confirmed by the interviews with staff. Operations staff expressed a growing concern about the number of poles in very poor condition. A recommendation for a pole replacement program has been made in section 10 of this report.

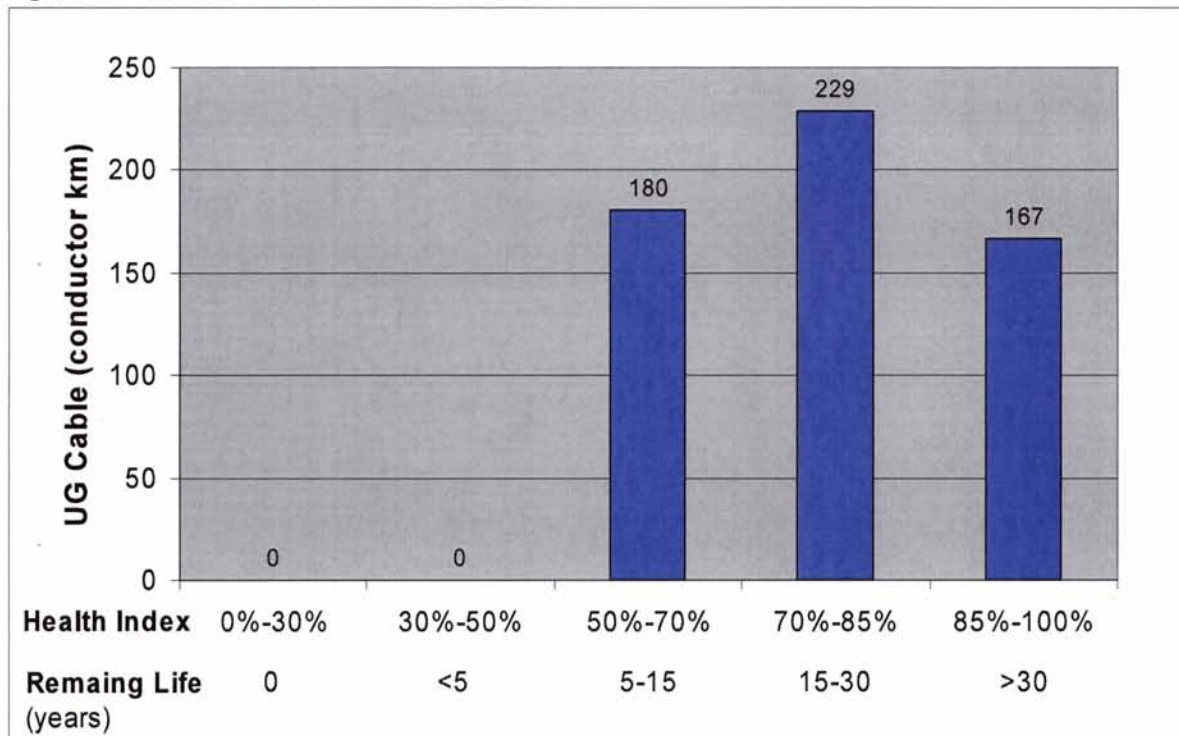
**Figure 8 UG Cable Health Index Results**

The overall good condition of underground cable indicated by the health index has been confirmed by interviews with staff and the low failure rate experienced. The staff interviews identified that there is a targeted replacement program to eliminate the direct buried XLPE cable, about 5% of the installed cable.

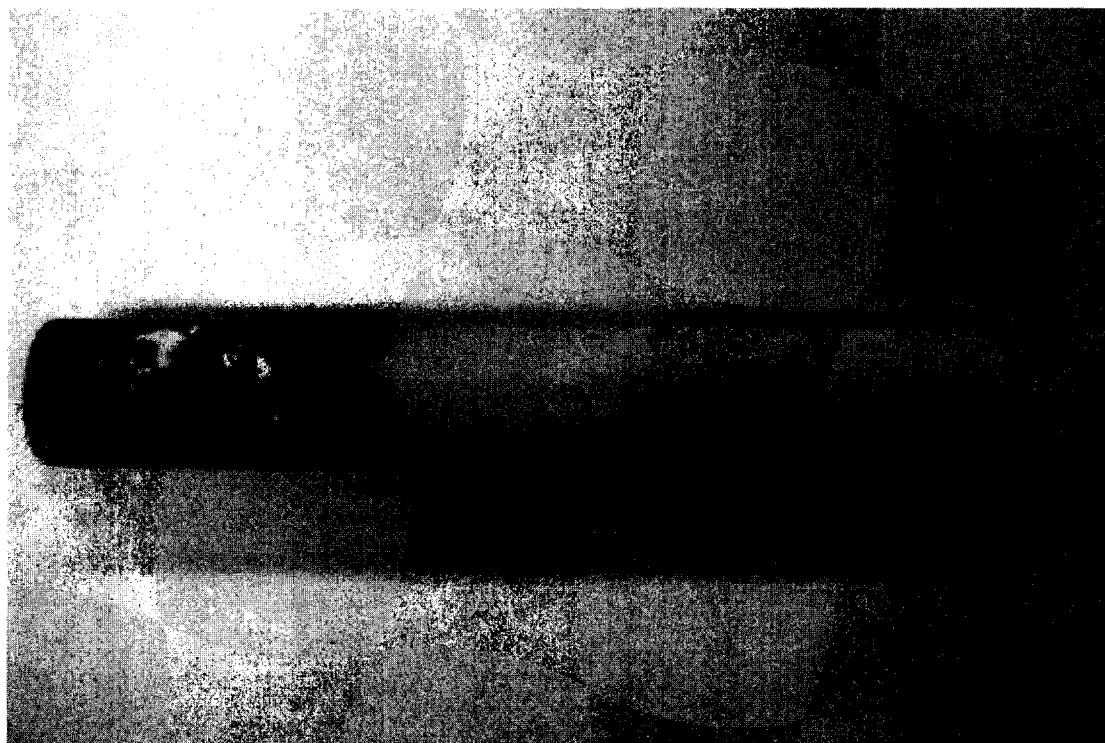
Figure 2: Close-up of the failure.

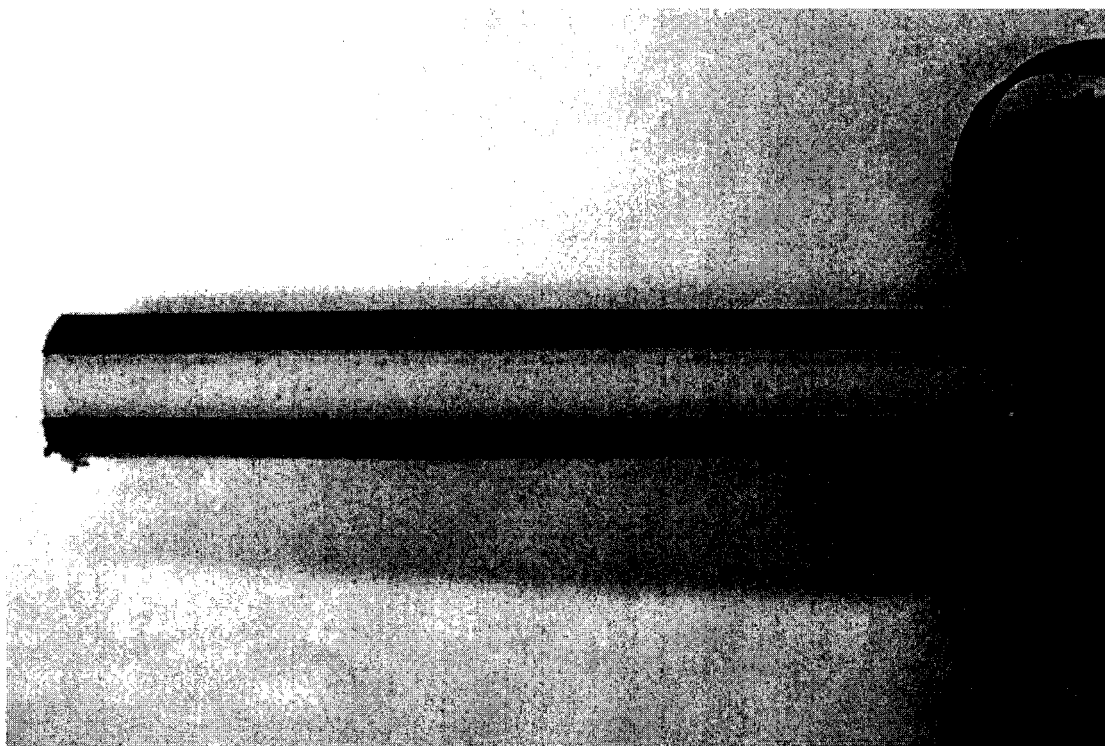
**Figure 3:** Failed cable section with removed insulation shield.

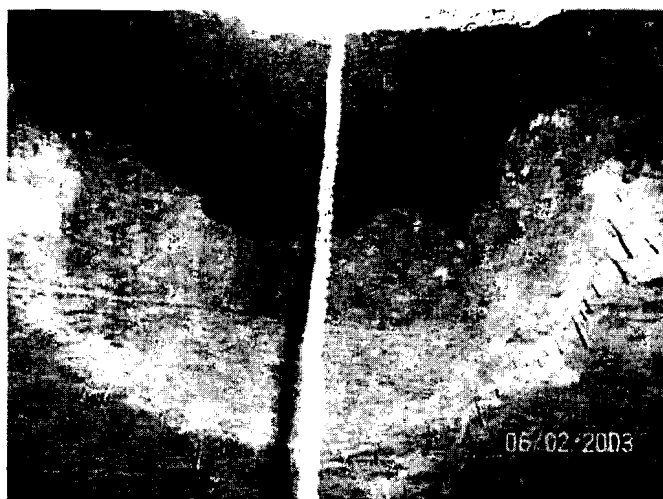
LINE OF STALACTITES  
(OLD CHIMNEY LOCATION)  
MODERATE CORROSION & SPALLING @  
CHIMNEY. APPEARS THAT CHIMNEY HAD BEEN  
CUT & OLD LOCATION INFILLED.

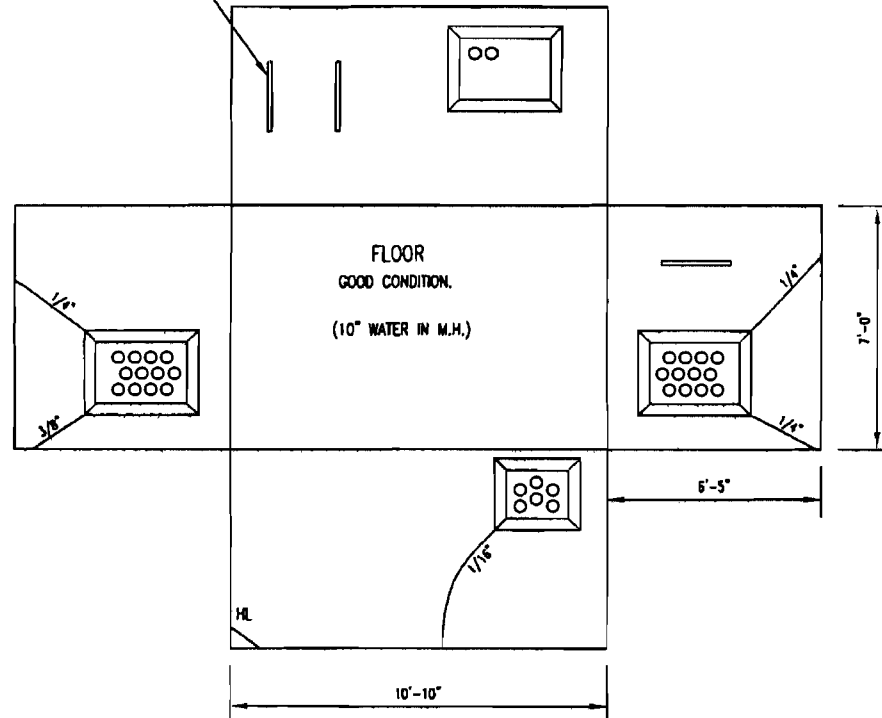
UNISTRUT & BRACKETS ANCH. TO WALL (OK) MILD  
CORROSION TYP.

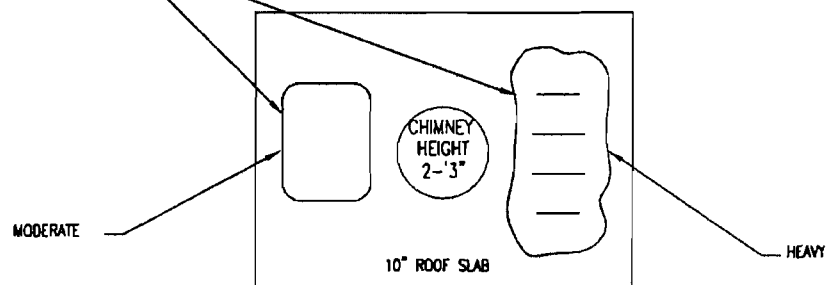
SPALLED CONC. HEAVY REBAR  
CORROSION ( $<1/2"$  COVER)

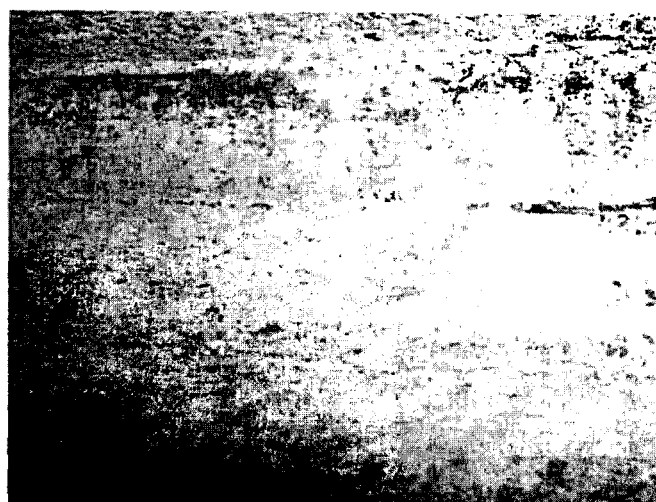
South Wall (crack)
