Festival Hydro Inc. Substation Condition Assessments Seaforth, Ontario Report

Festival Hydro Inc. has retained Costello Utility Consultants to assist with a comprehensive review of the two substations (Chalk DS and Welsh DS) in Seaforth Ontario and to provide a recommendation on the merits of replacement of these assets or to invest in a voltage conversion program to ultimately phase these stations out of service.

Appendix B – Site Photos

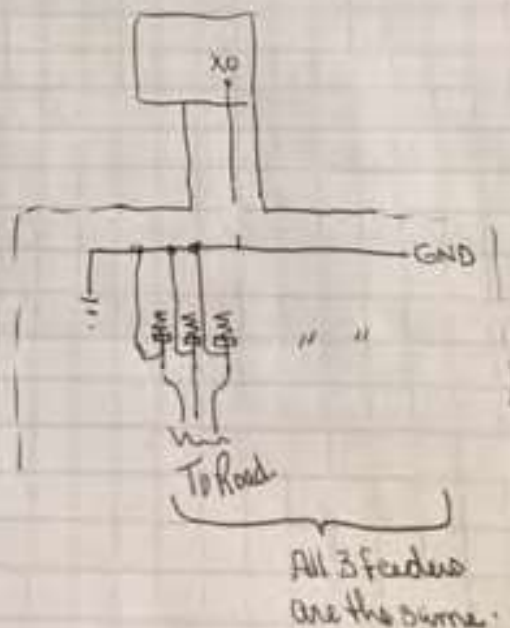
LV Swgr

- no external grounds to grid
- one visible connection grid bus to grid??
- 2 fuse holders appear to have been smoked but no evidence of damage in the cell.

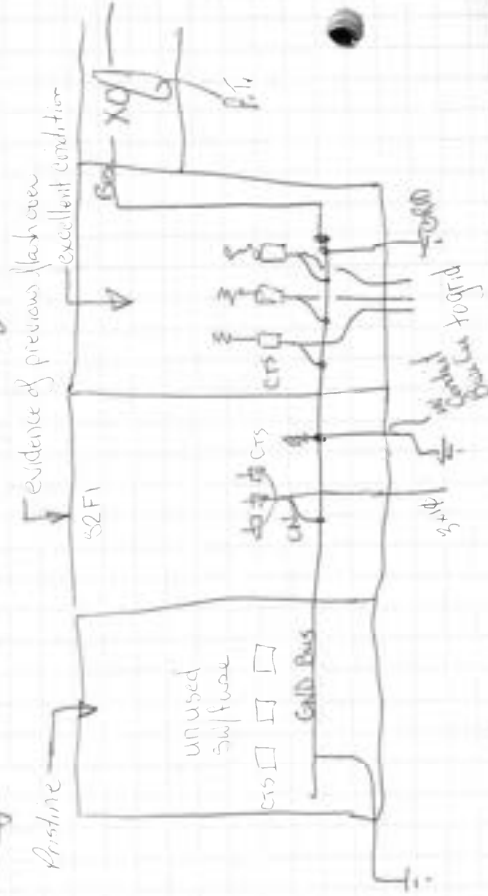
Transformer - 2 chassis grounds present.
- XC. 8004 to SWGR 01

5KV Singr - no visible external changes prob.

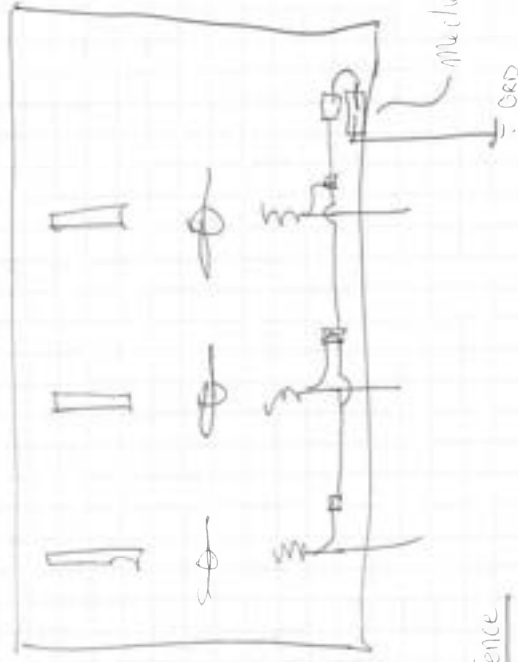
- no anticondensation on interior
surf.

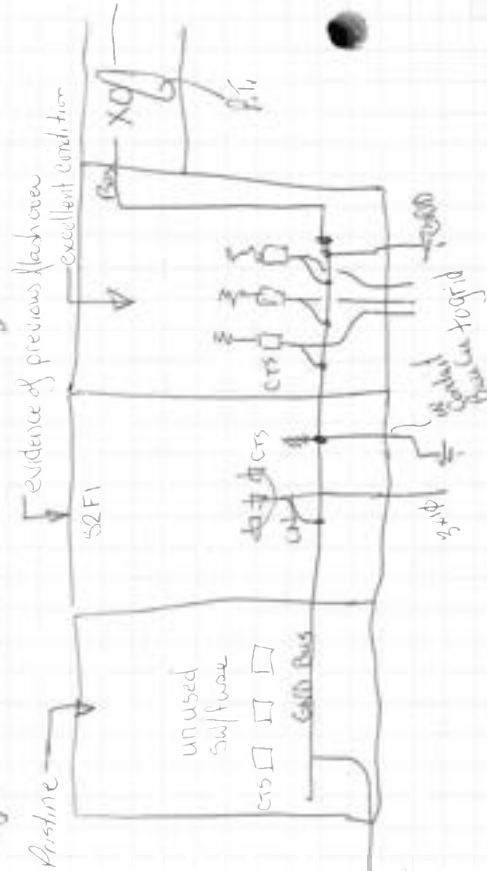
Singr - no visible external channels prob.

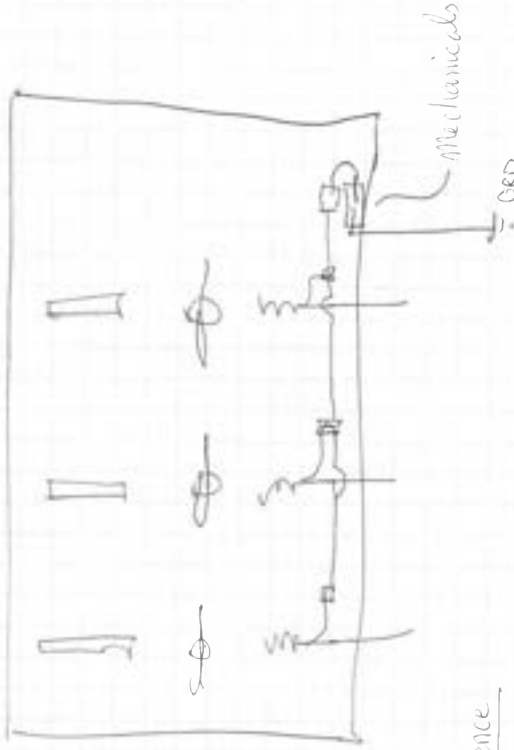
-no anticondensation on interior
surf.

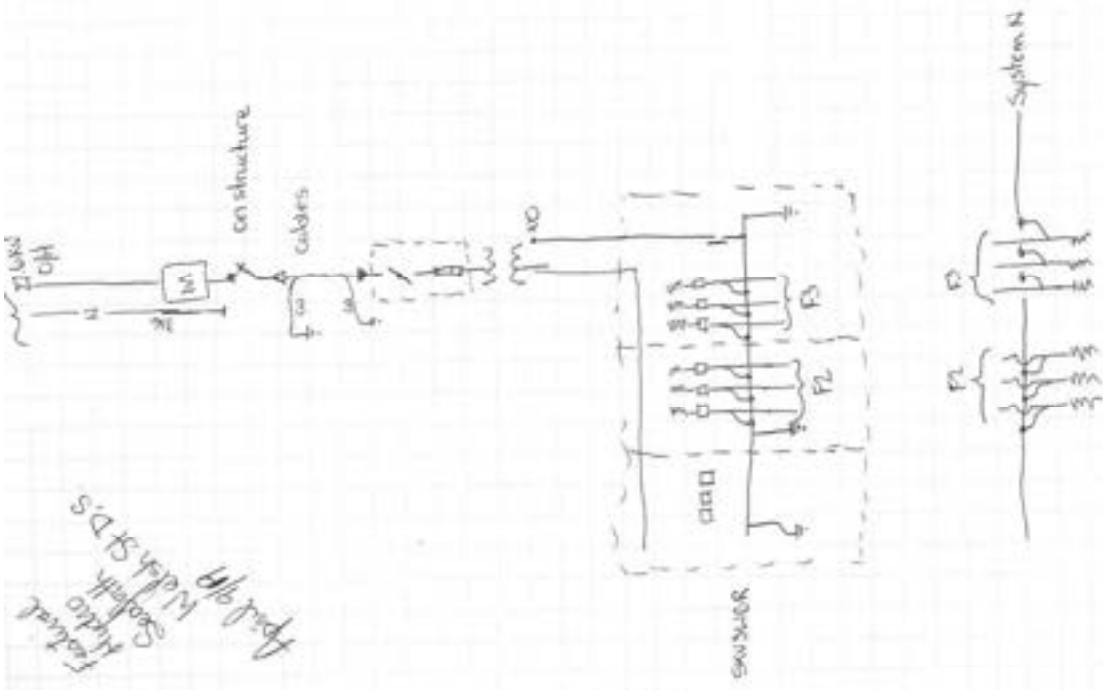
Old T-bar/bare fence within 8' of str fence
Outside grid?
